**HERITAGE IMPACT ASSESSMENT OF THE  
PROPOSED DAMS AND ORCHARDS FOR THE  
GUBENXA VALLEY, E. CAPE**

**FOR INDWE ENVIRONMENTAL CONSULTING CC**

**DATE: 25 FEBRUARY 2021**

**By Gavin Anderson**

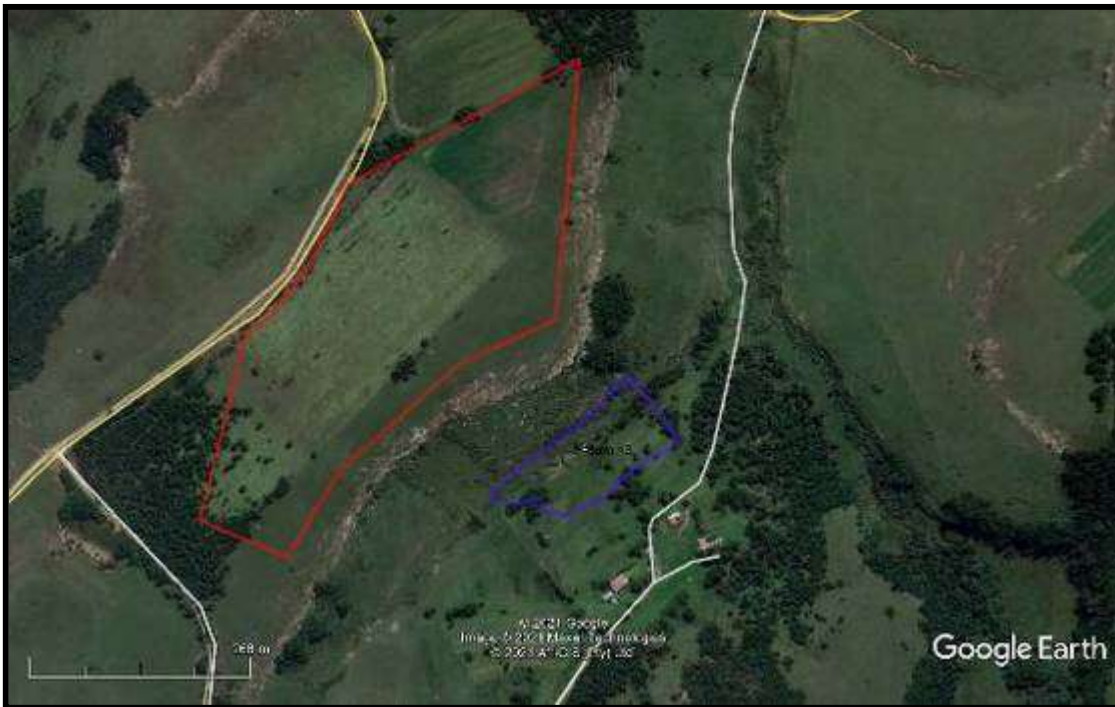
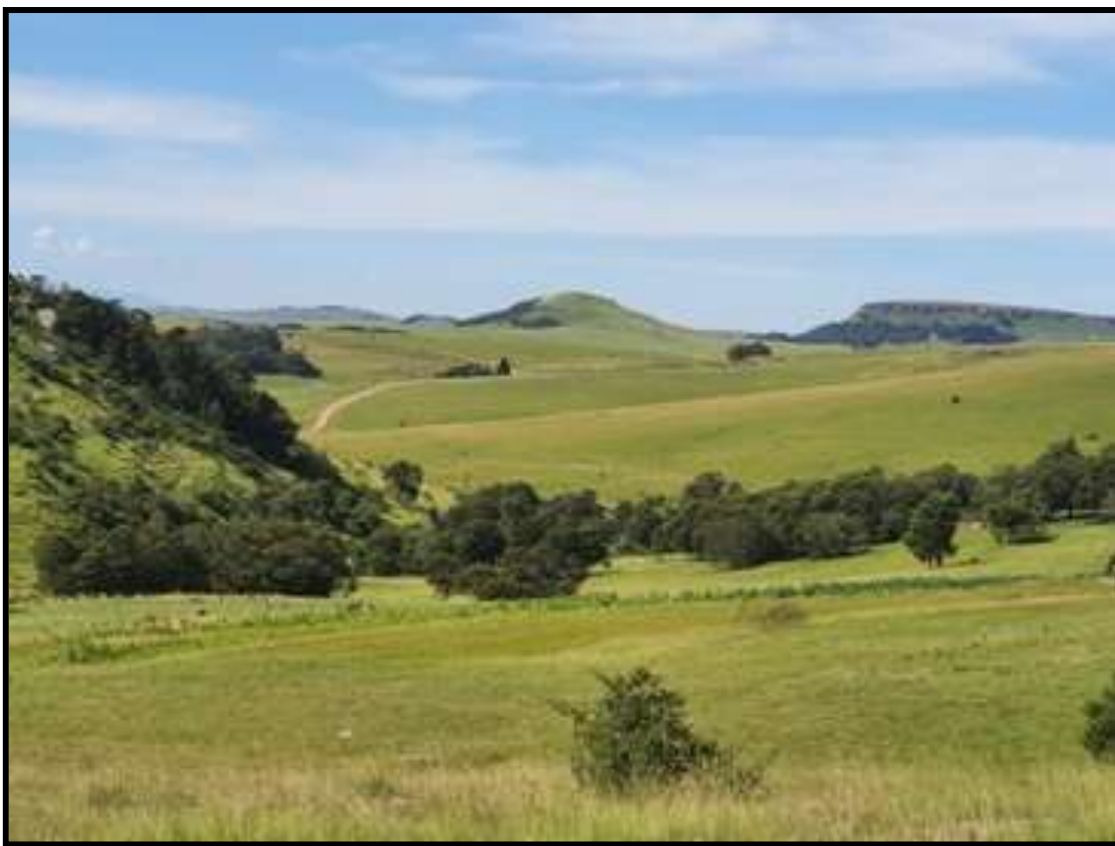
FIG. 34: DAM 13

No heritage sites were noted within the dam or orchard areas (fig. 34).

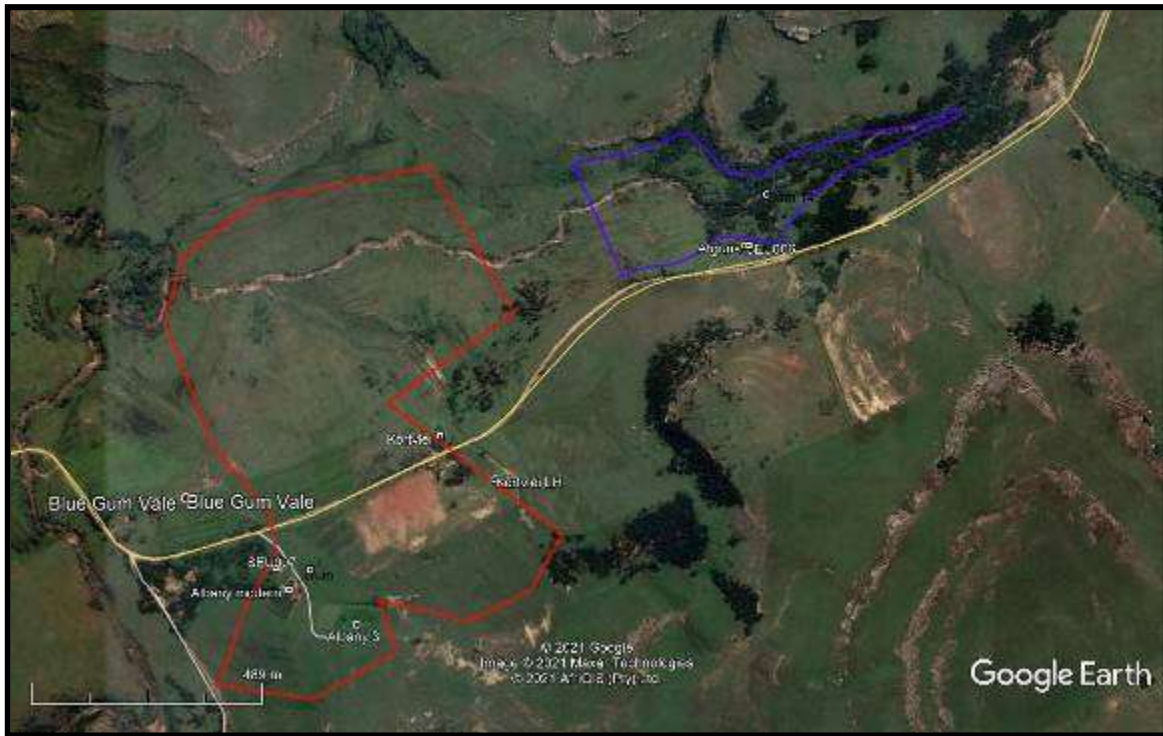
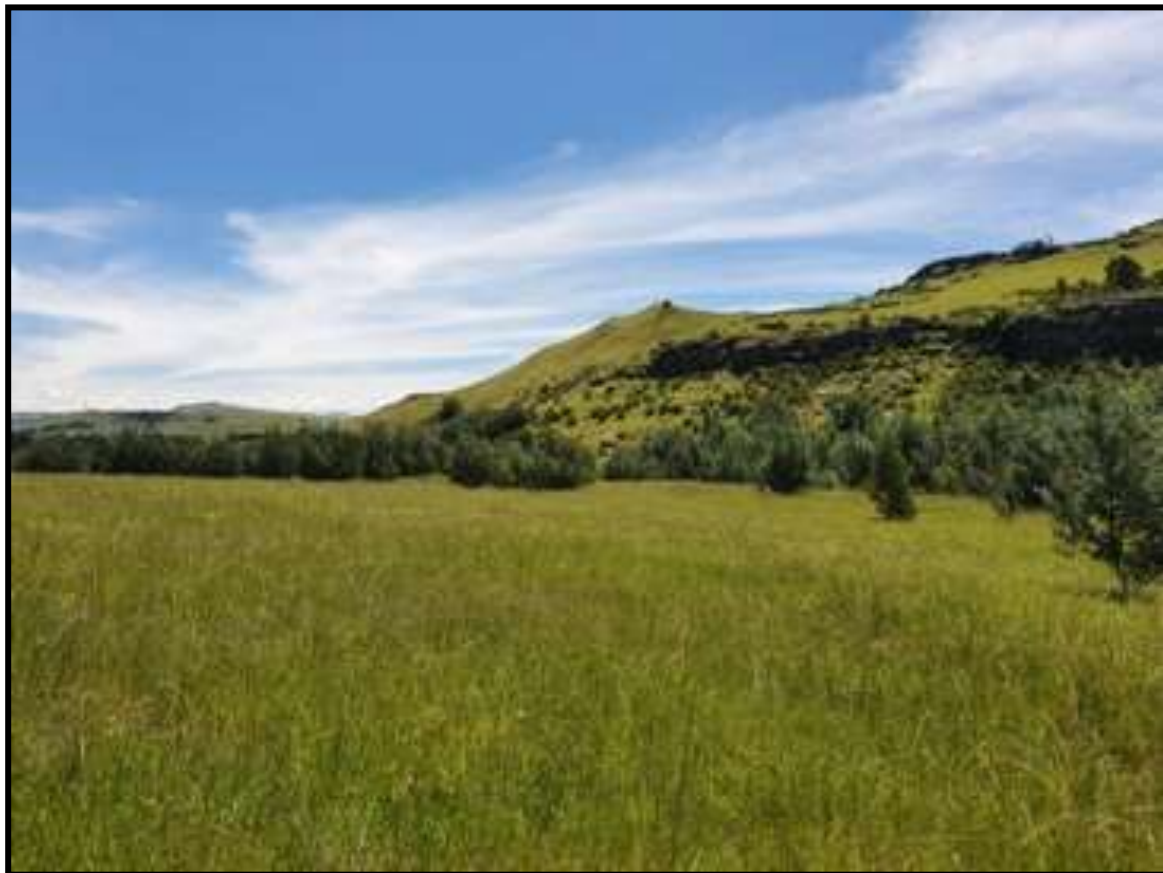
FIG.35: DAM 14

No heritage sites were noted within the dam area; however, some built structures were noted in the orchard (fig. 35). The sandstone overhangs at the dam were surveyed; however, no rock art occurs on them. The farmhouse Afguns and its structures will be 14m away from the full supply level of Dam 13. The FSL may affect the buildings.

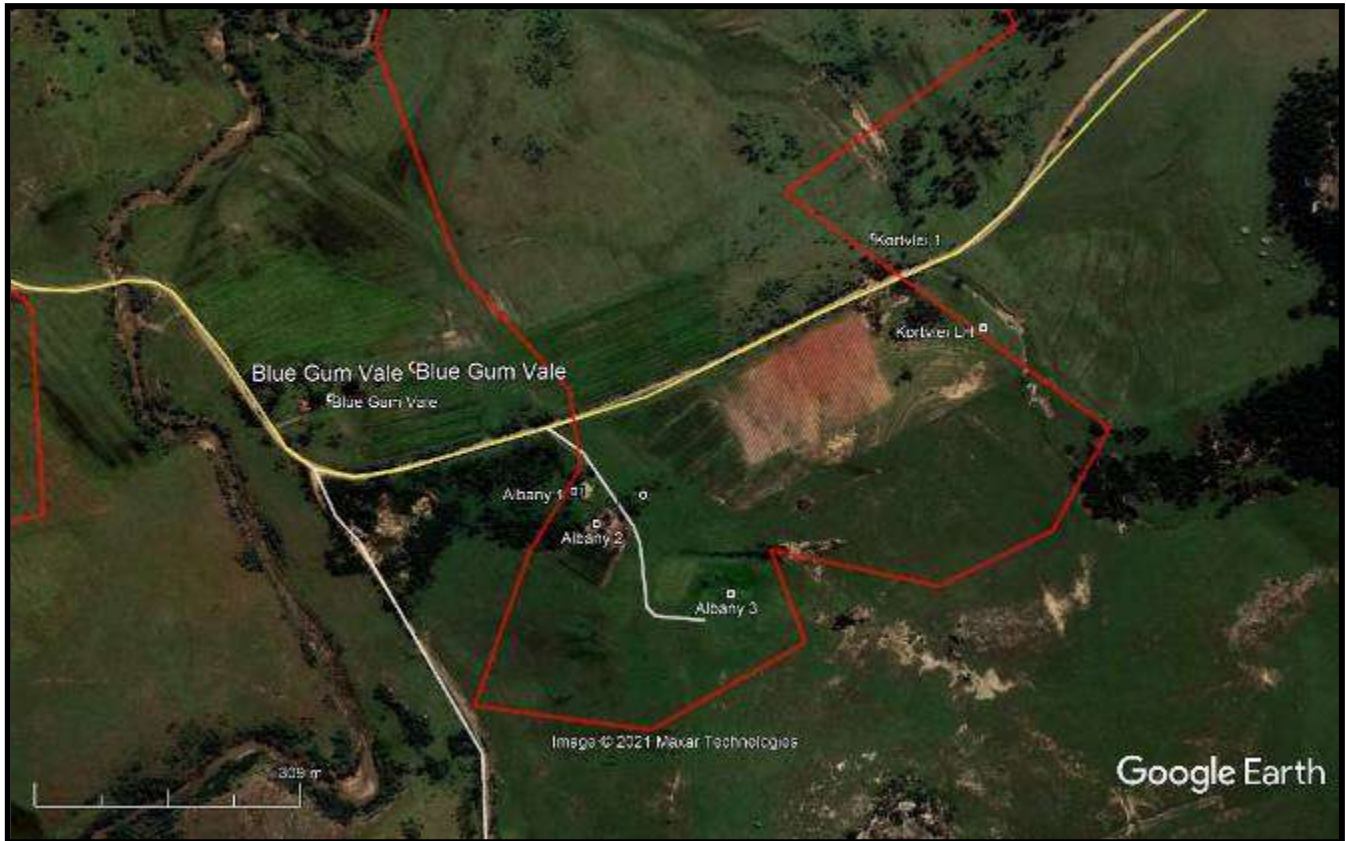
**FIG.36: LOCATION OF BUILT STRUCTURES ON QANGULE ORCHARD**

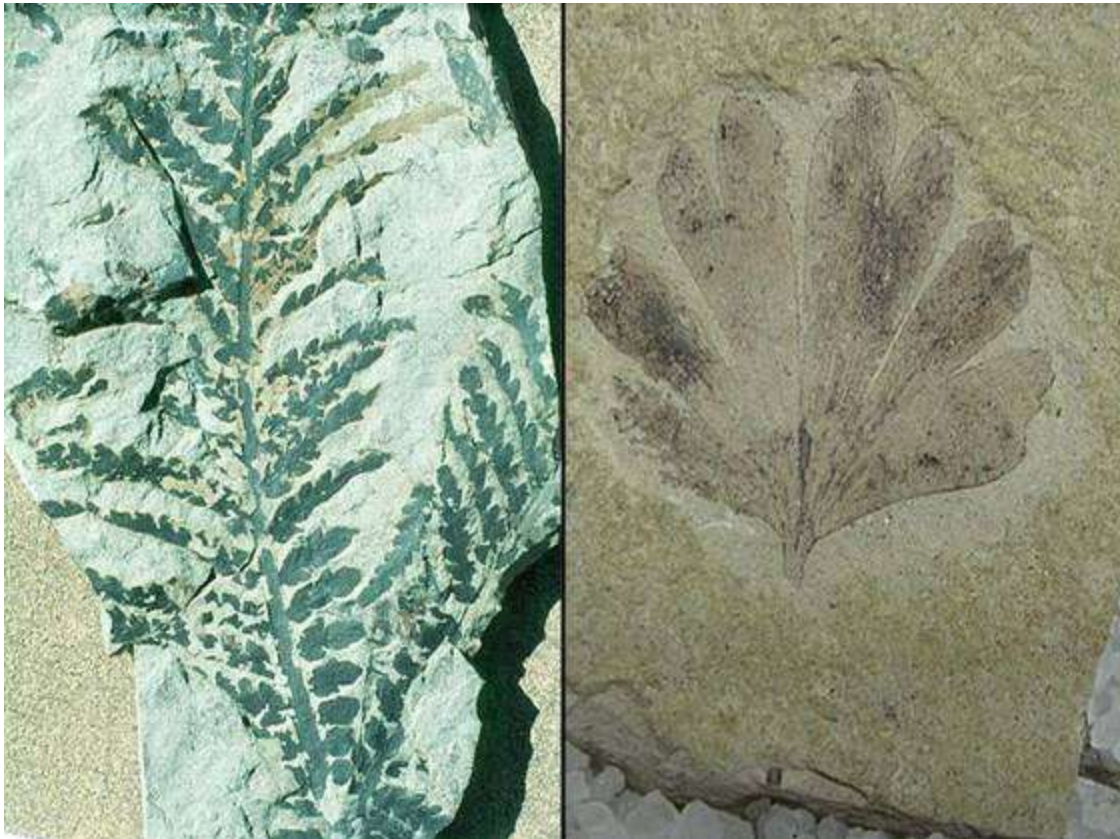
**Fig. 3: *Dicroidium* (left) and *Ginkgo* (right) fossils of the type which could be found in the Molteno Formation (source Wikipedia commons).**

The Molteno formation is generally coarse-grained sandstones and less likely to contain fossils. However the finer-grained rocks are fossiliferous (Bordy et al., 2005) and contains plant and insect fossils (Anderson, 1974). The Molteno Formation contains fossils of 204 plant [species](#) and 333 insect species. It is one of the richest Upper [Triassic](#)-age plant and insect assemblages. The [insect fauna](#) contains well-preserved [fossil](#) insects which are very rare (Anderson and Anderson, 1997). The dominant [fossil flora](#) is associated with seven recognized [habitat](#) types, , two of these include [Dicroidium](#), an extinct arboreal genus of seed fern that grew in either [riparian forests](#) or [temperate woodlands](#) (Fig. 3). Nineteen species of *Dicroidium* alone have been recovered from the Molteno Formation (Anderson & Anderson, 1997).
