HERITAGE IMPACT ASSESSMENT FOR A PROPOSED LOW WATER CROSSING OVER THE GOURITZ RIVER NEAR HERBERTSDALE, RIVERSDALE AND MOSSEL BAY MAGISTERIAL DISTRICTS, WESTERN CAPE

(Assessment conducted under Section 38 (8) of the
National Heritage Resources Act (No. 25 of 1999) as part of an EIA.)

1st draft: 09 February 2012
Revised: 14th March 2012

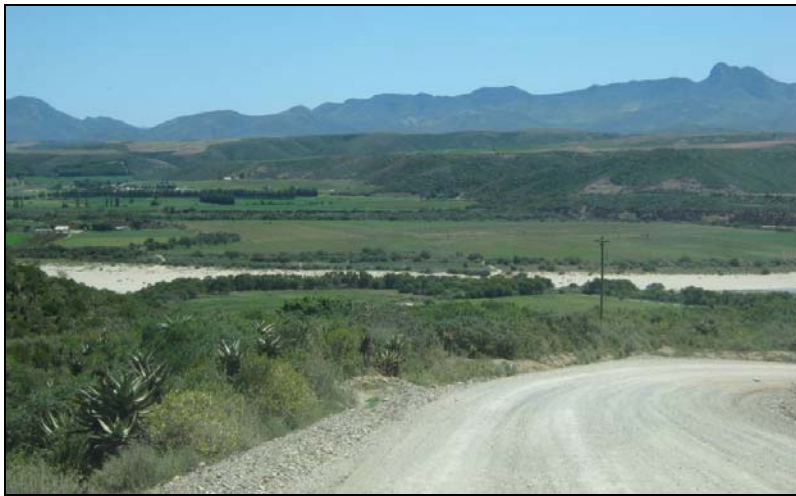
Figure 3: General view of the study area showing typical landscape characteristics and vegetation coverage.

The area is strongly agricultural and most of the flat land in the valleys is under crops (Figure 3). Steeper ground is still under indigenous vegetation. The farm land is locally variable with some fields covered by grass, others by low crops and others by tall crops (Figures 4). Still others have dry land agriculture where the crops have been harvested and soil is exposed (Figure 5). Along the northern edge of the river at Site C is a dense thorny thicket with grass patches in between (Figure 6). The slopes at the southern end of the Site C study area have indigenous vegetation (Figure 7) and the proposed road would run along this interface, probably just outside of the agricultural lands (Figure 8).

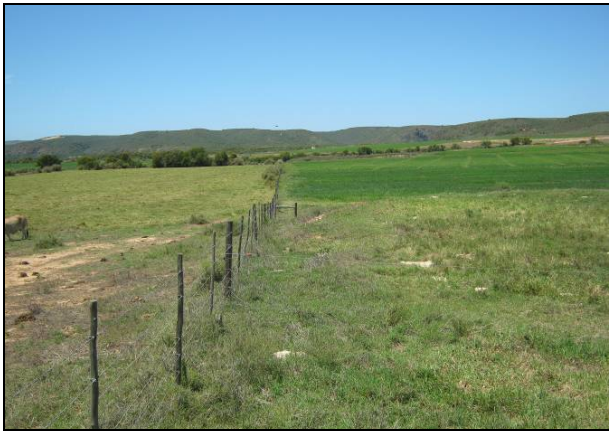
Figure 4: View towards the south from the northern end of the study area. Here the road would run along the right hand side of the fence where grass and low crops are growing.

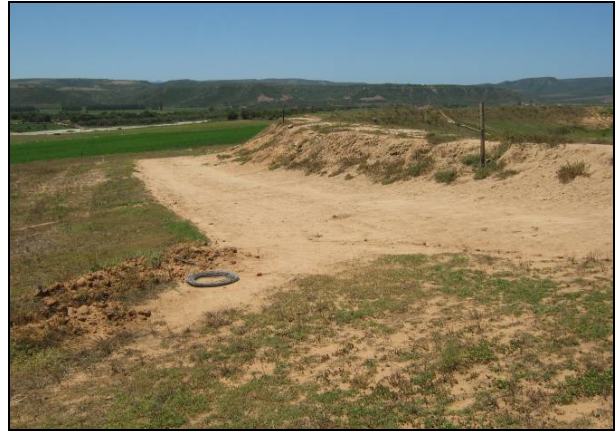
Figure 5: View towards the northeast showing dry land agriculture, a dam and, in the background, densely vegetated agricultural lands.

This is a low density scatter of LSA artefacts in a ploughed area (Figure 12). The artefacts were found in the foreground of Figure 5 above. The following artefacts were noted: 1 crystal quartz chip, 1 quartz core, some silcrete flakes, 2 quartzite irregular cores, some quartzite flakes and chunks and 1 quartzite chunk / hammer stone. A few other cobbles and cobble

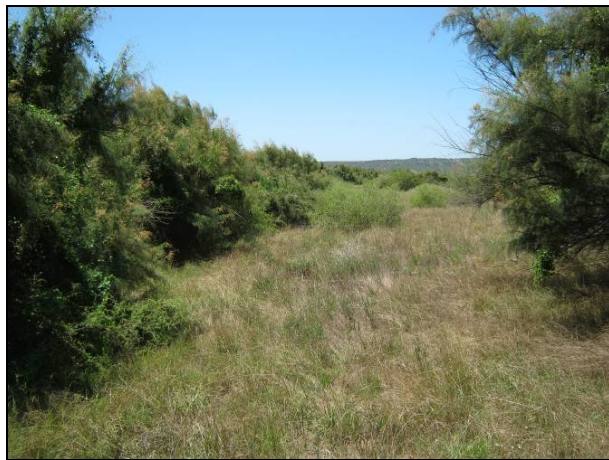
Figure 6: Thicket and grass patches along the margin of the river.

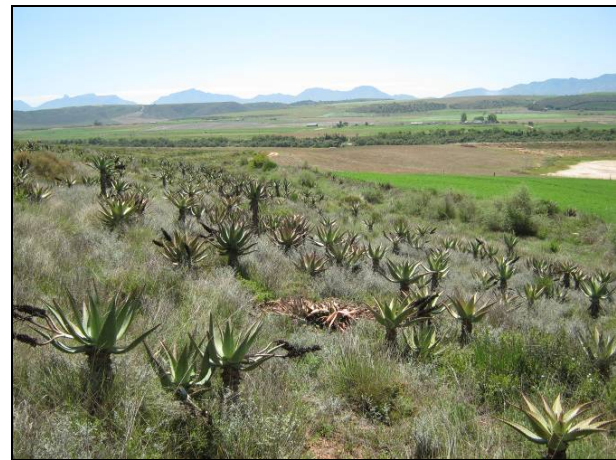
Figure 7: View towards the northwest showing the indigenous vegetation in the southern part of the study area.

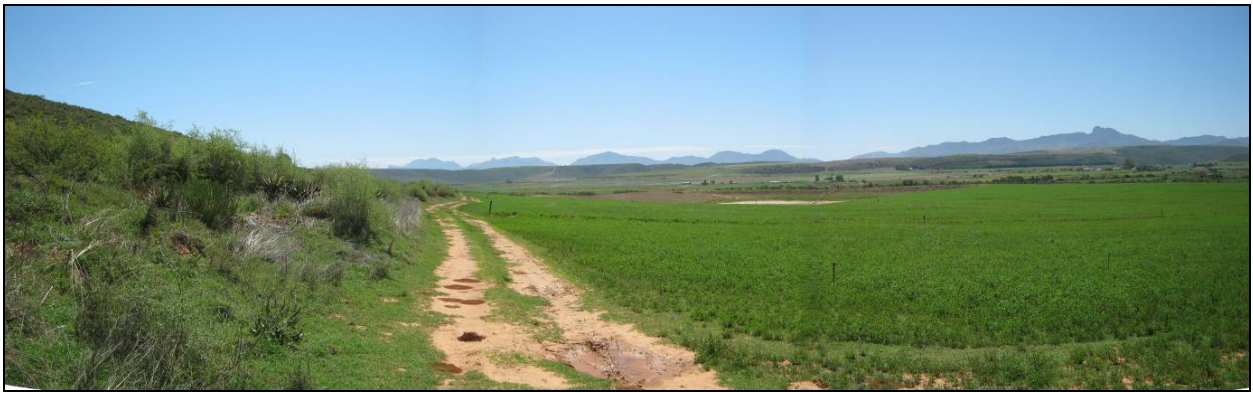
Figure 8: View towards the west showing the interface between indigenous vegetation on the steep ground and agriculture below at Site C. The proposed road would run along the area.

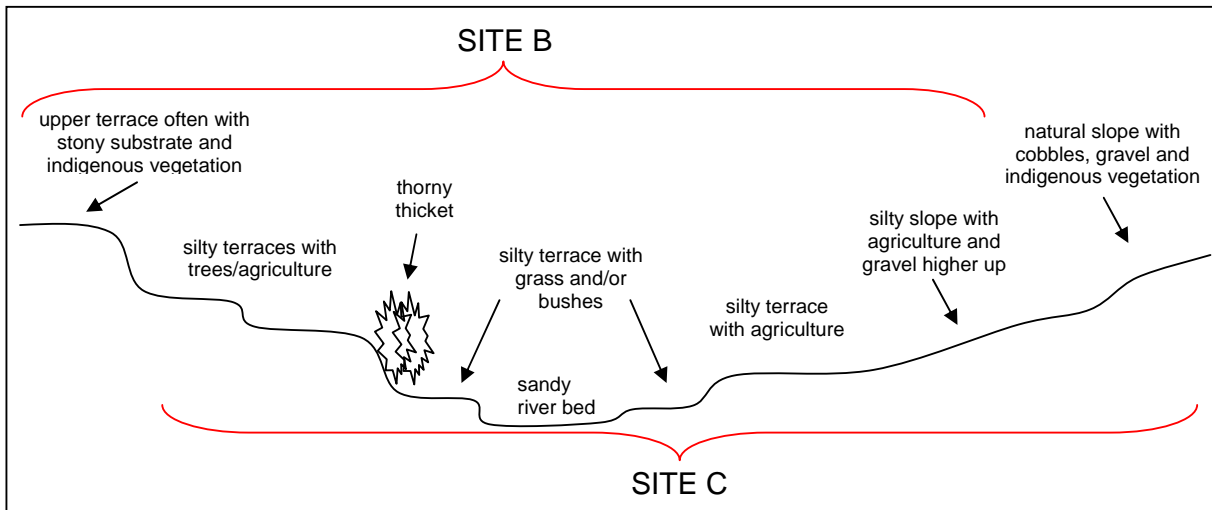
Figure 9: Generalised schematic cross-section through the banks of the Gouritz River incorporating aspects of both sites currently under examination. The red brackets indicate the environments covered by the two sites.

Figure 9 presents a schematic cross-section through the study area indicating the various environments and terraces that are present in the Gouritz River valley. Due to topography, the environments crossed by the two sites were not entirely the same as indicated in the figure.

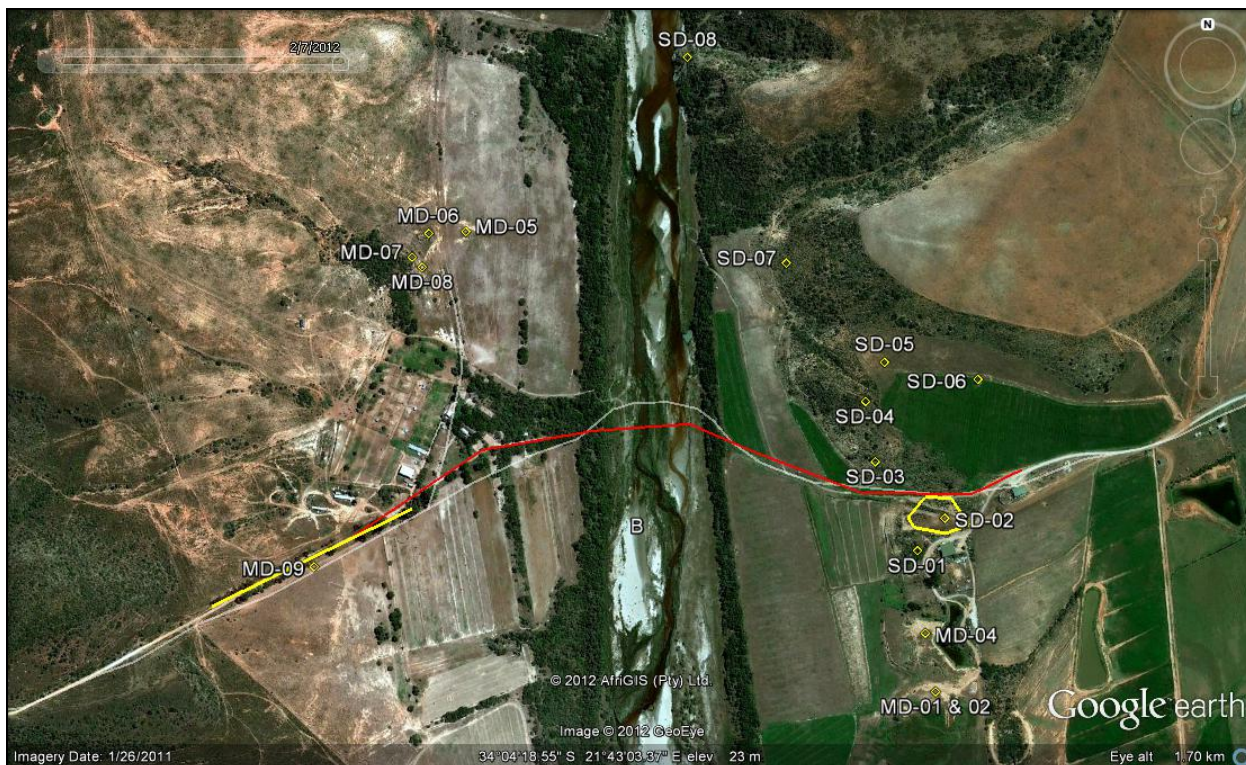
Figure 10: Aerial view of the Site B study area showing the location of the planned structure and road (red line) and all heritage occurrences found in the area (yellow).

Only two heritage concerns exist at Site B. One is the archaeological site that occurs immediately alongside the road at SD-02 (see Figure 10). The site could be disturbed during road widening but, given the size (c. 100 m) and density of the site, no highly significant impacts to the site are expected. No mitigation is suggested. A very small chance of finding human burials beneath the surface does also exist.

The second concern is the gum tree lines at MD-09 (see Figure 10). Should the road be upgraded within its current footprint, or else left as is, then no impacts are expected. However, should the road need to be widened, then the tree line on one or other side of the road, and thus the general landscape, may be impacted. The new structure would not result in any landscape impacts, since it is the type of structure expected within the local landscape context. It would be low and humble and would not in any way dominate the landscape.

Monitoring of excavations through the river terrace in the vicinity of SD-02 should be conducted by the ECO such that any human burials intersected could be noted at the earliest stage. The burial would need to be reported to an archaeologist or to HWC and then subsequently recovered by an archaeologist at the expense of the developer.

At least one side of the tree line at MD-02 must be retained. Should any road widening be required then this must be carried out on one side only such that the trees along one side of the road can be retained. This would help retain the sense of place created by the trees.

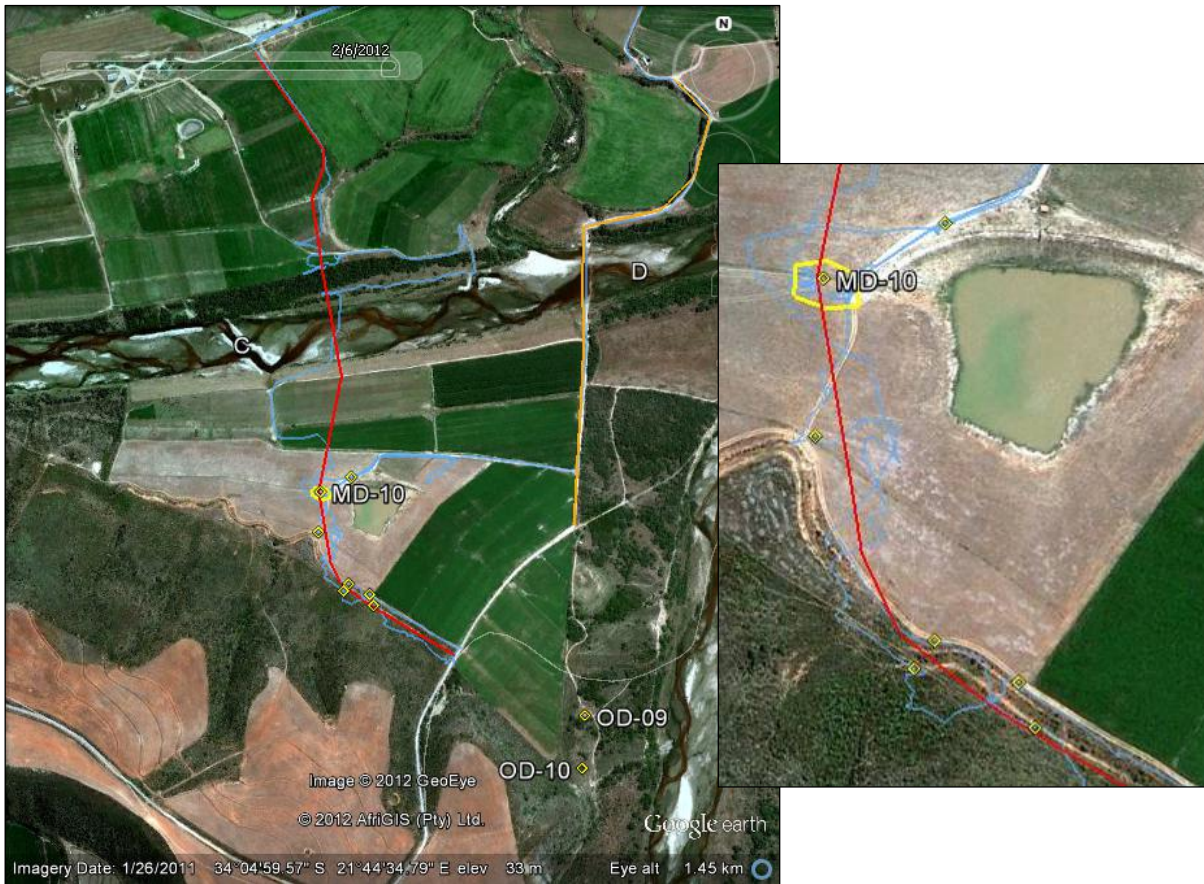
Figure 11: Aerial view of the Site C study area showing the location of the planned structure and road (red line) and all heritage occurrences found in the area (yellow). The inset shows a detail from the area in which Stone Age material was recorded.

A detailed record of newly found heritage resources from Site C is now presented. These are mapped in Figure 11.

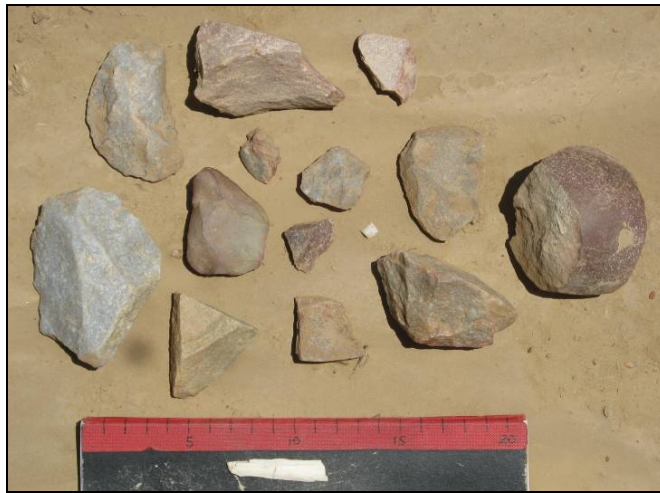
Figure 12: Stone artefacts and one bone fragment (on the notebook) found at MD-10. Scale in cm.

fragments may have been brought to the site but could also be natural. One possible grindstone fragment was noted. Given the disturbed context and low artefact density it is considered to be of low significance and the landform suggests that it is an eroding rather than depositional context such that *in situ* deposits should not be present beneath the surface.

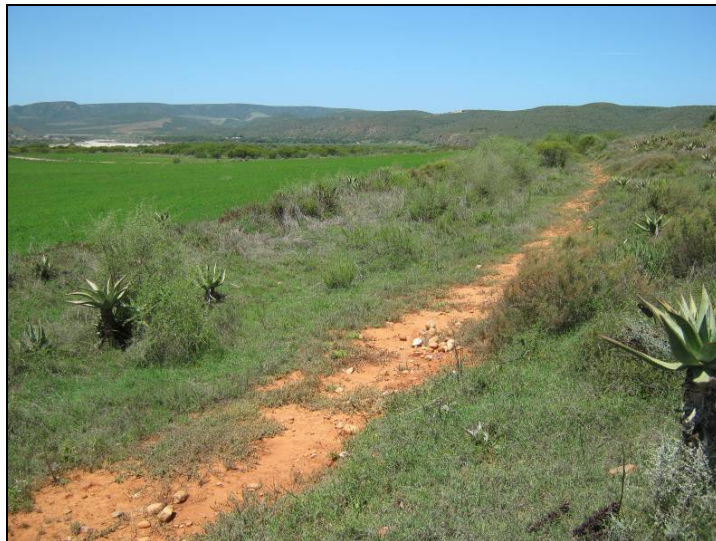
Figure 13: View of the furrow (MD-11) that runs along the base of the slope above the ploughed lands.

This is a furrow that has been excavated along the foot of the slope to catch run-off and channel it to the west (Figure 13). Its age is unknown but one section has been filled in and it is no longer fully functional. Its significance is low.

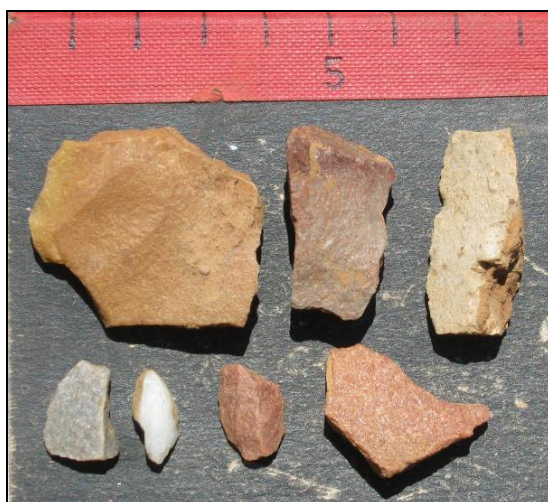
Figure 14: Stone artefacts found at MD-11. Scale in cm.

This is not a site but rather just an exposure of stone artefacts, probably of MSA or ESA origin. The former seems more likely based on the absence of larger forms from the observed scatter. Such artefacts probably occur widely on the local landscape. It is a very low density scatter associated with cobbles and gravel along the lower slopes of the mountain. Many were revealed in an old furrow that separates the ploughed and unploughed land. The artefacts are mostly of quartzite, but silcrete and quartz were also present (Figure 14). Since it is not a site, the occurrence has not been labelled on Figure 11 but is represented by the cluster of symbols along the interface between ploughed and natural land. These artefacts are of low archaeological significance.

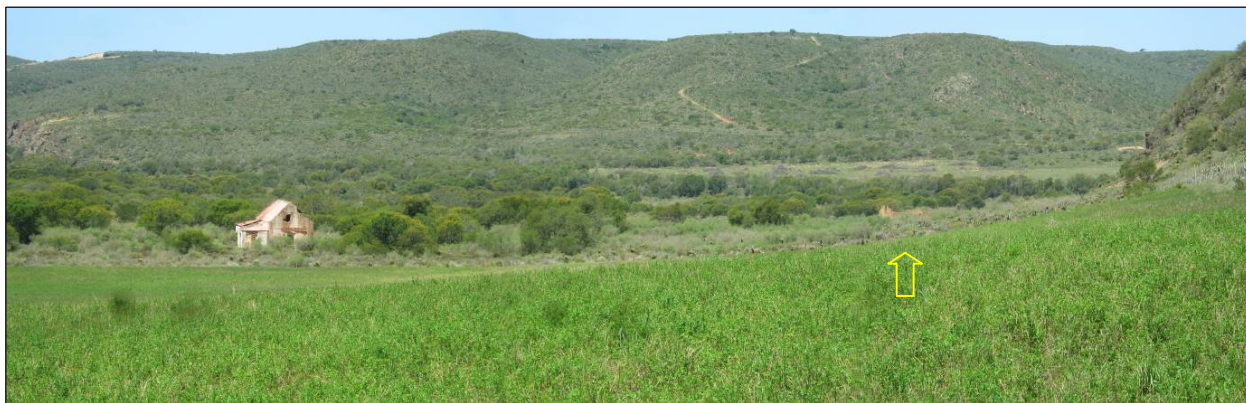
Figure 15: View towards the house (OD-09) and ruin (OD-10). The house is obvious but the position of the ruin is marked by the yellow arrow. The photograph is taken from the road at the south-eastern end of this alternative.

This is a small vernacular house in ruined state. It was not visited but only noted from a distance. It is 300 m away from the project area, would not be impacted and is noted only for the record (Figure 15). It is likely of medium significance.

This is a ruined structure which was also not visited (Figure 15). It is 360 m away from the project area, would not be impacted and is noted only for the record. It is likely of low-medium significance.
