HERITAGE IMPACT ASSESSMENT FOR BOSCHENDAL FARMLANDS, DWARS RIVER VALLEY

**Heritage scoping study for the entire Boschendal Farmlands and
HIA for the proposed Founders Estates development**

APPENDICES: VOLUME 2

BOSCHENDAL HERITAGE ASSESSMENT: BUILT ENVIRONMENT SURVEY AND EVALUATION

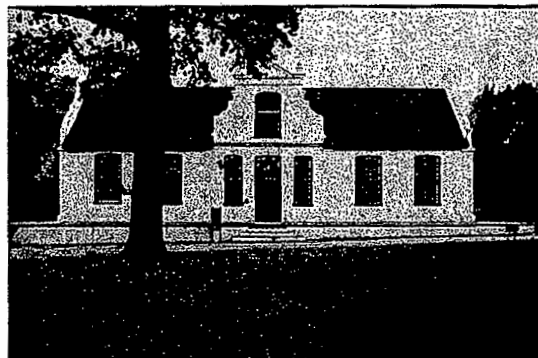
FEATURE NO: Farmstead 3 (FS 3)
POSITION: S33° 52.766. EO 18°57.438
OFFICIAL NAME: Rhone
HISTORIC NAME: Le Rhone
CHRONOLOGY: Dutch Colonial

Splayed walled werf with manor house, slave quarters, winery, wagon house and stables. Most of the complex is in use as offices and part of the extensive Boschendal winery. Iconic Cape farmstead appearing prominently in all publications on Cape architecture. The complex is in a good condition.

MANAGEMENT RECOMMENDATIONS: A conservation management plan has to be developed for the complex.

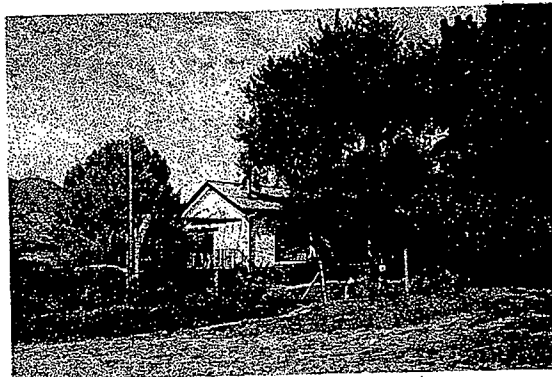
HISTORIC NAME: Rachelfontein

Ranch style house with Big 6 sheet roof, wide eaves, plastered and painted on face-brick plinth. Steel window frames. Probable rebuild on pre-existing site.

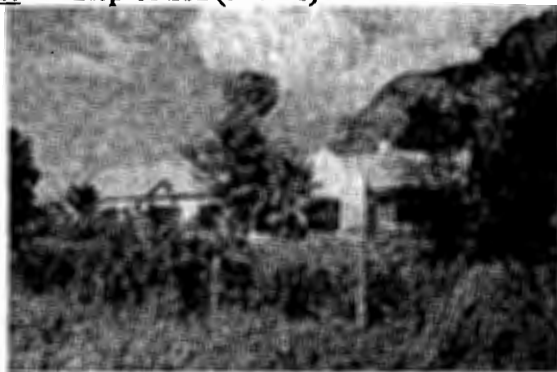
'Longhouse' single storey building with forward projecting bay and rear wing. Stripped 'Cape' style with 45° IBR roof and parapet gables with restrained stepped mouldings. Unpainted sliding sashes with small panes and shutters. There is a swimming pool. Monterey pine and palms in the garden. Beautiful elevated setting. Constantia suburban quality.

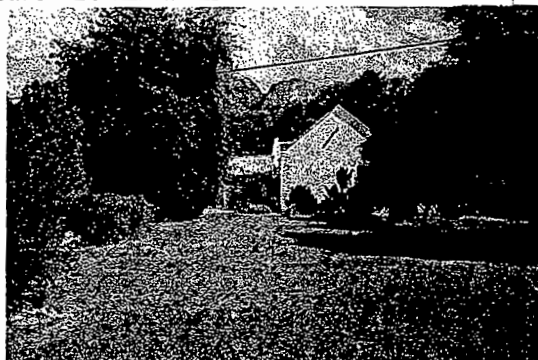
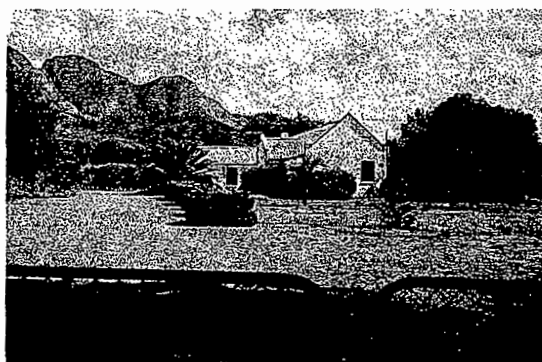
HISTORIC NAME: Champagne

Similar to MH5 probably built in 1970's. Stripped "Cape" style with 45° IRB roofs and parapet gables. Wood sash windows and louvre shutters. Suburban character. Suspect 1970's origin. Well built and maintained in attractive gardens.

MANAGEMENT RECOMMENDATION: Record. Consideration should be given to retention.

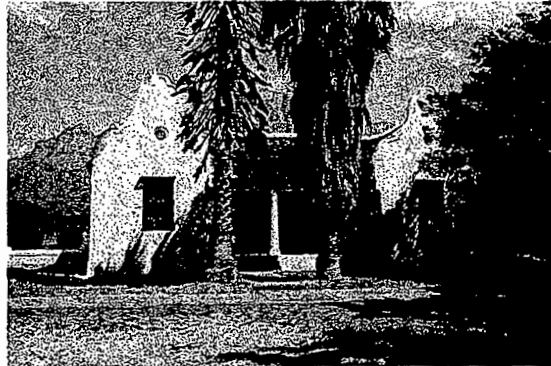
Typical Herbert Baker twin gabled house. H shaped plan. Thatch roof with covered entrance stoep with doric columns. Combination of Cape vernacular and arts and crafts. Combination of unpainted sash and casement windows hooded in the arts and crafts manner. The four alternated shaped gables are moulded and curvilinear with circular louvered vents. A rear gable end is fitted with a modern ranch style casement window and the rear court has been enclosed by means of a low pitched IBR roof. There is a typical Baker style verandah bench on the north elevation. The interior is largely intact. There are two impressive palm trees in the front garden close to the house. The house has recently been renovated and a parking area with new low white walls constructed on the south.

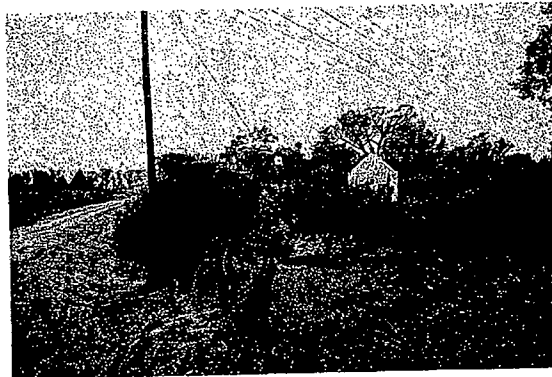
L- shaped house C 1950. 45° pitch roof under cement ties with parapet gables providing slight Cape reference. Sited at oblique angle to the R310. Trees largely hide the house from view.

MANAGEMENT RECOMMENDATION: none

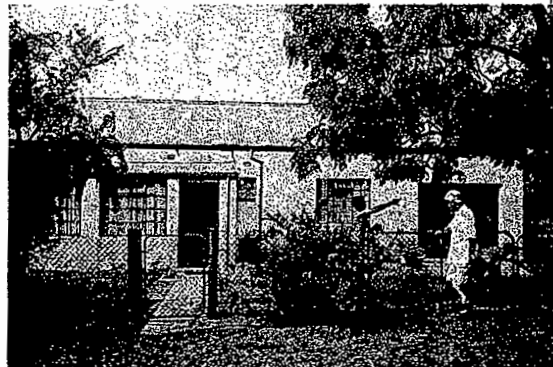
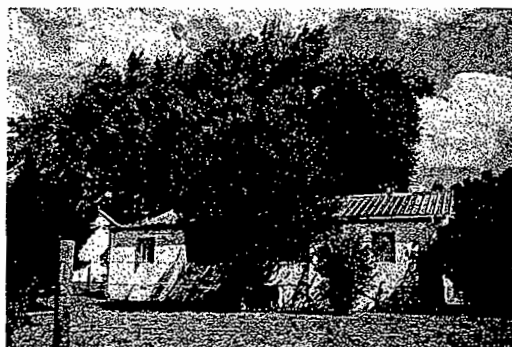
HISTORIC NAME: Excelsior

A group of three dwellings and a garage against the boundary to the cannery. Plastered and painted with steel windows. The building closest to the R45 has corrugated iron roofing while the garage and other two Canadian pattern asbestos sheeting. They are currently occupied and are in reasonable condition. They are more modest than any of the managers houses or the Cannery Row houses.

MANAGEMENT RECOMMENDATION: Should be recorded

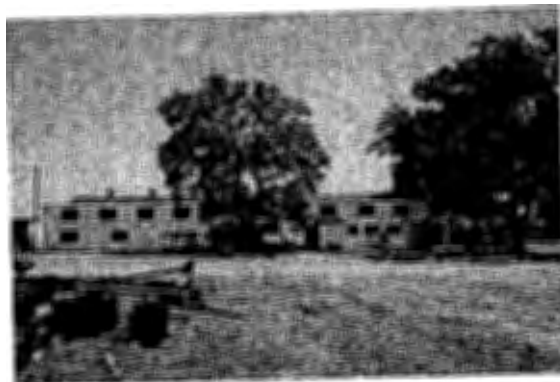
FEATURE NO: Farm Building 8 (FB 8)
OFFICIAL NAME: Excelsior
POSITION: 609' S33°51.874 EO18°15.908
HISTORIC NAME: Excelsior
CHRONOLOGY: British Colonial - Union of SA

The core of the complex is a double pitch roofed barn probably 19th C in origin with numerous lean-to and double pitch roofed extensions.

Steel industrial glazing. The complex is used as workshops and store and is within a high security fenced area. It is in fair condition. There is a large related open yard where trailers, implements etc. are stored.

The complex is being actively used and the historic core be subject to damage.

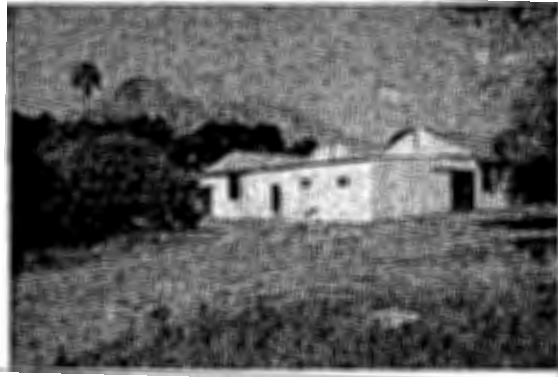
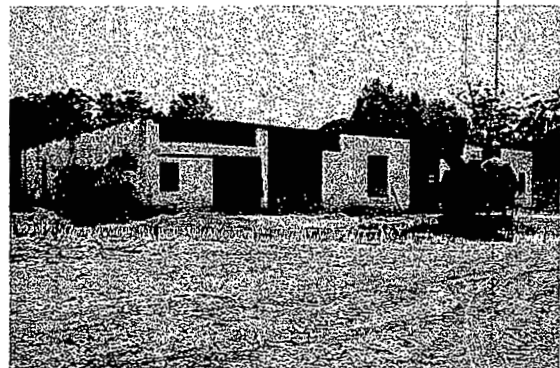
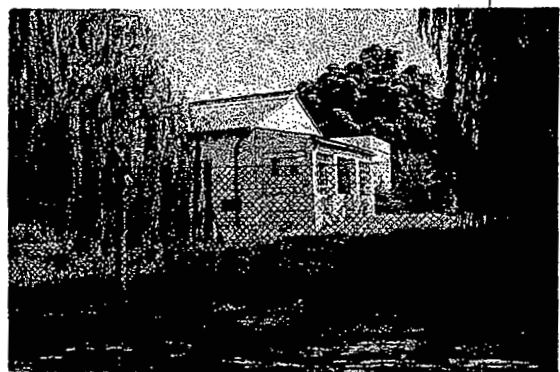
HISTORIC NAME: Bossendaal

Complex of 5 buildings, workshops and dwellings at north east corner of the estate next to the railway line. Parts of the complex (house and brick workshops) are more than 60 years old, probably built in the late 1930's. Appears to be stylistically related to the old jam factory north of the railway line. More recent workshops in plastered and painted masonry. Simple isolated timber frame cottage immediately to the south of the complex's security enclosure. Most of the complex is not in use.

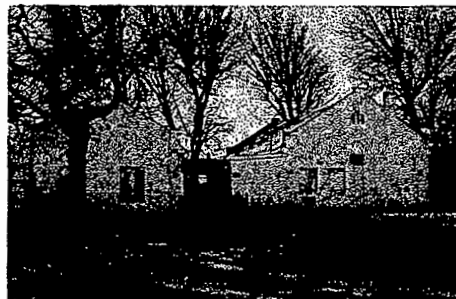
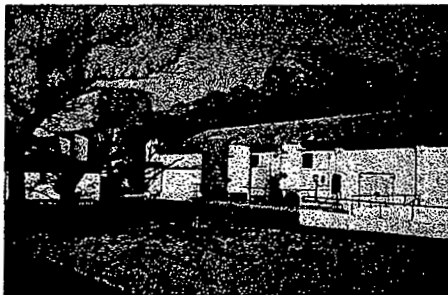
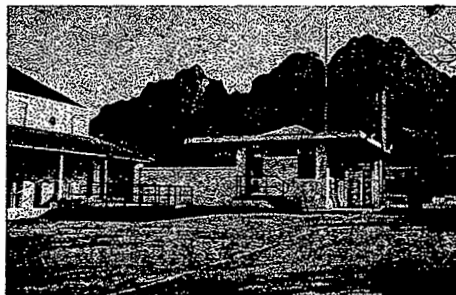
HISTORIC NAME: La Rhone

Very large modern winery adjoining historic Rhone winery building. Free-standing office in centre of complex was probably managers house as is domestic in character. Old oak trees in courtyard. Main building related to R310 is vaguely classical in character; green IBR roof, university plaster, pilasters (idiosyncratic order), giant cove cornice. Verandah reduce scale. Most of complex of the building screened by berm planted with indigenous vegetation and wall grown of cork oak trees.

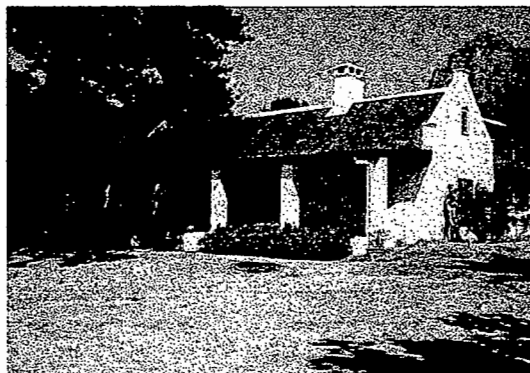
HISTORIC NAME: Nieuwedorp

The cottage was built in 1901 (completed after death of Rhodes in 1902) by Harry Pickstone, then General Manager of Rhodes Fruit Farms to a design by Sir Herbert Baker for Cecil John Rhodes. Pickstone had assembled the Dwars Valley Farms for Rhodes and had established RFF. The cottage was to be used by Rhodes when visiting and could accommodate a secretary and manservant.

The cottage is thought to have been built on the foundations of the Nieuwedorp homestead. The two old oaks in front clearly predate the construction of the cottage and reinforce this. (one oak remains)

The building has a typical Baker U-shape cottage plan. Rhodes generally travelled with a secretary and a manservant and the layout reflects this. The asymmetrical fenestration indicates strong Arts and Crafts influences. The building has undergone some changes. The original corrugated iron roof and original gable was replaced between 1937 and 1942 and a bedroom window has been repositioned. A modern kitchen was installed in the 1990's. The cast-iron stove has been removed from the kitchen though the chimney remains intact. Bathroom mid to late 20C. Cottage closely related to annexe (Farm Building 12), also used as guest accommodation. Said to be built on the site of a mill.

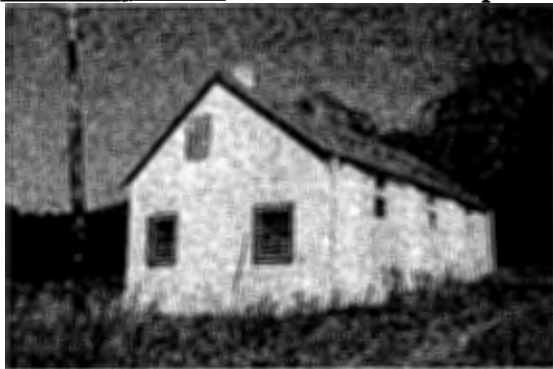
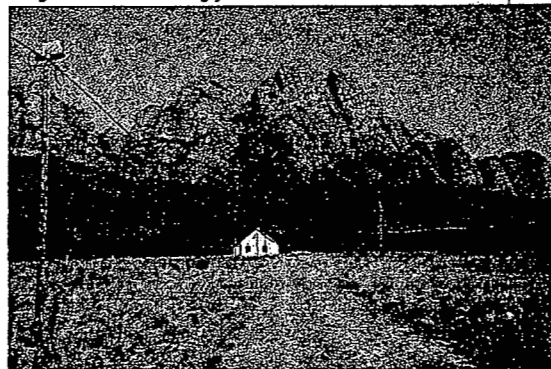
HISTORIC NAME: Good Hope

This is a 15mx7m gable building. It has a green corrugated iron double pitched (45°) roof with slightly projecting eaves. The structure has external buttresses and a stone plinth. A lean-to on the south contains ablution facilities (probable addition). The building is tall, with Paarl type ventilator grilles and a loft door. There is a chimney with a double band plaster moulding at one end. The building is dramatically sited at the top of a road, formerly an avenue (1949 aerial photograph) with its gable front against the mountain. The building is on axis with Rhone and has a church like appearance.

MANAGEMENT RECOMMENDATION: Should be conserved

Re-use recommended and landmark status to be retained.

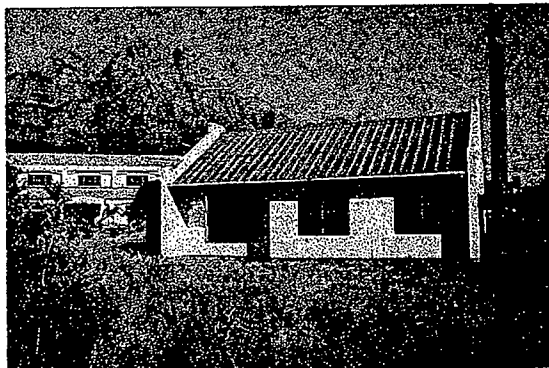
HISTORIC NAME: Good Hope

Small rectangular dwelling 8x12m. Plastered and painted on facebrick plinth under 45° pitch IBR roof. Cape style chimney gables. Lean-to kitchen at rear and garage. Sited next to cricket oval and close to large Dröebaan cottage cluster. Appears to be house of senior farmworker or foreman. Some attempt in design to relate to historic context. Some vandalism at rear of building.

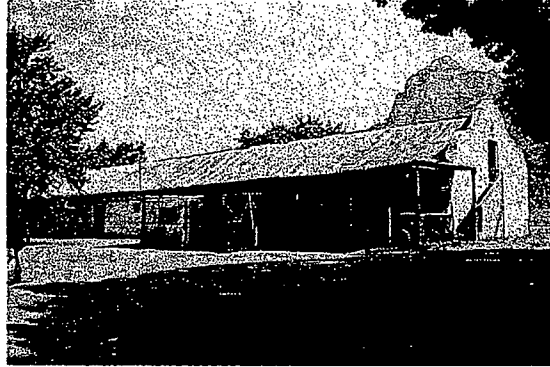
FEATURE NO: Farm Building (barn) 20 (FB 20)
OFFICIAL NAME: Nieuwedorp
POSITION: Rear of farmhouse: 816' S33° 52.671 EO 18°57.398
HISTORIC NAME: Nieuwedorp
CHRONOLOGY: British Colonial / Dutch Colonial RFF: De Beers

Cape longhouse barn with very thick walls on stone base. Probably altered by Baker when the Manager's House was built. End gables match farmhouse with exaggerated mouldings. Roof pitch altered, probably originally steeper and thatched. Loft door and masonry stair provide access to loft store. Building currently used as garage and workshop/ stores. The building is in a poor condition.

Protected by NHRA. Building is in a poor condition and requires attention. Future HIA will determine future.

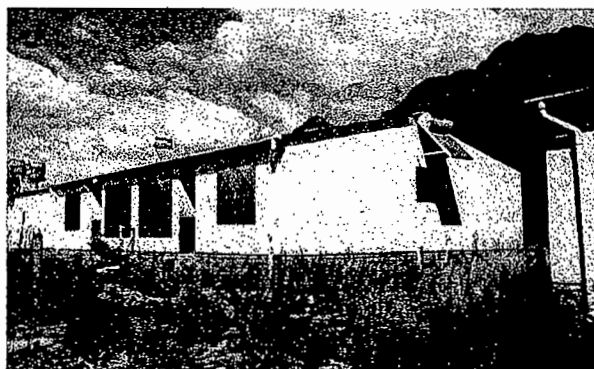
HISTORIC NAME: Rachelfontein (check oral history)

This is a farmworkers housing complex consisting of 13 double units (semi-detached). They are plastered and painted 8m x 14m rectangular buildings on yellow facebrick plinths. They have low double pitch (15°) IBR roofs with projecting purlins on the gable ends. Entrances are recessed. They have solar heating units on the roofs and on gable ends. These elements are highly conspicuous. The buildings have been effectively sealed by means of galvanised steel sheeting, which prevented inspection of the interiors. The buildings appear to be in a reasonably good condition but are starting to deteriorate. There is a water storage tower on the south side. The buildings are arranged around a central space which seems too large to be effective as the scale of the house are too small to act as enclosing elements. There are a few dying stone pines at this cluster.

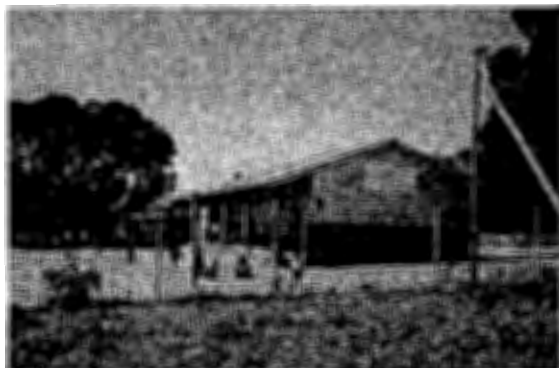
HISTORIC NAME: Boschendal

L-shaped complex of 10 buildings with central soccer field. Three single units and seven doubles. The double unit nearest the R310 has been enlarged and accommodates a school. The complex appears to have been built in two stages with the line of cottages perpendicular to the R310 being the oldest with higher ceilings and 35° pitch roofs. These were probably built in the 1950's. The other group 1970's, similar to other Amfarm's cottages with solar panels small gardens, low pitched roofs. School still in use. Has veranda and enclosed playground. Complex intrudes into Boschendal axial space.

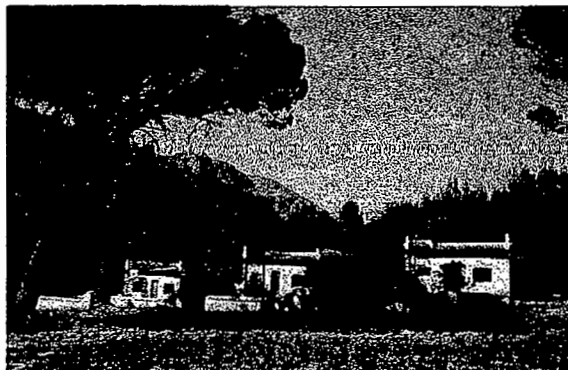
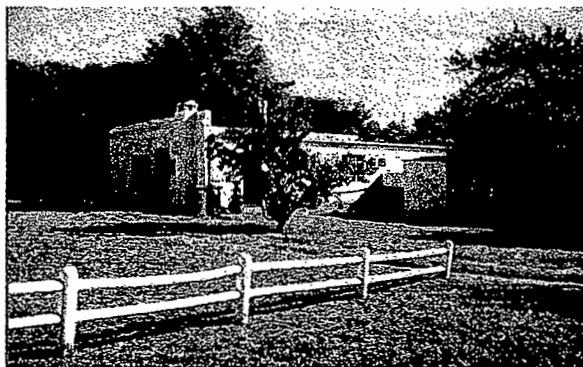
HISTORIC NAME: Bossendaal

Row of three box like farm workers cottages aligned perpendicular to Boschendal's 'lead in' avenue. Monopitch roofs sloping towards the open space and front gardens. Parapets with substantial mouldings, steel horizontal type fenestration flanking central doorways. Unlike other farmworkers houses, these are not boarded up. The front garden walls have moulded copings and gateposts. The backdrop of trees and random stone pines and front open space contributes to the rural quality.

Another similar house to the east has been modified and extended as a kitchen for 'le picnique'. This building has a steel flue, air-conditioning and refrigeration unit. It forms the last structure in a row of

four early 20th century 'L' shaped cottages aligned parallel to the Boschendal avenue, separated by a 6-7 metre high Hakea hedge. These buildings display Baker / Languedoc / RFF characteristics, with 35° double pitched corrugated iron roofs, steel windows and loft doors in the gable ends. Woodwork and windows are painted green. The buildings are similar in style though configured differently and alternately. They provide a coherent group with the entrance doors facing the open square space to the south, and form an 'L' shape together with the 3 cottages described above. This effectively structures the open space. These buildings are in a relatively poor condition, compared to other farmworkers buildings on the estate. (see photographs)

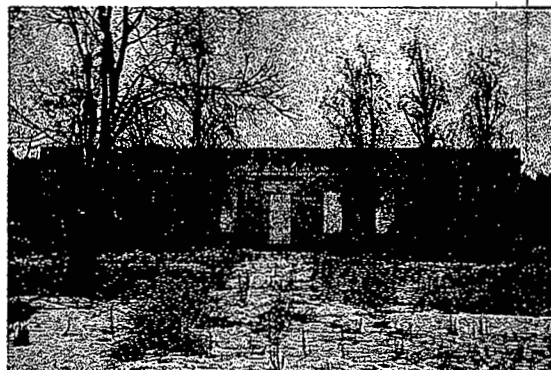
HISTORIC NAME: Thembaletu

The complex consists of an arrangement of 30 pairs of flat roofed cottages, forming a rectangular space with two smaller squares on the north west side. There is a hall located in the central space. The village is accessed by a special gate with a pub / shop at the entrance. The layout suggests an introverted system of spaces, consistent with the idea of separation of these workers from the others on the estate. The buildings are laid out and are designed in the classical style which is remarkable for its purpose and era. The contrast between Thembaletu and the rest of the estate is striking, though there is some similarity with Cottage Cluster 6 near Boschendal.

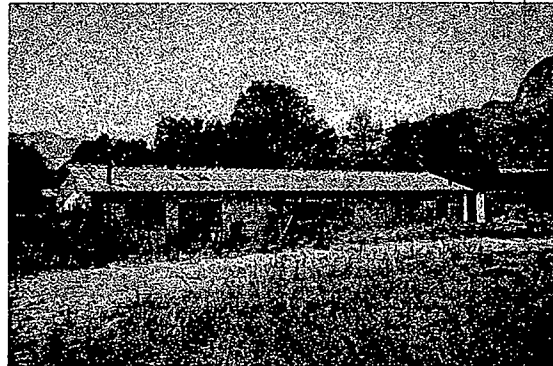
HISTORIC NAME: Nieuwedorp

Cluster of 28 units in two forms of building (two periods). Four double units are sited on terraces 250m to the north of Rhodes' cottage. These have 15° double pitch Canadian pattern asbestos cement roofs.

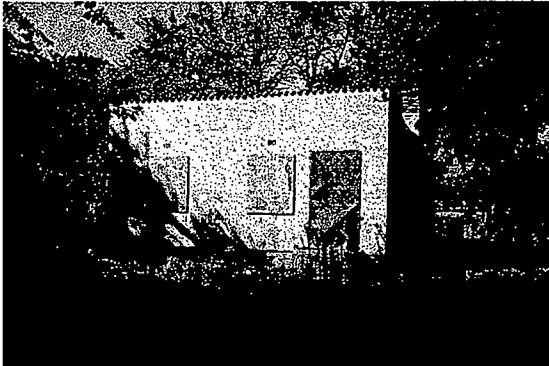
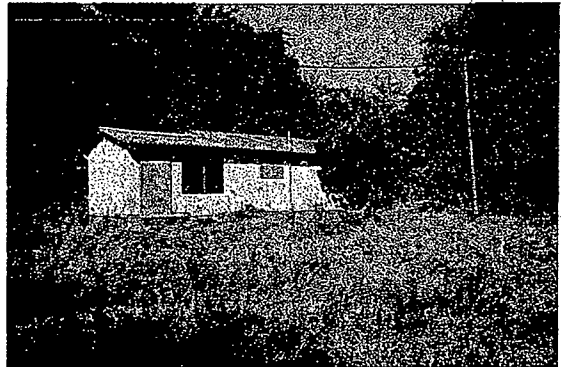
HISTORIC NAME: Goede Hoop

Linear cottage complex of 4 vacant units about 500m to the east of the Good Hope farmstead. (The only other linear cottage complex is on the Kylemore boundary and dates from the 1950's or 60's). There were originally 6 units but 2 units have been incorporated into the cricket club grounds. They are sited within a corridor of old oaks (CQ1) between two water furrows. The oak lined furrows probably date from the late 17th Century. The units vary in size and shape and have both mono and double pitch roofs of asbestos cement sheeting. (Post WW II material). They are aligned parallel and longitudinally to the stream. They are built on brick plinths. It is suspected that this complex could have been built on the footprints of the mid-19th C. Good Hope cottages because of the layout of the complex and variation in form. They are the smallest of the cottages in the area and have external hearths and chimneys.

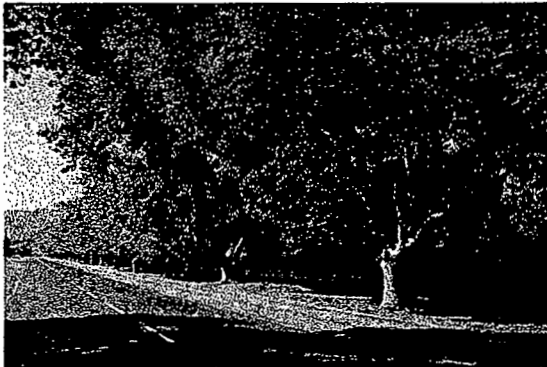
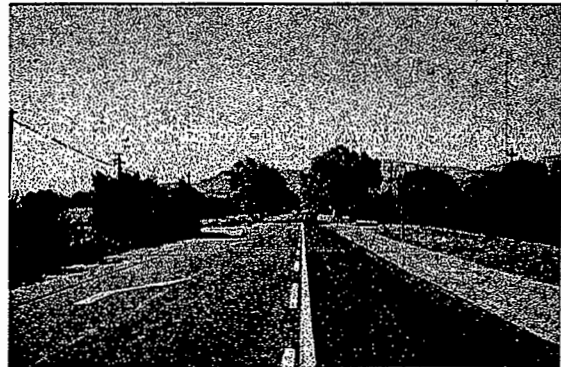
HISTORIC NAME: Boschendal

An avenue of over 1km in length of planes planted in the late 1930's to replace an earlier flowering gum avenue.

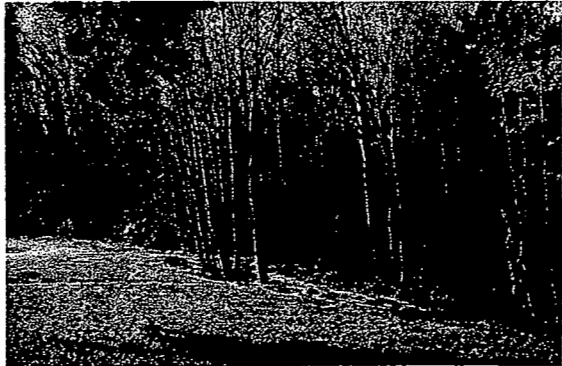
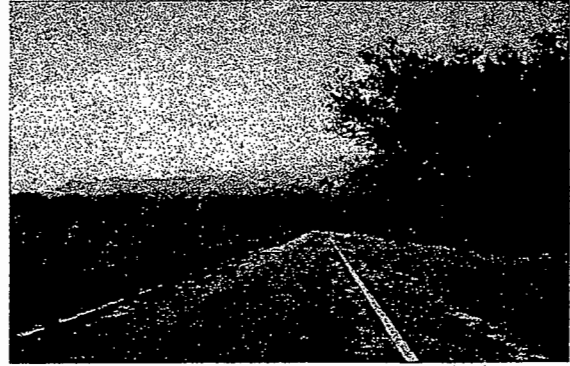
HISTORIC NAME: Bossendal

A block of grey poplar (*Populus canescens*) covering an area of about 2 Ha to the south of the werf. The grey poplar has been an important element of the valley landscape since the 17th Century and should be retained in some areas.

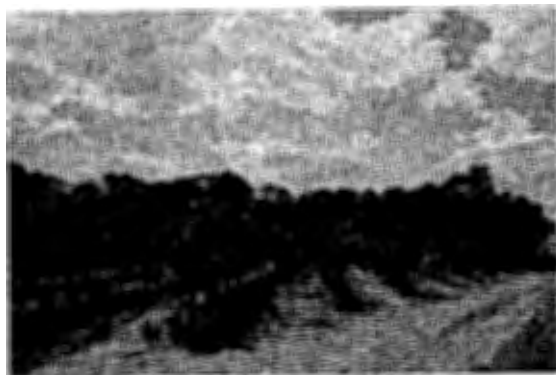
HISTORIC NAME: Nieuwedorp

A block of between 100 and 150 oaks extending over an area of about 2,5 Ha. It is related to Rhodes' Cottage, site of original Nieuwedorp homestead. They are fairly tall because of the close spacing of the planting

Condition: Fair with some signs of senescence.

The existing trees should be maintained. A replacement programme should be implemented with Turkey oak as the replacement species.

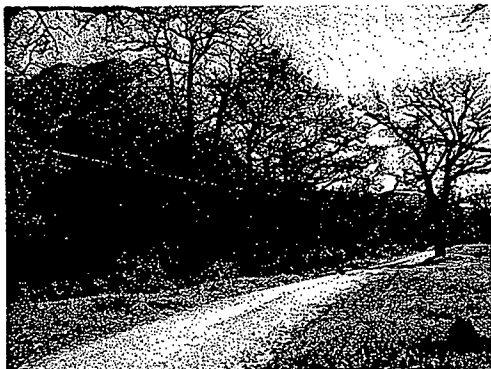
HISTORIC NAME: Bethlehem

This is a major landscape feature. A corridor of closely spaced oaks lining either side of a furrow/tributary of the Dwars River.

Condition: Poor. Many trees have been lost and never replaced. Invasive alien trees, particularly black wattle is taking over and choking the corridor.

The existing trees should be maintained. A replacement programme should be implemented with Turkey oak as the replacement species.

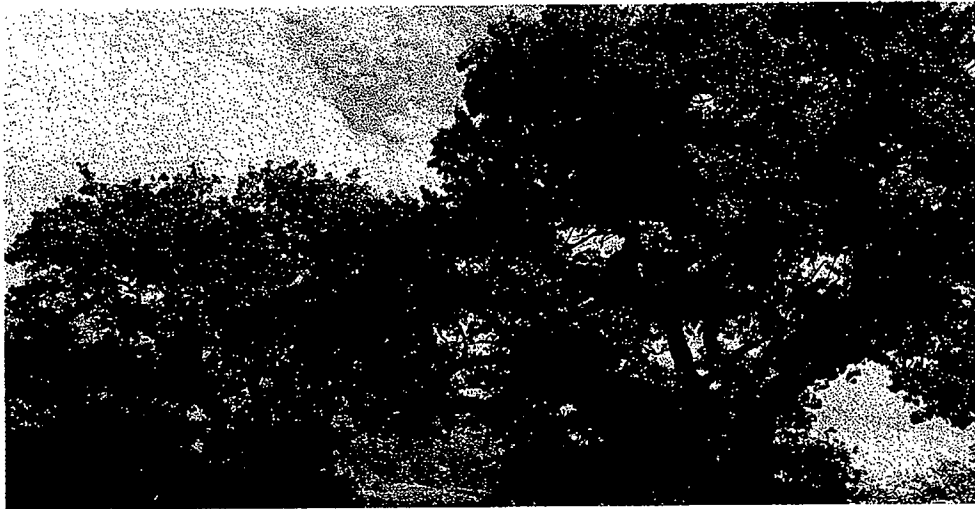
HISTORIC NAME: Bossendal

Corridor of oaks east of the werf lining a stream or furrow at an oblique angle to the Dwars River.

Condition: Fair, some signs of senescence

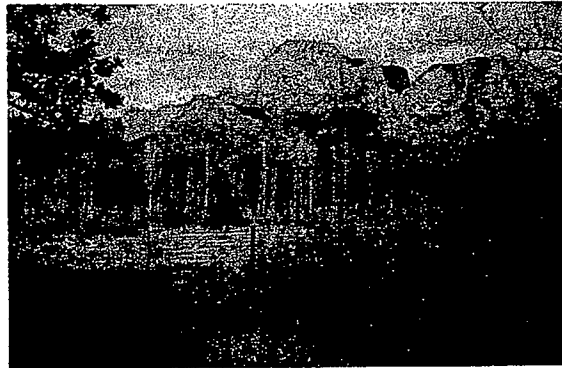
HISTORIC NAME: La Rhone

A windbreak of Lombardy poplars about 150m in length. Probably longer in the past.

Condition: Poor with signs of senescence and many dead specimens.

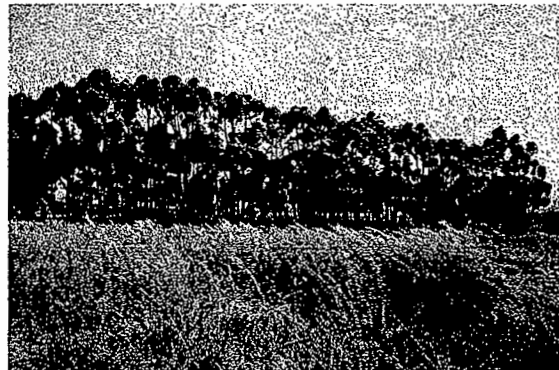
HISTORIC NAME: Nieuwedorp

A windbreak of sugar gums about 350m in length perpendicular to the road from Rhodes' Cottage to Champagne.

Condition: Fair with some signs of senescence.

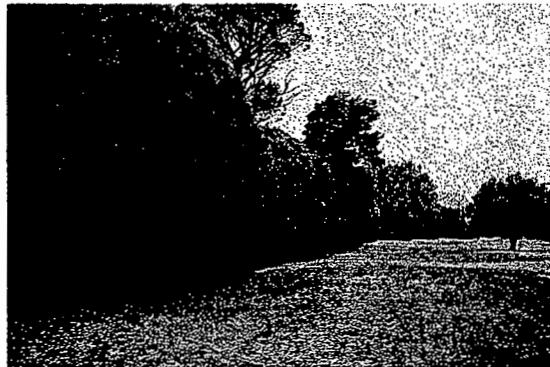
FEATURE NO: Windbreak Hakea 1 (WH1)
OFFICIAL NAME: Boschendal
POSITION: 604' S33°52.567 E018°58.517
HISTORIC NAME: Boschendal
CHRONOLOGY: Republic of SA

The hedge of willow hakea (*Hakea saligna*) was planted at some time in the 1970's, designed to screen the farmworkers' cottages, CC12 from view from the main drive leading to the manor house. It is a prominent landscape feature creating "outdoor rooms". Willow hakea was a very popular hedging plant in the 1960's and 70's because it is fast growing and young leaves have attractive purplish-red tips. It can reach a height of 6m. There are a number of these hedges in the area. This hedge is about 150m long and is 25m from the edge of the road. Willow hakea is not listed as an invasive alien but has been placed considered to be potentially invasive. It is probable therefore that willow hakea may at some time in the future no longer be grown.

Condition: Good, there are no signs of senescence or stress

VULNERABILITY: Great. The hedge will last another 15-20 years and no replacement programme has been initiated.

A new replacement hedge should be planted alongside the existing hedge.

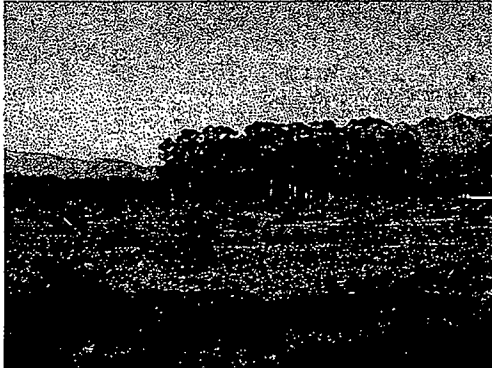
HISTORIC NAME: Bossendal

A windbreak of old blue gums about 500m long. Originally grown to protect fruit trees.

Condition: Fair could benefit from topping

The trees have a lifespan of about 100-120m years. A replacement programme should be initiated.

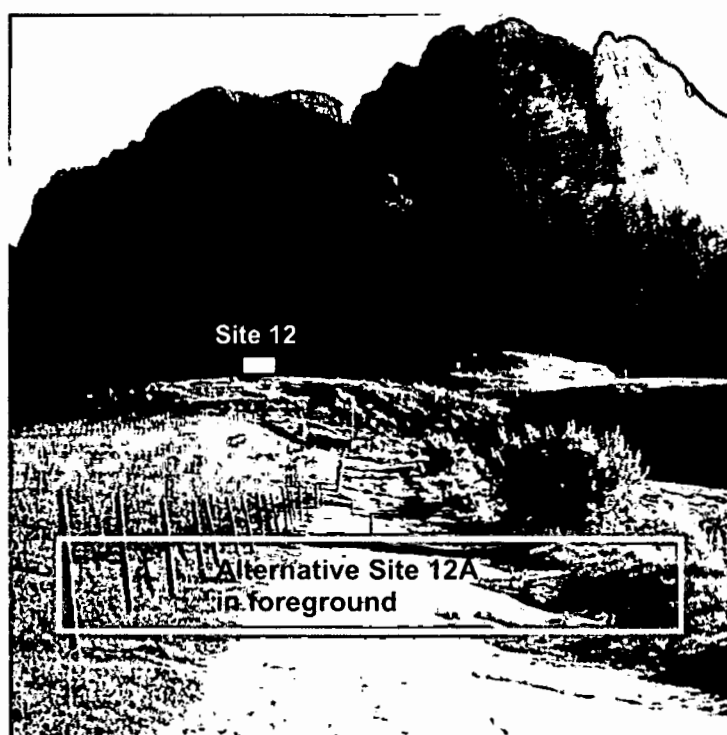
Figure 1

Photographs indicate location of previous homestead sites and recommended relocation of sites to lower slopes (Sites 6A and 12A)

Sites 5, 6, 8, 12 and 15, and to a lesser extent, sites 2, 9 and 16 were considered to be problematic, and could result in high visual impacts. Alternative sites have therefore been suggested, and these would require only minor adjustments to the farm boundaries.

The alternative sites, 8a and 15a, could potentially have a high visual impact, and it is recommended that a full visual impact assessment (VIA) of the actual building footprint and design for these 2 sites be undertaken. It is also recommended that separate design guidelines be prepared for these 2 sites in tandem with the VIA.

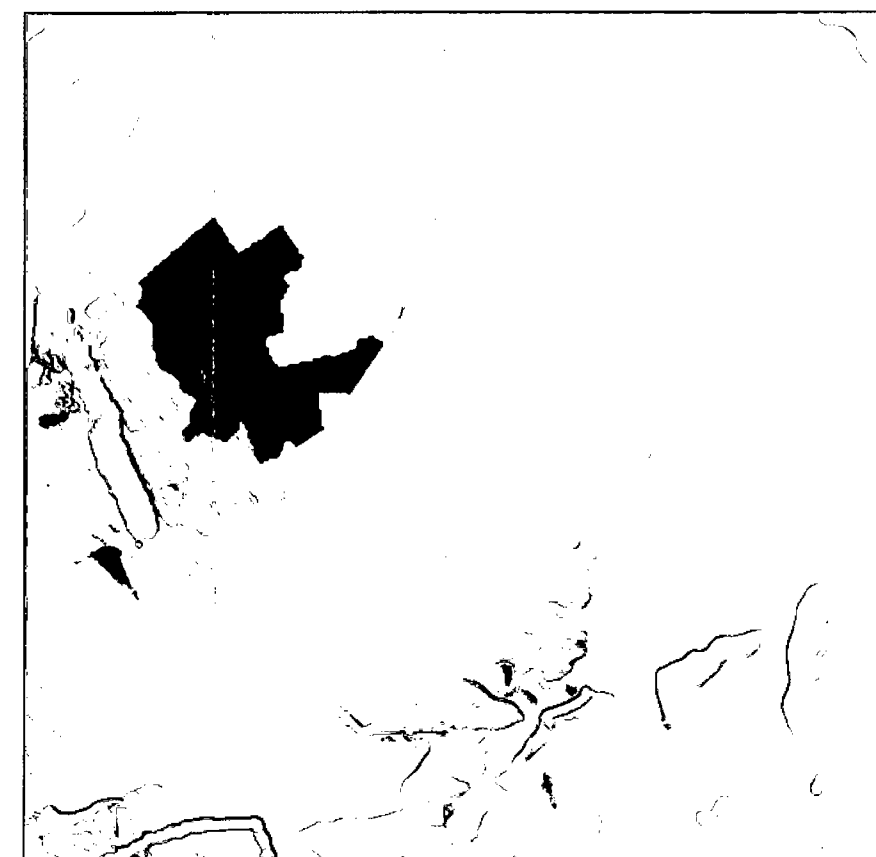
DTM illuminated by light source at Boschendal entrance gateway (NE perspective view).

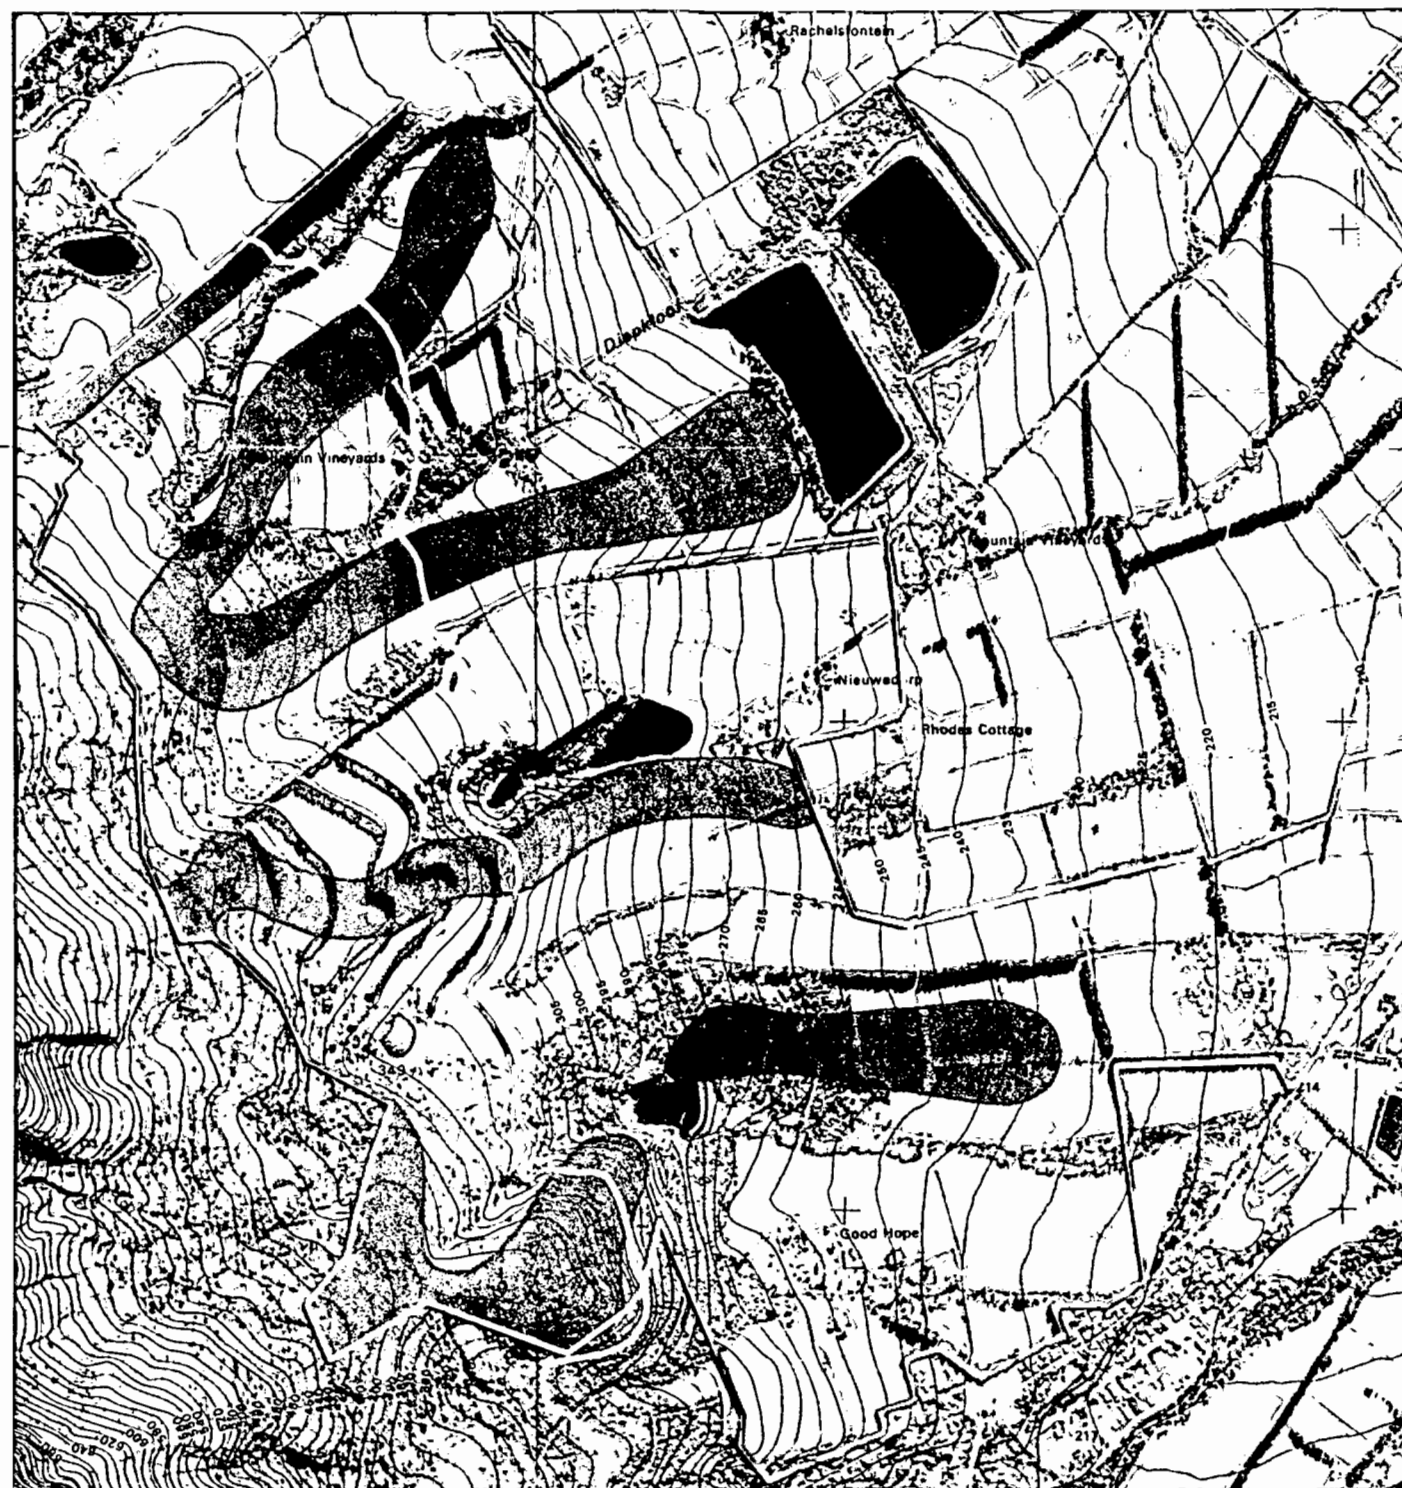
Fig 5 • Viewshed from Major Routes

Scale : 1: 50 000

View corridors tend to be represented by the more important arterial and scenic routes, which in this case are also the wine routes (R310 and R45). Local topography, foreground vegetation or buildings, and curves in the road will determine the viewing experience of the road-users. (See Fig.5).

4.2 Visual Exposure (Fig. 5)

Although the viewshed tends to be defined mainly by topography, it should be remembered that tree shelterbelts and other large mature trees would influence visual exposure at a more local scale. The view catchment area shown in Fig. 5 is therefore nominal.

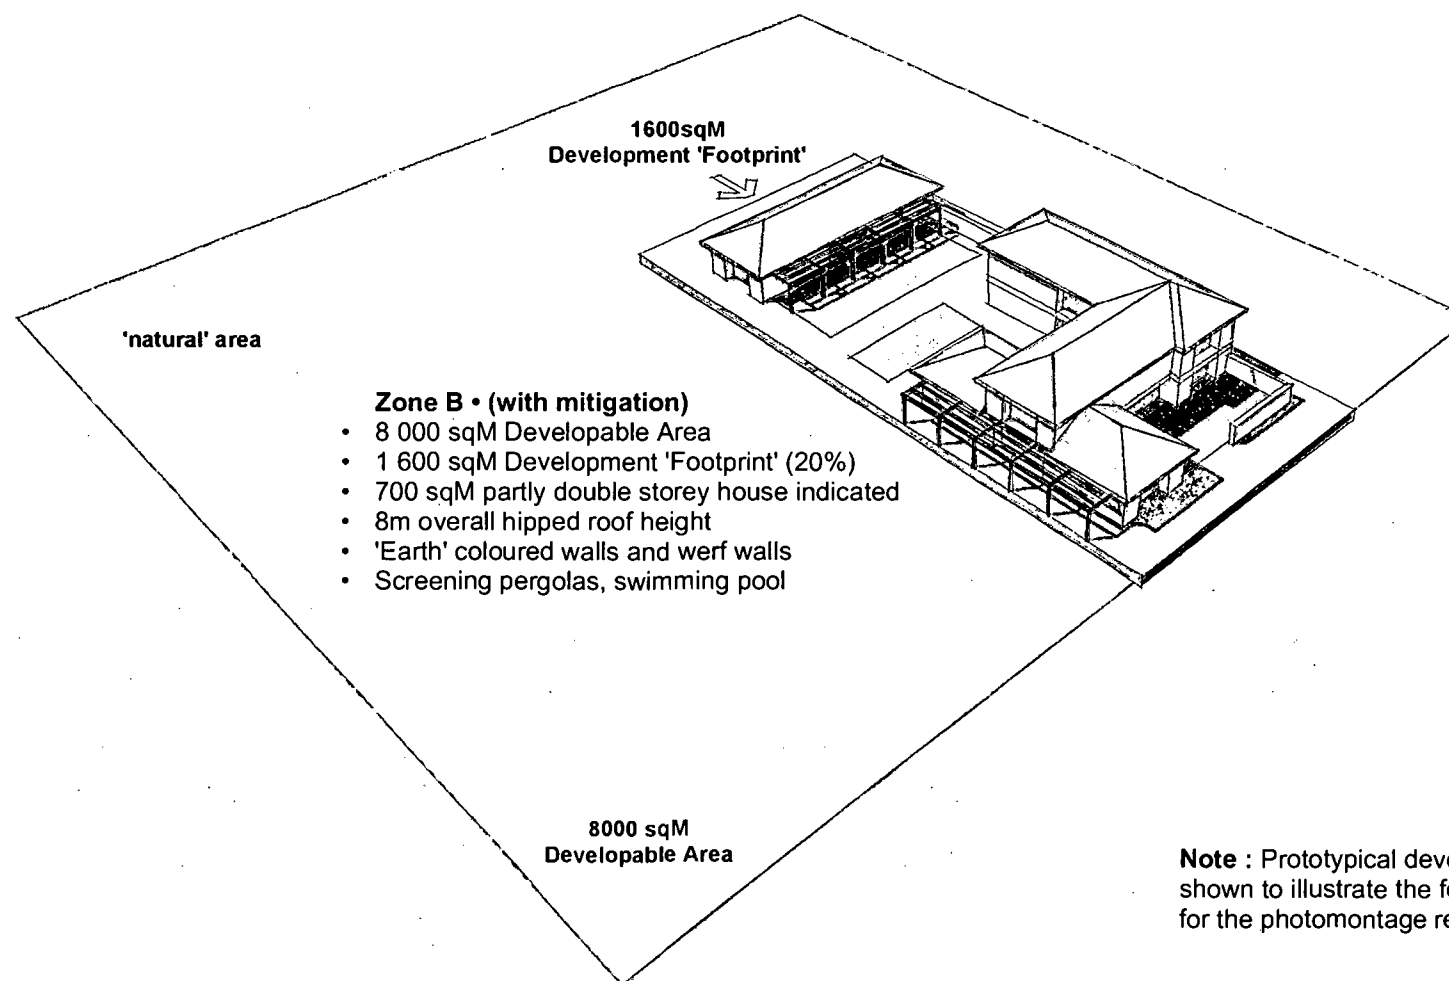
Fig 7 • Prototypical Development Footprints

Note : Prototypical development footprints are shown to illustrate the form of the 3D models used for the photomontage renderings which follow

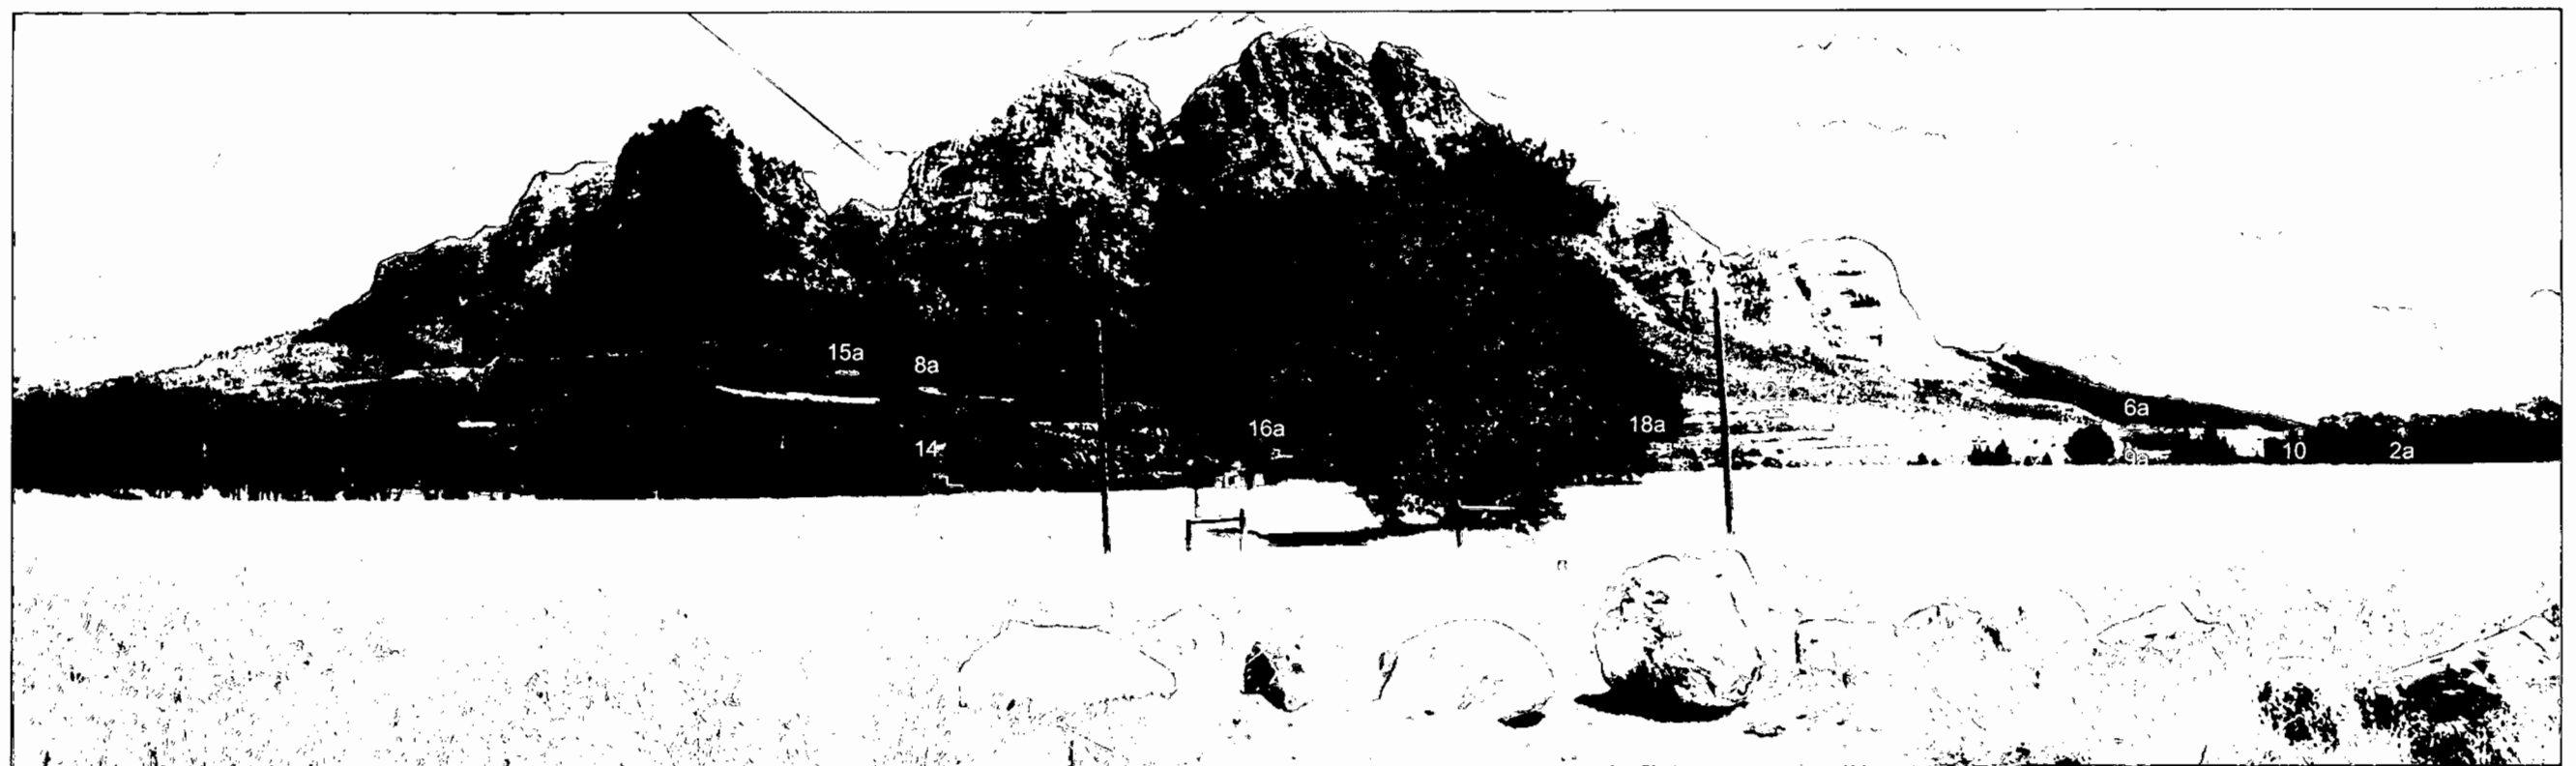
View of development (unmitigated)

distance to closest development site 18a : 450m
