# **ARCHAEOLOGICAL IMPACT ASSESSMENT**

## **Proposed borrow pit (Karusa North) on the Farm Rheebokke Fontein 209 Remainder near Sutherland, Northern Cape**

**DECEMBER  
2015**

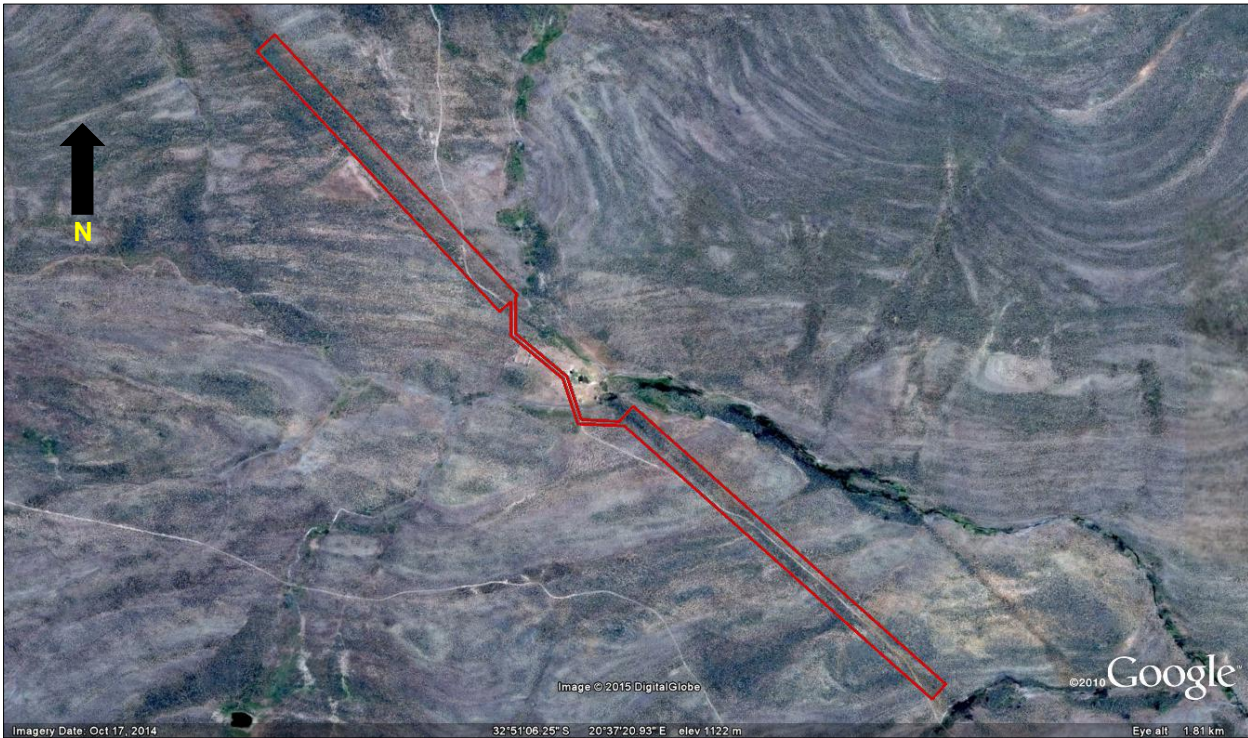
Figure 4. Google satellite map illustrating the proposed application area for the Karusa North Borrow Pit

The proposed Karusa North borrow pit, on the Farm Rheeboeke Fontein 209 Remainder, is located some 52kms south of Sutherland (Figure 4). Access to the site is along the Kamsberg public gravel road, via the R354/Matjiesfontein-Sutherland road. The dolerite dyke, an extension of the Karusa East dolerite dyke/borrow pit (Kaplan 2015a), is reasonably level in the south, rising in the north up the steeper vegetated mountain slopes (Figures 5 & 6). The substrate is characterised by a thin layer of weathered soils and gravels underlain by weathered dolerite (the source material). There are no significant landscape features on the site, although there is a small outcropping of

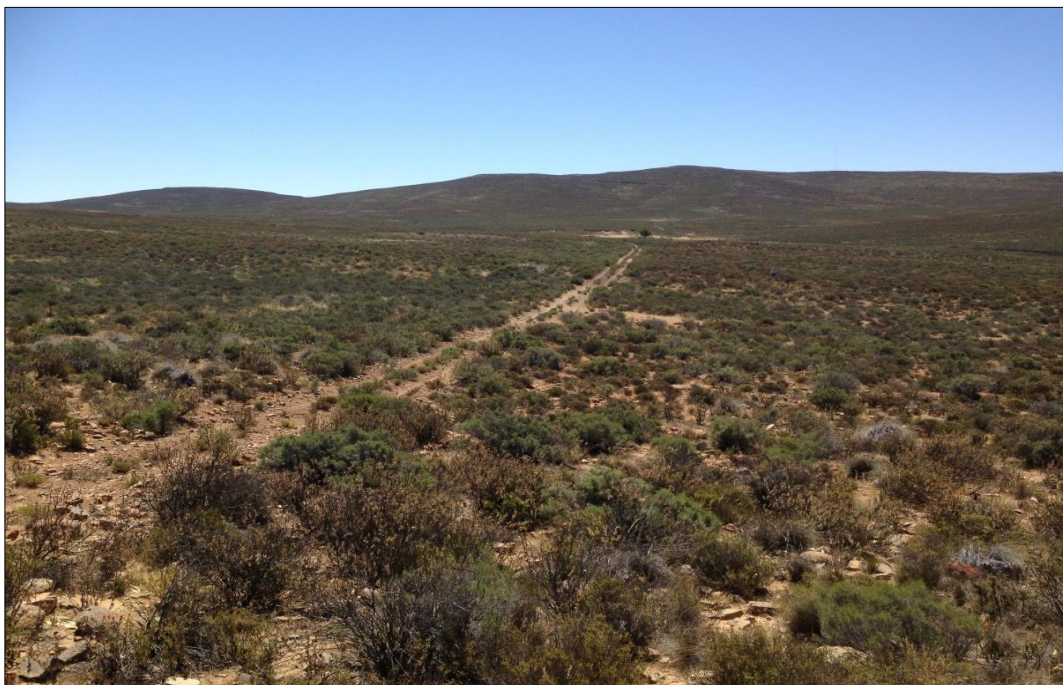
Figure 5. Proposed Karusa North Borrow Pit. View facing north.

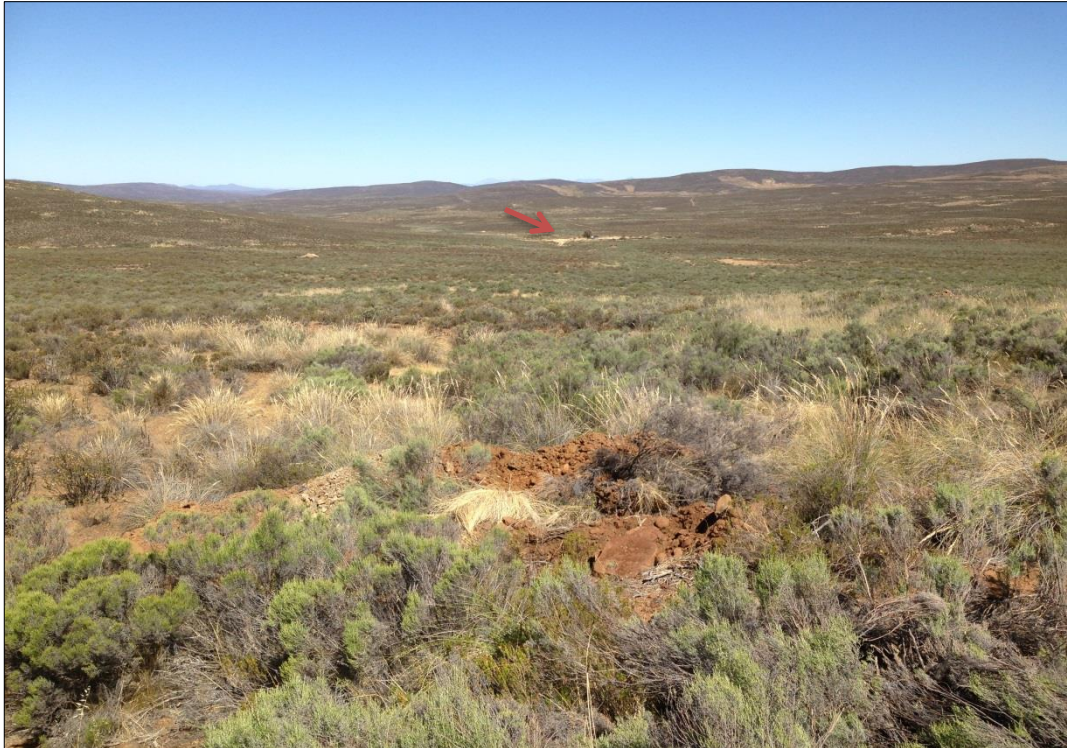
Figure 6. Proposed Karusa North Borrow Pit. View facing north. Arrow indicates the outspan area (kraal, reservoir & windmill). Note the test pit in the foreground and the surrounding densely vegetated land.

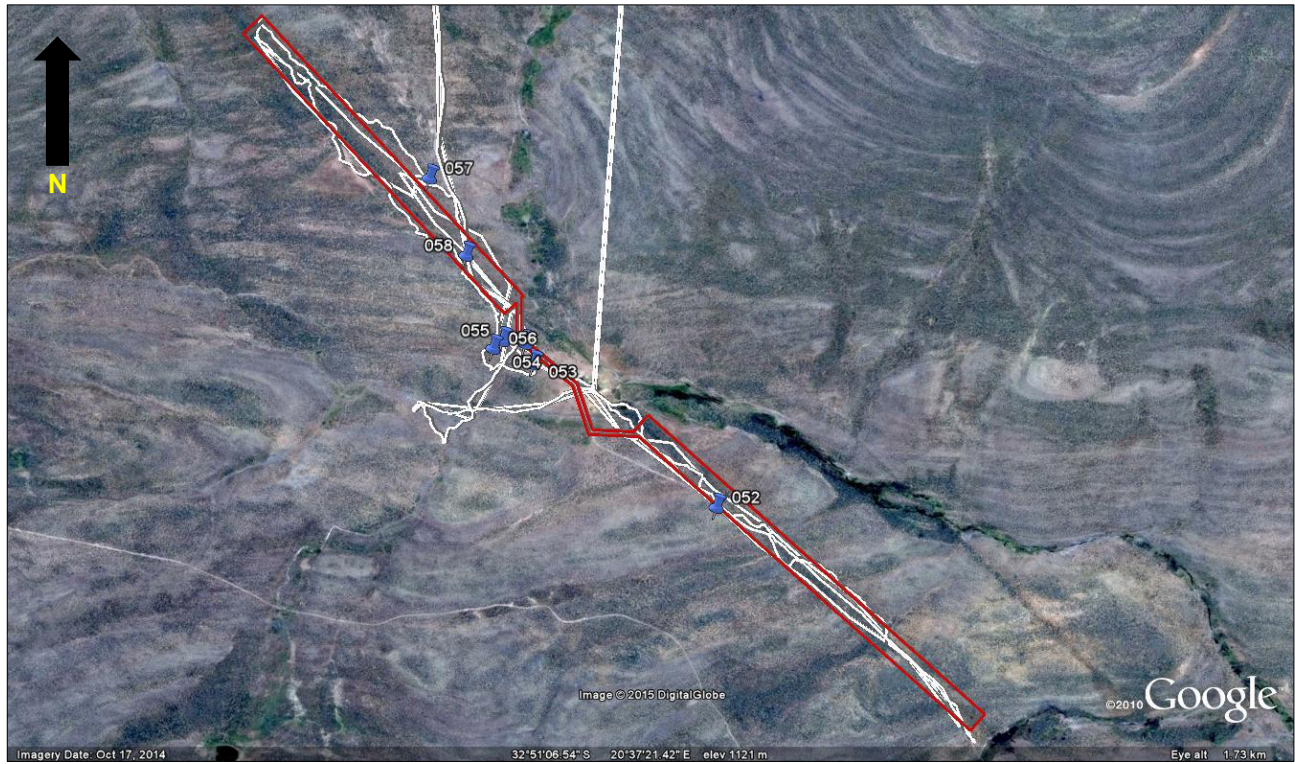
Figure 8. Waypoint of archaeological finds. White lines are track paths

A Google satellite image of the proposed Karusa North Borrow Pit illustrating waypoints of archaeological finds and stone ruins is illustrated in Figure 8.

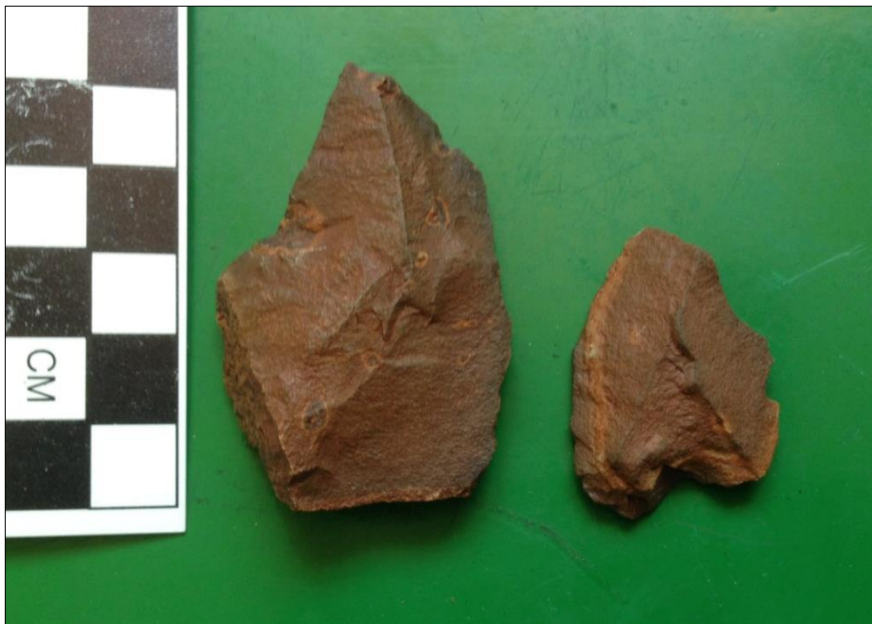
Two utilized/miscellaneous retouched flakes (Sites 052 & 058) were recorded, but the remains have been graded as having Low (Grade 3C) significance (Figure 9).

Figure 9. Site 052 & 058. Scale is in cm

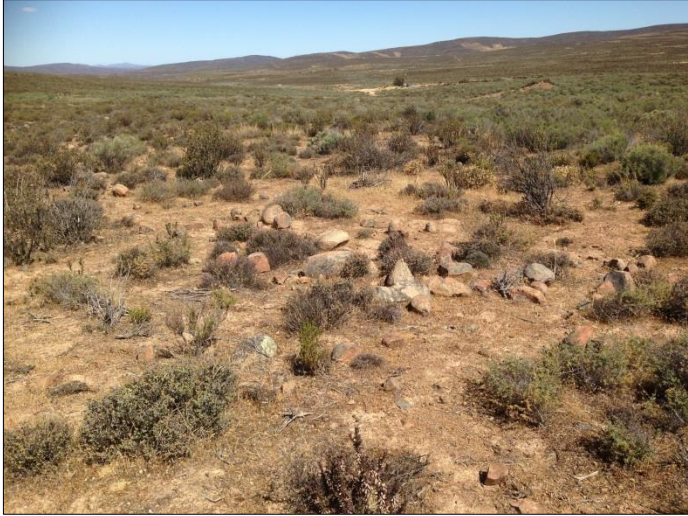
The remains of a possible Later Stone Age Khoekhoen kraal (Site 057) of Low (Grade 3C) significance was located about 20m from the north eastern edge of the proposed borrow pit. The feature has been completely destroyed and there is no integrity to the remains (Figure 10). One stone chunk was found. The surrounding area was searched in detail but no further evidence, or any other cultural remains were found.

Figure 10. Site 057. View facing south

2. A buffer of 20m must be established around Site 057 (possible remains of a Khoekhoen herder kraal).
3. Should any unmarked human remains be uncovered during mining operations these must be immediately reported to the South African Heritage Resources Agency (Mr Philip Hine 021 462 4502), or the archaeologist Jonathan Kaplan (082 321 0172).
4. The recommendations must be included in the Environmental Management Plan (EMP) for the proposed project.

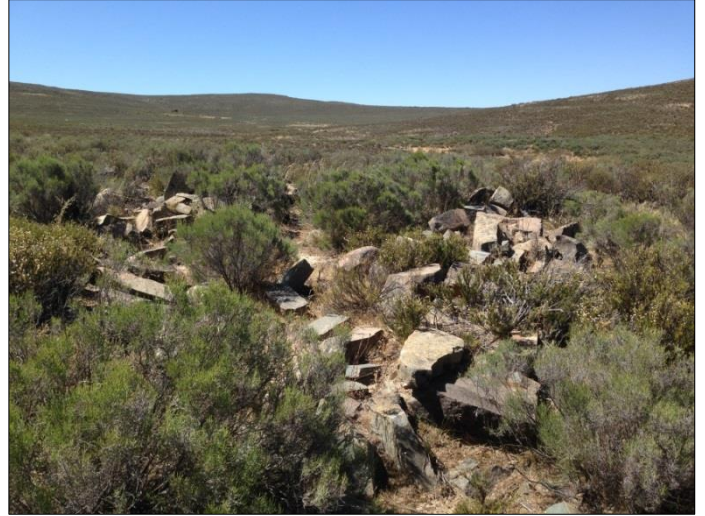
Two more ruined structures were located about 20m north of the large sheep enclosure and about 25 west of the application area. These comprise a collapsed stone kraal (Site 055), while a collapsed farmhouse (Site 056) with a raised and stamped clay/mud floor was located about 15m further west (Figures 13-15). Some historic glass and a few fragments of Oriental ware were found lying outside. According to the farmer (Mr Erasmus van Zyl pers. comm.), the ruins, which are not older than 100 years, were built by early bywoners (white settler farmers) and Coloured farm workers/shepherd's (skaapwagters). Although the historic ruins are protected under Section 34 of the

Figure 13. Site 055. View facing north west

Sites 055 and 056 may be indirectly impacted by proposed mining operations.

1. Conserve/protect historic buildings and kraals (Sites 054, 055 & 056). The stone ruins must be demarcated (with danger tape or hard fencing) throughout the operational phase of the borrow pit. The ruins/structures must not be demolished or damaged. Minimal intervention is advocated.
2. A buffer of 20m must be established around Site 057 (a possible Khoekhoen herder kraal).
3. Should any unmarked human remains be uncovered during mining operations these must be immediately reported to the South African Heritage Resources Agency (Mr Philip Hine 021 462 4502), or Jonathan Kaplan (082 321 0172).
4. The recommendations must be included in the Environmental Management Plan (EMP) for the proposed project.

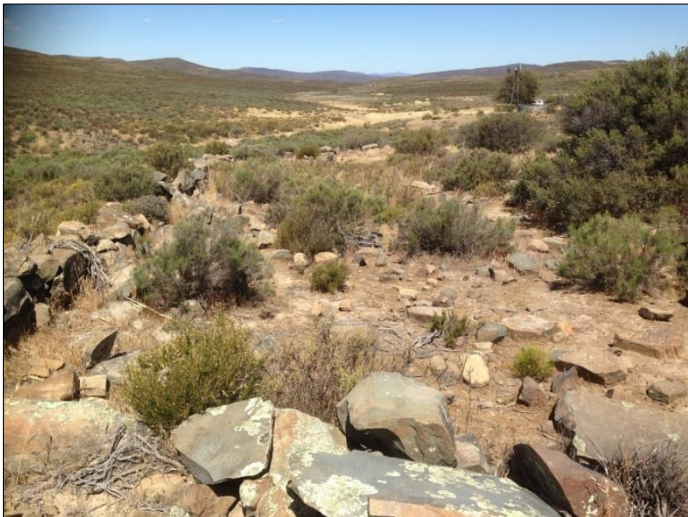
A, dry stone kraal (Site 054) of Medium-Low (Grade 3C) significance was recorded alongside the gravel access road near the entrance to the application area, and about 40m west of a small stream (Figure 11). No artefactual remains were found inside or outside the historic kraal, which is located about 10m from a large sheep enclosure (Site 053) that is currently being used by the farmer (Figure 12).

Figure 11. Site 054. View facing south

The stone walled kraal (Site 054) located alongside the gravel access road near the entrance to the application area might be impacted by possible upgrading/widening of the road.

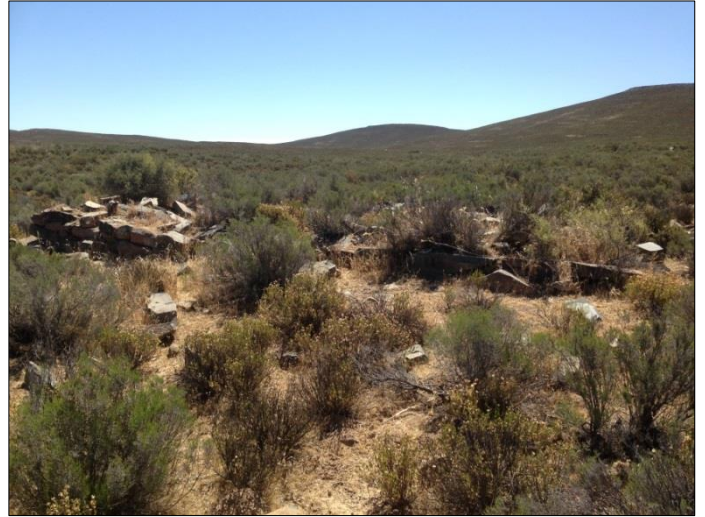
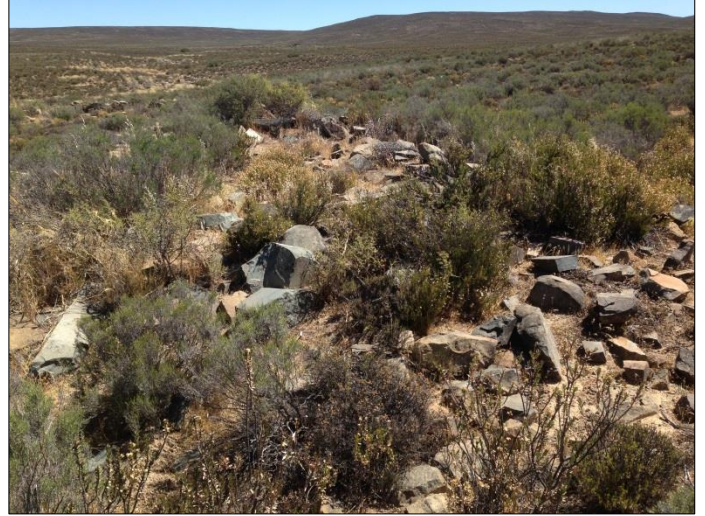
National Heritage Resources Act (Act No. 29 of 1999), the structures have been rated as having Medium-Low (Grade 3C) significance.

Figure 14. Site 056. View facing north

Figure 15. Site 056. View facing north west

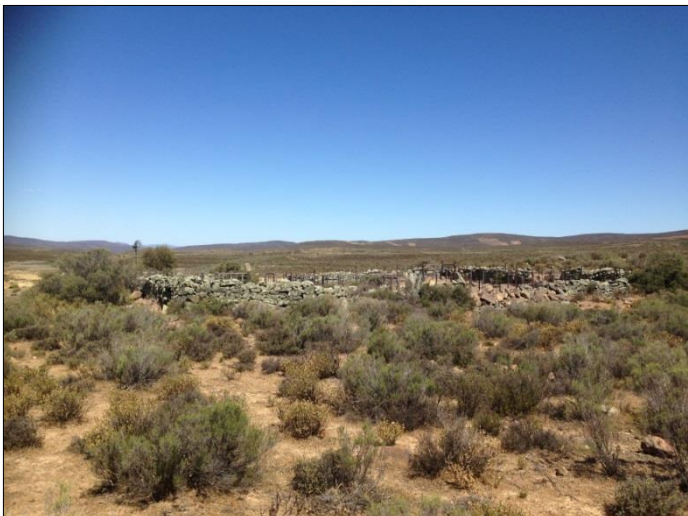
Figure 12. Site 053. View facing south west
