HERITAGE IMPACT ASSESSMENT:
Scoping and Environmental Impact Assessment for
the proposed development of the Edison PV 100 MW
Photovoltaic Facility near Dealesville, Free State

Required under Section 38 (8) of the National Heritage Resources Act (No. 25 of 1999).

01 February 2016

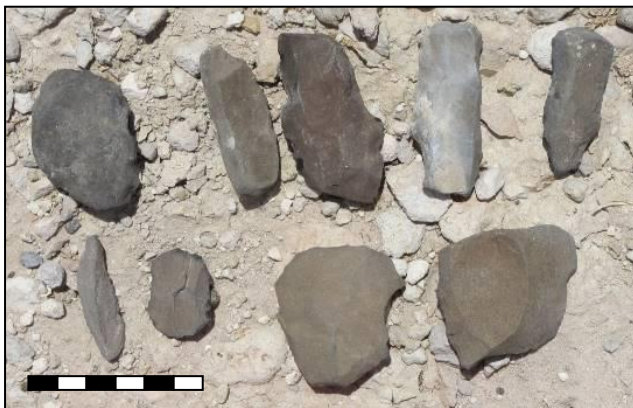
Figure 8: Stone artefacts from waypoint 888. The scale is in cm.

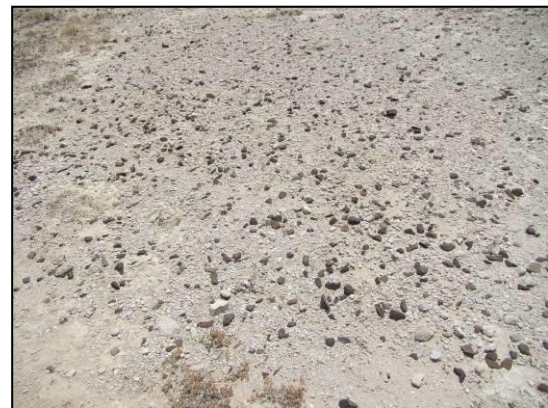
Figure 9: The ground surface at waypoint 895. All the dark spots are stone artefacts.

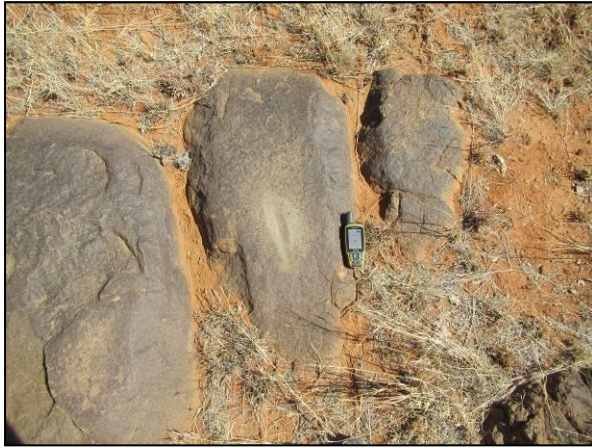
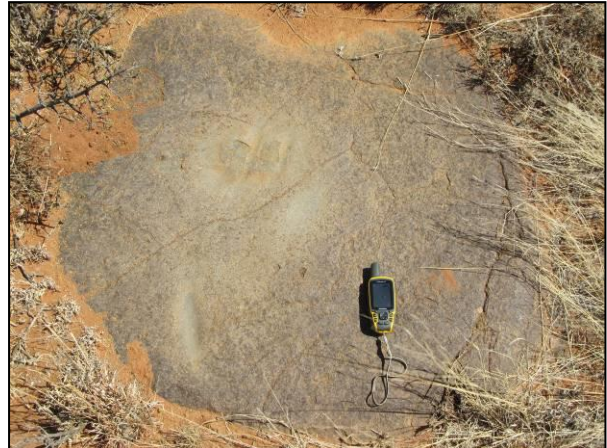
In a few places in the overall project area some grinding hollows and grooves were located. The best examples were at waypoints 872 and 874 where a number of them were located on a low rocky hill right inside the edge of the EGI corridor (Figures 10 & 11). These may have been used for grinding seeds. They are not very old because they have yet to develop patina. No other artefacts were seen on the hill. A very interesting find was made at waypoint 907 to the east of the large pan but within the EGI corridor. It was a small boulder with three 'cupules' ground into it (Figure 12). That these are not recent is betrayed by the fact that their inner surfaces are well patinated, having taken on the same colour weathering rind as the rest of the boulder. Such finds are unusual but are known to occur on small, vertical rock faces in the Northern Cape (Orton & Webley 2012). The cupules are clearly older than the grinding grooves described above.

Figure 10: A grinding groove at waypoint 872. **Figure 11:** Grinding grooves at waypoint 874.

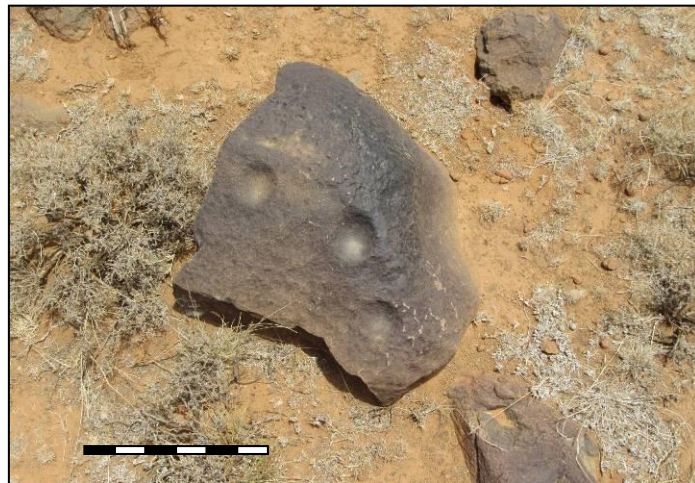
Figure 12: Small boulder with three ground cupules in it at waypoint 907. Scale in 5 cm intervals.

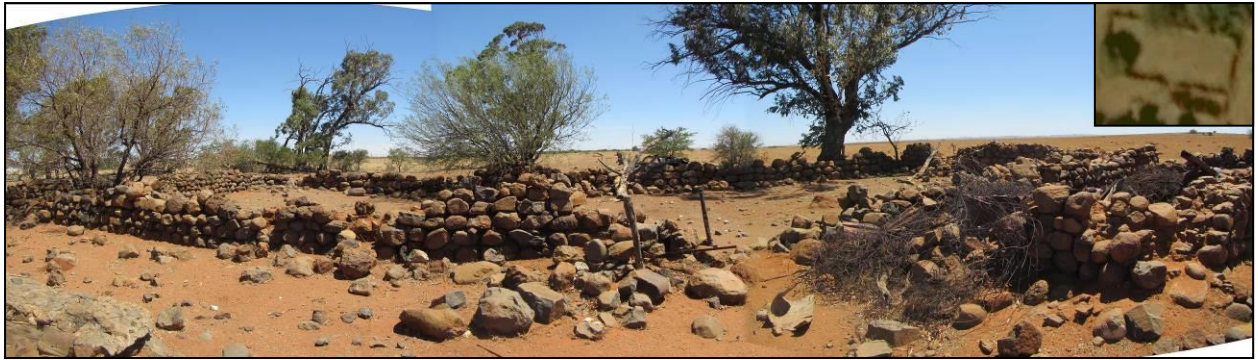
| Project | GPS No. | Co-ordinates | Description | Heritage significance |
|---|---|---|--|---|
| Edison EGI | 870 | S28 39 24.0 E25 41 48.6 | Dolerite stone kraal. It is in poor condition with sections of walling having collapsed. It is 27 m long and 12 m wide but with a 10 m by 5 m addition to its northern side. | Medium AVOID or record |

Figure 13: The ruined stone kraal at waypoint 870. The inset shows the plan view.

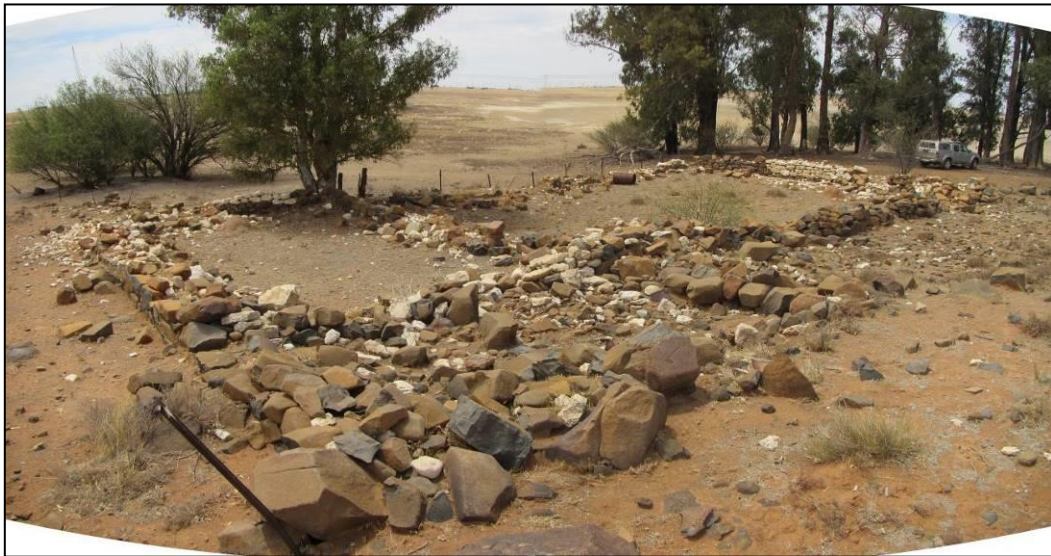
| Project | GPS No. | Co-ordinates | Description | Heritage significance |
|---|---|---|--|--|
| EGI | 897 | S28 39 30.7 E25 40 01.0 | Historical stock enclosure built of dolerite and calcrete. It has four enclosed spaces within it. It should be noted that rocks have been removed from these structures for use along the current fence. | Low-Medium AVOID or record |

Figure 14: Stone kraal at waypoint 897.

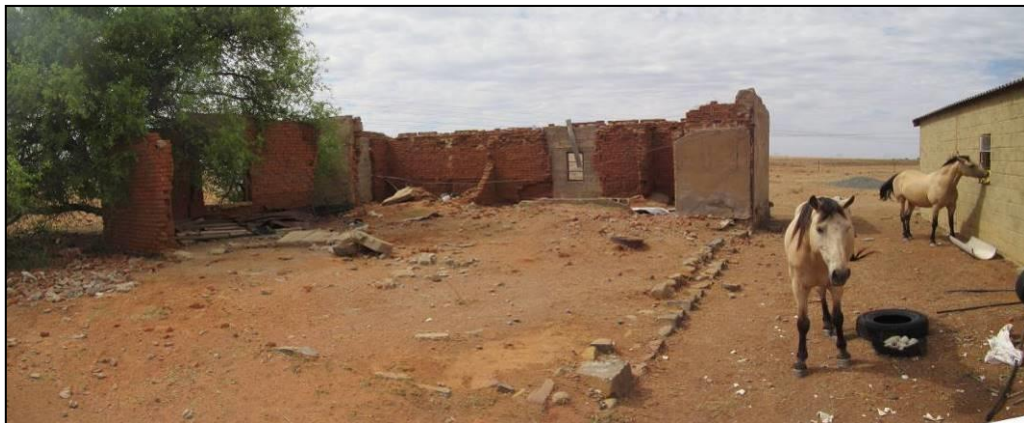
| Project | GPS No. | Co-ordinates | Description | Heritage significance |
|---|---|---|--|--|
| Edison EGI | 886 | S28 39 50.6 E25 41 58.4 | Farmhouse ruin with stone foundation and both sun-dried and fired bricks in the walls. Modern (early-mid-20 th century) additions have been made. Largely collapsed now. | Medium AVOID or record |

Figure 15: The ruined farm house at waypoint 886. A modern shed stands to the right.

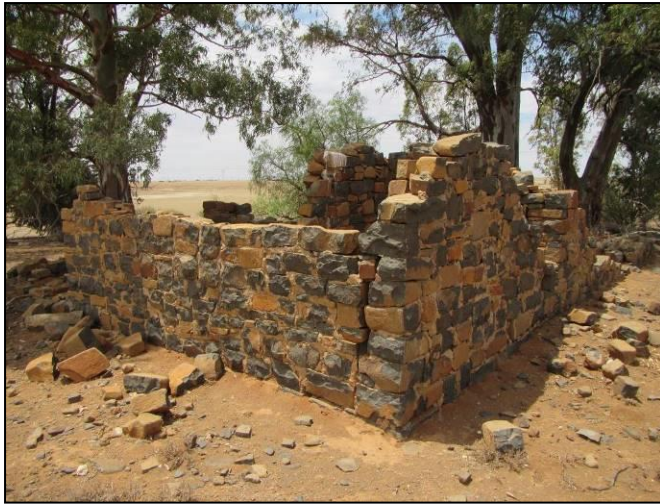
Figure 16: Ruined stone house at waypoint 900.

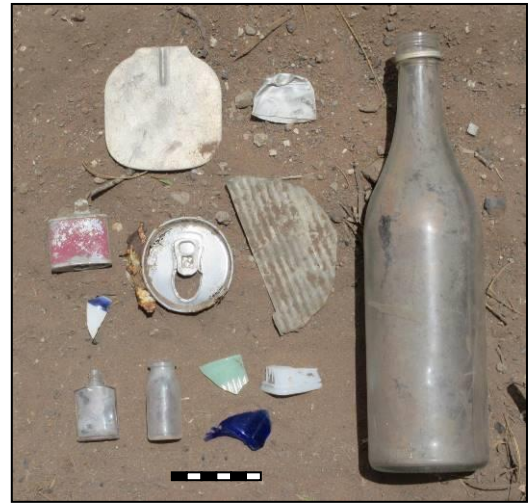
Figure 17: Artefacts from the ash heap at waypoint 899. Scale in cm.

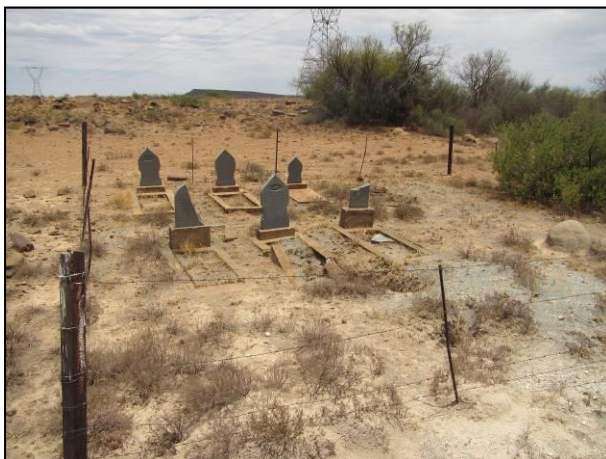
Figure 18: The small graveyard at waypoint 912 to the east of the large pan.

- All graves should be avoided with a buffer of at least 5 m; and
- Earthy-coloured paint should be used on the built elements of the project so as to reduce the visual contrast in the landscape.

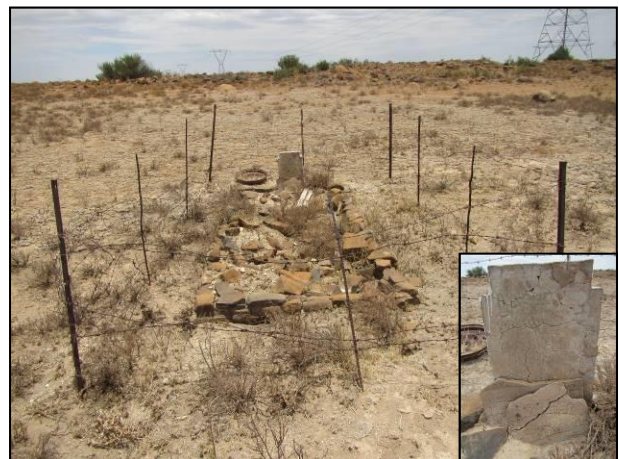
Figure 19: Single formal grave at waypoint 910 to the east of the large pan.

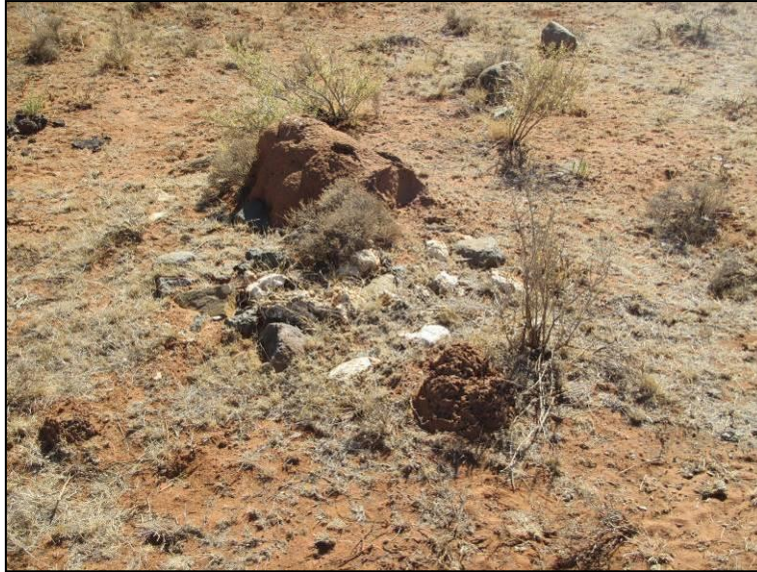
Figure 20: An isolated grave at waypoint 881 located close to other historical features. (Note the apparent head- and footstones are actually termite mounds.)

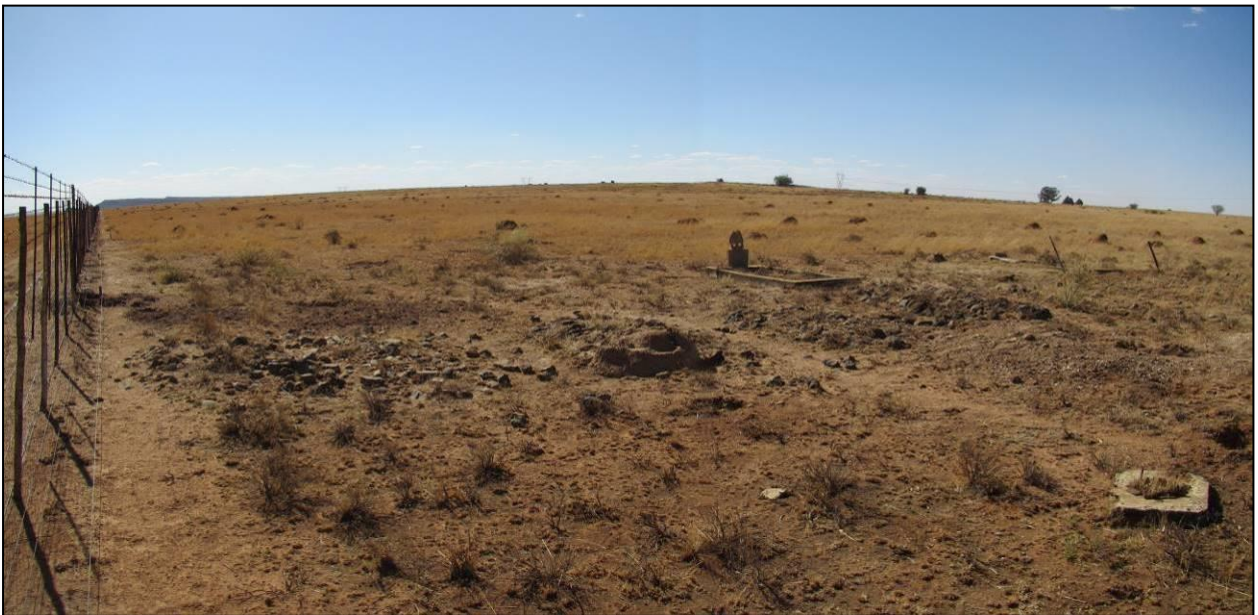
Figure 21: An unfenced graveyard at waypoint 883. The Edison study area is located to the left of the fence but the graveyard is in the middle of the EGI corridor.

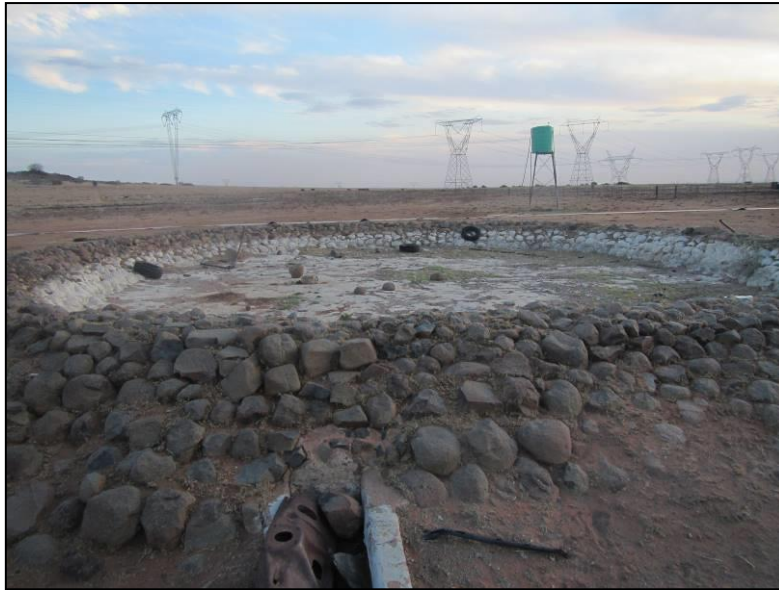
No standing heritage buildings were located within the study area. Two stone-built dams were located, one immediately outside the Edison footprint (Figure 22) and the other just outside the EGI corridor. The age of these features is unknown but they almost certainly predate the easy access to round concrete reservoirs.

Figure 22: Stone dam at waypoint 929.

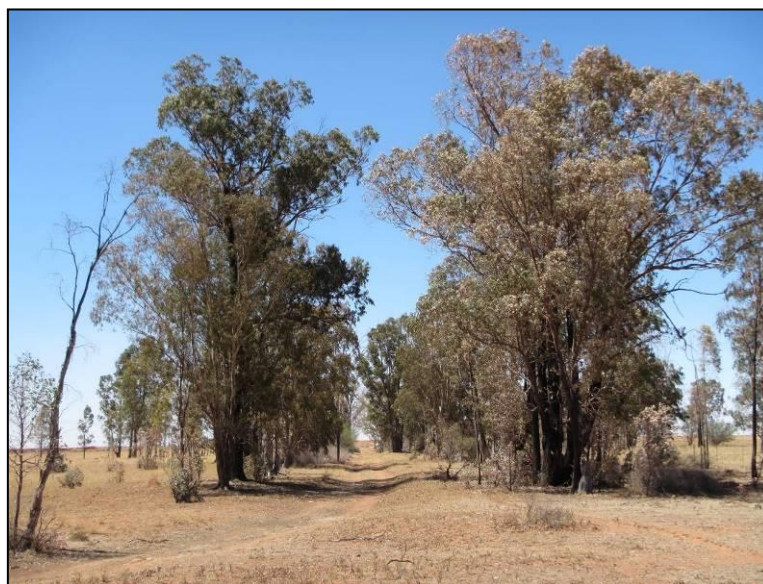
Figure 23: Gum tree-lined avenue leading into Cornelia located at waypoint 871.

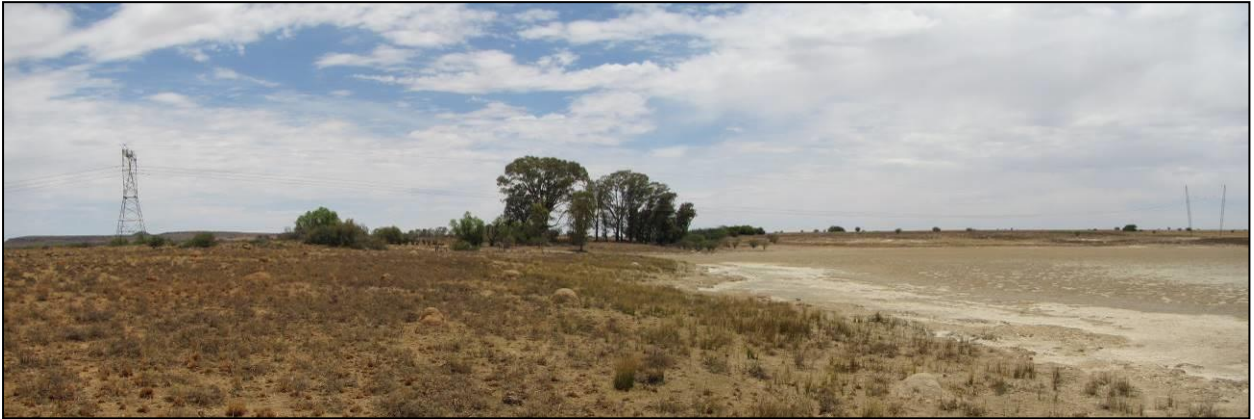
Figure 24: Gum tree cluster around the old farm complex on Modderpan in the vicinity of waypoint 913.
