HERITAGE IMPACT ASSESSMENT:
Scoping and Environmental Impact Assessment for
the proposed development of the Maxwell PV 100 MW
Photovoltaic Facility near Dealesville, Free State

Required under Section 38 (8) of the National Heritage Resources Act (No. 25 of 1999).

01 February 2016

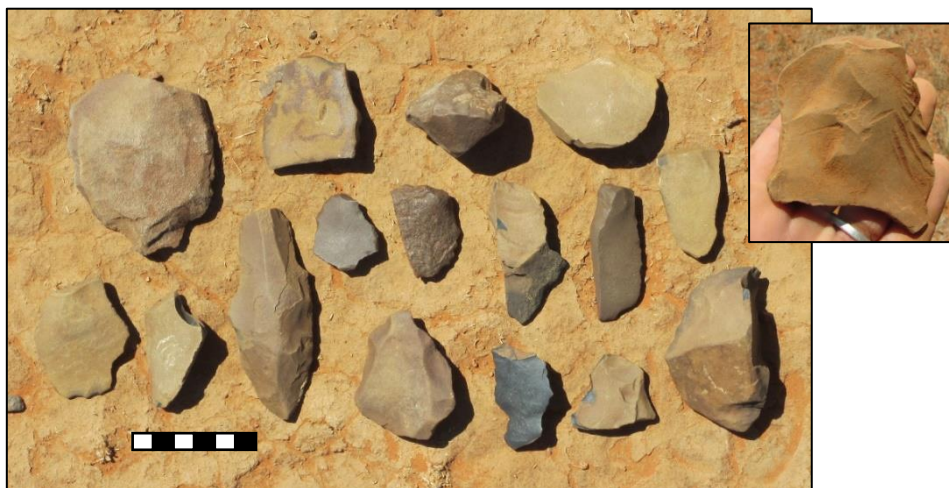
As expected because of the sand cover over the site, Stone Age archaeological resources were extremely sparse within the PV study areas. About a third of the surface area of Option A was comprised of old agricultural lands which had been thoroughly ploughed and, with the exception of occasional isolated artefacts in the northern part brought to the surface by the ploughing (Figure 9), appeared devoid of archaeology – none would be expected in this sand which also lacks gravel. In one part of Option A there had been a large, shallow excavation. This excavation had removed the cover sands and in its base was an ephemeral scatter of artefacts associated with low density gravel (Figure 9). In Option B four scatters of Stone Age artefacts were found associated with the margins of the small pan and the low sand dune to its south; all are excluded from the development footprint though.

Figure 9: Stone artefacts from waypoint 860 in Option A. The scale is in cm. The inset shows one of the isolated artefacts found in the ploughed lands. It is about 7 x 8 cm.

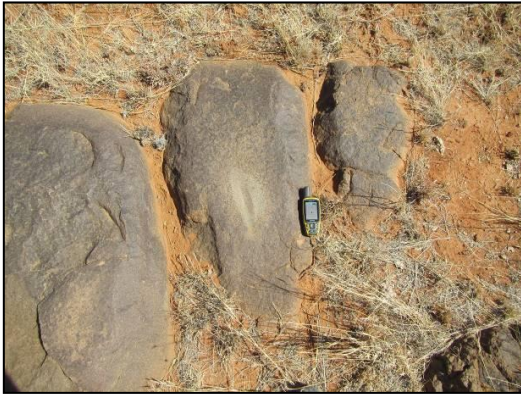
A number of archaeological finds were made within the EGI corridor. These include several LSA bedrock grinding grooves on the low rocky hill at waypoints 872 to 874 (Figures 10 & 11). These may have been used for grinding seeds. They are not very old because they have yet to develop patina and there were no associated artefacts though. In the area to the south of Option B and, along the edge of the large pan, there were many thousands of stone artefacts dating to the MSA and LSA (Figures 12 & 13). Although in poor (eroded) context, they still have scientific value in the technological information they can provide.

Figure 10: A grinding groove at waypoint 872.

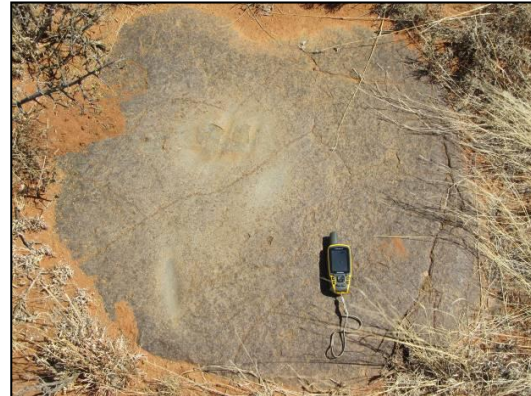
Figure 11: Grinding grooves at waypoint 874.

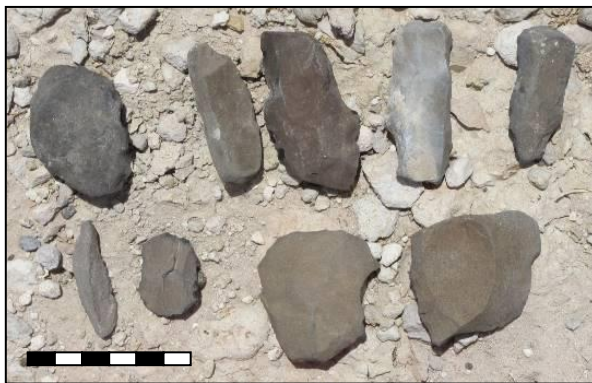
Figure 12: Stone artefacts from waypoint 888. The scale is in cm.

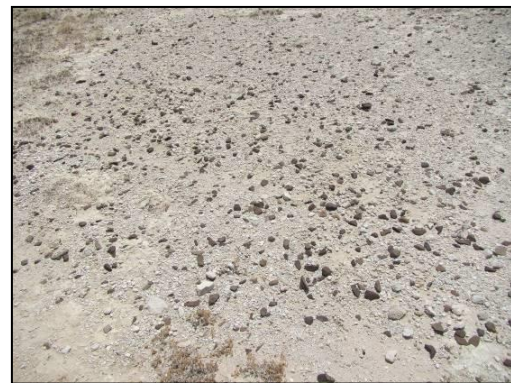
Figure 13: The ground surface at waypoint 895. All the dark spots are stone artefacts.

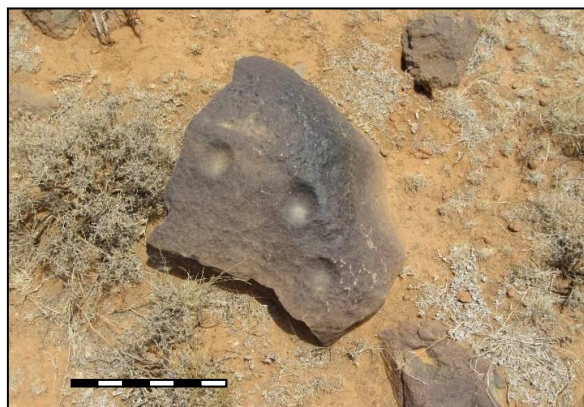
A very interesting find was made at waypoint 907 to the east of the large pan but within the EGI corridor. It was a small boulder with three ‘cupules’ ground into it (Figure 14). That

these are not recent is betrayed by the fact that their inner surfaces are well patinated, having taken on the same colour weathering rind as the rest of the boulder. Such finds are unusual but are known to occur on small, vertical rock faces in the Northern Cape (Orton & Webley 2012). The cupules are clearly older than the grinding grooves described above.

Figure 14: Small boulder with three ground cupules in it at waypoint 907. Scale in 5 cm intervals.

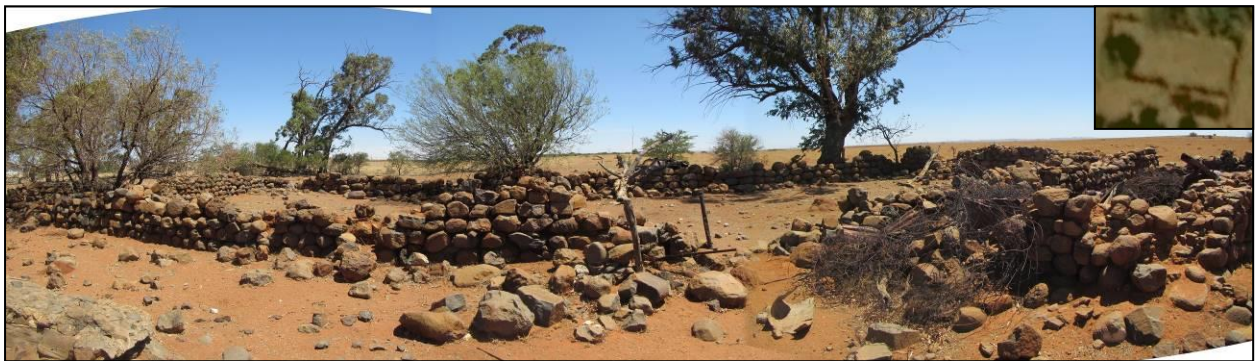
EGI	870	S28 39 24.0 E25 41 48.6	Dolerite stone kraal. It is in poor condition with sections of walling having collapsed. It is 27 m long and 12 m wide but with a 10 m by 5 m addition to its northern side.	Medium AVOID or record
EGI	871	S28 39 21.8 E25 41 51.6	Various stone, brick and cement features in this area. Not very old cement. This is also the southern end of the tree-lined avenue. It is only the avenue that is significant.	Medium AVOID avenue
EGI	872	S28 39 25.6 E25 41 31.4	Dolerite rock on the crest of a low hill with grinding patches on it. There are also three proper grooves. Another rock a few meters away has two more ground patches. No artefacts were seen.	Low- medium
EGI	873	S28 39 25.4 E25 41 32.5	Dolerite rock with a single shallow grinding groove on it.	Low
EGI	874	S28 39 25.4 E25 41 31.0	Dolerite rock with a single grinding groove on it.	Low
EGI	875	S28 39 22.7 E25 41 35.5	Historical foundation in brick but with lots of calcrete lying around the area.	Low

Figure 15: The ruined stone kraal at waypoint 870. The inset shows the plan view.

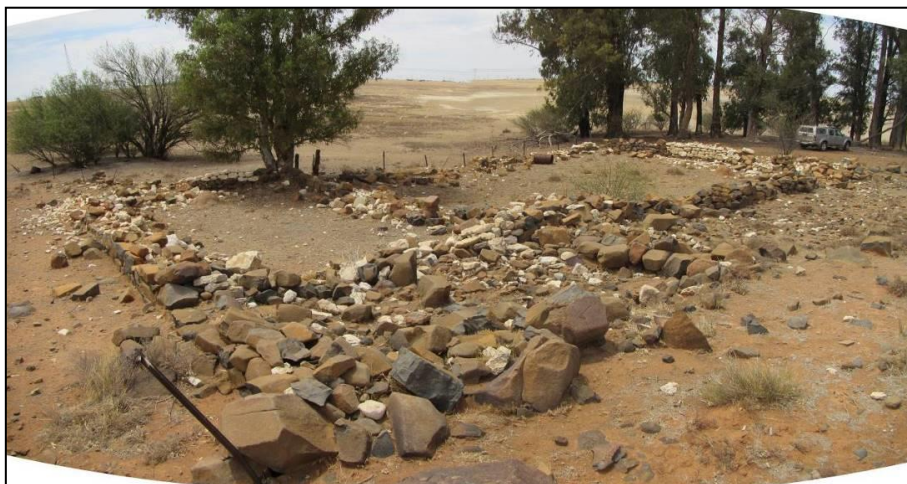
Figure 16: Stone kraal at waypoint 897.

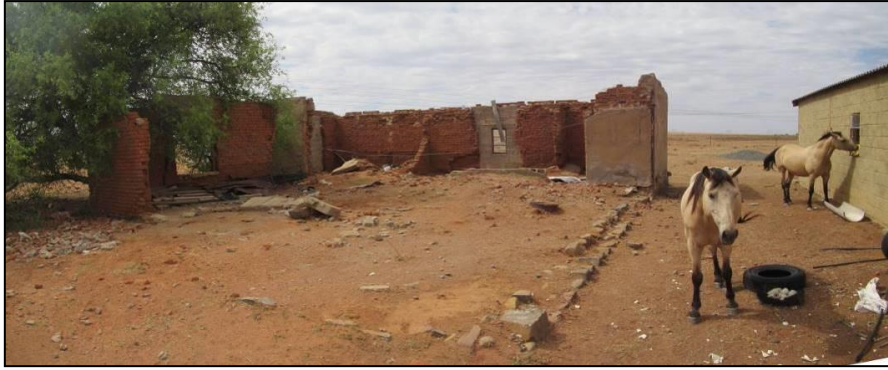
Figure 17: The ruined farm house at waypoint 886. A modern shed stands to the right.

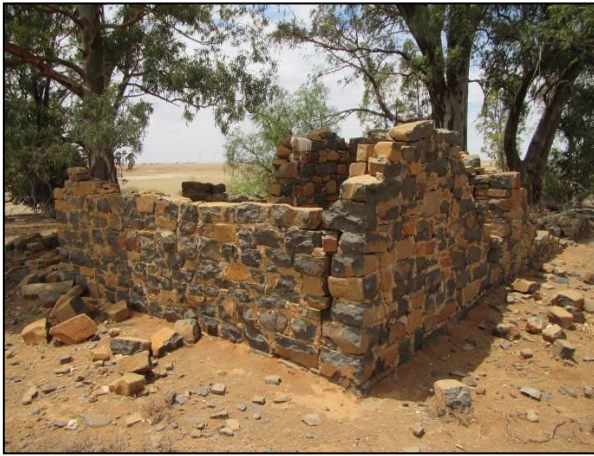
Figure 18: Ruined stone house at waypoint 900.

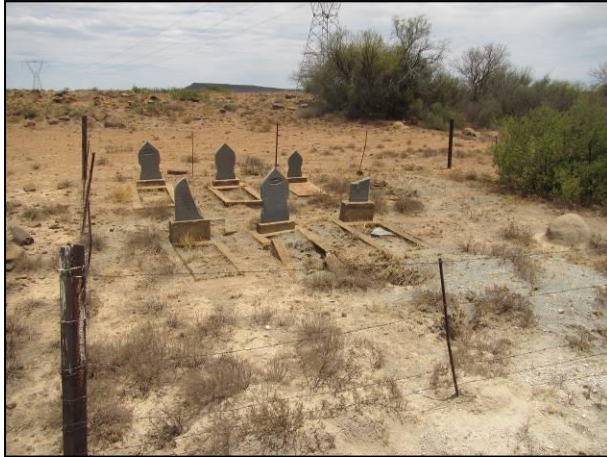
Figure 20: The small graveyard at waypoint 912 to the east of the large pan. Note the vandalised headstones.

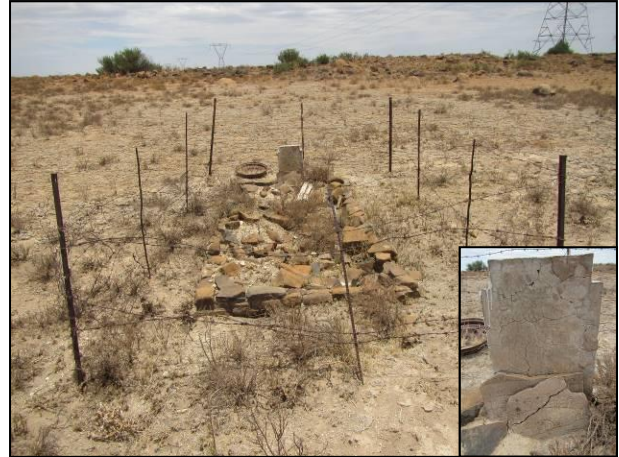
Figure 21: Single formal grave at waypoint 910 to the east of the large pan.

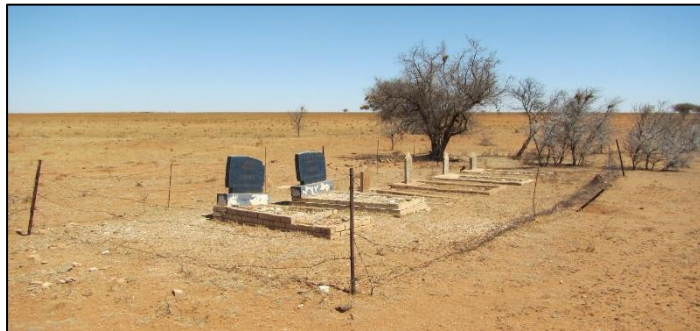
Figure 22: The small graveyard at waypoint 861 just inside the eastern edge of Option A.

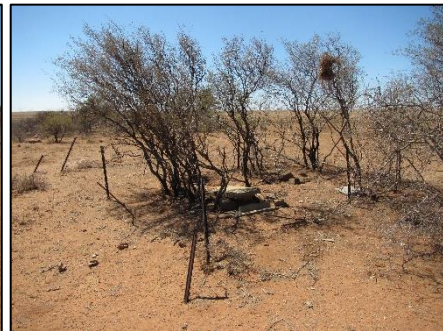
(Maxwell A)	862	S28 38 37.6 E25 42 27.8	Two graves of (presumably) white people. One is dated 1900 (Bekker) while the other was a baby who died in 1887 (Muras).	High AVOID
Maxwell A	863	S28 39 02.9 E25 42 40.1	A lightly deflated area where dolerite gravel has become exposed. A few MSA artefacts are evident amongst the gravel.	Very Low
(Maxwell A)	864	S28 38 28.3 E25 42 25.0	Historical foundation of stone. Some are disturbed.	Low
(Maxwell A)	865	S28 38 29.4 E25 42 24.6	Historical foundation of stone. Some are disturbed.	Low
(Maxwell A)	866	S28 38 29.4 E25 42 25.9	Historical foundation of stone. Some are disturbed.	Low
Maxwell A	867	S28 38 30.6 E25 42 23.7	Two stone-packed dolerite grave mounds.	High AVOID
(near Maxwell A)	868	S28 38 25.7 E25 42 43.6	A historical stone foundation but with a pile of bricks lying at one end.	Low
(near Maxwell A)	869	S28 38 26.8 E25 42 43.5	An area of packed calcrete rocks. Seems too large for a conventional grave, though it could either be a double grave or something else entirely.	Unknown (High?) AVOID or test and exhume

Figure 23: The single formal grave at waypoint 862 just outside Option A.

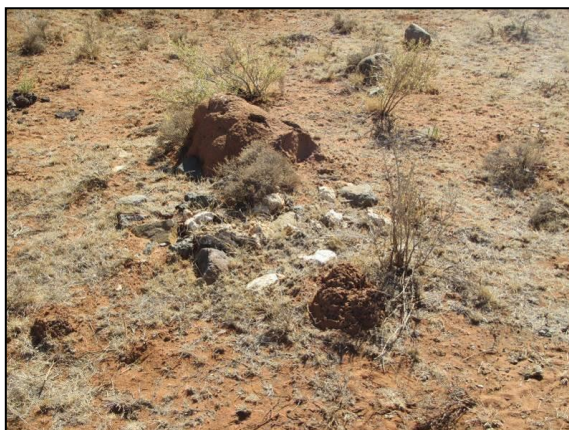
Figure 24: An isolated grave at waypoint 881 located close to other historical features. (Note the apparent head- and footstones are actually termite mounds.)

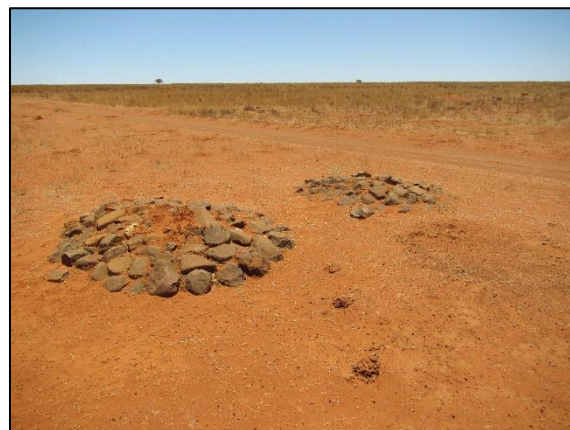
Figure 25: Two isolated informal graves just inside the eastern margin of PV Option A.

- For Option B only, any significant archaeological sites that cannot be avoided with a buffer of at least 20 m should be mitigated well in advance of the start of construction. The possible grave in Option B should also be tested. It should be noted that it is permissible for transmission lines to span archaeological sites, but any associated service roads and the facility access roads must avoid them;

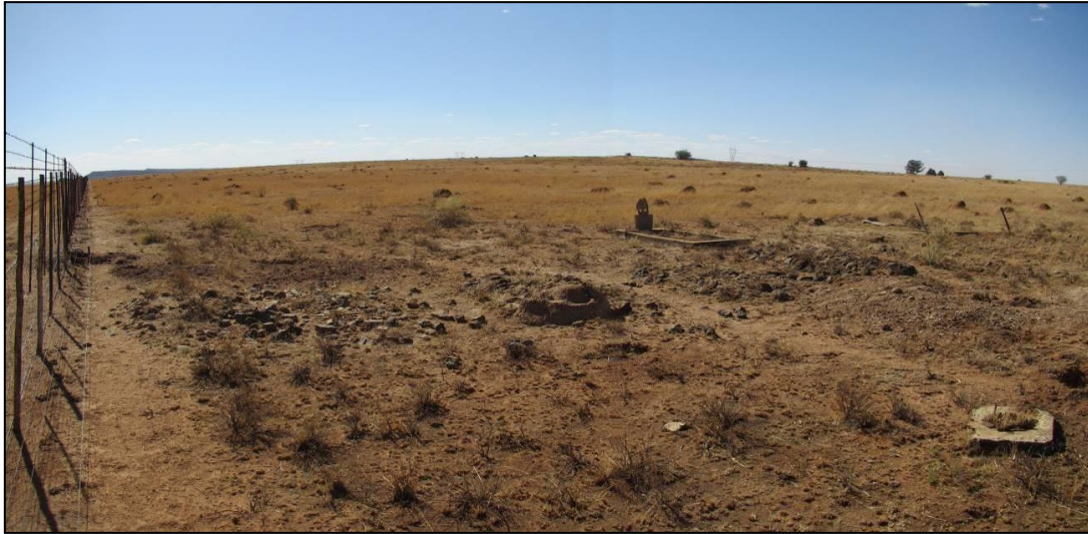
Figure 26: An unfenced graveyard at waypoint 883 lies in the middle of the EGI corridor.

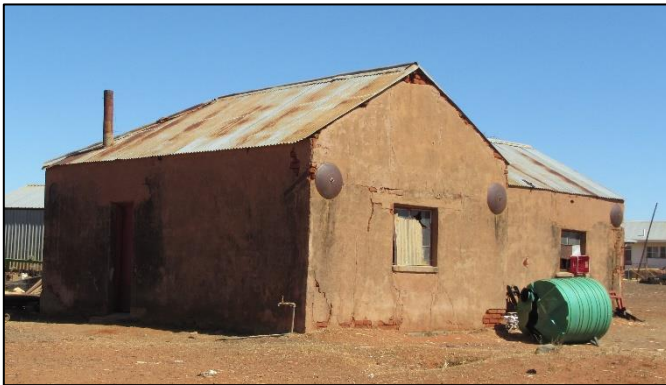
No standing heritage buildings were located within either PV study area, although one historical house was present in the extant farm complex outside the study area (Figure 27). Three stone-built dams were located, one within the EGI corridor (Figure 28) and the other two immediately outside of it in the south-western part of the broader study area. The age of these features is unknown but they almost certainly predate the easy access to round concrete reservoirs. They are not significant.

Figure 28: The historic house at the Carlton farm complex.

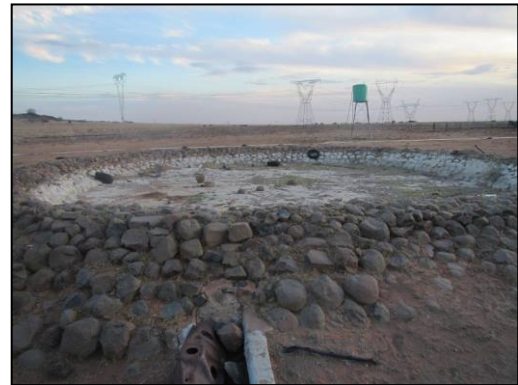
Figure 28: Stone dam at waypoint 929.
