PROPOSED TOURISM DEVELOPMENT FARM 956 SIMONDIUM

DRAFT PHASE 1 HERITAGE IMPACT ASSESSMENT
Prepared in compliance with **Section 38(3)** of the National Heritage Resources Act
(No 25 of 1999)

AIKMAN ASSOCIATES
HERITAGE MANAGEMENT
P O Box 140
Tulbagh 6820
Cell 083 306 67 68
aikman@wol.co.za
HWC Case number: 20030508

August 2020

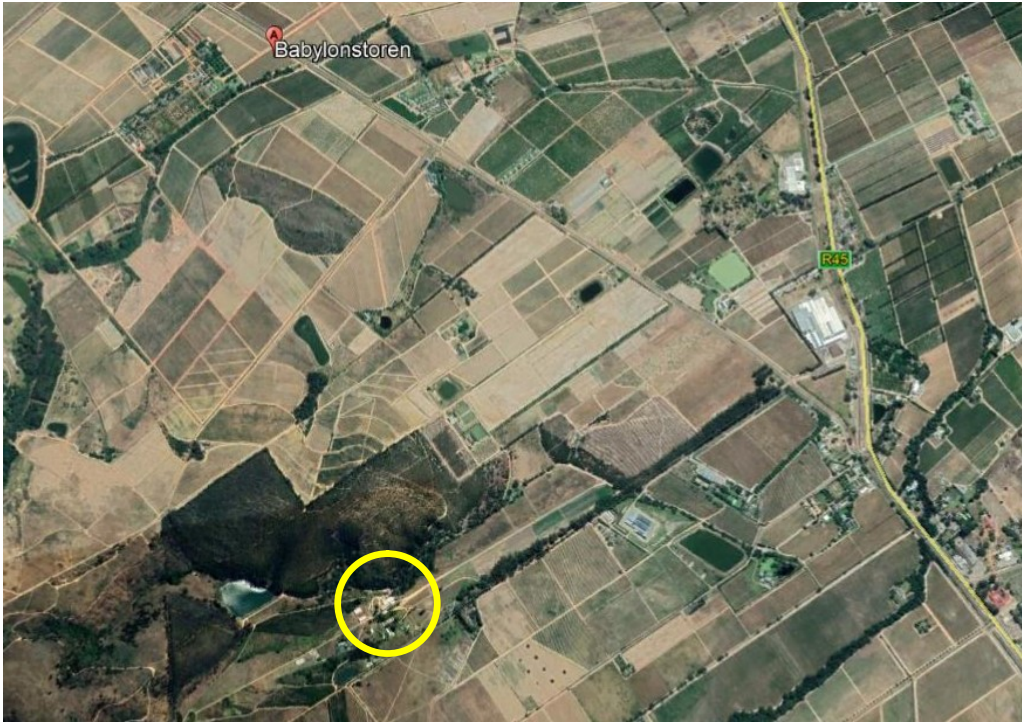
Figure 2: The farmstead (circled) is sited towards the south western end of the farm. The Simondium church and commercial centre on the R45 can be seen on the right

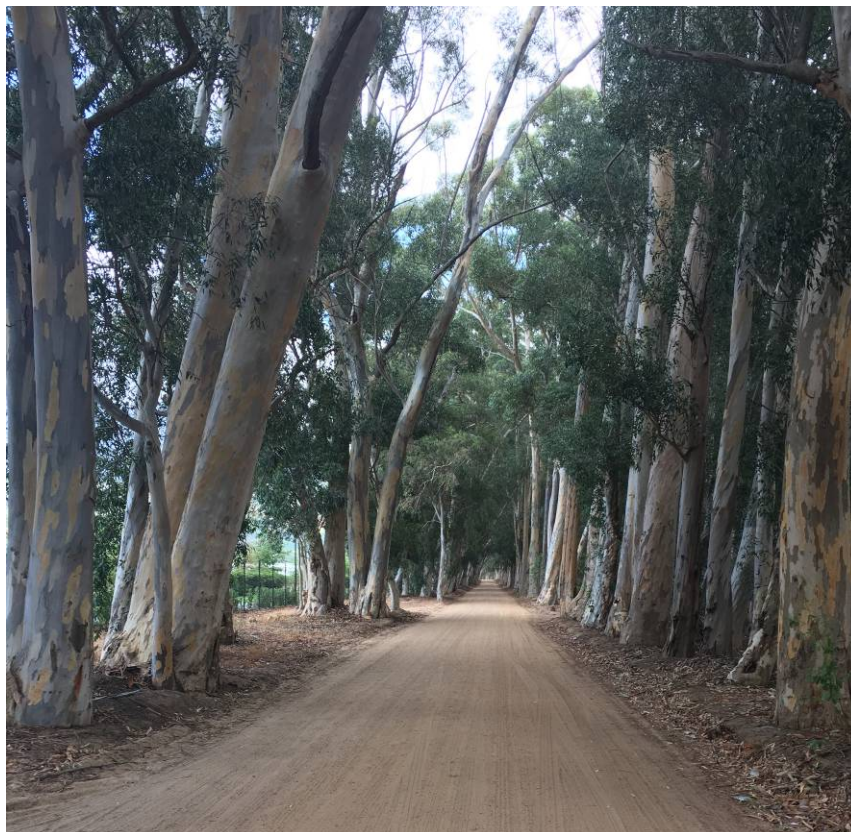
Figure 6: The old avenue is probably over 100 years old

These trees *eucalyptus globulus* were probably planted by Koch soon after he acquired the farm. They were widely used in the fruit farming areas as a source of nectar for the bee pollinators. This species can live for over 200 years so we are assured that they could still be there for another 100 years. The avenue should be graded II.

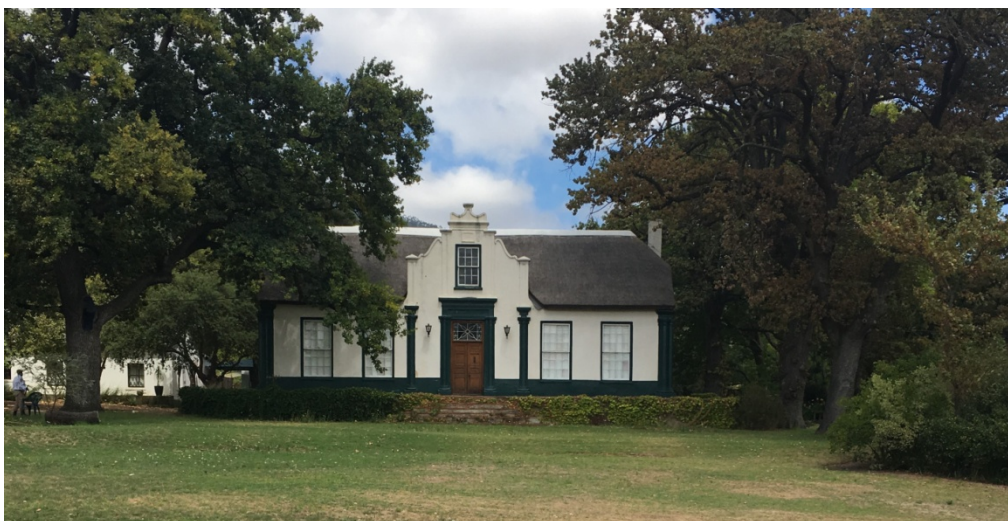
Figure 7: The main facade

The U-shaped thatched roof homestead has a gable dated 1851 and its plan form is typical of homesteads of the mid 19th Century. It has an entrance hall rather than a “Voorhuis”. The only natural light into the entrance hall is from the fanlight over the split front door. There are decorative pilasters on each corner of the facade and on either side of the front door. There are 12 over 12 sliding sash windows on either side of the front door. It has been altered with various additions over the life of the building. The courtyard between the two wings was roofed over fairly recently and the north west wing was lengthened. There are various minor alterations with pre-existing doors being bricked up and other openings made. A bathroom was introduced into the main front bedroom.

Until further research into the layering that has taken place is complete no interventions should be undertaken. To this end an application for a permit to strategically remove plaster has been submitted to HWC.

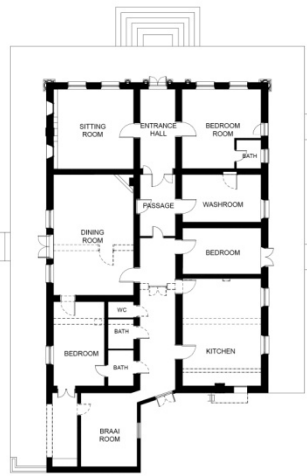
1. Dining Room wall moved to create bigger bedroom / school room
2. Kitchen relocated
3. Braai room added on the South Western corner
4. Back door moved to the South Western end
5. Bathrooms added
6. Two windows added flanking the fire place

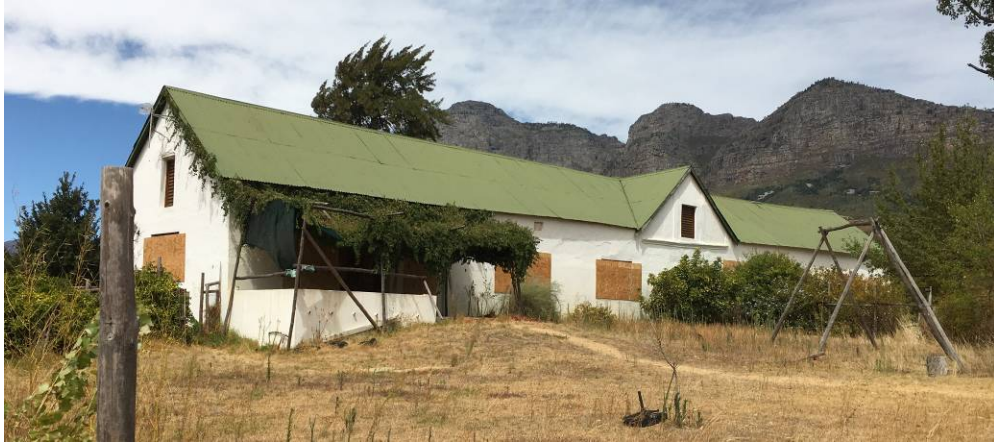
The T-shaped outbuilding to the northeast of the homestead with a clipped central gable and the remains of four pilasters has been converted into two separate dwellings with brick walls creating bedrooms, bathrooms and kitchens. Historical photographs indicate that it was indeed a stable complex probably accommodating mules, tack room and feed stores with doors along the main facade. It is now roofed with corrugated iron sheeting but must have been thatched originally. Fransen speculates that it may have been the original dwelling but there is little or no evidence of this and the ruins of a large earlier dwelling and outbuildings in the area known as Agterbos has been identified in the AIA.

Figure 8: Main facade

A permit to remove plaster to understand the layering has been submitted to HWC.

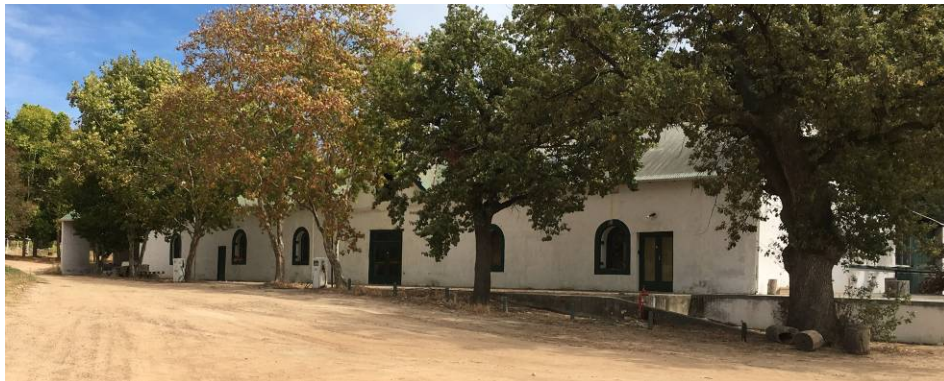
The core of this T-shaped structure is identical in form to the stables and has a matching clipped gable, string course and also with the remains of four pilasters. Unlike the stables it has arched openings on the main facade. Given that the Koch family were fruit farmers and it seems probable that wine farming ceased in the late 19th Century, the cellar has not been used for wine making for over 100 years.

Figure 9: Main facade of the cellar

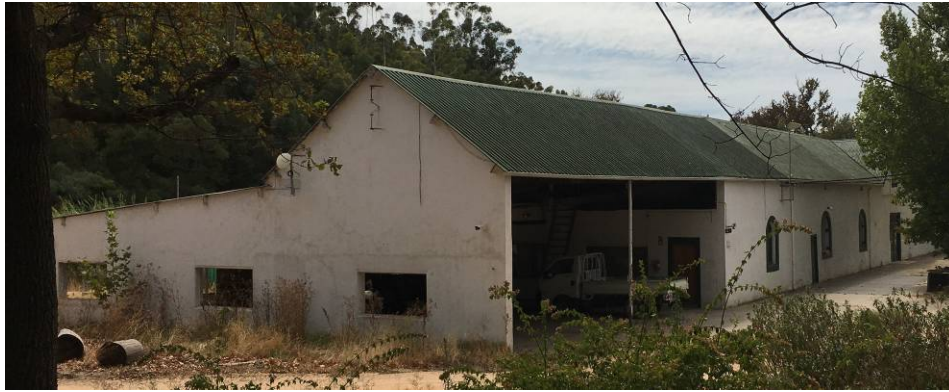
It has been extensively and unsympathetically altered and extended with lean-to roofing to accommodate storerooms, workshops and offices. The Koch computer company operated from the old core.

Figure 10: The original structure has been incrementally extended

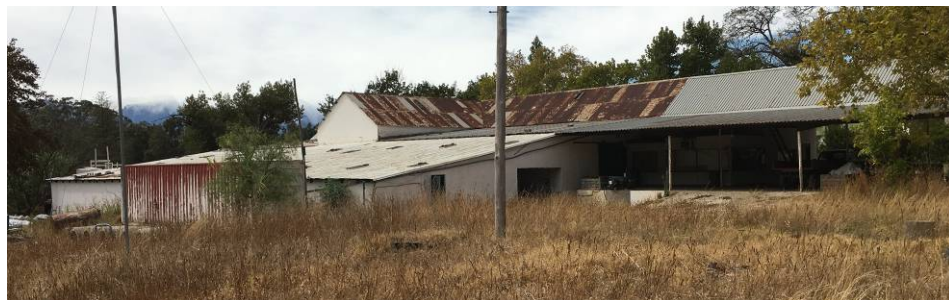
Figure 11: Lean-to additions at the back of the structure

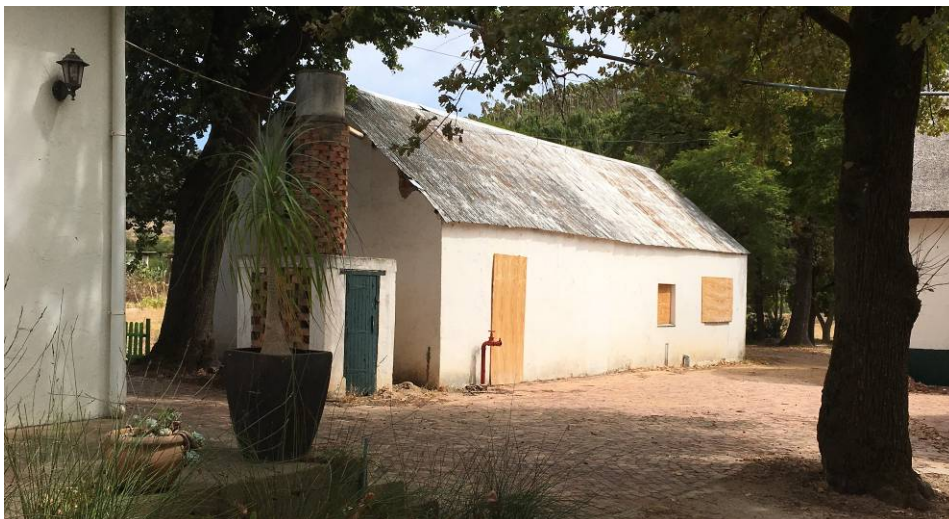
Directly behind the homestead is a small rectangular structure which is the same width as the homestead and probably built at the same time. One of the old photographs indicates that it may have used to stable carriage horses.

Figure 12: Staff quarters

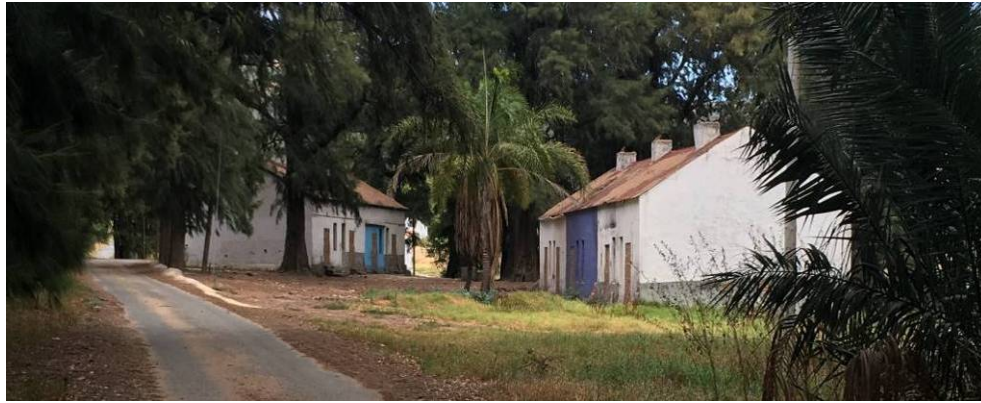
There are two late 19th Century cottages some distance from the farmstead. They are listed in the Drakenstein Heritage Survey 2010 as a 3C resource (Resource No 953).

Figure 13: These buildings accommodated five families before they were vacated

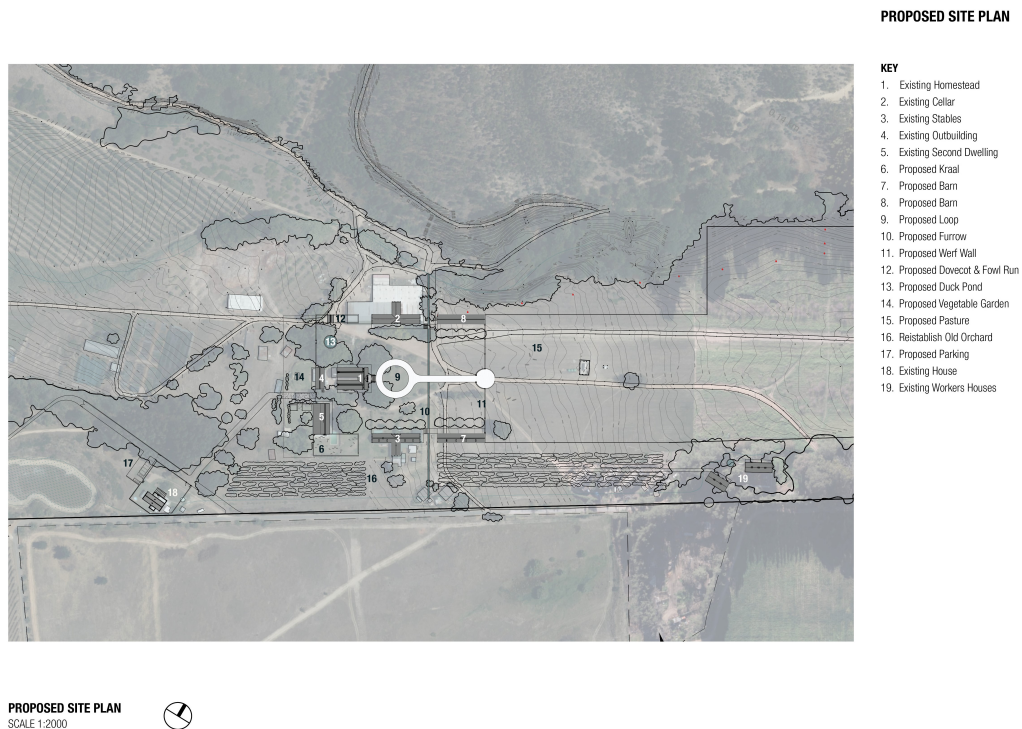
The attached Architect's Statement sets out the analytical process followed that led to the proposed Site Development Plan (SDP). As depicted in the drawings prepared by Open City Architects the existing homestead and outbuildings are to be repurposed and new structures are to be added to the ensemble.

Figure 14: Conceptual layout

The broad concept at this stage is for the farmstead to be brought back to life as the centrepiece of a traditional mixed-use working farm with existing outbuildings and additional structures that could be introduced accommodating for example a blacksmiths shop, leatherwork, carpentry and joinery shop, bakery, kitchens, delicatessen, restaurant, wagon sheds and animal barns. These would function both as a tourist destination and as an educational facility. The central werf space would be used for family picnics and displays of farm vehicles and equipment from time to time. Access for the public to the complex would be via an old track linking Donkerhoek to Babylonstoren. Apart from staff vehicles, public parking would be at Babylonstoren. All the development would be related to the werf with nothing planned near the two ruined structures.
