Heritage Impact Assessment of the proposed reverse osmosis plant and associated infrastructure, Brandvlei, Hantam Local Municipality, Northern Cape.

December 2012

First Draft

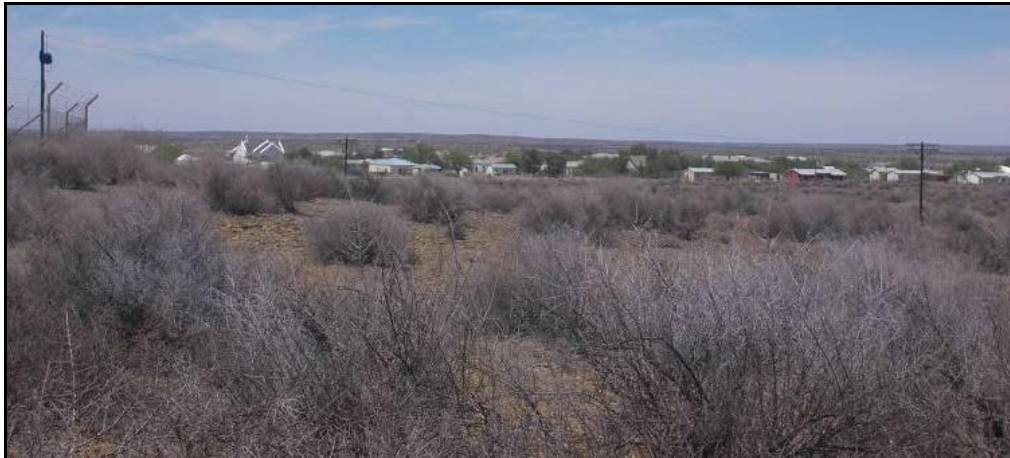
Plate 1: View from the current reservoir in a southerly direction, towards Brandvlei. Note the sparse vegetation and good ground visibility.

Visibility is good, with the vegetation around the reservoirs consisting of a low woody scrub (Plate 1). The boreholes are located on the edge of the Sak River and the soil here is very silty and the vegetation cover is extremely spare, reaching only to ankle height. There is an occasional thorn tree (Plate 5).

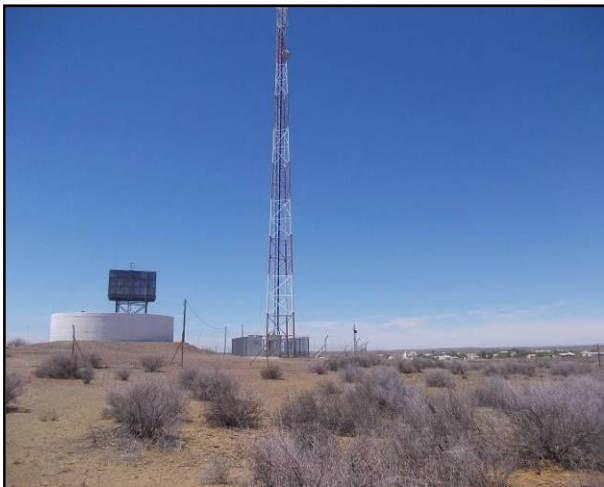
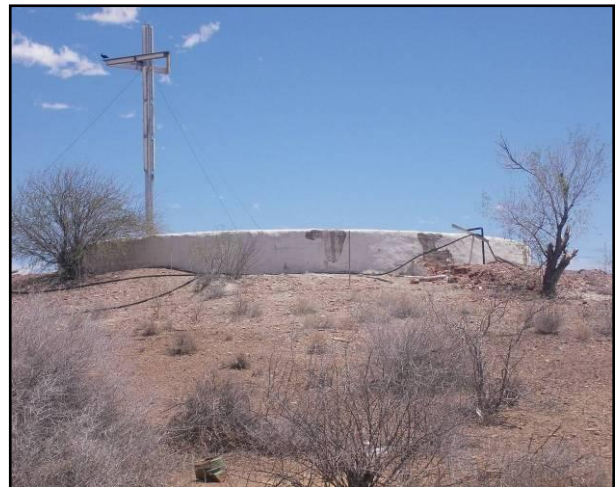
Plates 2 & 3: Infrastructure (reservoirs and cell phone tower) on top of the slight rise at the edge of town.

The reverse osmosis plant will be constructed on Erf 339 which is communal agricultural property owned by the Hantam Local Municipality. There is already a reservoir and cell phone tower on the property, which has the highest elevation in the vicinity of the town. There is evidence of considerable disturbance of the top soil, resulting from the construction of the current infrastructure.

There are no built environment issues on this site identified for the reverse osmosis facility. The reservoir and cell tower are all of recent date. The houses on Korster Street, all date to the last few decades and it is not expected that the construction of the facility will have any visual impact on the landscape of the town.

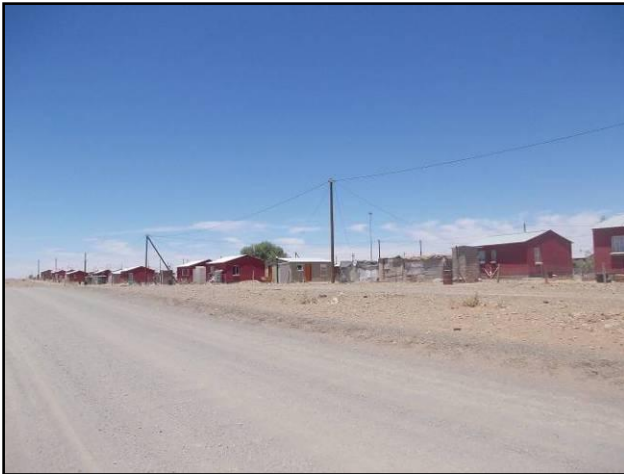
Plate 4: The houses along Korster Street which look towards the boreholes. **Plate 5:** The location of the boreholes on the edge of the Sak River.

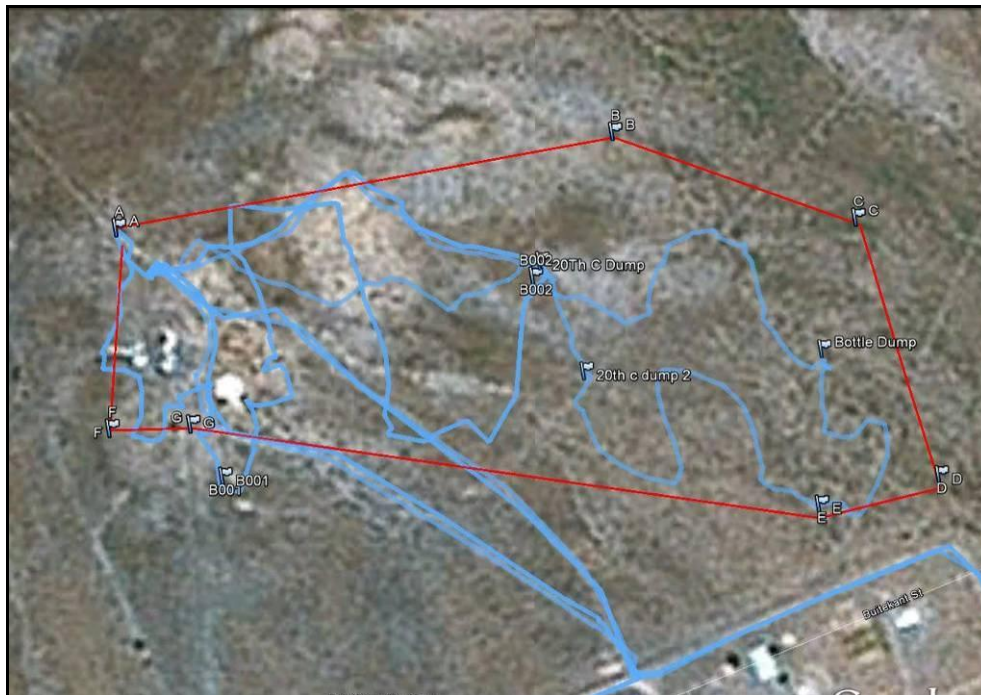
Figure 3: The survey tracks for the reverse osmosis plant on the north of town.

We did not record any pre-colonial archaeological remains. Site B001, immediately outside the study area (Figure 3) is a small scatter of stones under a bush. They do not appear to be a cairn and are unlikely to be of archaeological significance.

Apart from this, the only other remains are historical dump material (Table 1). We found scatters of 20th century dump material on at least three places (Figure 3). The scatters do not represent large scale dump events. Rather, they are very light scatters, possibly of a single site visit. These remains are of low significance.

Light scatters of 20th century dump material were recorded (Table 1). They are of low significance and no mitigation is required.

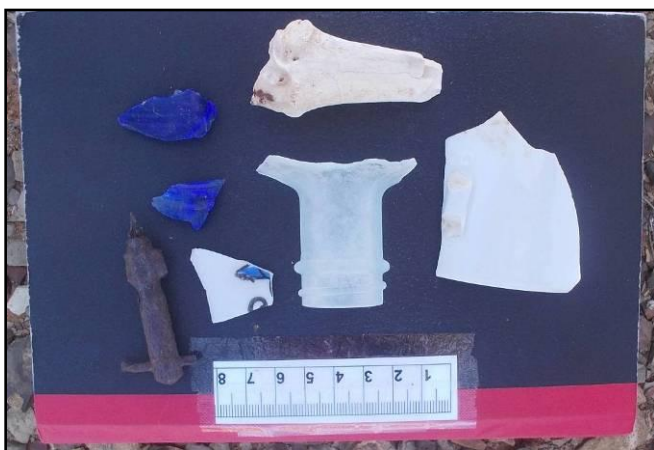
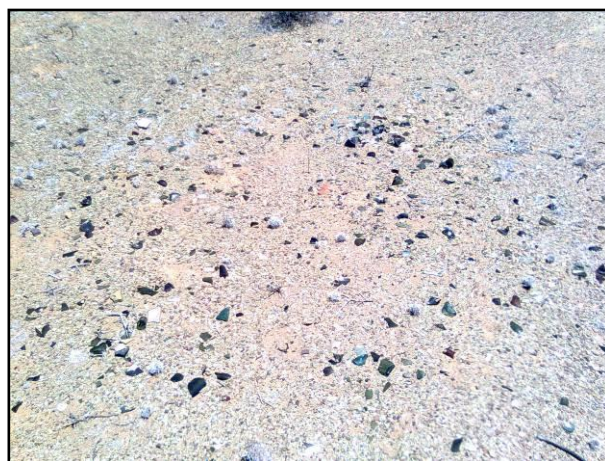
Plate 6: Twentieth century dump material from Site B002; **Plate 7:** Green bottle glass dump material.

A few scatters of 20th century dump material, such as glass fragments, rusted tin cans, ceramic and bone were identified and mapped. Concentrations are very low and they do not represent important historic dumps. The remains are considered to be of low significance.

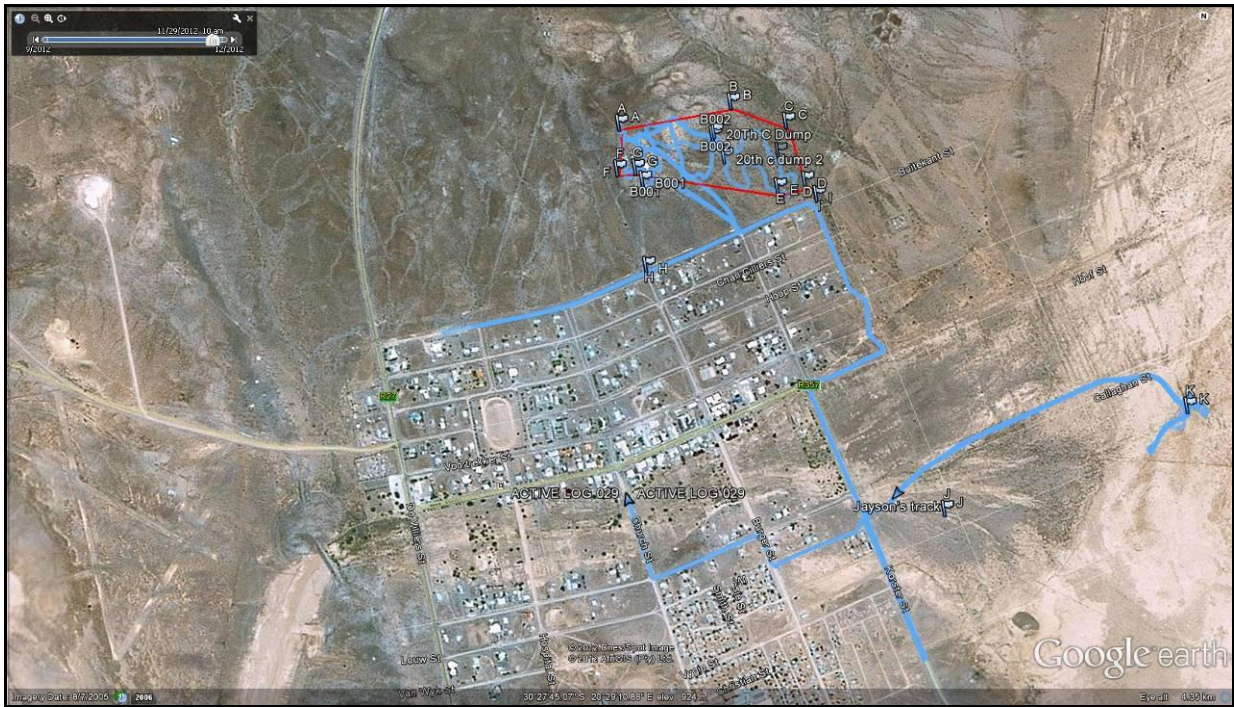
The site for the proposed reverse osmosis plant was examined on foot. We drove along the route of the proposed pipeline and powerline, and made spot checks on foot along the route. We also examined the area around the proposed boreholes.

Figure 4: The blue line represents the survey tracks along the powerline/pipeline and to the borehole.
