Heritage Assessment Cape Recife Waste Water Treatment Works

**HERITAGE IMPACT ASSESSMENT (HISTORICAL COMPONENT)
PROPOSED UPGRADE OF THE CAPE RECIFE WASTE WATER
TREATMENT WORKS IN PORT ELIZABETH, NELSON MANDELA BAY
MUNICIPALITY, EASTERN CAPE**

This document presents the historical component of the Heritage Impact Assessment assessing the area of the proposed upgrade and expansion of the Cape Recife waste water works in Port Elizabeth, Nelson Mandela Bay Municipality, Eastern Cape. The project will include a survey of shipwrecks in the vicinity of the proposed new sea outfall for treated effluent and the effect of the approximately 8 km long sludge pumping main from the Driftsands Waste Water Treatment Works that will traverse a portion of the Nelson Mandela Metropolitan University's property.

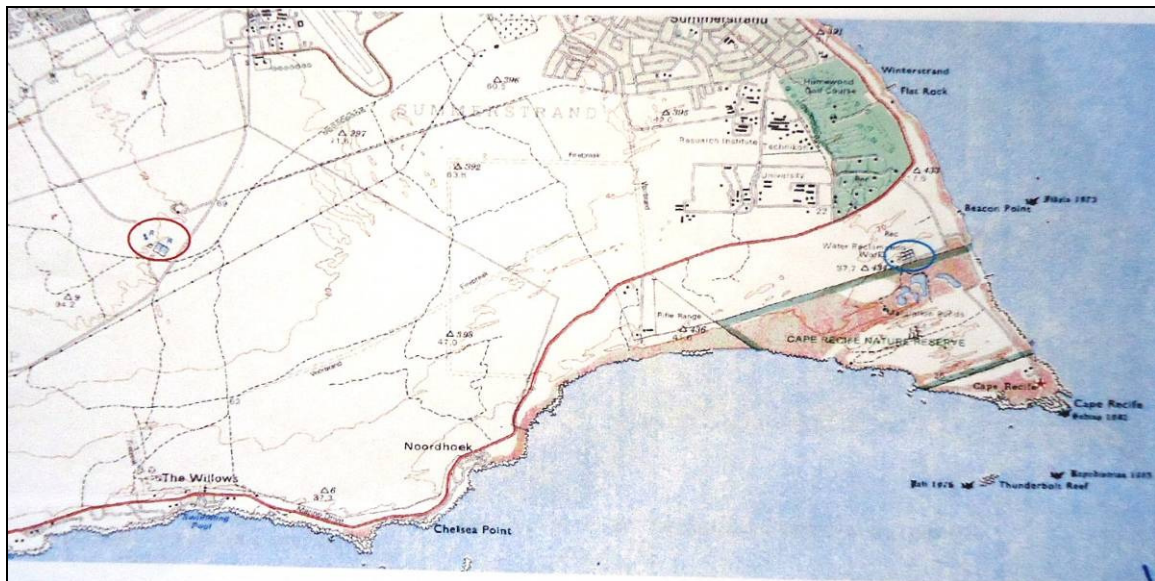
Fig 3 An extract of a 1:50 000 topographical map showing the relative location of the Cape Recife Waste Water Treatment Works (blue oval) and the Driftsands WWTW (red oval).

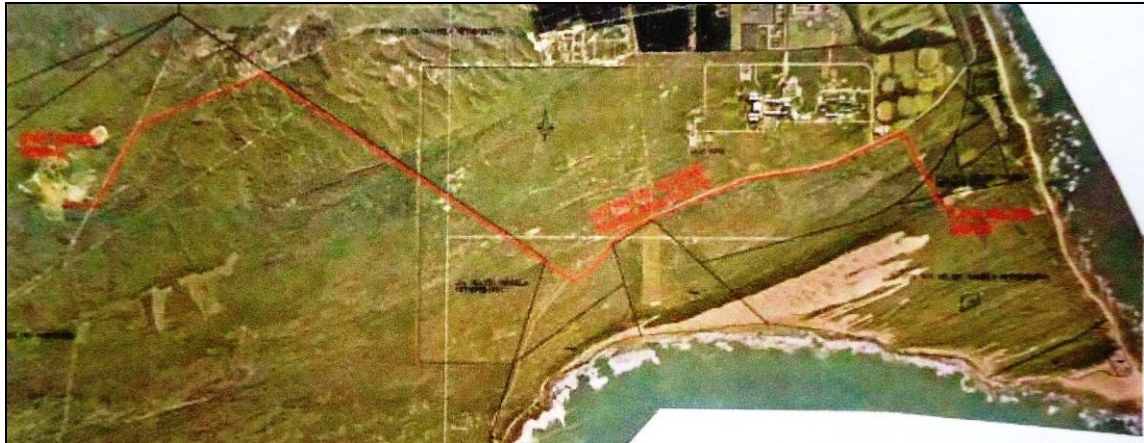
Fig 4 Aerial view showing the location of the Cape Recife WWTW, Driftsands WWTW and possible alignment of the sludge pumping main

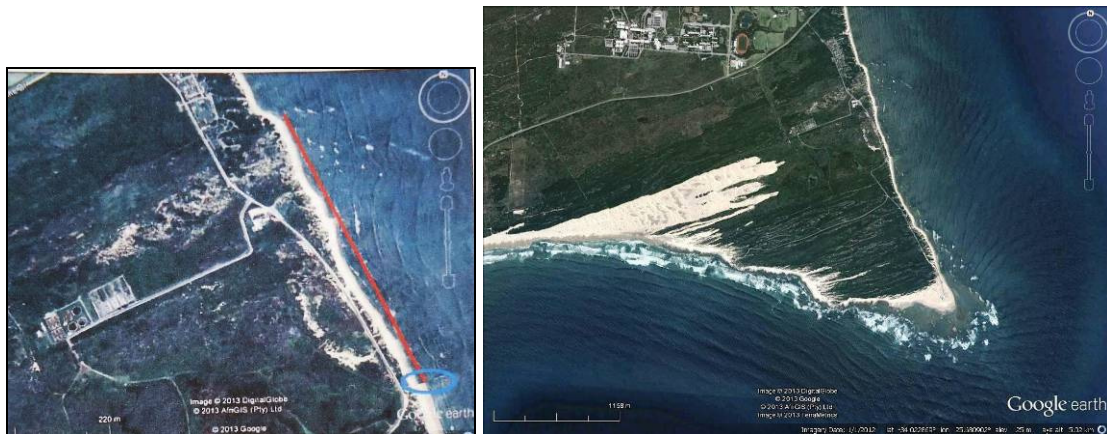
Fig 5 & 6 An indication of the area to be surveyed for new sea outfall

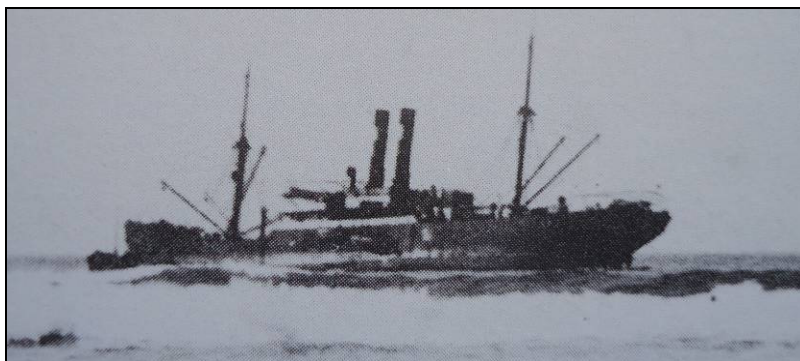
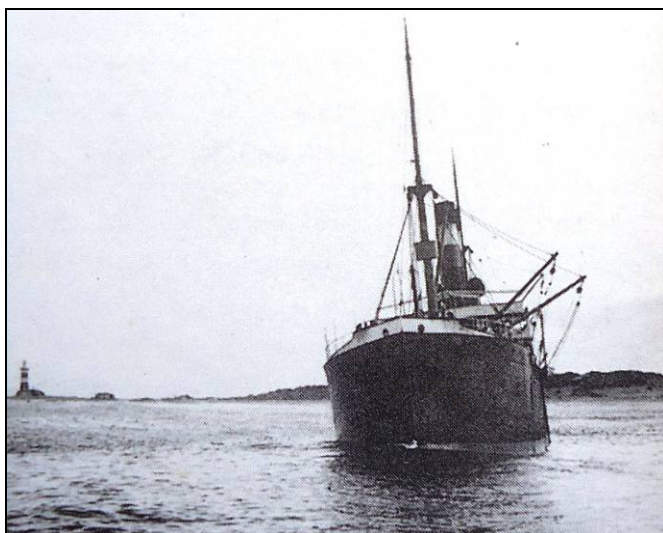
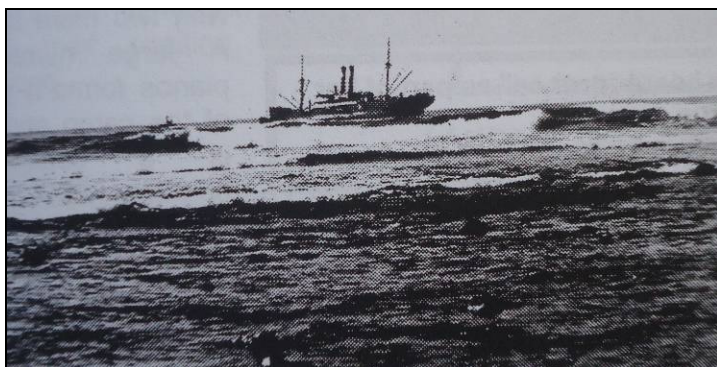
The twin-funnelled screw-steamer, *Itzehoe*, of the German Australian Line struck a reef opposite the first beacon a little north of Cape Recife lighthouse about a quarter of a mile from the shore, on a clear night. The lighthouse keeper summoned help and all were rescued, although the captain was injured falling from the bridge. The cargo included railway materials, pianos and soft goods.

Fig 11 Itzehoe wrecked 1911 *(Public Library)*

Fig 12 Itzehoe, Cape Recife lighthouse in background *(Public Library)*

Fig 13 Itzehoe *(Public Library)*

NB It is recommended that cognisance be taken of this wreck when the new outfall pipe is aligned.

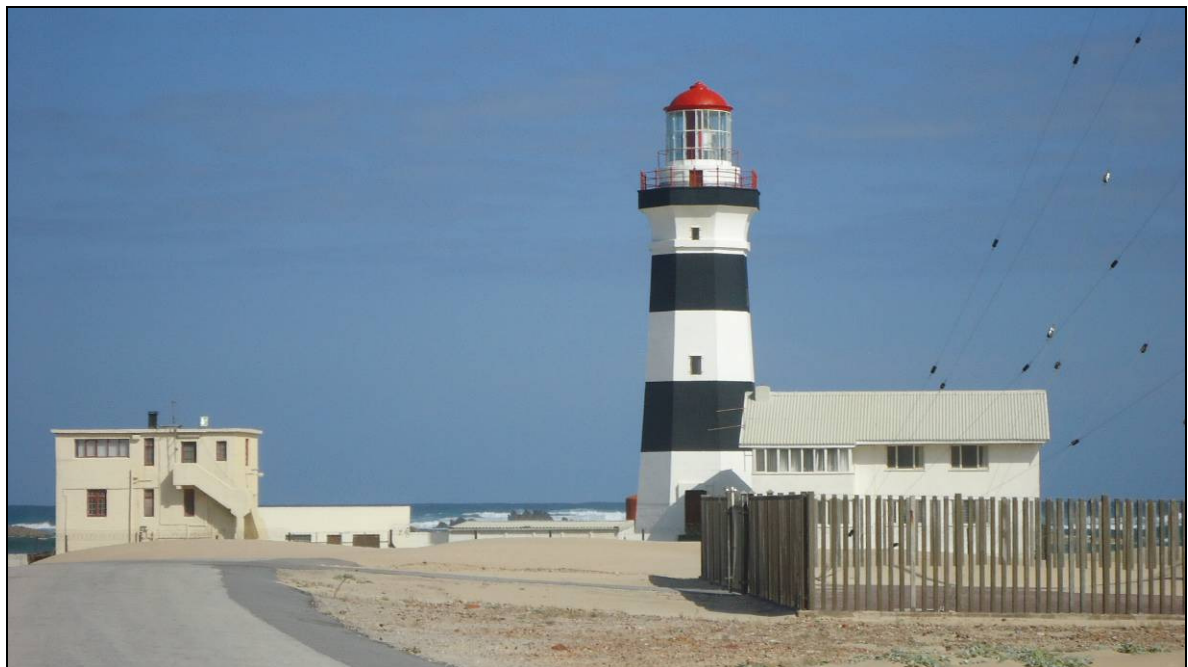
Fig 15 Cape Recife lighthouse, Sept. 2013

The Cape Recife lighthouse is the third oldest of the 56 lighthouses along the South African coastline. For the last 162 years the light has continued to burn although many changes have taken place to keep up with modern technology.

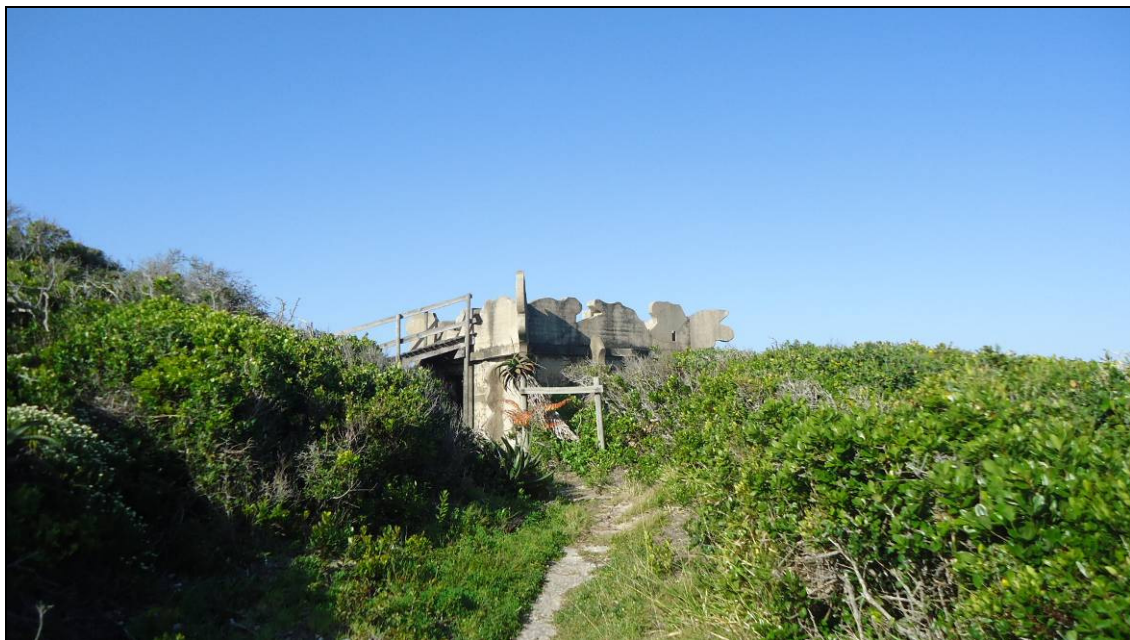
The F.O.P.s were built in 1940 – double-storeyed with a flat roof accessed by a steel ladder, with a loop-holed free-form parapet rising above the roof. Each was protected by a wire fence or entanglement. The FOP at Cape Recife also had a complex of barracks and other buildings. Towards the end of the war most of the coast artillery batteries were “mothballed” as the threat of enemy action decreased. By 1955 they were obsolete.

Fig 26 Fortress Observation Post

The Seahill Fortress Observation Post at Cape Recife is situated in the Cape Recife Nature Reserve in overgrown bush up on a hill with a view to the sea. Amongst the ruins two toilet cubicles can be identified and one of the small brick Rifleman's Posts building is to be found in the bush north of the FOP.

A Heritage Resource Management Plan should be developed to record these significant sites and structures, and provide recommendations for the monitoring and preservation thereof. Some buildings have become degraded due to neglect and it is essential that they do not continue to slide into disrepair. These structures could form part of a conservation/ preservation project for the Defence Force.

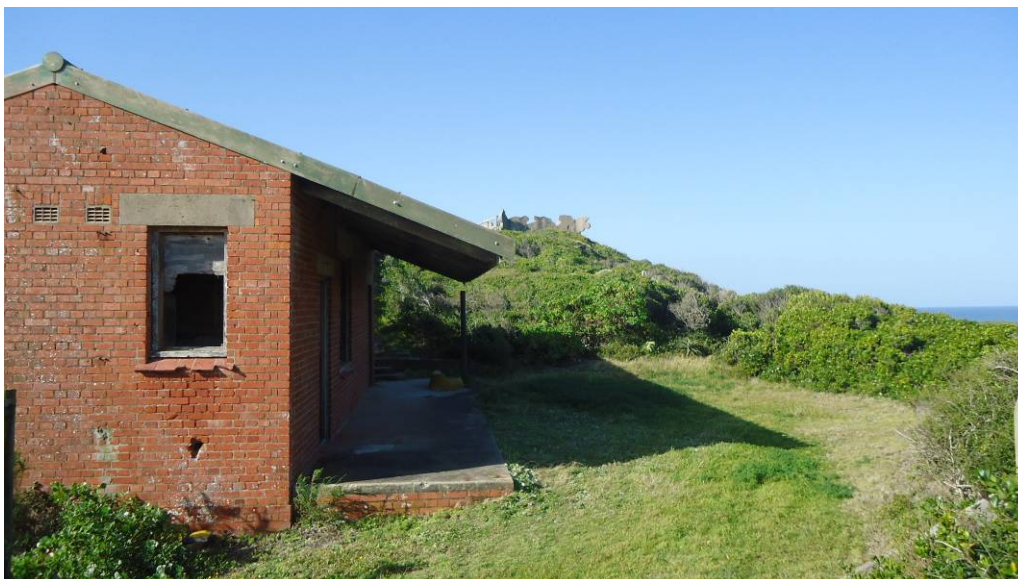
Fig 27 Guard House

To the west there is also a brick building with a gabled roof of timber and asbestos sheeting (possibly a guard house). There are two small buildings next to the access track from the road and a row of five roofless buildings used for barracks and offices, with ablution blocks and toilets, alongside the road.

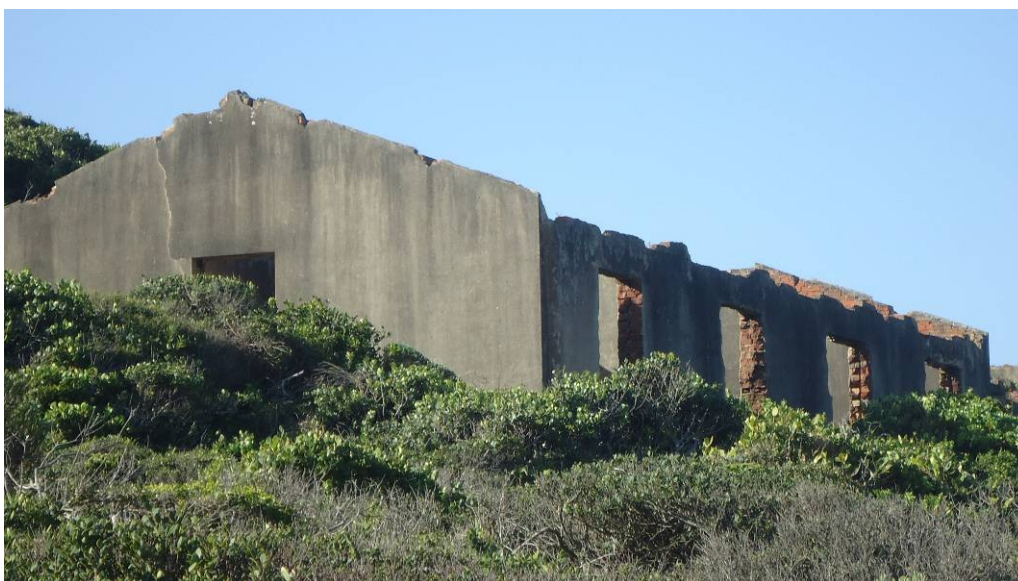
Fig 28 Roofless barracks

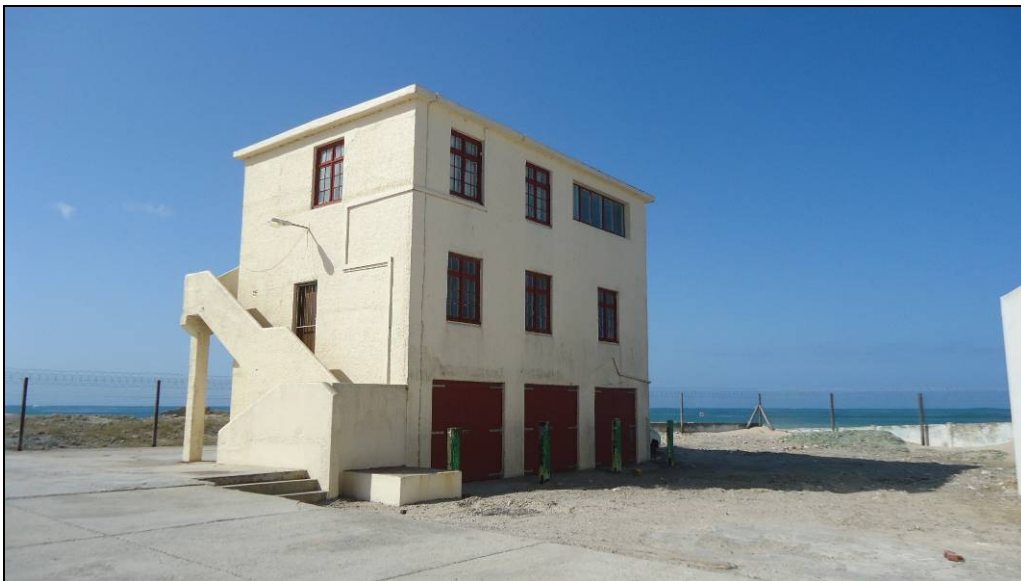
Situated on the Cape Recife peninsula this detached three storeyed flat-roofed building is to the left of the Cape Recife lighthouse. The lower floor consists of three lock-up garages. The middle floor was living accommodation and the upper floor offices. The observation room, at the second level, still retains its original east side lift-out windows. On the north side external stairs service a mezzanine storeroom and two upper floors. The buildings and lighthouse are the property of Portnet and are excellently maintained. (2013).

Fig 30 Cape Recife Port War Signal Station

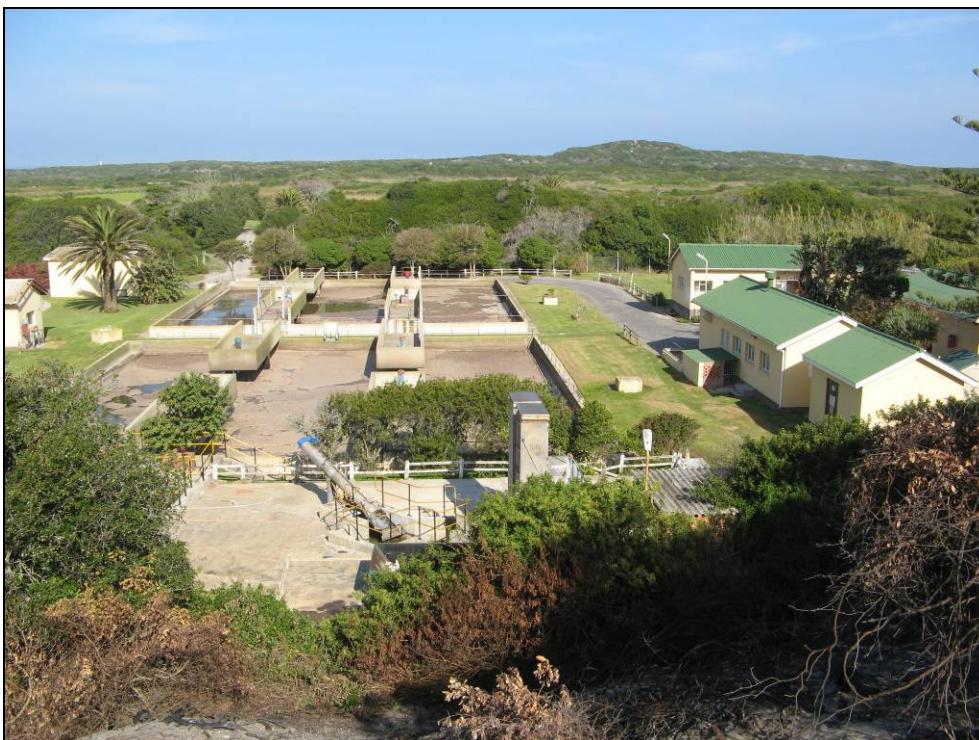
Fig 40 Cape Recife WWTW after the fire 2013 *(Photo: G Smith)*

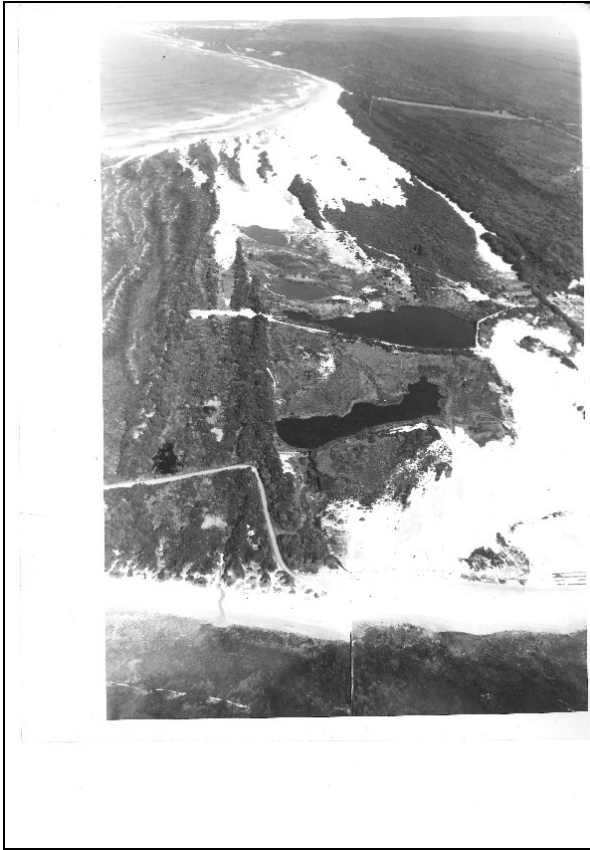
Fig 42 Cape Recife WWTW outfall sewer 1975

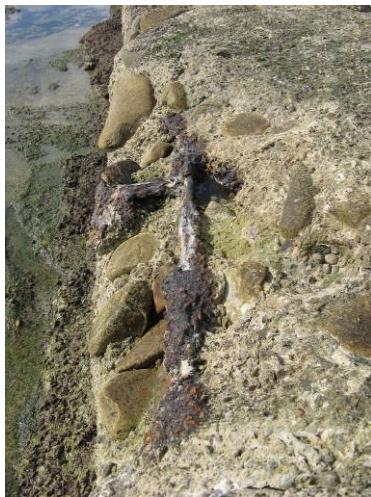
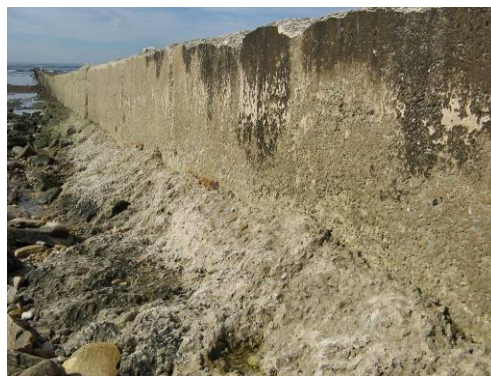
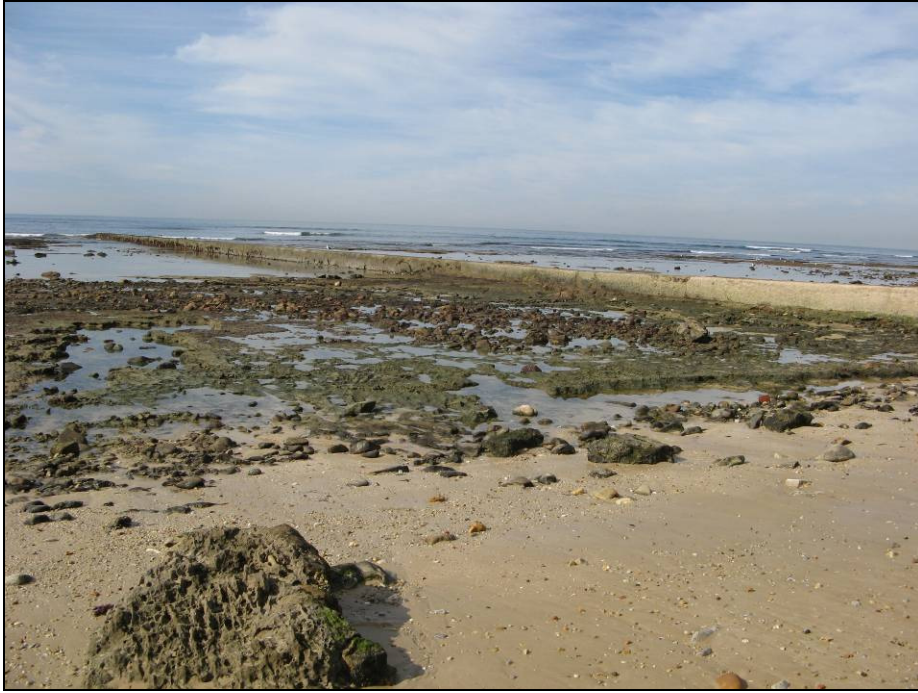
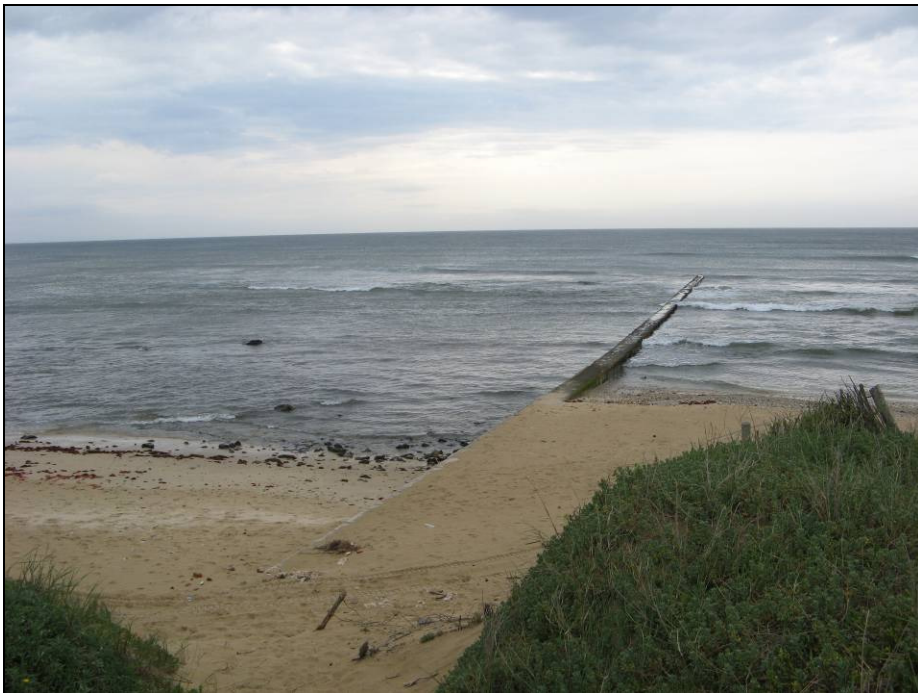
Figs 43-46 Outfall pipe Cape Recife

- Four wreck sites are in the possible vicinity of the outfall sewer pipe
- The lighthouse (in excellent repair) and the World War II FOP's (in derelict condition) are in need of preservation
- The Cape Recife WWTW and Driftsands WWTW do not fall into the 60 year clause and can therefore be altered
- SAMREC is new, but management needs to be kept informed of the developments likely to take place in the vicinity
- There do not appear to be any graves, formal or informal, along the proposed 8km pipeline between Cape Recife WWTW and Driftsands WWTW, but work should halt immediately should any be found
- No impact on heritage sites, features or objects can be allowed without a valid permit from SAHRA

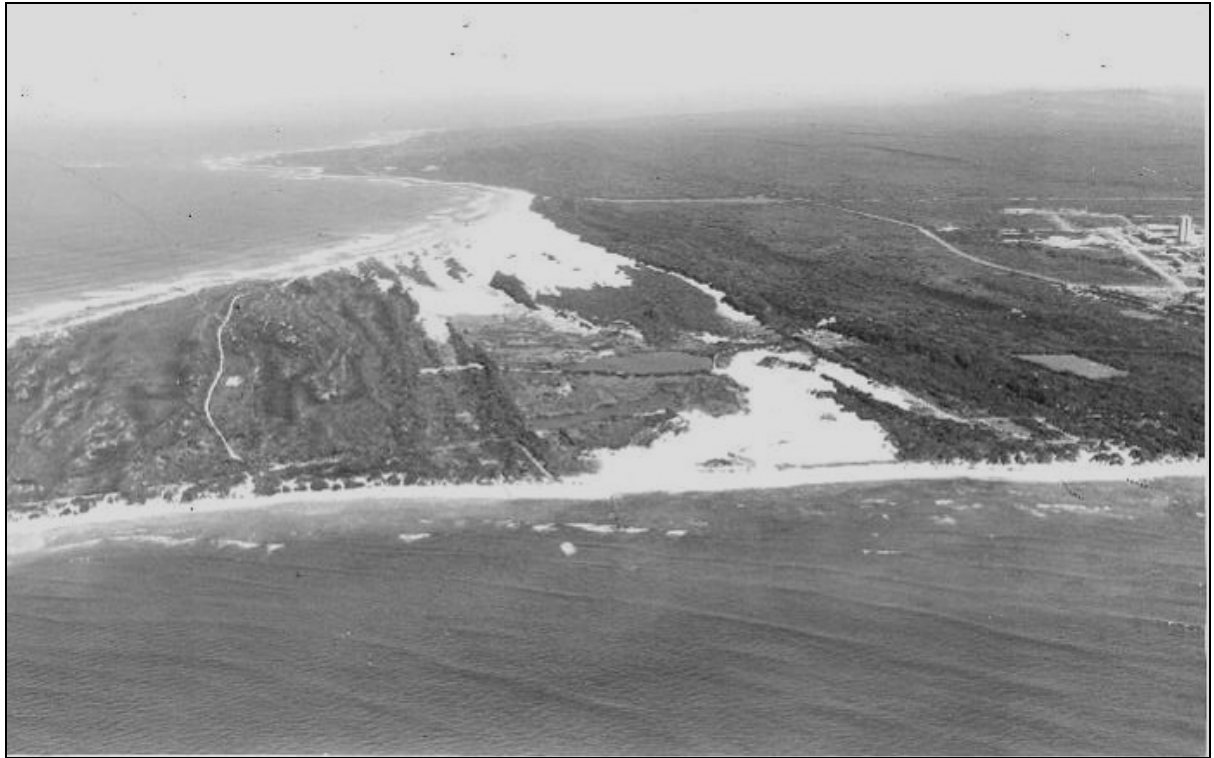
Fig 47 Cape Recife dune fields 1975

Fig 48 Google Earth dune fields comparison 2013

It is interesting to compare aerial photographs dating from 1975 with the Google Earth views of today (2013). Although considerable vegetation cover has occurred over the past 35 years, once again it would appear that the gulches at Cape Recife are on the move.

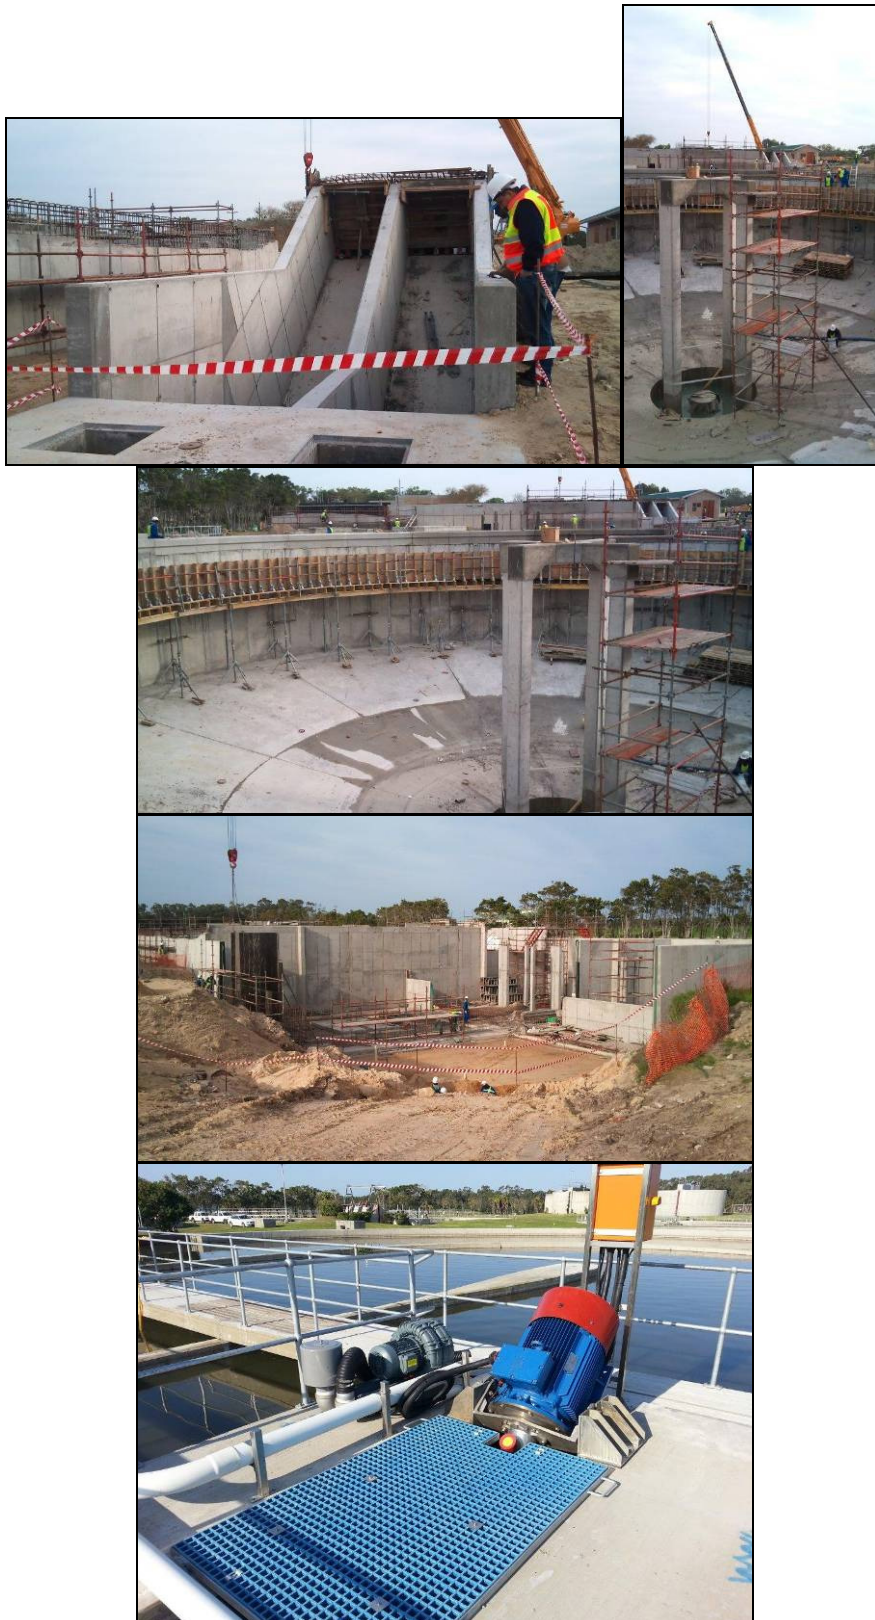
Fig 51-55 Driftstands WWTW under construction 1980's

NB Upgrades at the treatment works should not impact negatively on any heritage resources.
