HERITAGE IMPACT ASSESSMENT

FOR THE KRANSPAN MINING RIGHT EXTENSION PROJECT, NEAR CAROLINA
MPUMALANGA PROVINCE.

December 2022

Revised February 2023

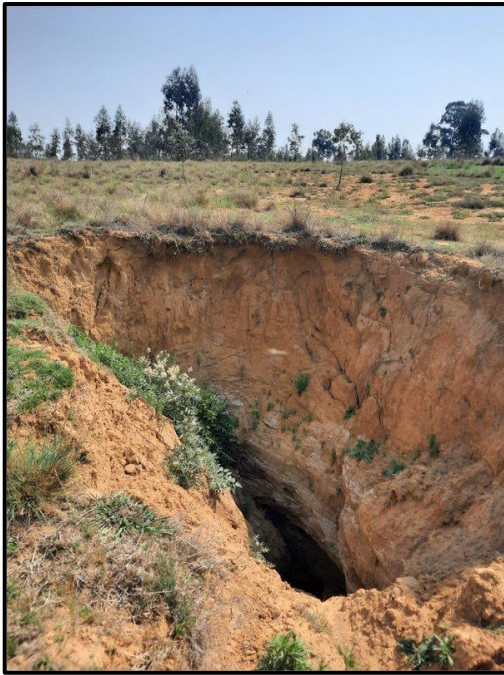
Evidence of previous mining activities seems to have taken place on the farm Roodebloem, marked by several sinkholes scattered over the landscape. The vegetation of the general area and the proposed site consists of Eastern Highveld Grassland (Mucina & Rutherford 2006). General site conditions area illustrated in Figures 7.1 to 7.4.

Figure 7.5. Large sinkholes are scattered across the area east of the R36, possibly indicating previous mining activities.

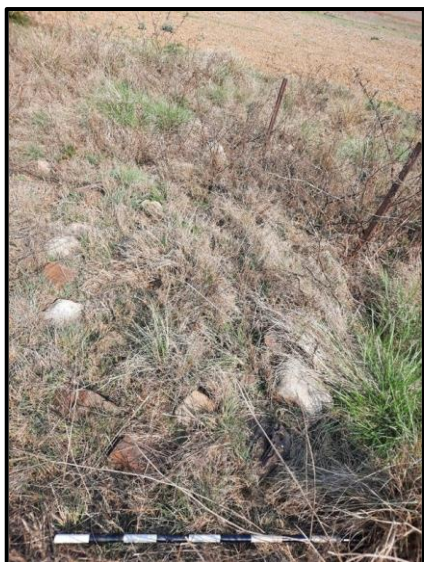
Figure 8.2. Stone packed grave at C002.

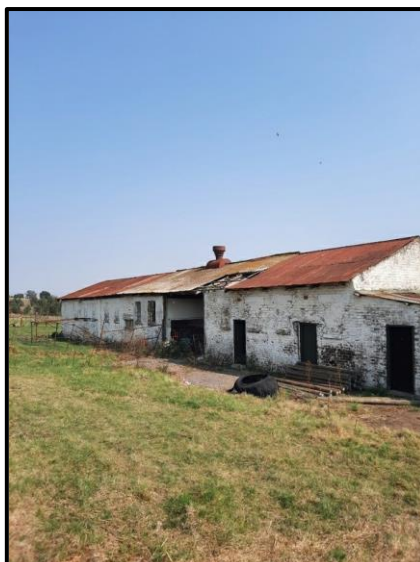
Figure 8.3. Farmstead at C003.

- Historical structures (C003, C006, C007, C010A, C015A, C016, C101) should be assessed by a conservation architect who will make suitable recommendations for mitigation, after which a destruction permit can be applied for from the relevant heritage authority;

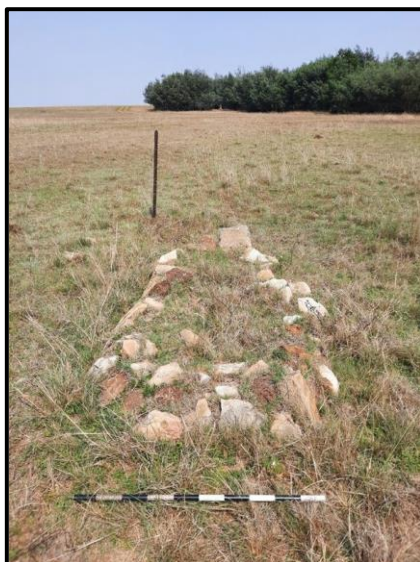
Figure 8.5. Stone packed grave at C008.

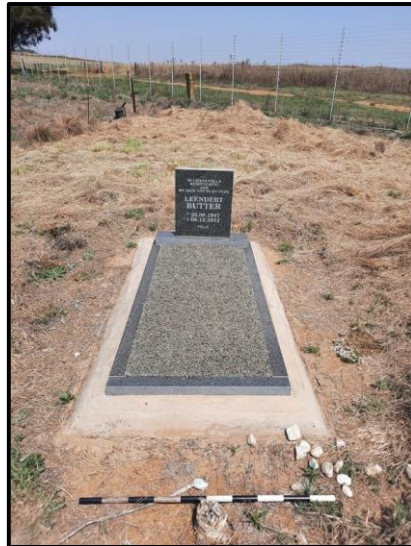
Figure 8.7. Modern grave with formal grave dressing at C015.

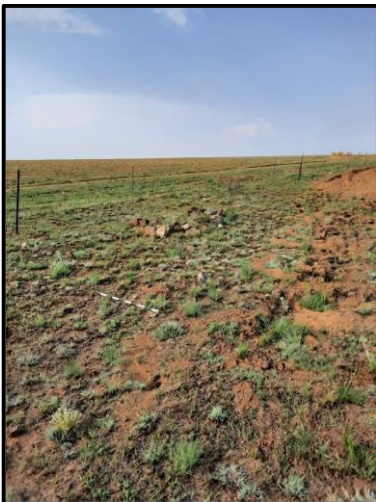
Figure 8.8. General view of a cemetery with 8 – 10 stone packed graves at C018.

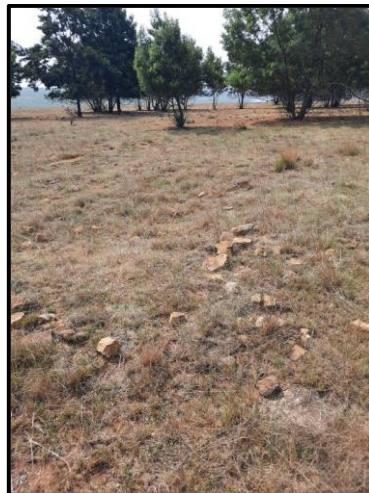
C025	30° 03' 55.7207" E	26° 11' 14.6148" S	Built Environment	Small series of mounds or the remnants of packed stone foundations, possibly indicating the remains of an informal settlement or worker's homestead. The site is situated neat the main access road along the eastern edge of the proposed project area. The site measures approximately 5 x 5 m.	Low Significance - GP C	Direct impact Open Cast Pit	1711,902
C026	29° 56' 23.3520" E	26° 12' 10.5695" S	Built Environment	Large historical farmstead situated on a large open field on a highly elevated portion of the landscape. Large agricultural fields are situated west of the farmstead and are still being cultivated. The farmstead includes multiple degraded structures such as the main farmhouse and a store or garage structure situated south of the main farmstead. The main building is mostly intact with only the roof missing and some of its walls showing signs of degradation. The structure is built from cut stone blocks and the site extent is 50 x 150 m	Medium significance - GP B	No impact	1712,238

Figure 8.9. Ephemeral remains of stone packed foundations at C025.

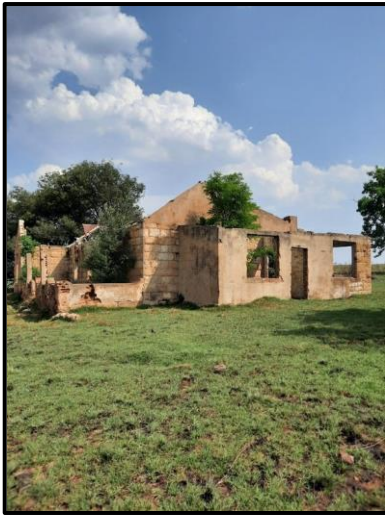
Figure 8.10. North facing walls of the remains of a farmstead at C026.

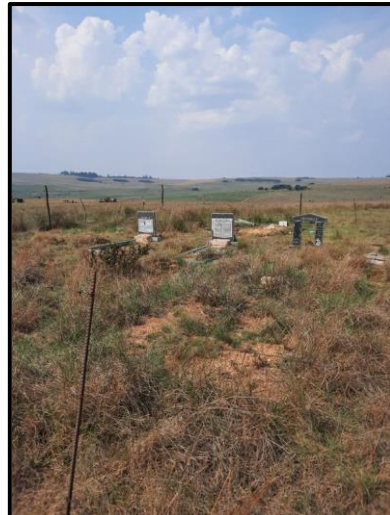
C027	29° 57' 40.5073" E	26° 13' 00.4908" S	Burial Site	Small modern cemetery situated near a small informal settlement nearby. The cemetery contains multiple modern graves with granite headstones, covers and skirting. The cemetery is also fenced off with a wire fence. Various other graves are visible within the small settlement itself. Access to the cemetery was difficult due to community members moving through the area. 10 - 15 graves were noted and the site measures approximately 10 x 15 m.	High significance - GP A	Direct impact - Overburden stockpile Open Cast Pit	1706,612
C028	29° 57' 40.3282" E	26° 12' 55.7461" S	Burial Site		High significance - GP A	Indirect Overburden stockpile Open Cast Pit (Buffer Zone)	
C101	29° 59' 06.0575" E	26° 13' 37.5349" S	Built Environment	Large existing farmstead situated near the main road running along the southern edge of the Project area. The site includes multiple structures that are scattered around the main farmstead. Some of the structures seem to be of historical age having been built from large cut sandstone blocks.	Medium significance - GP B	Direct impact - Open Cast Pit	1729,294

Figure 8.11. Small, modern cemetery at C027 and C028.

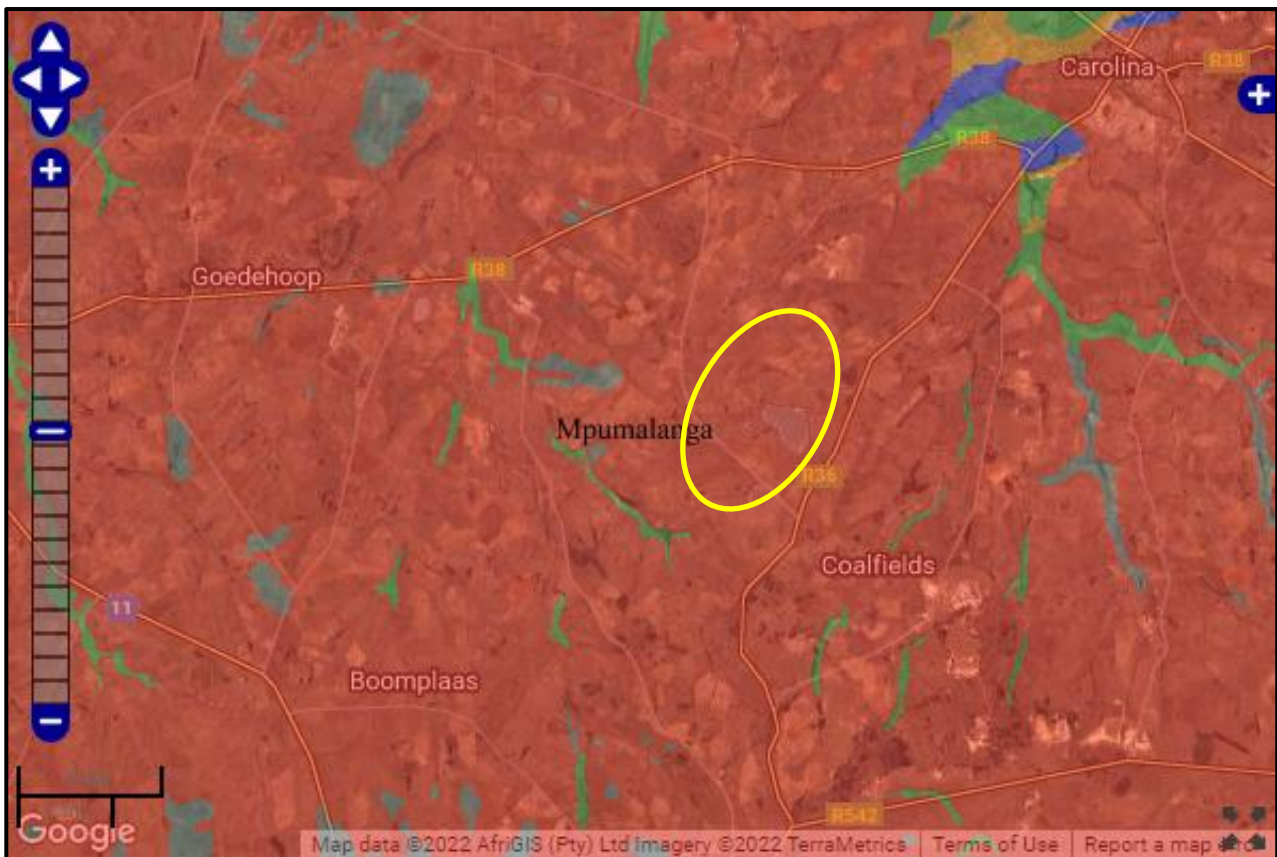
Colour	Sensitivity	Required Action
RED	VERY HIGH	Field assessment and protocol for finds is required
ORANGE/YELLOW	HIGH	Desktop study is required and based on the outcome of the desktop study, a field assessment is likely
GREEN	MODERATE	Desktop study is required
BLUE	LOW	No palaeontological studies are required however a protocol for finds is required
GREY	INSIGNIFICANT/ZERO	No palaeontological studies are required
WHITE/CLEAR	UNKNOWN	These areas will require a minimum of a desktop study. As more information comes to light, SAHRA will continue to populate the map

Figure 8.12. Paleontological sensitivity of the approximate study area (yellow polygon) as indicated on the SAHRA Palaeontological sensitivity map.

According to the SAHRA Paleontological map the study area is of very high paleontological significance (Figure 8.12) and this aspect was addressed in an independent paleontological assessment by Prof Marion Bamford (2022). The study found that the proposed sites lie entirely on potentially very highly sensitive rocks of the Vryheid Formation (Ecca Group, Karoo Supergroup) that could preserve impressions of fossil plants of the *Glossopteris* flora. The site visit and walk through by the palaeontologist confirmed that there are NO FOSSIL PLANTS of the *Glossopteris* flora present on the surface. The area is flat and open with secondary grassland or glades of invasive trees. Most of the area has been cultivated previously. It is unknown if there are fossils below the ground surface, therefore, a Fossil Chance Find Protocol should be added to the EMPr
