# CONSTANTIA UITSIG

Proposed Development on Erven 3025 and 9795 Constantia  
Spaanschemat River Road, Constantia

## HERITAGE IMPACT ASSESSMENT

## PHASE 1 REPORT

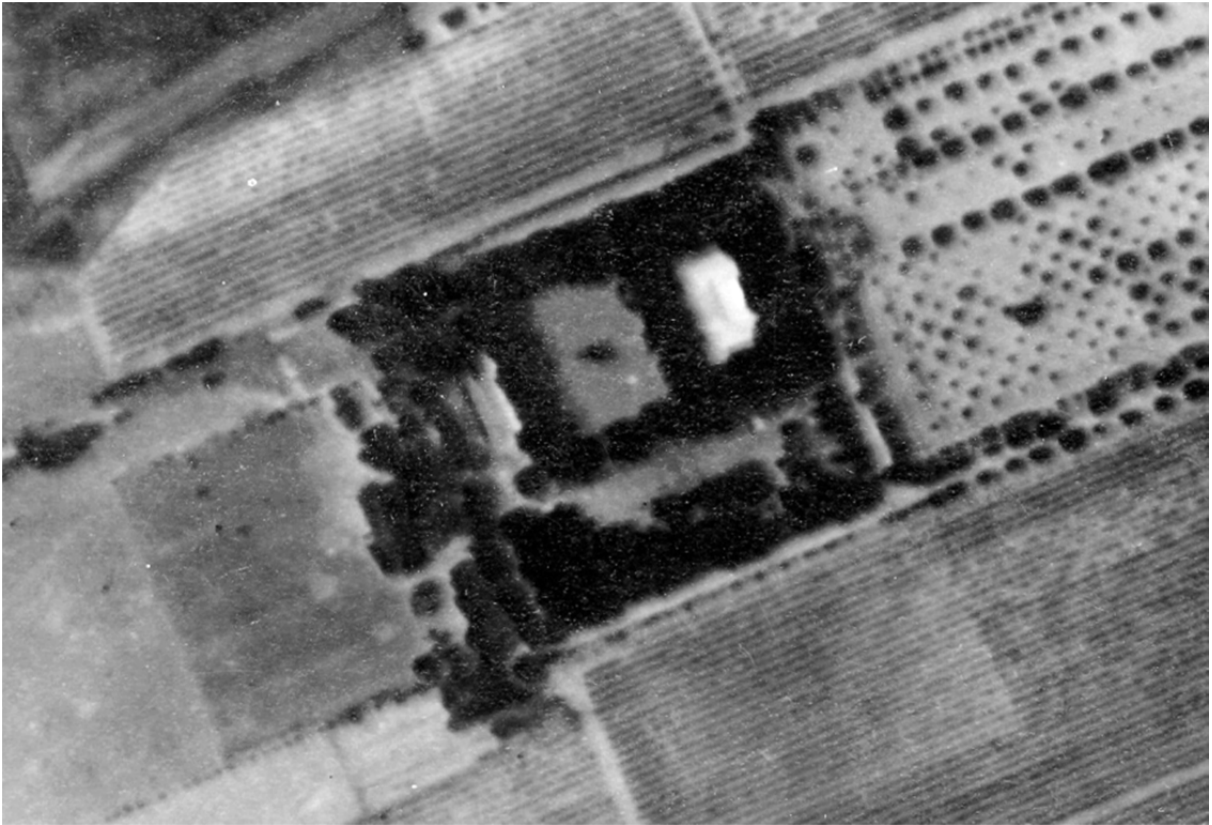
**Figure 7:** A 1926 aerial photo of the 'Constantia View' werf, showing a shed on the left and homestead on the right in a structured garden. To the east is an orchard, with vineyards to the north and south (Chief Directorate Surveys and Mapping).

The existing Cape Revival homestead with twin gables in the north-eastern corner of the Uitsig werf is 1920s stylistically, including its window and door finishes. Archaeological investigations have revealed this to be a refurbishment of the original homestead that Willem Lategan built in the mid-1890s and the original walls, approximately 500mm thick, have been built from lightly fired homemade bricks and prepared mud/daga are still extant<sup>23</sup>. The refurbished H-shaped building with a shiny new roof is clearly visible on the 1926 aerial photograph (see **Figure 7**).

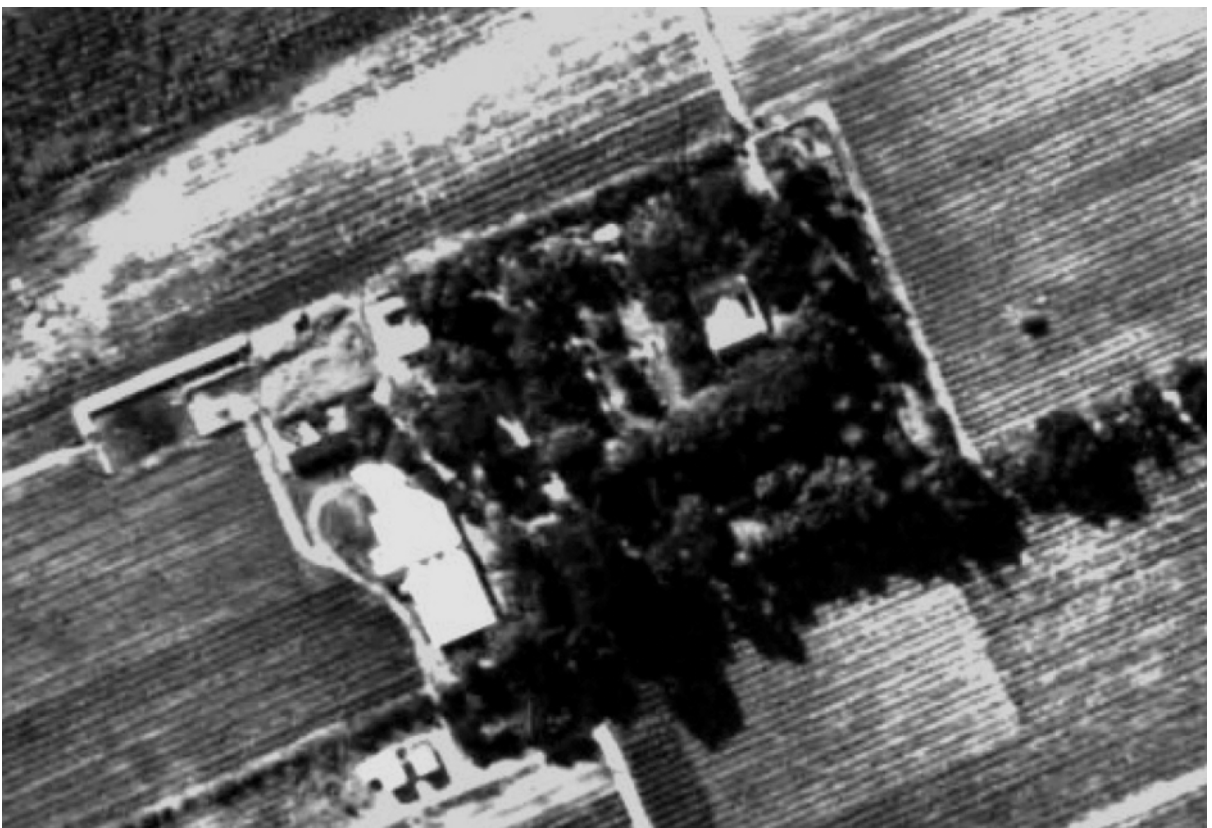
**Figure 8:** A 1945 aerial photo of the 'Constantia Uitsig' werf, showing an H-shaped homestead and a large wine cellar to the west of the werf. Vineyards are now discernible on all four sides, with no orchards remaining (Chief Directorate Surveys and Mapping).

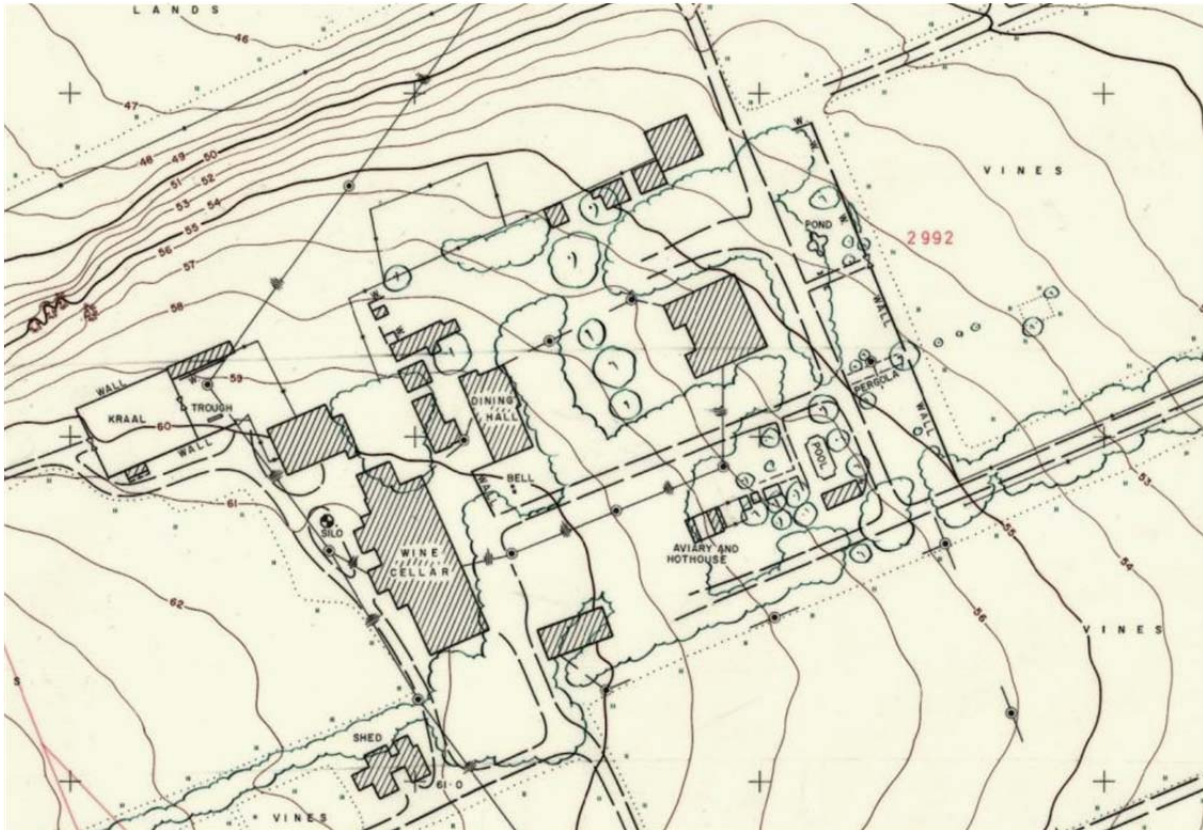
**Figure 9:** 1978 topographical plan of the Constantia Uitsig werf, showing the homestead, wine cellar and other agricultural outbuildings (From Divisional Council of the Cape Sheet 5368A; courtesy of CoCT EHRIC)

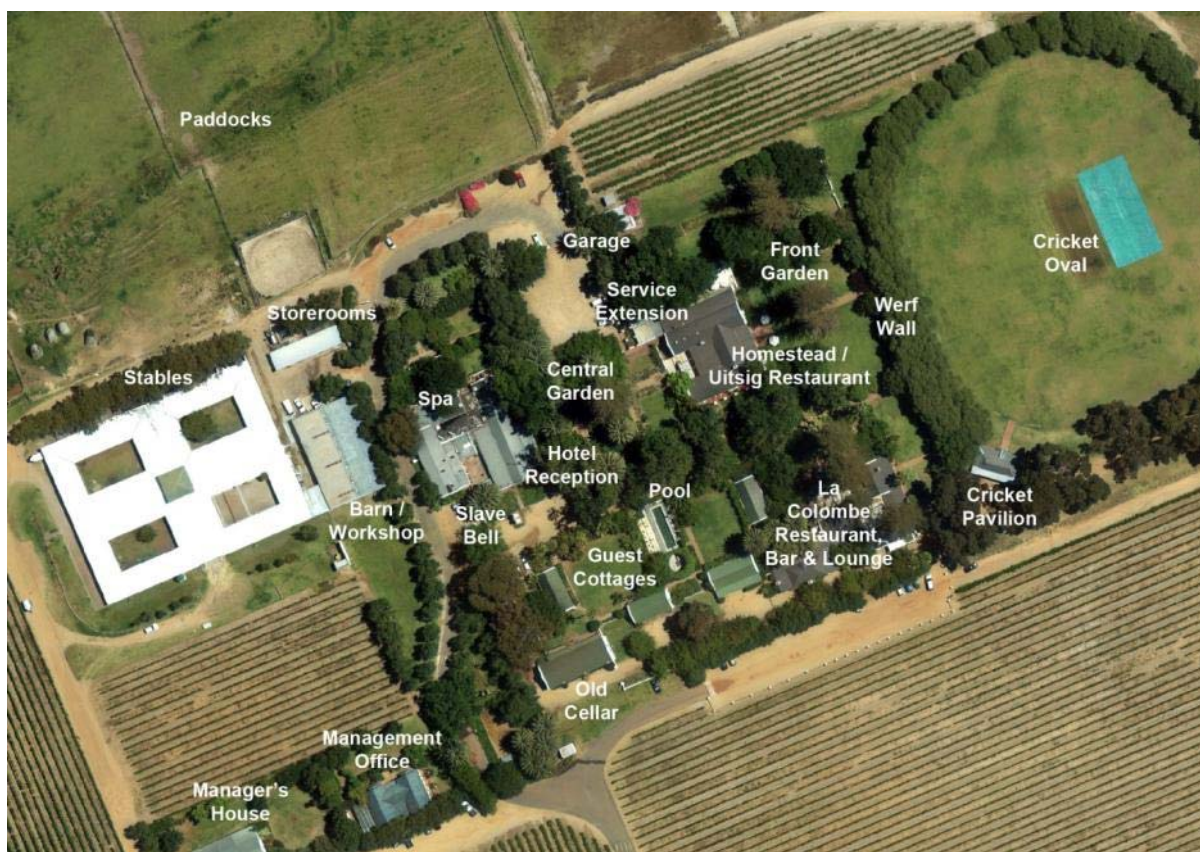
**Figure 10:** A 2012 aerial photograph of the Constantia Uitsig werf, naming the uses as they were at the time. North is at the top. (Source: City of Cape Town).

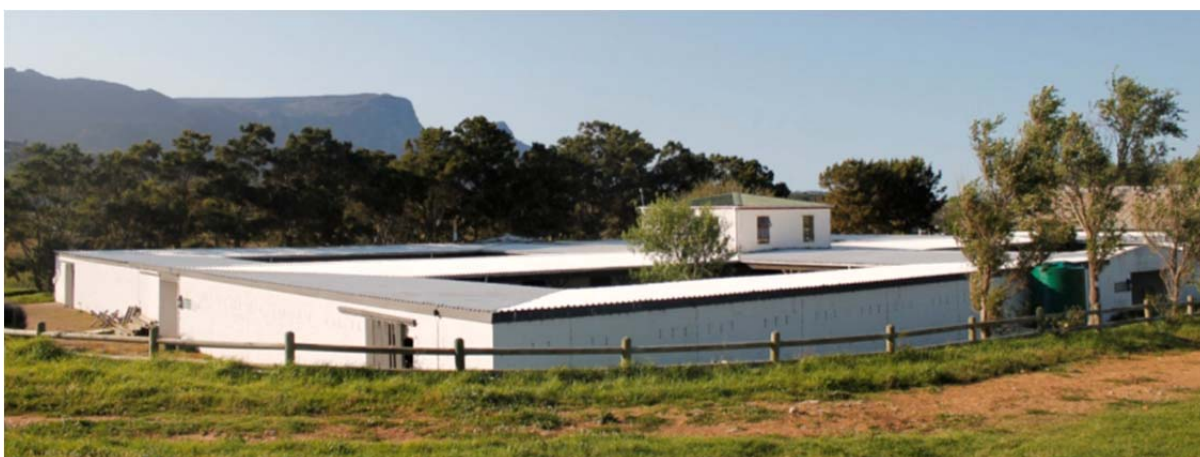
**Figure 11:** View of the 1980s stable block from the south-west

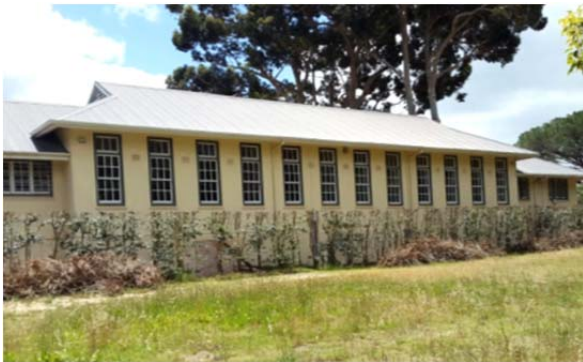
**Figure 22:** The former Tokai Primary School (1918), more recently known as the River Café, viewed from the south.

This former Afrikaans medium, public undenominational school, which was designed by prominent architect John Perry (1874-1943 (FRIBA) and built by the Union Government between 1917 and 1918. It replaced an earlier farm school, built by the Lategan family 1902.

Even though much altered internally when converted into a restaurant, The River Café, in the 1990s, this building retains many original features, including its public facades, hipped roof typology and evenly-distributed, vertically-aligned timber windows. In addition to its contextual significance as a landmark along the Spaanschemat River Road scenic route, it also has intrinsic architectural, historical and social significance and serves as a tangible reminder of Constantia and Tokai's more recent social history. It is conservation-worthy and is considered to be a **Grade IIIB** heritage resource. It is important that its southern and eastern facades, as viewed from the scenic route, remain intact and uncluttered and the building's landmark status is not diminished by new development or landscaping in the vicinity that would visually compete with it.

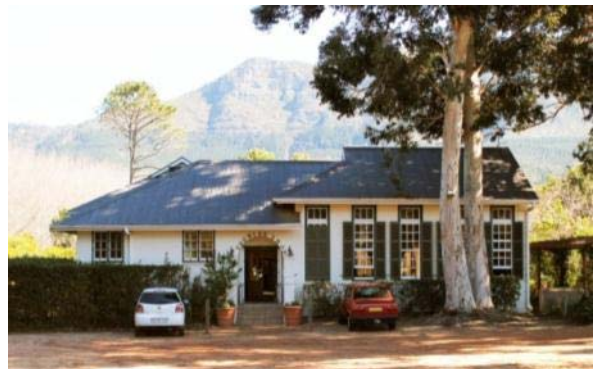
**Figure 23:** The main entrance to the River Café restaurant and wine shop from the parking area on the eastern side.

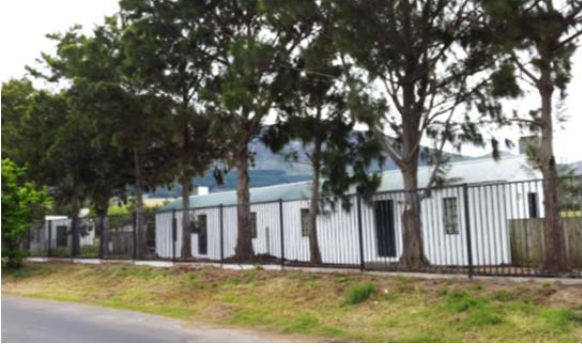
**Figure 24:** Long, pitched-roofed workers' cottages, viewed from Spaanschemat River Road, with the new replacement fence in the foreground. .

To the right of the main entrance of Uitsig and along the southern property boundary are five workers' cottages, built in the late 1950s and 1960s, which replaced eight earlier, square cottages, which were originally built closer to the road. They are built with cement blocks and have steel-framed windows. Some have flat roofs and others have pitched roofs. In 2014, building plans were approved by the City of Cape Town for the conversion of the flat roof cottage closest to the main entrance into a wine tasting and sales facility. The alterations were completed in January 2015.

Even though these mid-20<sup>th</sup> C cottages are of low architectural and aesthetic significance, they have considerable social and contextual value, as examples of modest, mid-20<sup>th</sup> C workers' housing (now quite rare in Constantia), are part of the history of history of Constantia and are authentic elements of a traditional working farm, contributing to the Grade 1 cultural landscape. They are conservation-worthy and are considered **Grade IIIC** heritage resources.

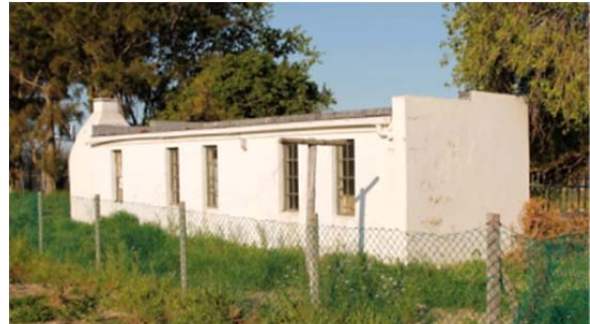
**Figure 25:** A flat-roofed workers' cottage, viewed from within the estate

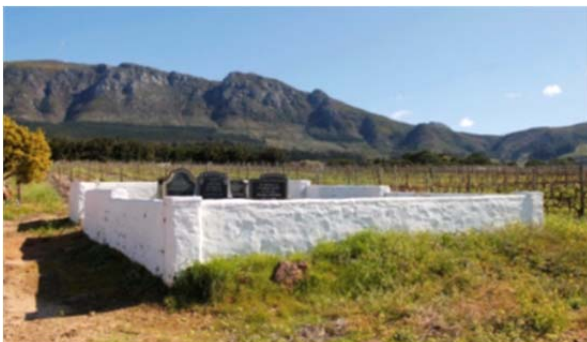
**Figure 26:** The walled Lategan family cemetery on the farm

This cemetery, which is now older than 100 years and is the final resting place of three generations of Lategans, has historical significance and is considered **Grade IIIA**.

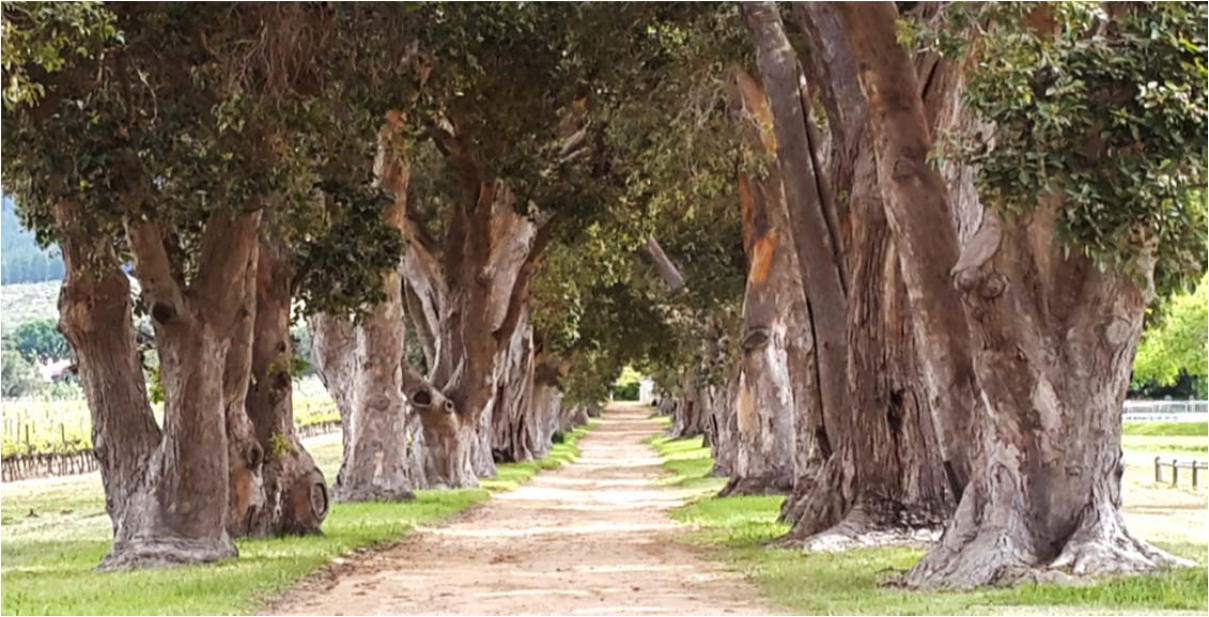
**Figure 28:** The historic avenue of Marri trees leading towards the werf from Nova Constantia Road, viewed from the east.

The trees are in a good condition, are at least 100 years old and have historical, aesthetic and contextual value. They are conservation-worthy and are considered to be of **Grade IIIC** significance.

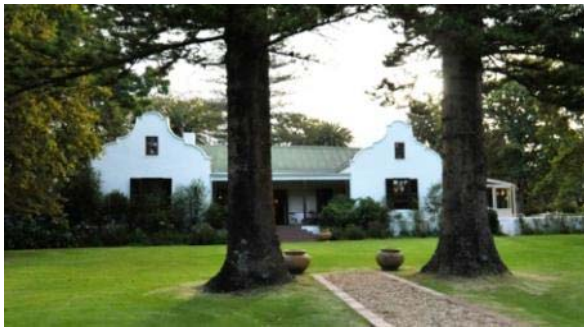
**Figure 30:** The front garden elevation of the Lategan homestead, built in c1894 and remodelled on the 1920s

Architecturally, the homestead has never been of great significance and its integrity has been compromised by the 1993 and 2008 alterations, but all of these are reversible. The building has some historical significance, was home to four generations of Lategans and contextually, it contributes to the Grade I cultural landscape, as noted in Todeschini & Blanckenberg (2006). It is conservation-worthy and a grading of **Grade IIIB** is proposed for the original H-shaped homestead, as well as its garden setting on the eastern side, up to the werf wall.

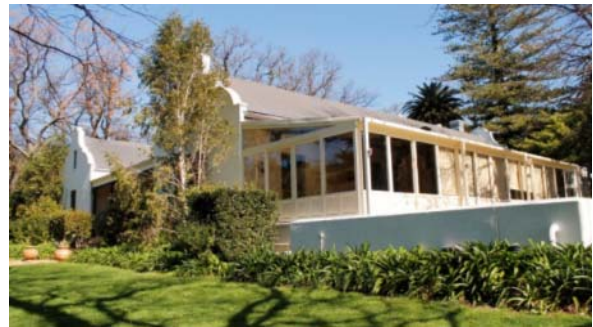
**Figure 31:** The intrusive 1993 conservatory addition and restaurant terrace viewed from the north.

It is also proposed that the kitchen extensions, storerooms and staff toilets, as well as the light-weight conservatory and restaurant terrace on the northern side be removed and that the side wall and openings be reinstated.

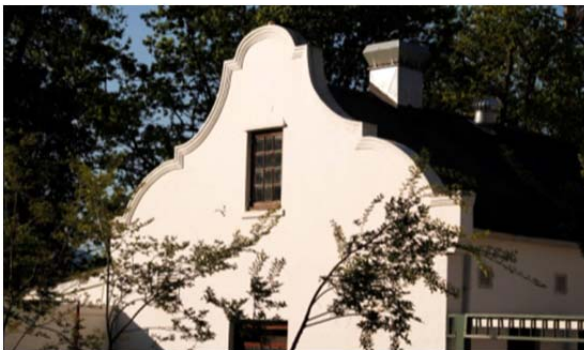
**Figure 32:** One of the gables of the rear elevation of the homestead, as remodelled on the 1920s

The most noteworthy building within the main werf is the H-shaped, Cape Revival homestead, which has two gables facing the central garden and two gables facing the cricket oval. The gables are slightly flattened versions of the historical 'holbol' (concave-convex) gable.

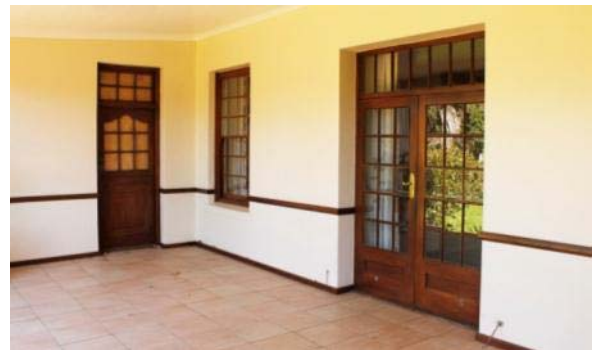
**Figure 33:** The front stoep of the homestead, with typical 1920s timberwork

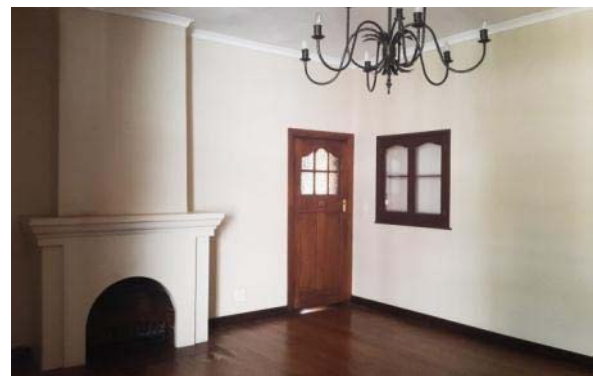
**Figure 35:** Interior of the homestead with a fireplace and typical 1920s timberwork

Until the estate was sold in 1988, this building served as the family home of the Lategans. In 1993 it was converted into a 120-seat restaurant. Several internal walls and doors were removed and openings enlarged. On the northern side, a lightweight restaurant extension was built, which compromised the symmetry and integrity of the homestead. In 2008, extensions were made to the service areas, which further compromised the building.

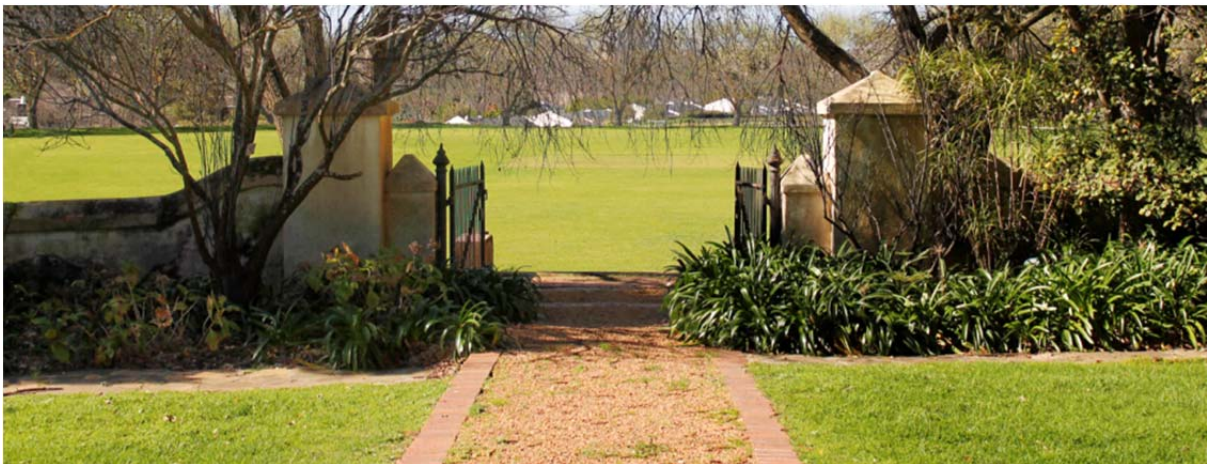
**Figure 36:** The front garden, werf wall and view of the cricket oval

The central section of the werf wall (see above) is older and thicker than the sections at the ends, which are more recent. Even though this wall is not of great age, it is an important landscape feature and defining element of the original front garden and edge of the werf. The entire wall has contextual significance, is conservation-worthy and is considered **Grade IIIC**.

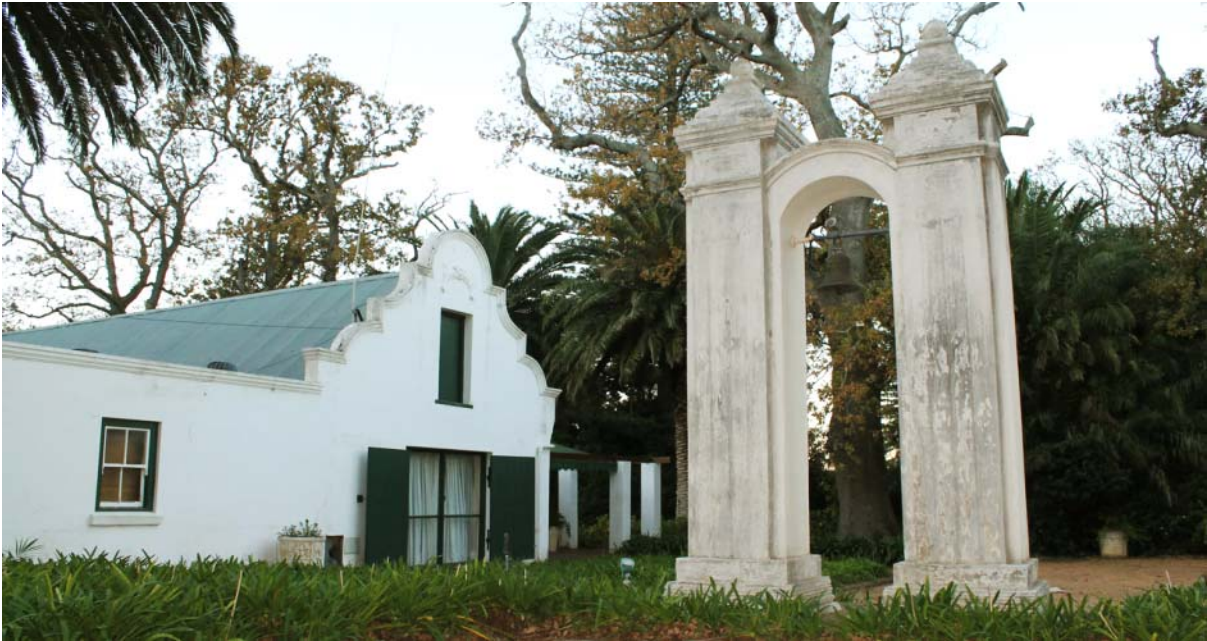
**Figure 37:** The former function room / hotel reception and slave bell, built c1910

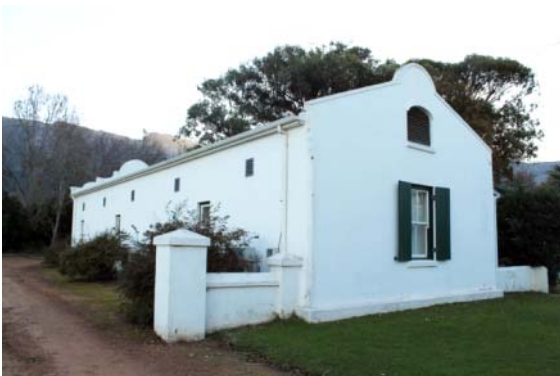
**Figure 38:** The former hanepoot cellar from the east.

The guest cottages on the werf were constructed between 1990 and 1992 and have no heritage significance, with the exception of the c1910 cottage with dissimilar end-gables. This was most possibly the first wine cellar on the farm and during the time that the large wine cellar existed on the farm (1930s to 1980s), this building was used as a hanepoot cellar. Even though substantially altered, with the ornate 1990s end gable on the south-western side being unfortunate, the building has some historical value, as well as contextual value. It is conservation-worthy and considered **Grade IIIC**.

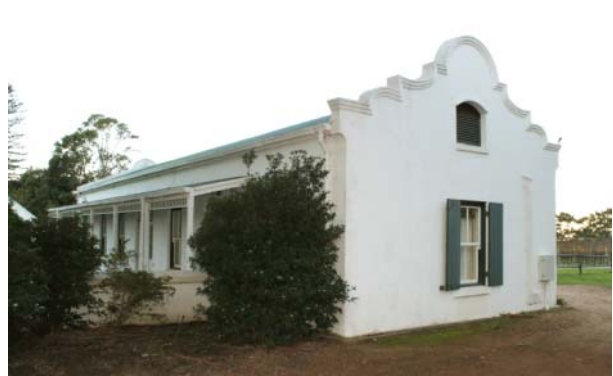
**Figure 39:** The ornate south-western end gable of the cellar

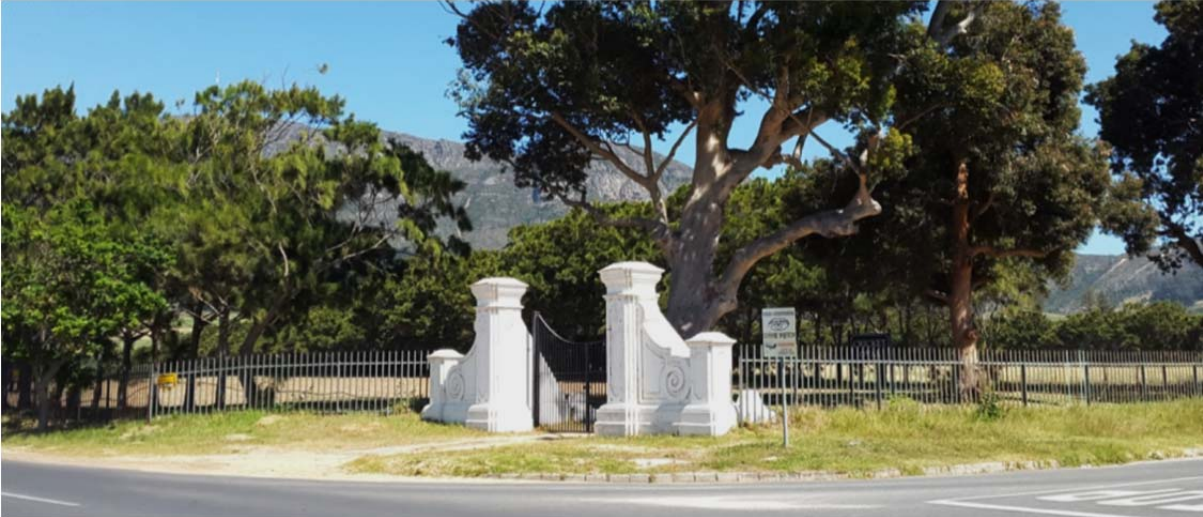
**Figure 40:** View of the corner of Spaanschemat River Road and Nova Constantia Road.

The ornate entrance gates at corner of Spaanschemat River Road and Nova Constantia Road were built by Senator SP Lategan in 1951<sup>35</sup>. These are clearly copies of the 18<sup>th</sup> C Boshof gates in Newlands, but without the urns on top. Whilst the replication of historic structures is not considered appropriate these days, these gates represent a stage in the more recent history of Constantia, they form a prominent landmark and announce the start of the flowering gum avenue of Uitsig. They have some contextual significance and a grading of **Grade III C** would be warranted.

The entrance gate to Constantia Uitsig at the corner of Spaanschemat River and Nova Constantia Roads was built in 1951 by Senator SP Lategan. The ornate piers are clearly copies of the Boshof Gate in Newlands. In 1957 and 1961 two long, rectangular labourers' cottages were built along Spaanschemat River Road and by the 1970s, all the labourers' cottages in that area had been replaced with new cottages, built further from the road.<sup>27</sup>

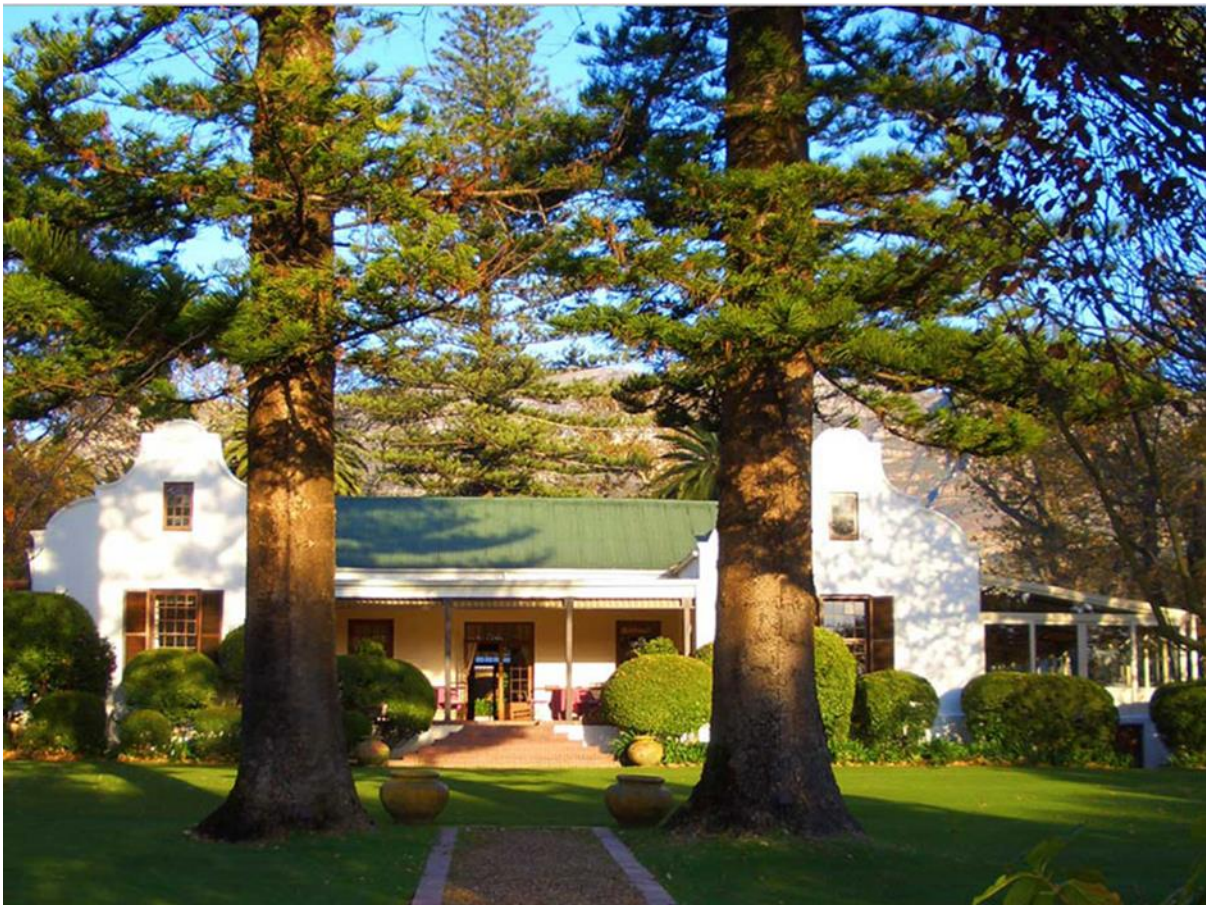
Figure 2. The structure under investigation

ACO Associates was appointed to undertake fabric analysis with the old Constantia Uitsig restaurant (Figure 1, Figure 2). The building was previously the residence of the Lategan family. The work was deemed necessary as available historic information was unclear in indicating if the residence was originally a Victorian structure that was renovated into a 1920's Cape Dutch revivalist building or whether the entire building was constructed by Willem Lategan circa 1921. The joinery within the building is typically early 20<sup>th</sup> century throughout and of consistent style and quality.

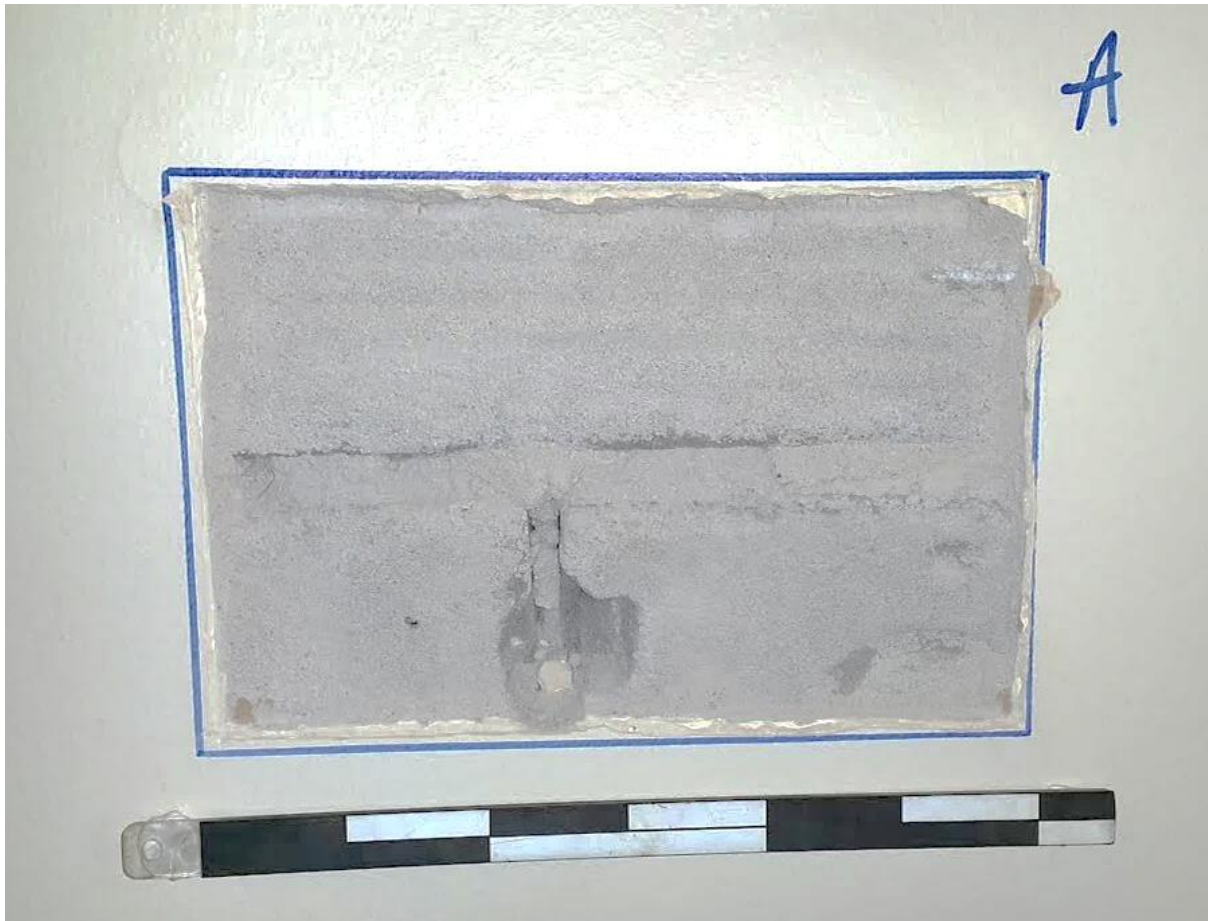
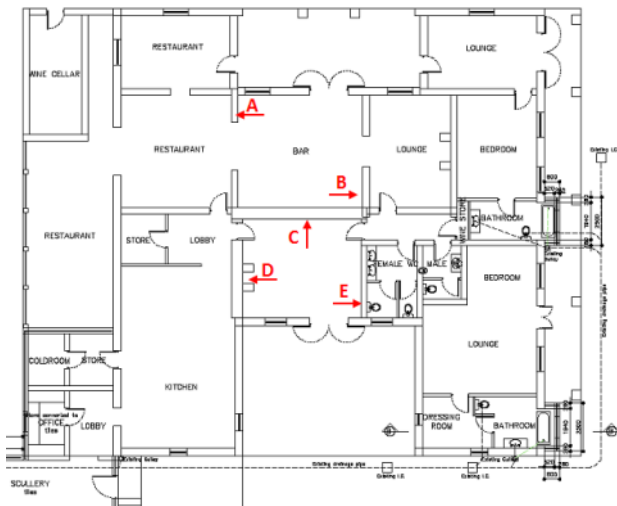
Internal wall A is built from grey cement brick and Portland cement. The brick is soft, possibly home made using a weak sand mix. The wall is seemingly 2 courses thick and younger than the thick walls.

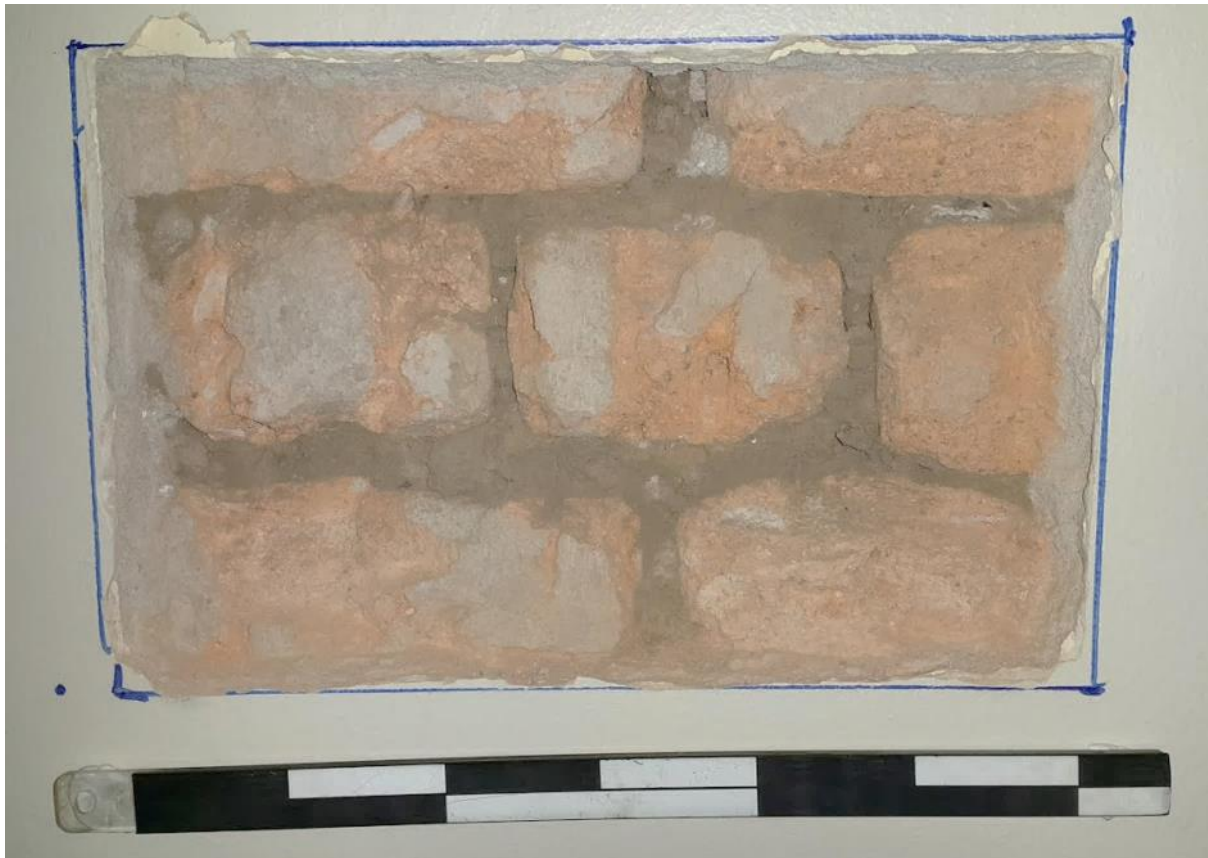
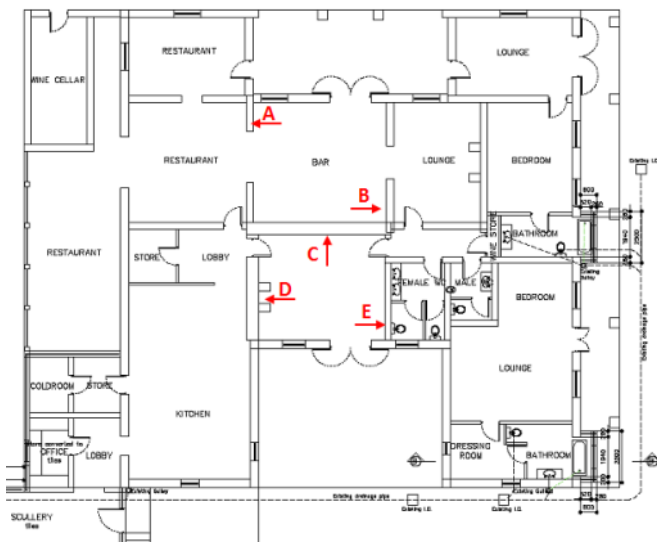
Internal wall B is a thick wall (about 500 mm) built from lightly fired homemade bricks and prepared mud/daga. It is interesting to note the use of Flemish bond. This wall is likely to late 19<sup>th</sup> century.

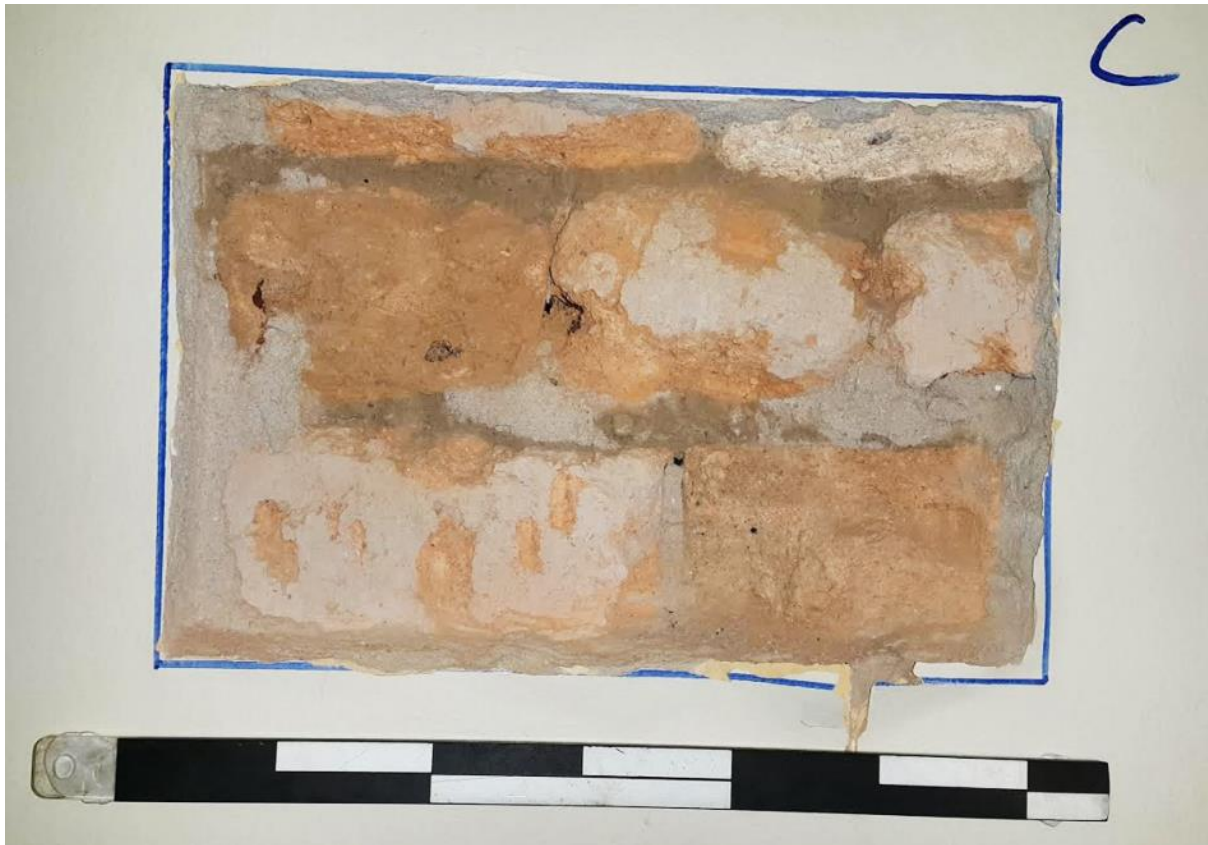
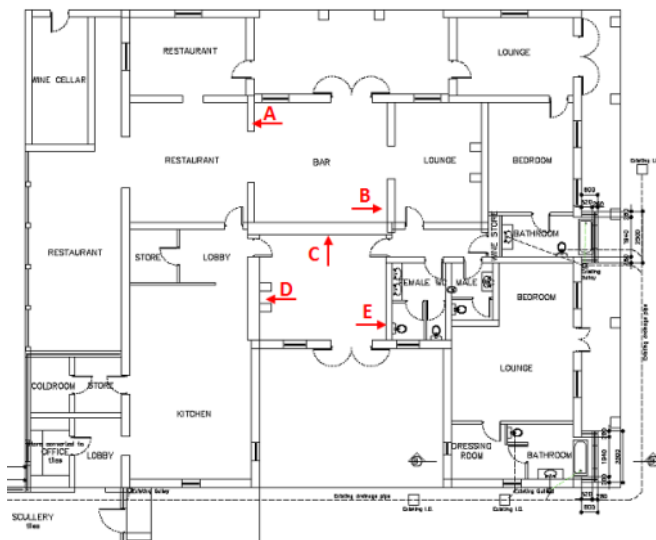
Internal wall C is a thick wall (about 500 mm) built from lightly fired homemade bricks and prepared mud/daga. It is interesting to note the use of Flemish bond. This wall is likely to late 19<sup>th</sup> century and is very similar to internal wall B.

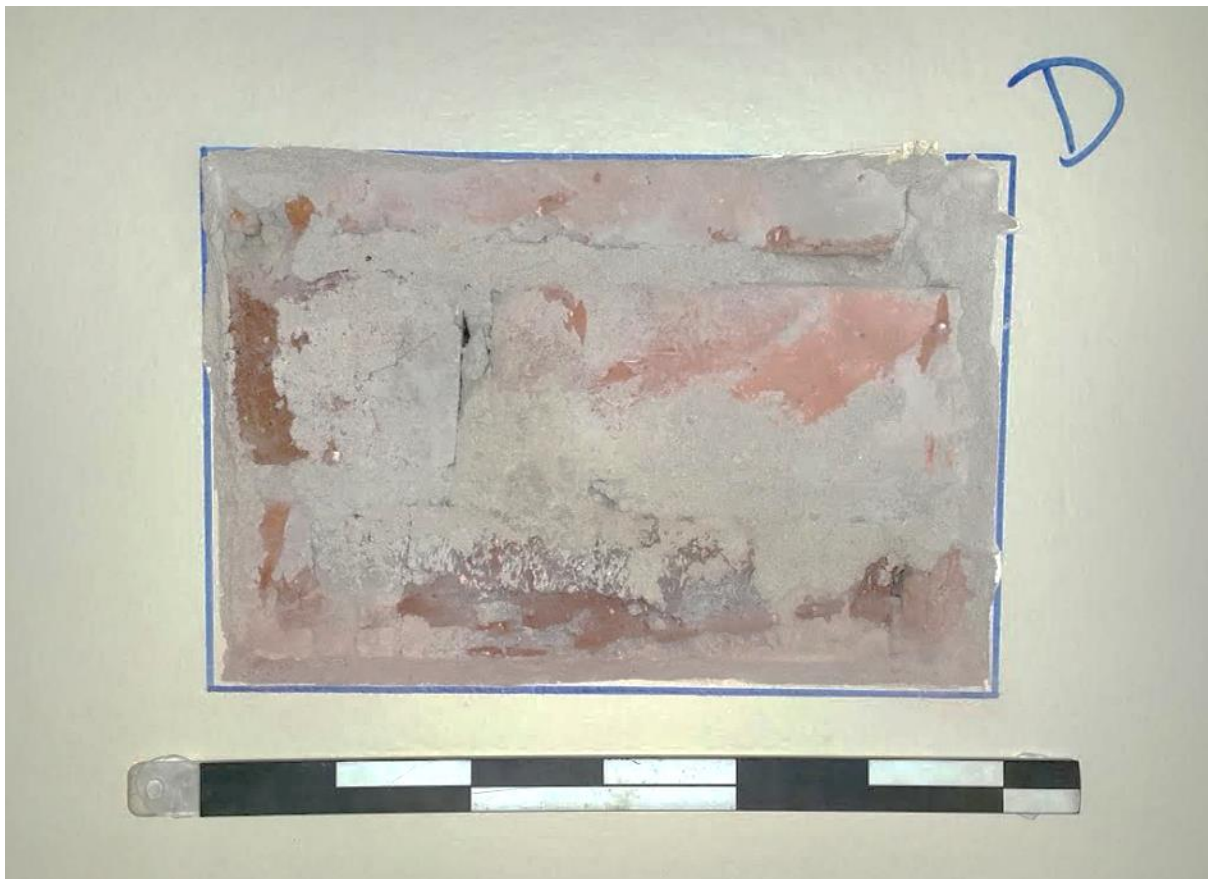
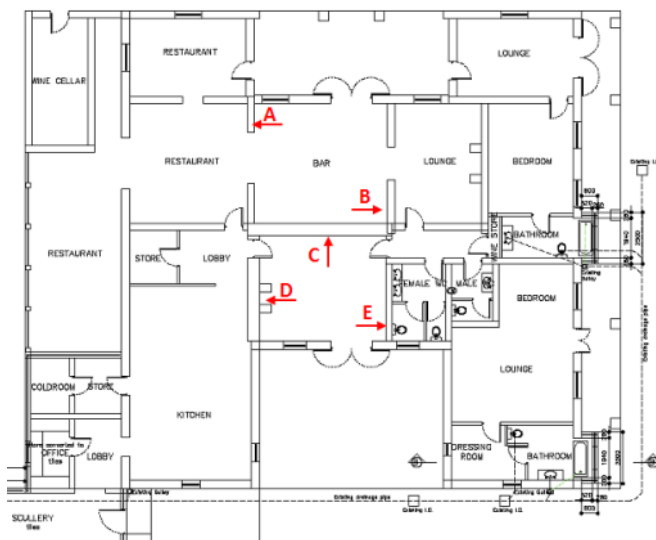
Wall D is situated above the mantelpiece of one of two similar fire places in the house. This is built from a hard standard modern brick and Portland cement. Although the chimney penetrates the ceiling snugly, it is a later addition. The other chimney in the house is very similar in form.

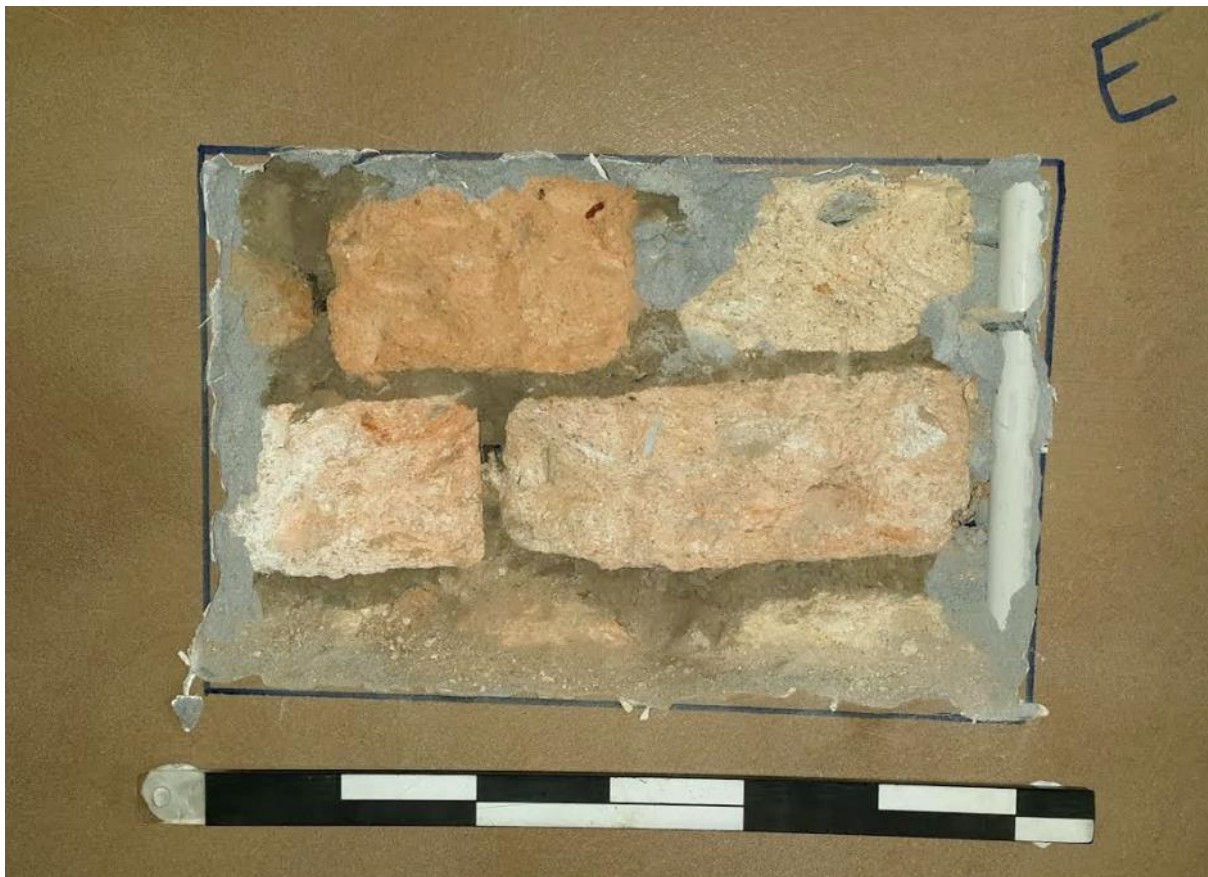
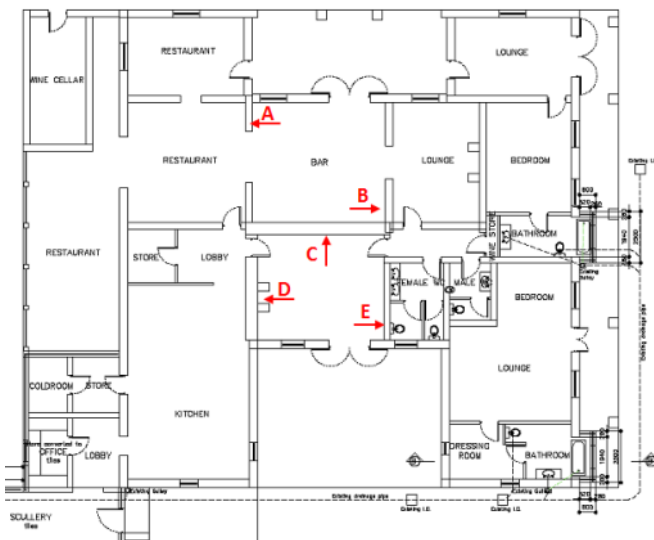
Although wall E is relatively lightly constructed, it too is made from a lightly fired homemade brick but of slightly finer quality. A possible early change.
