## AFRICAN HERITAGE CONSULTANTS CC

12 May 2010

# CULTURAL HERITAGE RESOURCES IMPACT ASSESSMENT OF STONE CREST RIVER ESTATE ON PORTION 3 OF THE FARM ROODERAND 510 IQ NEAR VENTERSKROON NORTH WEST PROVINCE

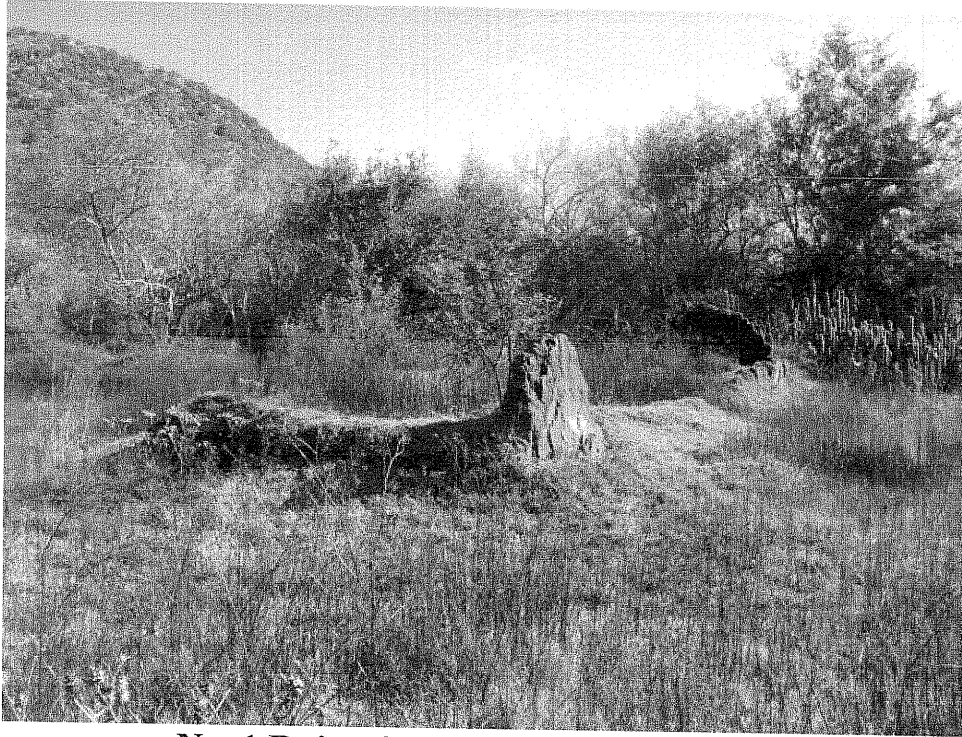
**No. 1 Ruin of farm workers settlement**

- B. *Farm Workers Settlement* (S26° 53' 51.2" & E27° 15' 31.1"). In this area are a number of farm workers ruins. The houses were mud and pole structures probably dating to the 1960 -80 periods (see photograph 1).

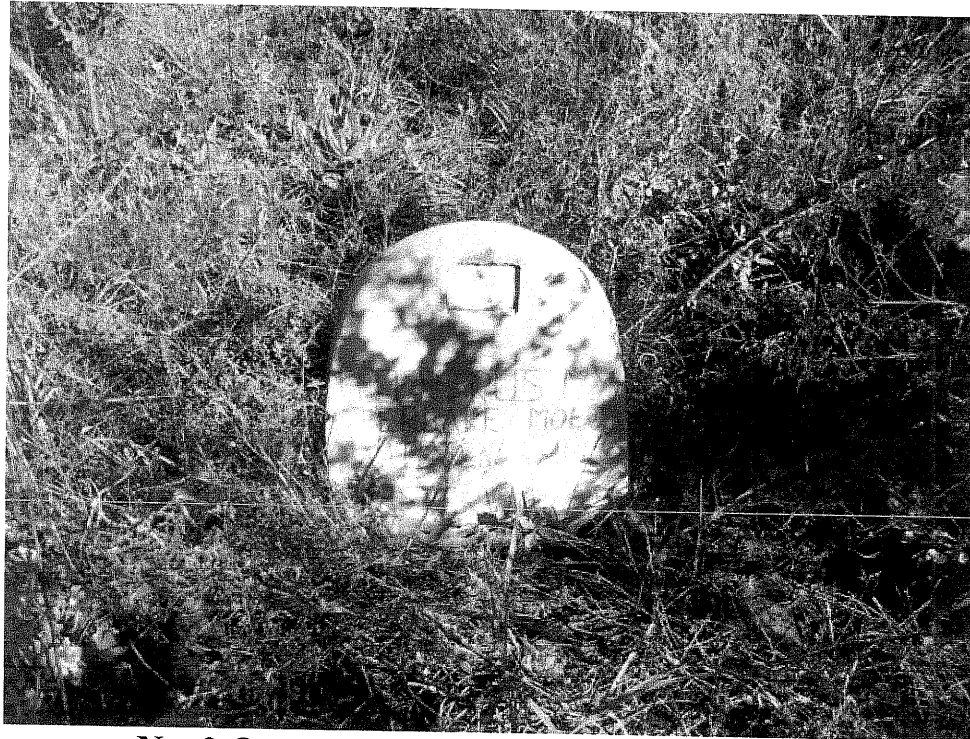
**No. 2 One of the tombstones in the cemetery**

- C. *Cemetery* (S26° 53' 53.9" & E27° 15' 28.8"). The cemetery in the South western corner of the property is totally overgrown by dense vegetation so that individual graves are difficult to recognize. There are ten or more graves visible of which only two have locally made tombstones. The inscriptions have faded away and no date could be found on any of the graves. The surname Terblanche could be recognized on one grave (see photographs 2 & 3). The two tombstones were made of concrete and most probably date to the 1940's. It may be the graves of family members of one of the previous owners of the farm. The rest of the graves are only heaps of stones and may be the graves of workers of the nearby farm workers settlement.

5.1 *The Cemetery*. This site like all cemeteries is protected and is of local importance.

The cemetery is protected by law. At this stage its age still has to be researched but it should be protected and cleaned.

- The Pioneer farm settlement be researched and fully documented after which a decision can be taken to preserve the site or to demolish it.
- The wrought iron gate should be preserved as a feature in the new development.
- The cemetery should be cleaned and researched. Hereafter a discussion can be taken to either fence in, preserve it in situ or to relocate the graves. For detail on grave legislation see annexure A.

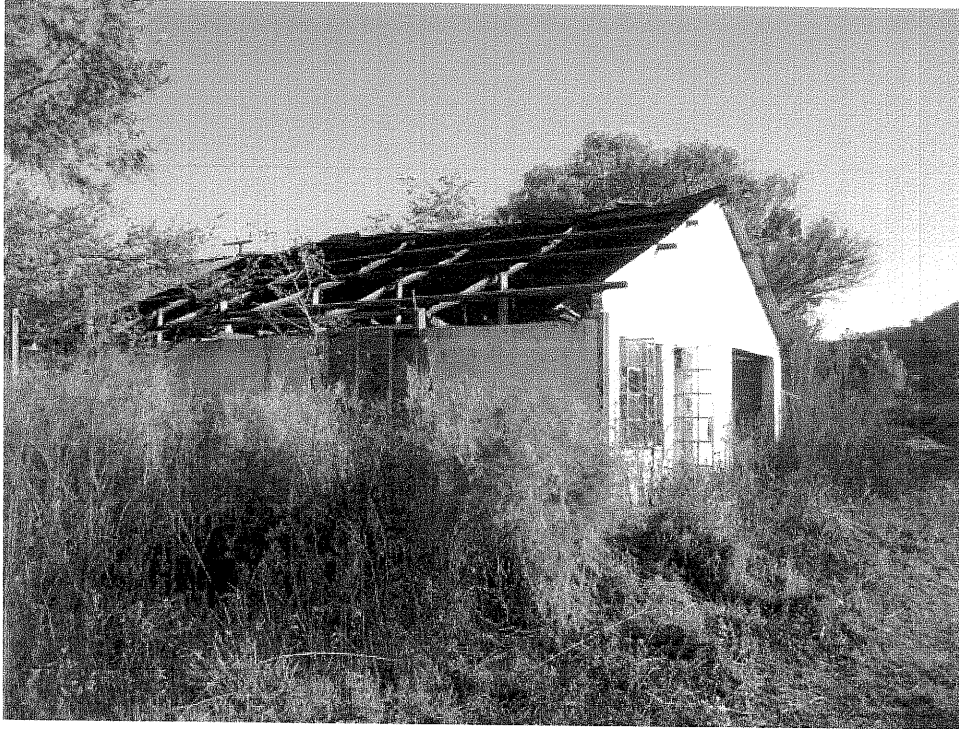
**No. 5 Structure of modern Farm shed**

- E. *Farm Shed* (S26° 53' 44.9" & E27° 15' 37.5"). This structure is modern and has a date of 1992 on its floor scratched into the wet cement (see photograph 5).
