**HERITAGE SURVEY OF THE PROPOSED PIPELINE
FROM ALEXANDRIA TO CANNON ROCKS RO,
EASTERN CAPE**

FOR COASTAL ENVIRONMENTAL SERVICES

DATE: 19 MARCH 2011

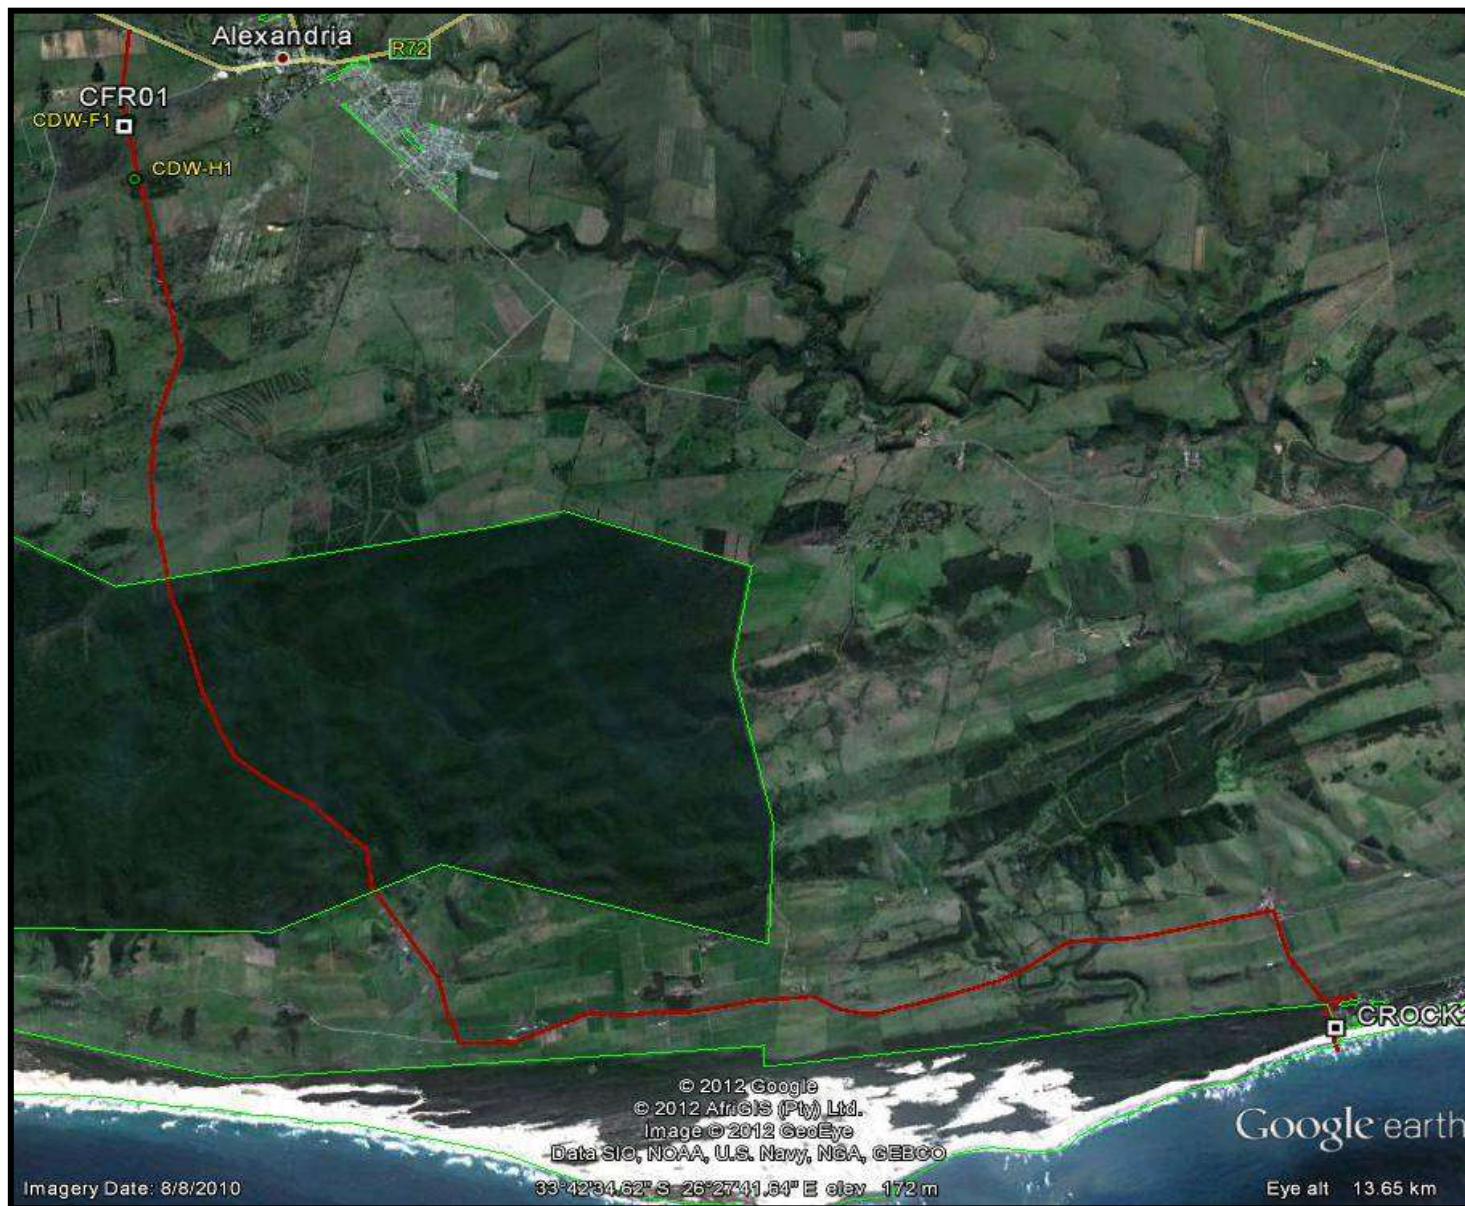
FIG. 5: LOCATION OF SURVEYED HERITAGE SITES

Figure 5 shows the locations of the finds, while Table 3 summarises the information.

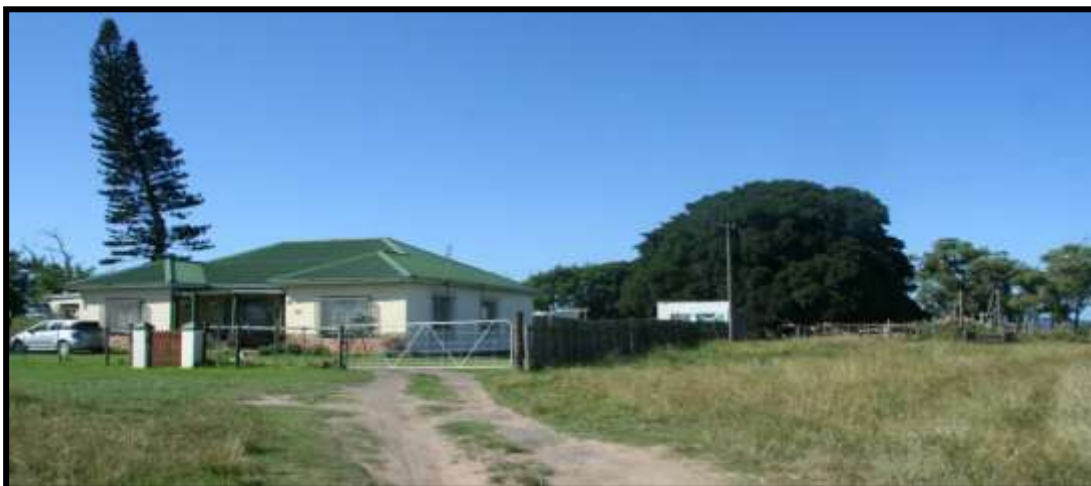
FIG. 7: FARMHOUSE AT CDW-F1

CDW-F1 is the farmhouse, Dekselfontein that appears on the 1966 topographical map. (Fig. 7) – there are several Dekselfonteins in this area and are subdivisions of the original farm. It appears to have little alterations since its initial construction. The pipeline will occur ~50m to the west of the house and will not affect the building.

Significance: The site is of low significance.

Mitigation: No further mitigation is required.

SAHRA Rating: 3C

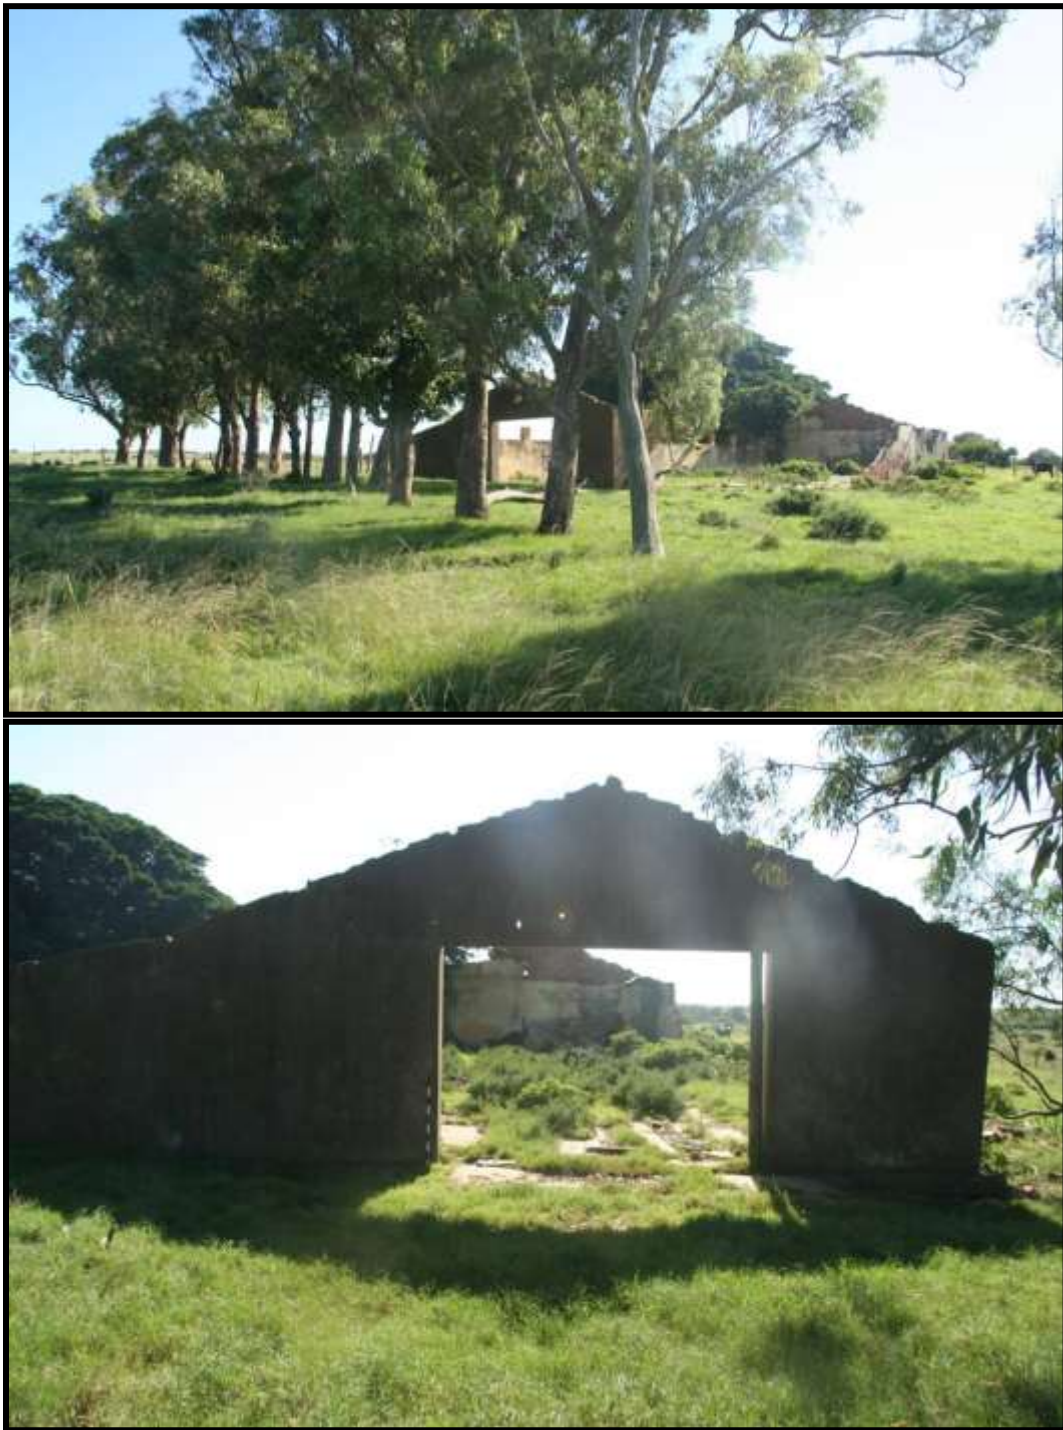
FIG. 8: FARMHOUSE AT CDW-F1

CR01 occurs behind the farmhouse CDW-F1 (fig. 8). It is a baked brick structure that is now in ruins. It is probably a shed related to the farm. The building appears to predate the building at CDW-F1. The southern side of the

barn has a row of blue gum trees that appear to be part of a boundary. The pipeline will occur ~50m away from the trees.

Significance: The site is of low significance.

Mitigation: The trees form part of the cultural landscape and should not be damaged.

SAHRA Rating: 3C

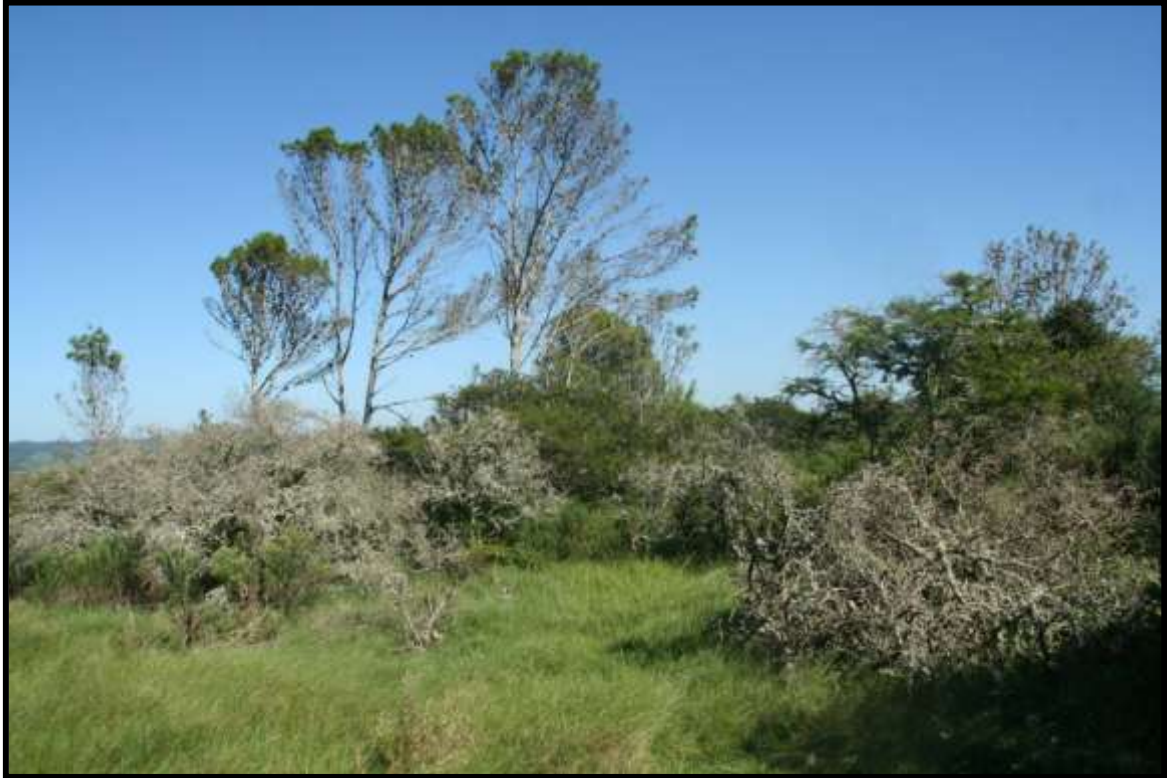
FIG. 9: AREA OF CDW-H1

CDW-H1 occurs on the 1955 topographical map and was located during the survey. There are no visible built structures in the area, except for one small rectangular “pit” that has been covered with planks. Much of the area is overgrown (fig. 9). It appears to have little alterations. The pipeline will occur ~50m to the west of the house and will not affect the building. The pipeline will be going through this settlement

Significance: The site is of low significance.

Mitigation: No further mitigation is required; however if a new pipeline is excavated, then the construction crew should be wary of possible human graves.

SAHRA Rating: 3C

The pipeline will be avoiding known heritage sites; however, there is one sensitive area that should be highlighted: CDW-H1. The area around CDW-H1 may have subsurface human remains. These would only be visible if exposed during construction phase. If this does occur, then all work in that area needs to be stop, and SAHRA and the SAPS need to be informed immediately. The SAPS needs to be informed as the skeleton would also fall under their jurisdiction; however, they are not allowed to remove any parts.

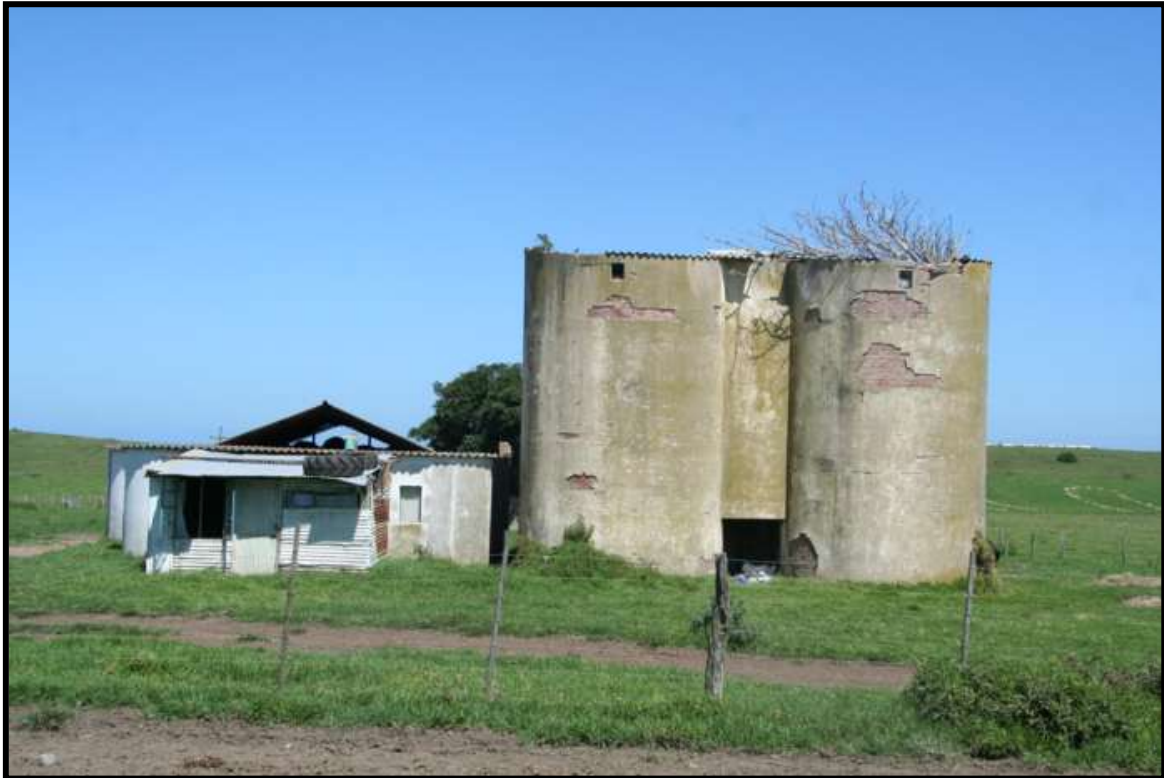
FIG. 11: BUILDINGS AT CDW-F5

CDW-F5 is located on the southern side of the road at the entrance to the farm Middel Plaas. The site consists of a shed and two silos that occur on the 1964 map (fig. 11). The shed is in use and has a corrugated iron addition, while the silos appear to be used for general storage.

Significance: The site is of low significance.

Mitigation: No further mitigation is required.

SAHRA Rating: 3C

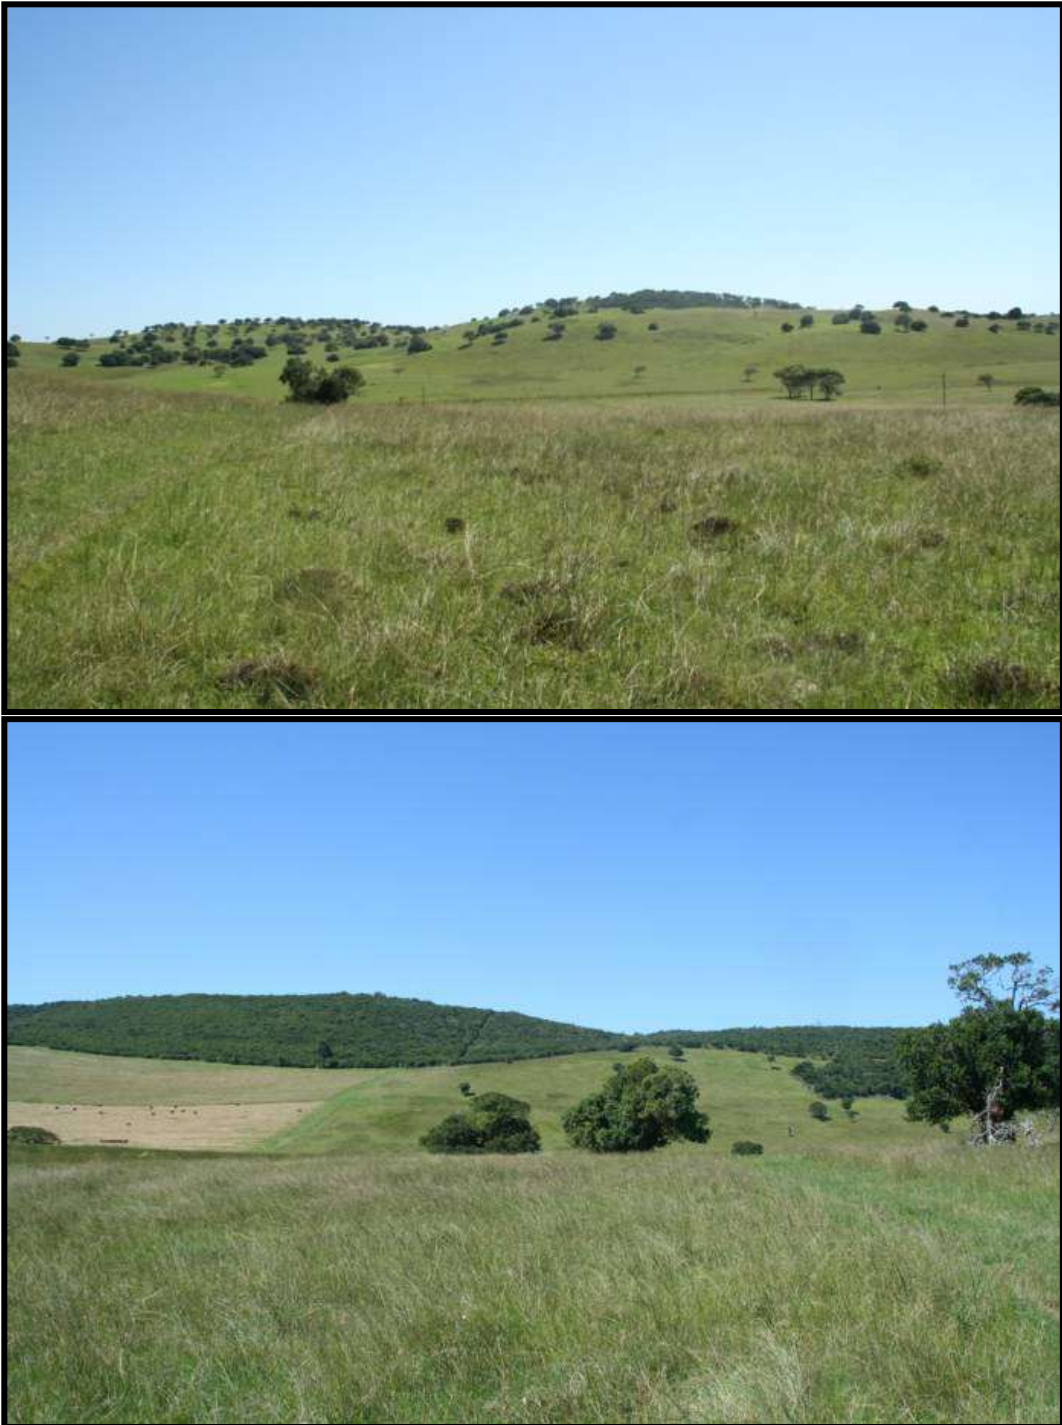
FIG. 11 PASTURAGE NORTH OF WOODY CAPE NATURE RESERVE

Lastly, the area has been converted to pasturage for over 100 years (fig 11). While there are shell middens do occur in this area, they would all be subsurface, only to be exposed during construction activities (see Webley 2007a). If the line route will replace the existing pipeline, then no mitigation is required. Areas such as the Woody Cape Nature Reserve have a limited servitude and the existing line is unlikely to uncover sites (see Fig. 12 for the dense vegetation either side of the servitude). However, if the line is to run parallel to the existing route then certain areas need to be monitored for potential archaeological sites.

The areas that will require monitoring during construction are as follows:

1. Kleinhoek 253
 - a. S33°40'59.73"; E26°23'47.50"E to S33°42'22.46"; E26°23'42.69"
2. Woody Cape Nature Reserve
 - a. S33°42'22.46"; E26°23'42.69" to S33°44'17.28"; E26°25'7.08"
3. Hollowdene
 - a. S33°44'17.28"; E26°25'7.08" to S33°45'11.77"; E26°25'41.88"
4. Cannon Rocks
 - a. s33°44'59.23"; E 26°31'40.96" to S33°45'11.91"; E26°31'45.75"

Any shell middens that are exposed during the course of construction, needs to be reported to the heritage Impact assessor, the ECO and SAHRA immediately.

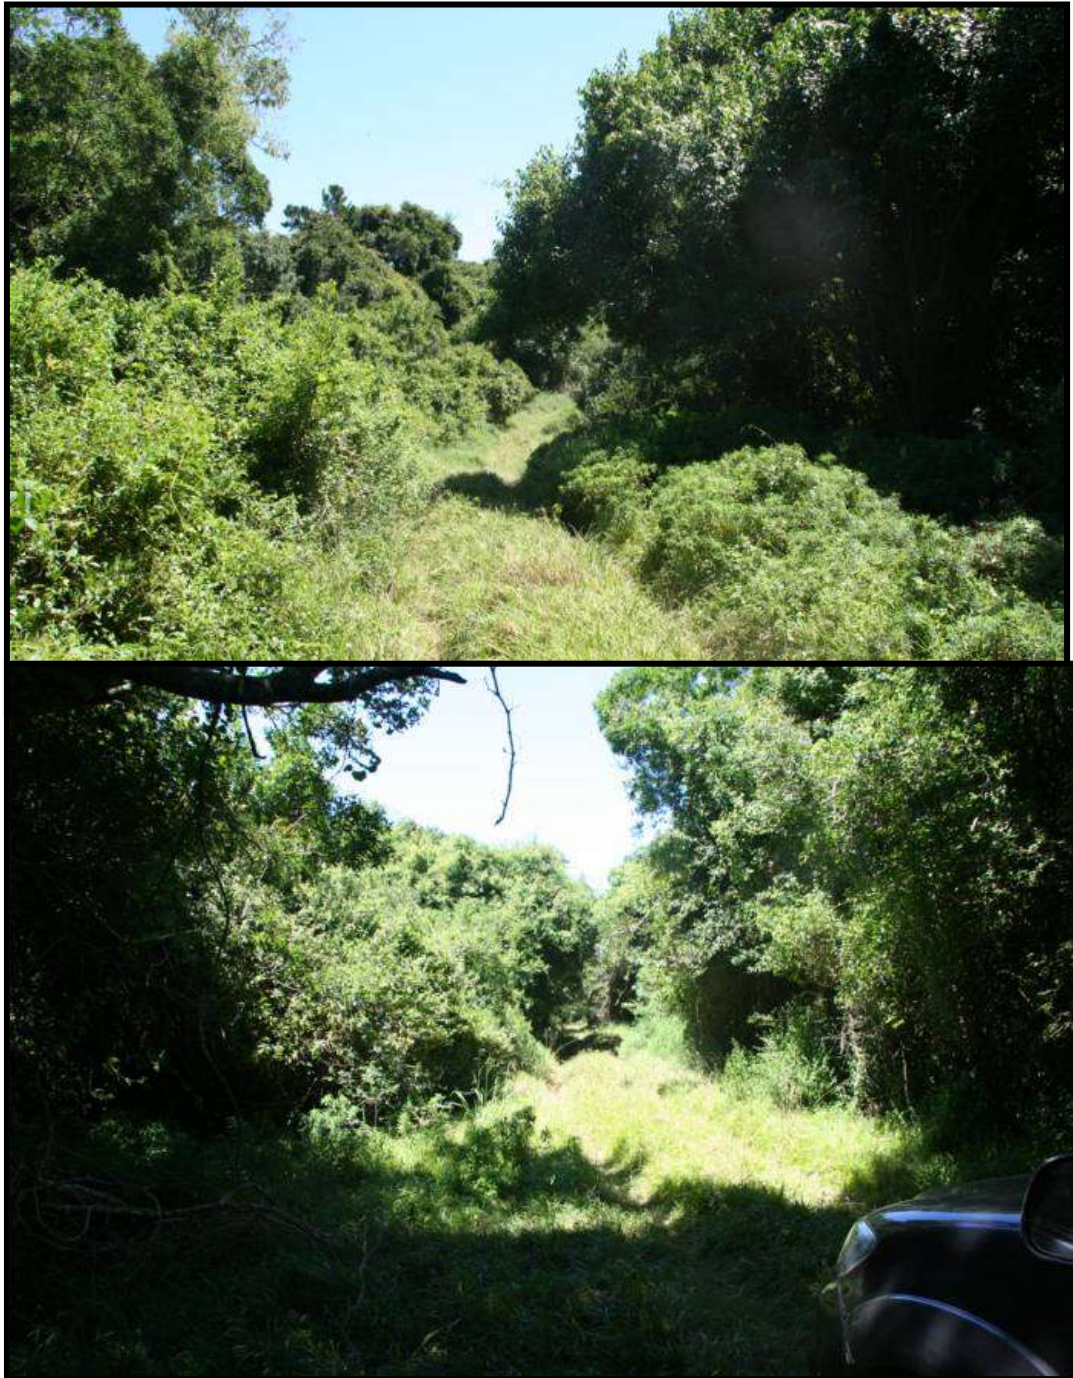
FIG. 12 EXISTING SERVITUDE AT THE WOODY CAPE NATURE RESERVE
