**HERITAGE SURVEY OF THE PROPOSED 66 kV LINE
BETWEEN ST FRANCIS AND RED CAP KOUGA WIND
FARM, EASTERN CAPE**

FOR COASTAL & ENVIRONMENTAL SERVICES

DATE: 2 August 2011

**Umlando: Archaeological Tourism and Resource
Management**

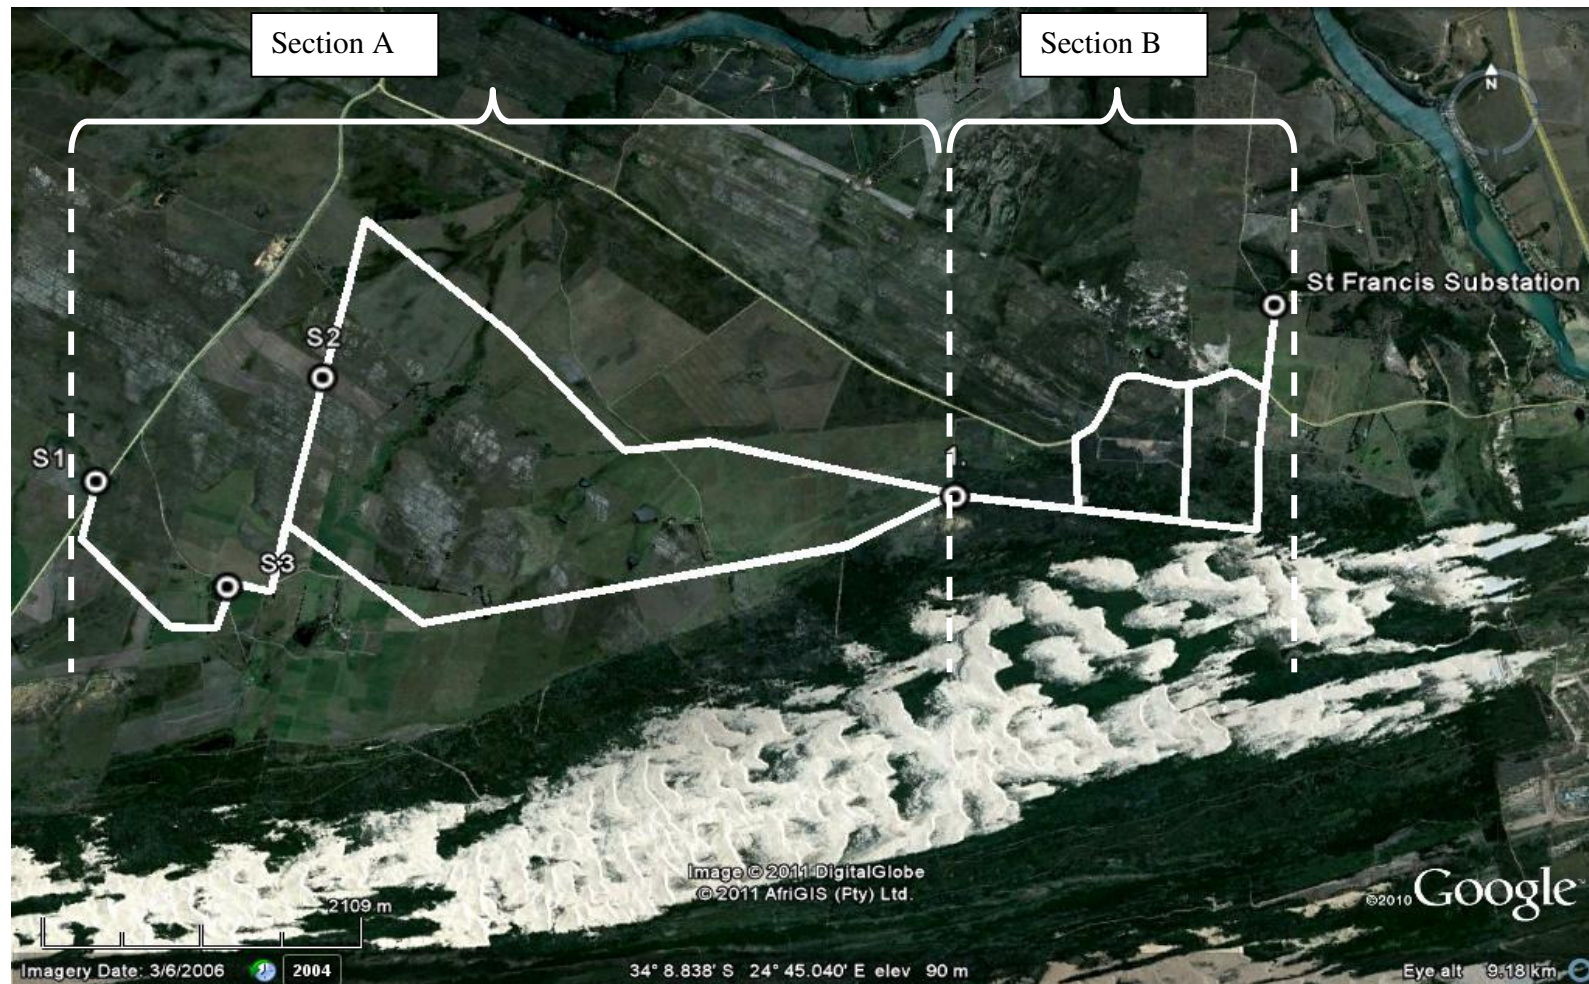
FIGURE 3b. SHOWING THE FINAL DIFFERENT SECTIONS IN THE STUDY SITE July 2011³

³ Section A has 4 alternative layouts namely A1, A2, A3 and A4 while Section B has 3 alternative layouts namely B1, B2 and B3 (Table 1).

There have been a few reroutes and route line name changes since the original survey and May 2011 report. This final report refers to the latest routes. Figures 3a/b and 6a/b show the old (referred to as 'a') and new routes (referred to as 'b').

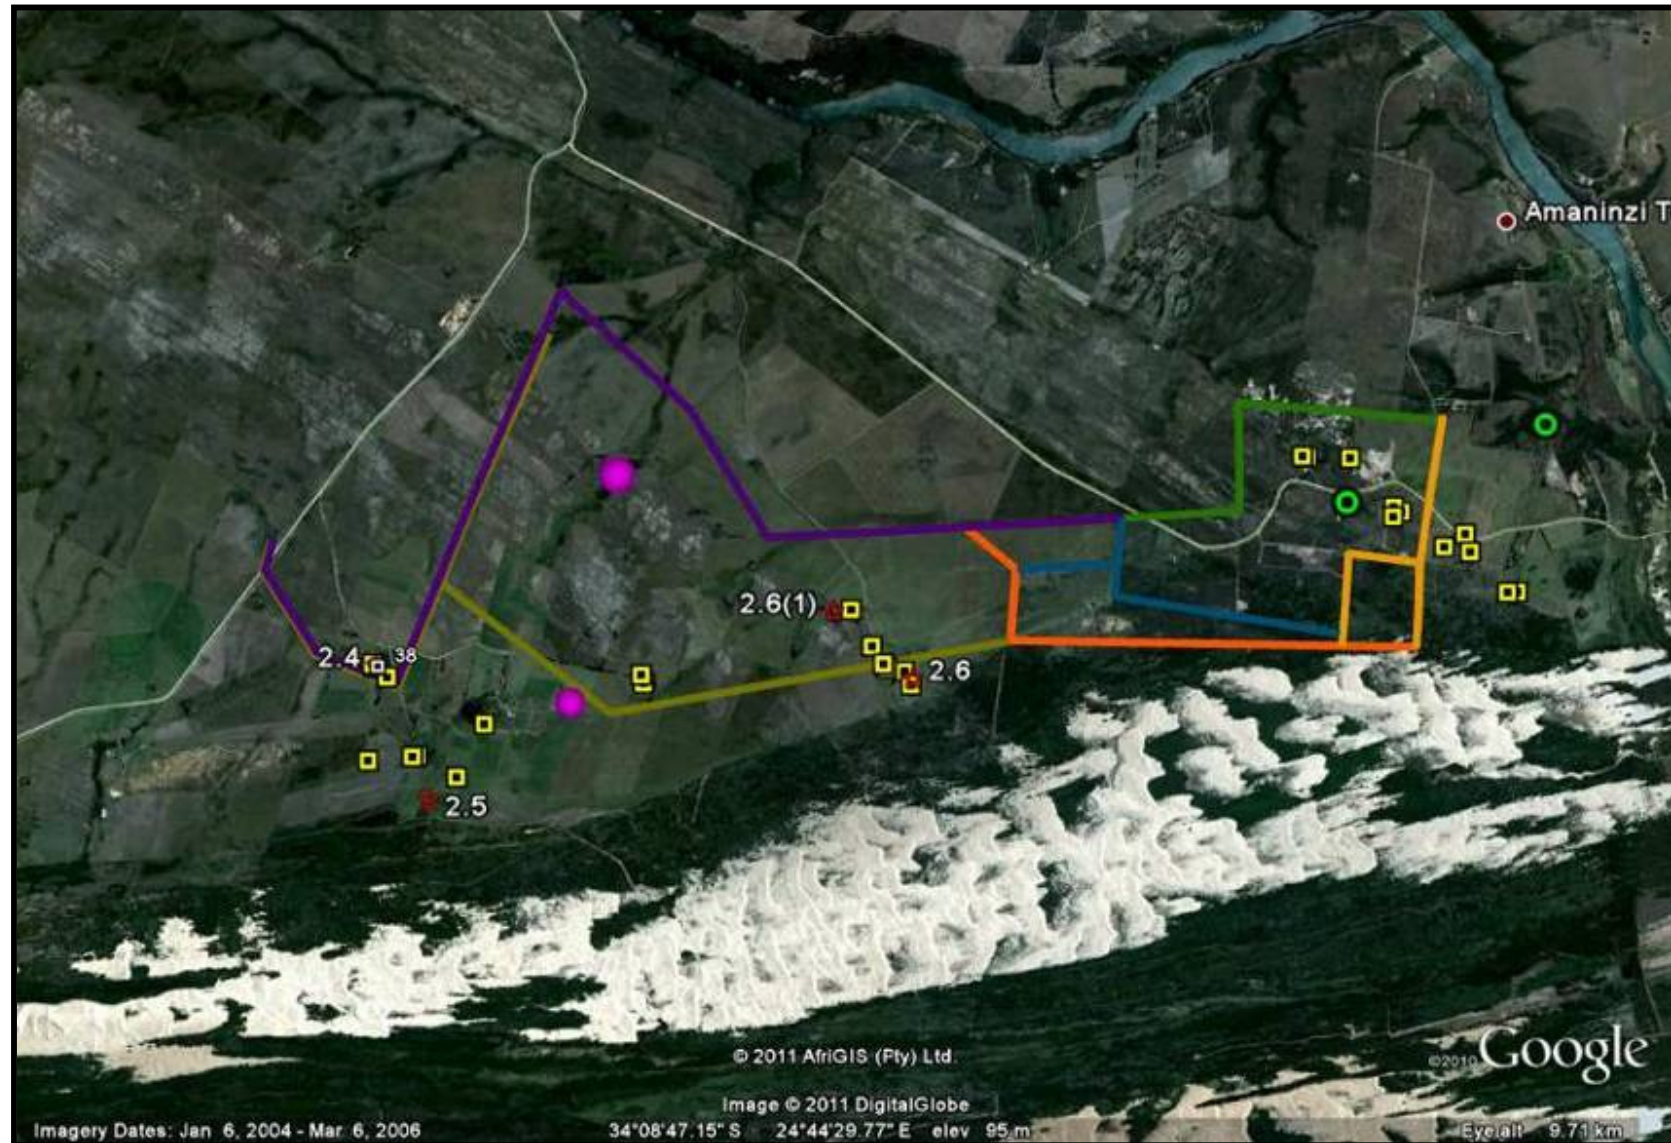
FIG. 5: LOCATION OF POSSIBLE HERITAGE SITES FROM THE DESKTOP SURVEY⁵

⁵ Pink circle = ruin, yellow square = house; green circle = school/factory; white square = Hart (2010), red star = van Ryneveldt (2010). Old routing applies

Only one building in the Buffelsbosch farm complex will be indirectly affected by the 66 kV line, and this is discussed below. In Figure 5 the lines appear to be on/over houses, however they are at least 25m away from any building. The line passes over a shed; however, the shed is a recent construction of corrugated iron.

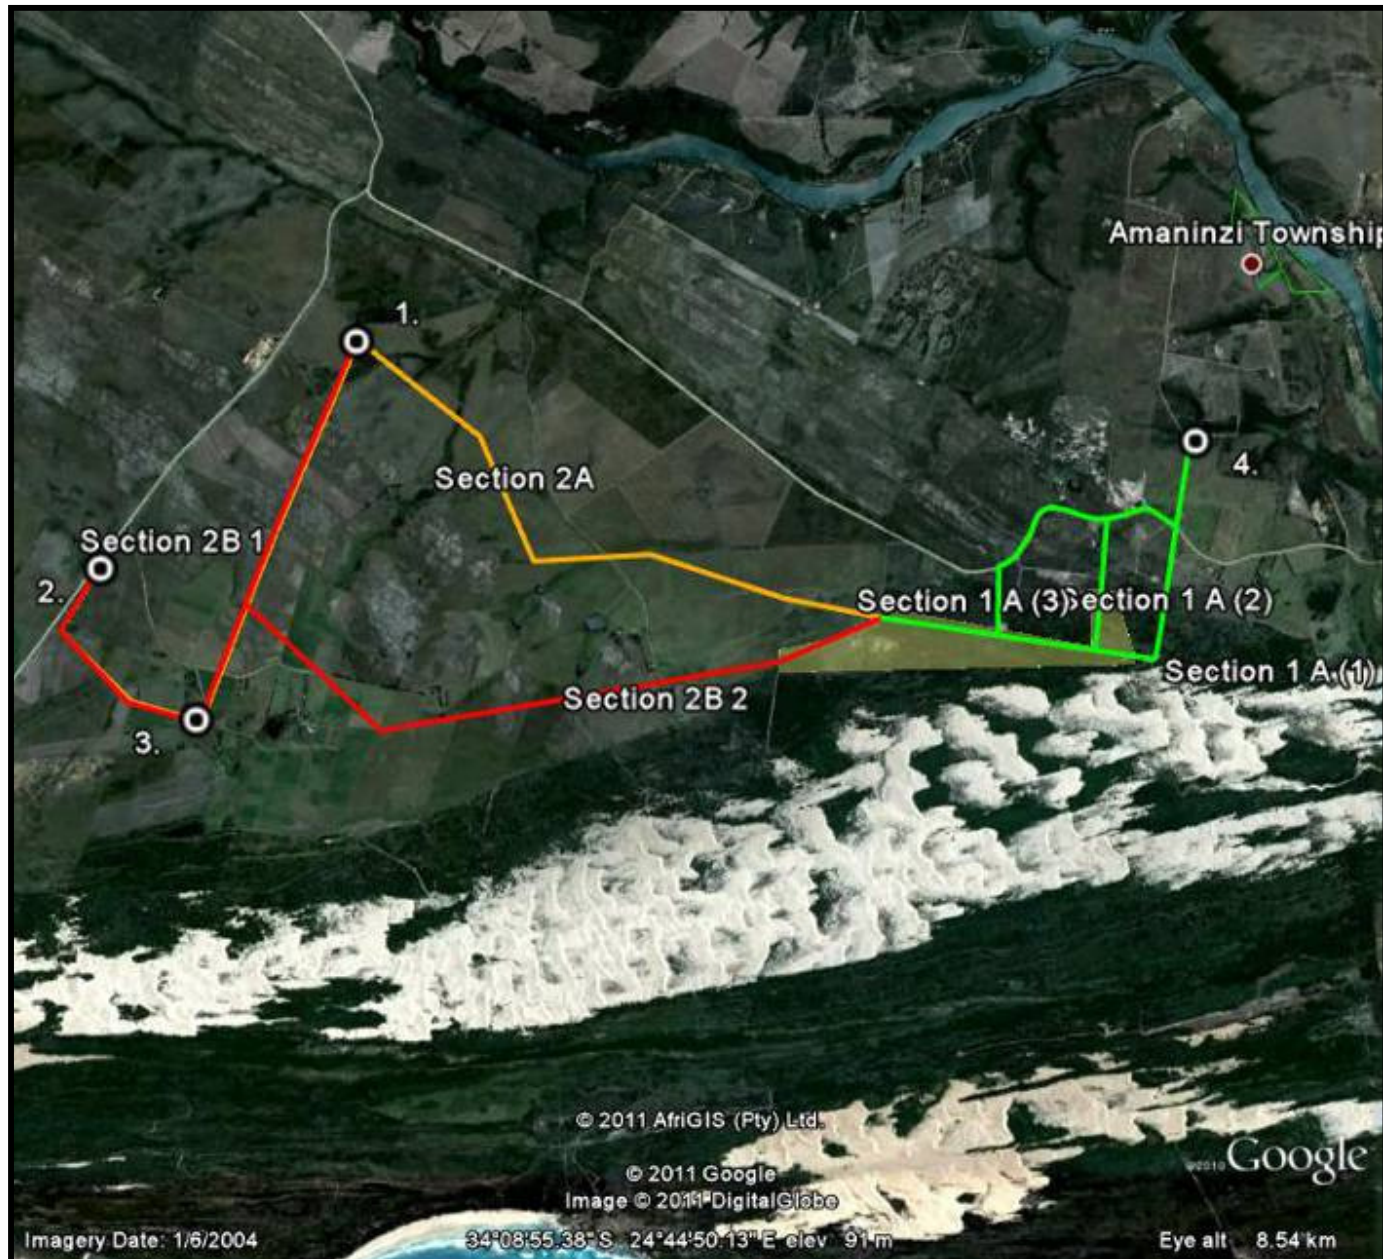
FIG. 6a: ROUTE ALIGNMENT & SUBSTATIONS FOR THE SURVEY⁶

⁶ Shaded yellow polygon is unsurveyed area; White circle is a proposed substation. Old routing applies

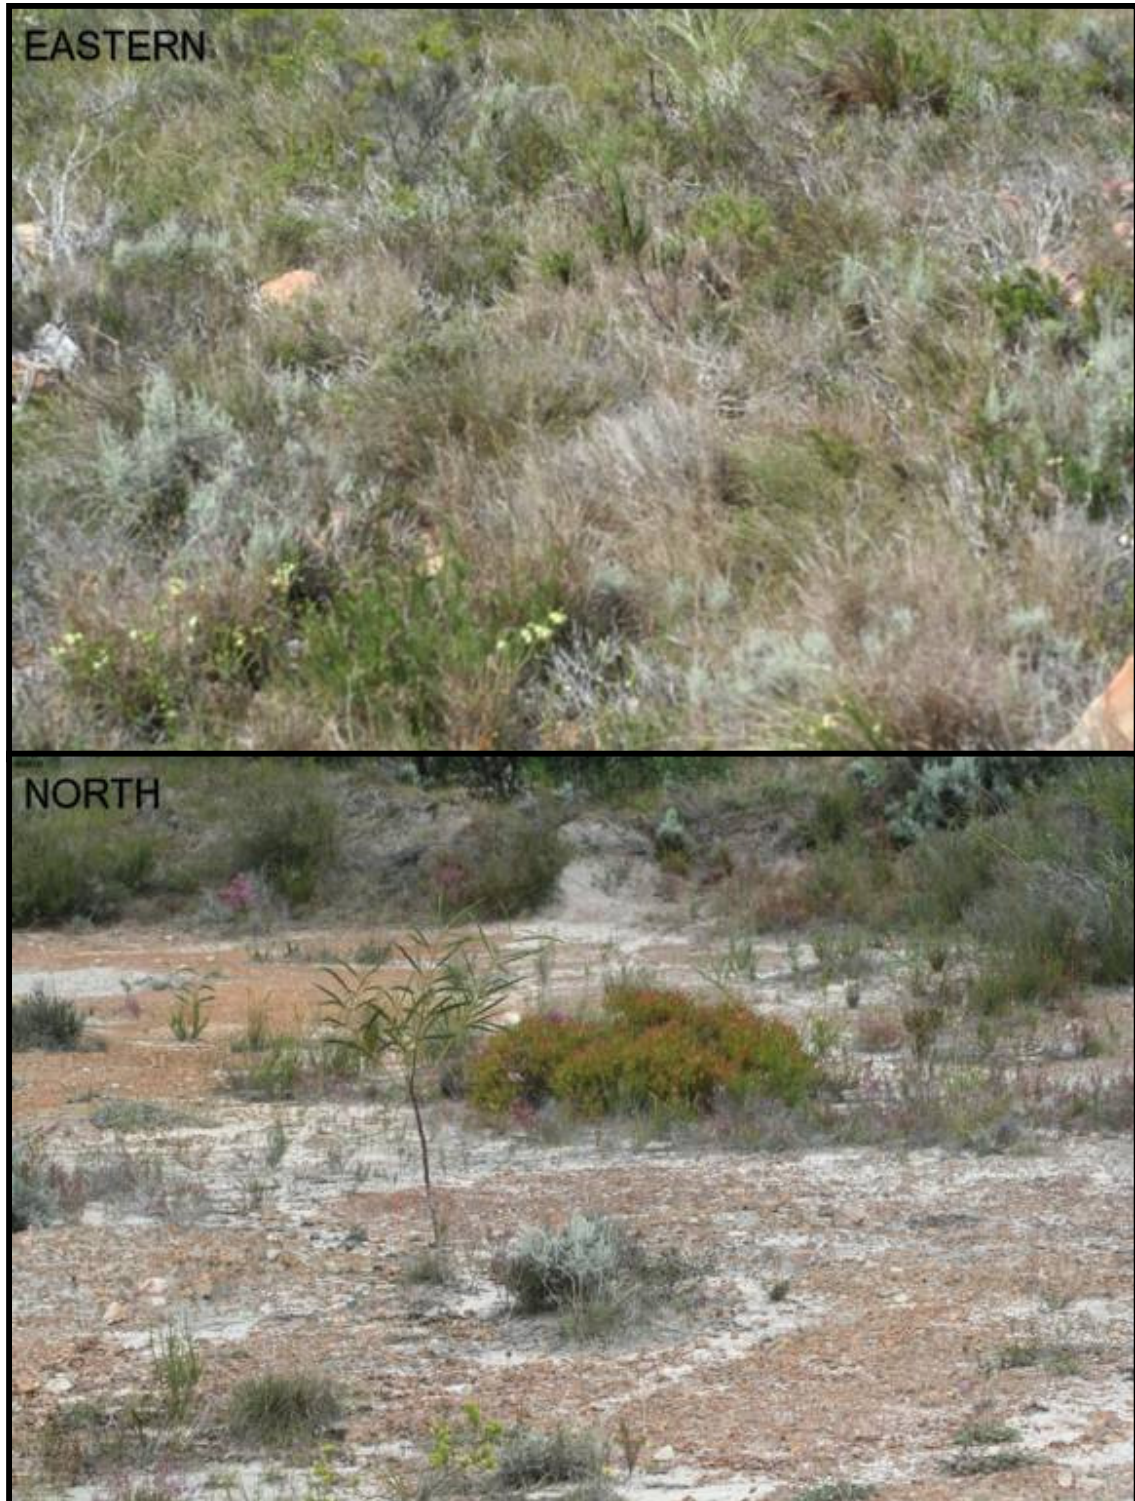
FIG. 9: VIEW OF RC011 to RC013¹⁰

¹⁰ This is located ~400m north of B3, original routing name

The results of the field survey are shown in Figures 6 – 8, and Table 2. Some sites have additional numbers and these are to indicate concentrations of artefacts on that specific hill. In most cases, the vegetation was not too dense to be a hindrance for visibility – this may be a seasonal condition (fig. 9). However, the line options along the first dune cordon (most southern portion of B1, B2 and B3 that runs east-west) was overgrown with wattle and natural coastal thicket, and this area was not surveyed (fig. 8 and 10). The route options that were in agricultural fields tend to have little, if any, archaeological material. However, material may occur below the surface, as observed along the northern parts of original field survey route.

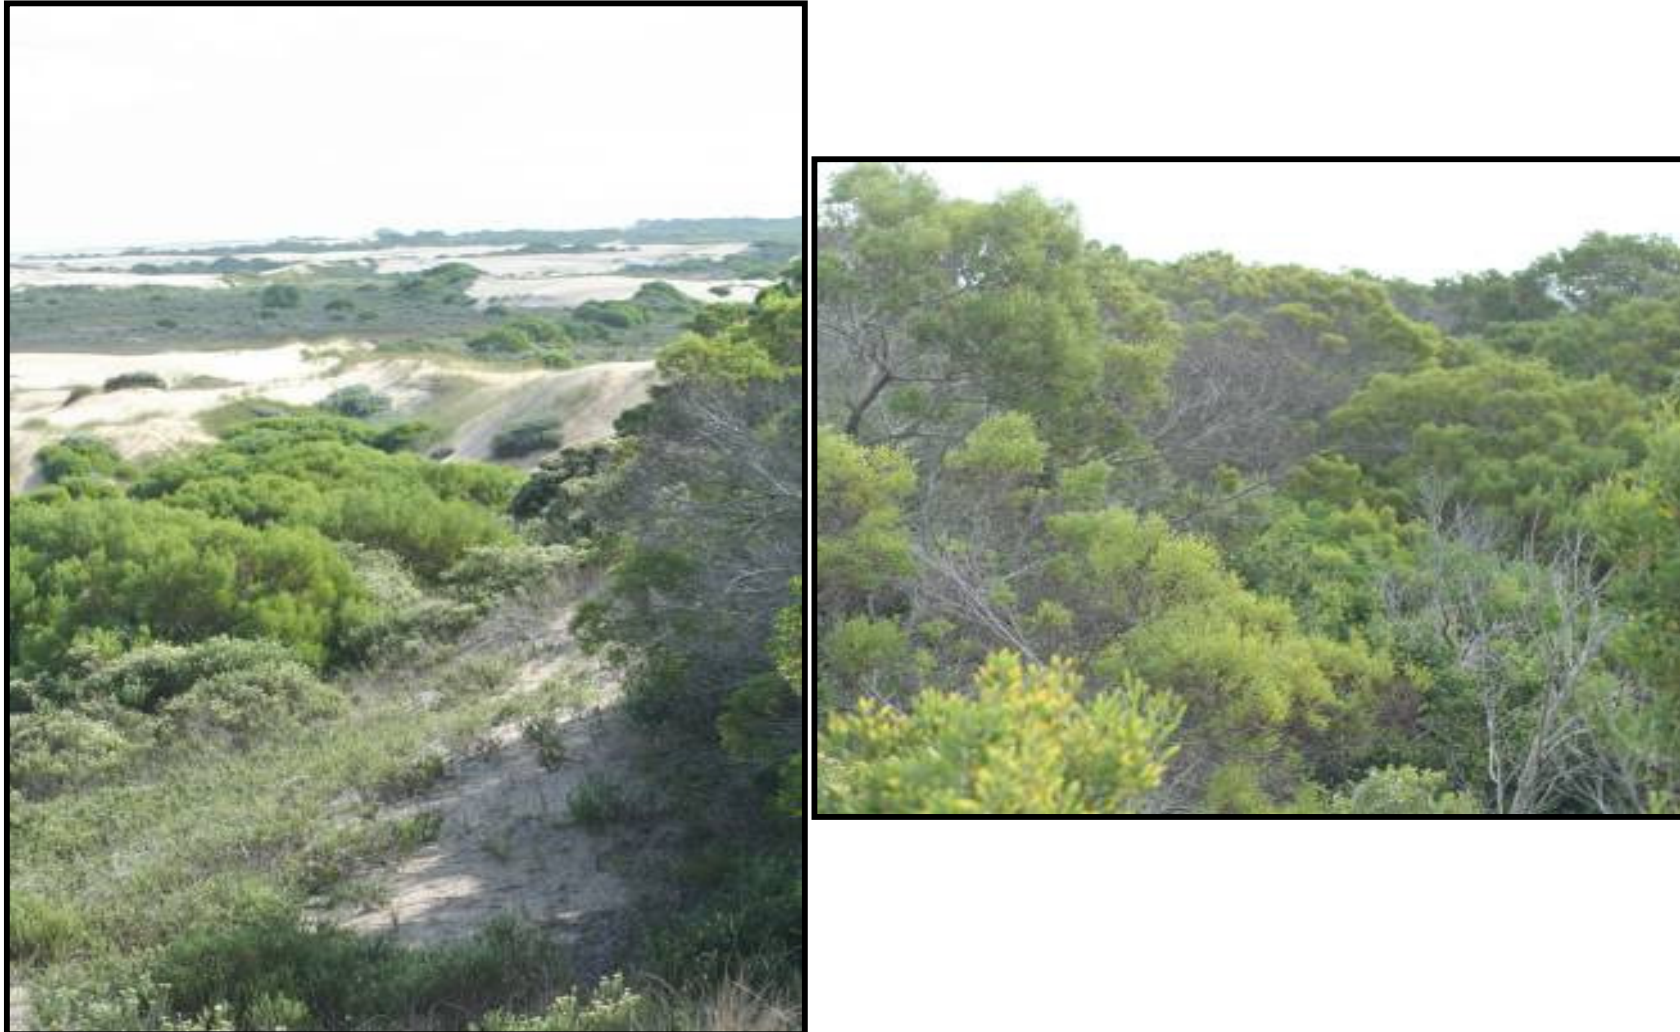
FIG. 10: VIEW LOOKING ALONG THE EAST-WEST SECTION OF B1¹¹

¹¹ The line runs along the top of the dune ridge for only the first 100m or so

Only the section of B1 that was not surveyed would require on site monitoring during vegetation clearance and construction phase. This is due to the fact stated above that no sites were observed along the surveyed portion of B1. If sites do occur along the unsurveyed portion they can most likely be mitigated.

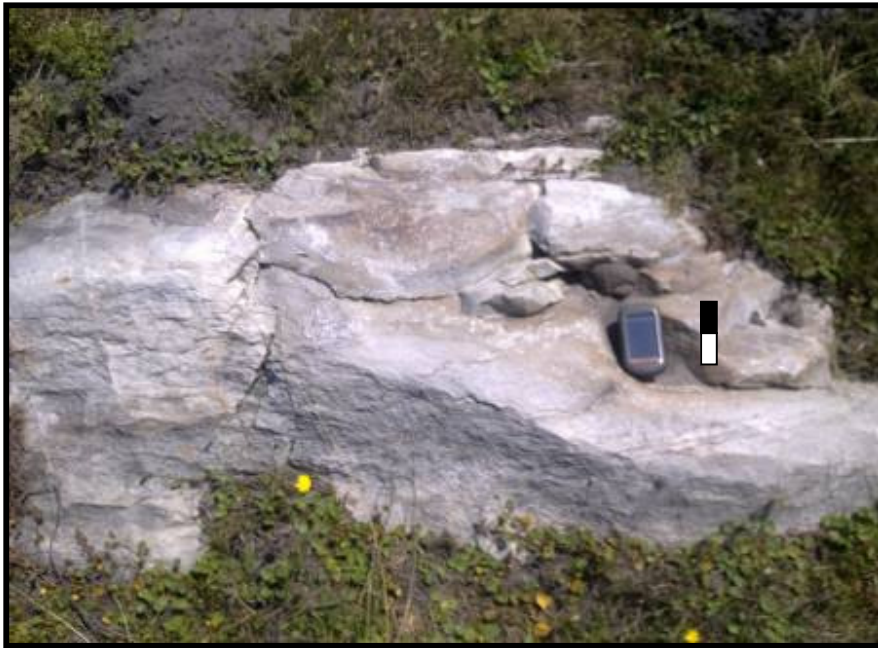
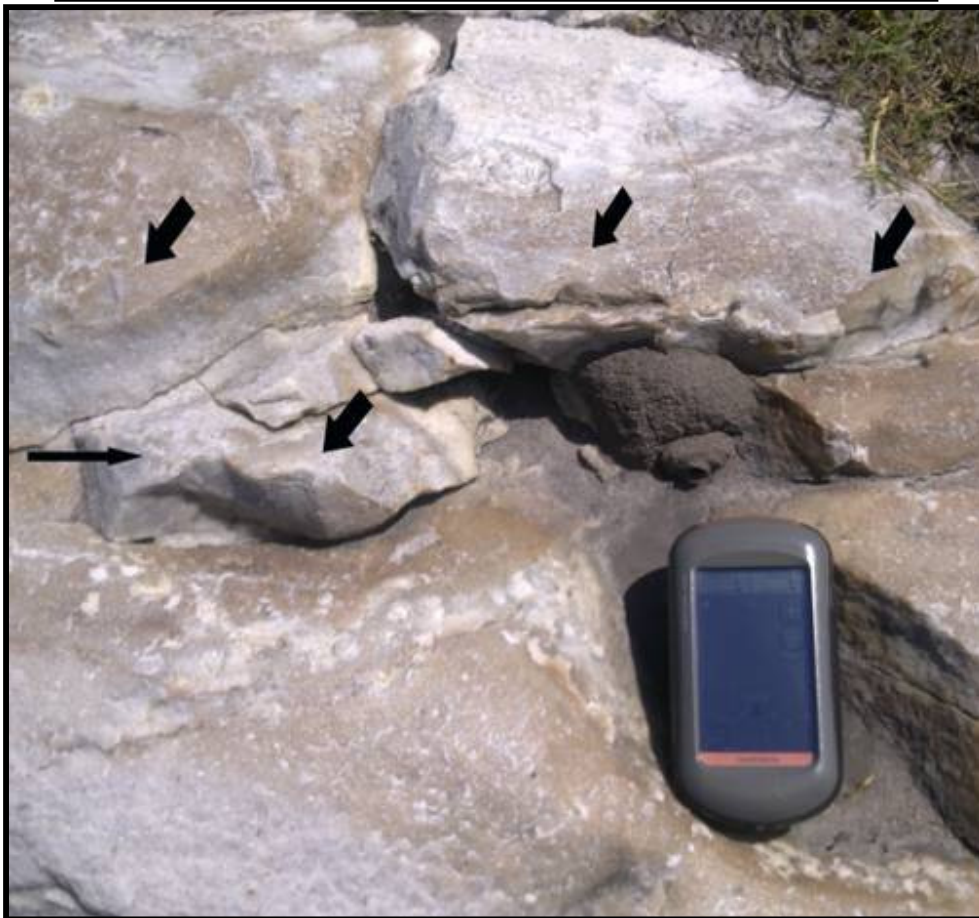
FIG. 13: QUARRIED ROCK OUTCROP AT RC01¹³

RC01 is located along the northern part of Section A1/A2. The site is a small rock outcrop (~1m x 1.5m) overlooking a stream. The rock is a local quartzite. There are at least four areas in the rock where flaking occurs to make stone tools, although it is not possible to state whether these are MSA or LSA flakes (fig. 13). The current route option occurs ~60m northeast of this singular rock outcrop.

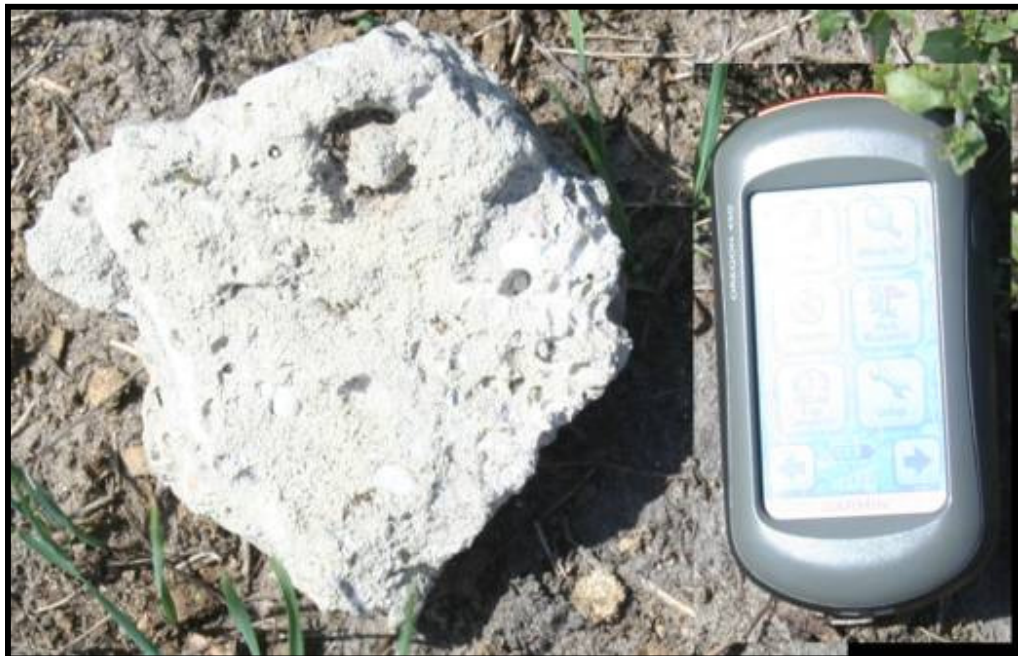
FIG. 15: COCQUINA CHUNCK AT RC03

RC03 occurs ~ 150m west of RC02a; however, the one site probably merges into the other. The site consists of large chunks of *coquina* (R. De Kok pers. comm.) along the surface. – see figure 15 and the PIA. The line has been moved away from the site.

Mitigation: See PIA report

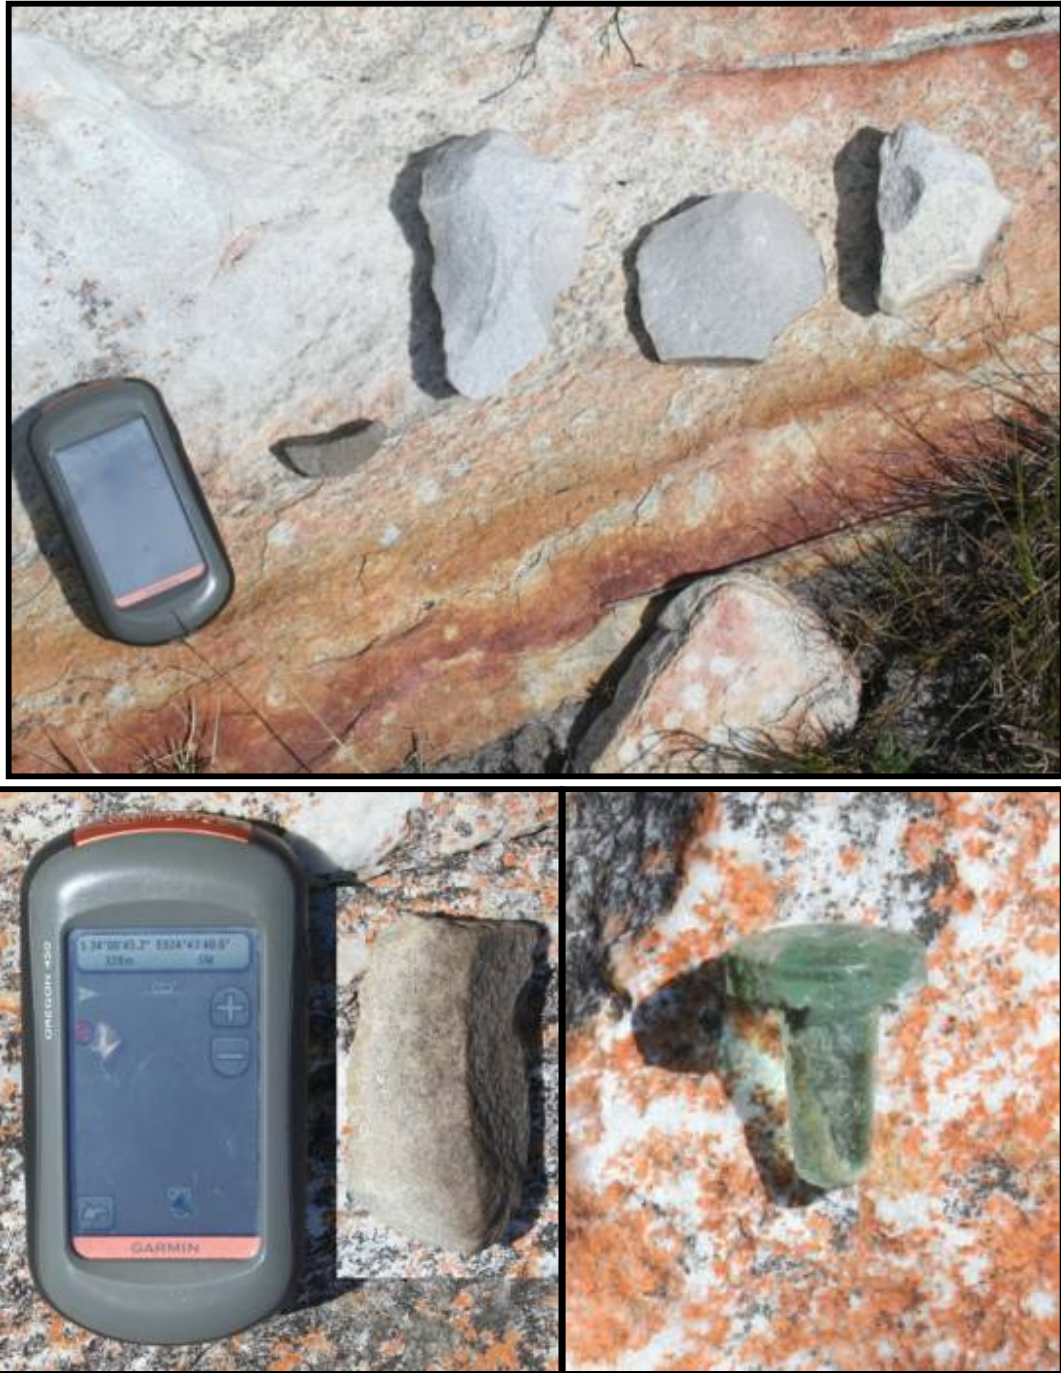
FIG. 16: ARTEFACTS AT RC04

RC04 occurs on a rock outcrop ~450m west of Section A1/A2. I surveyed the outcrop to test a hypothesis regarding rock outcrops and stone tool quarries in the area. I hypothesised that all rock outcrops would have been used as a raw material source and thus would be archaeological by default. If this was the case,

- Handaxe
- Cleaver
- Unifacial points
- Irregular cores
- Possible unfinished backed flake, or bifacial point – the tool was broken at both ends
- Several flakes of various sizes

A single glass stopper was observed amongst the rocks. The glass top is handmade (there are no seams and several bubbles occur) and it probably originates from the 19th century.

Mitigation: The site will not be affected by the current line route. However, if it is affected then each area around a pylon will need to be sampled. The method of line construction should also be noted. If any heavy-duty machinery is used along the line, then it has the possibility of damaging artefacts. If that is the case, then the line servitude should be sampled.

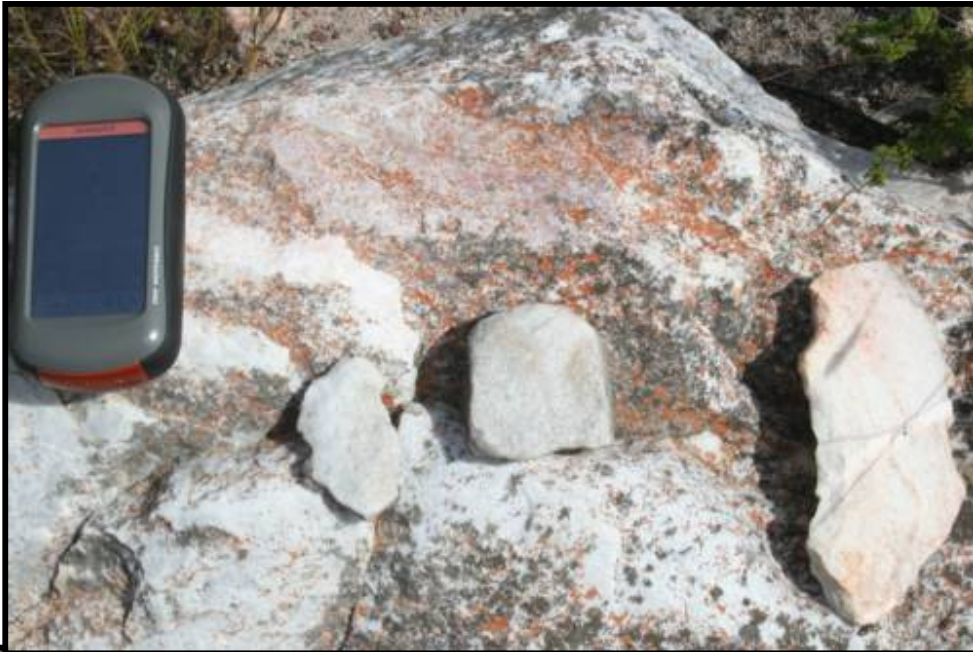
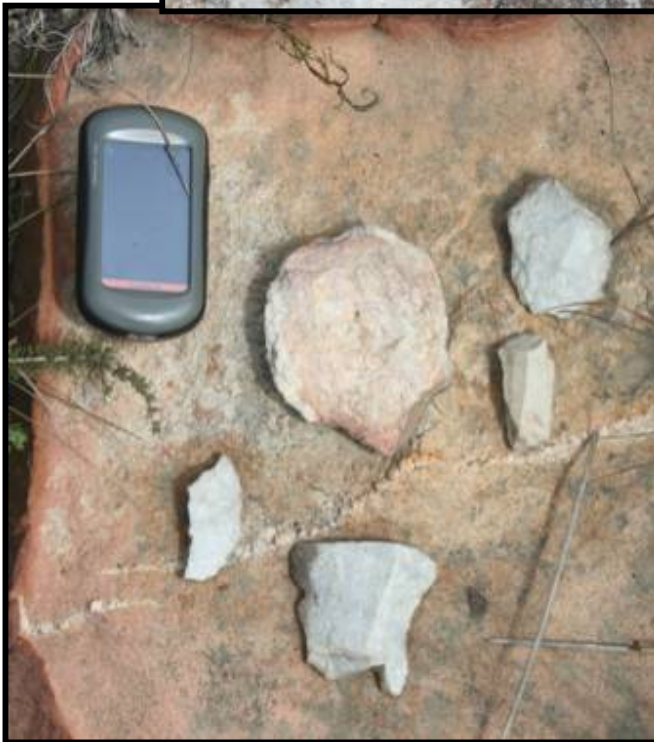
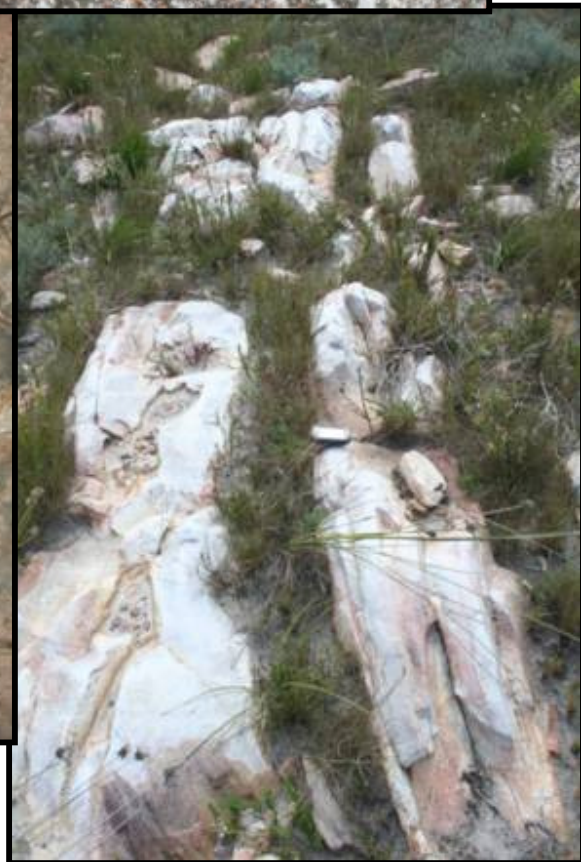
FIG. 17: ARTEFACTS & FEATURES AT RC05

RC05 is located along the north-western part of Sections A1/A2. It is concentrated on the area of the line route; however, the site does extend across the entire hill. The site, like RC04, consists of ESA and MSA tools (fig. 17); however, they appear to be more weathered. The outcrop consists of several concentrations of stone tools, as well as individual artefacts. All of the artefacts are from the local outcrop, which has also been used as a quarry.

Mitigation: The site will be directly affected by the current line route. Each area around the pylon will need to be sampled. The method of line construction should also be noted. If any heavy-duty machinery is used along the line, then it has the possibility of damaging artefacts. If that is the case, then the line servitude should be sampled. The rest of the site to the south can be assessed and mitigated if this line option is chosen

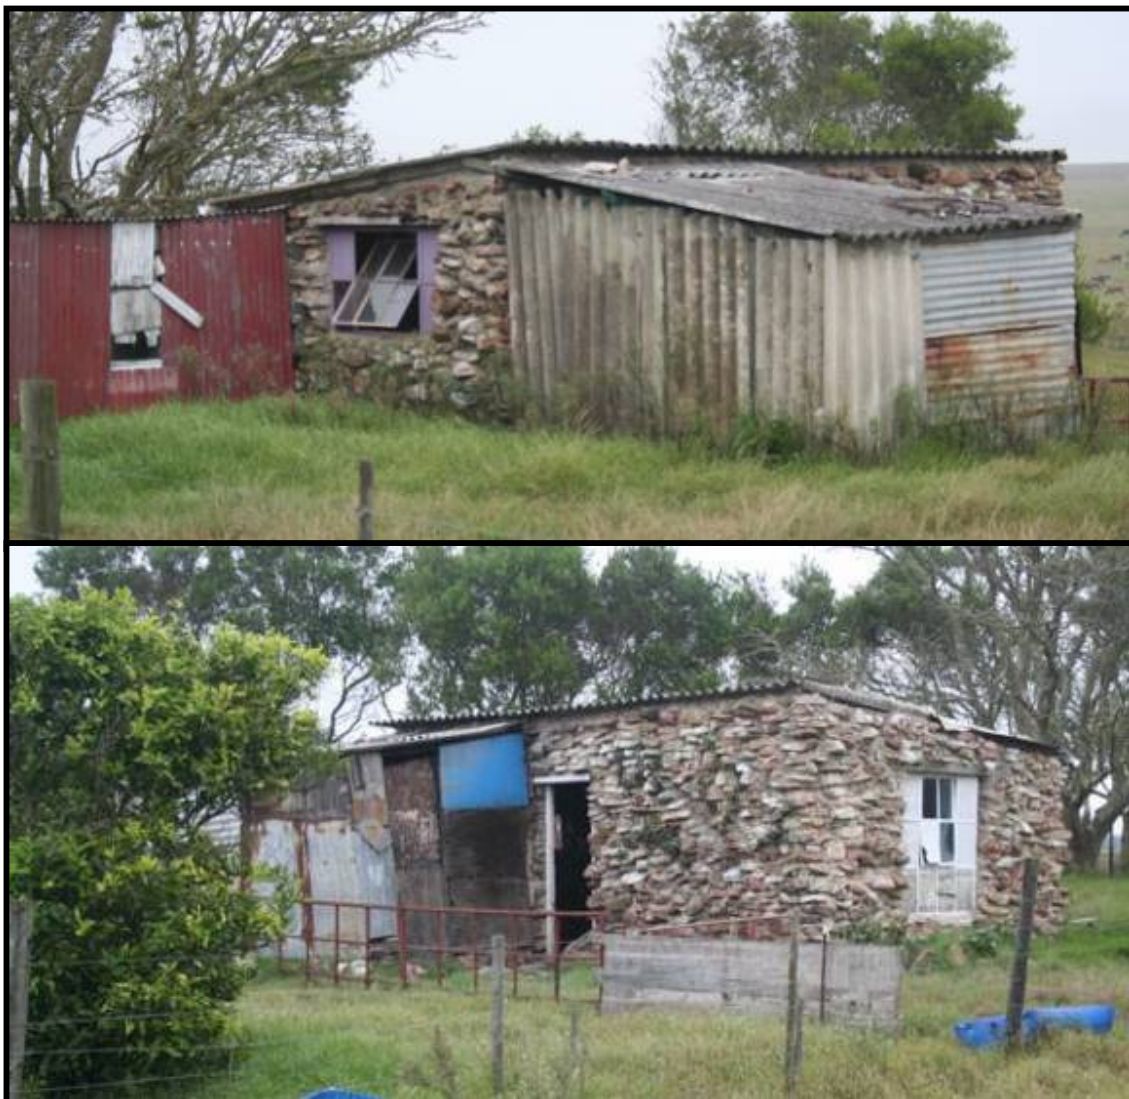
FIG. 18: HOUSE AT RC06

RC06 is located in the middle of the study area, and is not directly affected by the line. The site consists of a presumed labourer's house with corrugated iron additions. While the building is not new, it is not older than 60 years, as seen with the metal window frames and cement/concrete used for the walls. It appears that the house is currently used for livestock.

Mitigation: No mitigation is required since it is not affected.

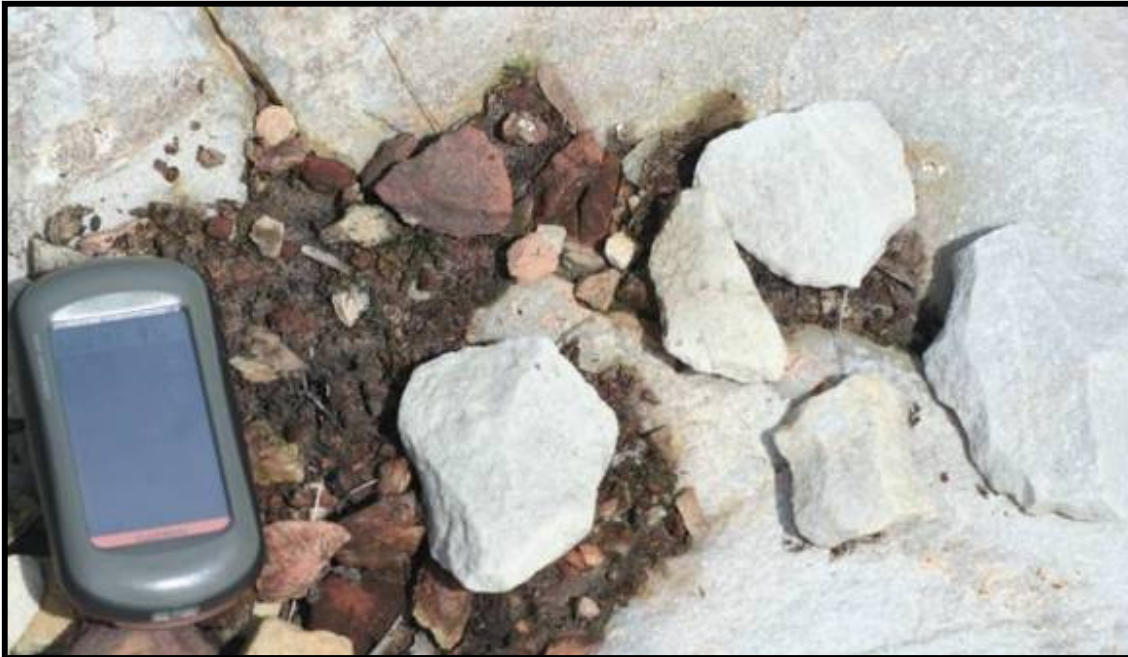
FIG. 19: STONE TOOLS AT RC07

The main part of RC07 occurs along eastern portion of Section A3/A4. The site is a general scatter of tools over the entire hill (fig. 19). As with the other outcrops in the area, the local raw material is used and several rocks have evidence of being utilised. The tools included:

The method of line construction should also be noted. If any heavy-duty machinery is used along the line, then it has the possibility of damaging artefacts. If that is the case, then the line servitude should be surveyed and sampled.

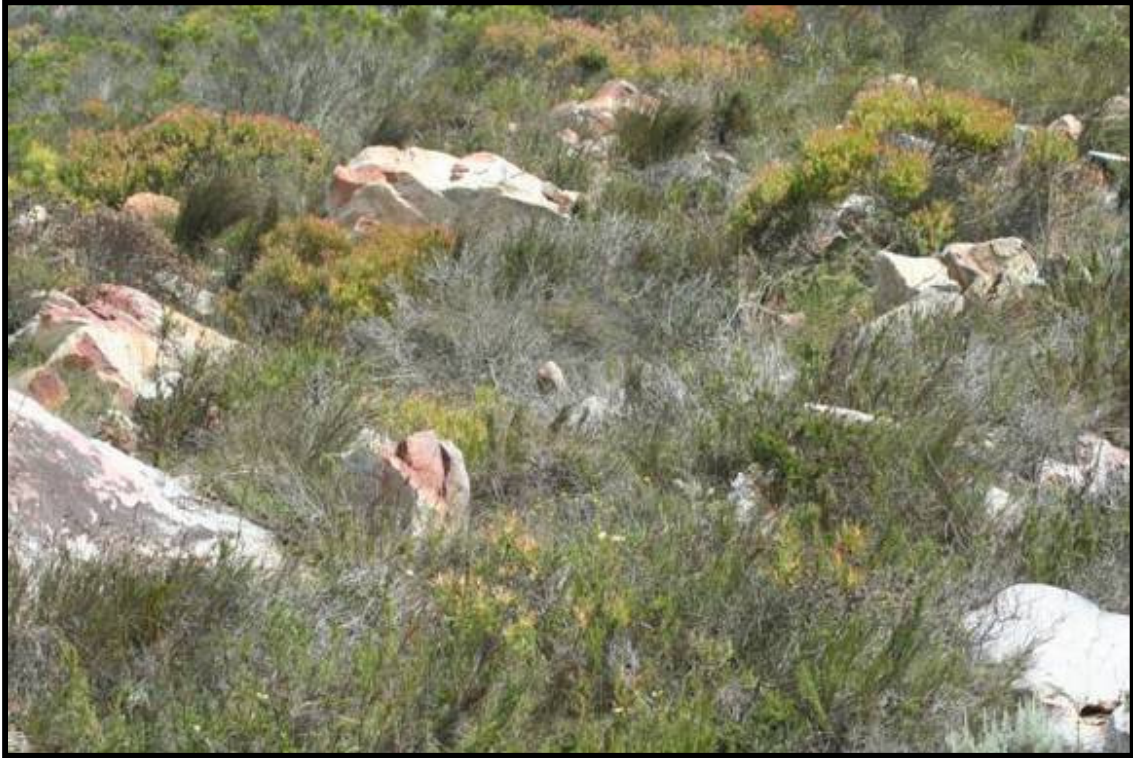
FIG. 19: DENSE FYNBOS VEGETATION AT RC08

RC08 and RC09 are located on top of a heavily (fynbos) vegetated hill. The entire hill (from RC08 to RC010) appears to have been extensively quarried in the past. There are many semi-circular holes along the hill and many of the rocks have “teeth mark scars” from mechanical instruments. Some of the machines have left pressure flakes from the rocks, resulting in false stone tools. However, there are occasional MSA flakes in the area.

Mitigation: No further mitigation is required since this area has been severely disturbed by quarry activity. The site will not be affected as the line option has moved away.

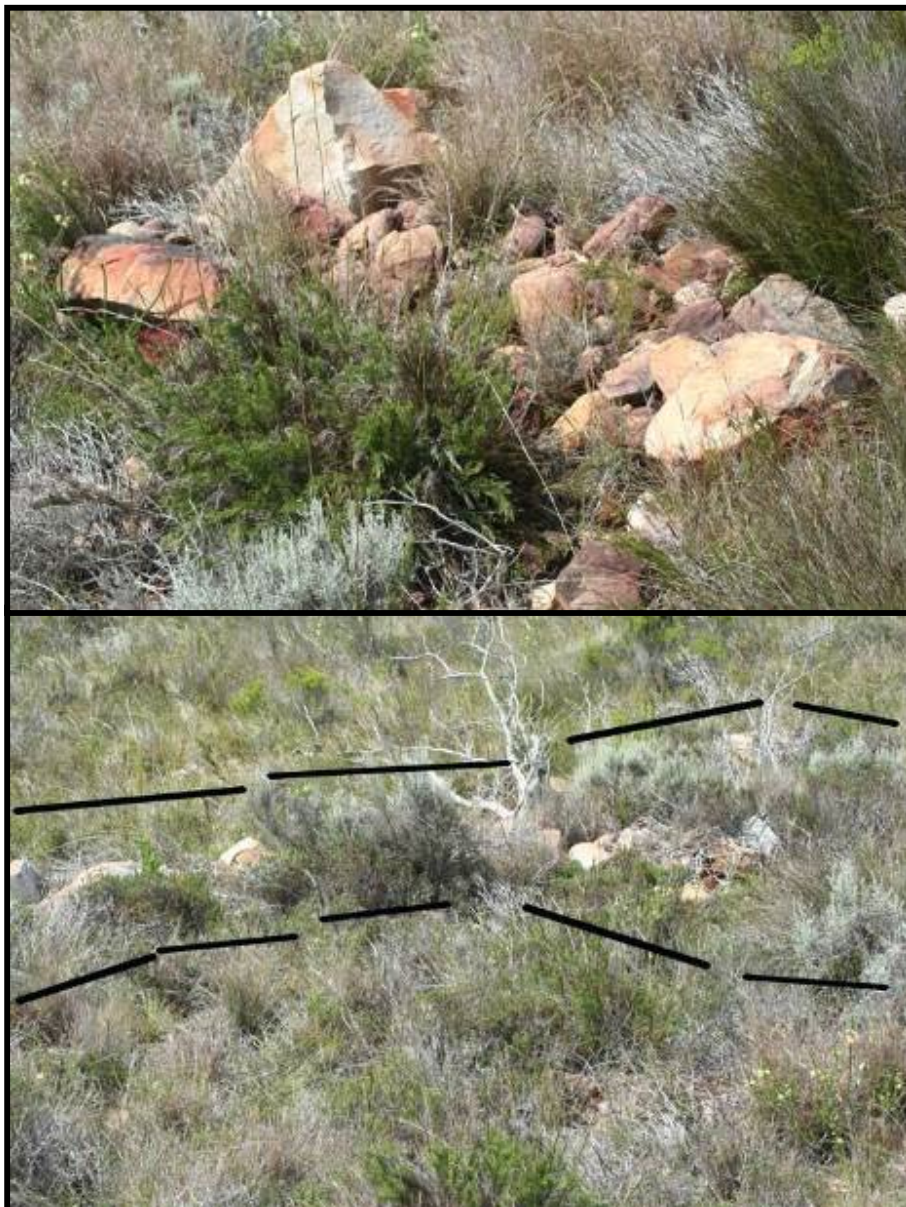
FIG. 20: POSSIBLE WALLING AT RC010

RC010 occurs near the northeastern side of the same hill as RC08 and RC09. The area has been quarried; however, four areas appear to look more like walls: they are larger and more circular than the other quarried areas. These walls also appeared to be stacked dry stone walling, whereas the quarried areas were more disjointed. The dense vegetation made it difficult to view the entire wall, and these would need to be re-assessed when the vegetation is less dense and/or if the area is affected. There were a total of four possible walls in this area (fig. 20). If these are dry stone walls then they may be kraals that may relate to Colonial farmers or pastoralists - this would need to be studied in depth before a final statement can be made.

Mitigation: Currently the area will not be affected as the line has moved. If the area is to be affected, then it needs to be re-assessed when the vegetation is less dense to determine if these are indeed walls or the result of quarrying activity. The (possible) walling would need to be mapped and photographed, and clearly demarcated, so that it is not damaged by line construction.

The area with the possible stone walling (RC010) should be monitored to ensure that the walls are not damaged. The sensitive areas would need to be clearly demarcated. **However, this site is currently out of the line route.**

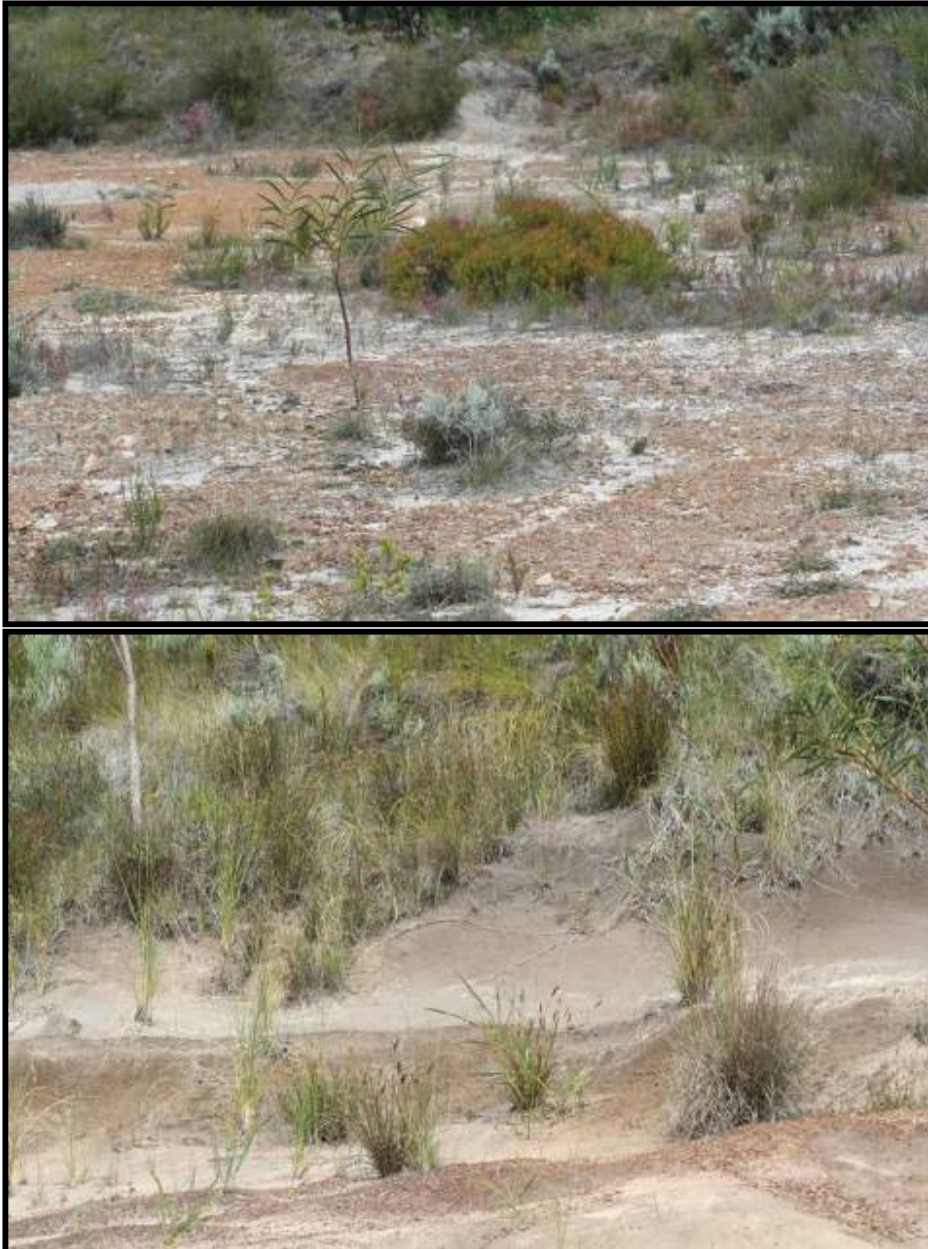
FIG. 21: GRAVEL BED AND SAND DEPOSITS AT RC011

RC011 occurs at the base of the hill where it becomes part of the plains for the Kromrivier. The site is a lag deposit that occurs on a gravel bed ~50cm below the surface (fig. 21). The artefacts are visible in the eroded area that is 200m x 150m in size. More artefacts would obviously occur in the uneroded areas. The areas of the site that is not eroded, is covered by wattle trees.

clearance is used, then the servitude corridor would need to be sampled as well. Any subsurface activity (i.e. more than 10cm), in the general area of the site would require a survey and/or sampling strategy.

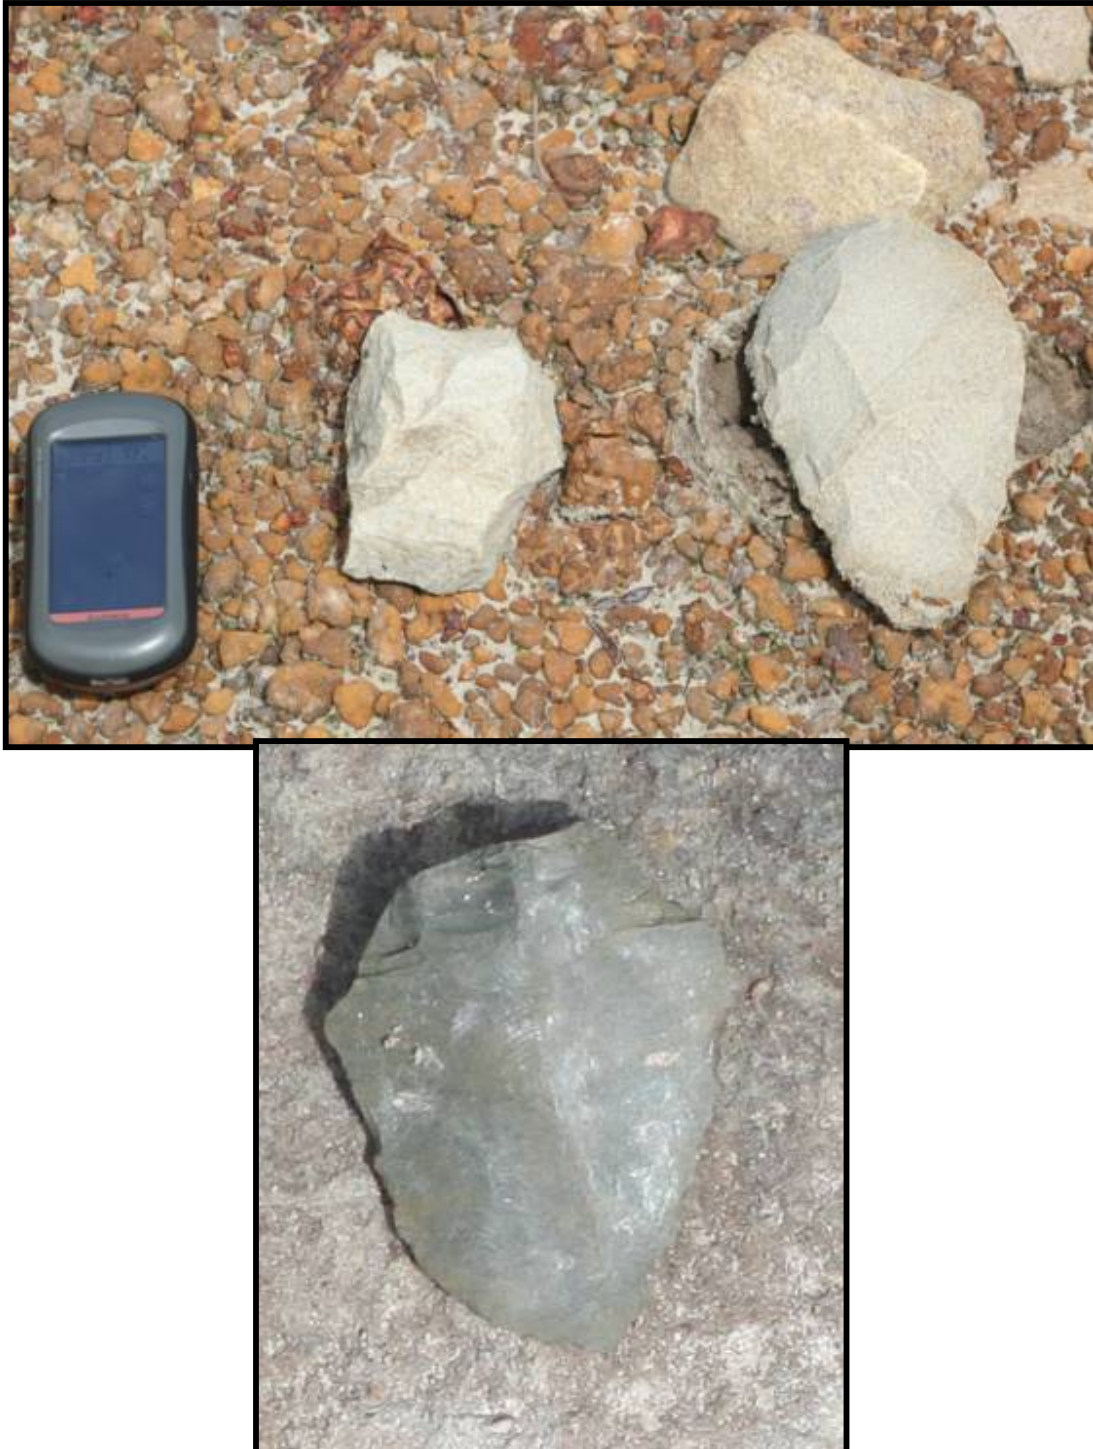
FIG. 22b: STONE ARTEFACTS FROM RC011¹⁴

¹⁴ Bottom tool is ~5cm in length
