**HERITAGE SURVEY OF THE PROPOSED 66 kV LINE
BETWEEN ST FRANCIS AND RED CAP KOUGA WIND
FARM, EASTERN CAPE**

FOR COASTAL & ENVIRONMENTAL SERVICES

DATE: 2 August 2011

**Umlando: Archaeological Tourism and Resource
Management**

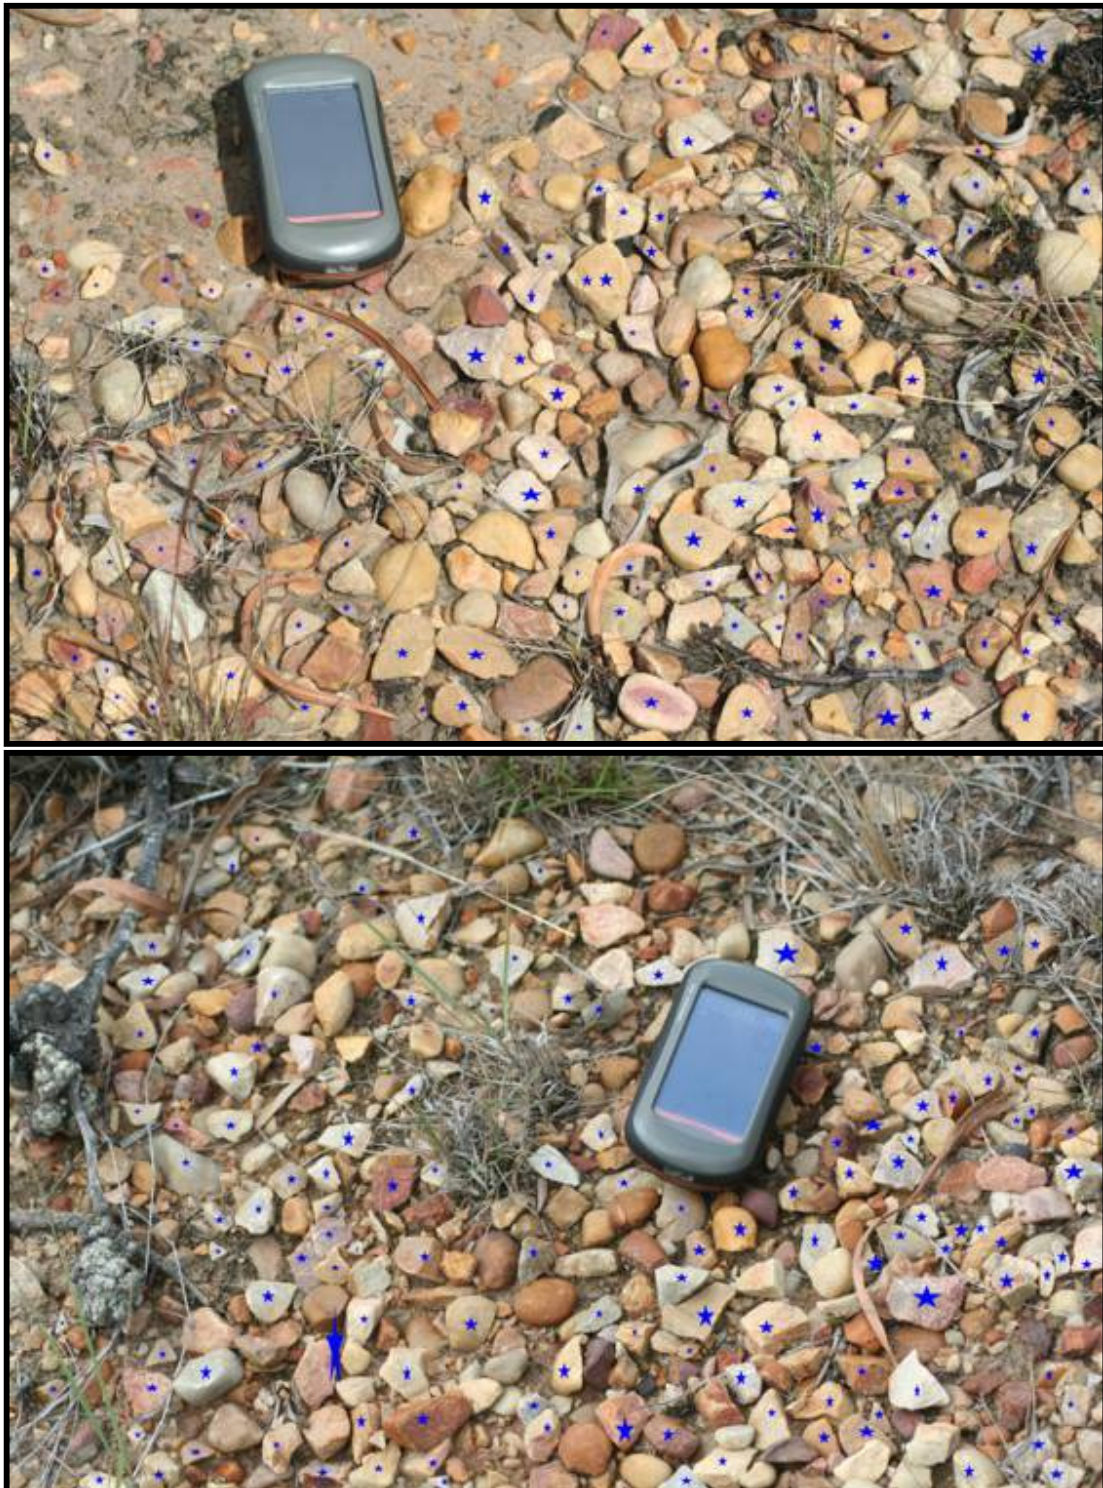
FIG. 24: CLOSE-UP VIEW OF STONE ARTEFACTS ON A GRAVEL BED AT RC012¹⁵

¹⁵ Blue star = stone tool: chip, chunk, flake or irregular core

Mitigation: The site will require mitigation if it is affected in any manner. The areas around each pylon will need to be sampled and or excavated if not exposed. The area along the final servitude will need to be demarcated and sampled, as bush clearance and/or construction equipment will disturb the site.

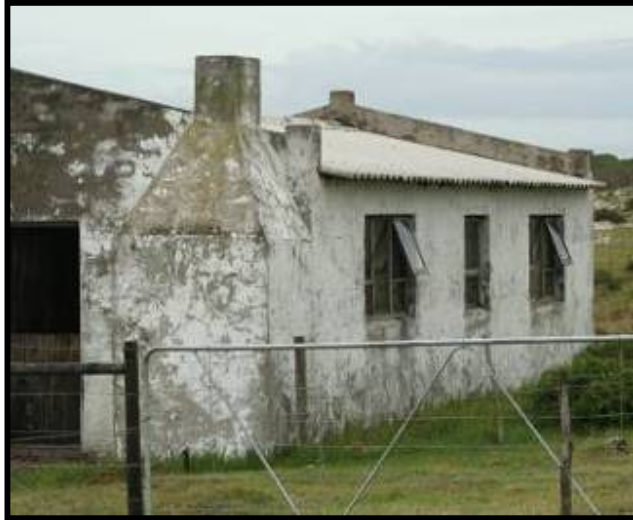
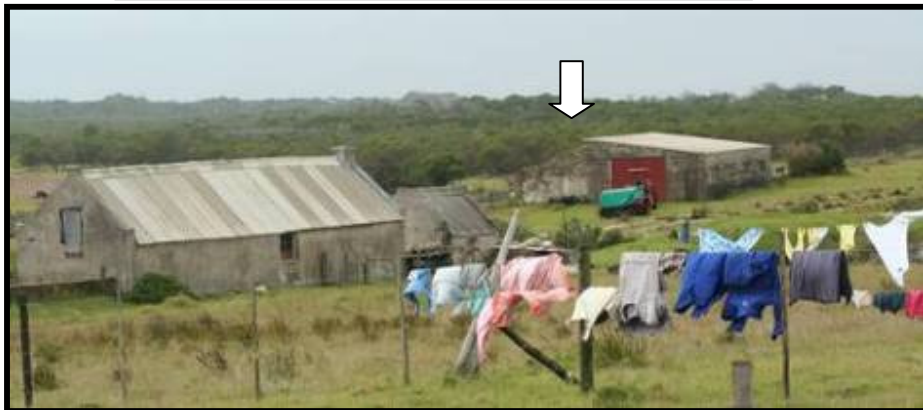
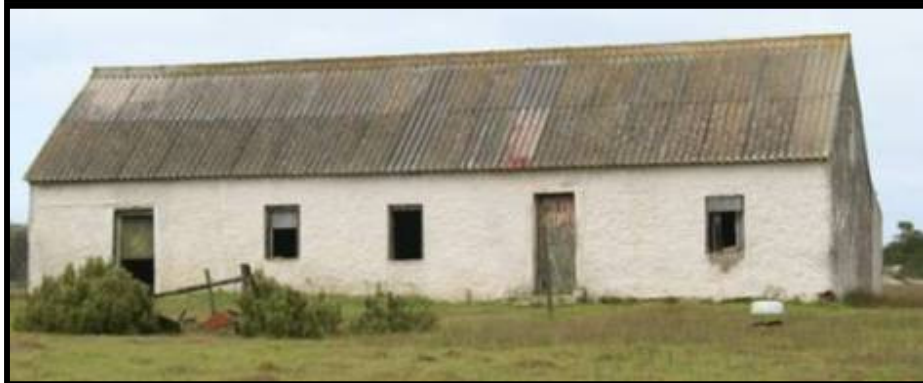
FIG. 25: BUILDINGS AT BUFFELSHOEK

Site 2.6 was initially recorded by van Ryneveld (2010) and is part of the Buffelsbosch farm complex. The site is along the eastern portion of Section A3/A4 . Several of the buildings predate the 60-year mark, and may even date to the 19th century (fig. 25). Both buildings are fairly run down: one is inhabited by farm labourers and the others have been modified for storage areas. One of the latter buildings has several cracks along the walls, especially where add-ons have been placed. This appears to be one of the original farm buildings.

Mitigation: Currently no mitigation is required

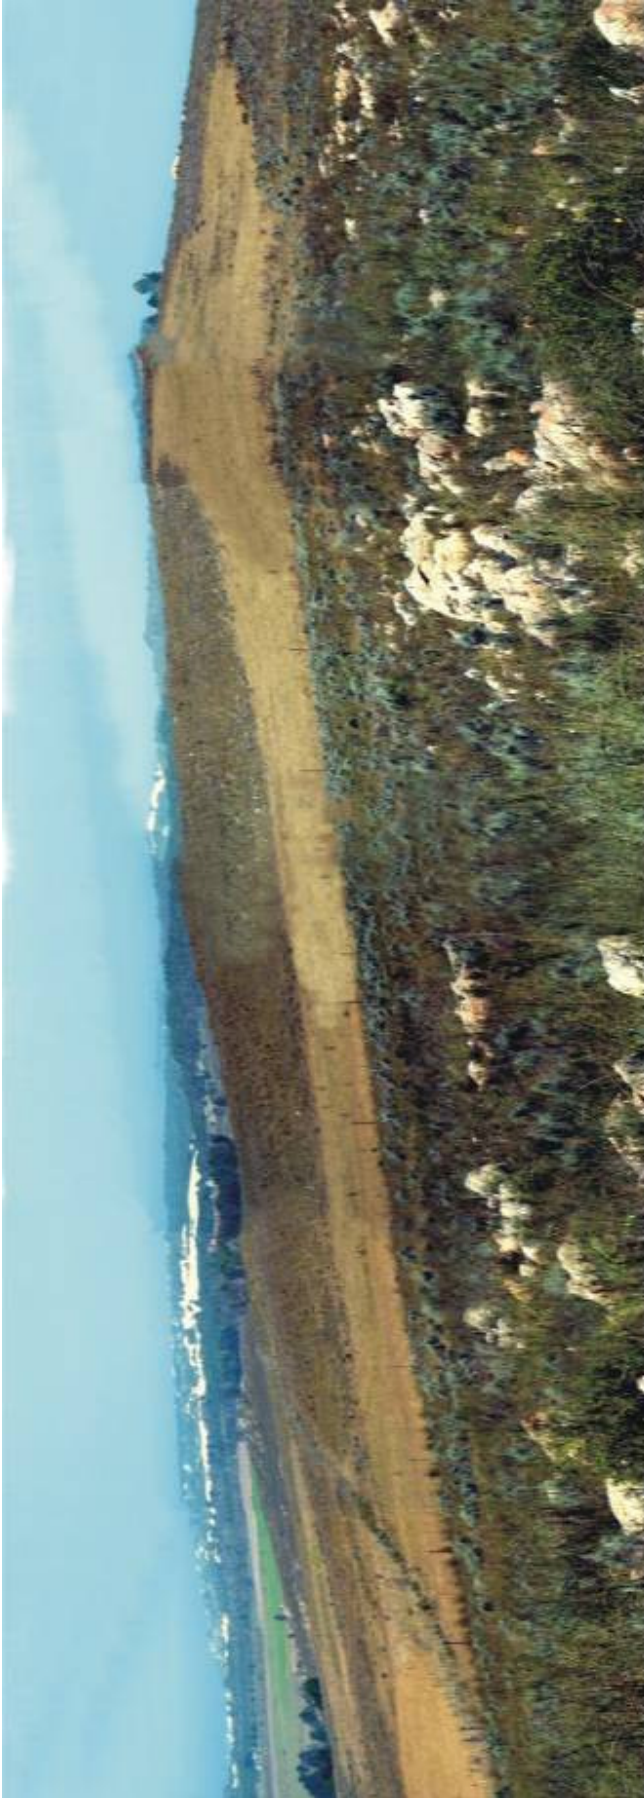
Figure 3. General view (looking east, southeast) showing the flat to rolling nature of the countryside. St. Francis Bay is situated top left in the photograph with quartzite outcrops in the foreground.

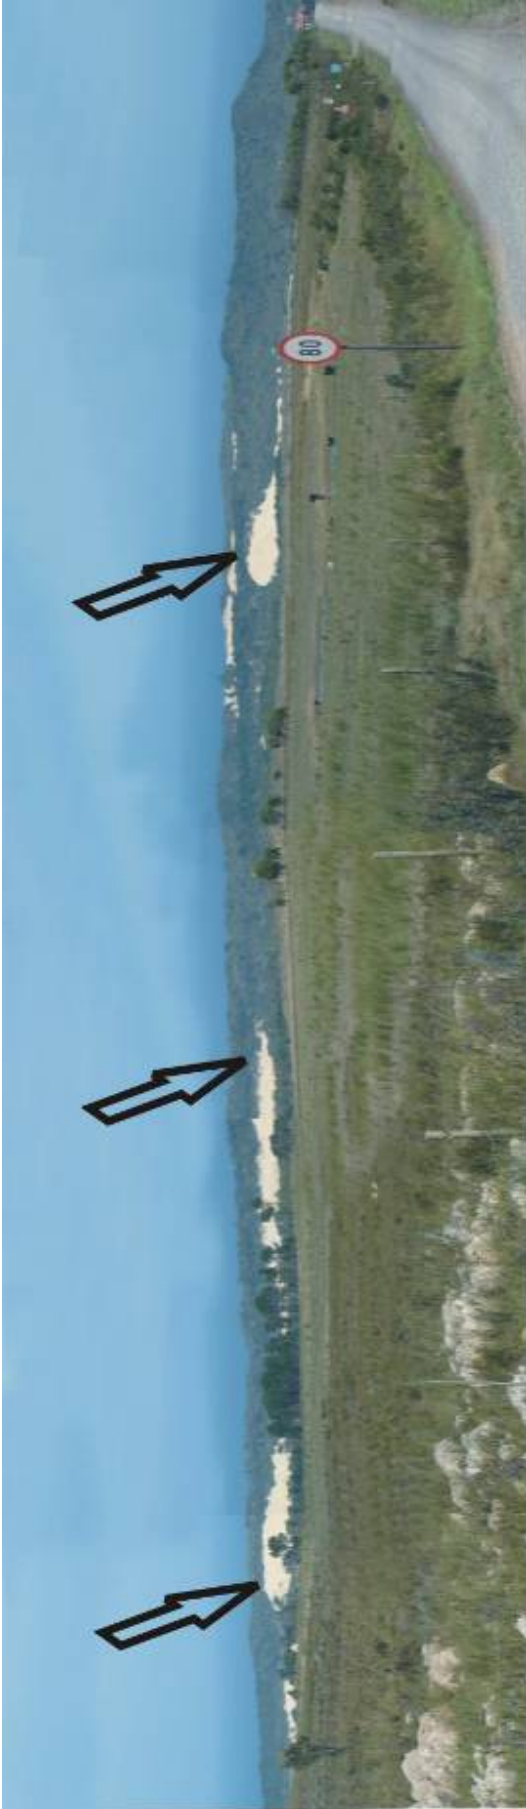
Figure 5. The shoreline south of the footprint is bounded by coastal dunefields that make up the Schelm Hoek Formation, which is the uppermost unit of the Algoa Group.

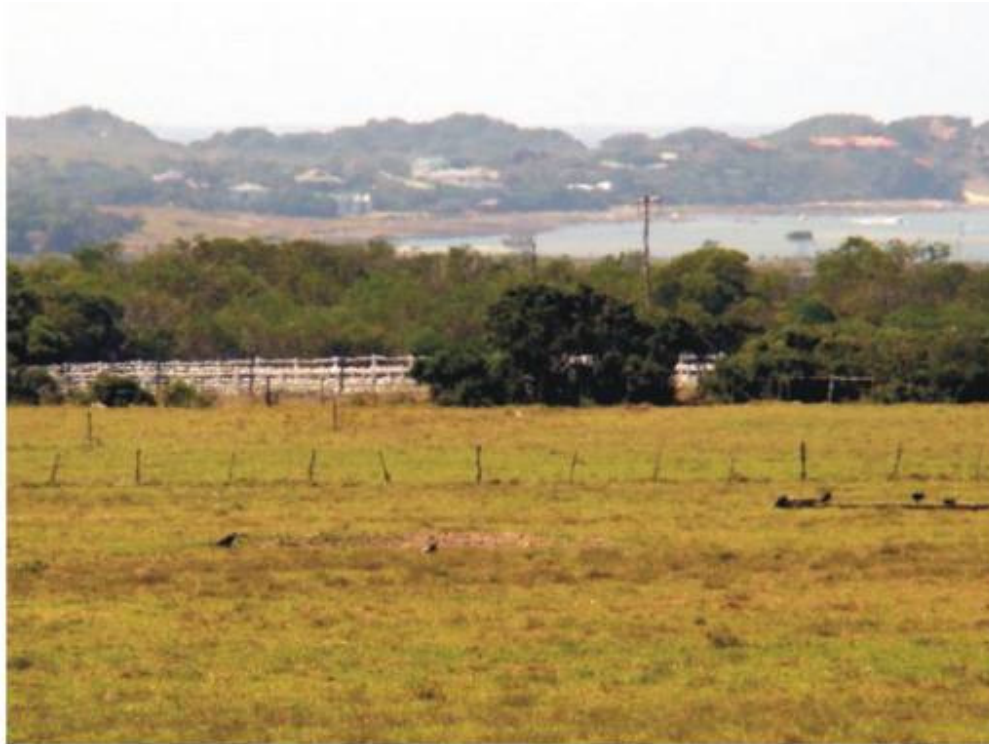
Figure 6. Section 1A. Featureless plain (looking east) with no apparent outcrop covering basal Bokkeveld Group sediments. Outcrops of Ceres Subgroup shales are well-exposed in road cuttings along the R330 between St. Francis Bay and Humansdorp.

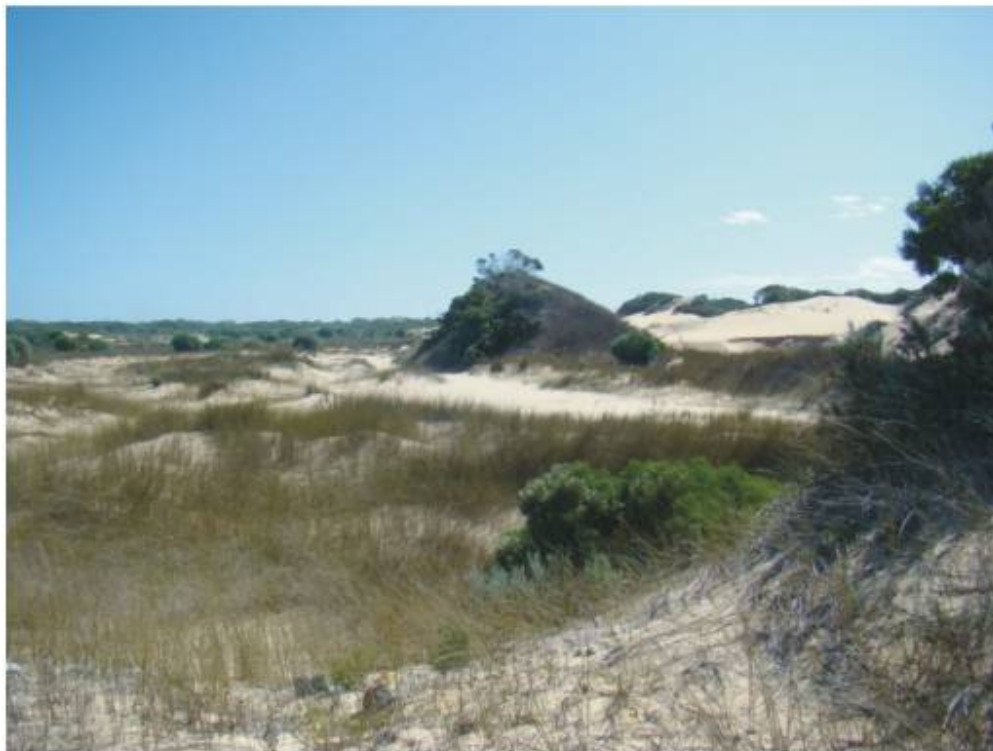
Figure 7. Calcareous and non-calcareous aeolian sands of the Schelm Hoek Formation (Algoa Group).

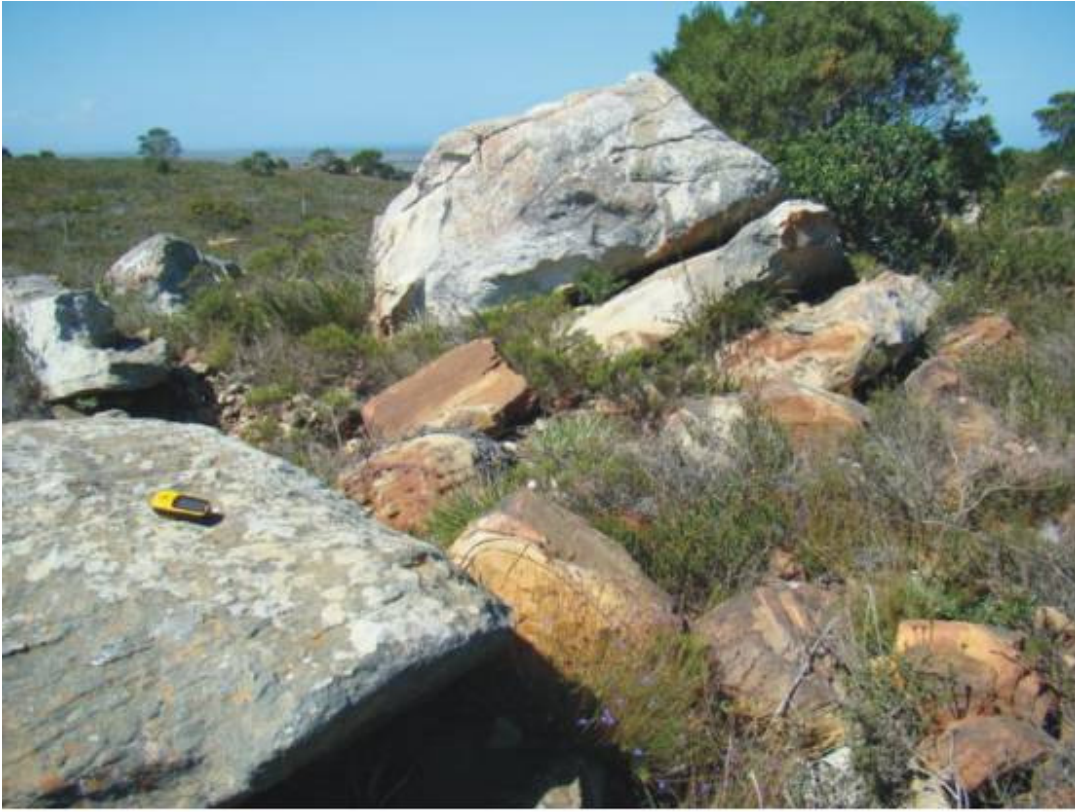
Figure 8. Section 1B. Brown-weathering quartzitic sandstone of the Goudini Formation.

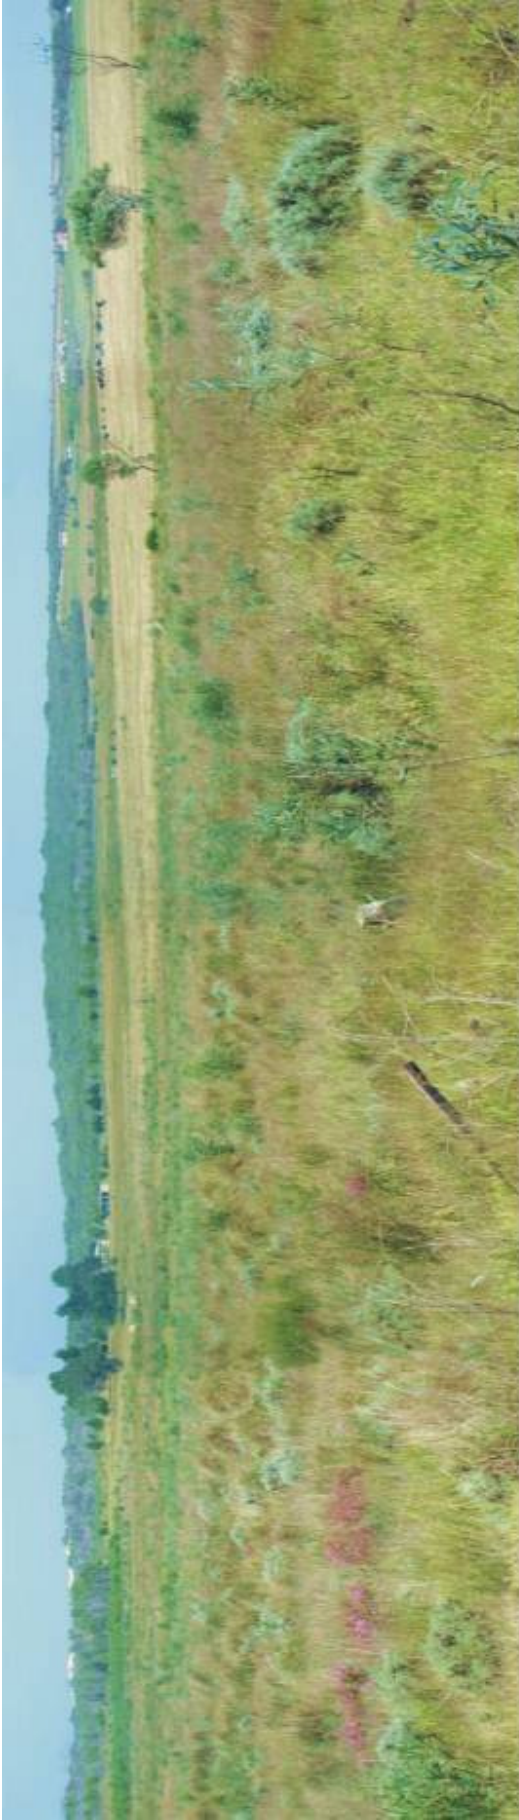
Figure 9. Section 1B. General view (looking west) showing a paucity of bedrock outcrop.

The section traverses approximately 2 km of Table Mountain Group sediments (Goudini Formation, *Sg*) along relatively flat-lying land (**Figs. 8 and 9**). The sediments in the demarcated area are not palaeontologically vulnerable and are of low palaeontological significance.

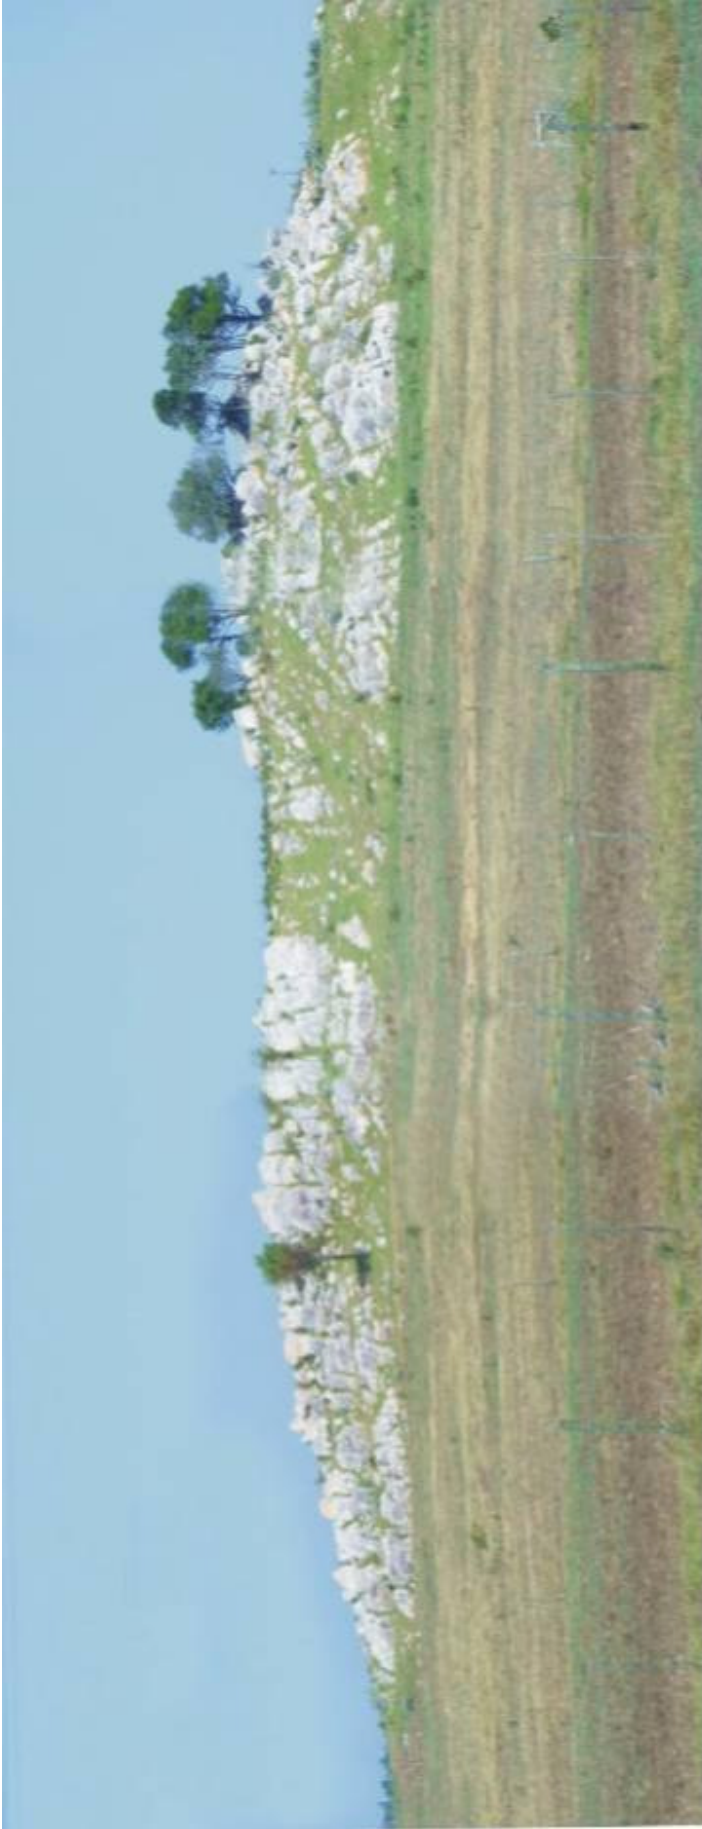
Figure 10. Section 2A. Isolated outcrop of quartzitic sandstone (looking south).

The section traverses approximately 8.5 km of Table Mountain Group sediments (Peninsula Formation *Op*, Cederberg Formation *Oc*, Goudini Formation, *Sg*) over generally flat countryside (**Figs. 10 and 11**). The only unit that may be palaeontologically sensitive in this section is the Cederberg Formation, which has yielded marine invertebrates, early vertebrates and primitive fishes (**Fig 12**). The outcrop of Cederberg shales occurs as a thin band and dissects Section A2 and A3 on the geological map. It will most likely not be negatively affected by this configuration. The rest of the geological units in the demarcated area are not palaeontologically vulnerable and are of low palaeontological significance.

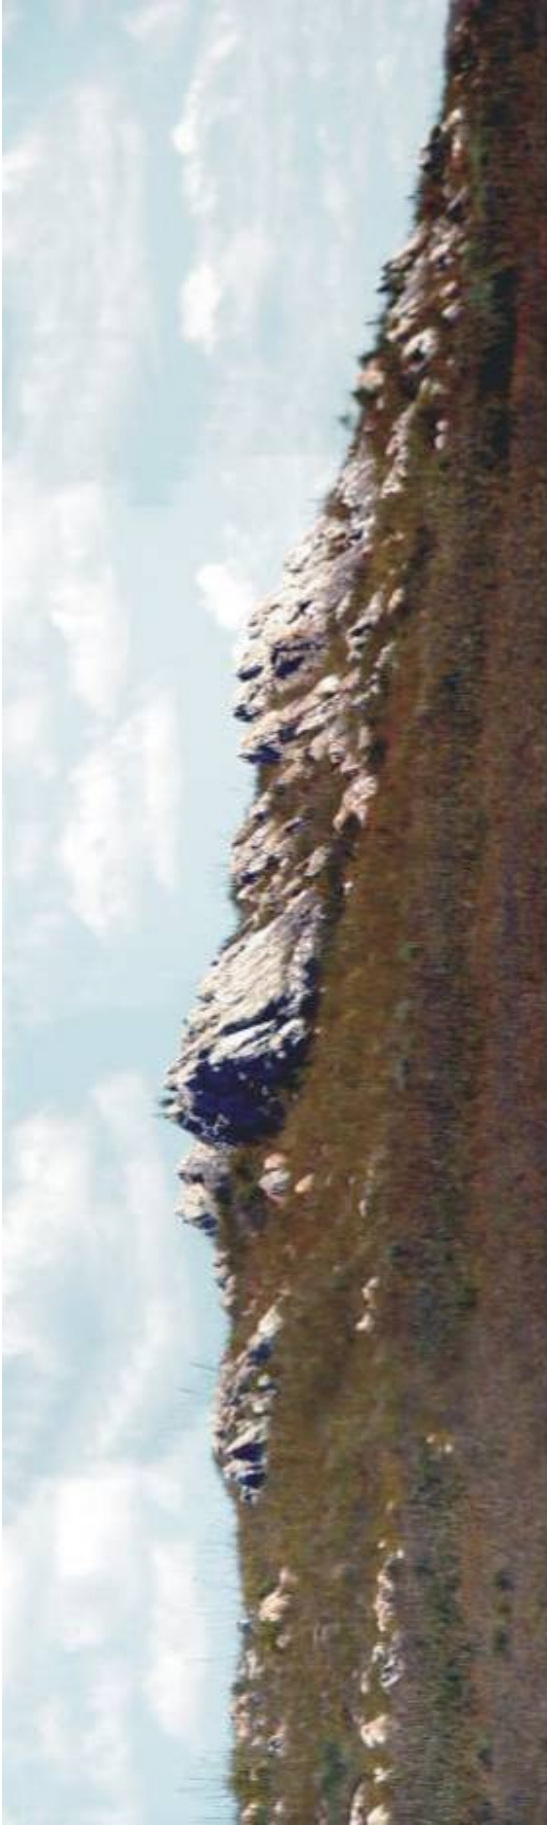
Figure 11. Section 2A. A weather-resistant Peninsula Fm. quartzite outcropping predominantly found on higher ground.

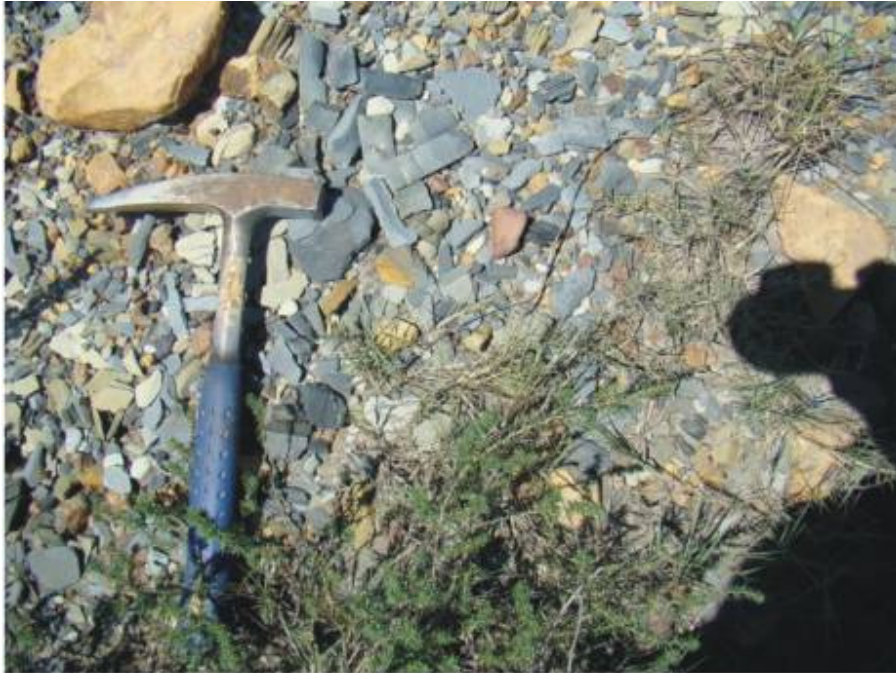
Figure 12. Section 2A. Eroded Cederberg shales. Exposed strata occurs in a thin band along the high ground.

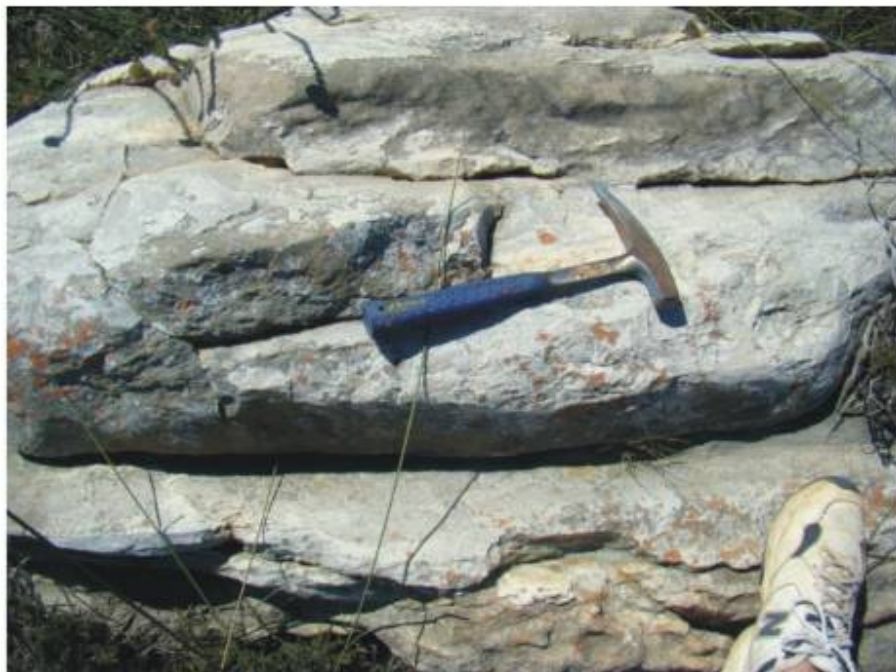
Figure 13. Section 2B. Quartzitic sandstone of the Peninsula Fm. predominate the underlying geology of this section.

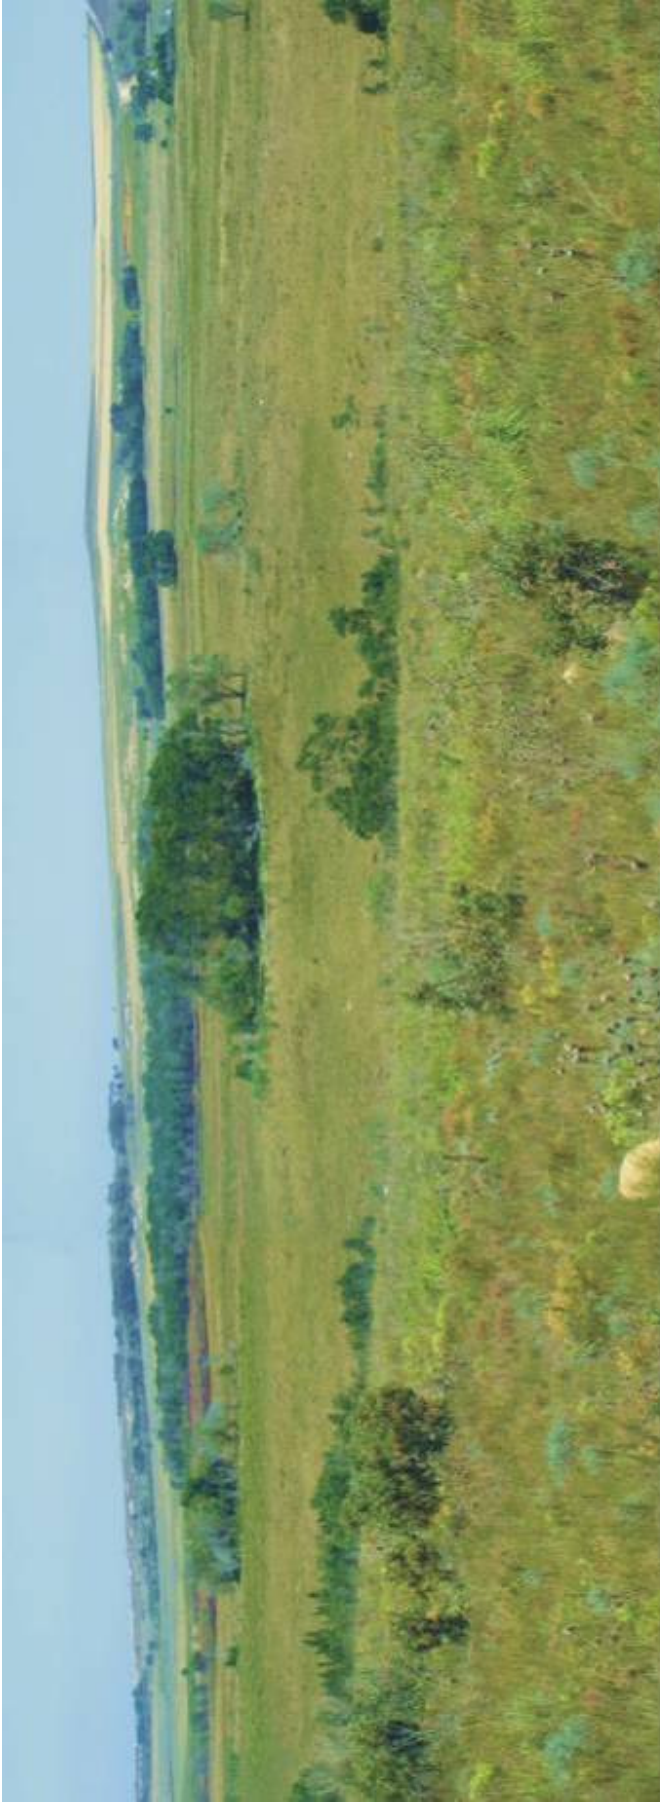
Figure 14. General view (looking south) of substation site Option 1, located on Goudini Frm. sandstones.

All the proposed substation localities are sited on Table Mountain Group rocks. Option 1 are located on Goudini Formation quartzitic sandstone (**Fig. 14**), while options 2 and 3 are both located on weather-resistant quartzitic sandstones of the Peninsula Formation (**Figs. 15 and 16**). All three options are sited on bedrock that is not palaeontologically vulnerable and that is of low palaeontological significance.

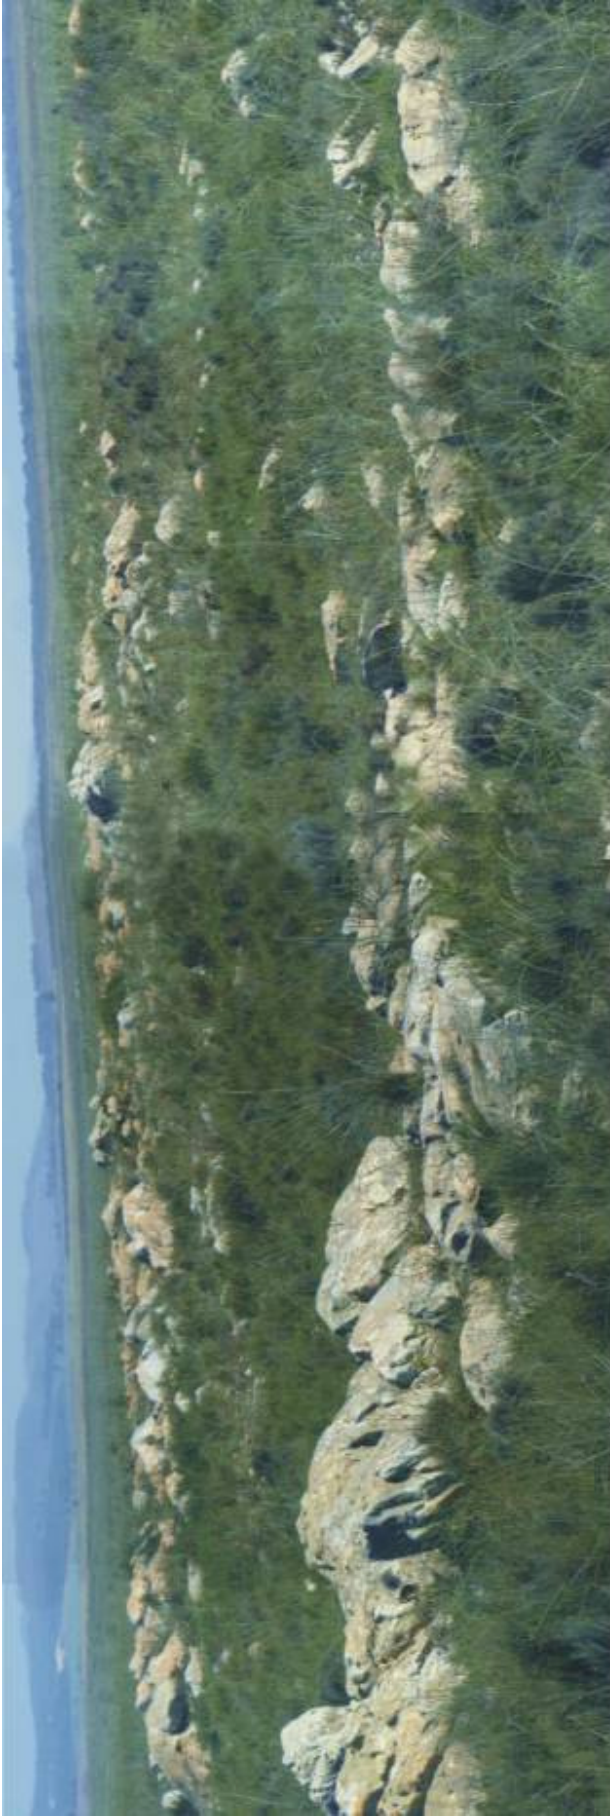
Figure 16. General view (looking west southwest) of substation site Option 3, located on Peninsula Frm. sandstones.
