**HERITAGE IMPACT ASSESSMENT FOR
PROPOSED CONSTRUCTION OF THE ESKOM GROBLERSHOOP
SUBSTATION AND THE GARONA-GROBLERSHOOP 132 kV POWERLINE,
GROBLERSHOOP, NORTHERN CAPE**

(Assessment conducted under Section 38 (8) of the
National Heritage Resources Act (No. 25 of 1999) as part of an EIA)

March 2013

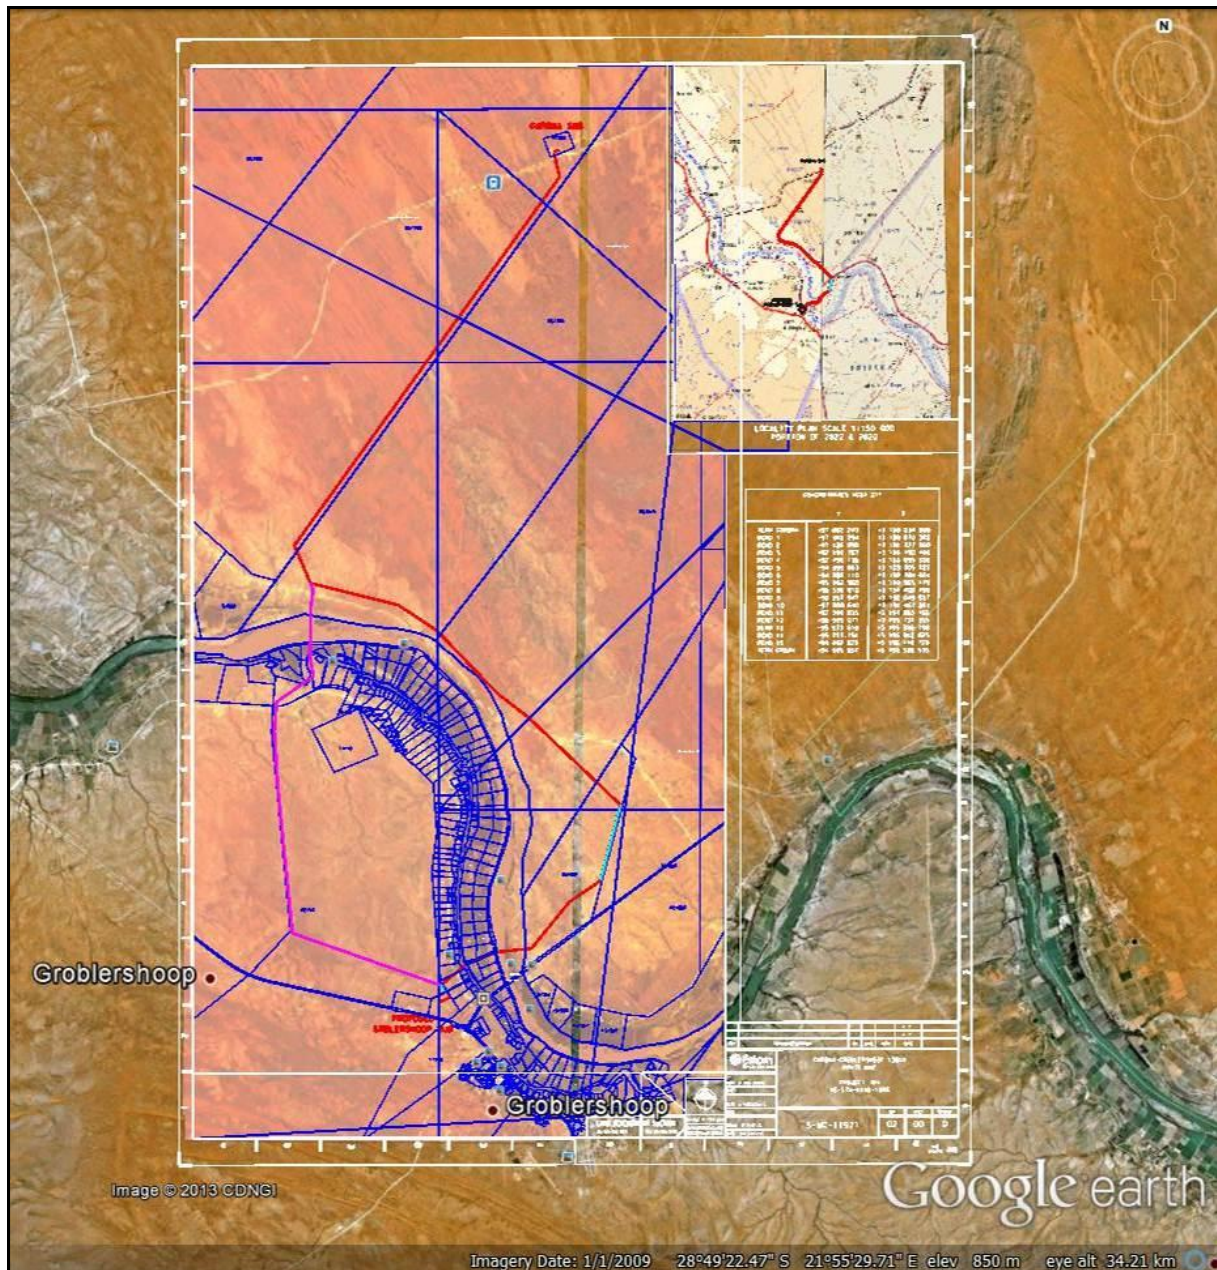
Figure 2: Overlay of the proposed routes on the aerial map for the study area. Both lines originate at the proposed Groblershoop sub-station. The preferred route (red) crosses the Orange River and follows the banks of the river before swinging in a north-easterly direction to connect with the Garona sub-station. The alternative route (pink) swings to the west, and crosses the Orange River further north, connecting with the preferred route to the east of the river.

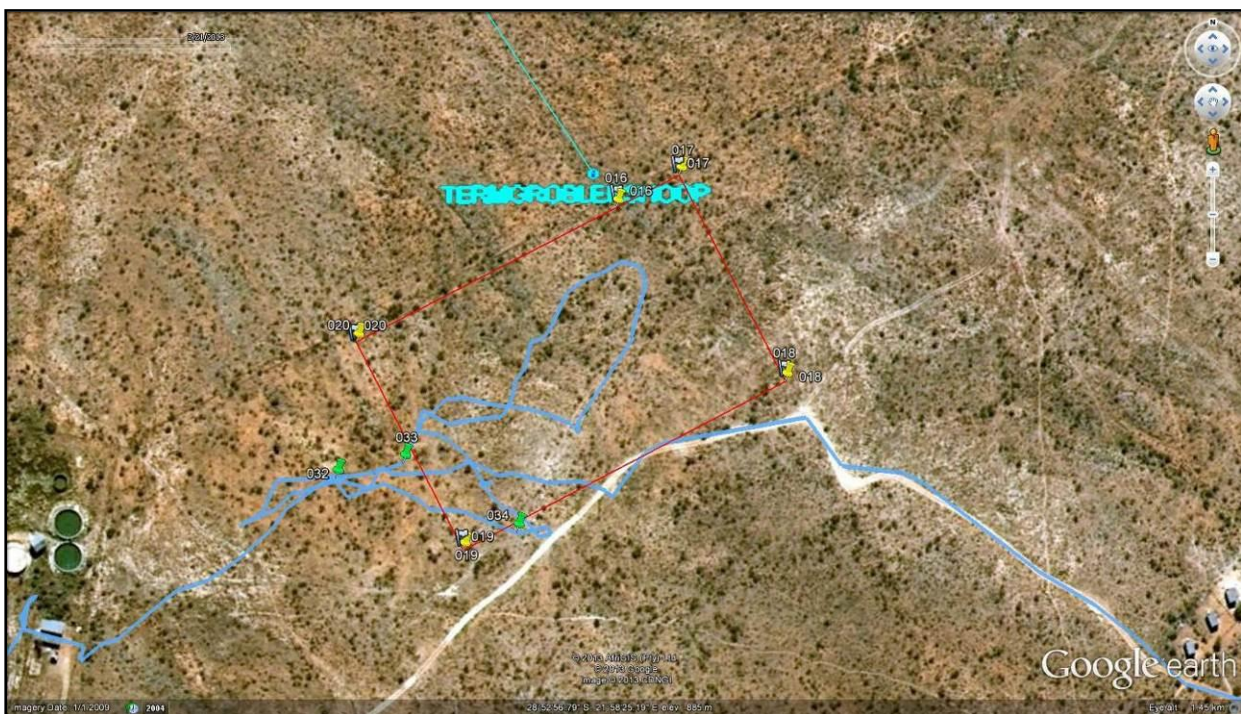
Figure 3: The red rectangle indicates the outline of the proposed Groblershoop sub-station, the blue lines are recorded tracks and the green pins are archaeological sites.

There is a scatter of weathered MSA material in the area identified for the proposed Groblershoop sub-station.

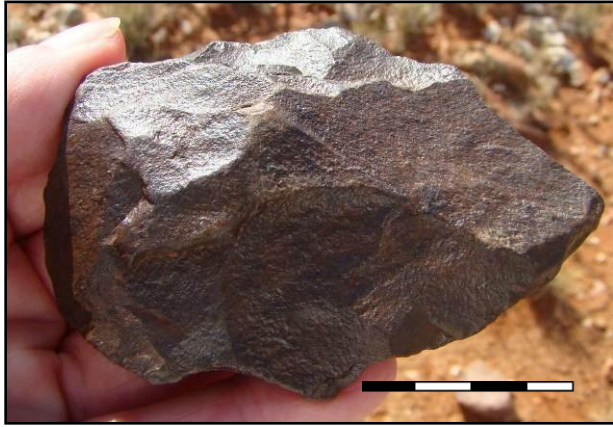
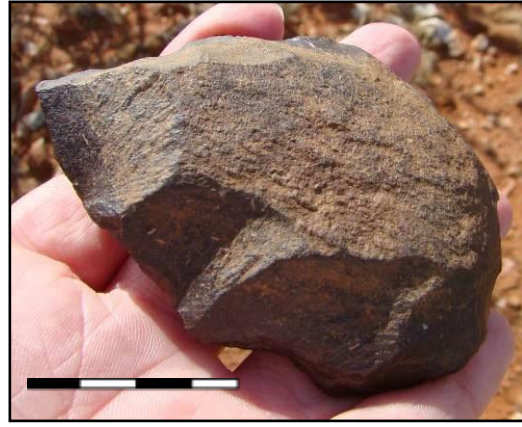
Plates 5 & 6: Both sides of a bifacially worked banded ironstone artefact, possibly a “Fauresmith” handaxe.

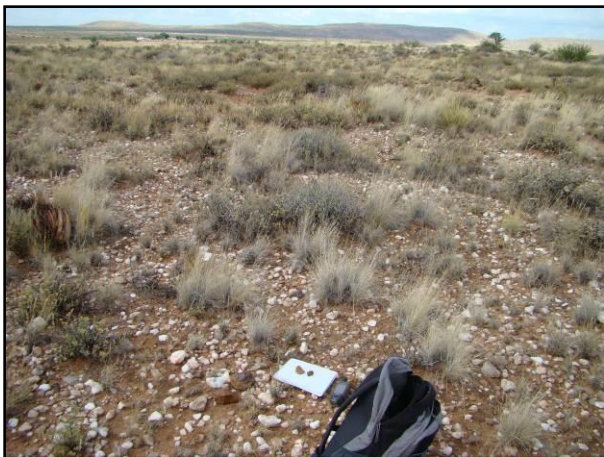
Two further sites (40 & 41) were recorded to the west of the River. Site 40 consisted of a scatter of MSA artefacts on a low koppie, while Site 41 was a more ephemeral distribution of artefacts across the slopes leading down to a drainage area.

Plate 9: Site 40 to the west of the river;

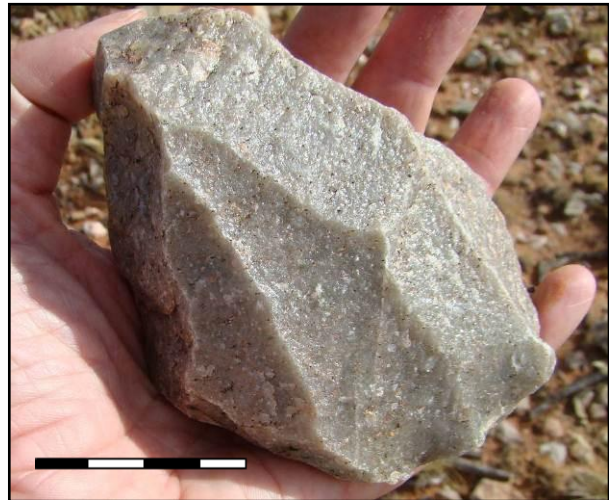
Plate 12: A quartzite core showing evidence of blade production.

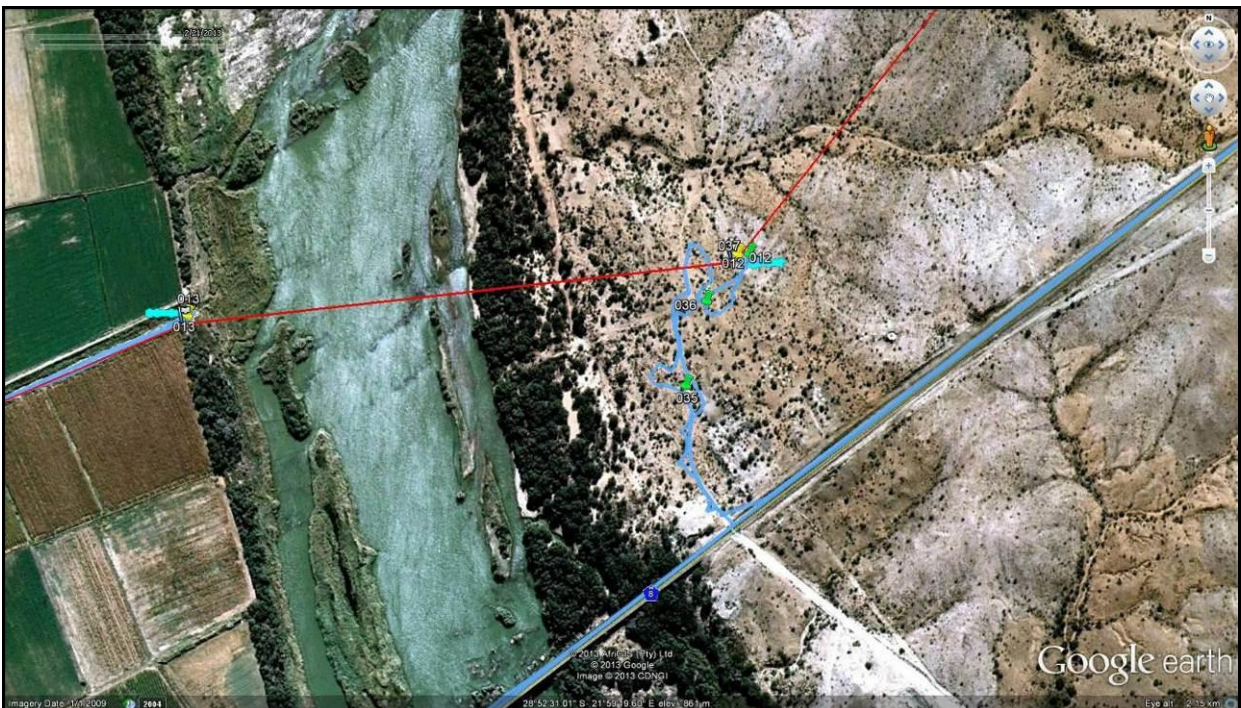
A number of stone artefact scatters were identified on the eastern margins of the River, on the loose river soils. Two of the sites (35 & 36) consisted of informally flaked hornfels cobbles and quartz flakes, which may indicate Later Stone Age sites, such as those identified by Orton & Webley (2012) further north, along the banks of the Orange River at Kakamas. Only Site 37 is in close proximity to the preferred line, but the presence of the other sites nearby suggests that this strip of land, possibly up to 800 m from the River, may have been settled by LSA peoples. They seem to have preferred the shade of the trees found near the river.

Figure 4: View of the eastern margins of the Orange River. The proposed 132 kV powerline crosses the river just north of the N8. The blue line indicates our tracks and Sites 35, 36 and 37 are located in the loose river sands.

The quartz flakes and flaked hornfels cobbles found to the east of the Orange River may represent Later Stone Age settlement along the River (in line with similar stone age assemblages recorded further downstream near Kakamas). These sites are potentially interesting as they can inform us on hunter-gatherer and/or pastoralist settlement patterns along the River. They have a medium significance and they need to be avoided during the construction of the pylon towers.

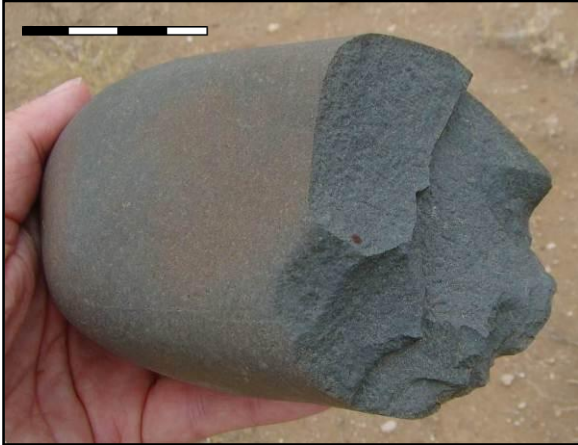
Plate 13: Flaked hornfels cobble from Site 35;

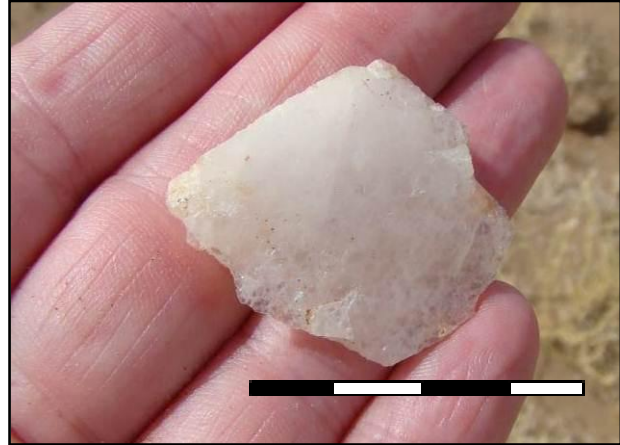
Plate 14: Quartz flake from Site 36.

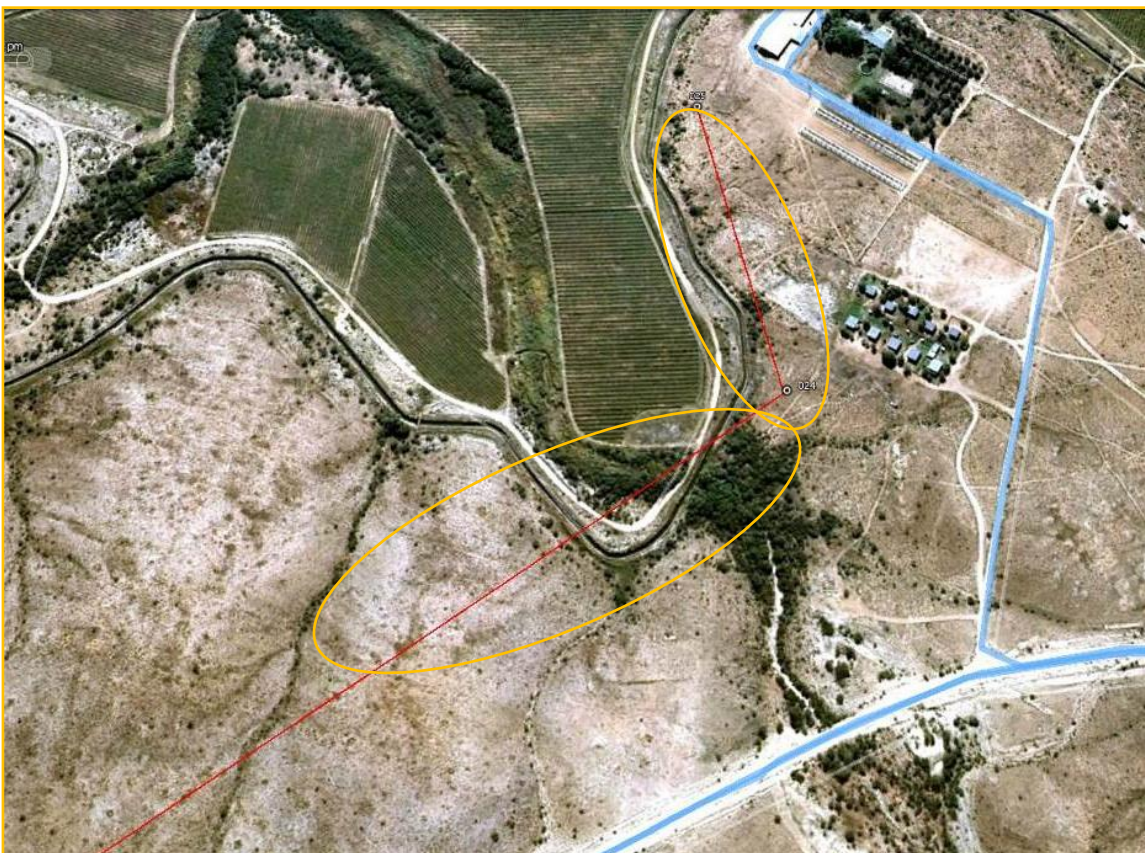
Figure 5: A section of around 800 m along the Alternative route for the powerline (Farm Hooggelegen) will need to be investigated further, if the alternative route is used. This particular area along the river

may have pre-colonial and colonial archaeological remains and/or graves. The blue line indicates the survey tracks.

In view of the presence of burial cairns further down river near Kakamas, it is recommended that a more detailed survey of the banks of the Orange River, specifically the eastern margins of the River, needs to be undertaken during the walk down phase (Figures 7 & 8). With respect to the western banks of the River, it is recommended that further field work is done to the south and west of the farm Hooggelegen (Figure 5).

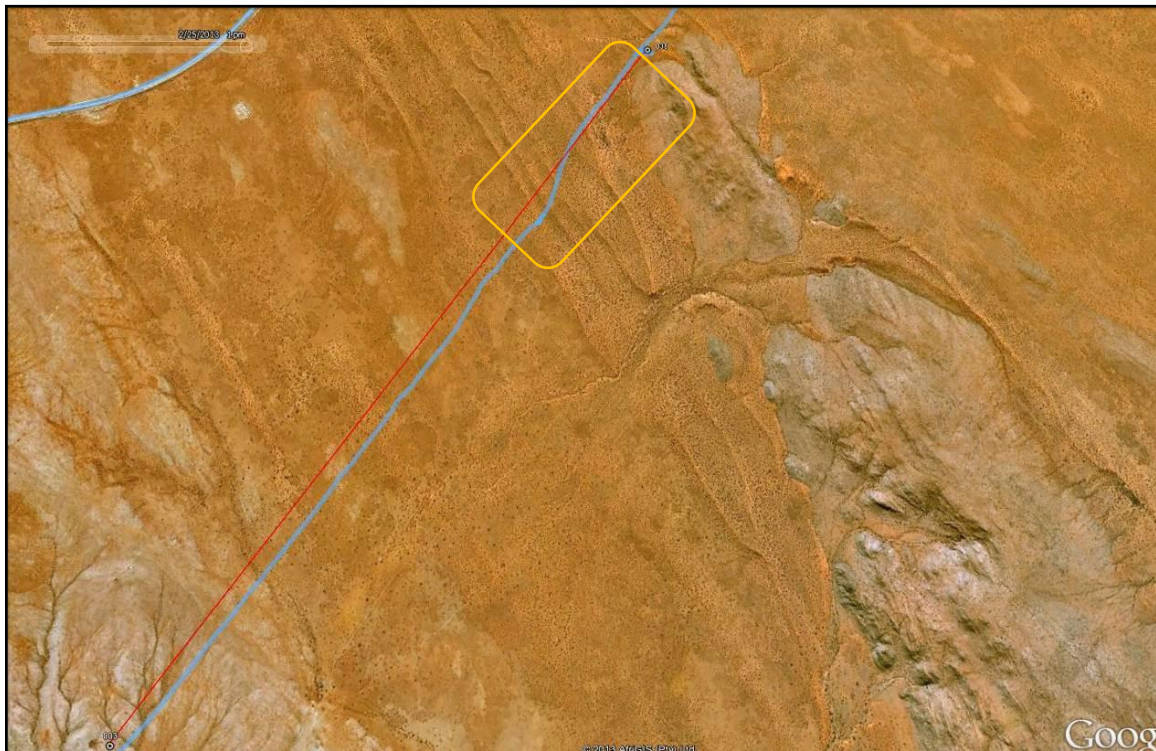
Both routes cross a section of Aeolian sand dunes near the Garona sub-station. Morris (2012) in his review of the archaeology of the area confirms that the crests of these dunes were used as “activity/dwelling locales in Later Stone Age times” and it is possible that archaeological remains may be found here. LSA sites may be found on the crest of the dunes or in the deflation hollows between the dunes and therefore the dune area needs to be examined more closely.

Figure 6: A short section of around 1 km of the proposed line crosses over some Aeolian sand dunes just before the Garona sub-station. This short section on the farm Rooilyf 389 needs to be assessed on foot. The blue line indicates the survey tracks.

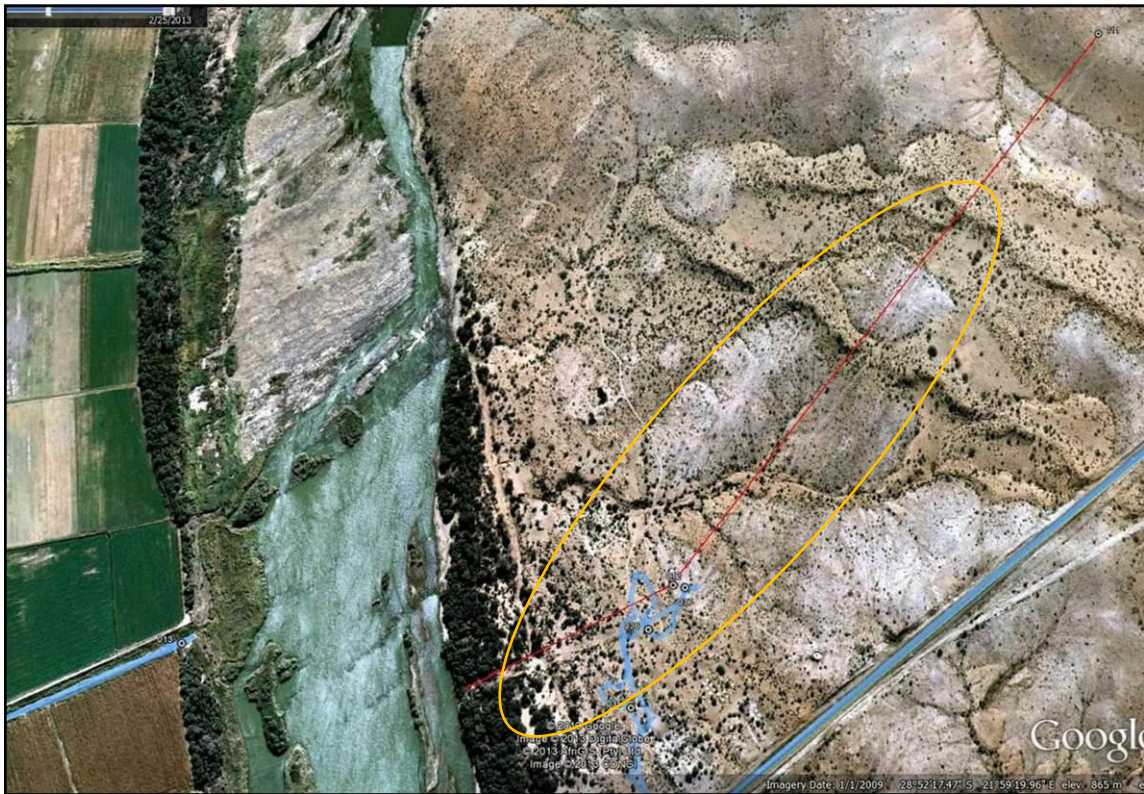
Figure 7: The section of the preferred route along the eastern banks of the Orange River, on the farm Rooisand 387 which needs more intensive investigation on foot. This section is 800 m long. The blue line indicates our survey tracks.

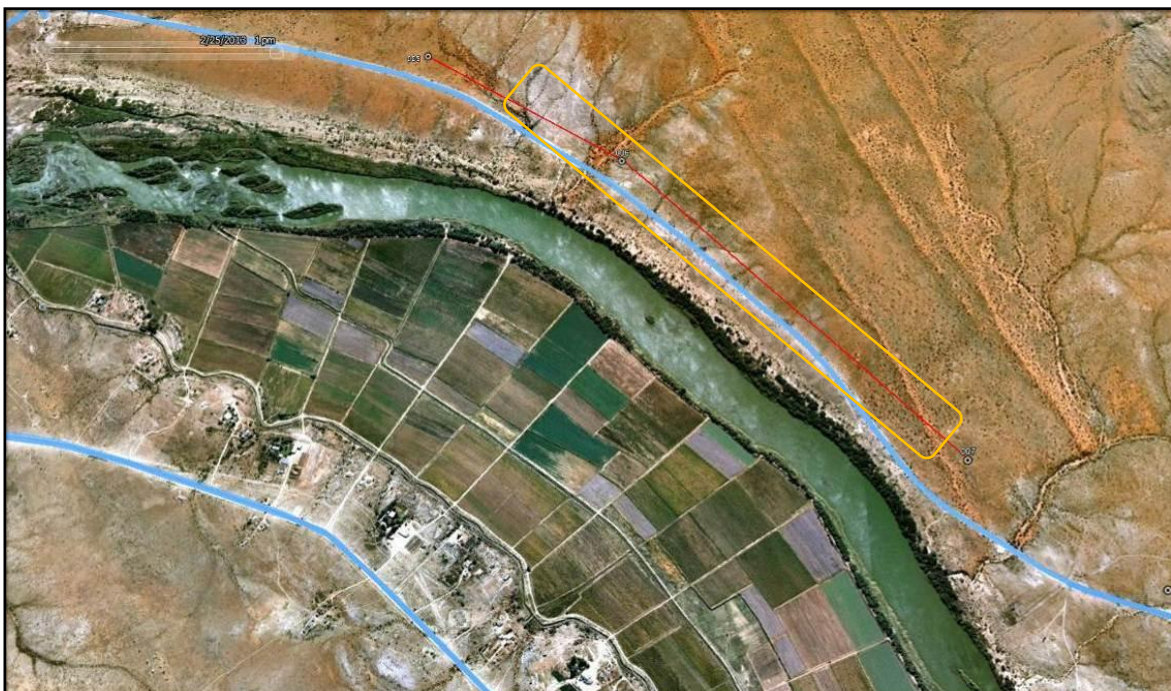
Figure 8: The preferred powerline runs parallel to the Orange River for about 1.8 km, at a distance of 300m from the River. The blue line indicates our survey tracks. The orange rectangle indicates the approximate area which should be subjected to a walk down.

A section of the preferred powerline runs parallel to the Orange River for about 1.8 km, at a distance of only 300 m from the River. This area needs to be examined in greater detail and on foot to determine possible impacts to pre-colonial archaeology, colonial archaeology and graves.
