**BASIC HERITAGE IMPACT ASSESSMENT**

**FOR THE PROPOSED  
IMPROVEMENT OF STRUCTURES ALONG THE R27 (INCLUDING THE WIDENING  
OF FIVE BRIDGES), SECTION 10 & 11  
BETWEEN KENHARDT AND KEIMOES**

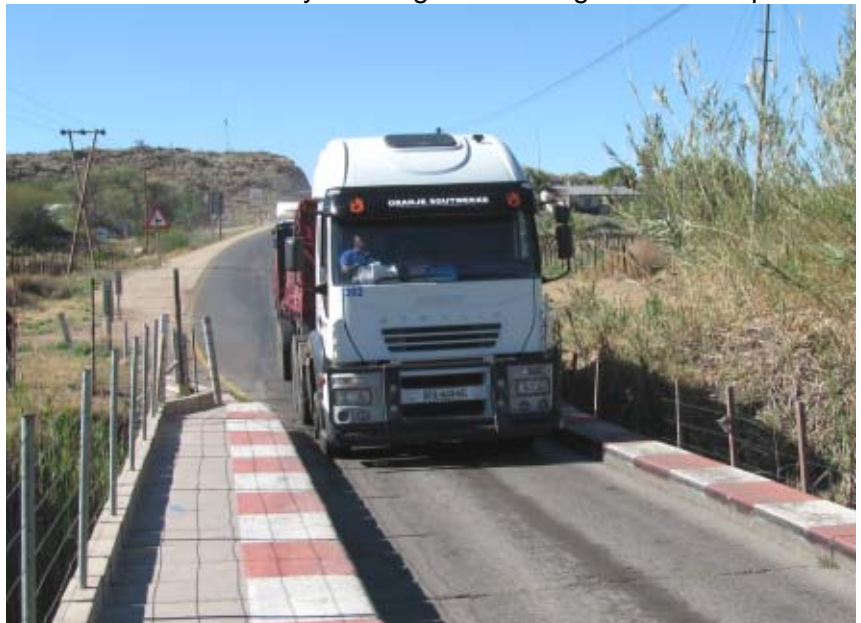
**Plate 1.** A heavy vehicle drives onto Groblers Bridge

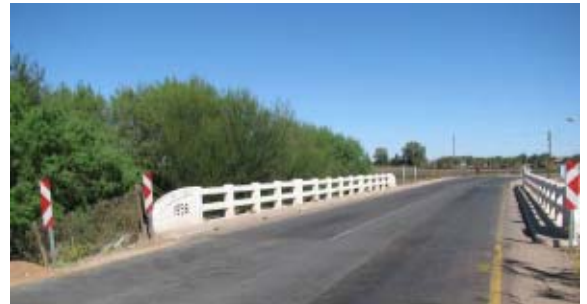
Plate 3. Bridge 2464 (looking south)

This is a relatively modern concrete bridge known as the "Witbrug" built in 1956. According to De Beer (1992) where the "Witbrug" is located today, there was at the turn of the century a reasonably easy drift, which was later spanned by a hang bridge. Since the hang bridge was always out of order, and the drift was often impassable during floods, petitions were made for a more permanent structure. The single lane cast concrete bridge was opened to traffic in 1916. As far as can be ascertained, the single lane bridge over the river closest to Neilersdrif was also built at the same time. The two bridges were more or less the same in terms of appearance and width. The one close to Nellersdrif is still in use although no longer suitable for heavy traffic. The old 1916 concrete bridge over the Keimoes Spruit was replaced in 1956/1957 by the "Witbrug" bridge. The site inspection revealed that there is no immediately visible physical evidence of the 1916 structure. The existing bridge is entirely recent and is therefore not subject to the general protections of the NHRA.

The proposal is to widen the bridge to provide a shoulder and improve pedestrian access. This is to be achieved by adding 3 m wide cantilevered extensions to either side of the existing structure to create a shoulder and pavement.

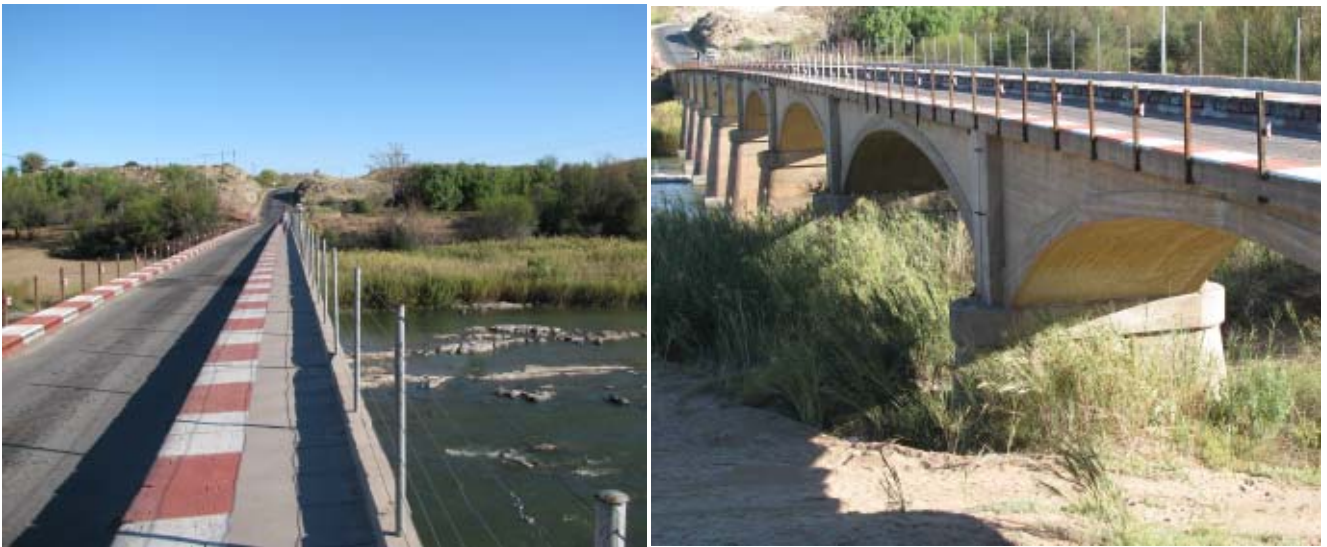
This bridge crosses the main stream of the Orange River. It was the largest of three built by Murray and Stewart in 1933 comprising 10 arches. The sense of entry onto the structure – a moderate descent onto a long narrow and apparently rickety rural crossing deprives the casual traveller of the knowledge of the well engineered and skilfully proportioned reinforced concrete arches that lie underneath. This bridge has stood the test of time having withstood some 80 years of significant annual floods. Although the bridge is structurally sound, it was never designed to handle the tonnage or size of modern heavy vehicles and is inadequate in terms of modern safety standards for pedestrian use. The single lane (10 feet wide) is scarcely able to accommodate the width of a large truck (see Plate 1), and the single pedestrian walkway with its simple wire balustrade is unsafe and insecure, although crossing on foot is an enjoyable experience as the bridge offers excellent views up and down stream. It is of interest to note that originally two pedestrian walkways were specified, but each bridge has only one.

Plates 4 (left) and 5 (right). Views of bridge 2463 showing the pedestrian walkway and arches

The proposal is to widen the bridge to modern specifications, namely two lanes with shoulders and adequate pavements and balustrades for safe pedestrian use. The proponent is mindful of the heritage qualities of the structure and does not wish to consider demolition. The proposal is to widen the bridge by removing the upstream edge and extending it laterally. The forms of the piers and arches will be continued so that in profile the bridge will look very similar to that of today. However the modern conservation principal of being able to distinguish old from new fabric will be applied. Visually permeable balustrades will be used so that the traveller's view of the spectacular expanse of river will be unimpeded. The successful widening of the graceful Carlisle Bridge in the Eastern Cape (another heritage structure) has been adopted by BKS (Pty) Ltd as a methodological model through which a suitable result can be achieved.

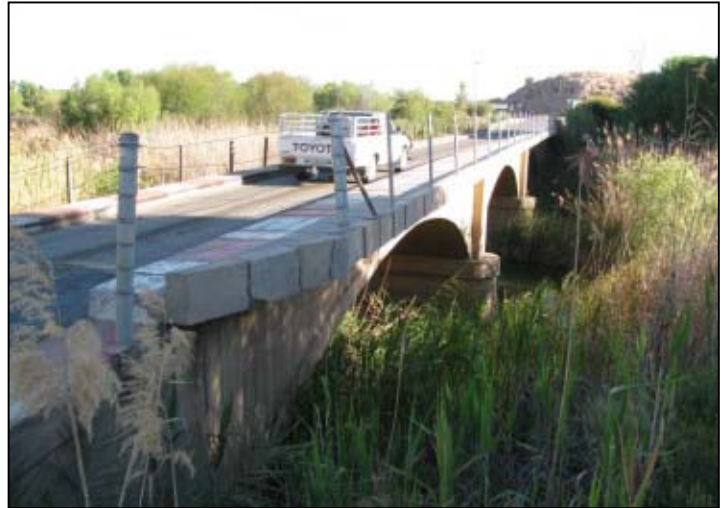
Plate 6. Bridge 2462

Collectively with bridge 2463 and 2461 this forms part of the Groblers Bridge complex. The bridge is a single lane 3 arch bridge similar in finish and detail to the other Murray and Stewart bridges. Although much smaller, it too is a pleasing structure, however, getting a good view involves leaving the road reserve to find a vantage point. The bridge connects Skanskopeiland to Rooikopeiland. In current terms it also shares similar inadequacies. Pedestrian access is inadequate, the single lane is too narrow. However its biggest failing is that the bridge overtops at times of peak flood cutting Keimoes off from the south bank and marooning the Skanskop Island community.

Given that this bridge is subject to overtopping, it is proposed that it is heightened by 1.8 m to lift the arches above the commonly experienced flood levels (1:20 years). As with the other bridges it is proposed that the bridge is widened on the upstream side to accommodate two traffic lanes as well as shoulder and pedestrian walkways. While the work will require extensive demolition and alteration, it is the intention of the design team to retain the essential form and appearance of the bridge in line with the wishes of the proponent and the community.

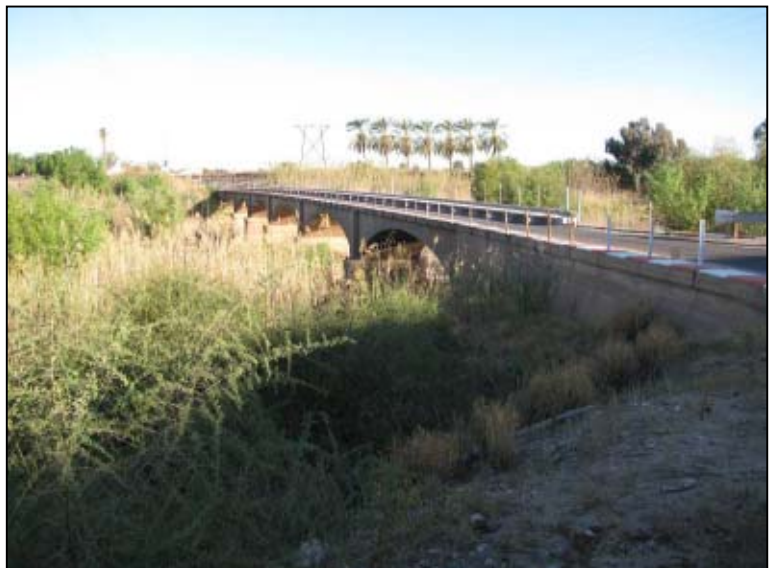
Plate 7. Bridge 2461

This is a single lane bridge built by Murray and Stewart Pty Ltd. Linking Skanskopeiland with Brakboseiland it consists of 6 arches with originally stone abutments (now mostly clad in concrete). The bridge enjoys similar aesthetic values to the others of similar design and is particularly spectacular when viewed from cleared areas of the river bank upstream. Unfortunately the casual motorist is not in a position to appreciate the structure unless he/she makes a particular point of leaving the vehicle. Like bridge 2462, bridge 2461 is subject to overtopping and needs to be both widened and raised.

It is proposed that this bridge is heightened by 1.8 m to lift the arches above the commonly experienced flood levels (1:20 years). As with the other bridges it is proposed that the bridge is

widened on the upstream side to accommodate two traffic lanes as well as shoulder and pedestrian walkways. While the work will require extensive demolition and alteration, it is the intention of the design team to retain the essential form and appearance of the bridge in line with the wishes of the proponent and the community. The bridge railings will be designed to be visually permeable to enhance the travellers' experience of the river crossing.

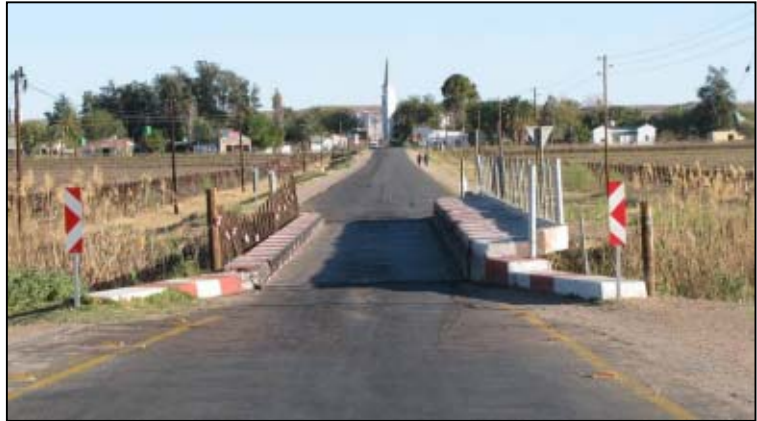
Bridge 2460 links Brakboseiland with the south bank of the river. According to De Beer (1992) this decrepit looking single lane bridge was built in 1916. Our own research has revealed that drawings exist produced by the Department of Public Works in 1919, confirming an unusually early date for this reinforced concrete structure. The bridge appears to be constructed from pre-cast concrete components which were probably in part assembled on site. The piers which have a very gracile appearance are cast into the riverbed. The bridge bears a very close resemblance to that depicted on drawings indicating that the structure is largely original, the only significant change being the walkway which has been cantilevered onto the structure. A visual inspection of the underside of the bridge revealed that spalling was taking place in places and the reinforcing steel was exposed. There were also noticeable cracks in major components. Of concern is the fact that a bridge that was designed 90 years ago for loads equivalent to a light motor vehicle or heavily laden wagon is now carrying heavy articulated trucks on an hourly basis.

Plate 8. Bridge 2460 built c1916-1919

In the absence of local comparative information, it is tentatively suggested that the Neilersdrift Soutrivier (or south bridge) represents an early rare example of local concrete bridge construction and is therefore of significance in heritage terms. In terms of its physical setting it serves as a “gateway” to the Nellersdrift village and imparts a strong sense of arrival.

The condition of the bridge is poor and its weight bearing capacity (even if the structure were in good condition) is dangerously inadequate. The proposal is to demolish the bridge in its entirety and replace it with a contemporary SANRAL design. Discussions with the project design engineers indicate that it is not possible to repair or rebuild the bridge in its current form that will adequately cater for modern transport needs. The diversion of the R27 to one side over a new bridge while retaining the original one is not considered a desirable alternative. The old bridge will create an additional hydrological impediment, and will continue to deteriorate if not managed. In addition a road diversion implies further loss of valuable agricultural land which is a very finite resource in this area. The balance of heritage significance as opposed to economic and safety needs unfortunately weighs in favour of demolition, however some actions are possible in terms of mitigation.

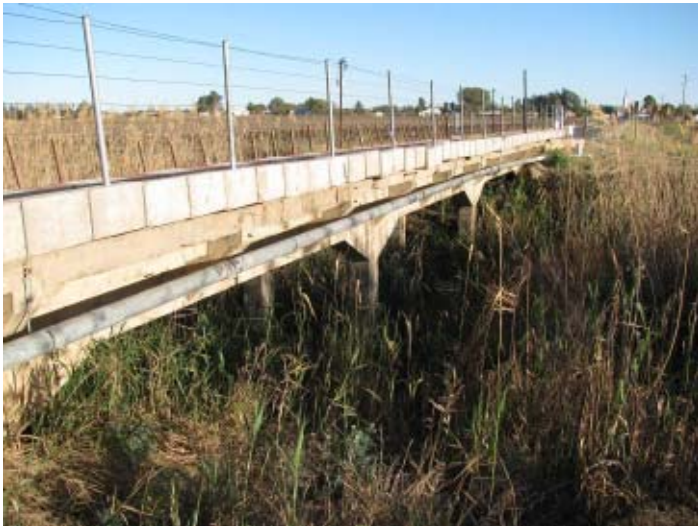
Plate 10 (bottom left). Bridge 2460 as it is today.

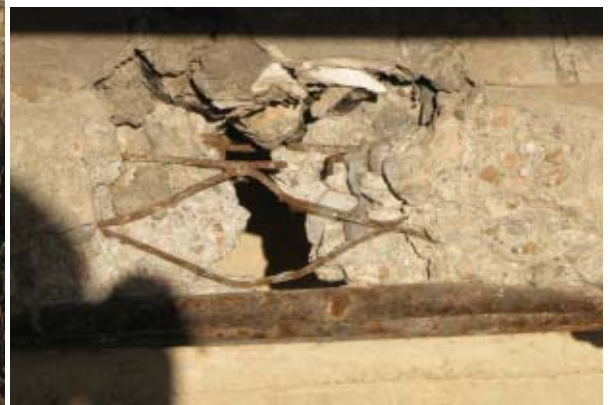
Plate 11 (bottom right.) Detail of cracking and spalling on underside of bridge 2460.

*Mitigation measures:* The total destruction of the bridge can only be mitigated in part through commissioning measured drawings and a photographic survey of the structure prior to demolition. A comprehensive photographic survey should be taken before work commences and during construction so that an archive of information can be generated. A compact disc containing such

The gateway view towards Neilersdrift should be borne in mind in designing the replacement structure. Building the new bridge on the same road alignment will go some way to maintaining this quality; however it is important that visual bulk is kept to a minimum.
