## AFRICAN HERITAGE CONSULTANTS CC

11 June 2007

### CULTURAL HERITAGE RESOURCES IMPACT ASSESSMENT OF PORTION 22 (A PORTION OF PORTION 8) OF THE FARM KLIPPLAATSDRIEF 82 H.P.

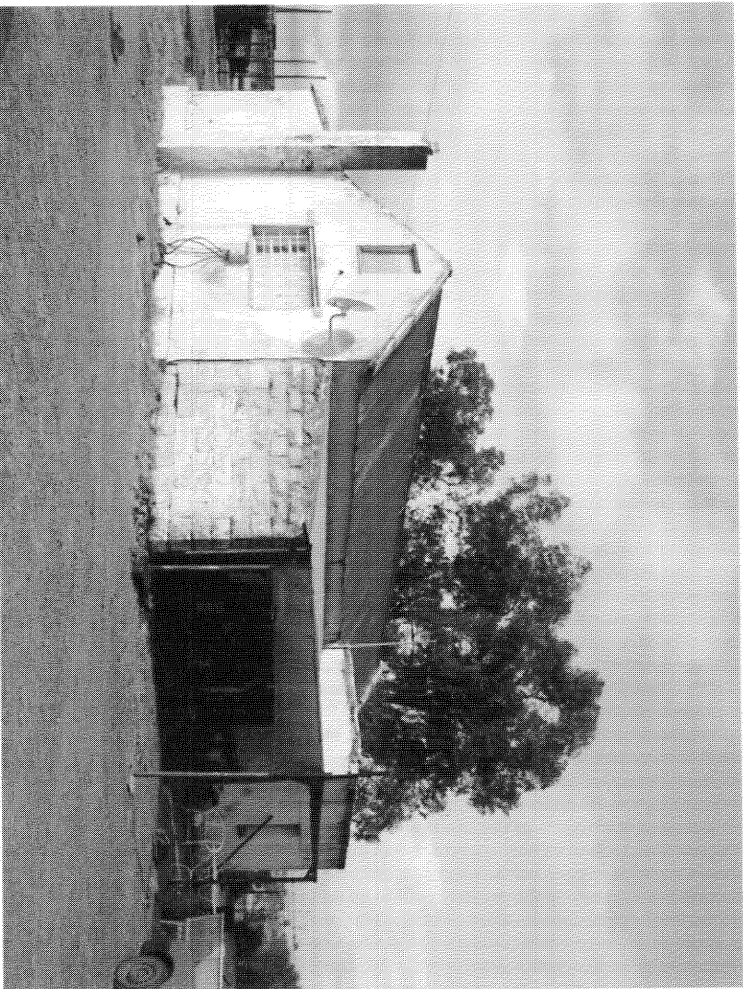
The original farmhouse stands at S27° 22' 48.3 and E26° 27' 15.1". Originally the farmhouse only consisted of three rooms. It was later extended to the east with a lean to-roof to make provision for a kitchen and additional bedrooms. A front veranda was also added of which the southwestern portion was later changed to make provision for an additional bedroom. The original house was burnt down in the Anglo Boer War and afterwards rebuilt (see photographs 1 and 2).

**No. 1 The old farmhouse with its lean-too and front veranda**

- The old farmhouse and outbuildings be properly recorded and restored.
- The two cemeteries must be properly fenced, cleaned, protected and recorded.
- The history of the Van Rensburg and Tswai families be recorded
- A management plan be compiled for the heritage sites on the farm

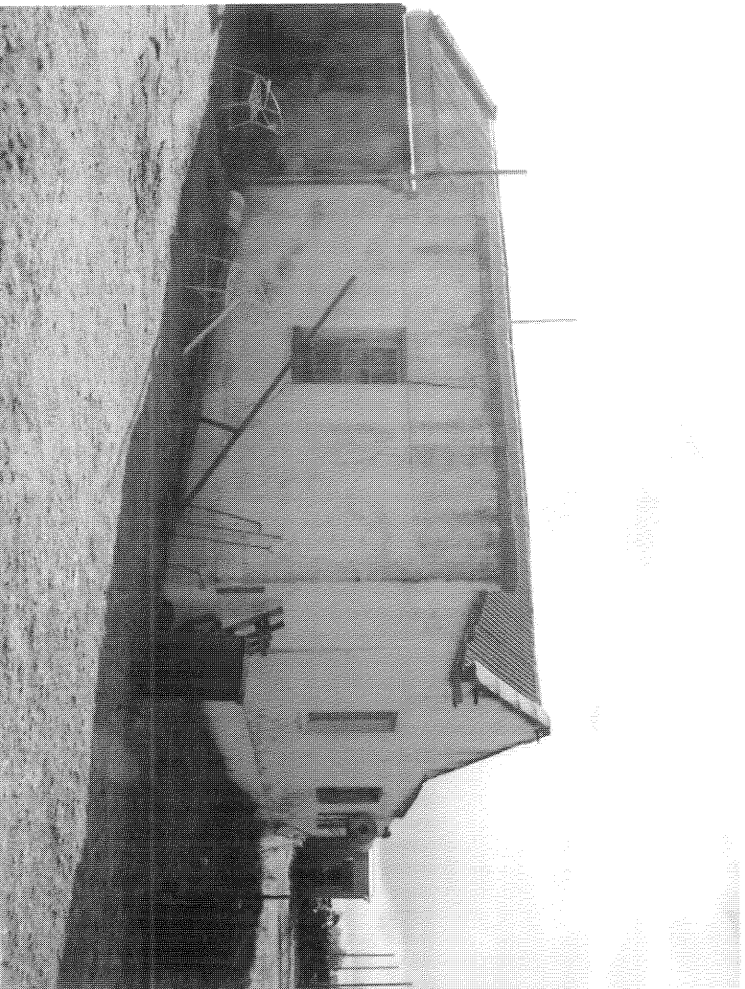
**No. 2 The additional bedroom added to the front of the house**

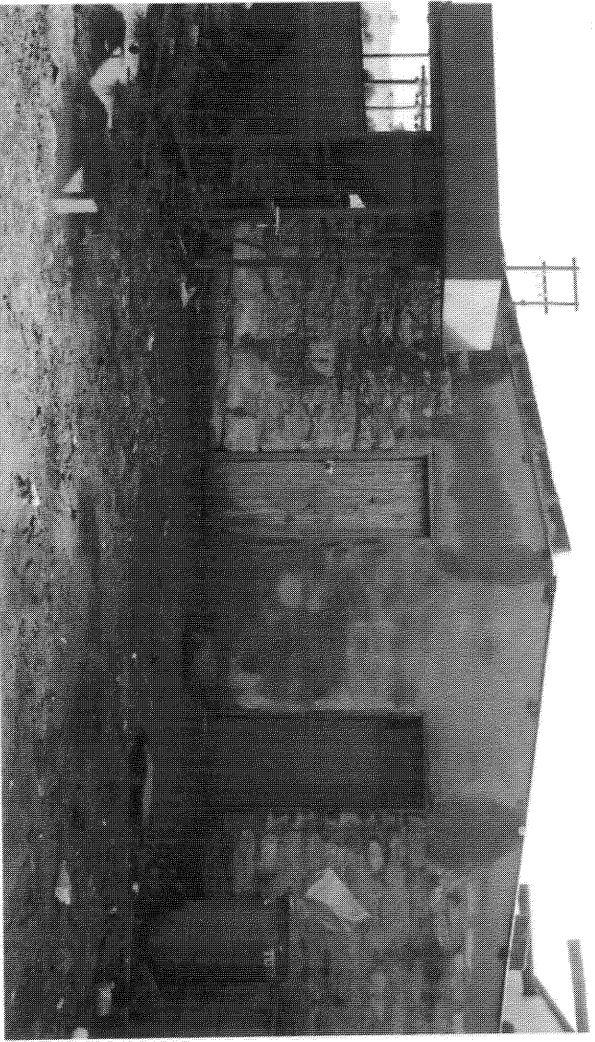
Next to the house on the eastern side are the remains of the outbuildings. The walls were built of sandstone but have partially collapsed. The building now has a flat roof. Most probably it originally had a thatched roof (see photograph 3).

**No. 3 The southern view of the outbuilding**

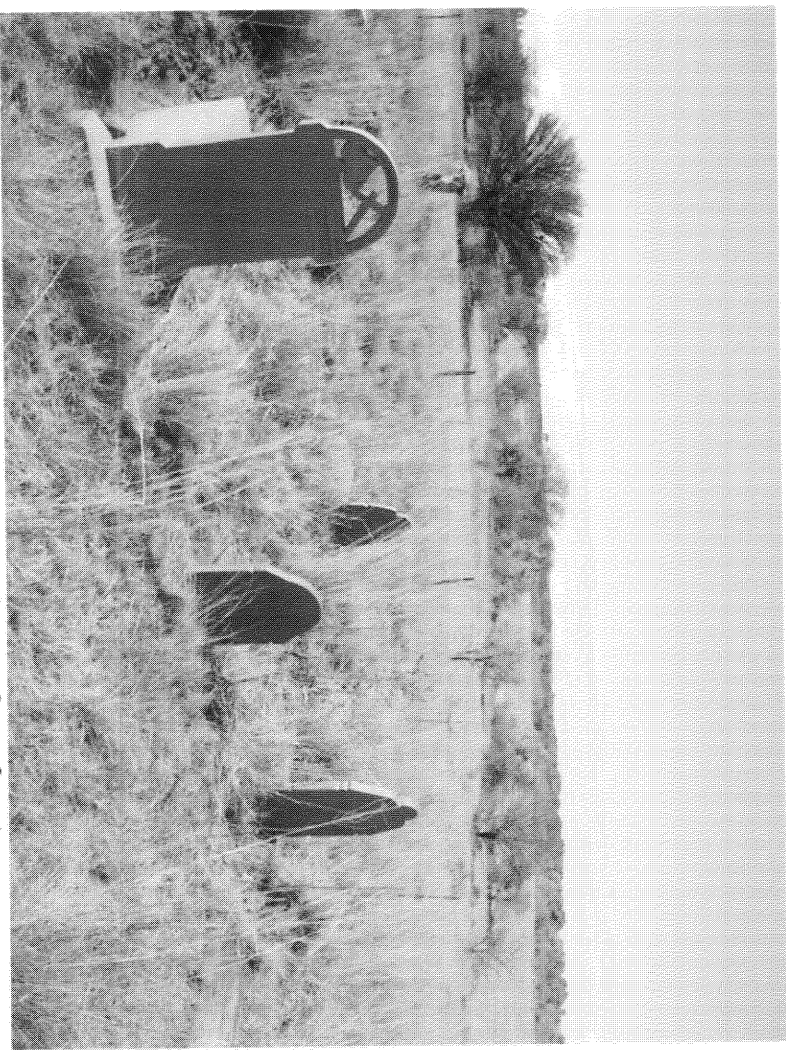
The farm is the family farm of the Van Rensburgs and is still in the hands of the family. The family cemetery is found at S27° 22' 54.0 and E26° 27' 26.0". In the cemetery are some thirty graves of the Van Rensburg family. The oldest tombstones are in the shape of a coffin and were made of sandstone. The inscriptions have weathered away and are now unreadable. The oldest readable date is 1919 (see photograph 4 and 5).

**No. 4 Some of the handmade tombstones made out of wonder stone**

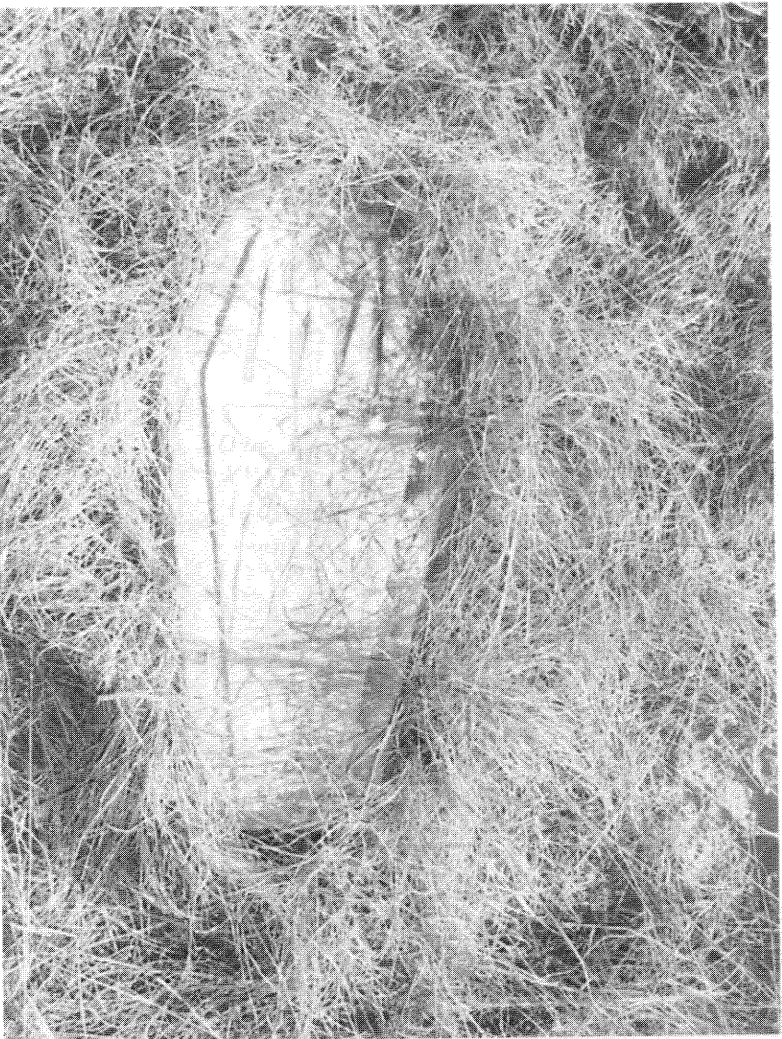
**No. 5 One of the oldest tombstones made of sandstone in the shape of a coffin**

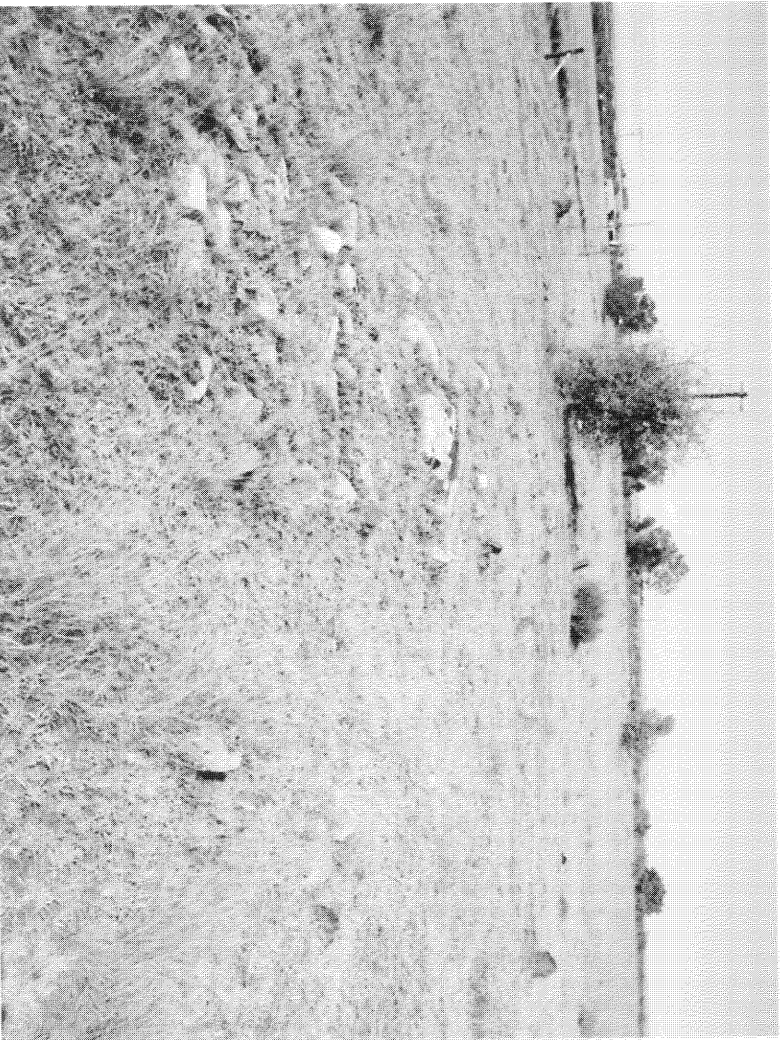
At S27° 22' 38.4 and E26° 27' 11.5" is the cemetery of the farm workers. There are some forty graves in the cemetery mainly of the Tswai family. According to the present owner the Tswai family has been living on the farm for many generations and are still living on the farm (see photograph 6).

**No. 6 Cemetery of the farm workers. Many of the graves are hardly recognizable.**
