**HERITAGE SURVEY OF THE PROPOSED MELKHOUT-
OYSTER BAY DISTRIBUTION LINE**

FOR COASTAL ENVIRONMENTAL SERVICES

DATE: SEPTEMBER 2010

By Gavin Anderson

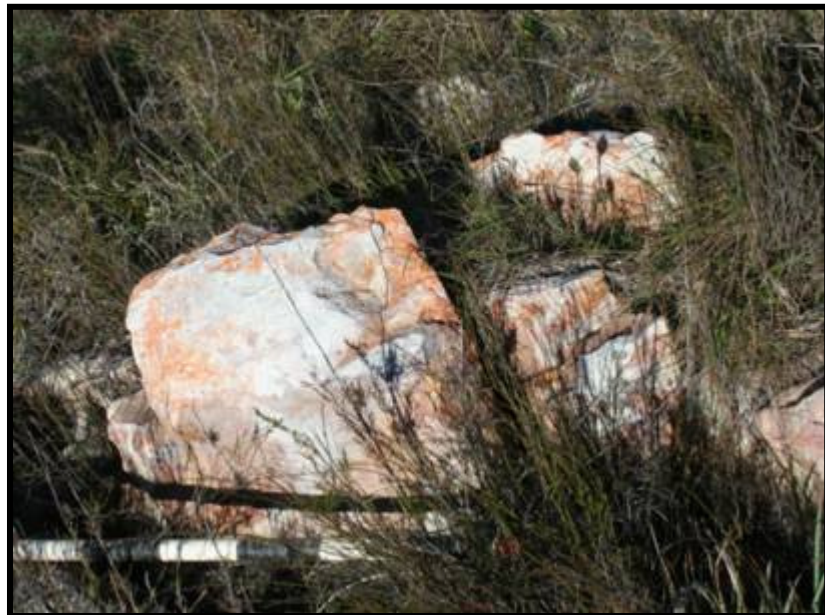
FIG. 8: ROCK OUTCROP AT MEL01

MEL01 is located near the Melkhout substation. The site consists of a low sandstone outcrop. The outcrop has been “quarried”: that is, several flakes have been removed from the rocks (fig. 8). Three flakes were observed on the ground.

Significance: The site is of low significance

Mitigation: No further mitigation is required.

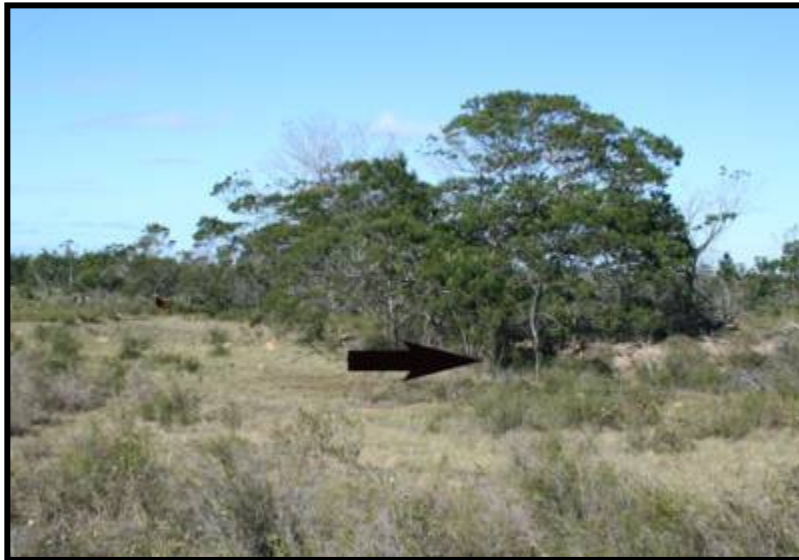
FIG. 9: RAISED AREA AT MEL02

MEL02 is located around a small raised area ~10m in diameter (fig. 9). The mound does not appear to be natural and there is a row of stones ~30m long at the base. These stones appear to be recent. There are a few Late Stone Age flakes in the raised area, and these are probably in a secondary context.

Significance: The site is of low significance.

Mitigation: No further mitigation is required.

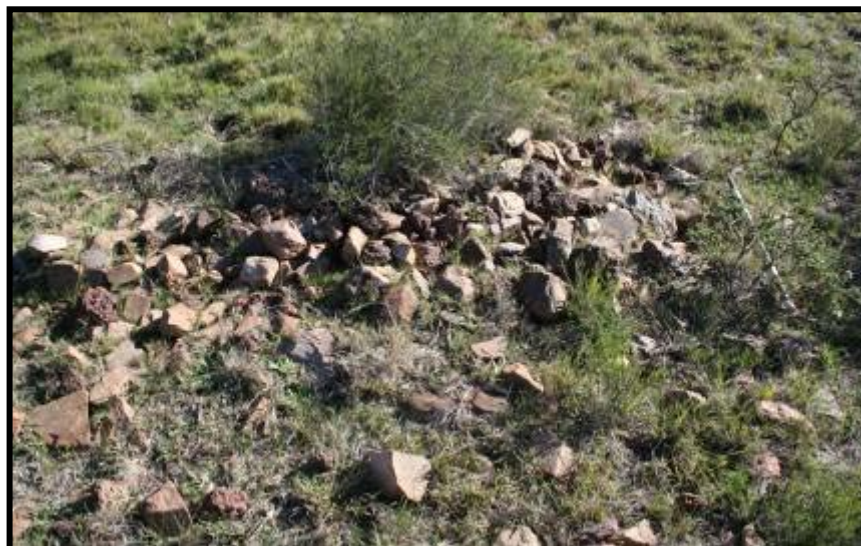
FIG. 10: STONE CAIRN MEL03

MEL03, is not a site per se, rather a single MSA flake amongst a stone cairn. The cairn is probably related to field clearance, and not a grave (fig. 10).

Significance: The site is of low significance.

Mitigation: No further mitigation is required.

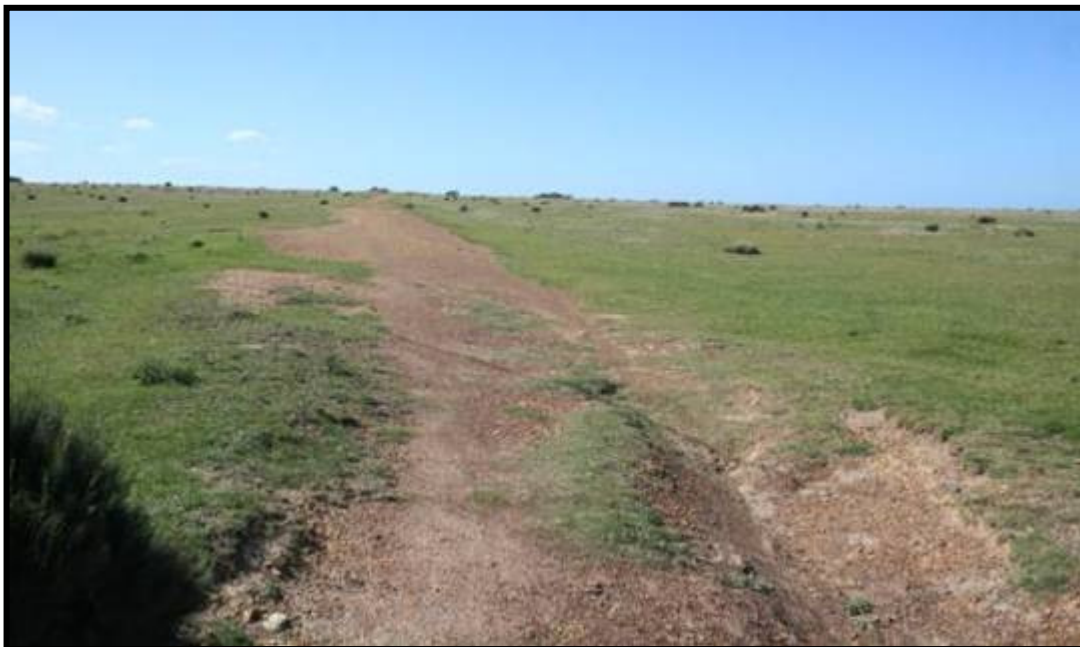
FIG.7: SHALLOW SOILS NEAR MEL05

MEL05 is located along the top of a hill. The soil is very shallow, and the sandstone layer is thus very close to the surface (fig. 7). The site consists of a small scatter of Middle Stone Age stone tools on the surface. These are flakes. These are probably in a secondary context.

Significance: The site is of low significance.

Mitigation: No further mitigation is required.

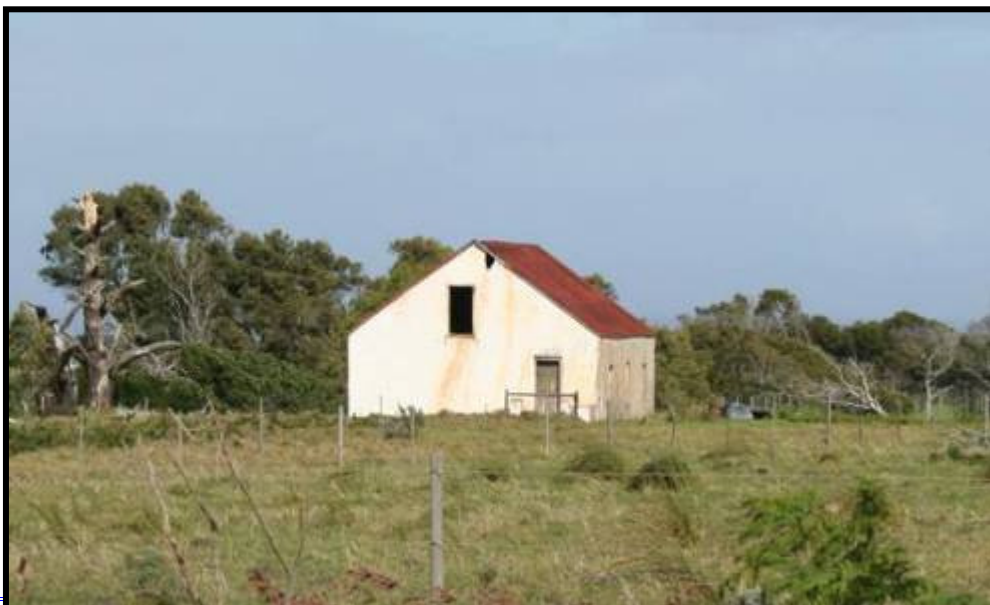
FIG. 8: OLD FARM BUILDING

MEL07 is an old farm building, probably a shed. The Distribution line, and/or substation, occur besides the building and will thus not affect the building. The substation will occur near this building

Significance: The building will need to be assessed by an architect historian if it is to be affected.

Mitigation: The building is unlikely to be affected and thus no mitigation is currently required.

All of the recorded sites are of low significance, with the possible exception of the old farmhouse. The proposed substation is currently situated across the road from this house. If this farmhouse, or any others that occur in a realigned, route, are to be affected, then it will need to be assessed by an architect historian. There should be no need to damage any of these buildings.
