**HERITAGE SURVEY OF THE PROPOSED
PHOTOVOLTAIC AND WIND TURBINE FARM AT
NCORA**

FOR COASTAL ENVIRONMENTAL SERVICES

DATE: 9 FEBRUARY 2011

**Umlando: Archaeological Tourism and Resource
Management**

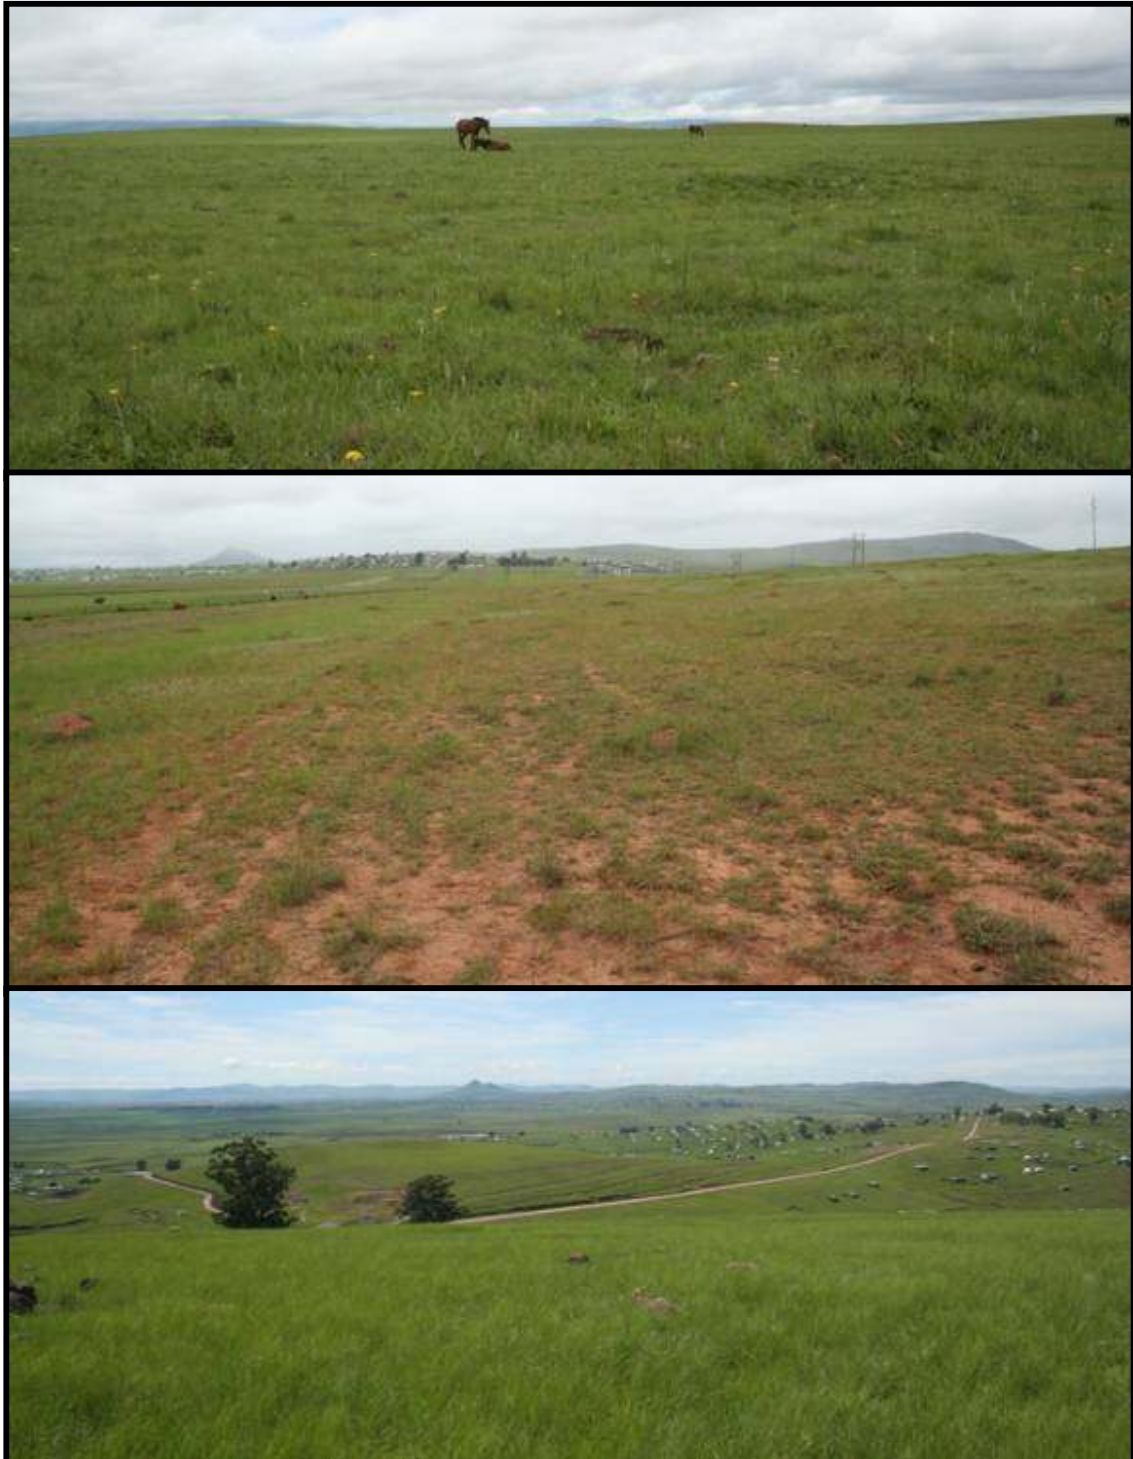
Figure 5 shows the three main areas: the southern hill, the area for the photovoltaic farm, and the northern hill.

FIGURE 5: LOCALITY VIEW OF SOUTHERN HILL, PHOTOVOLTAIC AREA AND NORTHERN HILL

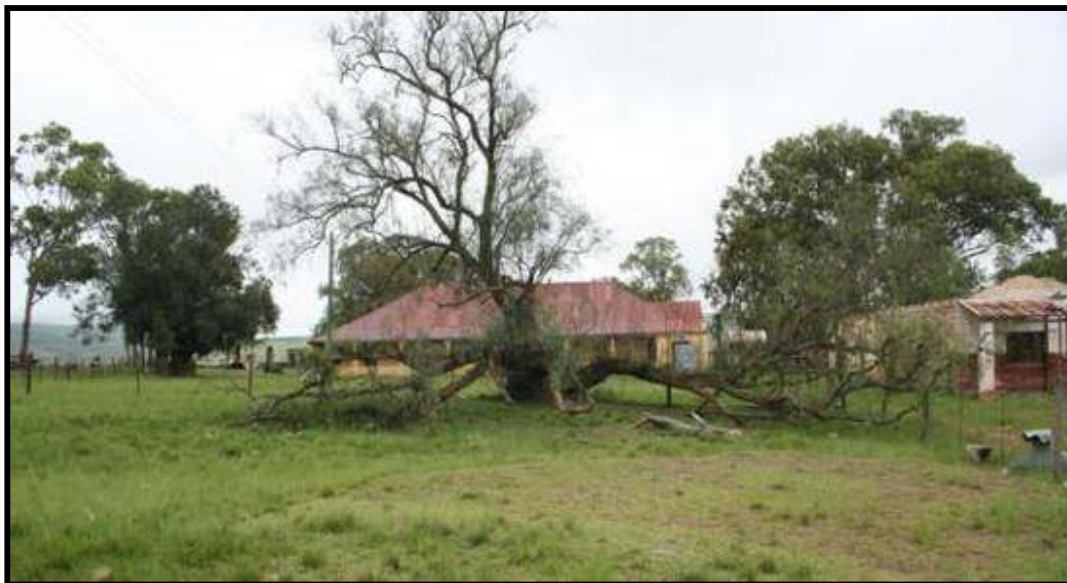
FIGURE 6: FARM BUILDINGS AT NC01

NCO01 appears to be the original farmhouse named Ncora (fig. 6). The buildings predate 1964 (fig. 4b), and are probably late 19th or early 20th century. The buildings appear to be a farmhouse and associated buildings, and a trading store. The buildings are mostly in ruin, although the main farmhouse appears to be inhabited. There are probably several middens related to the house in the general yard. I drove along the cable route that would be beside the road, and did not note any historical middens.

Mitigation: No mitigation is currently required; however, if the cable enters the premises, then the area would need monitoring for historical middens and artefacts.

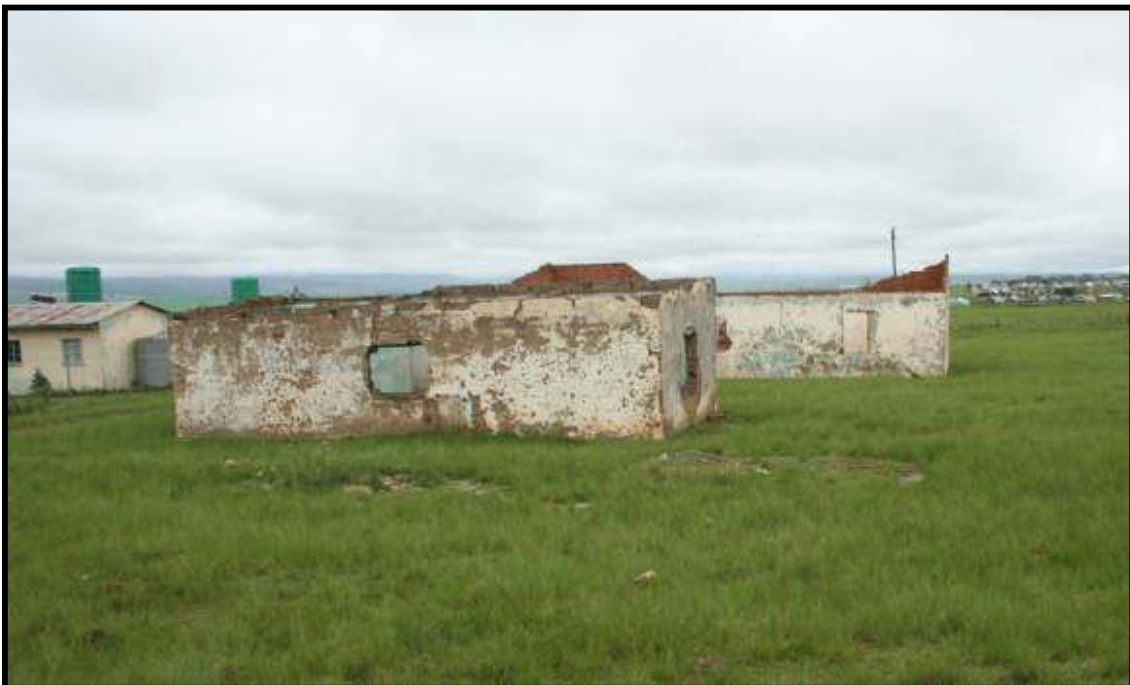
FIGURE 7: ABANDONED BUILDINGS AT NCO2

NCO2 is an area of abandoned houses. The houses date between 1964 and 1995, as seen on the associated topographical maps. These buildings may be associated with NCO01. I did not observe any graves in this area.

Mitigation: No mitigation is required.

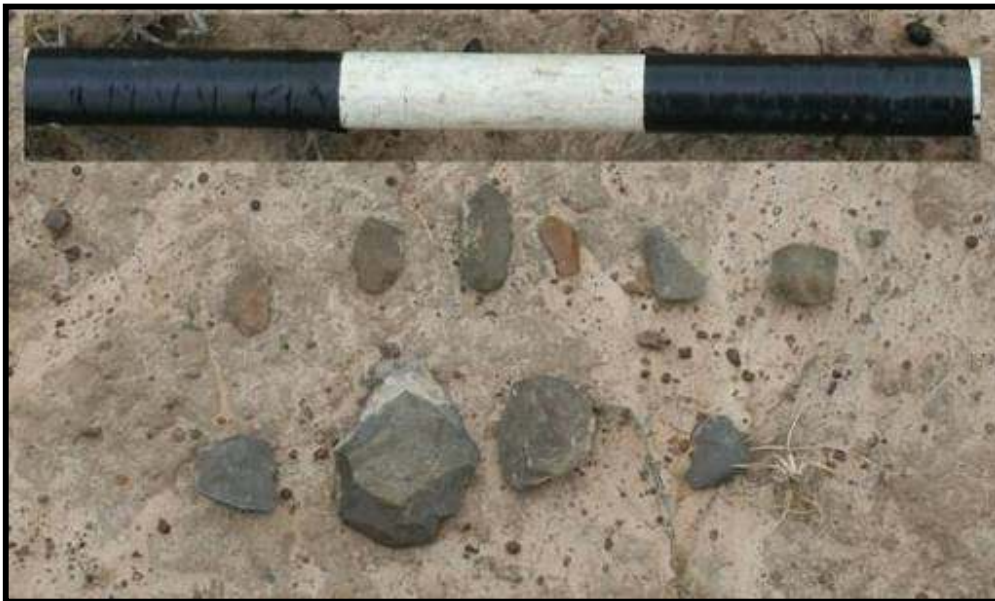
FIGURE 8: STONE TOOLS AT NCO3⁷

NCO03 (and NCO12) is a scatter of Late Stone Age (LSA) and Middle Stone Age (MSA) tools that were visible in eroded and ploughed areas. NCO03 is the southern side of the extensive scatter, while NCO12 occurs more to the north and west. They were originally given different site names, but have now been subsumed into a larger site of a scatter of artefacts.

Mitigation: No further mitigation is required for the cable line. If the photovoltaic farm is located in this area, then the site should be systematically sampled over several areas. This would entail setting up several squares and undertaking an analysis of the artefacts in each square. The artefacts should be sampled and donated to the nearest museum that is capable of curating them.

The photovoltaic area would significantly affect the extensive stone tool scatter. It is not common to find such an extensive scatter in this general area, as they tend to be isolated artefacts. While the artefacts are of low significance, the impact would be medium negative, as the artefacts would be either lost or broken during construction. I suggest that the site should be systematically sampled over several areas. This would entail setting up several squares and undertaking an analysis of the artefacts in each square. The artefacts should be sampled and donated to the nearest museum that is capable of curating them.

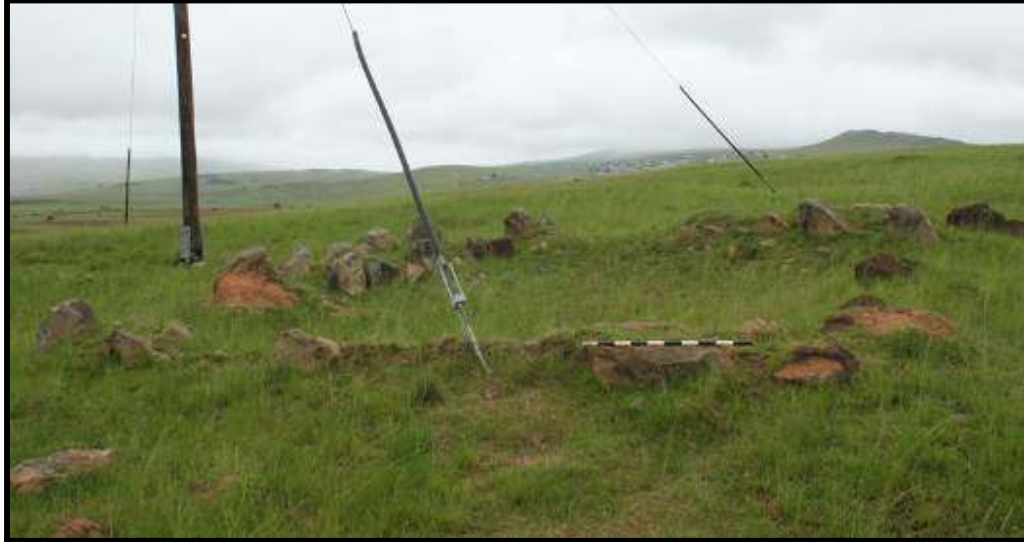
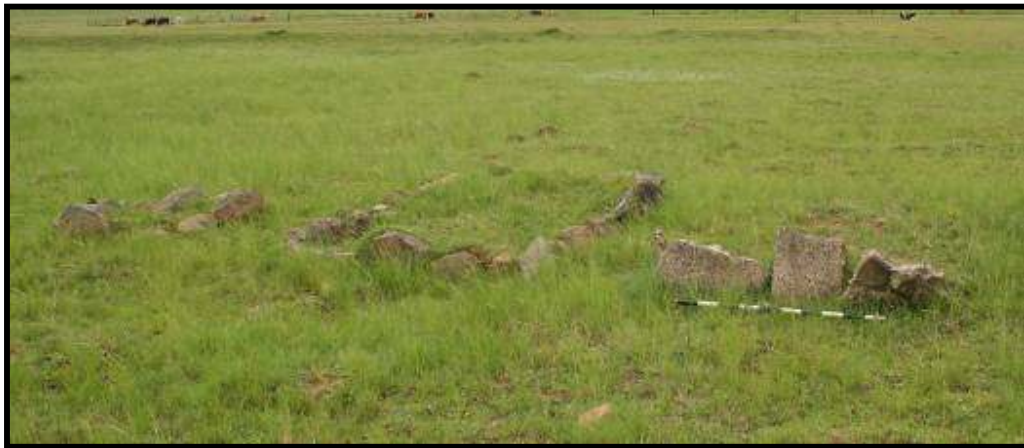
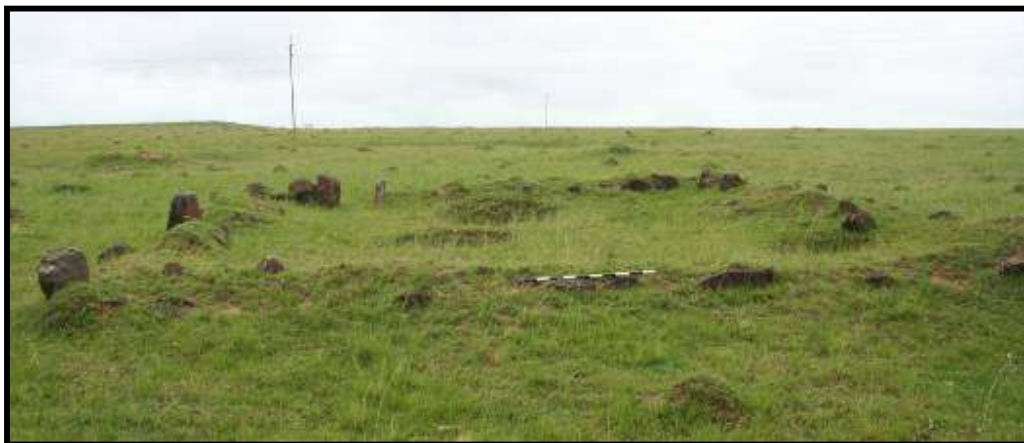
FIGURE 9: FEATURES AT NCO04: HOUSE FOUNDATION, GRAVES & CATTLE BYRE

NCO04 is also referred as Site 31 on the maps. The site is situated on the top of a hill overlooking the Tsomo River. NCO04 consists of a series of settlements over an area 920m x 420m in size. The 1964 map indicates it was called Fama and consists of ~35 houses. Most of the house and cattle byre remains are still visible, as are several graves, but vary in the degree of preservation (fig. 9). The houses tend to be in single rows of 3 – 4 houses per settlement. The foundations of the houses are circular or square. The cattle byres vary in size and style. Most of the byres are rectangular with low stone walling. The byres can consist of one or two compartments and the entrances have various orientations. Some of the byres are circular and they tend to be larger than the rectangular ones. The circular features may date to the turn of the century.

The current location of the photovoltaic farm needs to be changed. The area noted as NCO04 should not be affected. While the houses and cattle byres can be mitigated, I do not believe that a photovoltaic farm can justify the removal of human remains. Moreover, the graves (or ancestors) are linked symbolically to the settlement, and thus disturbing one would be disturbing the other. There are areas to the south and east that, where there are no human remains, can be used for the photovoltaic option. If this area was to be affected, the whole area would need to have a social impact assessment for the graves, the features would need to be mapped and partially excavated, and the area monitored during construction. This would be costly.

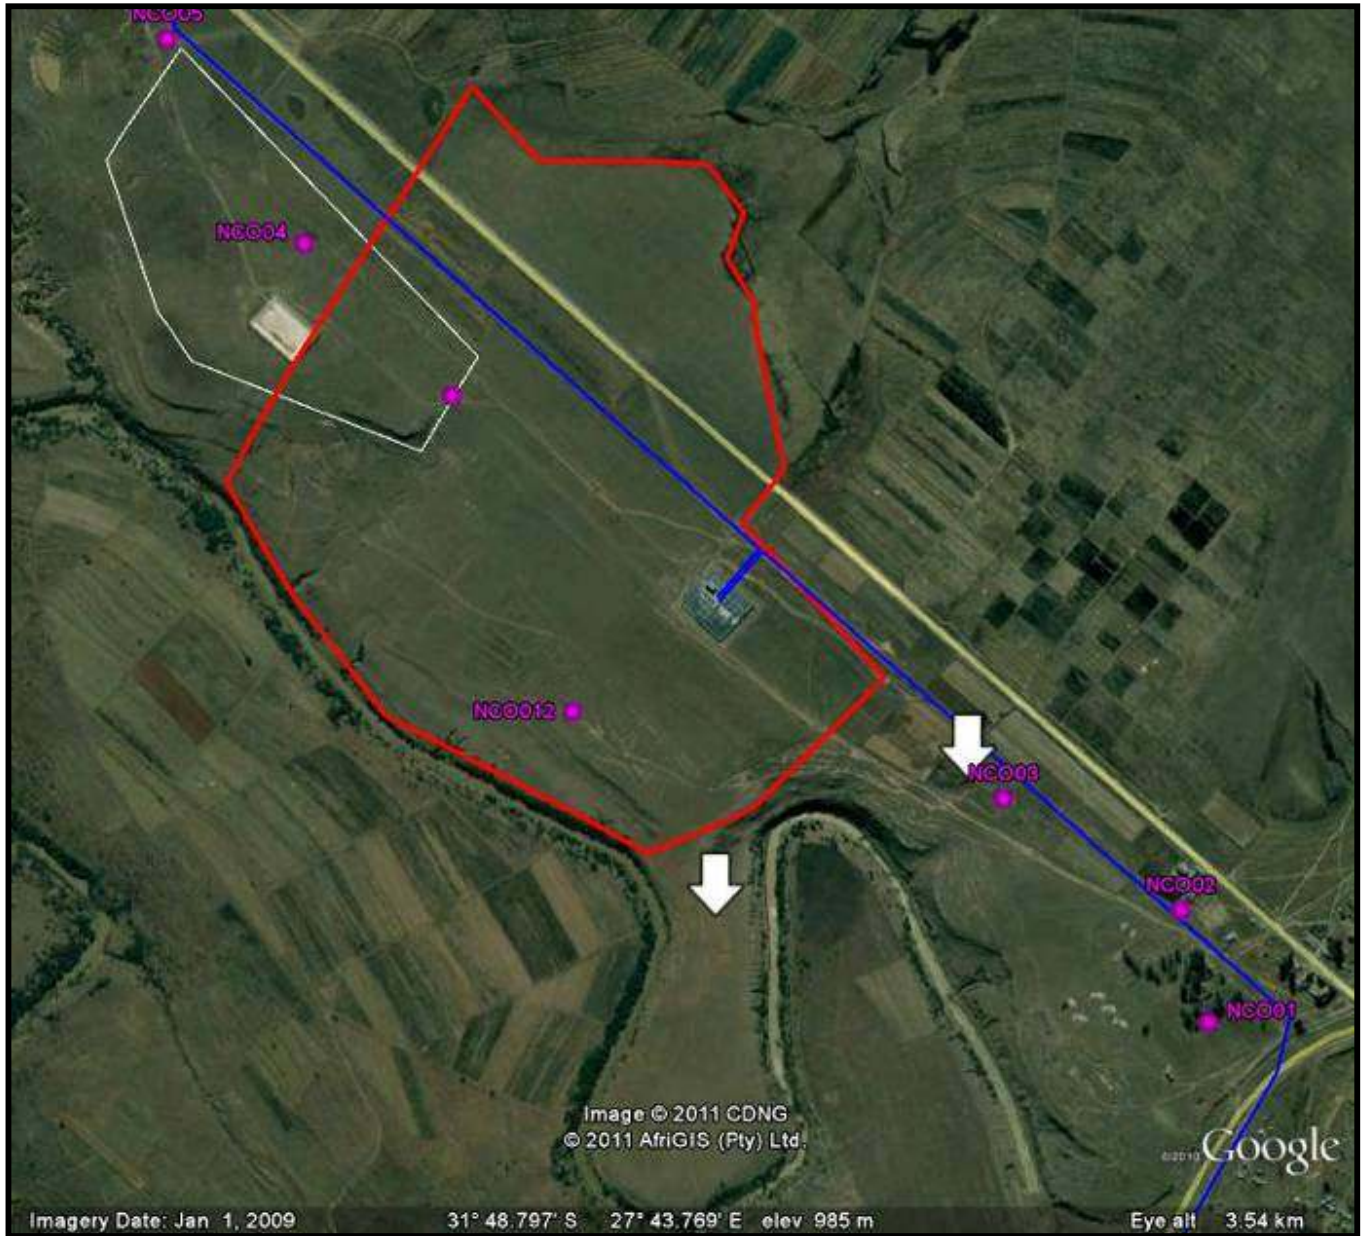
FIGURE 10: LOCATION OF NC04, THE PHOTOVOLTAIC FARM AND PROPOSED ALTERNATIVE AREA⁸

⁸ White outline = NC04, red outline = photovoltaic farm, blue line = cable line; white arrows = alternative areas for the photovoltaic farm

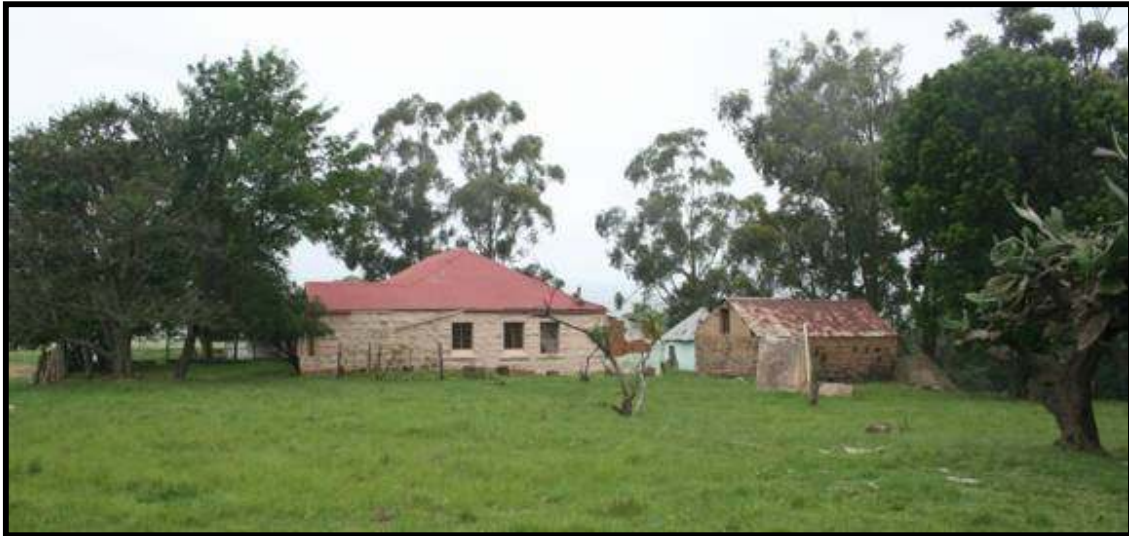
FIGURE 11: FARM BUILDING AT NCO6

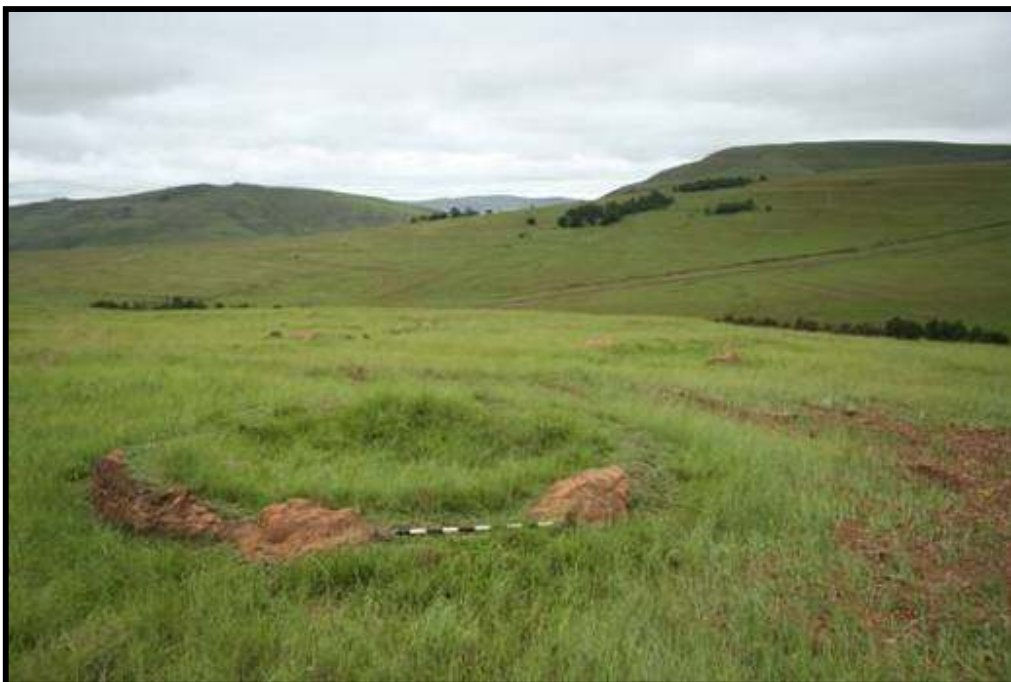
FIGURE 12: HOUSE FOUNDATIONS AT NCO9

has a rectangular byre. Several of the house foundations are well preserved (fig. 12). Only the settlement with the rectangular byre has well-preserved house foundations. I did not observe any graves, although they may be subsurface.

NCO09 consists of eight settlements and one school. Only the northern settlement and the school occur on the 1964 map, and I presume the others predate this as they are less well preserved. The school does not exist anymore. The area is referred to as Ngaca on the 1964 topographical map. All of the settlements have circular cattle byres, with the exception of the northernmost that has a rectangular byre. Several of the house foundations are well preserved. Only the settlement with the rectangular byre has well-preserved house foundations. I did not observe any graves, although they may be subsurface.

Mitigation: If the cable line affects the site then it will require some form of mitigation. This would depend on the extent of the impact. My main concern would be potential subsurface human remains. If the cable line is placed in this side, it will need to be re-assessed, first at a desktop level, then at an on-site level. The site may need to be accurately mapped before, and monitored during, construction.

NCO09 – NCO011b is a continual sensitive area with house foundations, cattle byres and potential graves. There are houses, and possible graves, that occur near the road. It will not be feasible to reroute the line with another road, as all of the roads in this general area have heritage sites nearby. The cable line will be restricted in terms of slope of the hills, and geology. The cable line needs to pass through NCO09 or NCO010. NCO010 has fewer features to be affected near the road, and the one area that will probably be affected is not well preserved. NCO09 has several sites that are better preserved that may be affected. If the cable line is placed on the northern side, then it will not affect NCO011b.

The final cable route will need to be re-assessed. The area will need to be monitored during construction activity. If any graves are observed within 50m of the cable line, then they will need to be fenced off. If NCO09 is affected then it will need to be accurately mapped before, and monitored during, construction activity. If NCO010 were affected then it would only require some mapping and site monitoring.

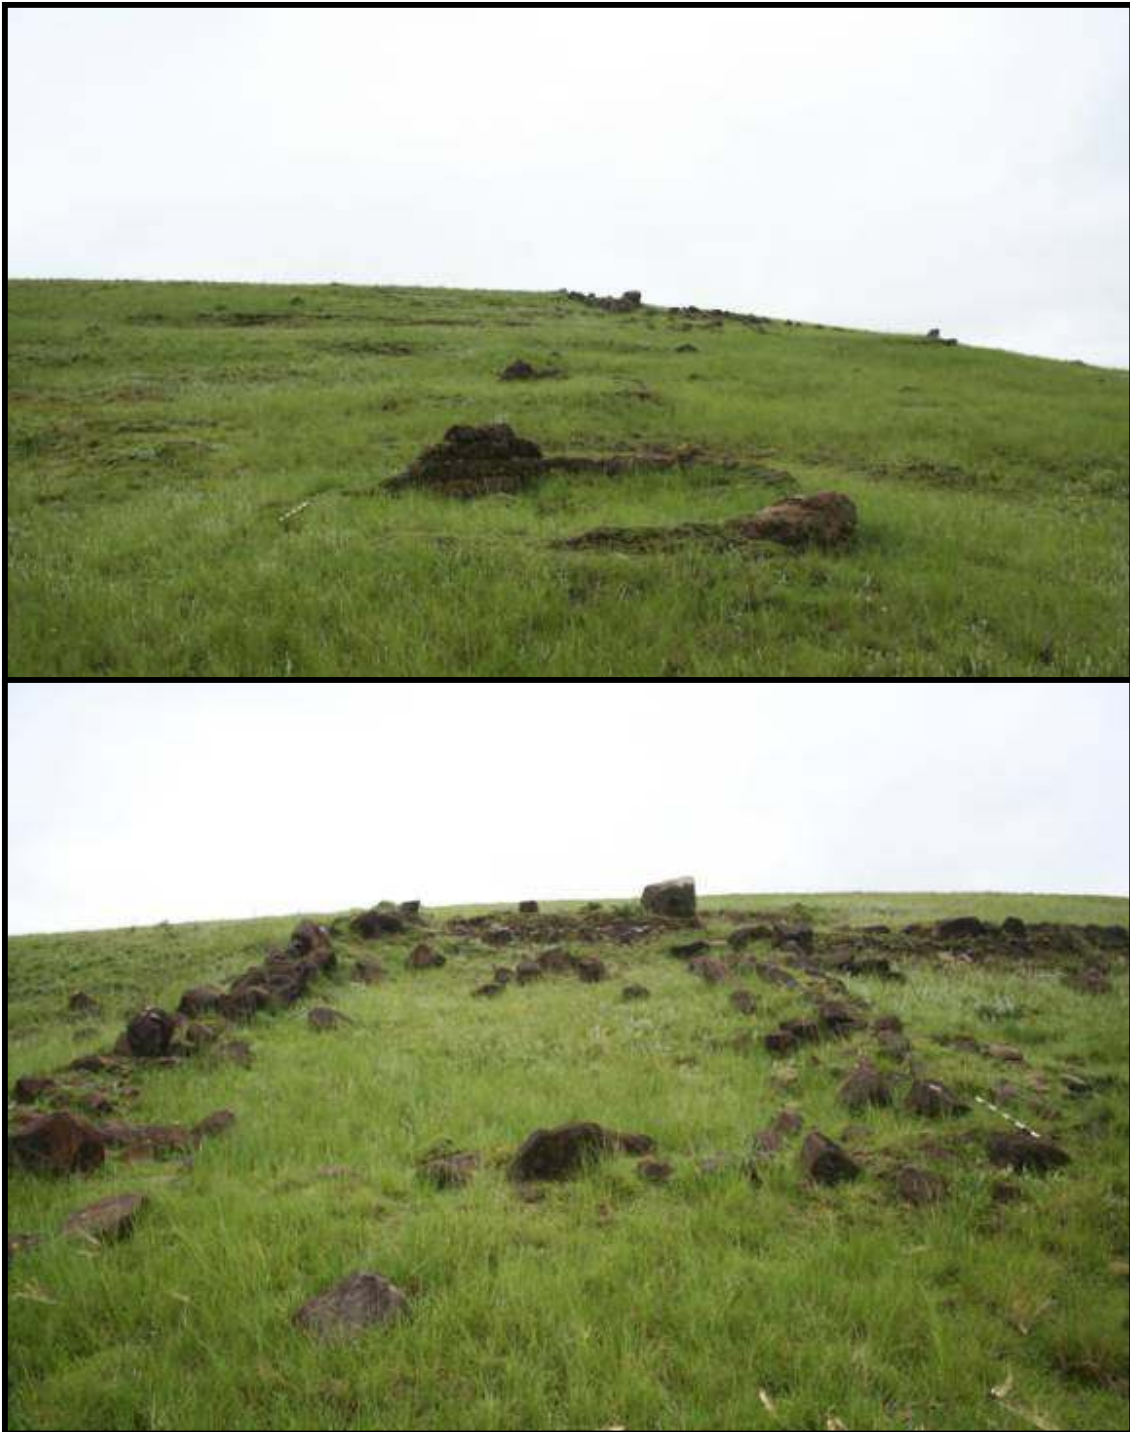
FIGURE 13: HOUSE FOUNDATIONS AND CATTLE BYRE AT NCO10

NCO010 is referred to as Mpotyo on the 1964 topographical map. The village has ~30 settlements of which NCO10, and NCO11, form a part. NCO010 consists of at least three settlements on the slope of the hill, and a fourth settlement on the less steep slope. Only these four were noted, as the cable line would not extend further. Each settlement has 3 – 4 houses in a row, but only one has a visible stone walled cattle byre (fig. 13). The lower settlement has a square cattle byre that is made from mudbrick foundations. The lower two sites do not occur on the 1964 map and probably predate it, as they are less well preserved. I did not observe any graves at the site.

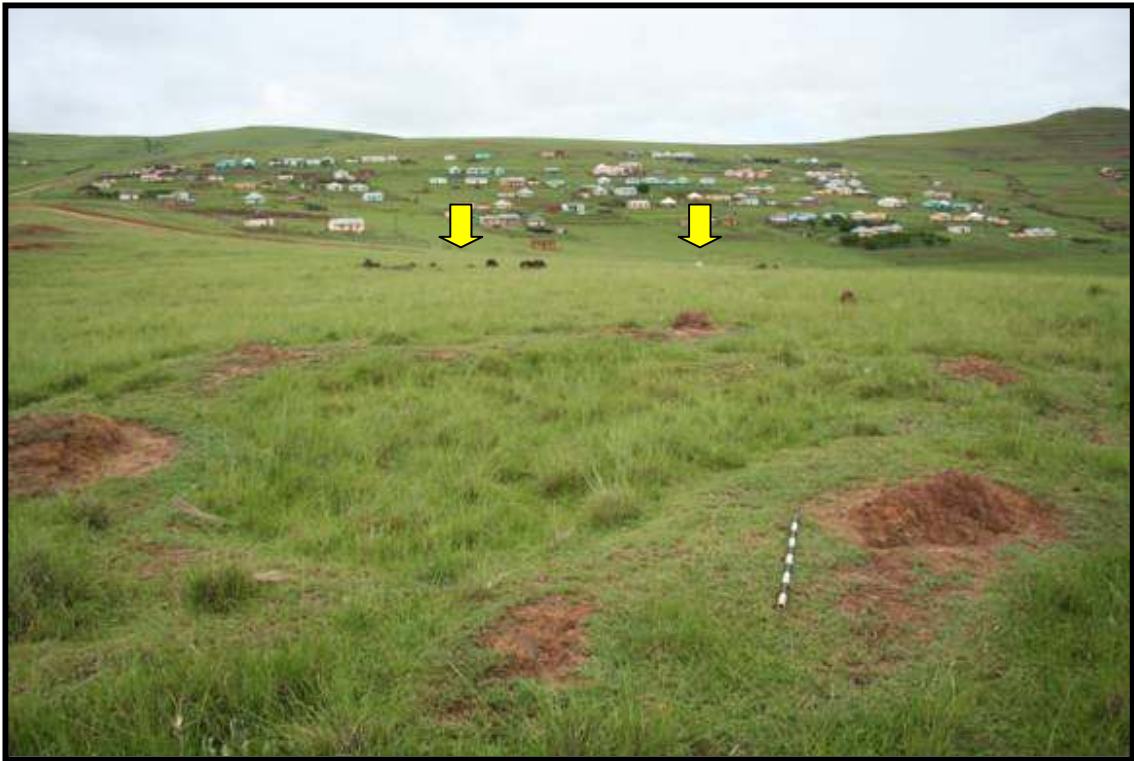
FIGURE 14: HOUSE FOUNDATIONS, CATTLE BYRE & GRAVE AT NCO11a⁹

NCO011a occurs on the opposite side of the hill to NCO010. The site consists of three house foundations, a rectangular cattle byre, and a grave (fig. 14). The grave dates to the 1970s, and occurs on the 1964 topographical map. There was another settlement ~120m to the west; however, it does not exist anymore. The site is located about 70m north of the cable line.

Mitigation: The cable line will not affect the site and no further mitigation is required.

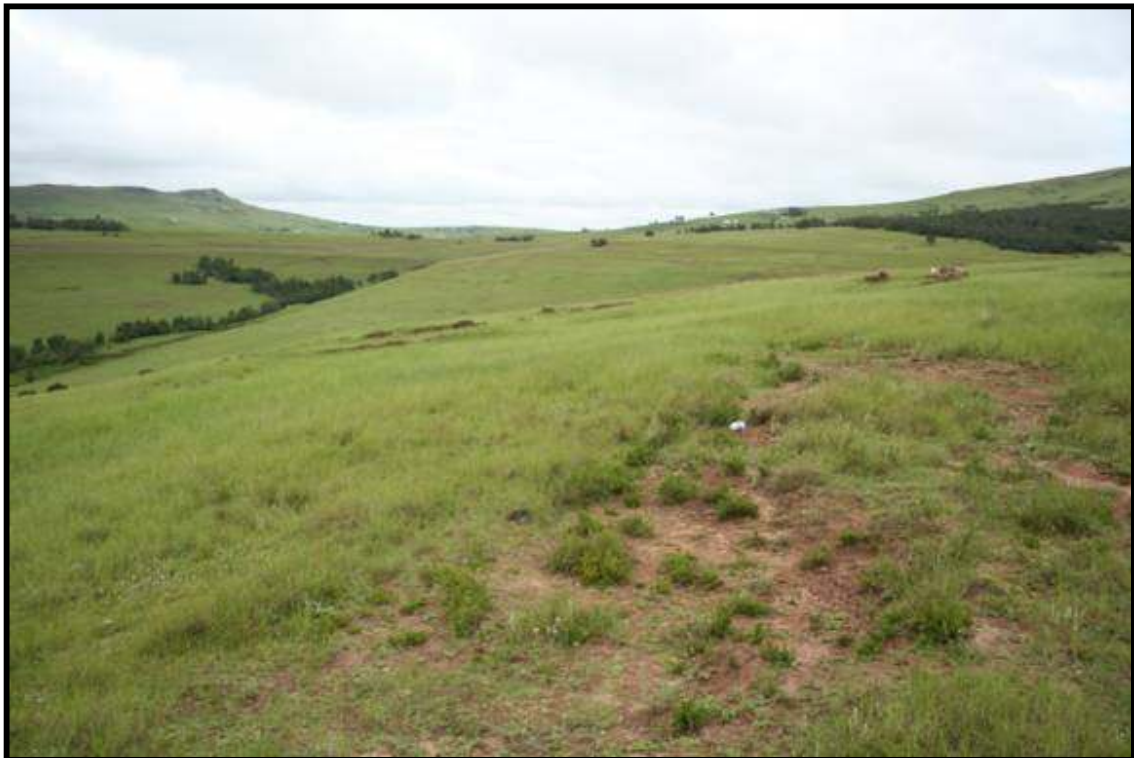
FIGURE 15: HOUSE FOUNDATIONS AND CATTLE BYRE AT NCO11b

NCO011b is part of the Ngcaca or Mpotyo area on the 1964 topographical map and includes site 051. This map only has five settlements, while the area contains ten settlements: the rest predate 1964. The clusters of sites occur on the flattened area on top of the hill and along the slopes of the hill. Each settlement has a single row of three – four houses, a small cattle byre, and an agricultural field. The byres tend to be near the houses, as opposed to NCO010 where they are further away. The settlements are in various stages of preservation, with those closest to the road the least well preserved. The eastern most settlement (fig. 15) has an extensive mudbrick outer perimeter wall. I did not observe any graves at this site; however, they may be subsurface.

Mitigation: If the cable line does occur on this side of the road, then the area will need to be mapped and monitored during construction.

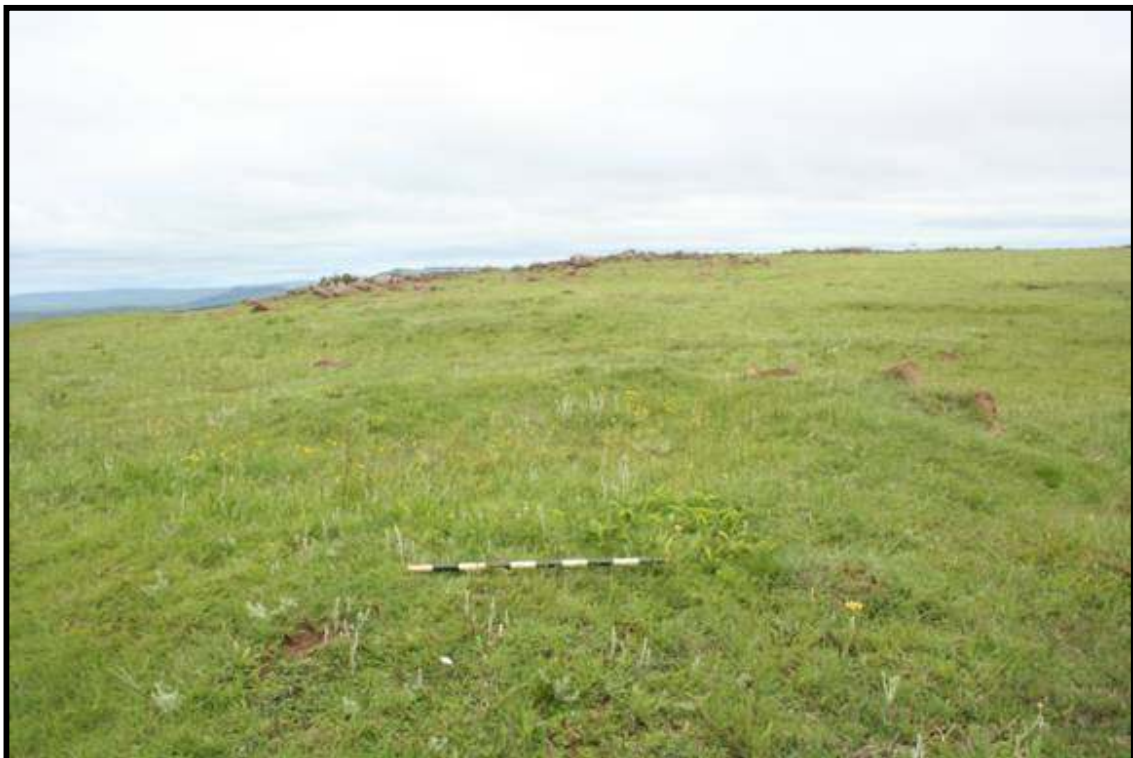
FIGURE 16: HOUSE FOUNDATIONS AT SITE 1

Site 1 is located on the top the hill and predates 1964. The site consists of four house floors (fig. 16). I did not observe a cattle byre or graves.

Mitigation: The site will not be affected by the current location of the turbine and cable line. No mitigation is required. If the site is affected it will need to be mapped and monitored.

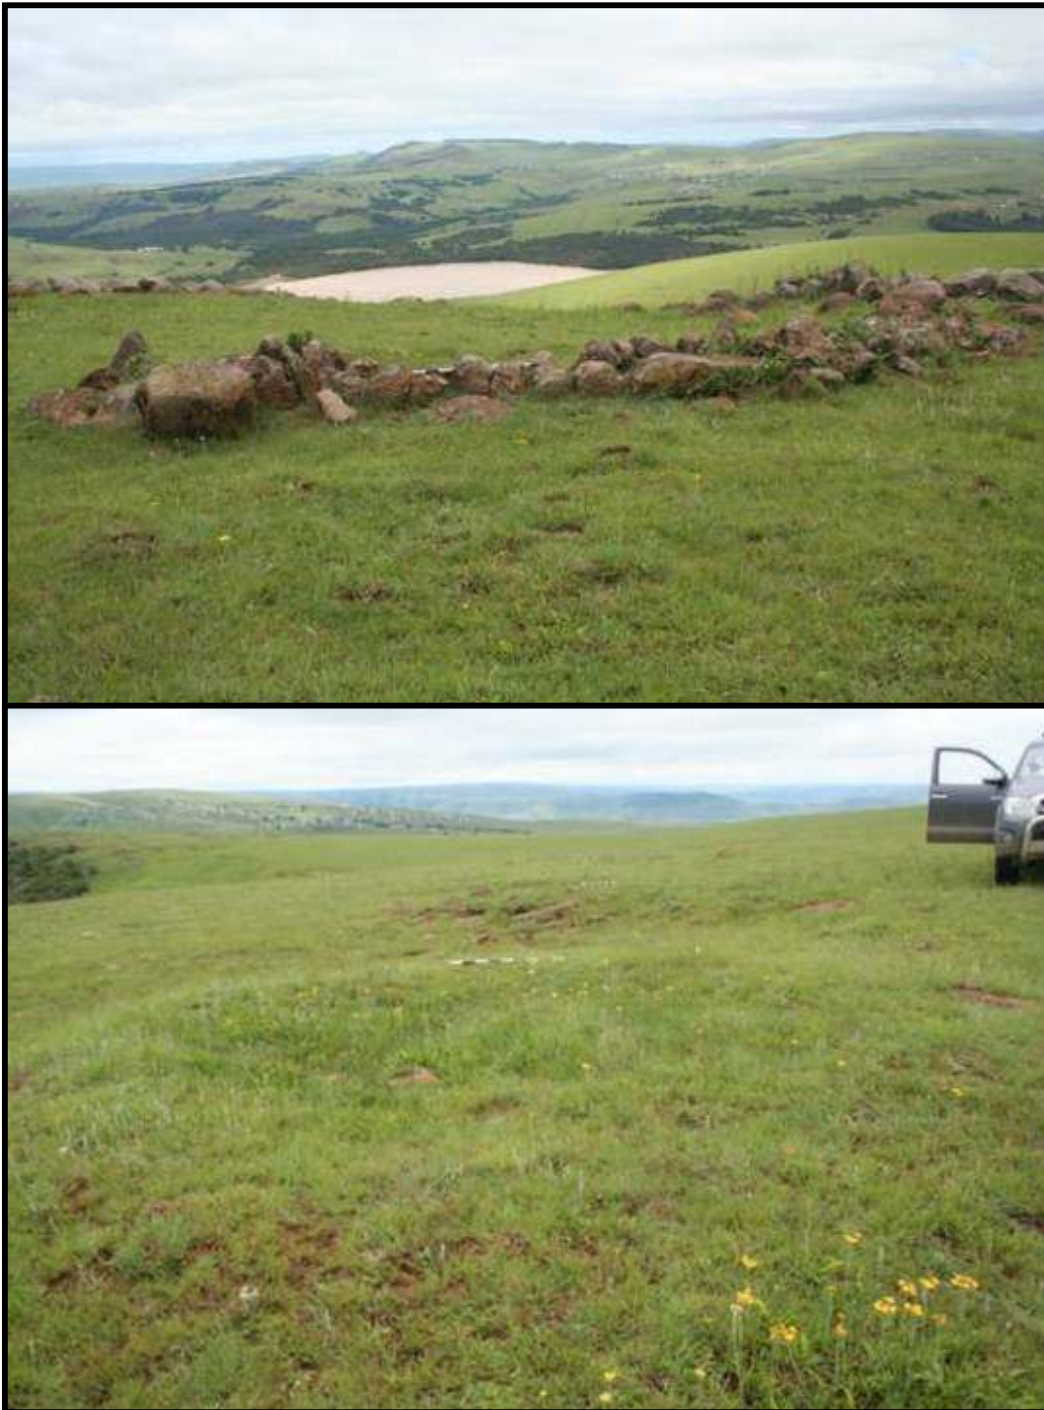
FIGURE 17: HOUSE & BYRE FOUNDATIONS AT SITE 2

The site is situated ~200m southwest of Site 1. It consists of three house floors and a stone walled cattle byre (fig. 17). There are only three sides of walling in the byre. I did not observe any graves at the site. The turbines or cable line will not affect the site. The site predates 1964.

Mitigation: No mitigation is required since the site will not be affected. If the turbine positions change, the site will need to be mapped and monitored during construction.

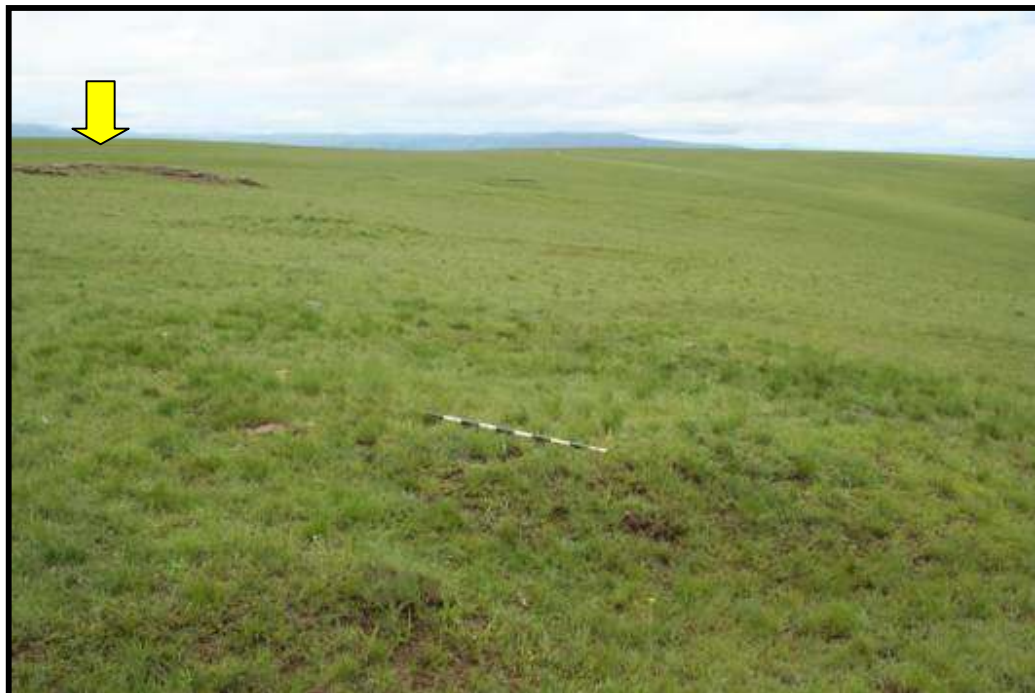
FIGURE 18: HOUSE & BYRE FOUNDATIONS AT SITE 4¹⁰

The site is situated ~150m northeast of Turbine WWD3 11, or V80 13. It consists of three house floors (fig. 18). I did not observe any graves at the site. The site predates 1964. The turbines or cable line will not affect the site

The site is situated ~80m north of Site 04. Site 05 consists of four house foundations and at foundations of a small byre (fig. 18). The byre is ~5m x 8m.

Mitigation: No mitigation is required since the site will not be affected. If the turbine positions change, the site will need to be mapped and monitored during construction.

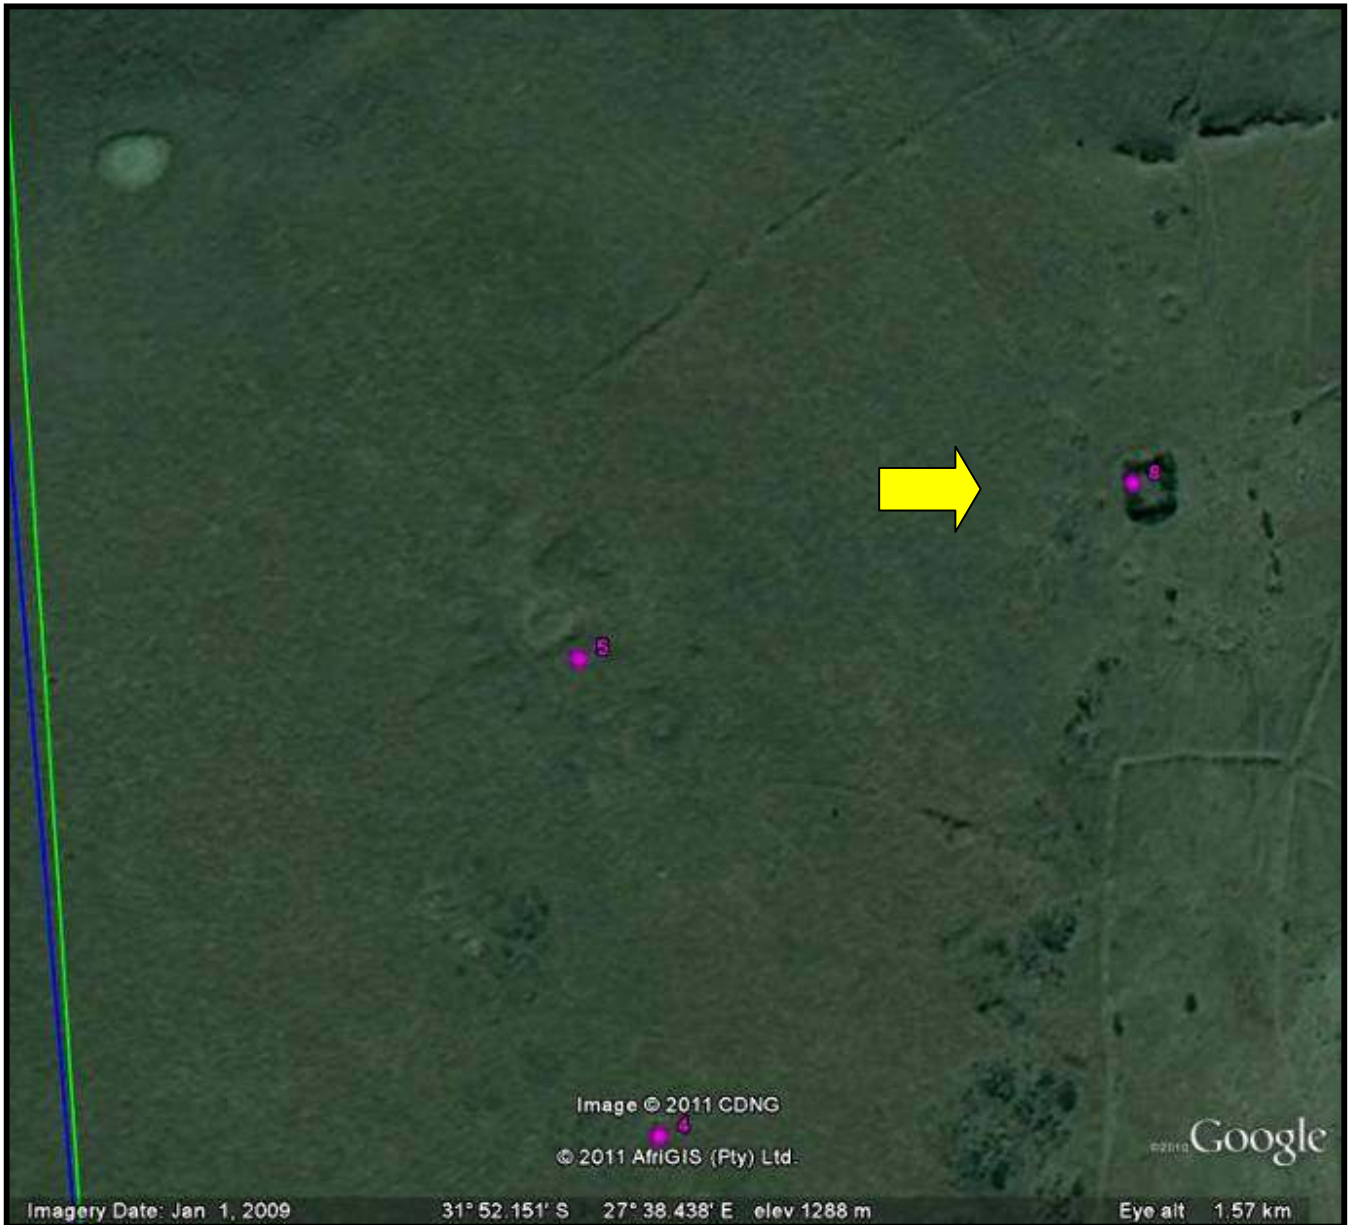
FIGURE 19: AERIAL VIEW OF SITE 08 IN RELATION TO THE CABLE LINE¹¹

Site 08 is located 280m east of the cable line and will not be affected. The site is also lower down on the hill and thus would not be affected by turbines. It is for this reason that the site was not surveyed, but only noted. The site consists of ~10 houses in a semi-circle around a small stone walled byre. The site is unusual in that the houses are not in the normal rows. Graves may occur at the site that also predates 1964. The features appear to be well preserved, as they are very visible in the aerial photographs (fig. 19).

¹¹ Yellow arrow indicates Site 08

Mitigation: The site will not be affected by the development. If any footprints change, then the site will need to be mapped, partially excavated, and monitored.

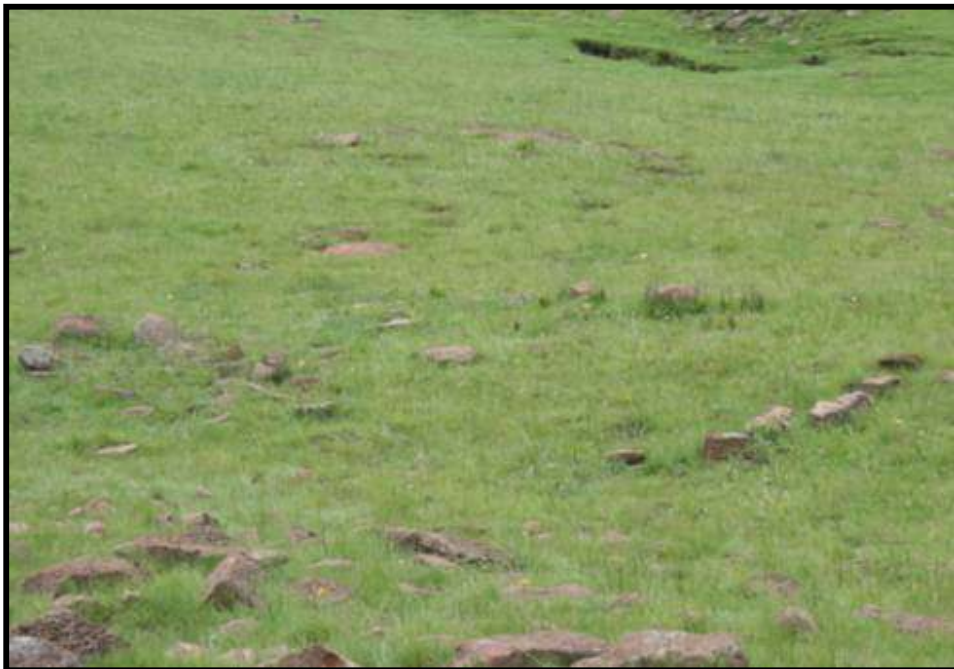
Site 015 is located just below the top of the main hill. It was surveyed, even though it is 500m from the line, in case a turbine is relocated nearby. The site consists of a single stone walled cattle byre, or the outer wall of a house.

Significance: The site is of low significance.

Mitigation: No further mitigation is required.

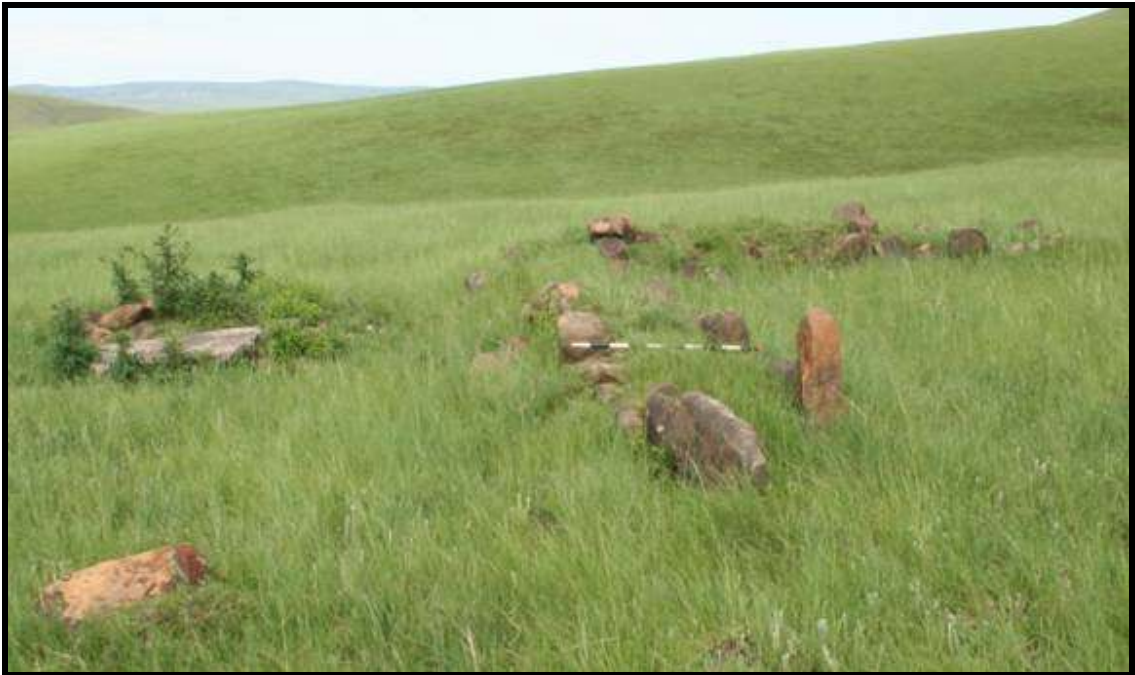
FIGURE 23: GRAVE AND STONE WALL AT NCO016

NCO16 consists of a stone walled cattle byre and a grave (fig. 23). There are possible house remains to the east. The cattle byre is one of the few walls in this survey that have a double row of stones with rubble infill. Only a part of the byre remains. The grave associated with byre has a concrete headstone that appears to have fallen over. There is no inscription on the headstone.

Significance: The site is of high significance due to the human grave. The grave is related to the byre as the male head of the household were traditionally buried near the cattle byre, and thus the two are symbolically linked.

Mitigation: The site may not be damaged or affected. The grave and byre should be clearly demarcated before any construction activity. The mitigation is discussed more below

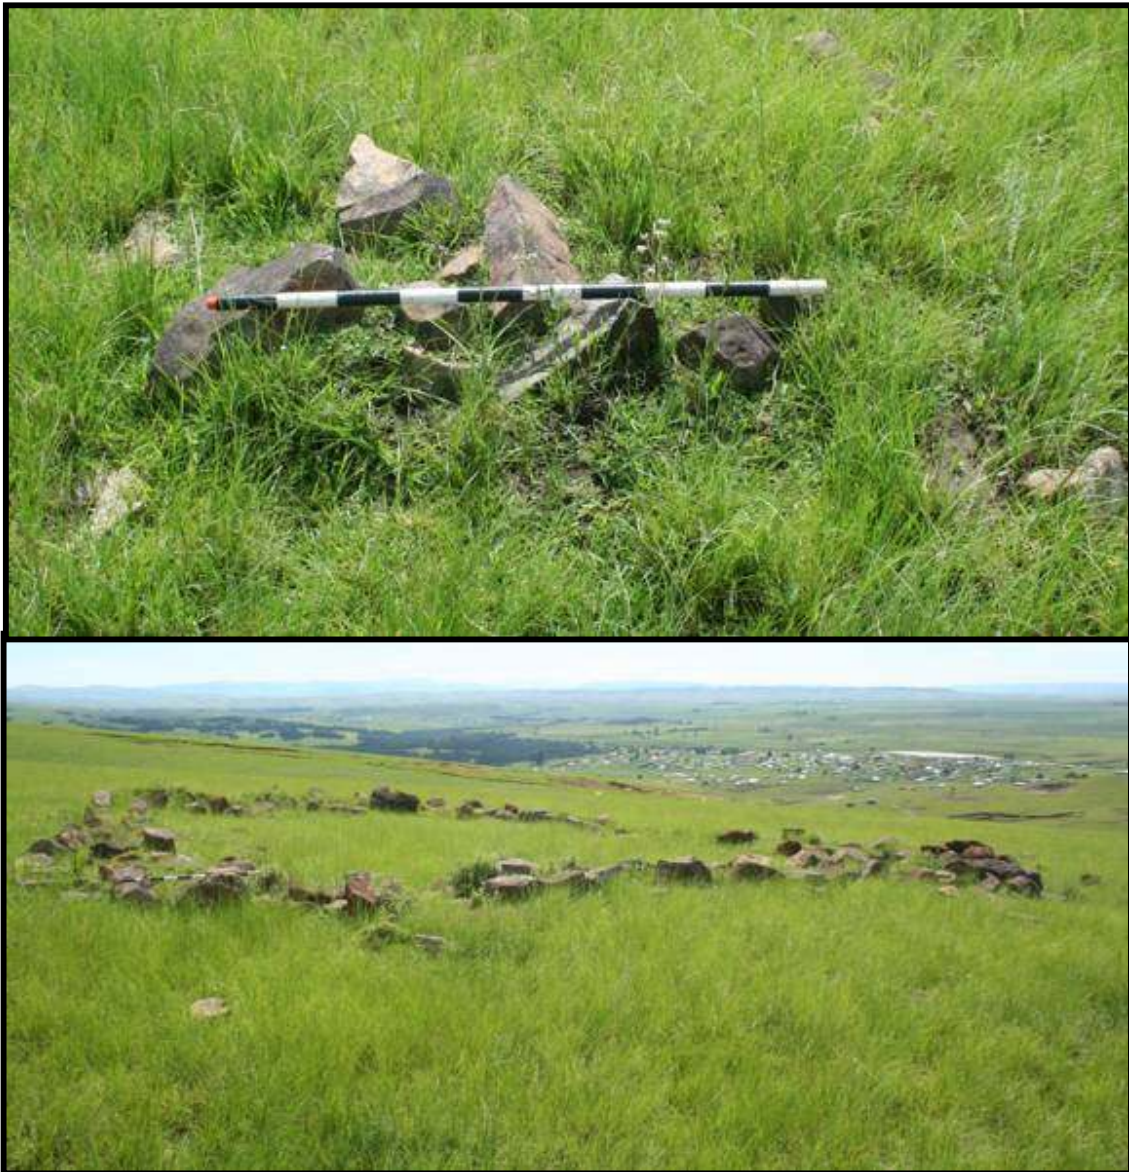
FIGURE 24: GRAVE AND STONE WALLING AT SITE 043b/c

The second settlement (a, b, c, f) consists of at least two houses (a, f), a stone walled cattle byre (c), and a grave (b) (fig. 24).
