**HERITAGE SURVEY OF THE PROPOSED
PHOTOVOLTAIC AND WIND TURBINE FARM AT
NCORA**

FOR COASTAL ENVIRONMENTAL SERVICES

DATE: 9 FEBRUARY 2011

**Umlando: Archaeological Tourism and Resource
Management**

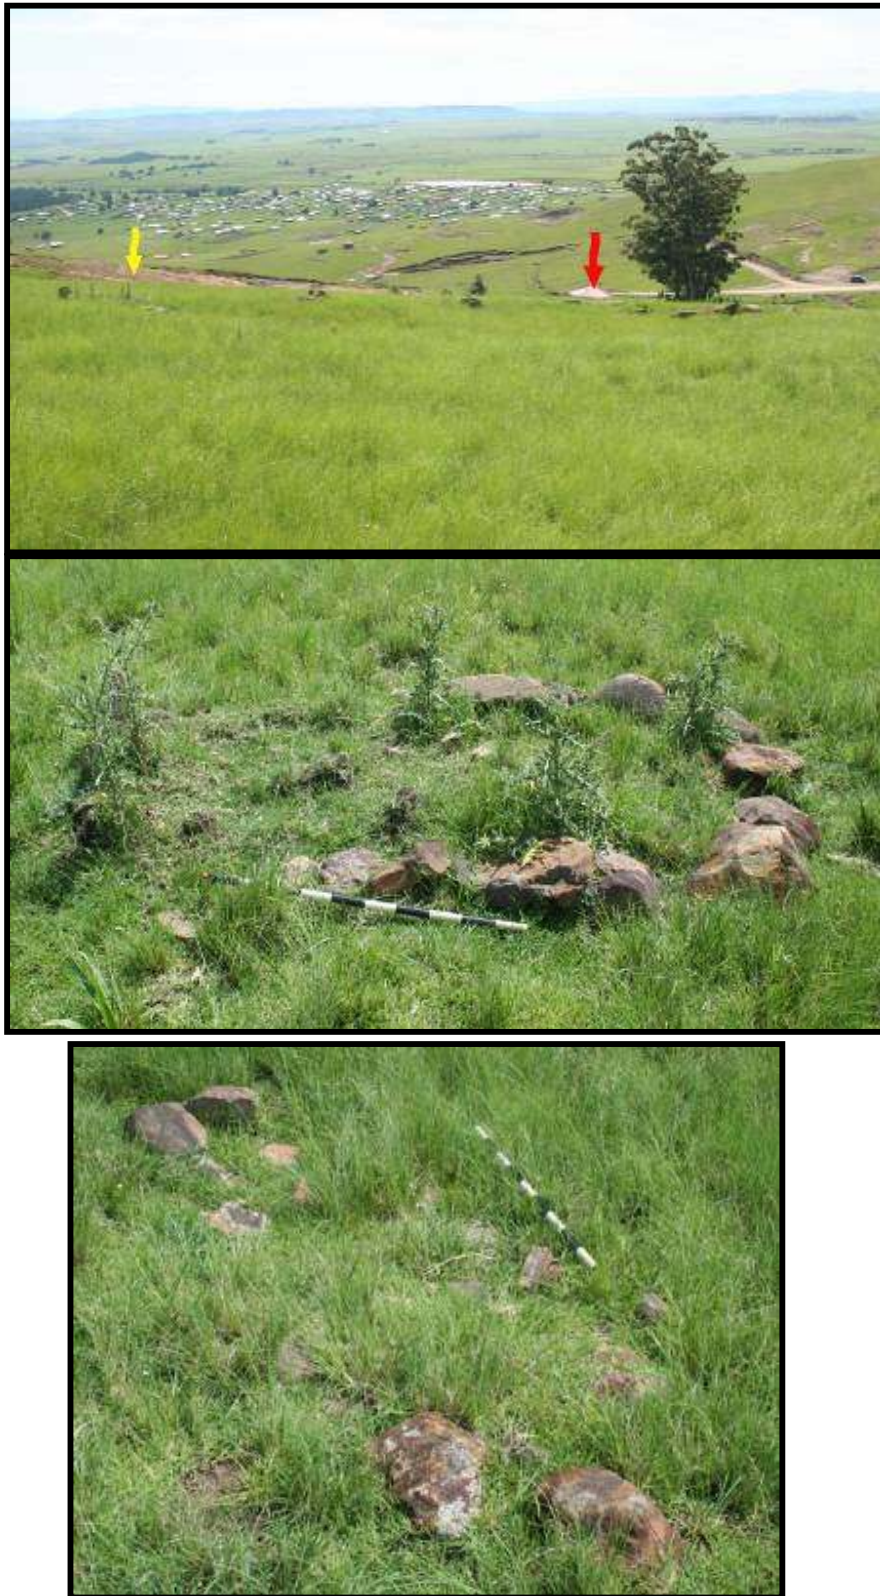
FIGURE 25 BYRE AND GRAVES AT SITE 043i/j/k

The next settlement (points g – k) consists of two – three house floors (g-h), a circular cattle byre (i) that has one side dug into the hill, and two graves (j-k) (fig. 25). The graves are unmarked and are associated with the byre. Only the graves are well preserved.
