**CULTURAL HERITAGE REVIEW**

**PROPOSED ESTABLISHMENT OF PHOTO VOLTAIC (SOLAR  
POWER) PANELS ON THE FARM TAAIBOSCHFONTEIN, NO 41,  
HANOVER DISTRICT, NORTHERN CAPE**

**(As part of the Environmental Impact Assessment for the overall project)**

**Compiled by:**  
**Jean Beater (MA Heritage Studies)**

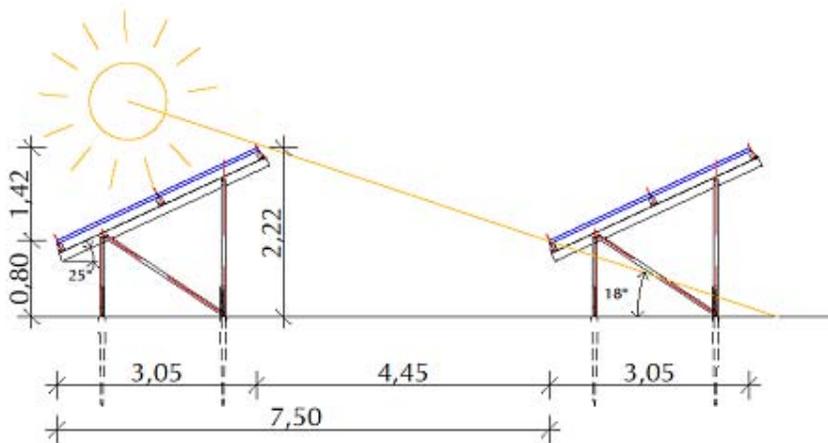
**Diagram 1: Schematic Diagram of Photo Voltaic Panels**

The panels will be approximately 2.2m in height above ground level with a width of approximately 3.0m. The panels are constructed of selenium based material encapsulated in a laminated plastic of high durability. Each panel is edged in plastic and feeds a small circuit board that delivers a direct current to the inverter that step up the current for delivery to the grid. The panels are non-reflective and are of a dark grey colour.

The schematic diagram below indicates the approximate size of the proposed solar panels.

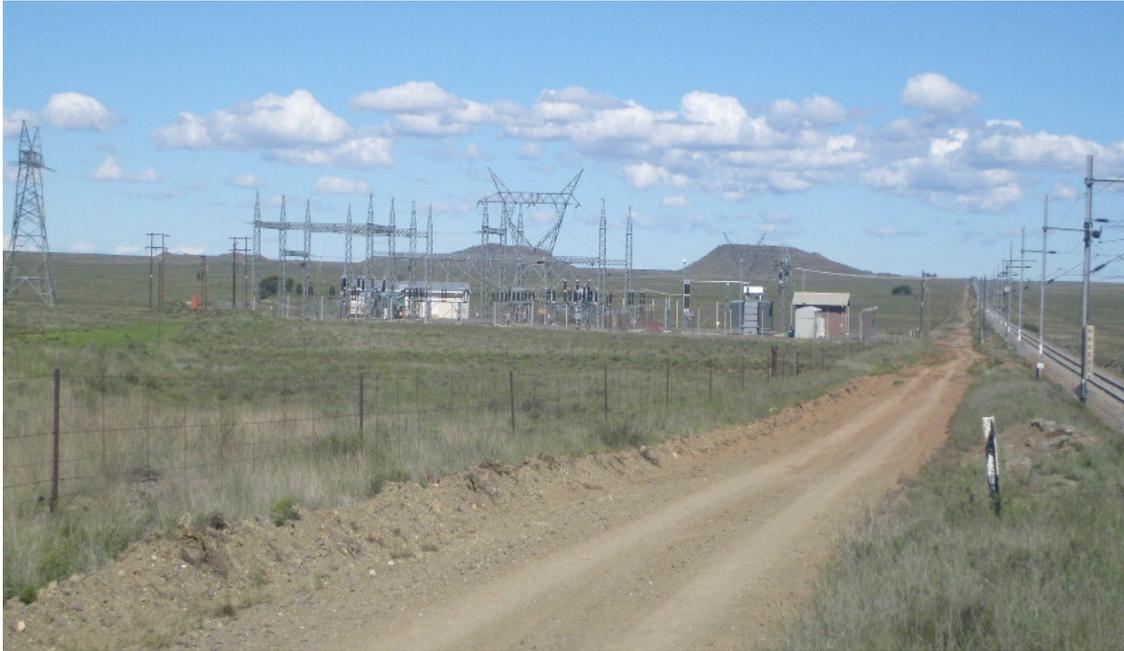
**Photograph 1: Existing infrastructure adjacent to and on farm Taaiboschfontein**

It was noted that the farm is already disturbed by sheep farming, the existence of an Eskom substation on the adjacent property and power lines that cross the farm under discussion after exiting the substation. In addition, a railway line and servitude road for both the substation and railway line run on the eastern boundary of the farm. See Photograph 1 below.

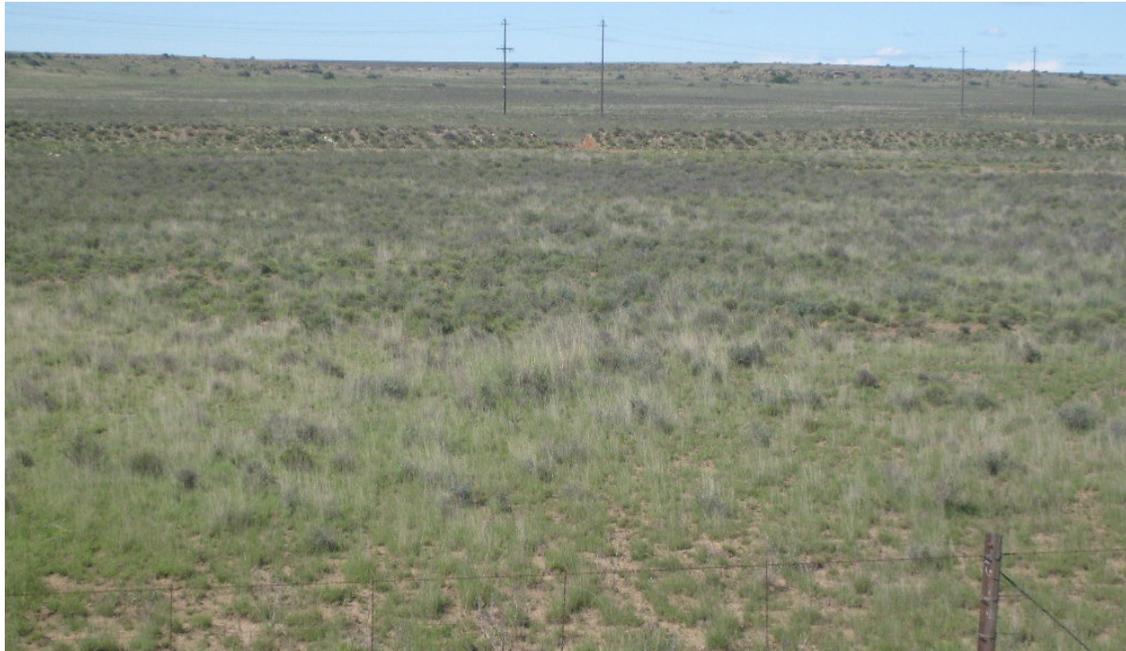
**Photograph 2: Elevated Track of Old Railway Line with Boundary Fence in foreground**

An elevated area north of the redoubts was reported to be the remains of the old railway line<sup>16</sup>. It was also identified as a drainage berm by the geo-technical specialist.<sup>17</sup> According to the owner of the farm, Mr Stefaans du Plessis, this elevated or raised area is the remains of the old train line track and that no remnants of the old railway track have remained.<sup>18</sup>

According to Mr du Plessis, a train was derailed on his neighbour's farm during the war. The farm is called de Bad and this incident may refer to the same derailing as reported in Section 8 above regarding the derailing of a train at Taaibos. He said that those responsible for derailing the train thought there were supplies on the train but instead the train was carrying horses only.<sup>20</sup>

It is however recommended that no solar panels be placed on the elevated area and, if feasible, the solar panels are situated away from the elevated area.

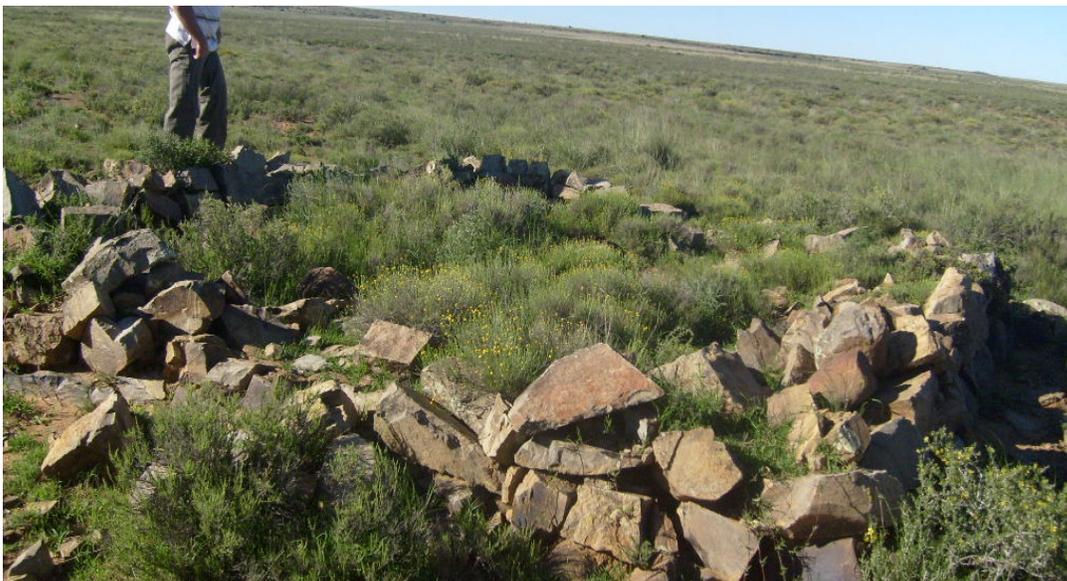
### Photograph 3: Redoubt in Fair Condition

There are five redoubts in varying conditions. Some are relatively well preserved whilst others have collapsed over the years with areas covered in stone marking the site of the redoubt. All the redoubts are overgrown with the local bush and grass but are still visible. The redoubts are made of local stone and are rough circular structures approximately one to two metres high. Remains of tins of food still can be found in and around some of the redoubts. See photographs 2, 3 and 4.

That these stone structures are something other than redoubts is possible but appears unlikely. There are no (visible) entrances to the structures hence it appears as if they were not used as kraals or enclosures for animals. The remains of tins seems to indicate that there were used by people and the lack of roofing material indicates that there also not used for storing food, supplies, etc. The lack of roofing also indicates temporary structures that were built to used for short term piquet duty and not for long term use such as block-houses that were built also during the Anglo Boer War.

Demolition of the structures is not recommended as the structures will have little impact on the proposed development as they are located in a row parallel to the access road and not scattered throughout the proposed project area. It should also be noted that the nature of the proposed development is such that the redoubts can be avoided through variation in layout of the solar panels if this is necessary.

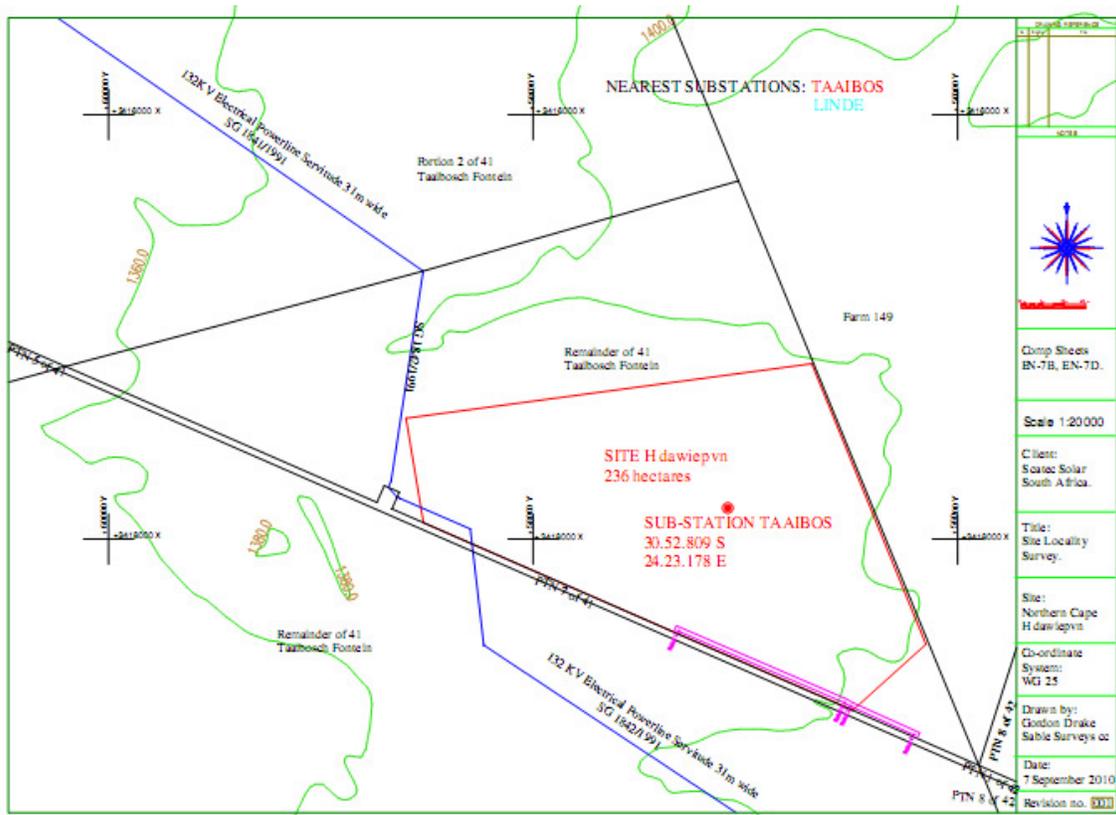
**Map 4: Cadastral of Site H: Farm Taaiboschfontein**

The map below indicates the position of the redoubts and the 15m buffer in purple within the context of the project site as a whole. The map also indicates the substation position, contours, power lines and railway line.
