# DRAFT BASIC ASSESSMENT REPORT

Basic Assessment for the proposed development of the Padloper Solar PV Facility 4 (i.e., Padloper PV 4), the proposed development of a 132 kV Overhead Power Line between the Padloper PV 4 and the proposed authorised Ishwati Emoyeni Collector Substation (i.e., Padloper EGI 4), and their associated infrastructure, near Murraysburg in the Northern Cape and Western Cape Provinces

## APPENDIX D.3: Archaeology, Palaeontology and Cultural Heritage - Padloper EGI 1-4

**HERITAGE IMPACT ASSESSMENT:  
BASIC ASSESSMENT FOR THE PROPOSED DEVELOPMENT OF A 132 KV  
OVERHEAD POWER LINE AND ASSOCIATED INFRASTRUCTURE BETWEEN THE  
PROPOSED PADLOPER SOLAR 4 AND THE PROPOSED AUTHORISED ISHWATI  
EMOYENI COLLECTOR SUBSTATION (i.e., PADLOPER EGI 4), NEAR  
MURRAYSBURG, MURRAYSBURG MAGISTERIAL DISTRICT, WESTERN CAPE  
AND RICHMOND MAGISTERIAL DISTRICT, NORTHERN CAPE**

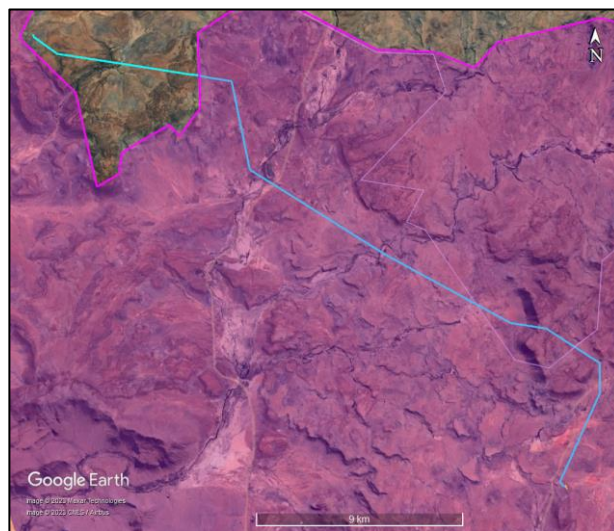
**Figure 6:** Map showing the powerline route falling partly within the Beaufort West REDZ (purple shading).

Infrastructure (EGI) Corridor (Figure 5) and partly within the Beaufort West Renewable Energy Development Zone (REDZ; Figure 6).

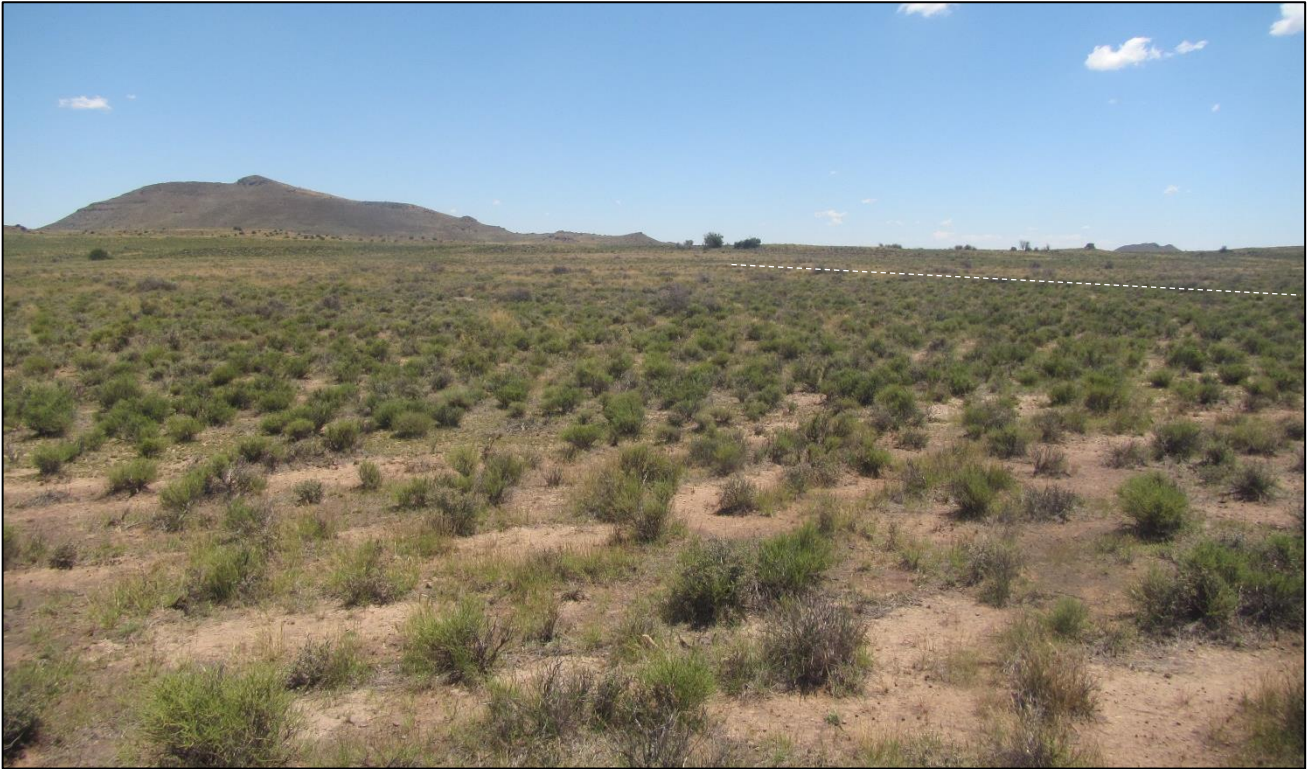
**Figure 7:** View towards the northwest near the north-western end of the route. The authorised substation at which the powerline would terminate lies on this plain. The white dotted line indicates the approximate alignment of the proposed powerline.

The powerline route traverses an undulating landscape characterised by silty/sandy plains, often with some gravel, and dolerite ridges with valleys in places. Vegetation tends to be low, but mature trees occur at farmsteads, usually in groves. Figures 7 to 12 show the nature of the study area, with specific features highlighted in the captions.

The physical nature of the landscape is shown in Figures 7 to 12 and it is evident that, with the exception of the farmsteads highlighted in Figure 40, the powerline corridor is largely natural in character with its cultural significance primarily due to its visual amenity. In this regard, the visual resources study by Winter and Oberholzer (2013) identifies no significant resources in the vicinity of the study area. The only significant features they note are in the steeper mountains to the south and southwest with one small area to the northwest (Figure 41).

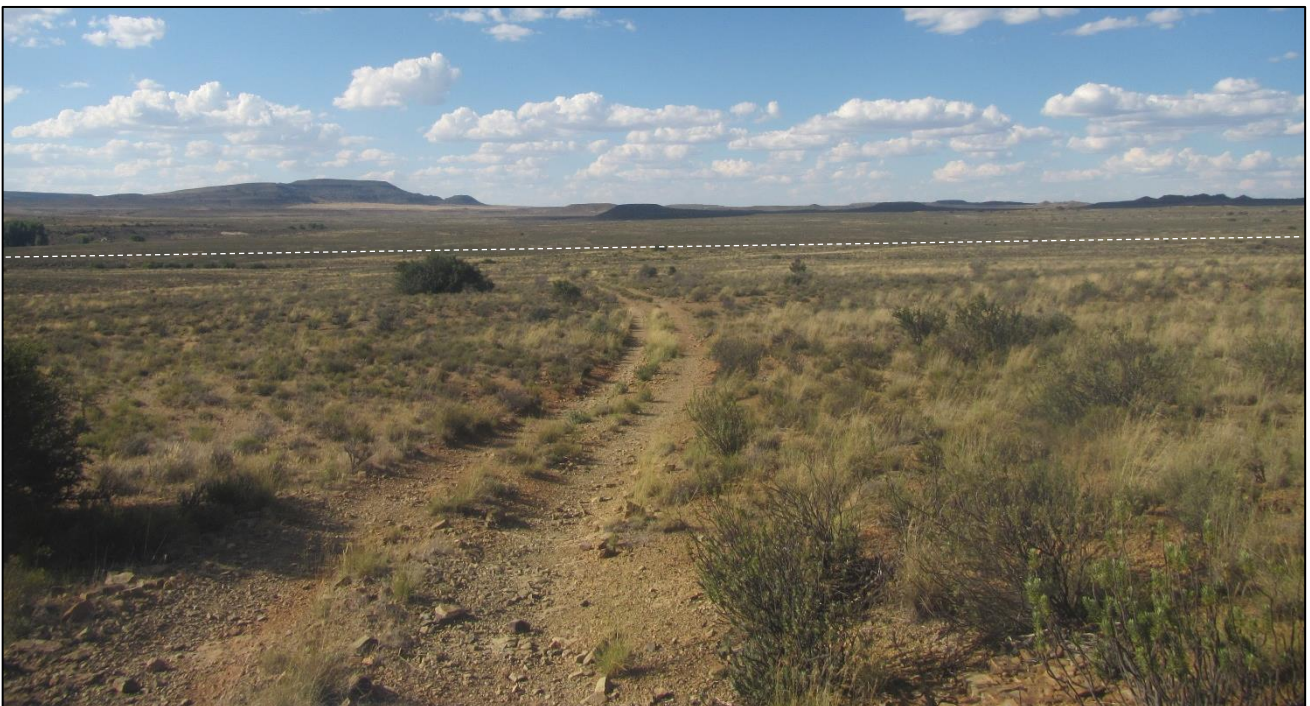
**Figure 8:** View towards the north in the west-central part of the assessed corridor. The powerline would pass through this view from right to left in the middle distance. The white dotted line indicates the approximate alignment of the proposed powerline.

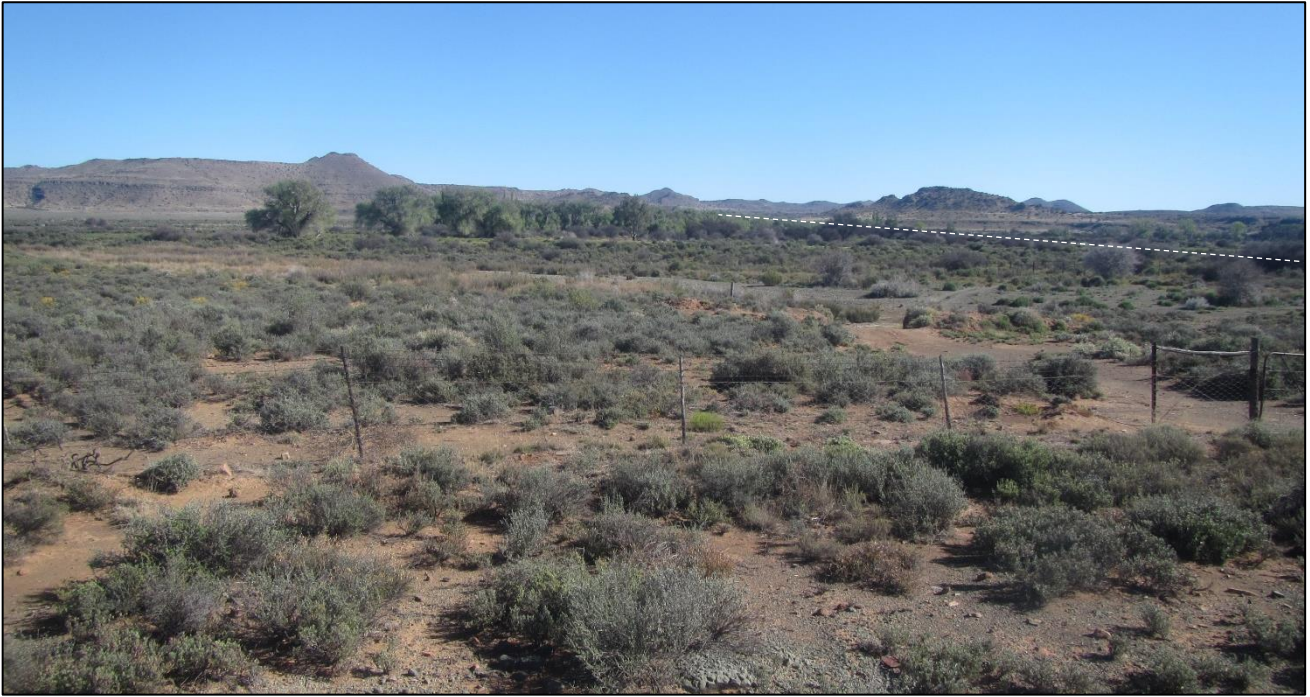
**Figure 9:** View towards the northwest in the east-central part of the assessed corridor where the powerline would cross the public gravel road. The white dotted line indicates the approximate alignment of the proposed powerline.

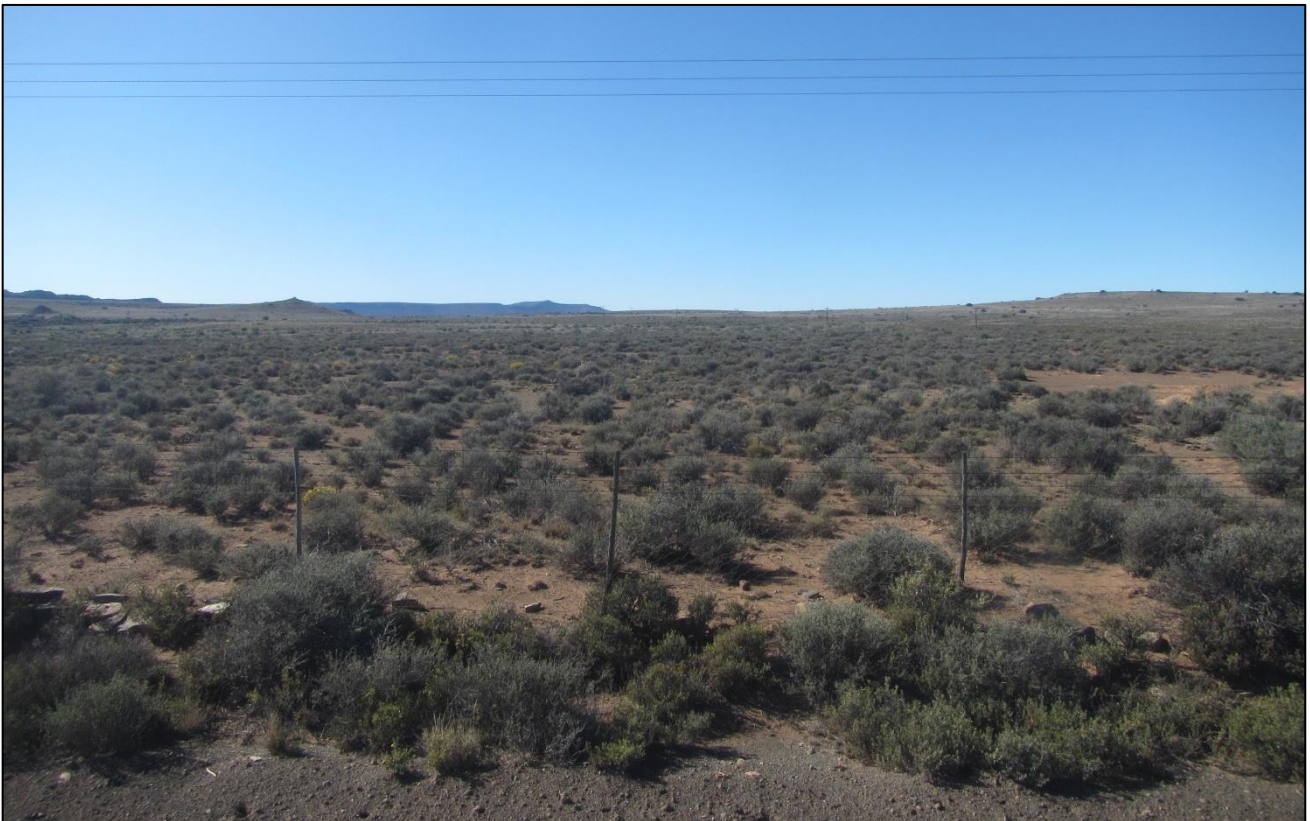
**Figure 10:** View towards the southeast in the east-central part of the assessed corridor where the powerline would cross the public gravel road. The actual alignment is just out of view to the left.

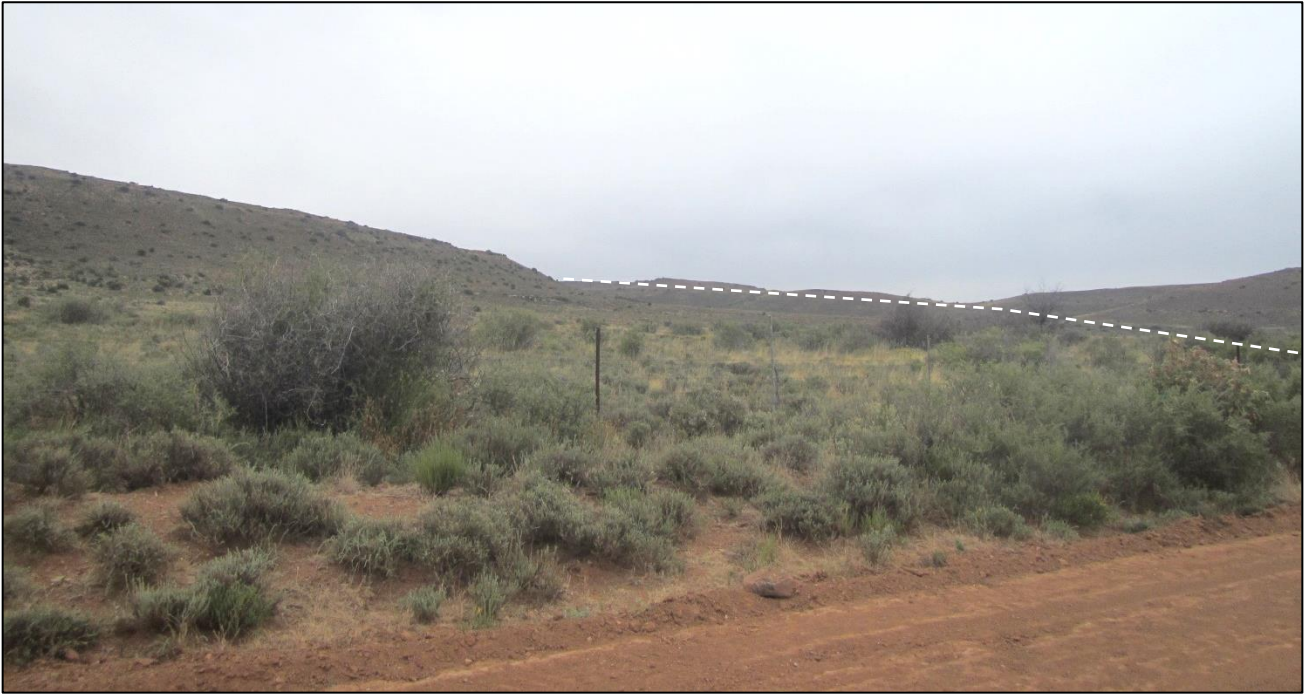
**Figure 11:** View towards the north showing the line coming off high ground towards a public road. The white dotted line indicates the approximate alignment of the proposed powerline.

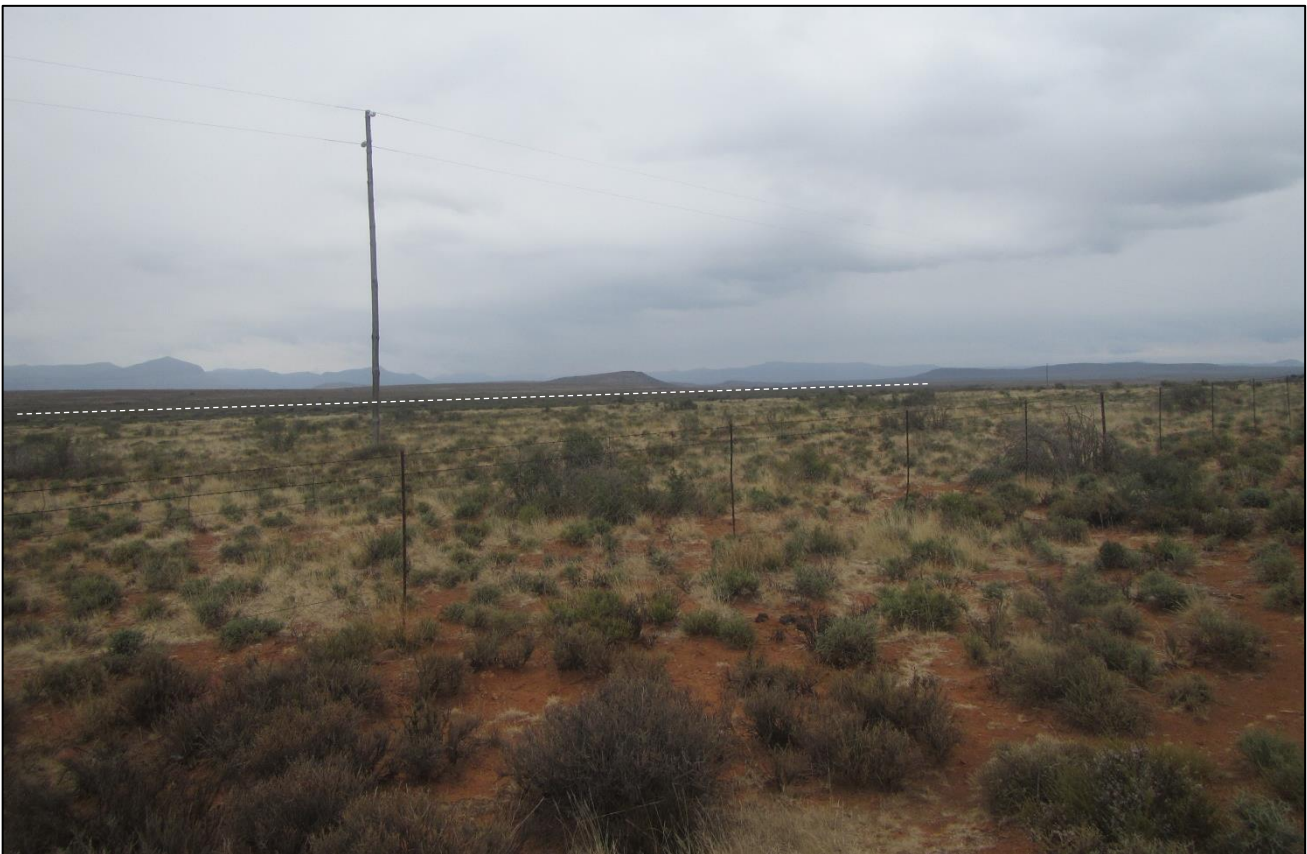
**Figure 12:** View towards the south towards the southeastern end of the powerline. The white dotted line indicates the approximate alignment of the proposed powerline.

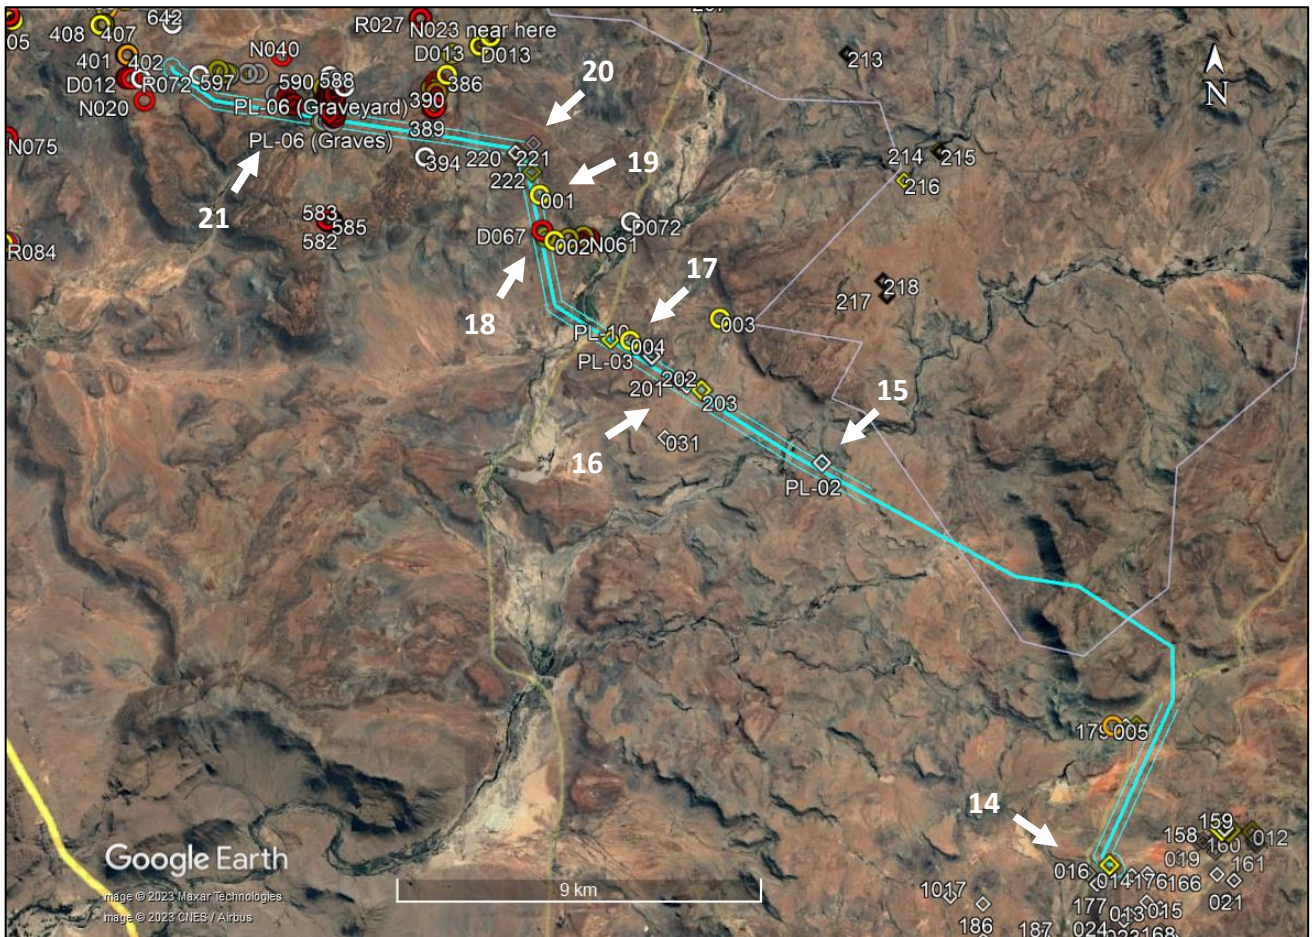
**Figure 13:** Map showing the distribution of finds in the Padloper EGI 4 corridor (the thin blue lines indicate the 200 m limit from the final powerline route). Red symbol = Grade IIIA (High for Halkett 2014), Orange = Grade IIIB, Yellow = Grade IIIC (Medium for Halkett 2014), white = NCW (Low for Halkett 2014). White arrows and numbers indicate the locations of the enlargements in Figures 14 to 21 below.

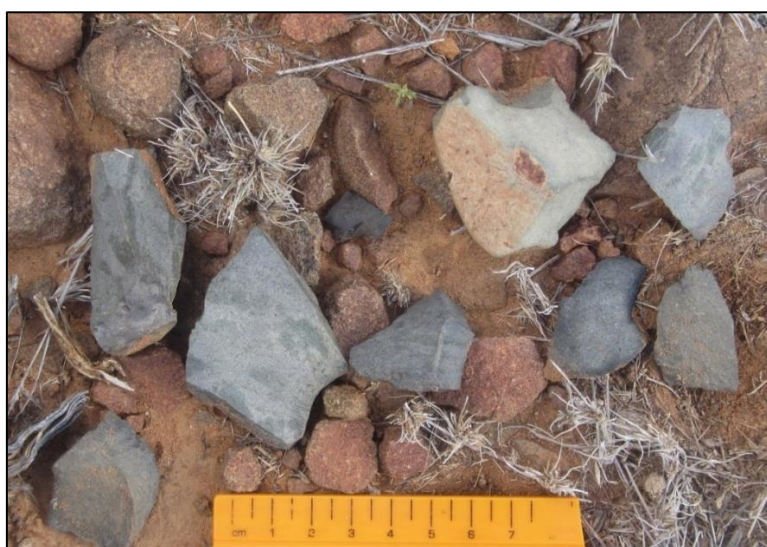
A number of stone artefact scatters were recorded in the wider area, with most being very ephemeral. Some denser scatters occurred at the historical farmstead described below. This association is no doubt due to the availability of water in the area. An ephemeral scattering of LSA artefacts made on tuff was found on a low outcrop of small dolerite boulders overlooking a stream at waypoint 201 (Figure 22). Other scatters reported from the corridor are even more ephemeral.

**Figure 22:** LSA stone artefacts from waypoint 201. Scale = 7 cm.

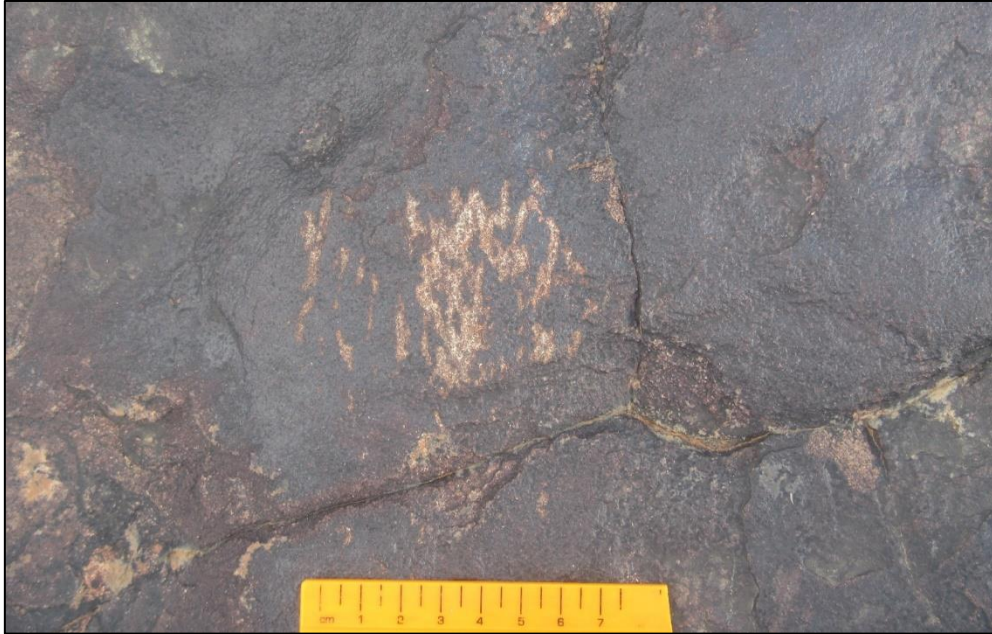
LSA rock engravings were seen in two places in the corridor, although others are known from outside the corridor in the northwest. One site, located in the southeast at waypoint 200, was only an informally 'scratched' dolerite boulder (Figure 23). In the north, at waypoints 220 to 222, another site was found on the edge of a high-lying area where a patch of exposed dolerite had several anthropogenically smoothed patches (Figure 24). At waypoint 222 there were two separate patches of smoothed rock, both of which had scratched/engraved cross-hatching on them (Figures 25 to 27). One of the patches was more heavily smoothed. The cross-hatched design on the second was clearer owing to the minimal smoothing. It is possible that the smoothing was done after the cross-hatching.

**Figure 23:** Scratched dolerite rock at waypoint 200.

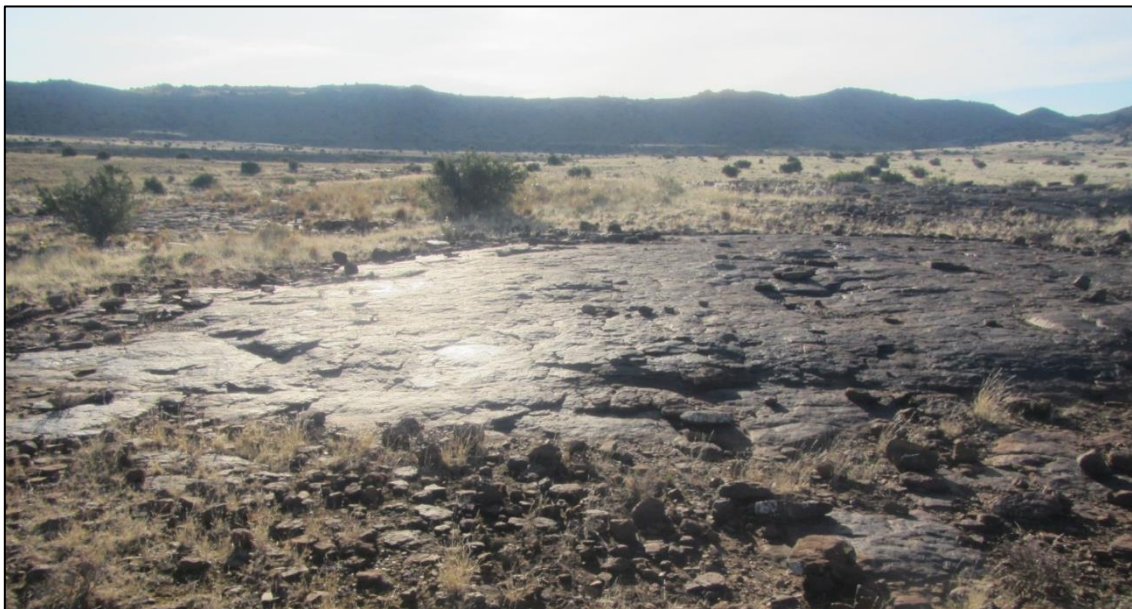
**Figure 24:** View of the dolerite bedrock outcrop with a smoothed and engraved patch in mid-picture (waypoint 222).

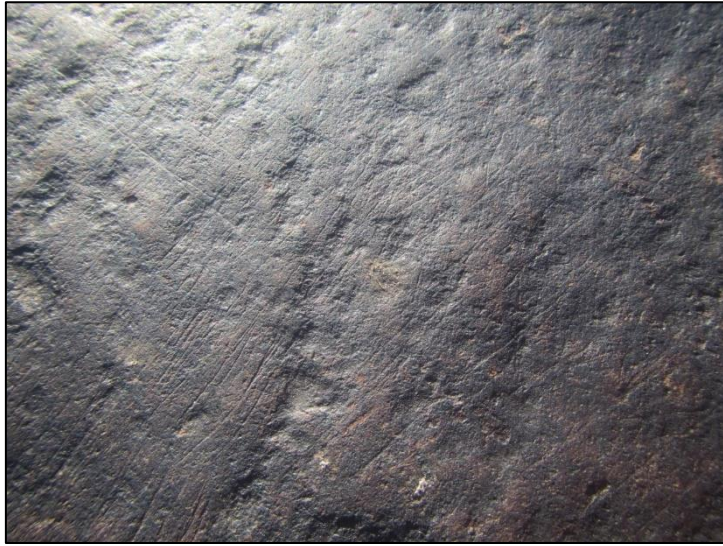
**Figure 25:** Close-up of the first smoothed and engraved patch at waypoint 222.

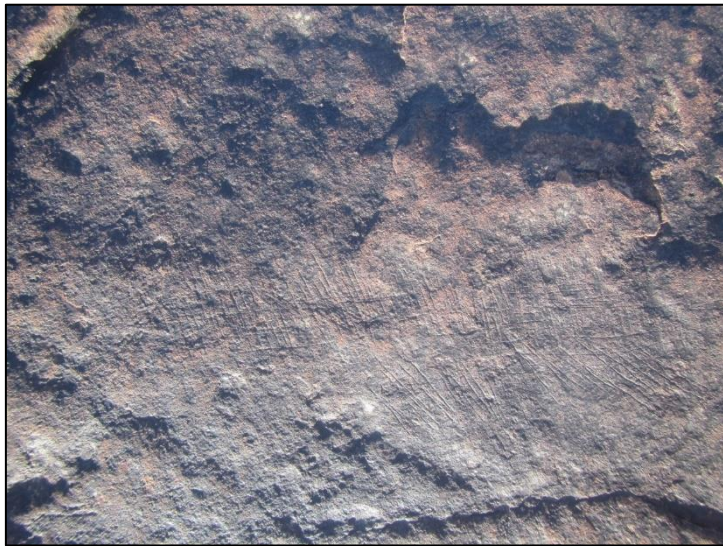
**Figure 26:** The second engraved patch at waypoint 222 which is less smoothed.

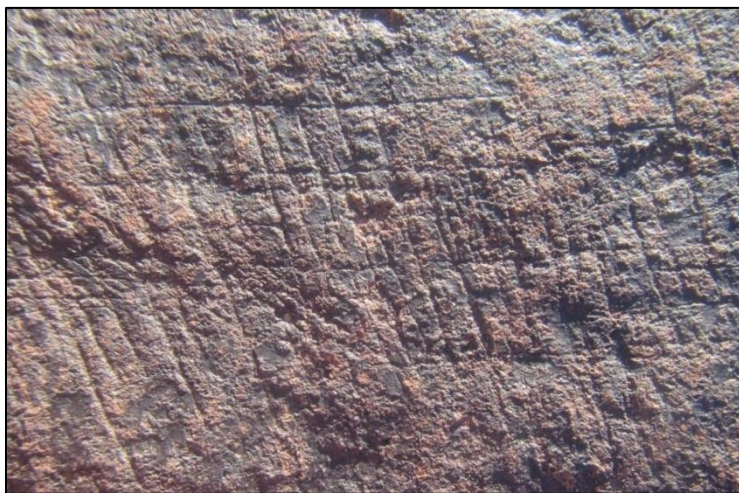
**Figure 27:** Close up of the second engraved patch at waypoint 222.

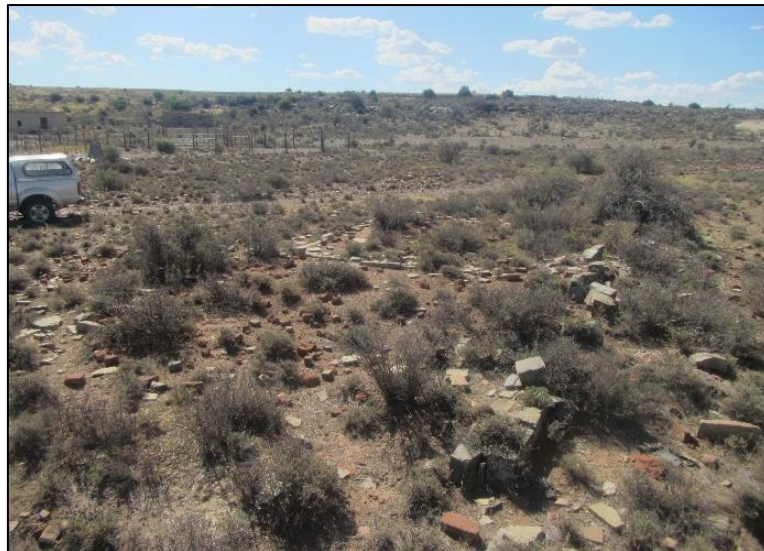
Historical archaeological resources were strongly focused in a single area where a historical farmstead was found. The wider site includes a variety of features scattered over an area measuring about 750 m by 250 m. The site includes ruins, kraals, ash and rubbish middens and many graves. Figure 28 shows a very poorly preserved ruin from which almost all the stones have been removed, presumably for reuse elsewhere on the farm. One stone-walled house ruin was much better preserved with only the roof and most joinery removed. Its walls were almost entirely intact (Figures 29 and 30). While the outer walls were of stone, the two interior dividing walls were of brick suggesting that the structure was originally just a single room.

**Figure 28:** *The remnants of a stone-walled structure at waypoint 634 (Orton in prep.).*

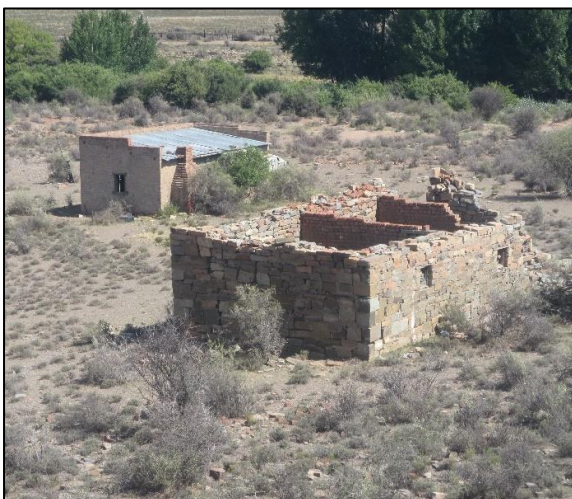
**Figure 29:** *A stone-walled house ruin in the foreground at waypoint 628 (Orton in prep.).*

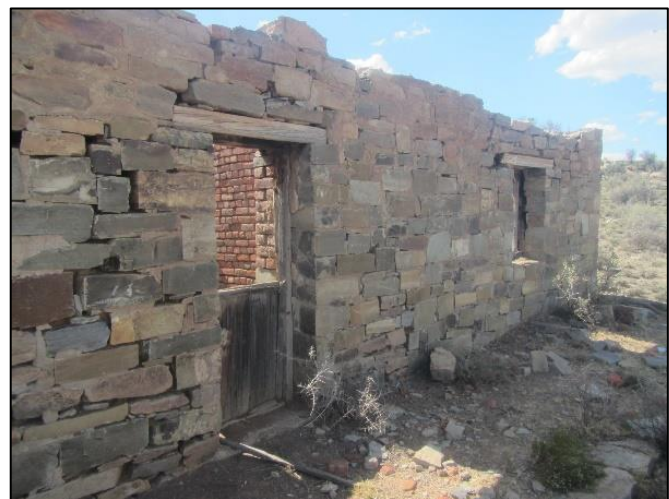
**Figure 30:** *The façade of the ruin at waypoint 628 (Orton in prep.).*

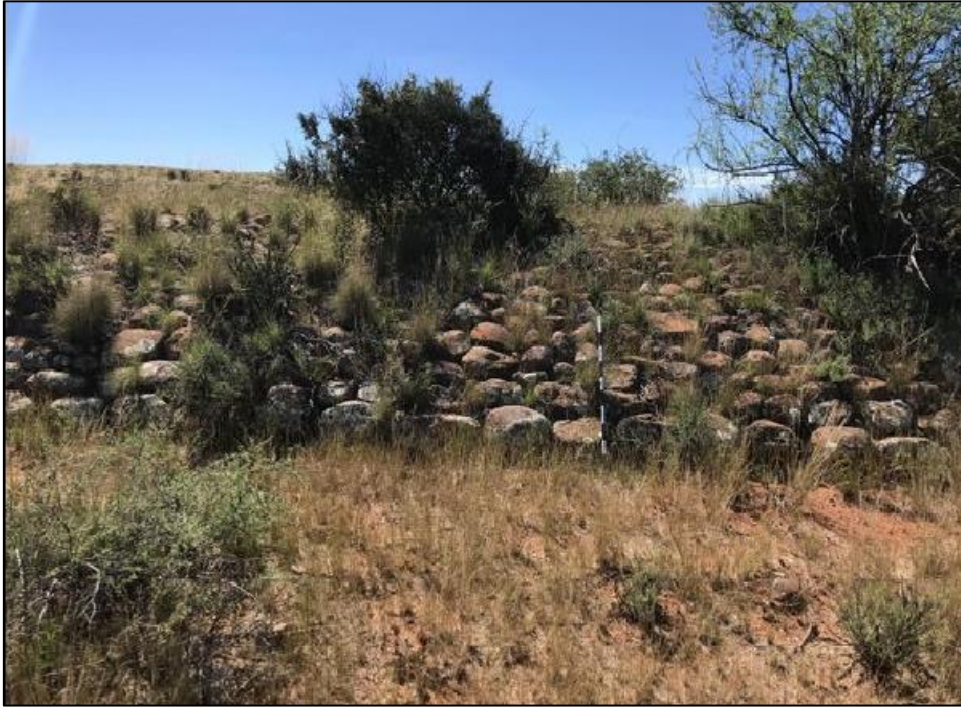
A number of historical farm dams were also recorded. One of those noted by Mann (2022) was clad in stones (Figure 31). Another dam was earth-walled but its spillway was lined with stones to prevent erosion (Figure 32). A number of other dams were recorded from aerial photography but it is not known whether they include stone-walled components or are simple earthen walls.

**Figure 31:** Stone clad dam wall at PL\_05 (Mann 2022: figure 73).

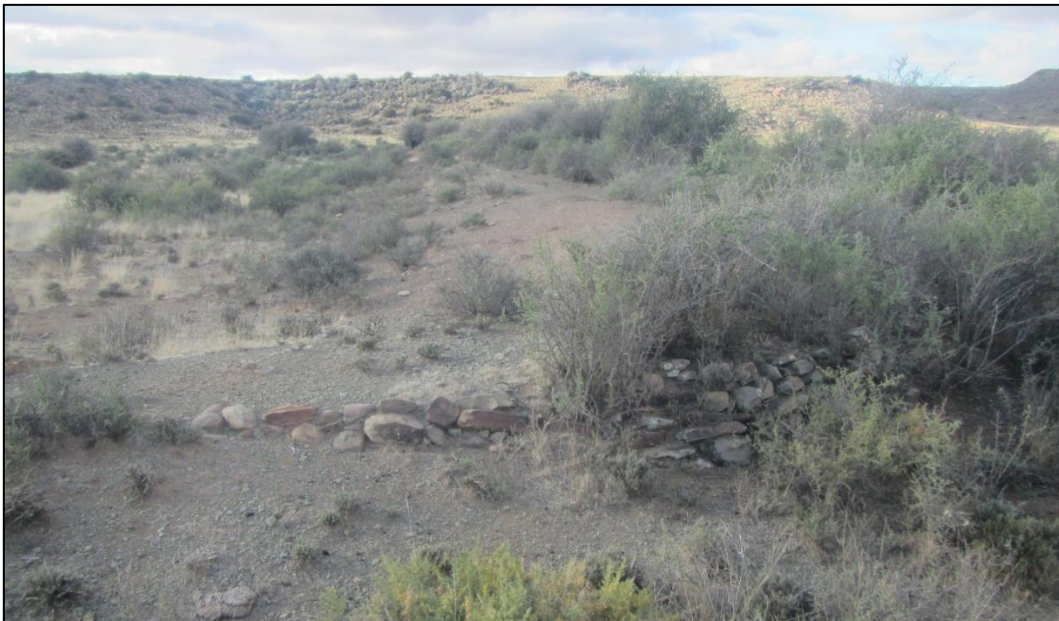
**Figure 32:** Low earthen dam wall (running away from the viewer) with a section of stone walling lining the spillway at waypoint 203.

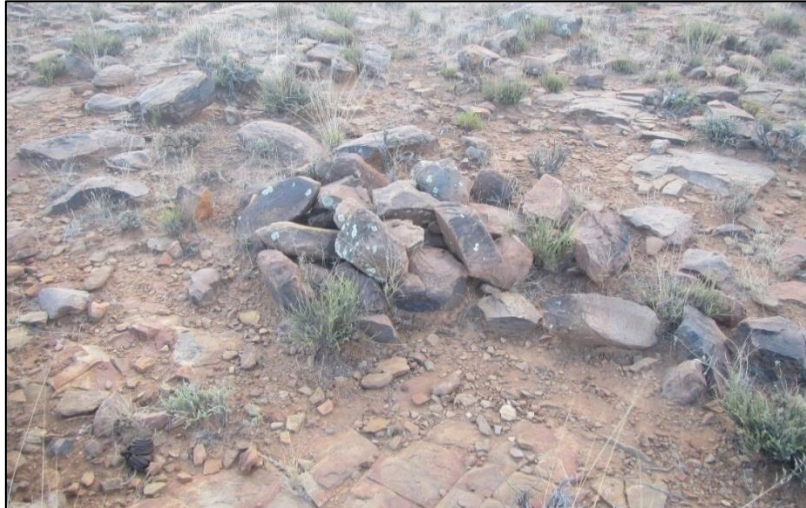
A few other historical features were also located. One was a small cairn of rocks whose function could not be determined. It is located at waypoint 202 (Figure 33). Another was a stone wall of indeterminate function at waypoint 016 (Figure 34). It is built using the conventional historical technique of making two stone 'skins' and filling the cavity with small rock fragments (Figure 35). This may be a hunting blind and is quite possibly modern, since many other similar – but generally less formally constructed – examples occurred elsewhere in the surrounding area. Some had rifle modern cartridges associated with them.

**Figure 33:** A small cairn of rocks at waypoint 202.

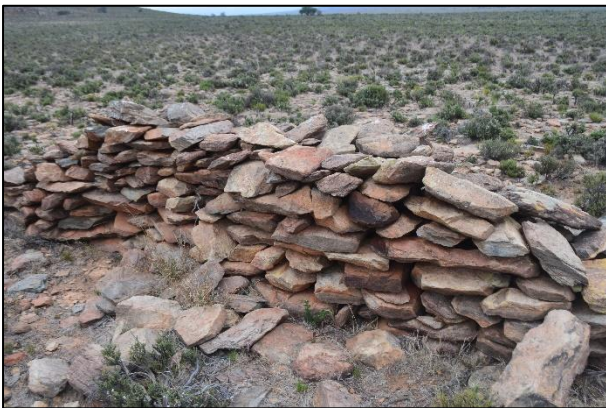
**Figure 34:** Stone walling at waypoint 016.

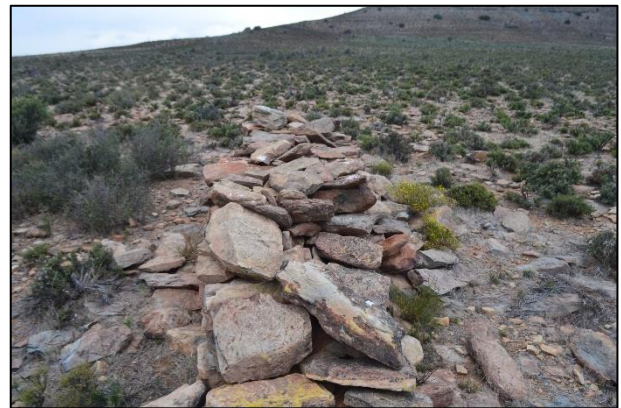
**Figure 35:** Cross-section of the stone walling at waypoint 016.

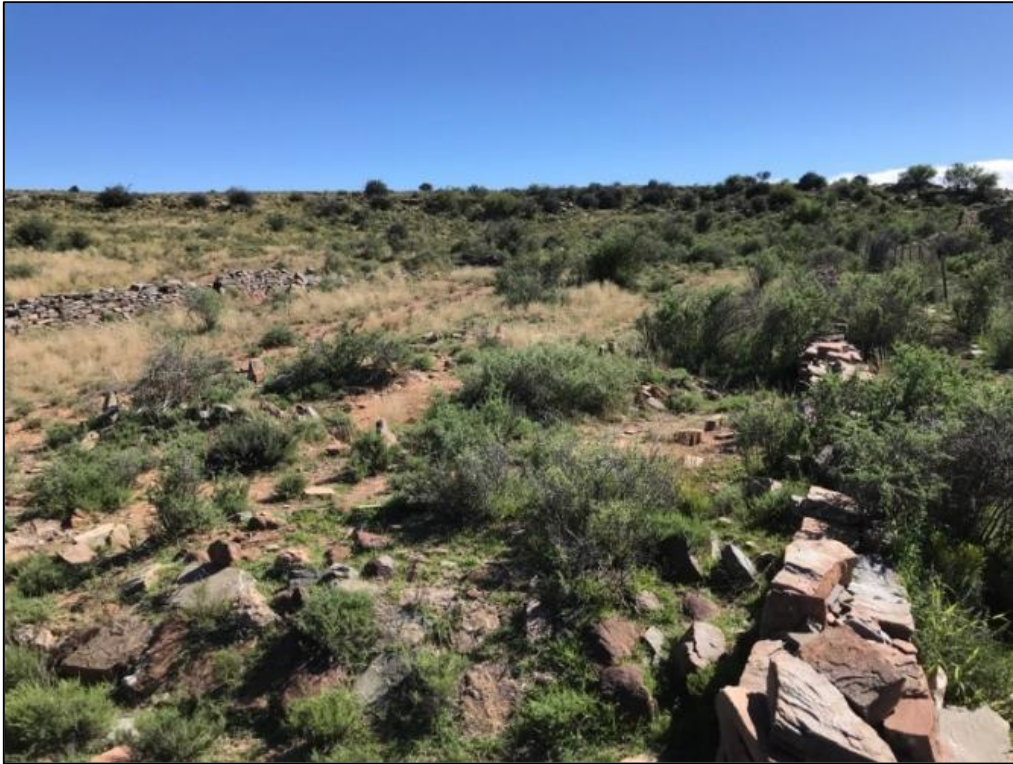
A number of graves and some possible graves occur in the study area. The main concern is a walled graveyard and an associated unwallied graveyard which lie at PL\_06 (Mann 2022). The graves are covered with stone and have stone head- and/or footstones (Figure 36). The chances of unmarked graves being present within the proposed footprint are extremely low because of the generally rocky nature of the substrate, although it is noted that a pre-colonial grave with a stone mound over it was encountered just outside the corridor. Inside the corridor, Halkett (2014) recorded a cluster of rocks that he thought might be a grave, although this seems unlikely (Figure 37).

**Figure 36:** The graveyard at PL\_06 as recorded by Mann (2022: figure 80).

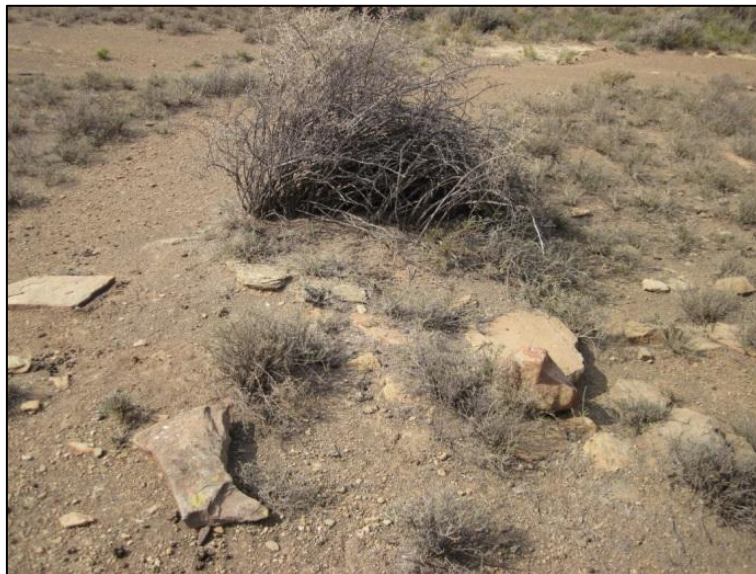
**Figure 37:** Rocks at waypoint D067 and suspected to be a possible grave by Halkett (2014: plate 50).

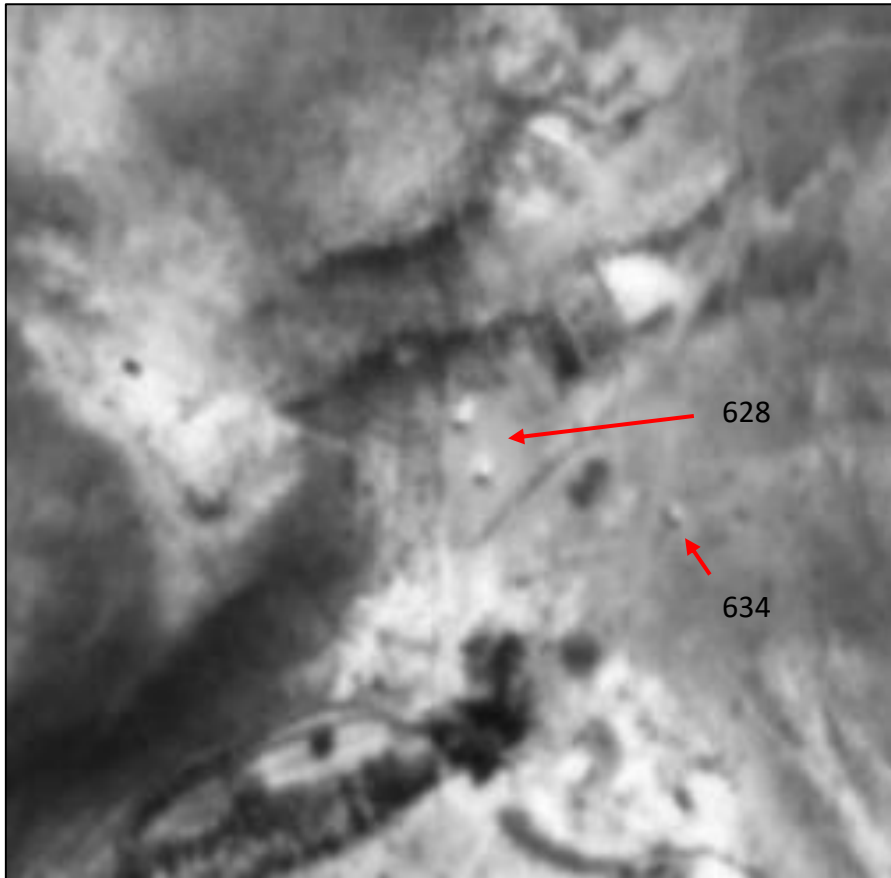
Only one historical structure has been recorded in the proposed powerline corridor. This was at the historical farm complex and it stood alongside the standing ruin. It is a Karoostyle dwelling built of unplastered bricks and cement with a flat corrugated iron roof (background in Figure 29). A hearth and chimney stack are on the rear wall. It does not look very old but aerial photography confirms it to be more than 64 years old (Figure 38).

**Figure 38:** Aerial photograph from 1959 showing the dwelling at waypoint 628 to have already been present. The other structure also still had its roof then, while the structure at waypoint 634 was also still standing.

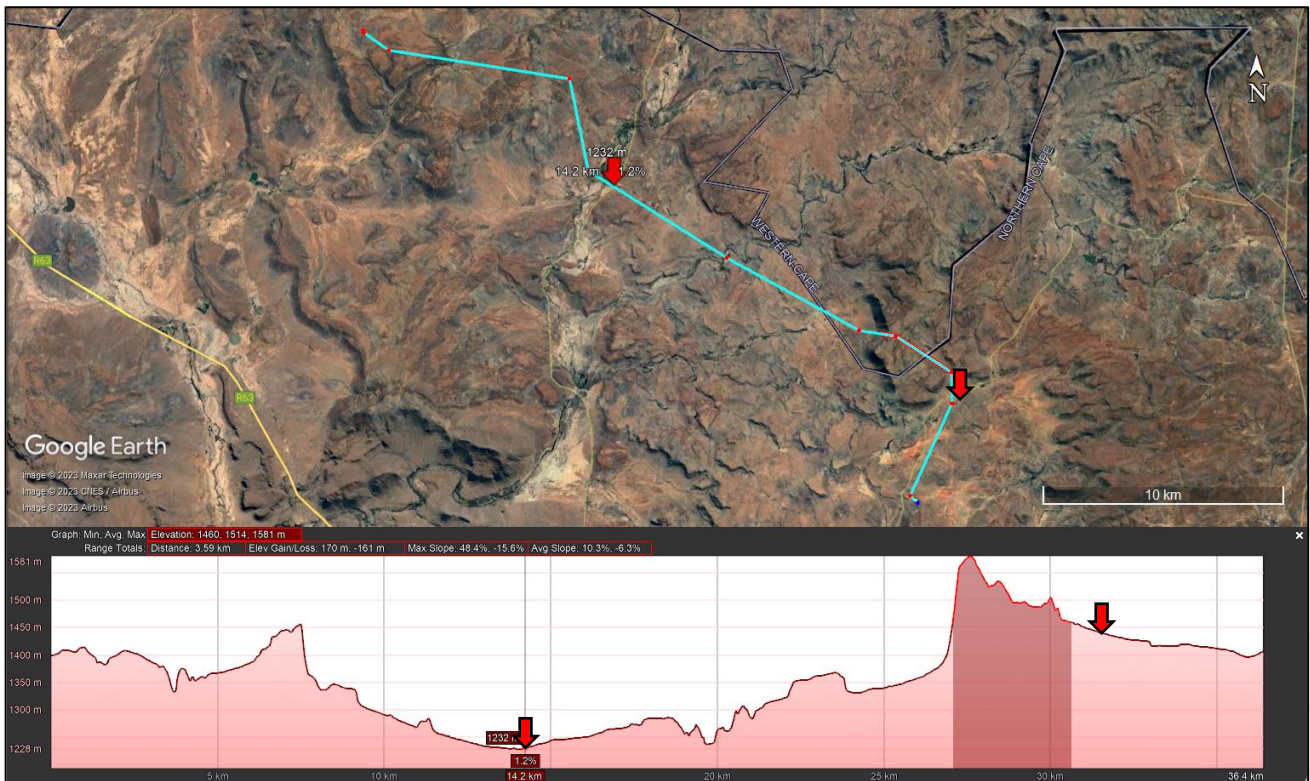
The Padloper EGI 4 is proposed in a high-lying and undulating area that varies in elevation between 1232 m above sea level and 1573 m (Figure 39). It crosses two public roads. One lies within the wide valley in the north-western part of the corridor, while the other lies in a higher-lying valley in the east. The line is otherwise proposed to be situated in very remote areas with no public access. Its overall visibility in the landscape from publicly accessible areas should be fairly minimal over most of the route with the exception being where it would run adjacent to the eastern road for about 5 km. In this area it will be openly visible in the landscape at distances not exceeding 800 m away. As such, the powerline should not result in a high degree of change to the local sense of place. According to Mucina & Rutherford (2006), the most extensive vegetation type occurring in the study area is Eastern Upper Karoo, interspersed with scattered patches of Upper Karoo Hardeveld. The vegetation cover across the study area is predominantly short and sparse and thus will not provide any significant visual screening.

**Figure 39:** Northwest to southeast cross-section following the route of the Padloper EGI4 powerline. The red shading on the cross-section shows the land above 1460 m and the red arrows mark the position of the two public roads.

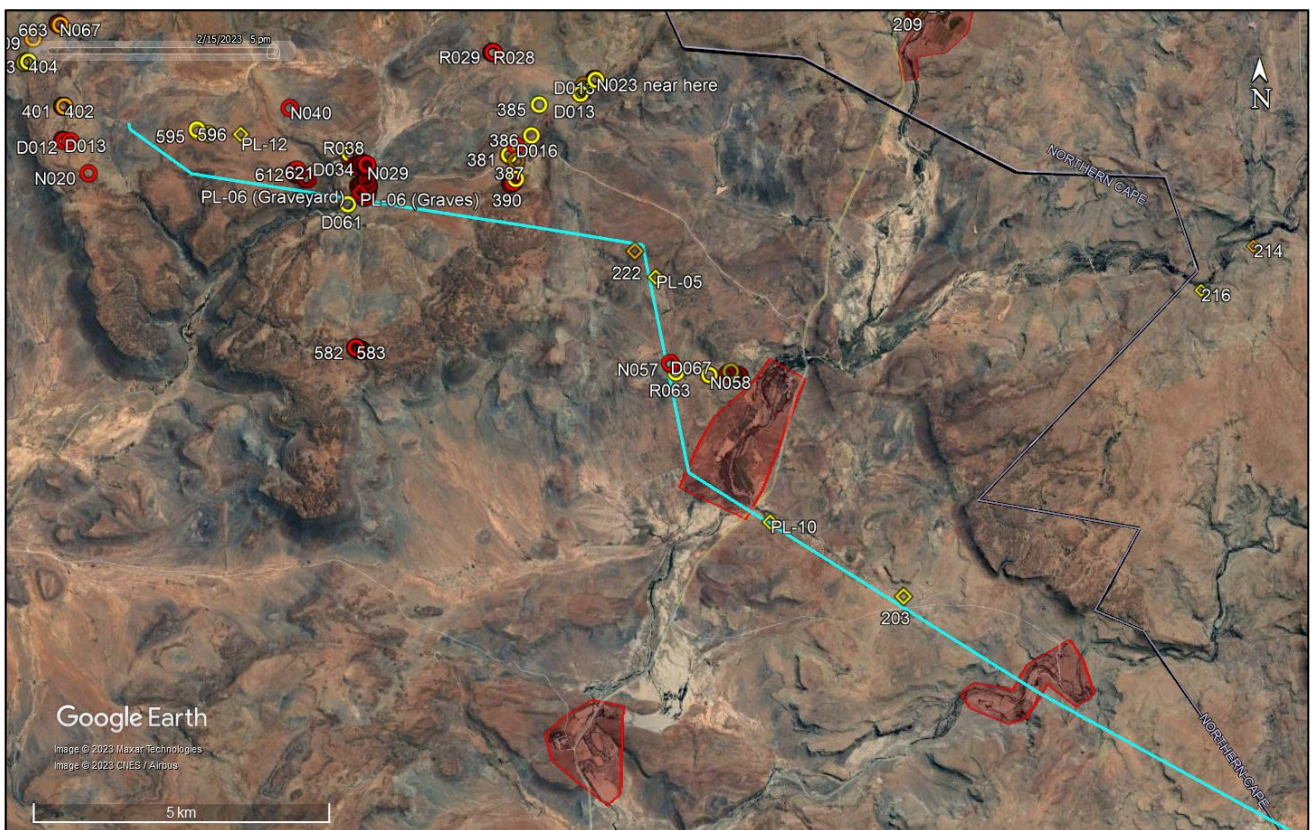
Figures 44 and 45 provides a grade map of the study area. Sites graded NCW are omitted from the map for the sake of clarity. For ease of merging data from multiple projects, the map shows waypoints for all specific sites and polygons for the areas of agricultural/rural cultural landscape.

**Figure 44:** Grade map of the Padloper EGI 4 route (northwest). Red = IIIA; orange = IIIB; yellow = IIIC.

- Uncontrolled damage to fossils should be minimised as far as possible.
- Archaeological sites should be protected with a buffer of at least 30 m if possible. Reusing of existing roads through the buffers is allowed but any widening must take place away from the site.
- Direct damage to archaeological sites should be avoided as far as possible and, where some damage to significant sites is unavoidable, scientific/historical data should be rescued.

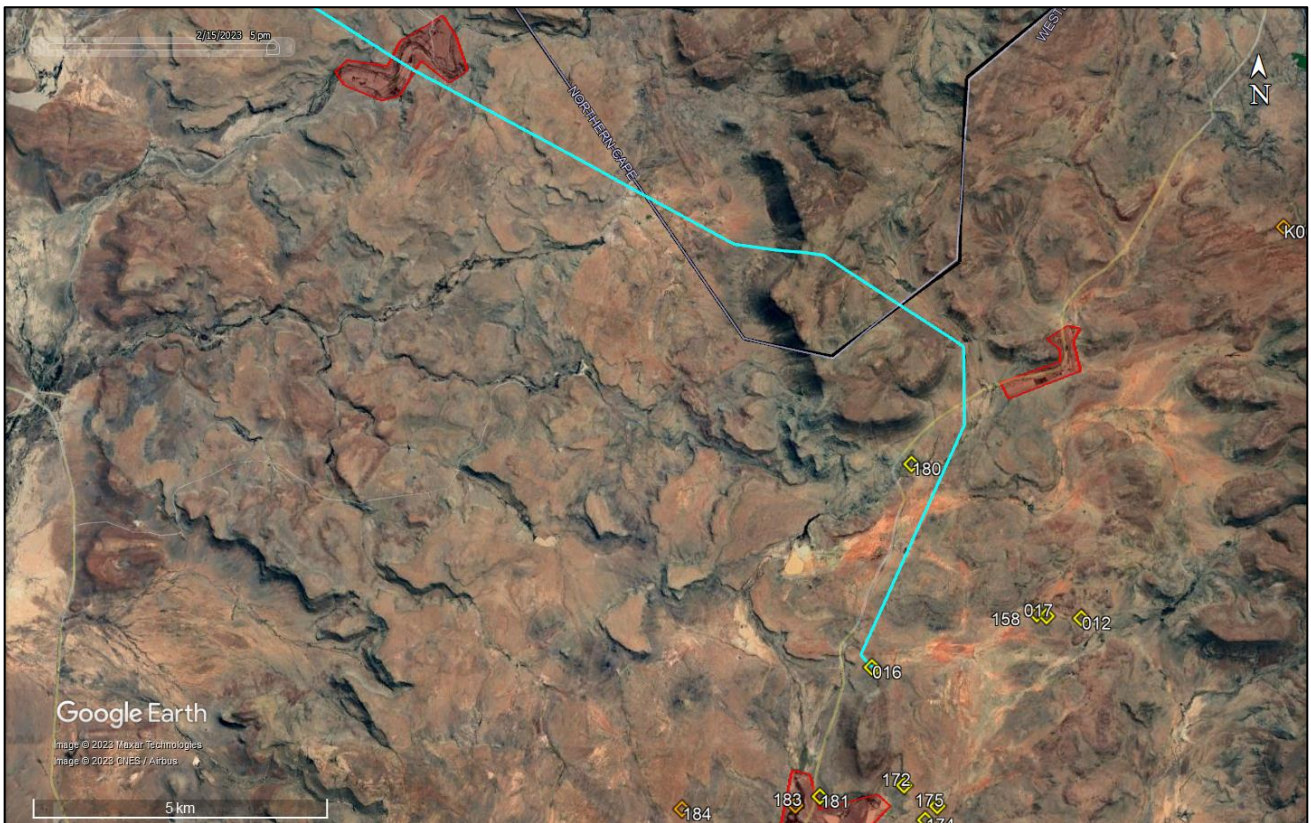
**Figure 45:** Grade map of the Padloper EGI4 route (southeast). Red = IIIA; orange = IIIB; yellow = IIIC.
