# DRAFT BASIC ASSESSMENT REPORT

Basic Assessment for the proposed development of the Padloper Solar PV Facility 4 (i.e., Padloper PV 4), the proposed development of a 132 kV Overhead Power Line between the Padloper PV 4 and the proposed authorised Ishwati Emoyeni Collector Substation (i.e., Padloper EGI 4), and their associated infrastructure, near Murraysburg in the Northern Cape and Western Cape Provinces

## APPENDIX D.3: Archaeology, Palaeontology and Cultural Heritage - Padloper EGI 1-4

**HERITAGE IMPACT ASSESSMENT:  
BASIC ASSESSMENT FOR THE PROPOSED DEVELOPMENT OF A 132 KV  
OVERHEAD POWER LINE AND ASSOCIATED INFRASTRUCTURE BETWEEN THE  
PROPOSED PADLOPER SOLAR 4 AND THE PROPOSED AUTHORISED ISHWATI  
EMOYENI COLLECTOR SUBSTATION (i.e., PADLOPER EGI 4), NEAR  
MURRAYSBURG, MURRAYSBURG MAGISTERIAL DISTRICT, WESTERN CAPE  
AND RICHMOND MAGISTERIAL DISTRICT, NORTHERN CAPE**

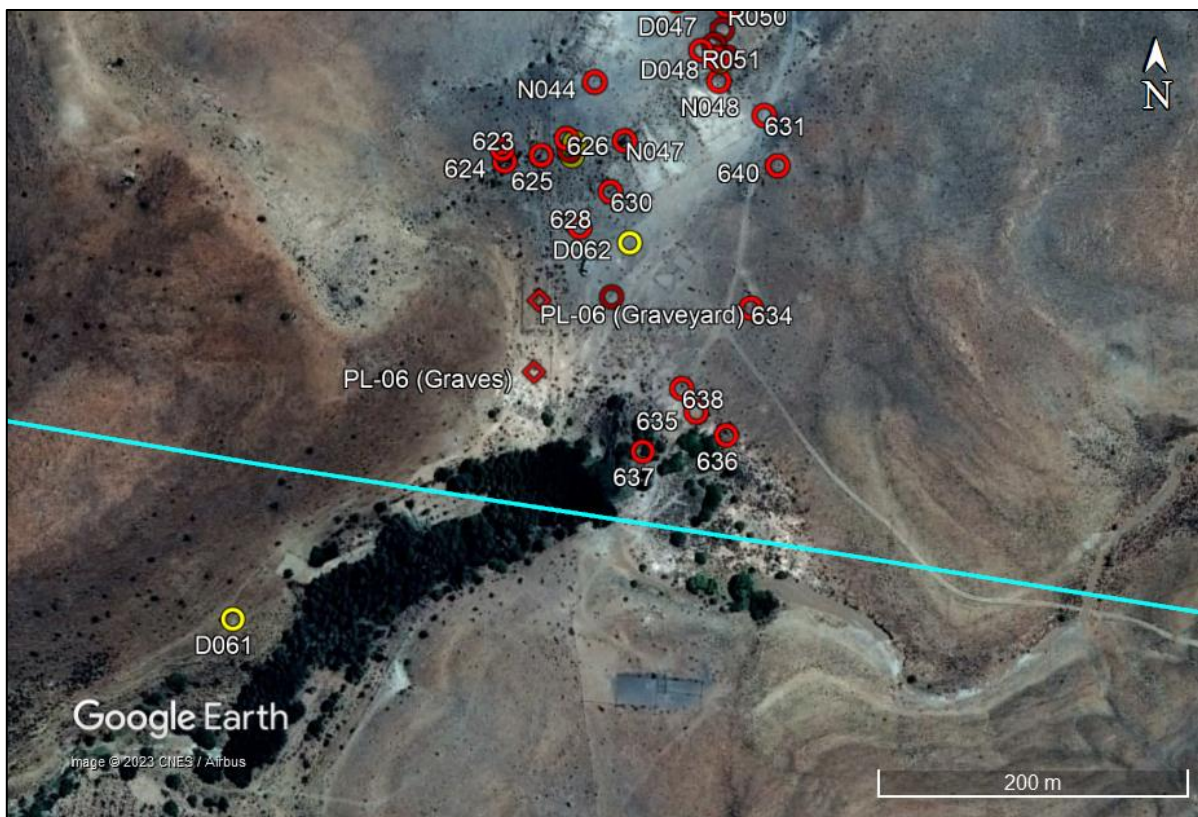
**Figure 48:** Aerial view of the southern part of the archaeological Driefontein farmstead showing that the powerline (blue line) has been designed to avoid the known heritage features.

It is noted that the power line will pass through the buffer of the ruined historical farm complex and may require that some poplar trees are removed. This is not of much concern since the complex has long been ruined and now has an archaeological character rather than a historical one. Mature trees are far more important to the character of an active farmstead.
