DRAFT BASIC ASSESSMENT REPORT

**HERITAGE IMPACT ASSESSMENT:
BASIC ASSESSMENT FOR THE PROPOSED
PADLOPER PHOTOVOLTAIC FACILITY 1 NEAR
MURRAYSBURG, RICHMOND MAGISTERIAL DISTRICT,
NORTHERN CAPE**

1st draft: 05 June 2023
Final report: 08 September 2023

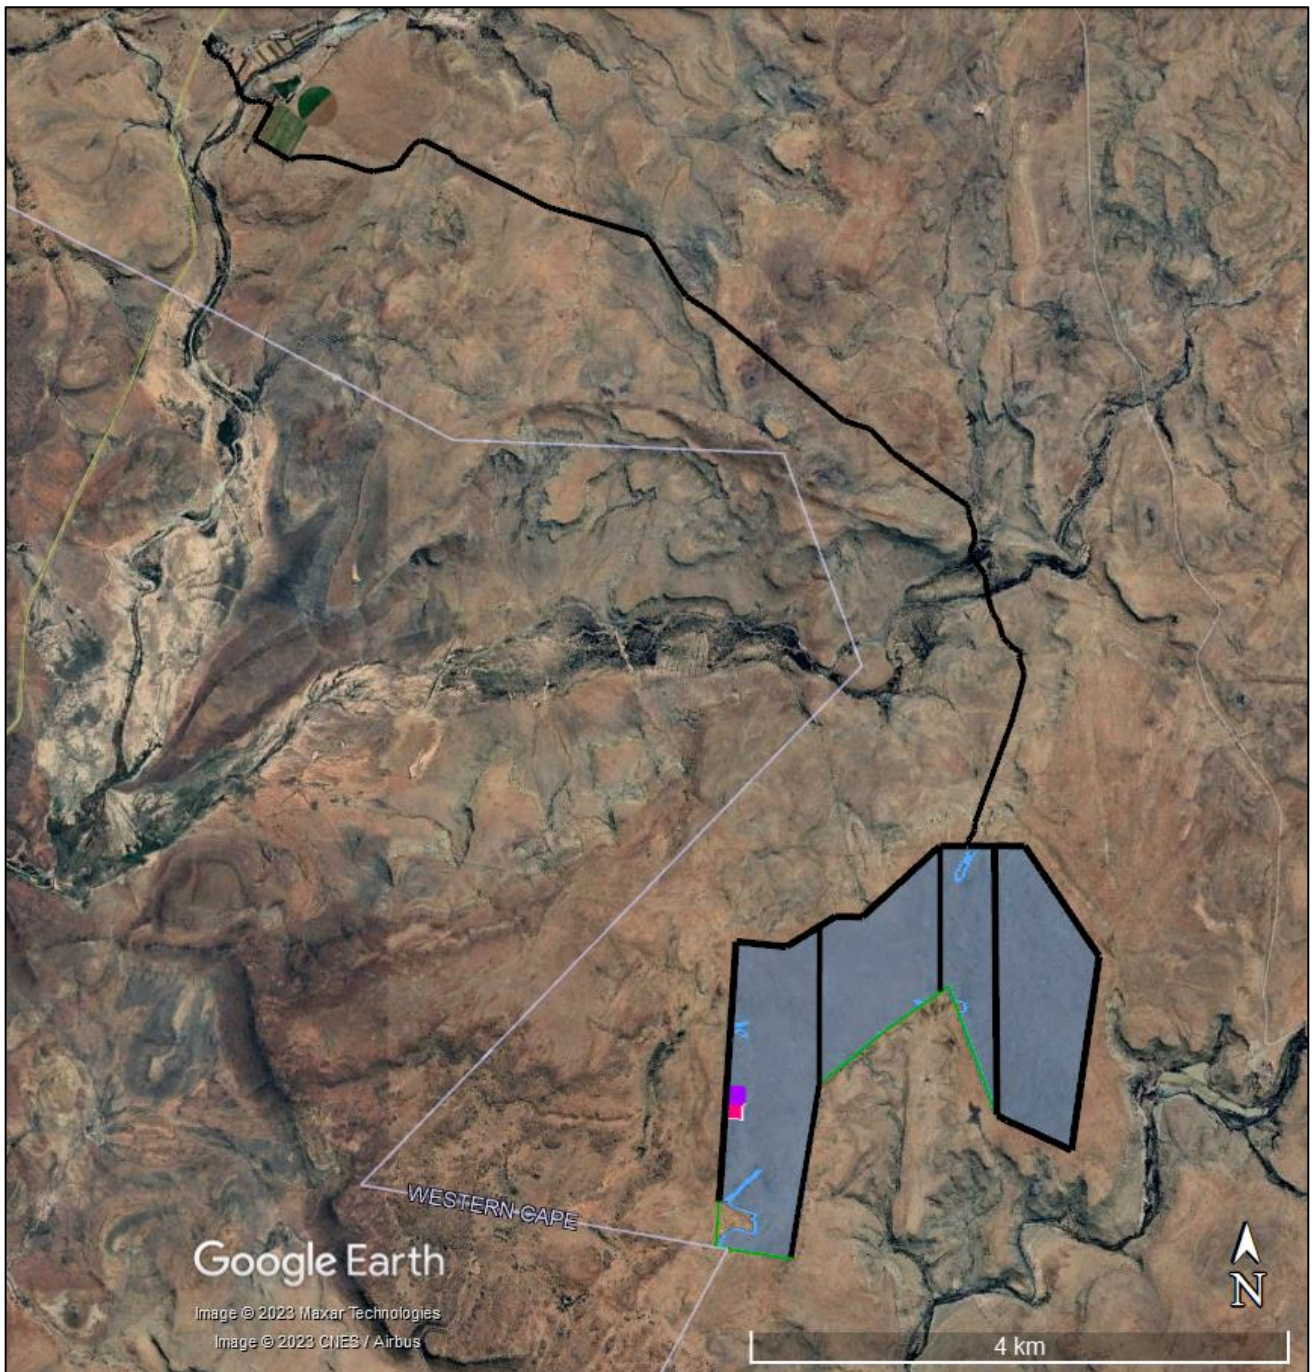
Figure 3: Aerial view of the study area showing the project layout. Black lines are access and internal roads, blue area is solar panels, purple block is the temporary laydown area, pink block is the facility substation complex, green polygon is the study area.

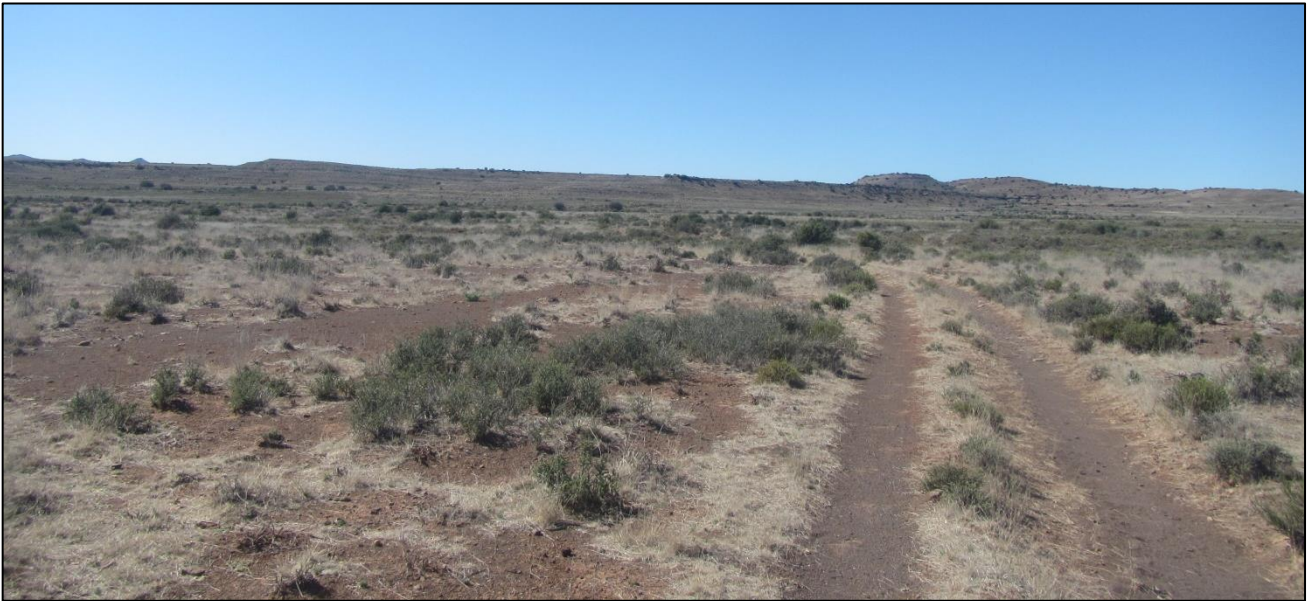
Figure 6: View towards the southeast in the northern third of the access road.

The access road to the Padloper Solar Facility 1 site follows an existing farm track and runs across relatively flat terrain but crosses some low ridges in places (Figures 6 to 8). The Padloper Solar Facility 1 site itself lies on a very flat plateau. There are few rock outcrops, and the substrate is a

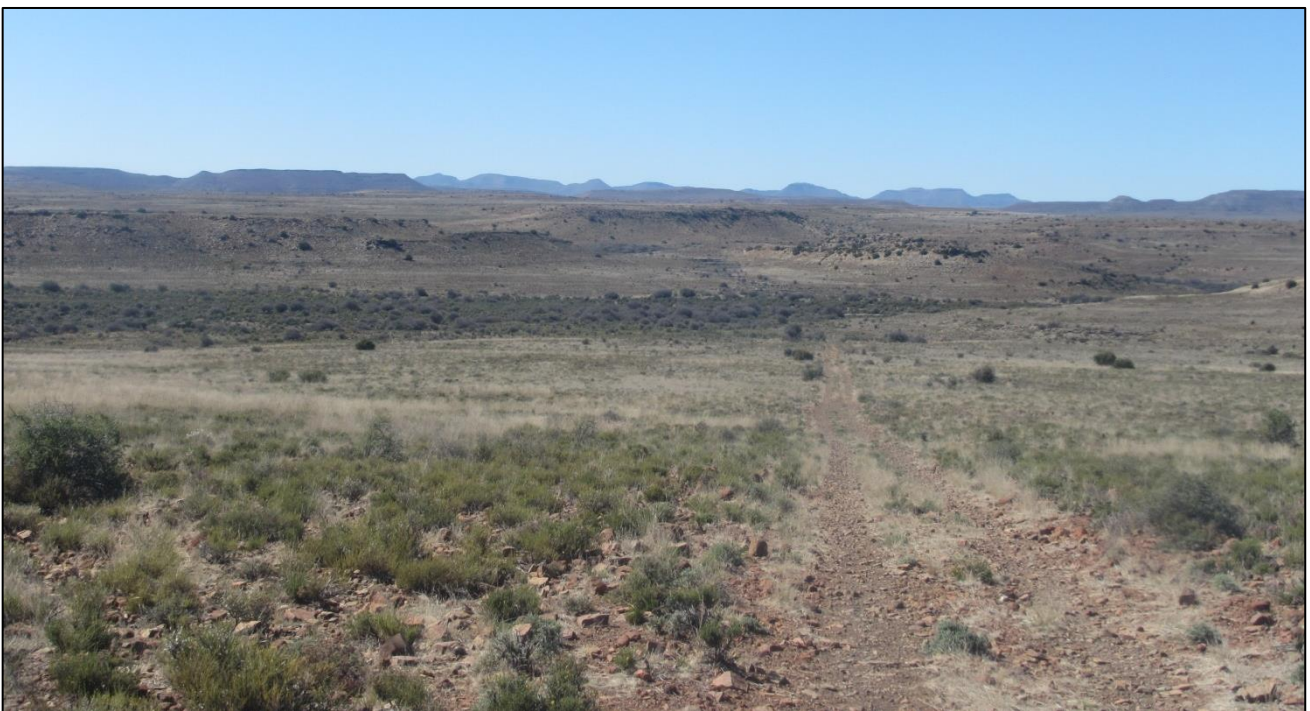
Figure 7: View towards the southeast in the central third of the access road.

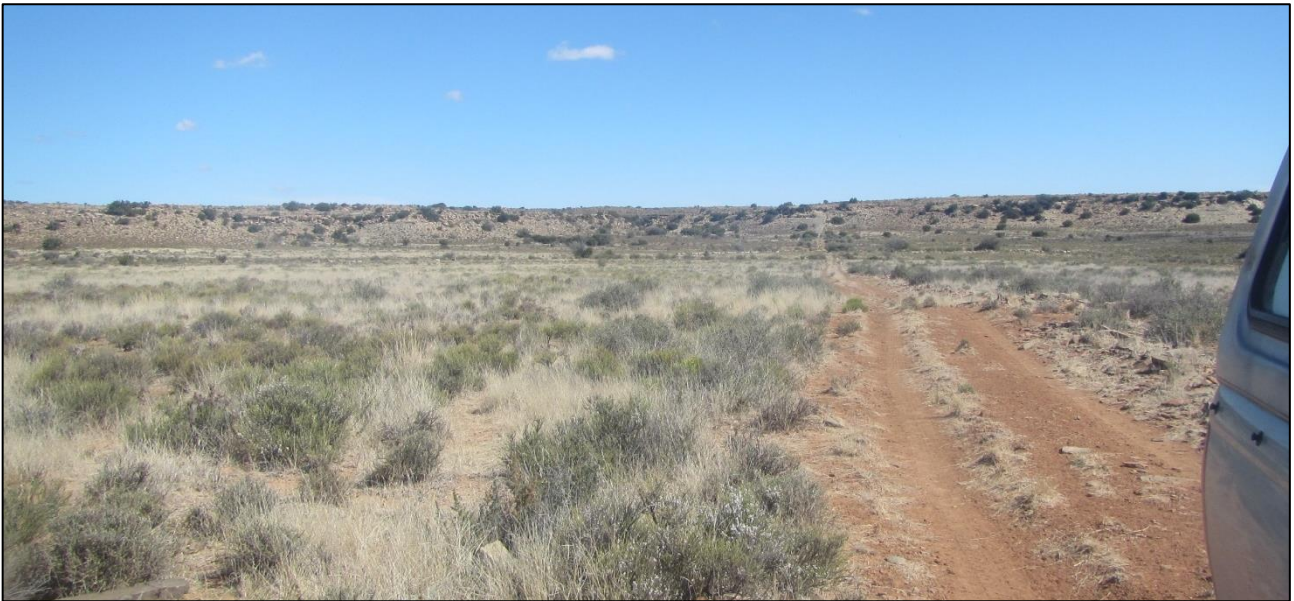
Figure 8: View towards the south in the southern third of the access road. The proposed Padloper Solar Facility 1 facility location is on the skyline plateau.

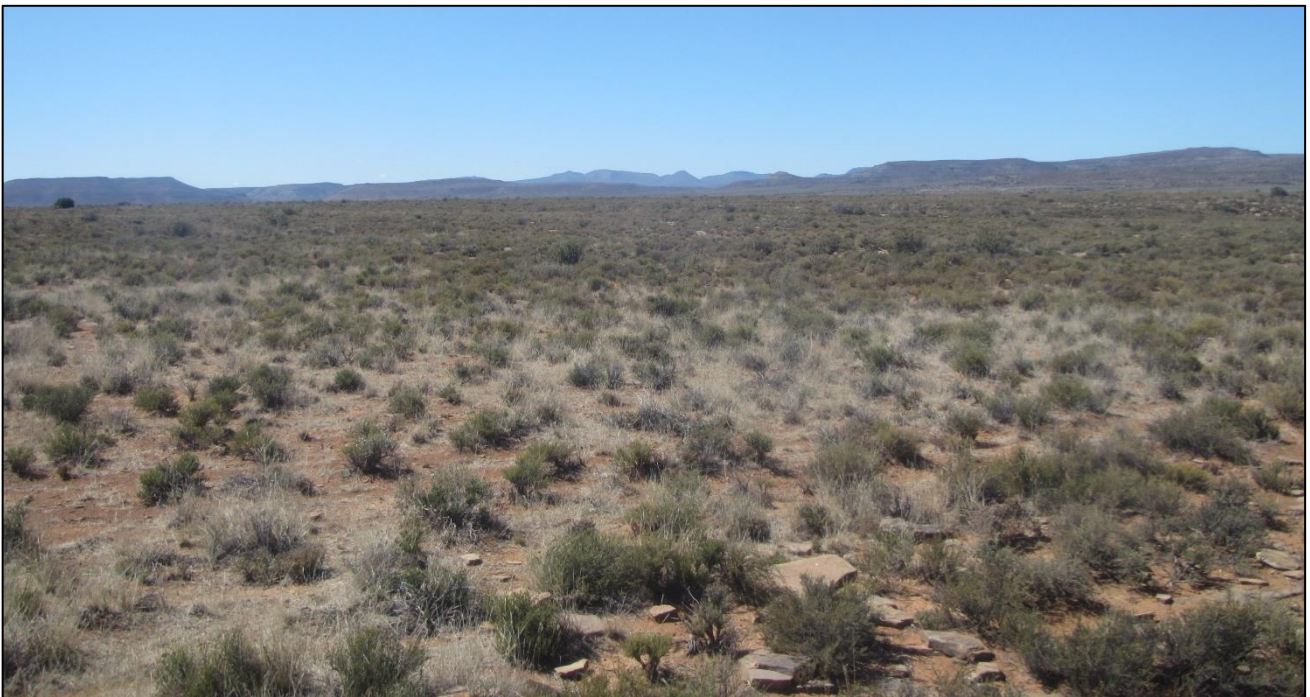
Figure 9: View towards the southeast across the eastern part of the Padloper Solar Facility 1 study area.

mixture of sand and gravel, with low vegetation. Figures 9 to 12 show the nature of the Padloper Solar Facility 1 study area, emphasising the generally very flat terrain.

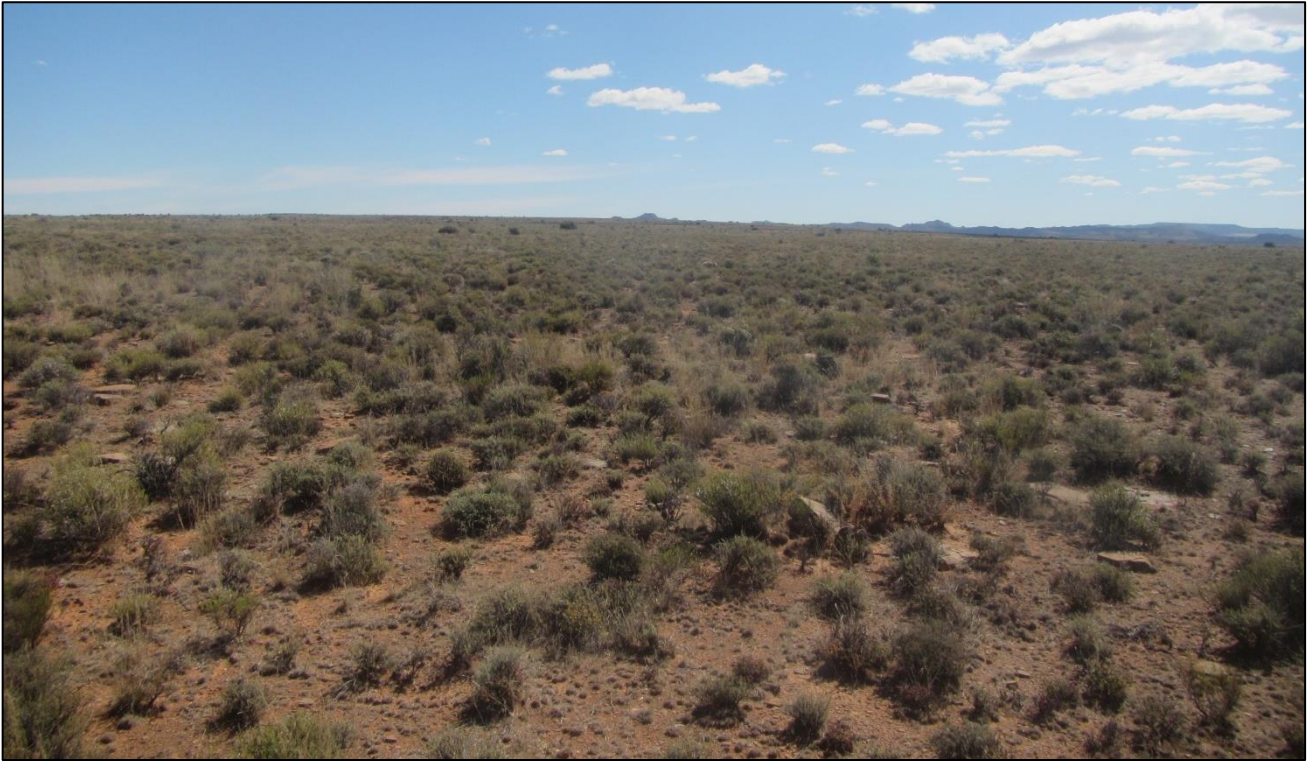
Figure 10: View towards the northwest through the northern part of the Padloper Solar Facility 1 study area.

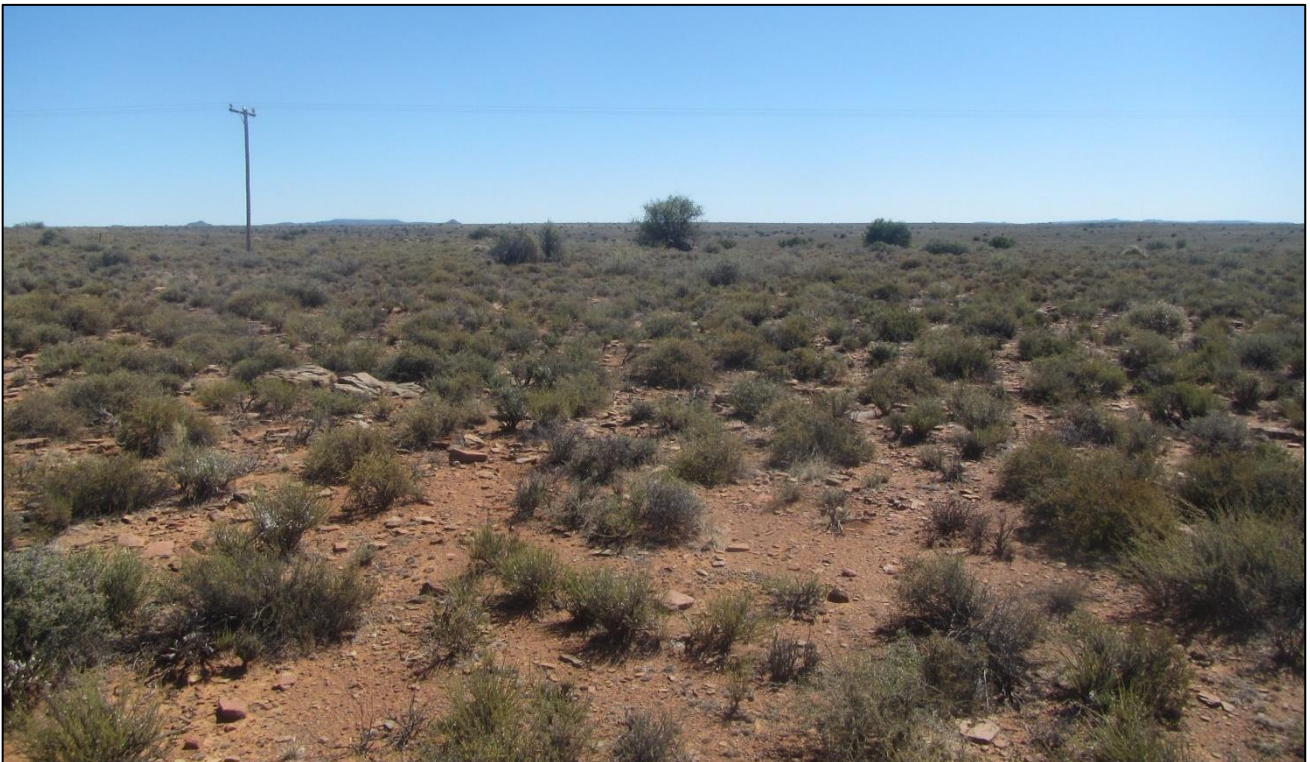
Figure 11: View towards the north in the south-western part of the Padloper Solar Facility 1 study area.

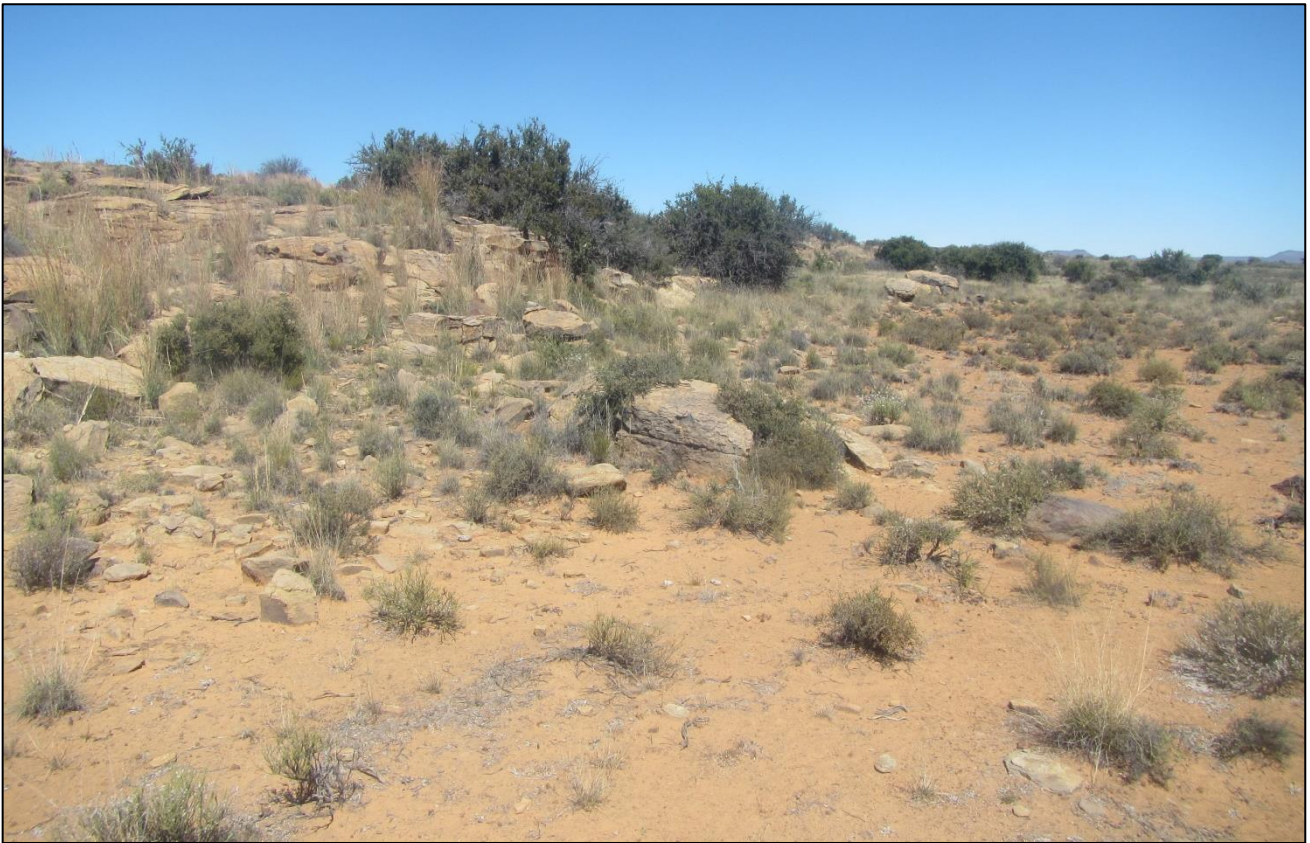
Figure 12: View towards the south in the south-western part of the Padloper Solar Facility 1 study area and showing a rare rocky outcrop.

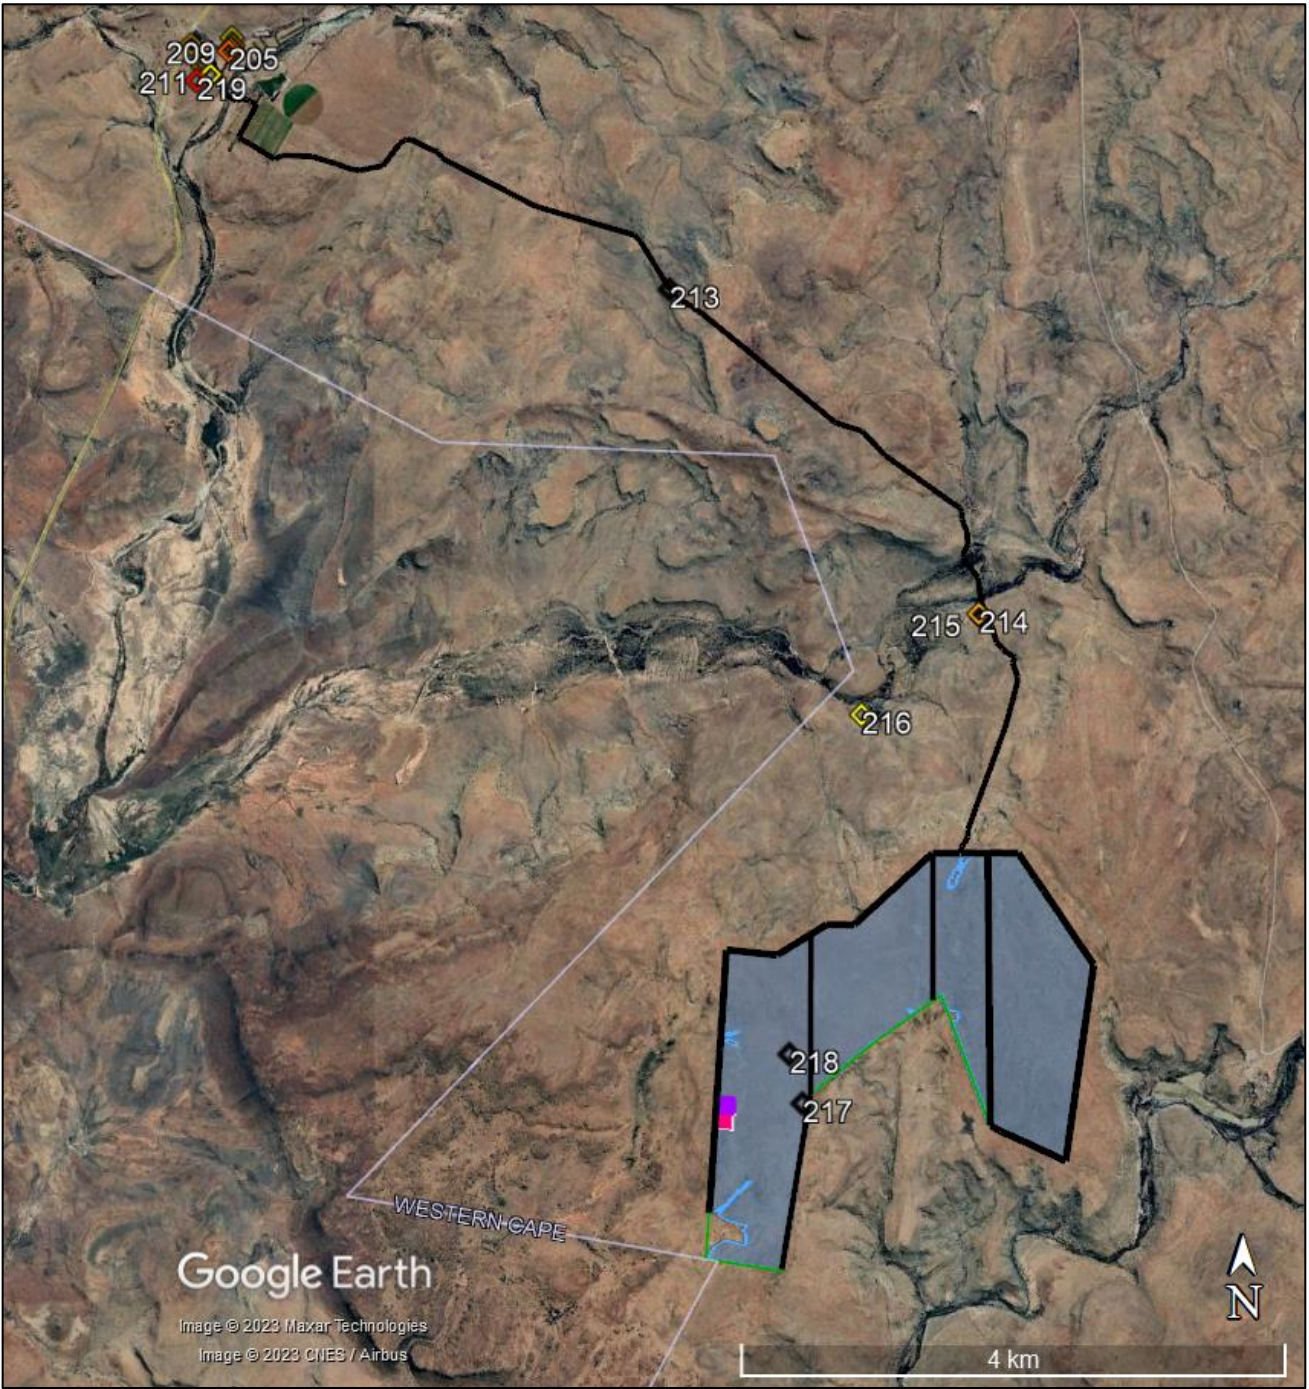
Figure 13: Map showing the distribution of finds from the survey.

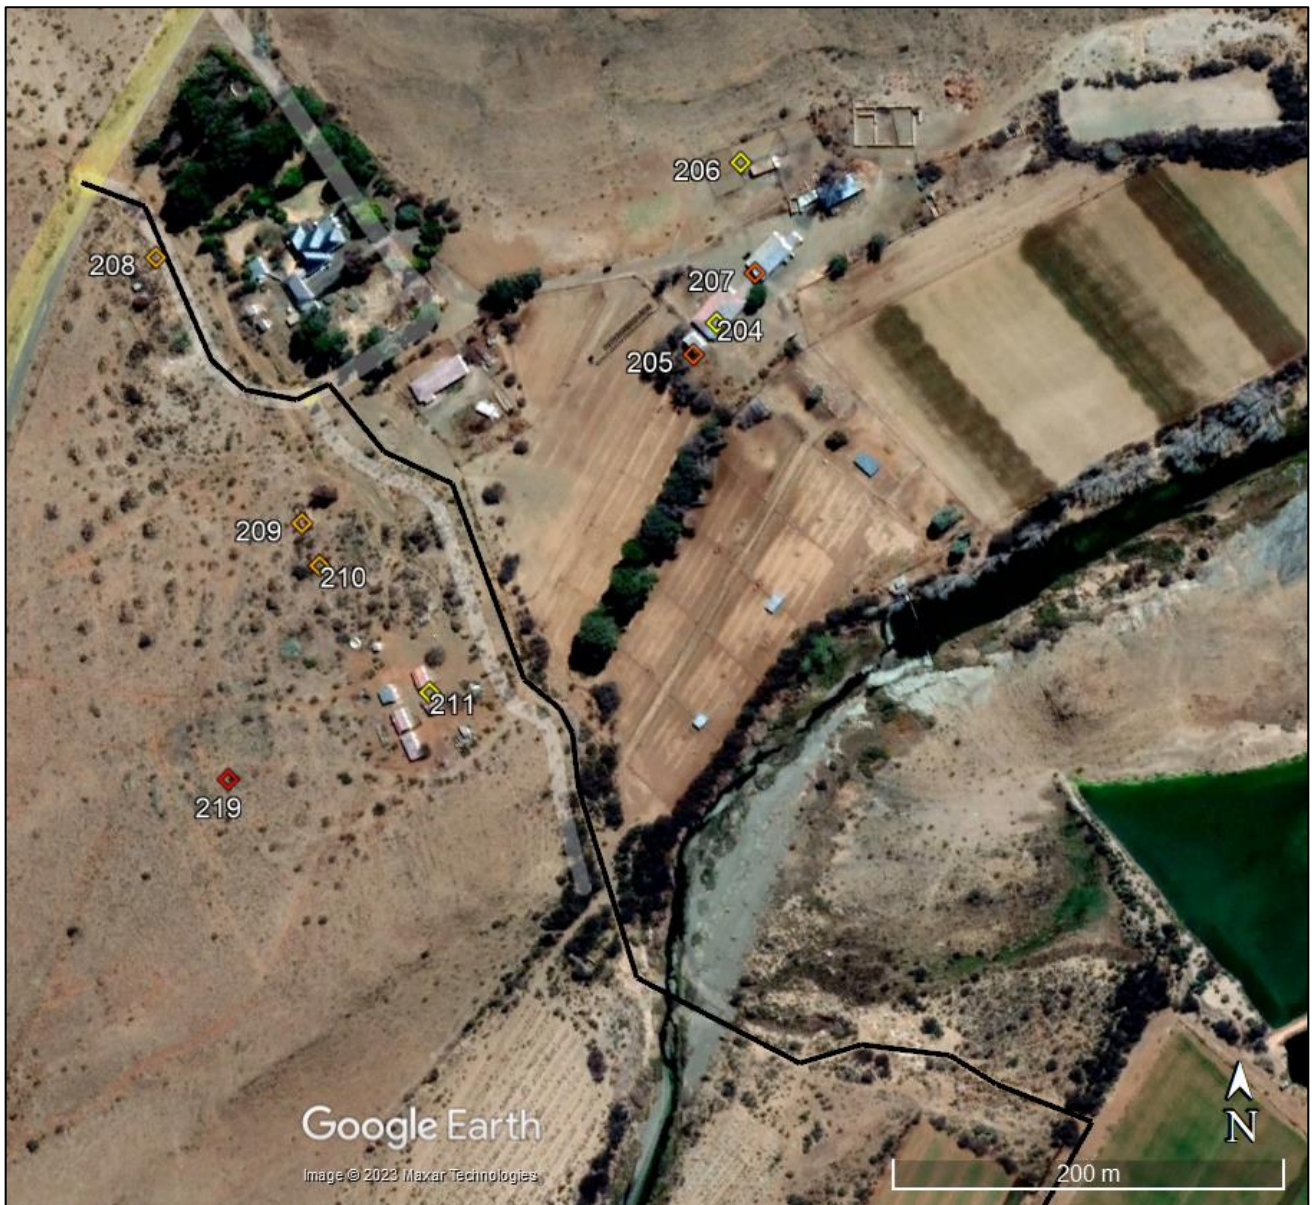
Figure 14: Map showing the location of finds at the Rooisandheuwel farmstead.

This section describes the heritage resources recorded in the study area during the course of the project. Finds from the survey are listed in Table 2 with their locations mapped in Figures 13 and 14.

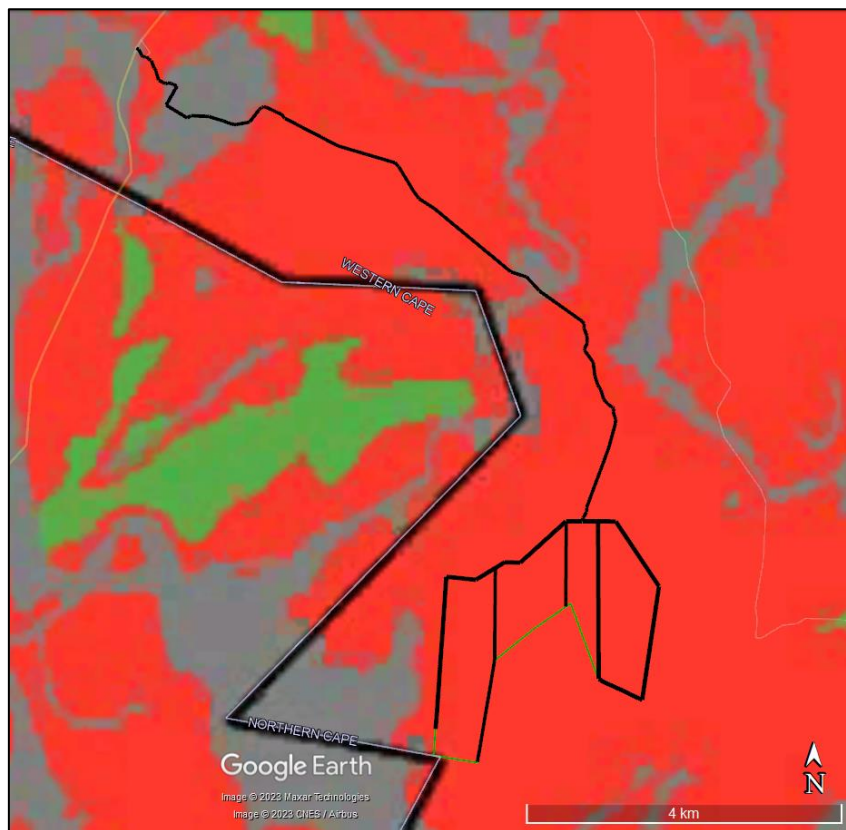
The SAHRIS Palaeosensitivity Map shows the site to be of very high palaeontological sensitivity (red shading; Figure 15), although the access road crosses areas of zero sensitivity (grey shading). For this reason, a specialist study was commissioned and is submitted along with the present report.

Figure 15: Extract from the SAHRIS Palaeosensitivity Map showing the Padloper Solar Facility 1 site (green = project study area, black = project roads).

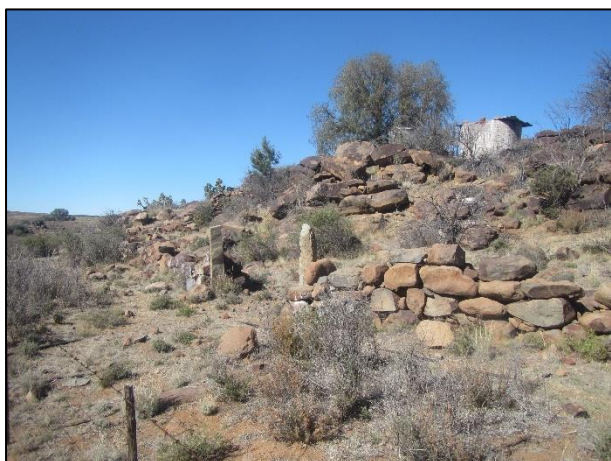
However, a number of historical archaeological sites were seen alongside the proposed access road. These are all stone-walled sites related to the historical use of the landscape for farming purposes. One site is a stone-walled kraal built around a rocky outcrop (Figure 16). This is an unusual design but it is common to build kraals on a slope to facilitate drainage. To the south, some historical ruins were seen. One of these looks as though it may have been a stable building (Figure 17) and the other a house (Figure 18). While the kraal is at least 10 m from the existing road, the other two ruined structures are approximately 40 m away from it. Another house ruin was found midway along the access road (Figures 19 to 21). It relates to a small outpost with just the one building in evidence but with a number of other agricultural features visible on aerial photography, including dams and fields. The last feature of note was seen well away from the study area and access road and consists of a line of historical fence posts made from stone (Figure 22). Given the rocks packed around the bases of the uprights, it is perhaps unlikely that they were ever strung with wire but rather served only as a line of beacons indicating a historic boundary line.

Figure 16: Stone walling built around a rocky hill to create a kraal.

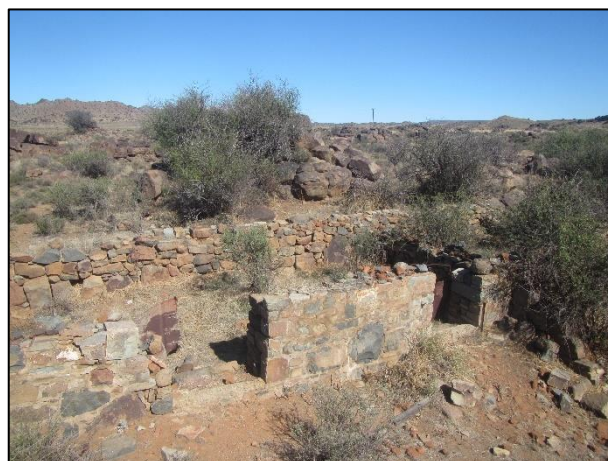
Figure 17: Ruined stone structure at waypoint 210.

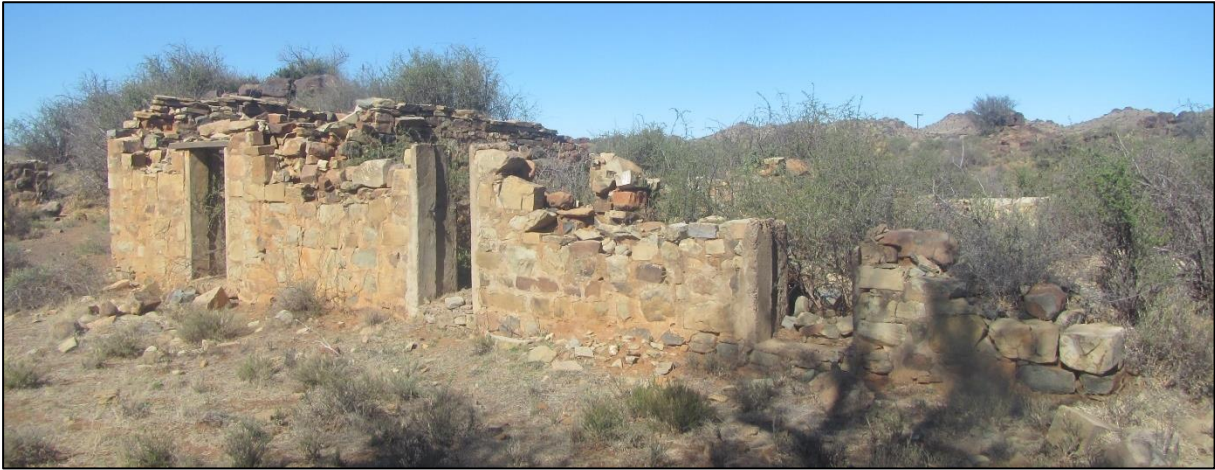
Figure 18: Ruined stone cottage at waypoint 209.

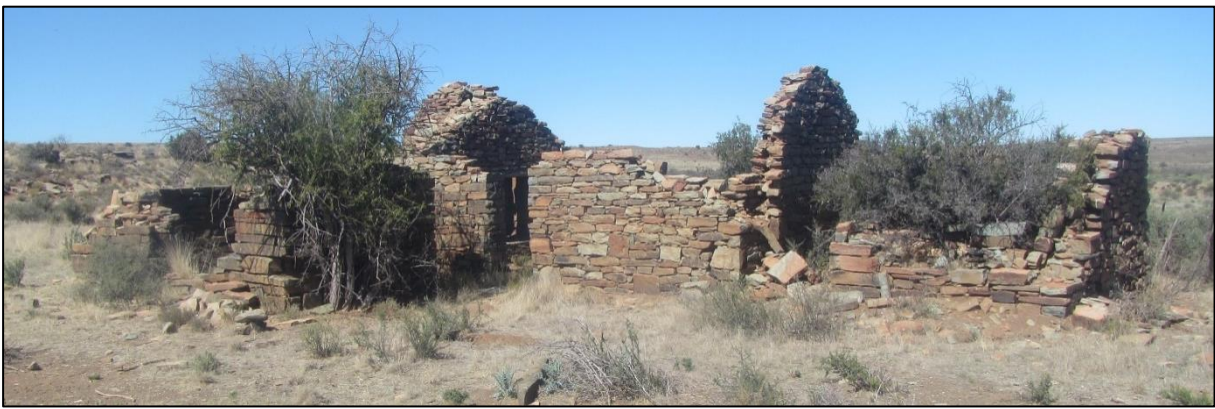
Waypoint	Location	Description	Significance Grade
214	S31 43 31.6 E23 51 26.4	<p>A small two-roomed, gabled, stone-walled cottage ruin facing to the northeast. The north-western room was added to the other room and has a window in its south-western wall. The earlier room contains a huge hearth that fills much of the south-eastern gable and the south-western wall of this room has almost entirely collapsed. An outside room has also been built onto the eastern corner of the structure and it has a muurkas in its south-eastern wall. There is no roof present, but a beam and a piece of corrugated iron lie in the outside room. The rubbish around the site seems to be modern and no ash dump was seen.</p>

Figure 19: Stone-walled cottage ruin at waypnt 214.

Whenever on site (at least weekly during construction period only)	ECO
Damage or destruction of any known sites	Avoid impacts	<u>Construction Phase</u> : Place No-Go signage at identified sensitive locations (waypoints 208 and 214).	Monitoring of No-Go areas (construction period only)	Ongoing basis	Construction Manager or Contractor
				Whenever on site (at least weekly)	ECO
Impacts to the cultural landscape					
Visible landscape scarring	Minimise landscape scarring	<u>Construction Phase</u> : Ensure disturbance is kept to a minimum and does not exceed project requirements. Rehabilitate areas not needed during operation.	Monitoring of surface clearance relative to approved layout	Ongoing basis	Construction Manager or Contractor
				As required	ECO
Intrusion into cultural landscape	Minimise visual intrusion	<u>Operation Phase</u> : Ensure that all maintenance vehicles and operational activities stay within designated areas.	Undertake visual inspections and report non-compliance	As required	Environmental Manager

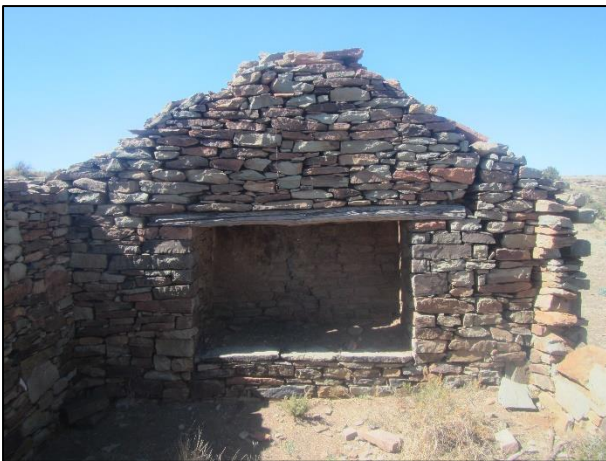
Figure 20: Internal hearth at waypnt 214.

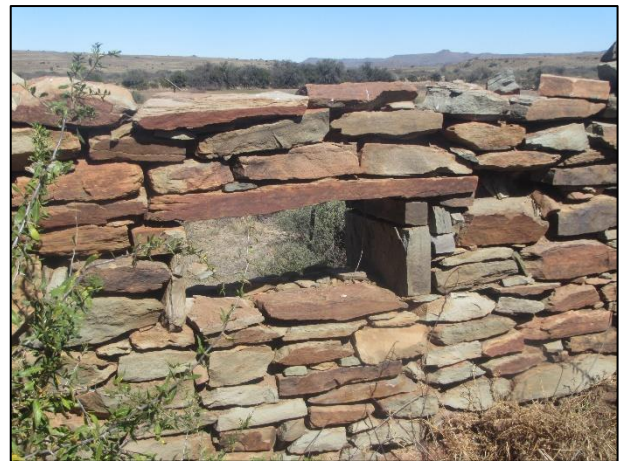
Figure 21: Window at waypnt 214.

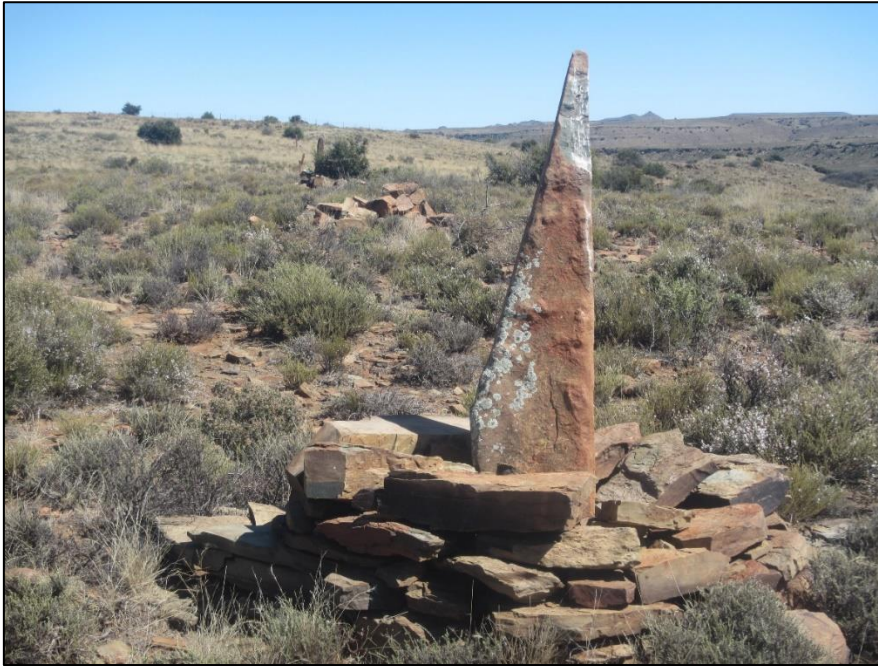
Figure 22: Historic fence line at waypoint 216 with stone fence posts/beacons that is no longer in use.

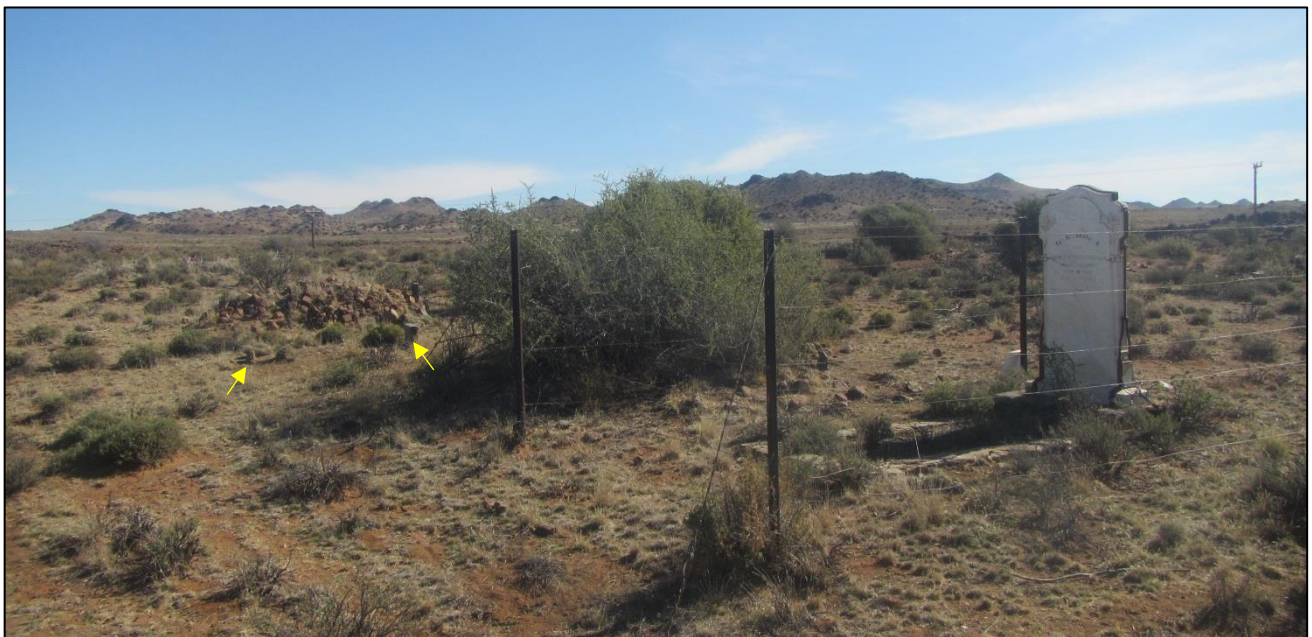
No graves were seen in the Padloper Solar Facility 1 study area or alongside the proposed access road. However, the landowner pointed out a set of nine graves located some 150 m from the access road, to the southwest of the farmstead at waypoint 219 (Figure 23). They are of varying styles and three headstones were present. The dates of death are 24 April 1917, 28 October 1918 and 29 October 1918. The chances of unmarked graves being present within the proposed footprint is extremely low.

Figure 23: The graves at waypoint 219. One with only head- and footstones is arrowed, while a second grave has a large stone mound (immediately behind the first in this view). The third at right is fenced.

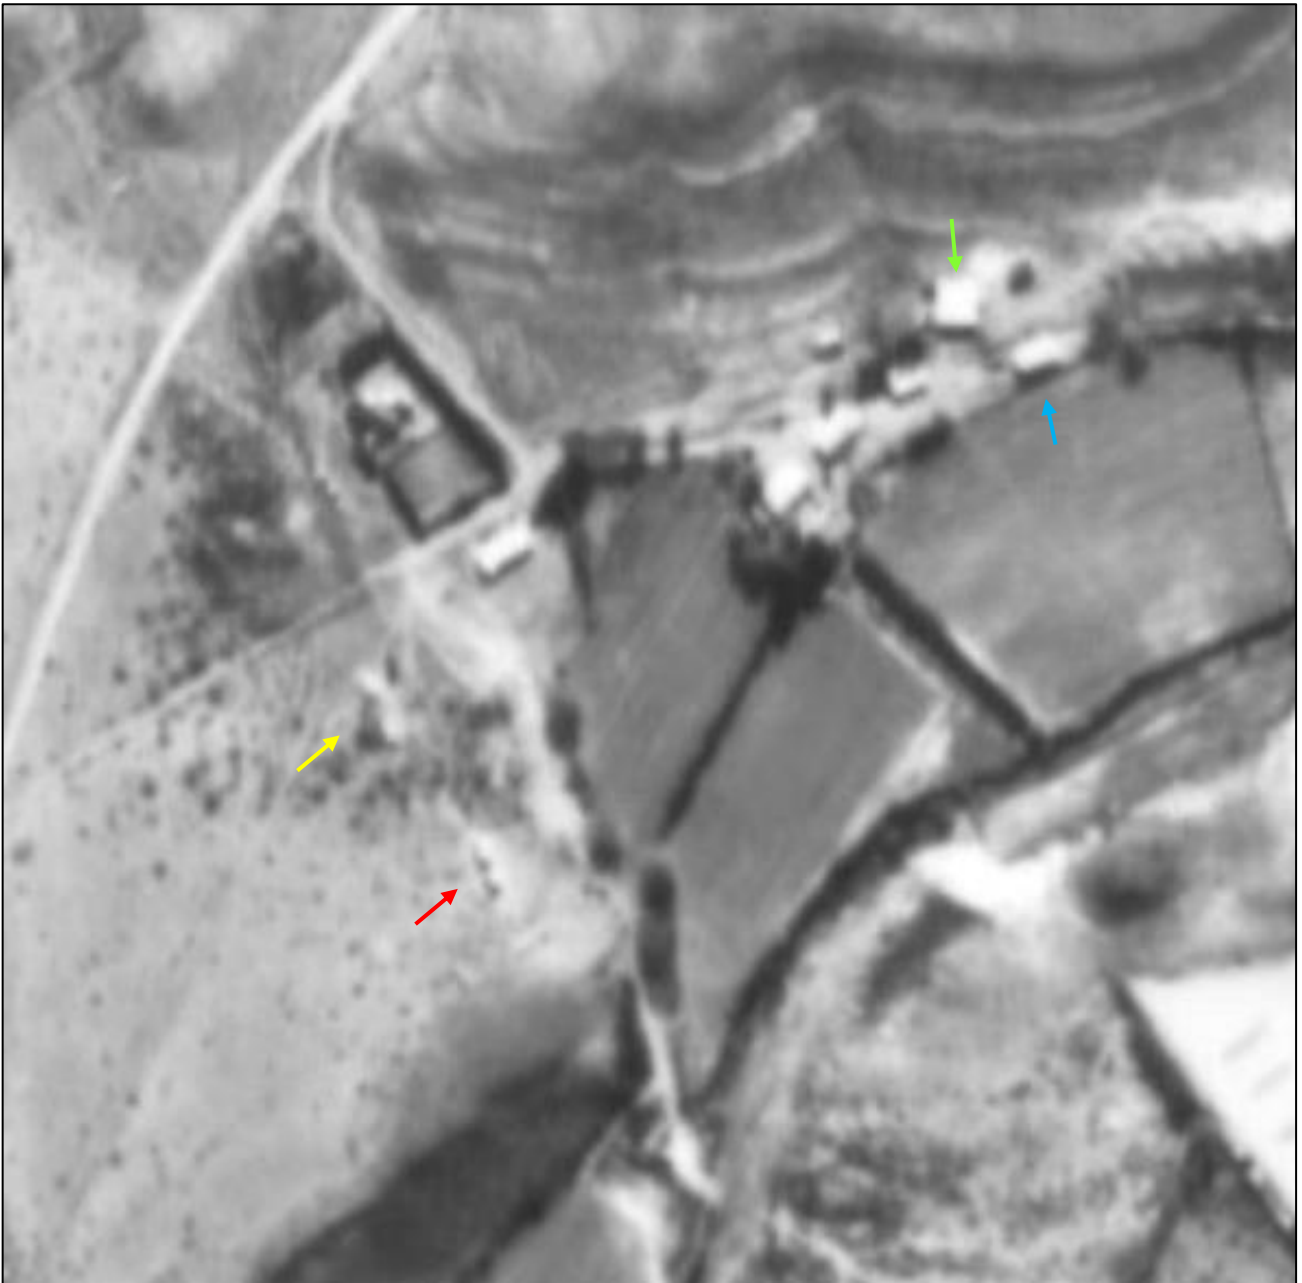
Figure 24: Historical aerial photograph from 1959 (Job 434, strip 013, photograph 06071) showing the Rooisandheuwel farmstead with most structures already present. The main differences are (1) the farm workers' accommodation has been expanded with only two cottages having been present in 1959 (red arrow), (2) two further historical structures to their northwest still had roofs (yellow arrow), (3) The stone kraal in the northeast was roofed in 1959 (green arrow), and (4) a structure alongside the field in the east has now been removed (blue arrow).

Historical aerial photography shows the Rooisandheuwel farmstead on Farm 102 to have been much the same today as it was in 1959 but a few key differences are noted in the captions to Figures 24 and 25. Figure 26 shows historical and modern views of a small farm building/outpost on Farm 109.

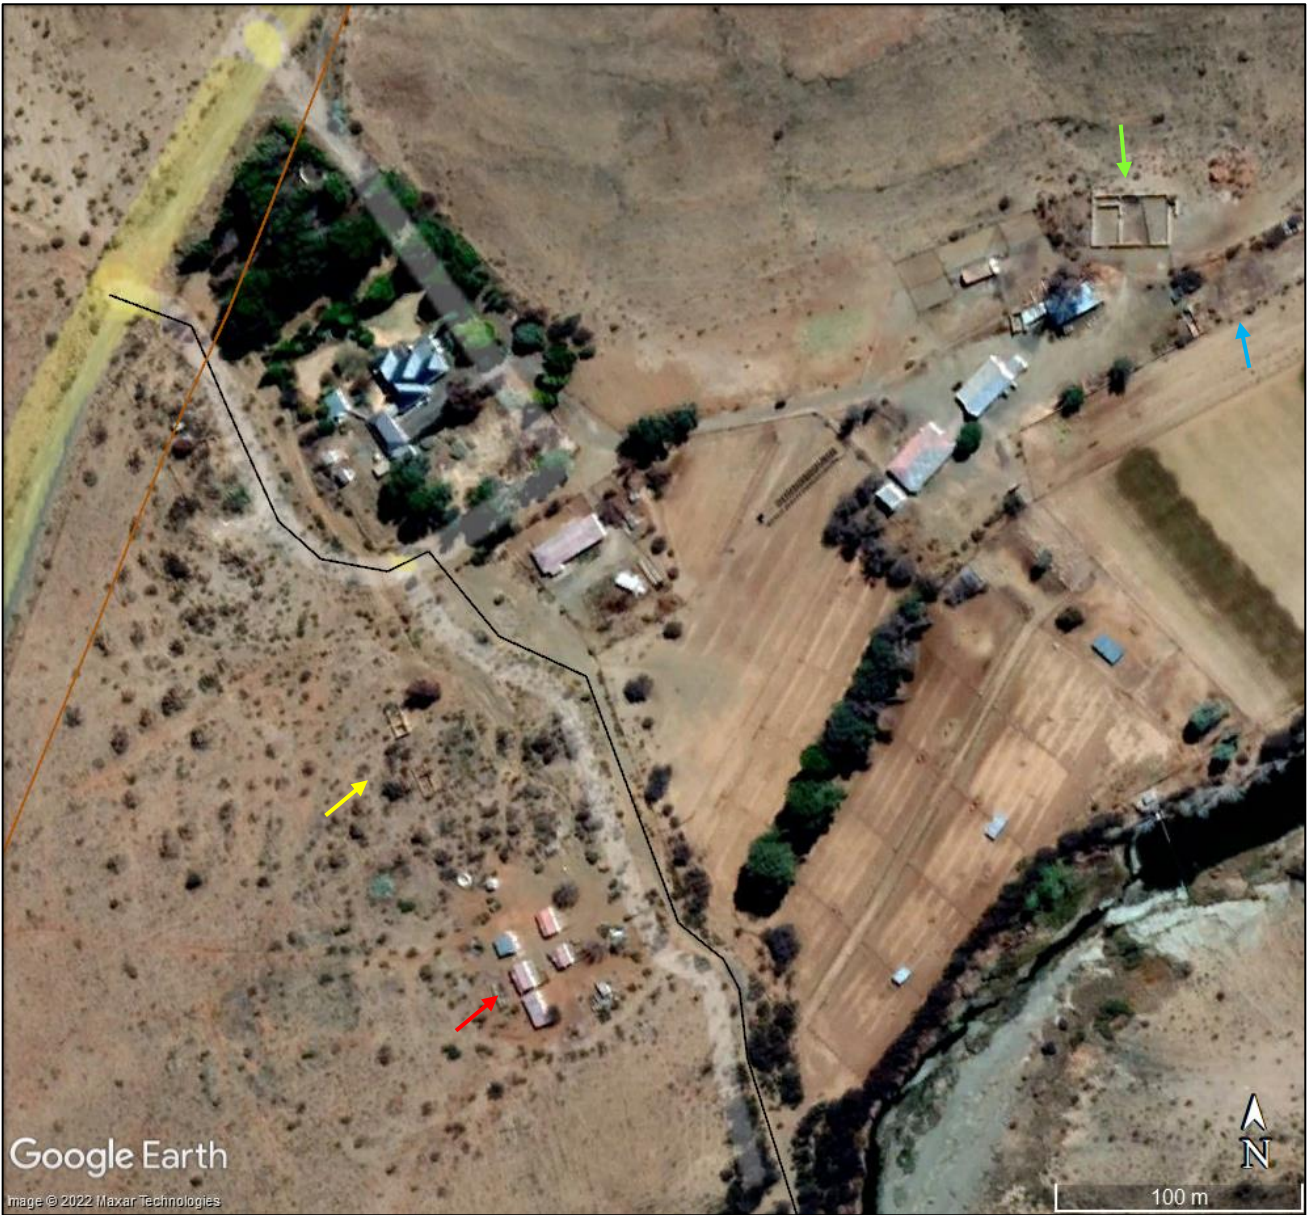
Figure 25: Equivalent modern view to the one shown in Figure 24 above. Key as per Figure 24.

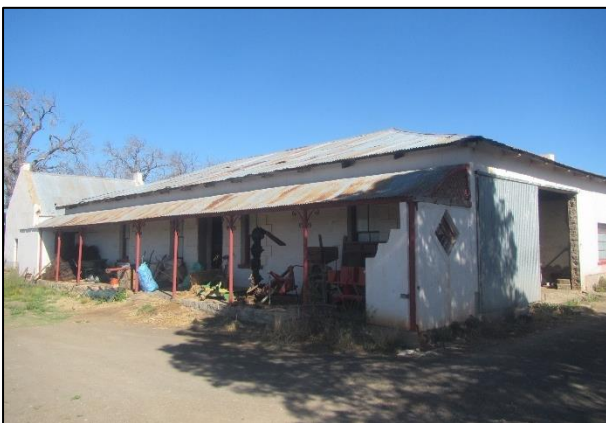
Figure 27: The southeast-facing front of the old farmhouse at waypoint 204. The north-eastern wall has had a large sliding door inserted. The gable in the background is a separate structure.

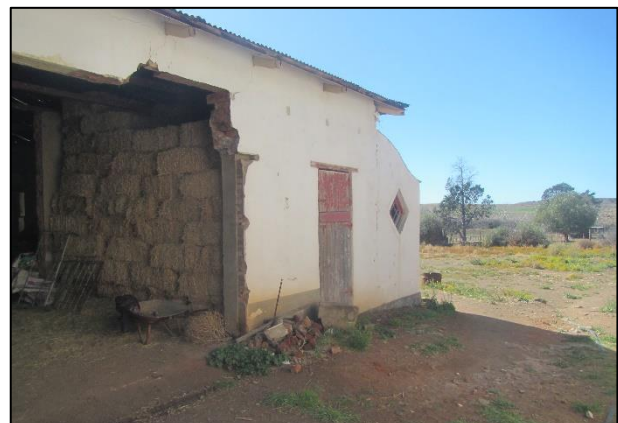
Figure 28: The south-western side of the old farmhouse at waypoint 204. A section of wall has been removed to facilitate large vehicle access.

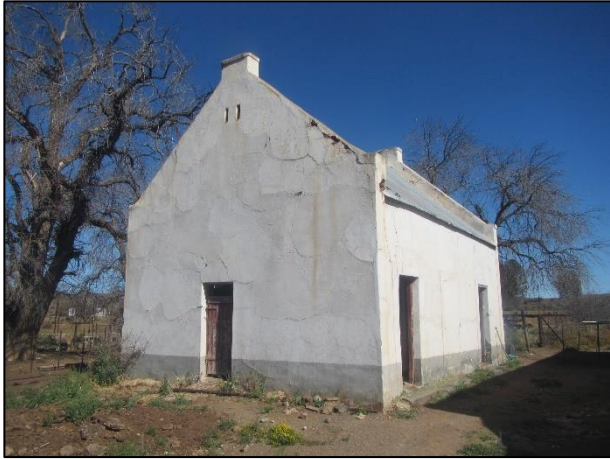
Almost all the historical and built environment features were located in the vicinity of the Rooisandheuwel farmstead. Some of these features are adjacent to the farm road proposed for use as the facility access road. It appears as though the previous farmstead was from the late 19th century, since the structure assumed to have been the main house has some Victorian features (Figure 27). It has been badly damaged in order to convert it to a barn – all internal walls have been removed, if it had gables then these have been removed and ad hoc entrances have been made (Figure 28). A small gabled structure sits just to the southwest of this building. It is in far better condition (Figure 29) and shows thick lower parts of its walls (Figure 30).

Figure 29: The small historical structure at waypoint 205.

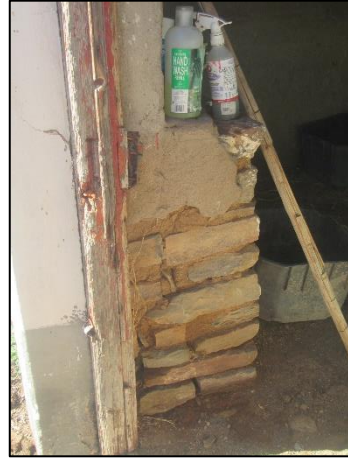
Figure 30: Thick stone and mud mortar wall inside the structure at waypoint 205.

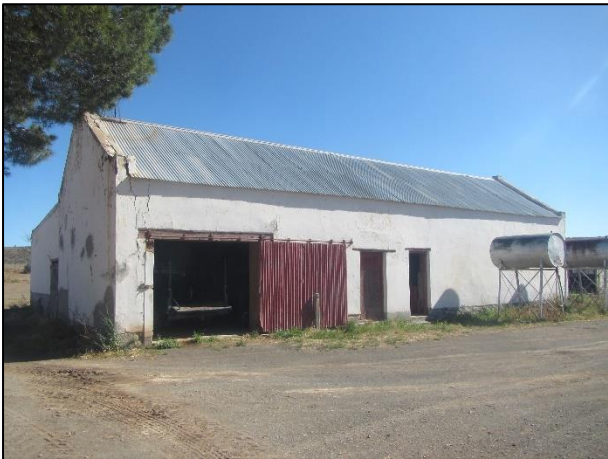
Just northeast of the waypoint 204 house is another structure that seems like it was always a farm outbuilding (Figures 31 & 32). It was built on the same axis as the house and has not been much altered. Another building in the complex appears to have lost its roof relatively recently and is not effectively in run and perhaps better regarded as an archaeological site (Figure 33).

Figure 31: Historical barn at waypoint 207.
