DRAFT BASIC ASSESSMENT REPORT

**HERITAGE IMPACT ASSESSMENT:
BASIC ASSESSMENT FOR THE PROPOSED
PADLOPER PHOTOVOLTAIC FACILITY 1 NEAR
MURRAYSBURG, RICHMOND MAGISTERIAL DISTRICT,
NORTHERN CAPE**

1st draft: 05 June 2023
Final report: 08 September 2023

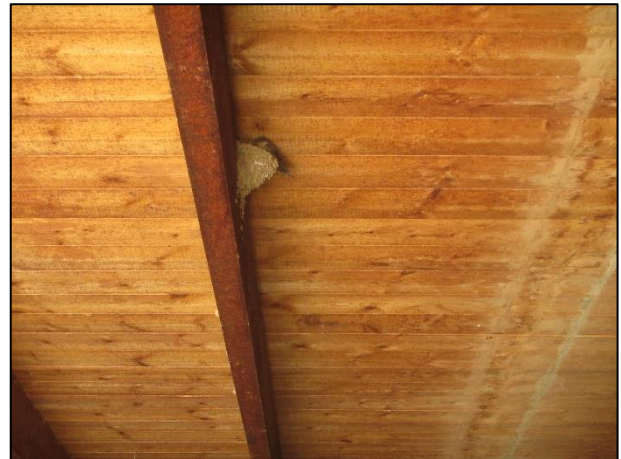
Figure 32: Well-preserved ceiling in the barn at waypoint 207.

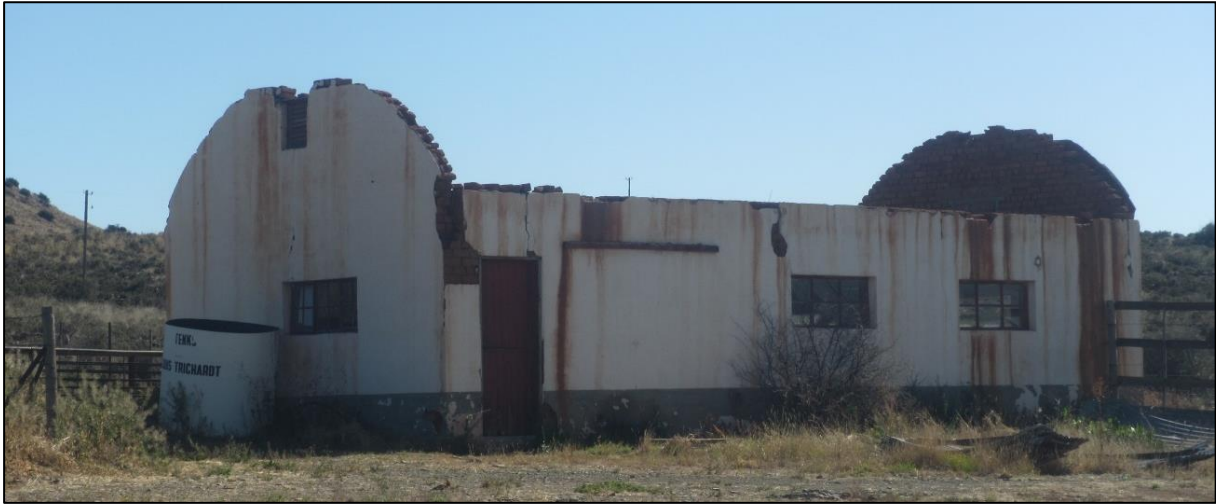
Figure 33: Ruined historical structure at waypoint 206.

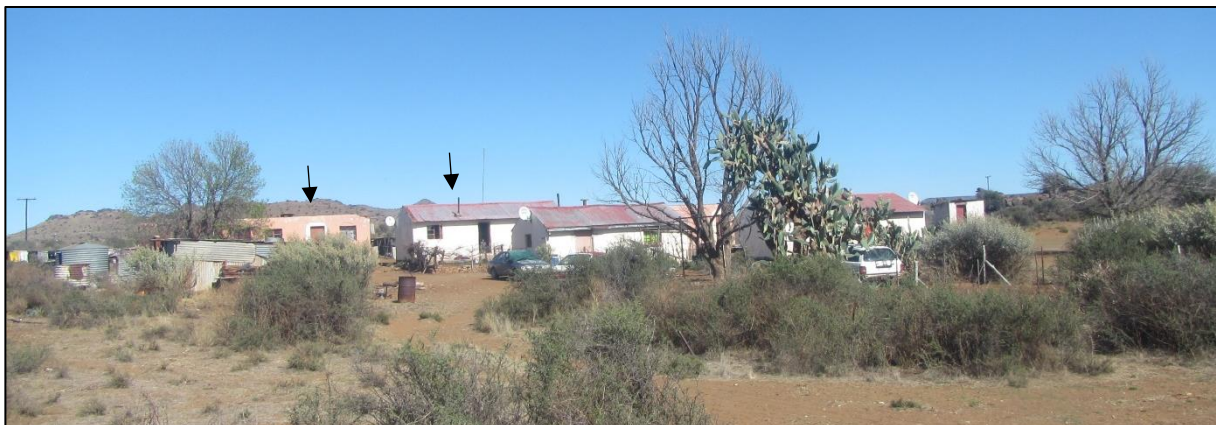
The farm labourers' village lies adjacent to the access road but the nearest structure is more than 20 m from the road (Figure 34). The buildings do not look old, but the historical aerial photograph in the desktop study confirms that two cottages were already built by 1959 and are thus heritage.

Figure 34: View of the farm workers' village at waypoint 211. The two structures that pre-date 1959 are arrowed.

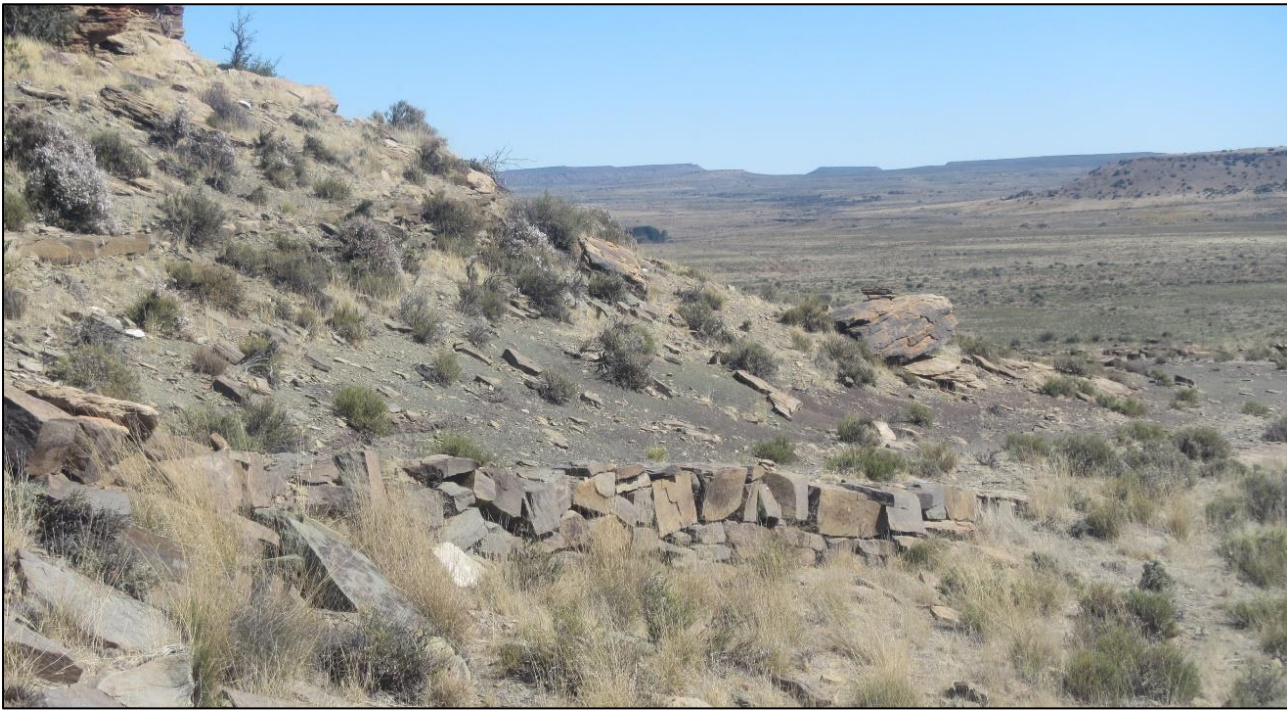
Halfway along the proposed access road, at waypoint 213, there is a short section of track that climbs a hill. A length of drystone retaining wall has been built along the edge of the road (Figure 35). There is no obvious sign of its age, but the desktop study shows that the track has been there for more than 60 years which suggests this wall to also be older than 60 years.

Figure 35: View of the stone retaining wall holding up the farm track at waypoint 213.

- No stones may be removed from any archaeological sites (with the exception of waypoint 213 if it cannot be preserved); and
- Lighting mitigation must be employed to ensure that light is directed only to where it is needed and, preferably, that it only switches on when needed;

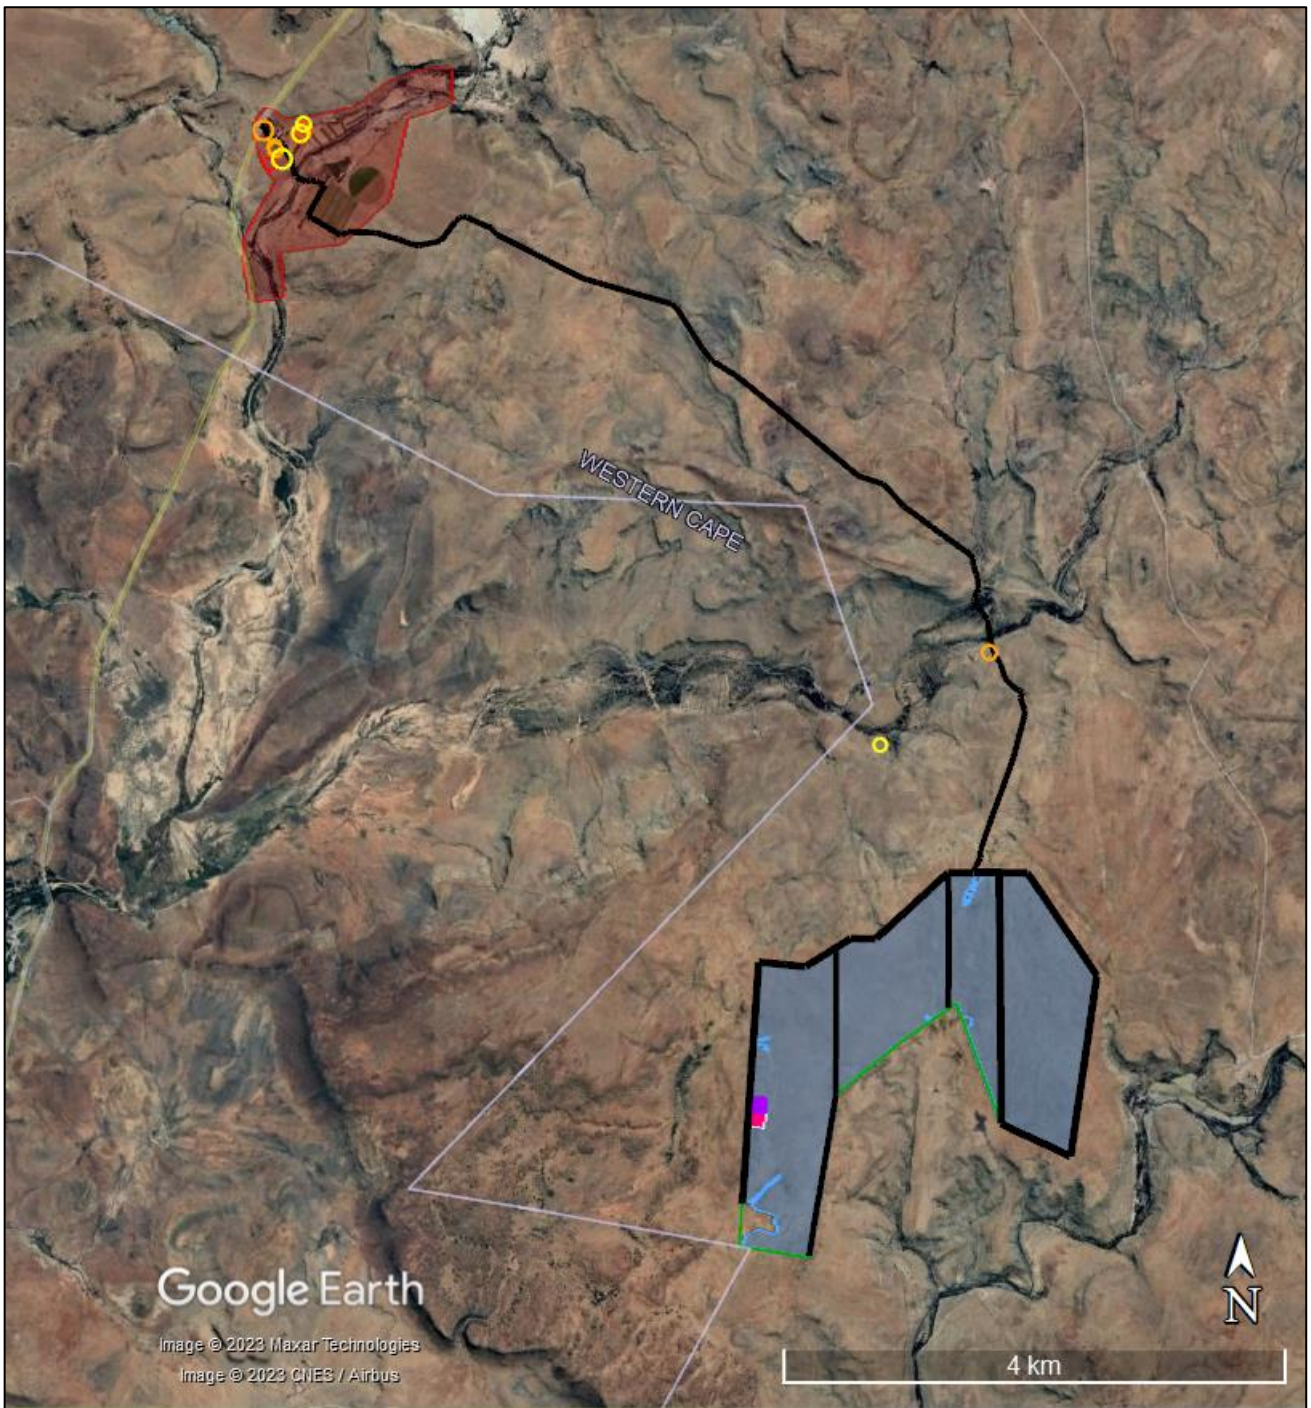
Figure 37: Grade map of the study area. Red = IIIA and IIIB, orange = GPA, yellow = GPB. Circles represent buffers and the polygon around the farmstead is a minimum of 50 m from all identifiable related features.

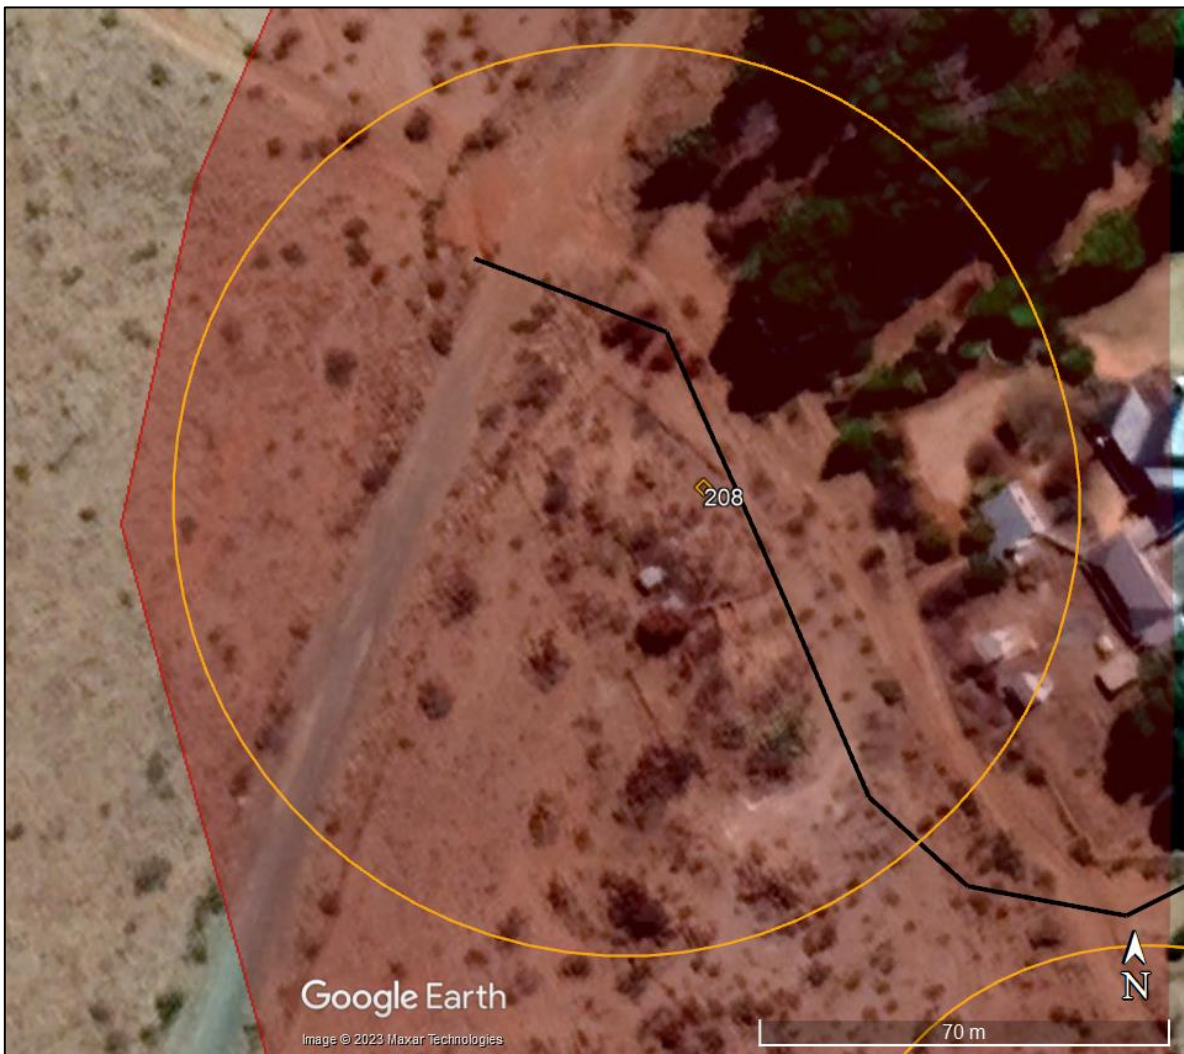
Figure 41: Aerial view of the stone-walled kraal at waypoint 208 (with 50 m buffer) with the farm road to be reused lying to its northeast. The distance between the road and the wall is approximately 14 m.

- The stone-walled kraal at waypoint 208 must be flagged as a no-go area and any road widening that occurs must not impact on the walling (enough space must be allowed for large loads to easily pass by without hitting the wall with approximately 5 m of clear space between the loads and the wall);

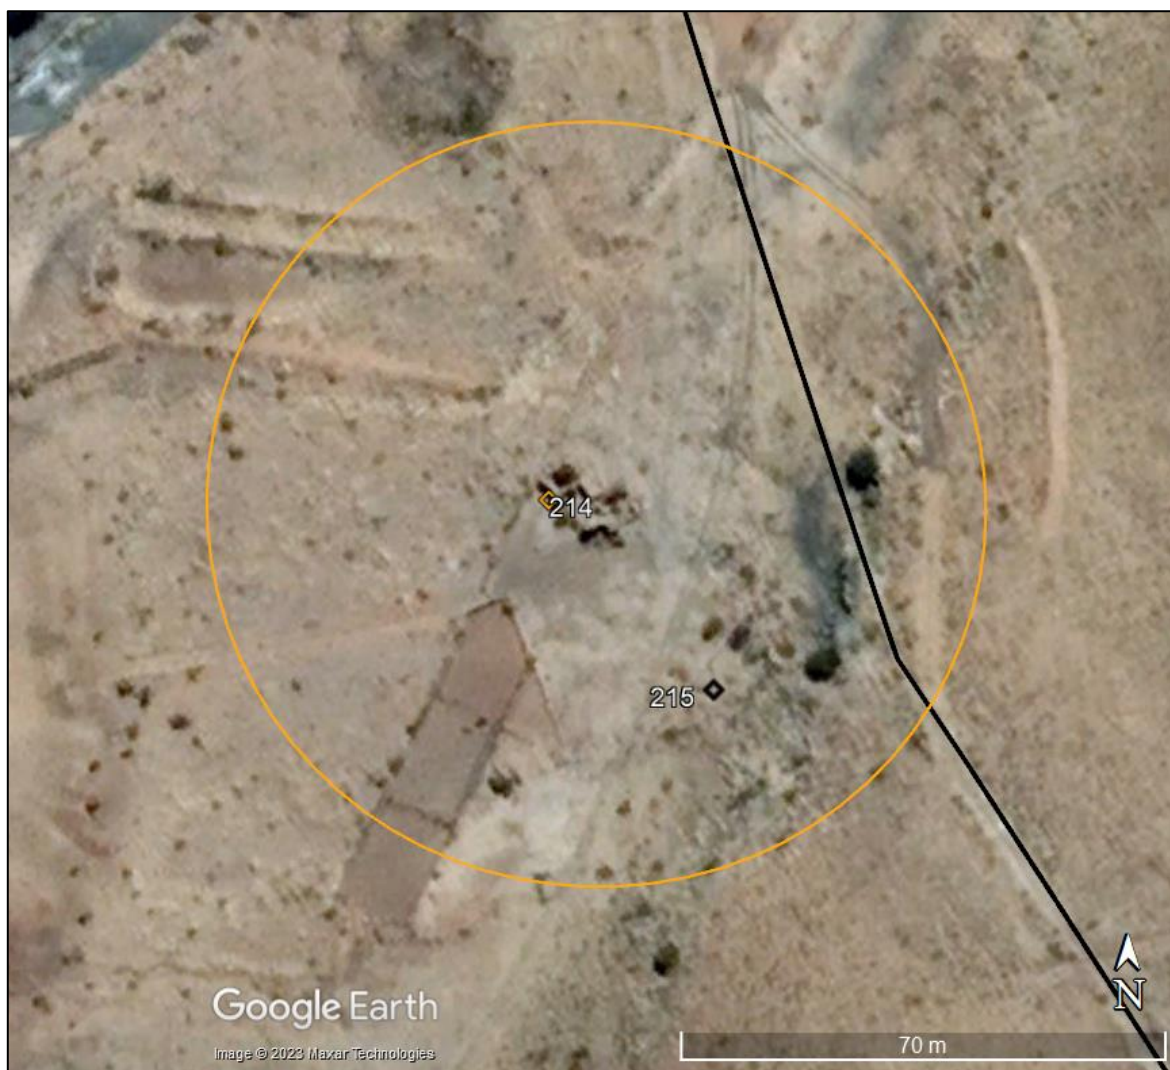
Figure 42: Aerial view of the stone ruin at waypoint 214 (with 50 m buffer) with the proposed project road lying to its east. The distance between the road and the ruin is approximately 28 m.

Whenever on site (at least weekly during construction period only)	ECO
Damage or destruction of any known sites	Avoid impacts	<u>Construction Phase</u> : Place No-Go signage at identified sensitive locations (waypoints 208 and 214).	Monitoring of No-Go areas (construction period only)	Ongoing basis	Construction Manager or Contractor
				Whenever on site (at least weekly)	ECO
Impacts to the cultural landscape					
Visible landscape scarring	Minimise landscape scarring	<u>Construction Phase</u> : Ensure disturbance is kept to a minimum and does not exceed project requirements. Rehabilitate areas not needed during operation.	Monitoring of surface clearance relative to approved layout	Ongoing basis	Construction Manager or Contractor
				As required	ECO
Intrusion into cultural landscape	Minimise visual intrusion	<u>Operation Phase</u> : Ensure that all maintenance vehicles and operational activities stay within designated areas.	Undertake visual inspections and report non-compliance	As required	Environmental Manager
