1 Phase

**Cultural Heritage Resources Impact Assessment For
Proposed New Development On A Property Known As
Figure A B C D E F G F , Middel Of Schoonspruit, J K
L M N Q R A Also Known As Erf 2179 Owing To
Consolidation Of Portions As Illustrated In The Town
Of Klerksdorp, Matlosana City Council.**

January 2009

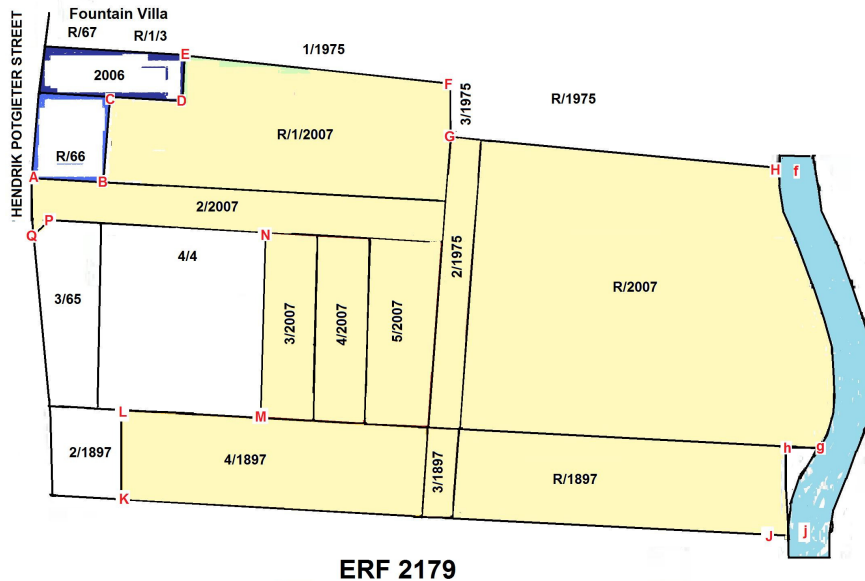
- a. Owing to change of ownership of land in the recent timeframe, a decision was made by THE DEVELOPER to develop a new generation of high density dwellings on the property illustrated here.

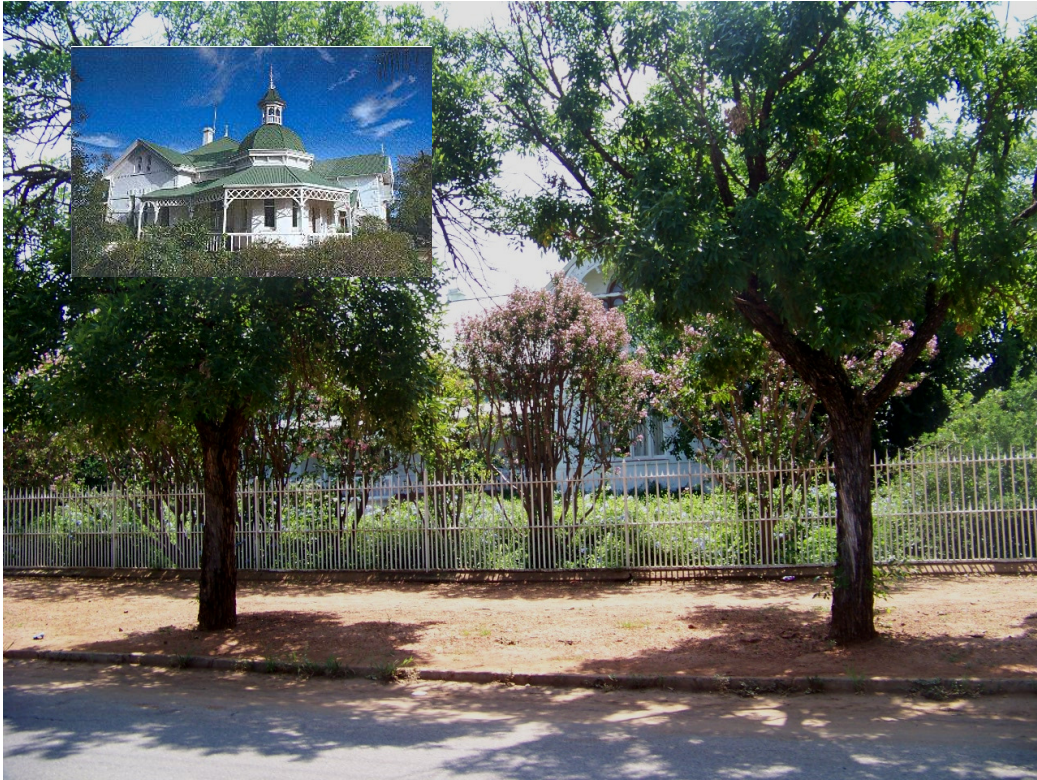
Victorian Fountain Villa

- i. These stands originally formed part of the most historic part of Klerksdorp dating back to the 1837 and together with the later Victorian house Fountain Villa as well as a number of other old houses in Hendrik Potgieter Street could have formed a historic architectural landscape in Klerksdorp (see photographs).

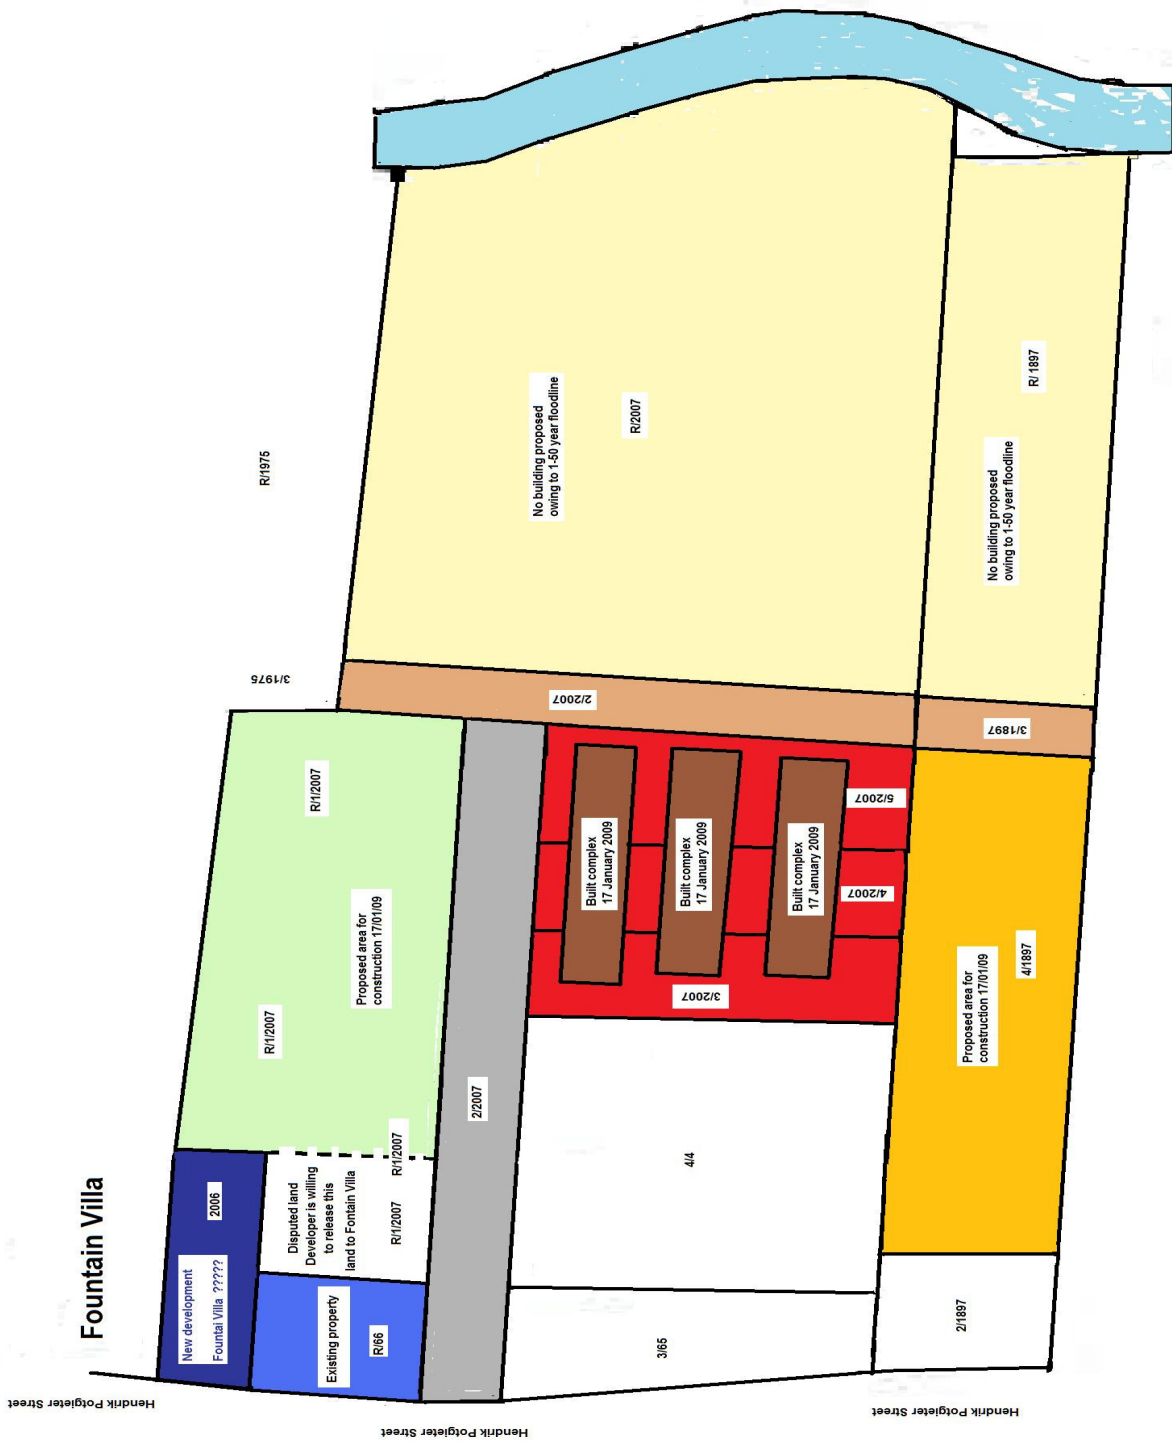
Surveyor map of ERF 2179 with indications of the present situation.
