Phase 1 Heritage Impact Assessment

Proposed Development of Farrar Park Ext. 1
Boksburg, Ekurhuleni Metropolitan Municipality, Gauteng Province

Project No: HU-2010-P112-FP1

Date: 31 May 2011

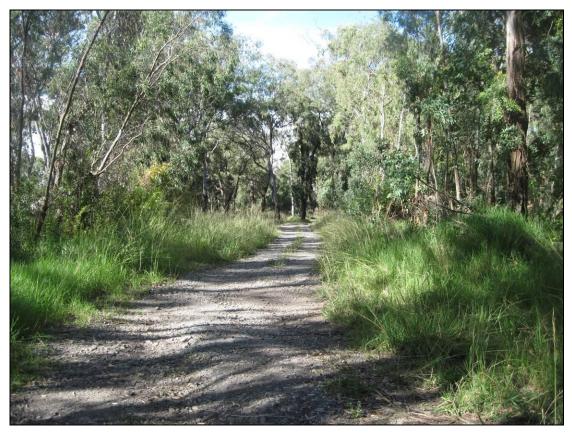
Plate 2 This gravel road runs through almost the entire study area and represents one of the man-made disturbances found on site.

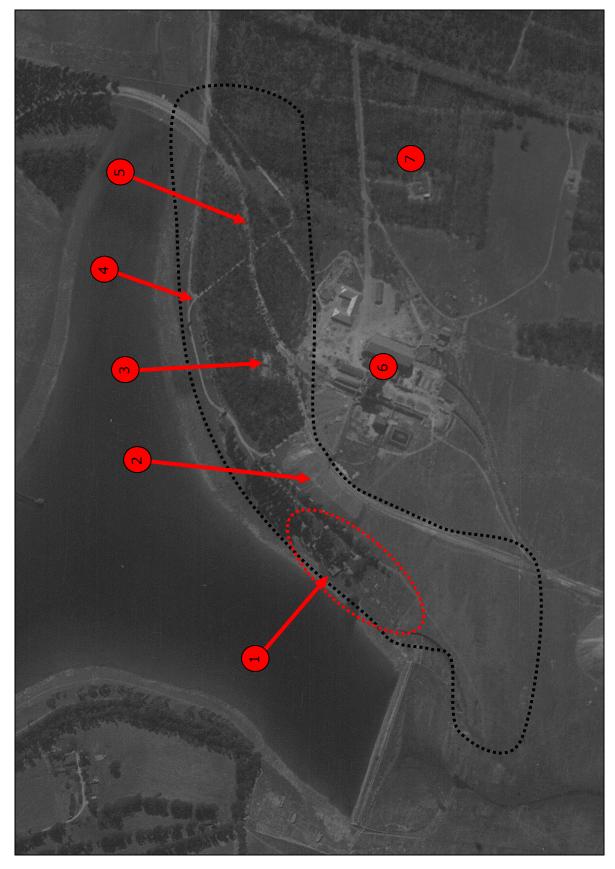
An enlarged section of the 1952 aerial photograph is depicted in Figure 3. Five features are depicted within the study area (see red markers with arrows):

A cluster of buildings associated with the East Rand Yacht Club is depicted here. Although it is difficult to establish exactly how many buildings are depicted here, it appears to be in the region of seven.

A mine heap is depicted here. The feature must have been associated with ERPM's South East Vertical shaft.

Enlarged section of the 1952 aerial photograph. The black dotted line provides an indication of the approximate position of the study area. Figure 3

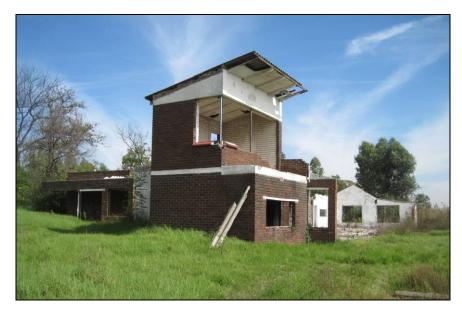
The site comprises a number of poorly preserved buildings which used to be associated with the East Rand Yacht Club. While very little architectural detailing has remained preserved, it is evident that the buildings were largely built from facebrick while the roofs were of corrugated iron. The most prominent building on the site is a double-storey viewing tower from where yachting activities on the dam were watched. Attached to this structure the remains of a large rectangular building were found. It appears to have been used as the yacht club's clubhouse.

The condition of the buildings is poor and very little remains preserved.

Two separate buildings are depicted in this vicinity on the June 1947 plan. It would appear that the smaller of these was an outside bathroom while the larger one was the clubhouse. Although the smaller building was not found during the survey, it seems likely that the larger building was incorporated into the expanded clubhouse building, the remains of which were identified in the field. It seems likely therefore that a section of the site is at least 64 years old.

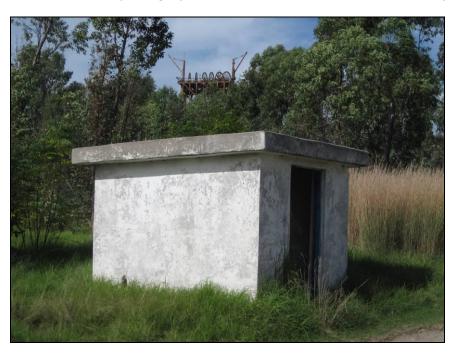
2. Guard House at entrance gate to East Rand Yacht Club

The site comprises a single stocky building of brick and concrete that is situated adjacent to the main entrance to the East Rand Yacht Club. Its location suggests that it must have been used as a shelter for guards opening and closing a gate. The condition of the building is reasonable. The building does not appear to be depicted on the 1952 aerial photograph and as a result is not older than 60 years.

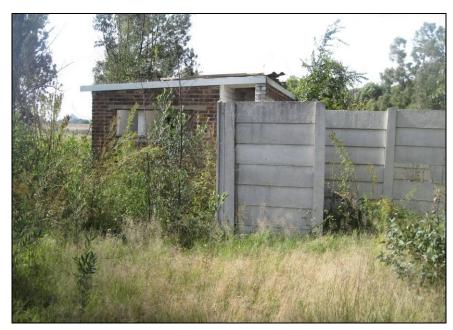
3. **Bathroom building in the vicinity of the East Rand Yacht Club**

A small facebrick bathroom building is located roughly 125m north-east of the clubhouse of the East Rand Yacht Club. It is in a poor condition. The building is not depicted on the 1952 aerial photograph and as a result is younger than 60 years.

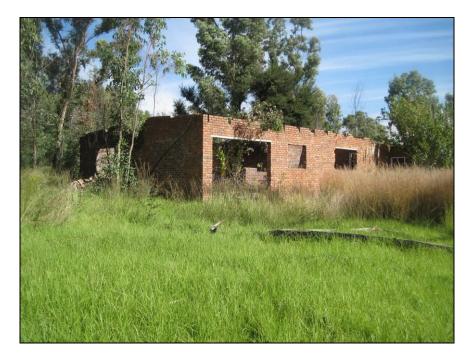
4. Clubhouse of the Transvaal Sub-Aqua Club

The site comprises a single rectangular facebrick building located 225m north-east of the clubhouse of the East Rand Yacht Club.

As the building is in a poor condition, very little can be said about its architectural details. What is known is that it was built using red facebricks, and likely had a corrugated iron roof and steel-framed windows.

The building was constructed as a clubhouse by the Transvaal Sub-Aqua Club in 1983, and was used as such between 1983 and 2002. It was built by Mr. Frikkie Kruger, the club's spear fishing officer at the time (www.cyberclub.co.za/tsa).

The building is not depicted on the 1952 aerial photograph and as a result is not older than 60 years.

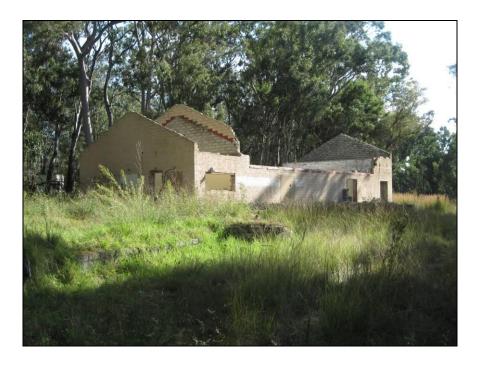
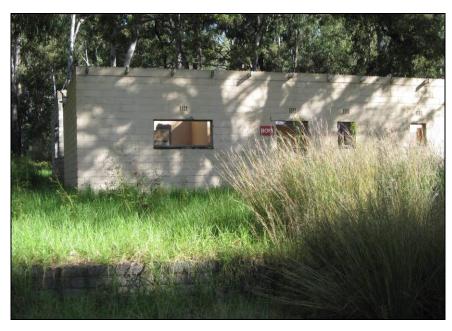
Two long rectangular brick buildings are located here. Although they are in a poor condition, it is evident that the buildings were constructed of bricks and must have had a corrugated iron roof and steel-framed windows. The buildings are not depicted on the 1952 aerial photograph and as a result are younger than 60 years.

The buildings are associated with a Boy Scouts camp ground known as "Owl's Nest". No further information is presently available on this site.
