Phase 1 Heritage Impact Assessment

Proposed Development of Reiger Park Ext. 18
Boksburg, Ekurhuleni Metropolitan Municipality, Gauteng Province

Project No: HU-2010-P112-RP18

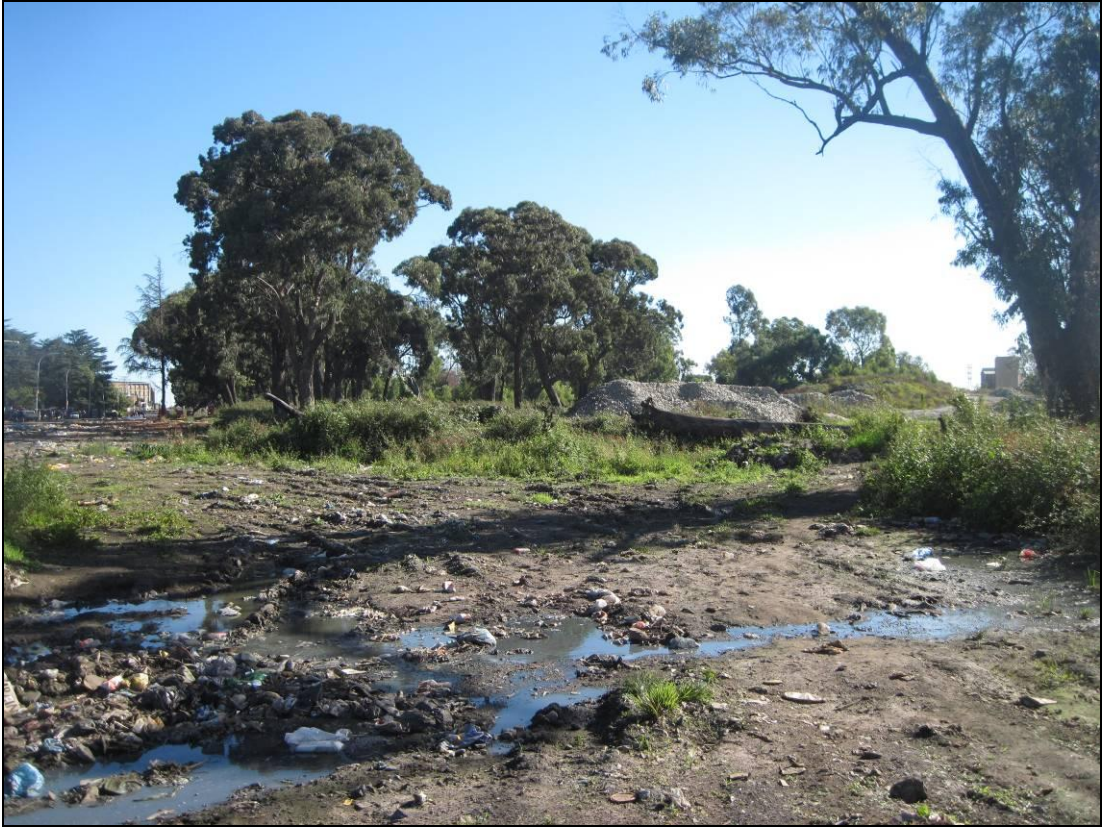
Plate 1 General view of the study area as seen from its north-eastern boundary.

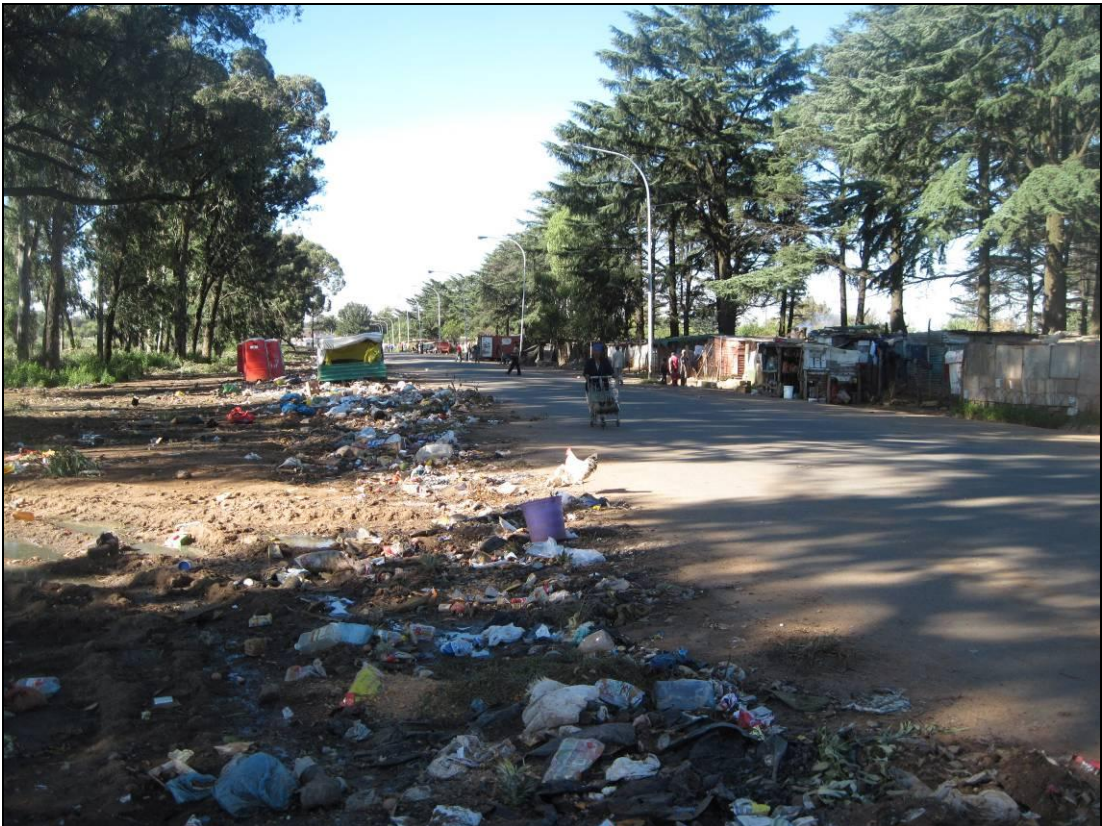
Plate 2 View along the south-eastern boundary of the study area. This road is known as St. Anthony's and defines the boundary of the site on this side.

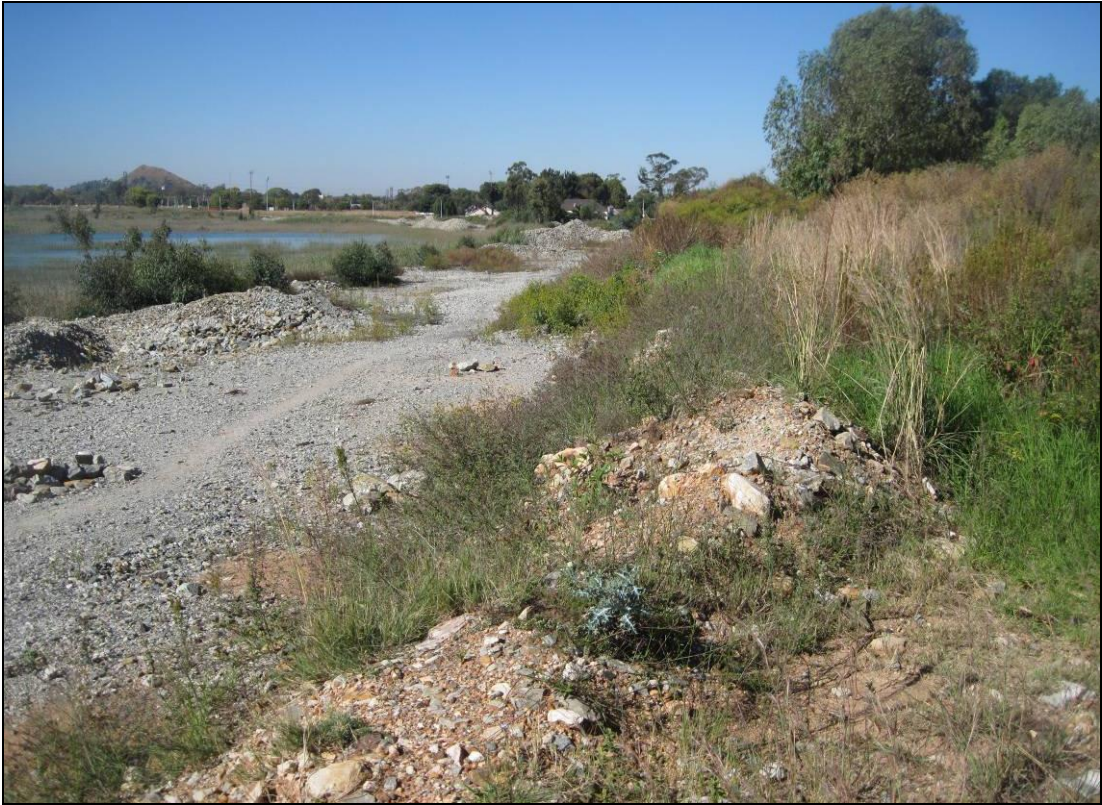
Plate 3 View along the north-western boundary of the study area. A section of Angelo Dam can be seen in the distance on the left.

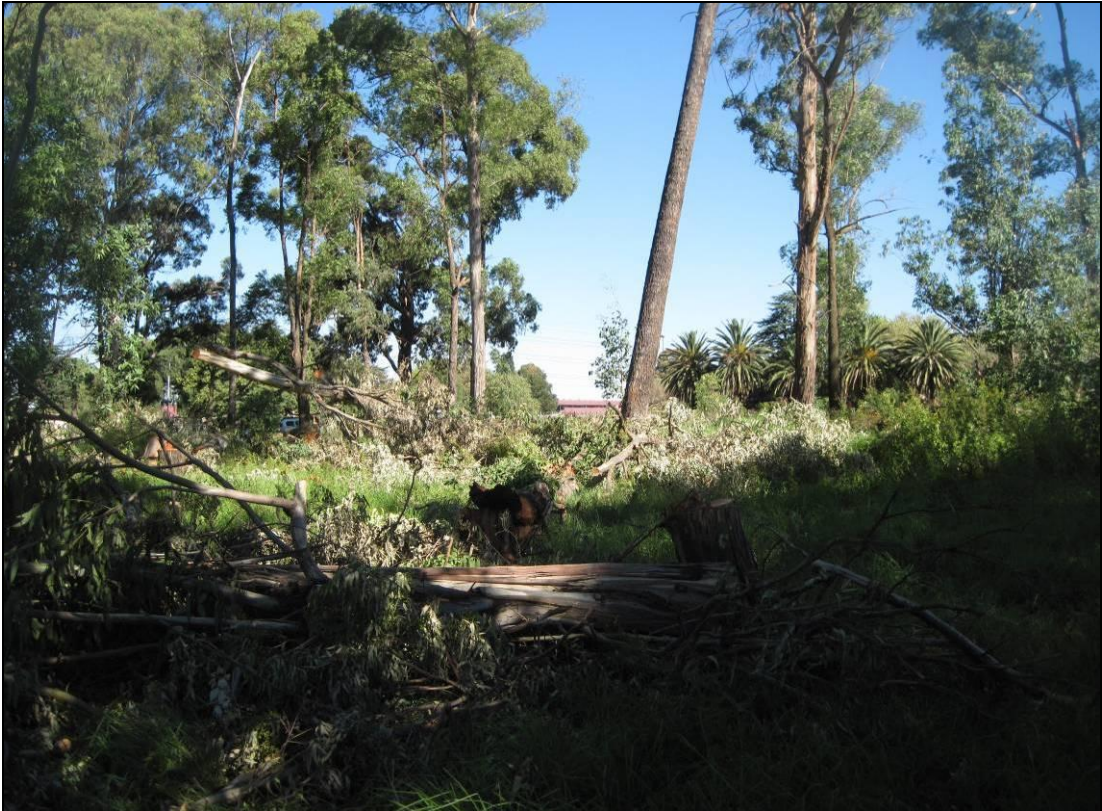
Plate 4 For the most part the study area is covered in pine and eucalyptus trees. This said it is worth noting that a significant number of these trees were found chopped down.

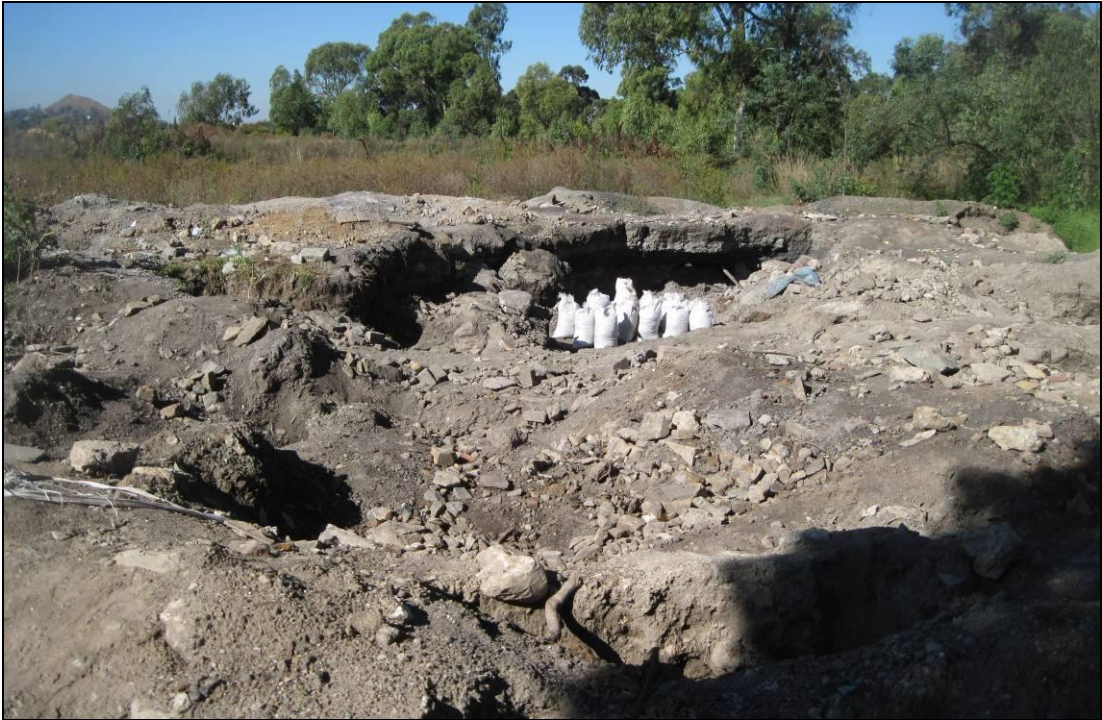
Plate 5 Excavations such as these were found across the study area where old ash and rubbish dumps are to be found. Conversations held with the individuals who undertake these excavations revealed that they salvage chunks of charcoal from the dumps to sell to local residents.

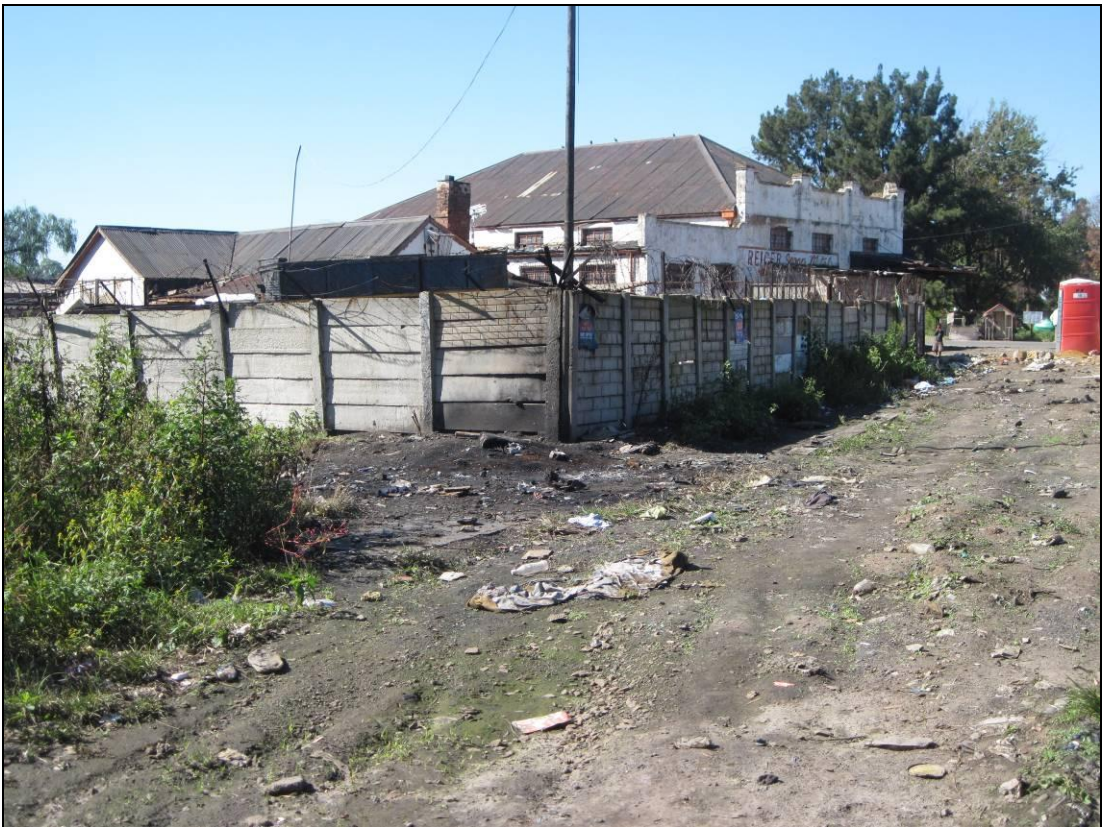
Plate 6 This old shop with associated buildings and walls is located directly outside of the study area's north-western boundary.

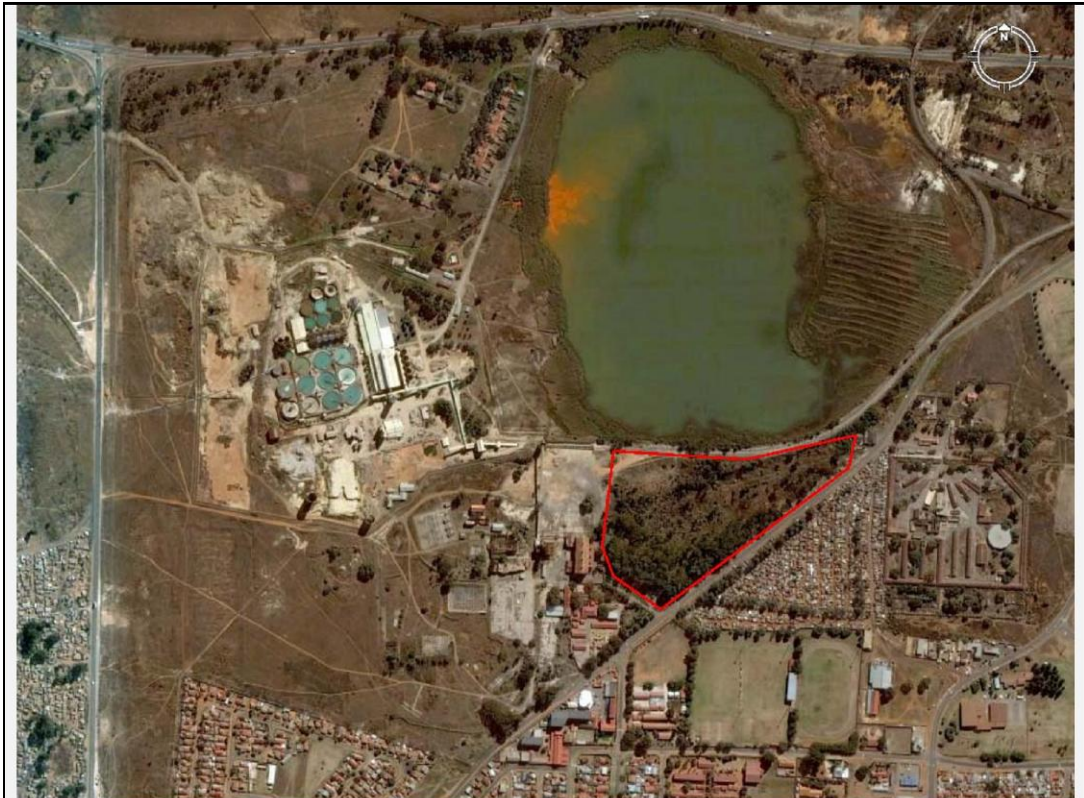
Figure 1: Aerial photo of proposed Reiger Park X 18

Figure 1 This image was supplied by the client. It shows a Google Image (top) with the study area's boundaries depicted in red line. The bottom image depicts the development layout plan.

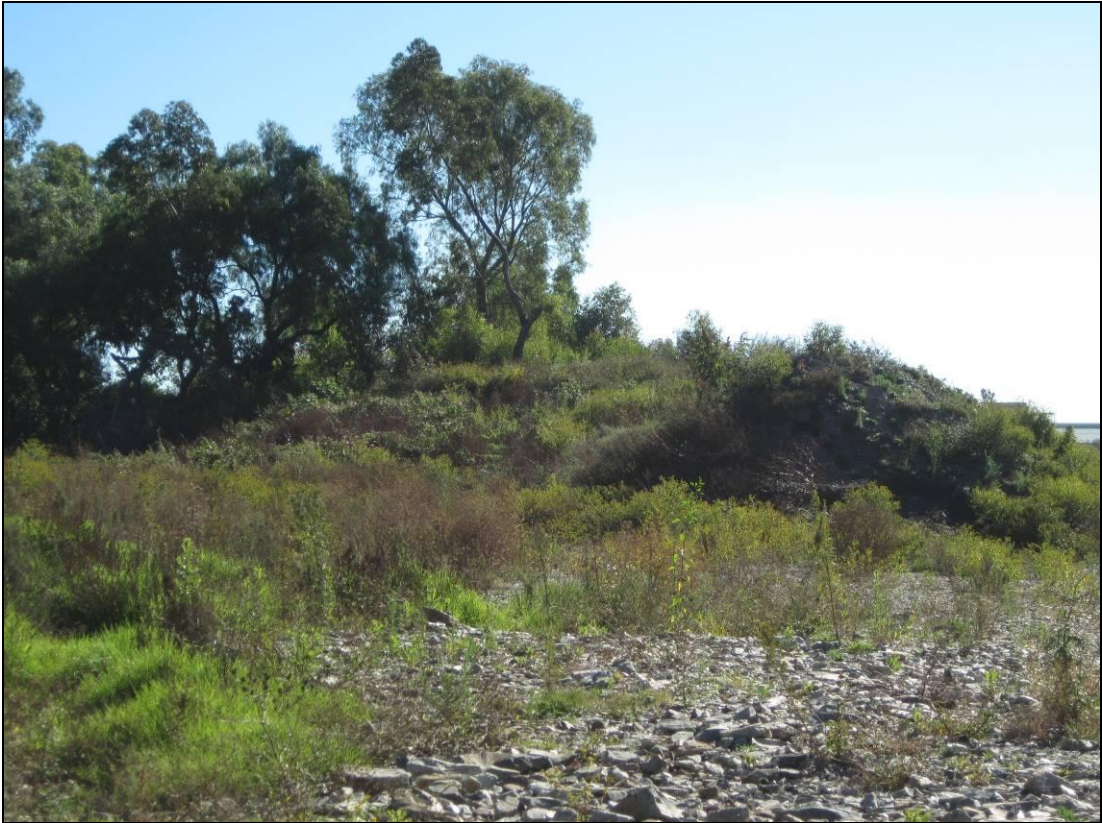
A large extensive rubbish heap is located along the northern boundary of the study area. In some places the feature is roughly 5m high and stretches over an area of approximately 100m in length. The heap comprises for the most part ash and charcoal, with cultural material in the form of bone, broken glass bottles and ceramic ware observed in places.

Although the relative date obtained for the broken lid is slightly older than 100 years, this date provides an indication of the date of manufacture for the dish and not when it was discarded on the rubbish heap. As some time would likely have elapsed between the manufacture and discarding of the artifact, the author is of the opinion that it seems very likely for the rubbish dump to date to the period younger than 100 years. As a result the rubbish dump cannot be considered an archaeological site.

Plate 7 General view of Site 1.

No mitigation measures are required.

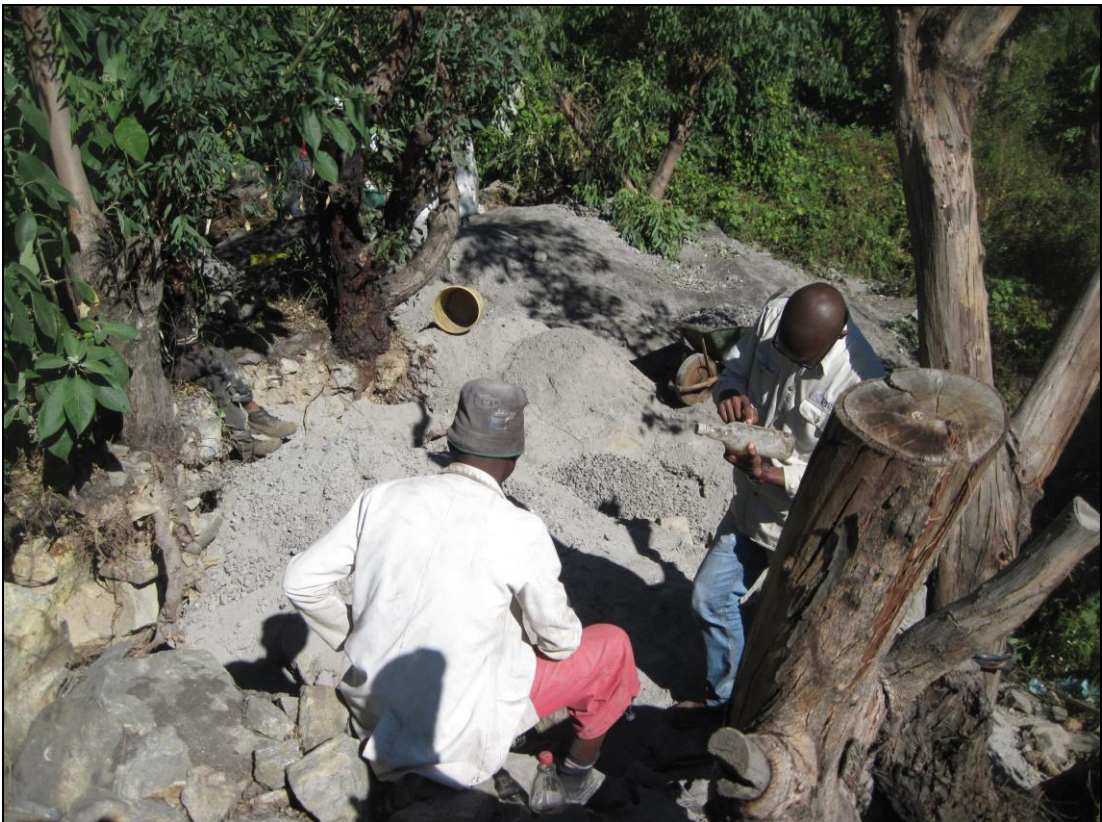
As a further way of dating the site three artefacts excavated from the lower (older) sections of the ash heap by local residents were taken to Ms. Corine Meyer at the Ditsong National Museum of Cultural History. These artefacts were a broken lid from a porcelain dish, a fragment from a glass bottle as well as a near complete bottle. Ms. Meyer tentatively dated the broken lid to c. 1905, the bottle fragment to roughly the 1930s and the near complete bottle to the 1940s (Meyer, pers. comm.)

Plate 8 PGS's Nathi Tomose assessing a bottle that was excavated by local residents in their search for coal.
