HERITAGE IMPACT ASSESSMENT FOR THE PROPOSED NEW FACILITIES AT HANTAM NATIONAL BOTANICAL GARDEN, NIEUWOUDTVILLE, CALVINIA MAGISTERIAL DISTRICT, NORTHERN CAPE

Required under Section 38 (8) of the National Heritage Resources Act (No. 25 of 1999).

19 September 2014

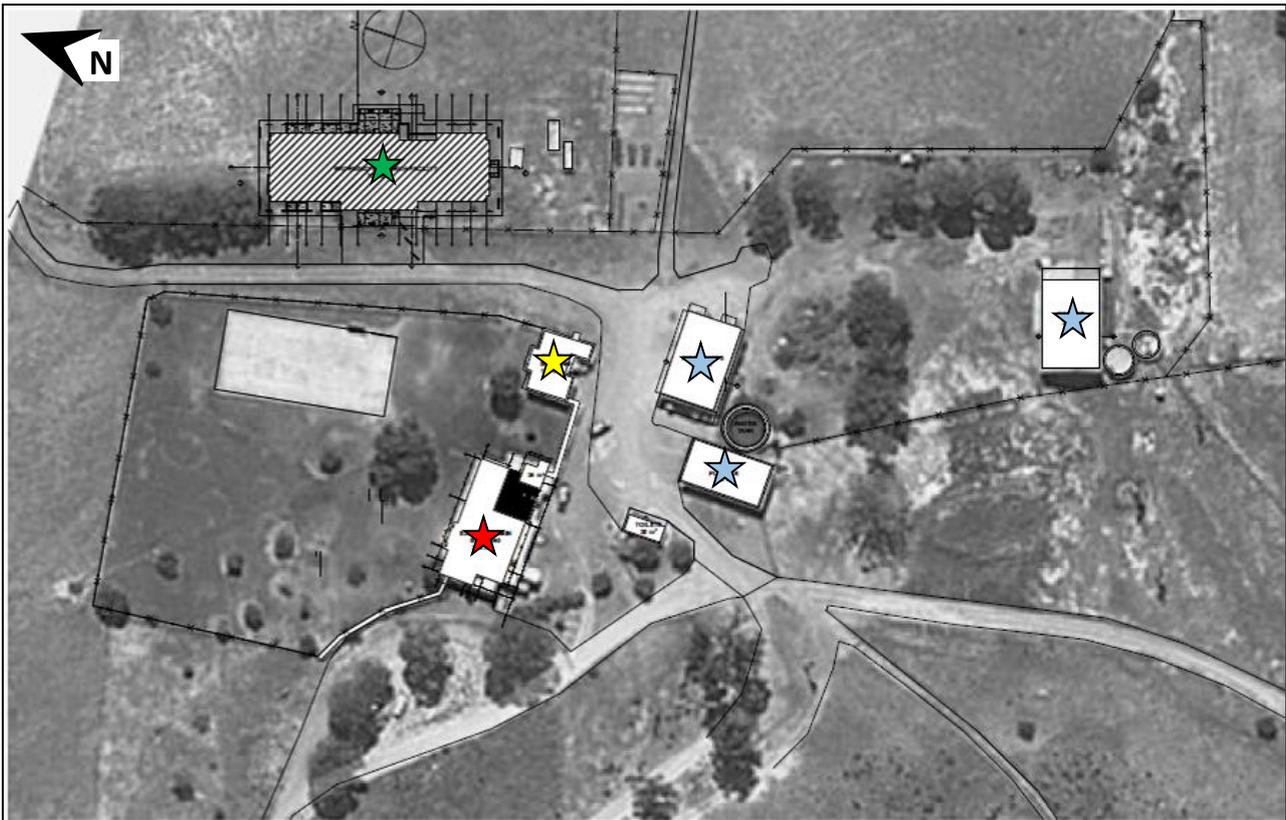
Figure 2: Aerial view of the current complex at the Hantam National Botanical Garden. Existing structures are indicated by blue stars, while the proposed new structure is marked by a green star. The red star denotes the present admin building, and the yellow star the present guest house to be changed into a meeting room.

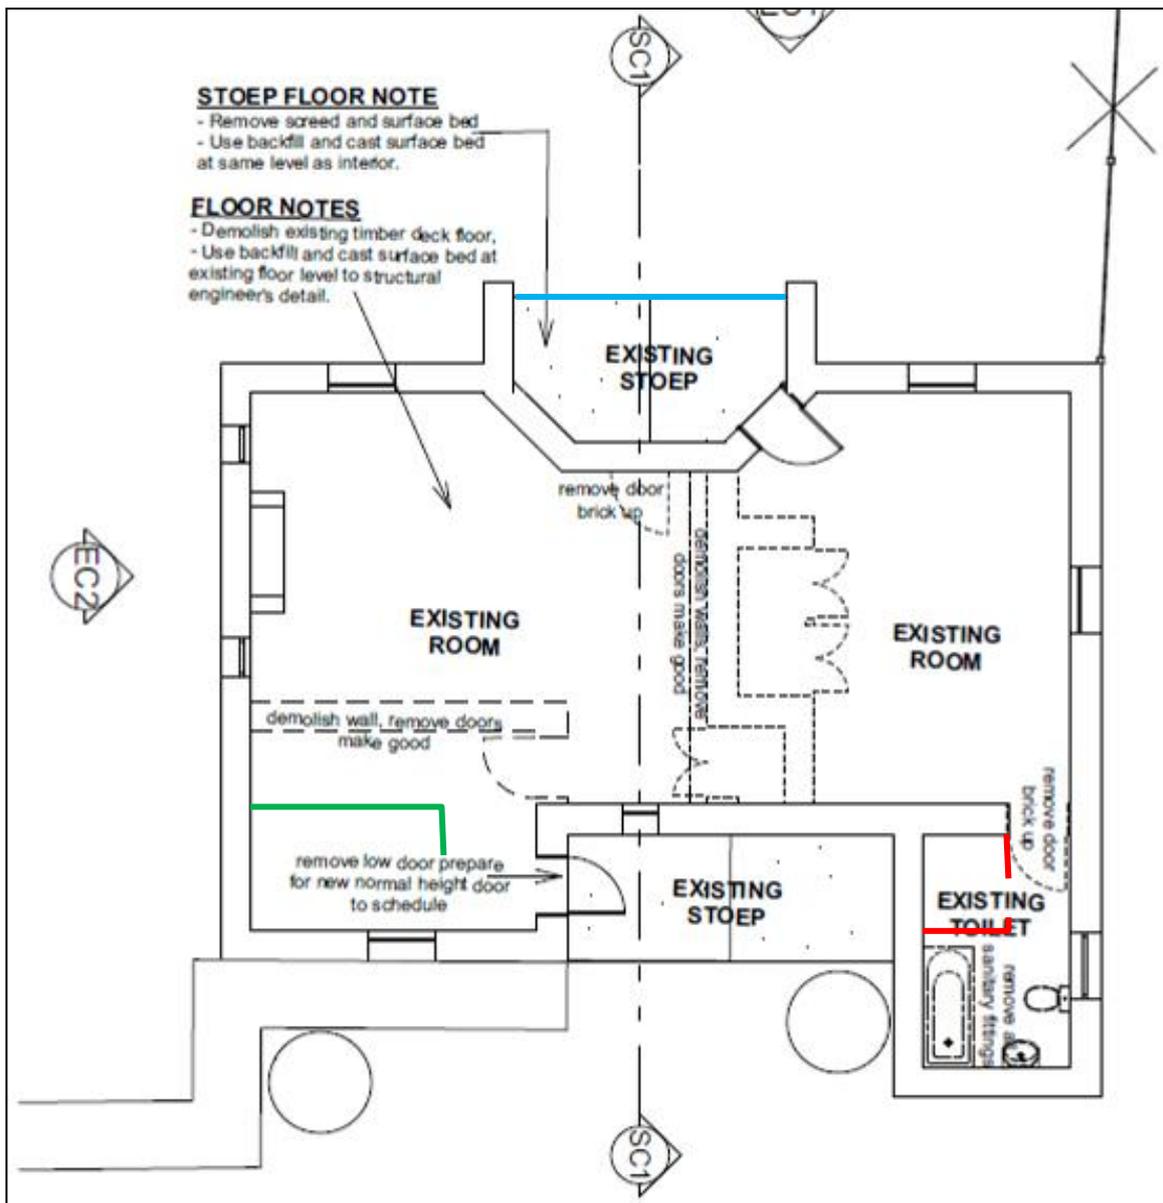
Figure 3: Proposed alterations to the present guest house to create a meeting room. New work will entail construction of a small internal wall in the southwest (green line) and southeast (red lines) corners, and closing in of the veranda (blue line).

- Extension of existing staff kitchen to accommodate the public ablutions;
- Refurbishment of the guest house to become a meeting room (*this will involve demolition of internal walls to create a single large space, construction of a new wall to create a kitchenette, closing up of main central entrance from veranda, and closing in of the veranda to create a small office space*; Figures 3 – 5);

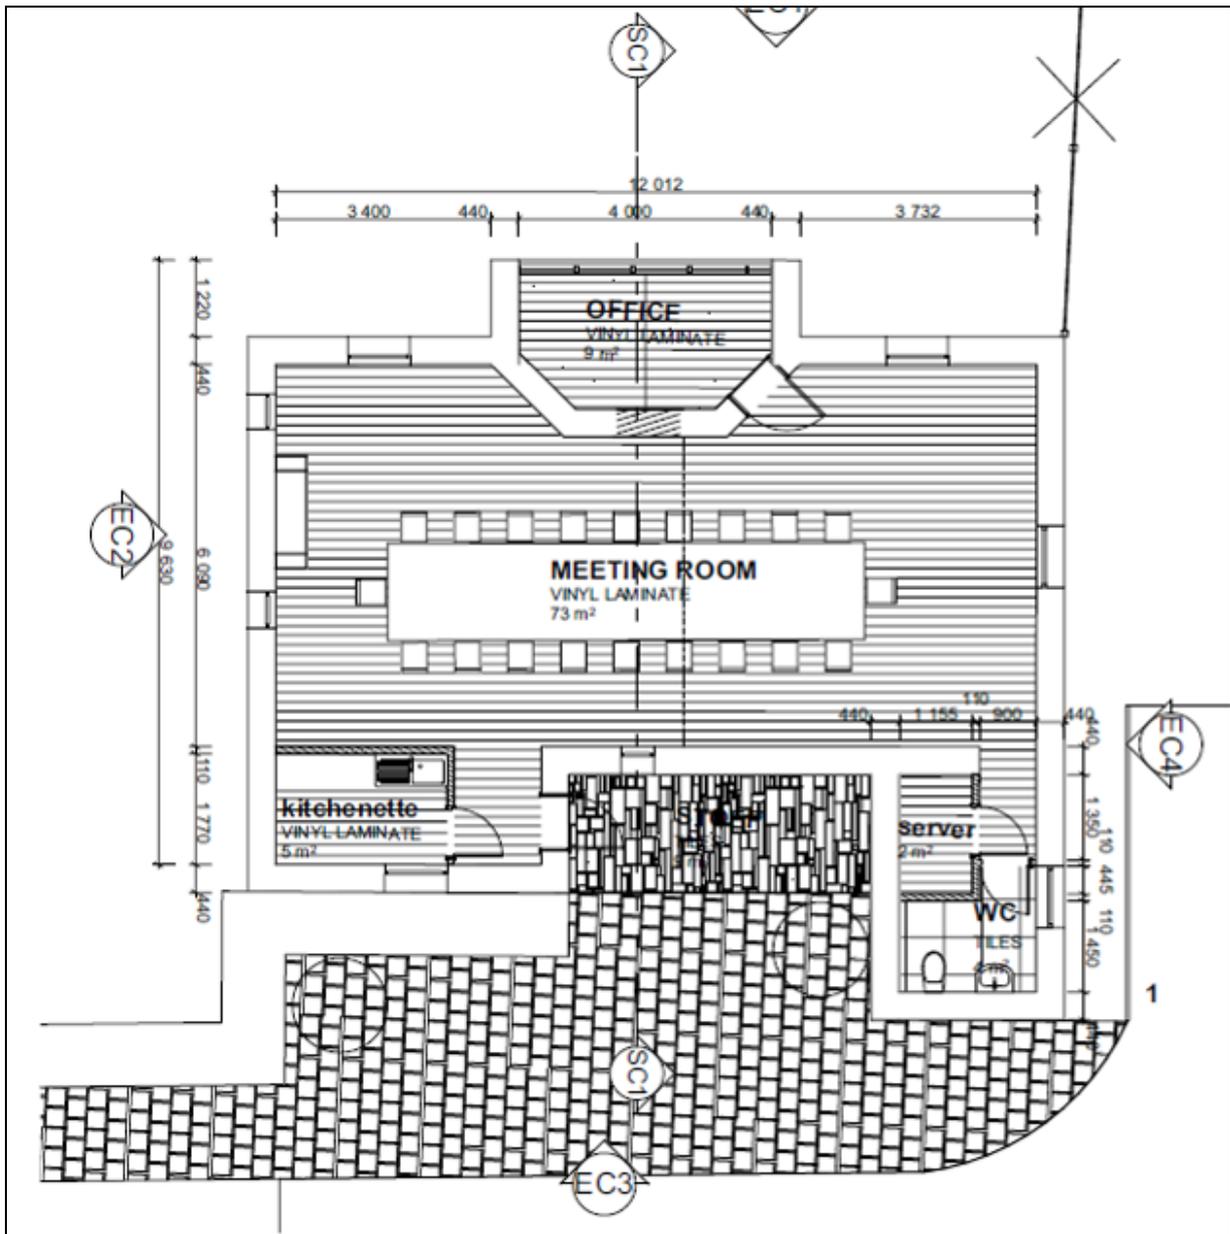
Figure 4: Proposed final layout of the 'meeting room'.

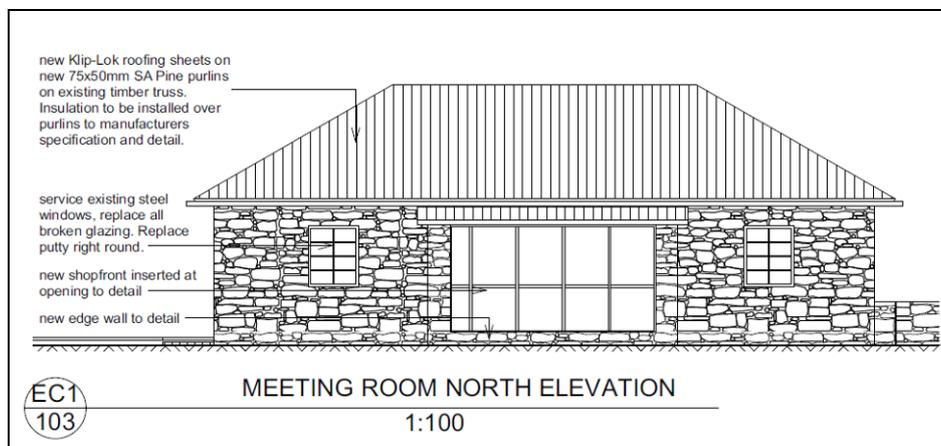
Figure 5: View of the proposed alterations to the façade of the guesthouse.

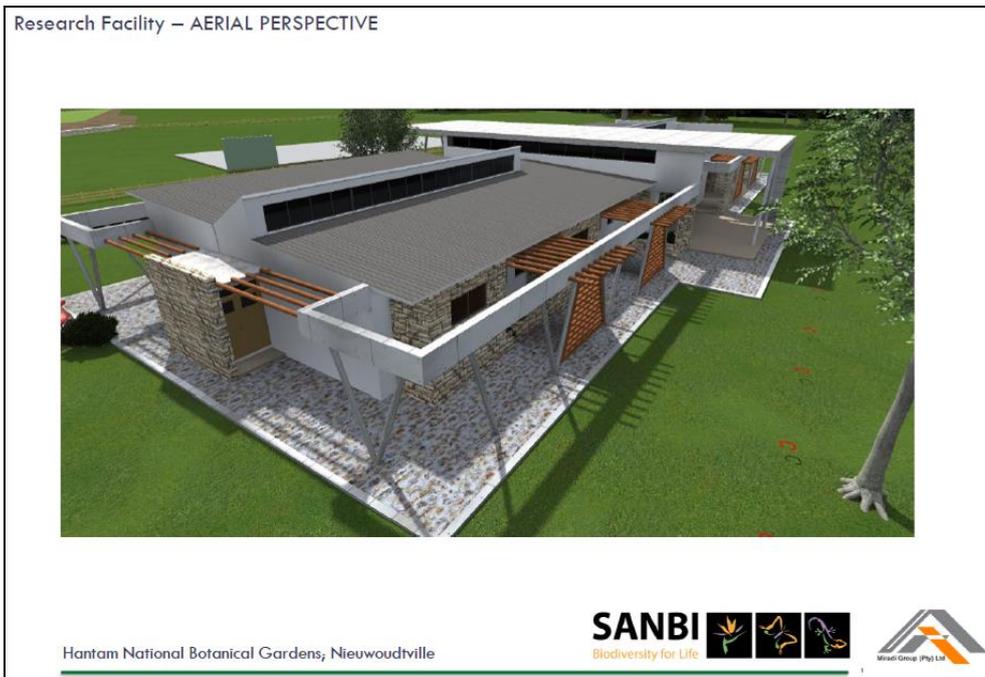
Figure 6: Aerial perspective of the proposed research and education facility. Image provided by Miradi Group (Pty) Ltd.

Phase 2 will entail the construction of a new, environmentally appropriate research facility with a small access road and parking area (Figures 6 – 8). The research facility will be approximately 740m² in extent and will be located to the north of the present administration building (Figure 2). The research facility will include the following:

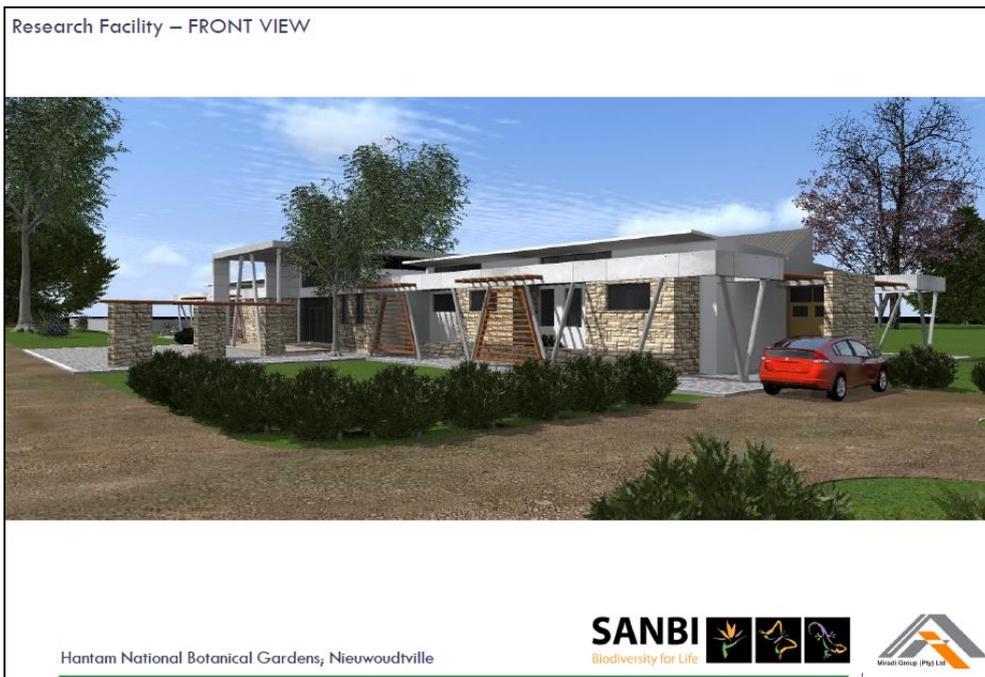
Figure 7: View from the southwest of the proposed research and education facility. Image provided by Miradi Group (Pty) Ltd.

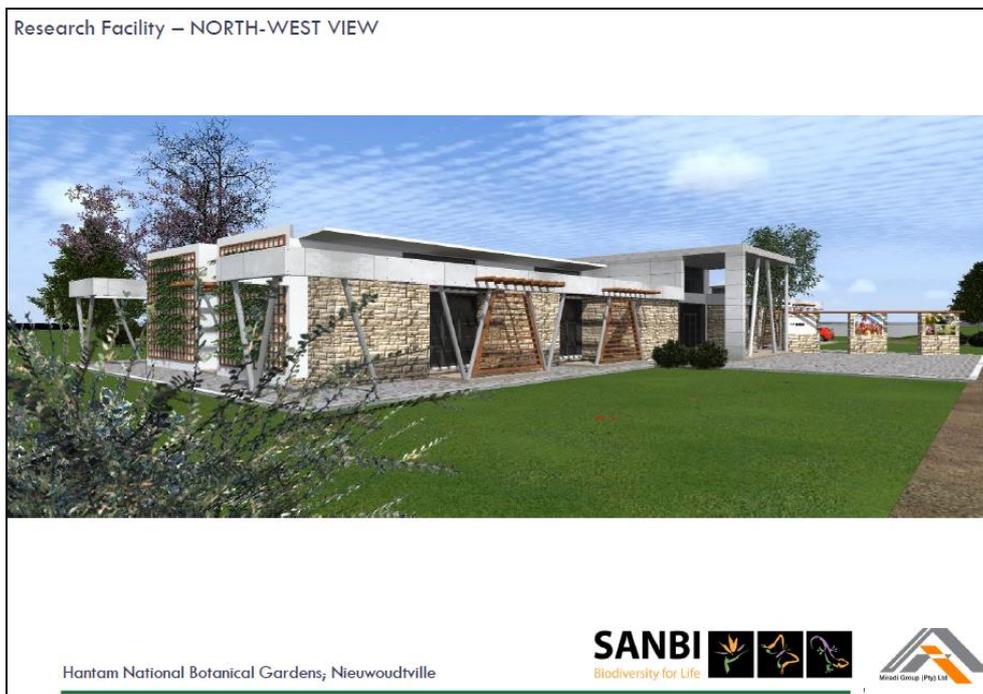
Figure 8: View from the northwest of the proposed research and education facility. Image provided by Miradi Group (Pty) Ltd.

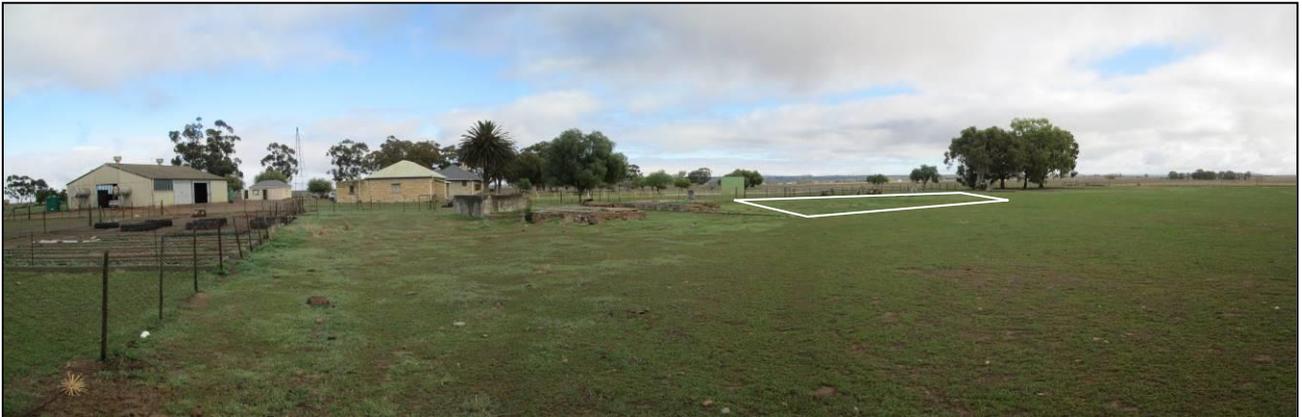
The site of the proposed new structure is a level, open field (Figures 9 & 10). A few large trees occur along the north-western edge but otherwise vegetation at the time of the survey was limited to grass. Figure 11 shows a view across the northern part of the werf towards the site of the proposed new structure. The rest of the project will be carried out in the existing werf area which has a scattering of buildings of varying size and form interspersed by gravelled areas, grassed areas and a number of trees. Some of this character is evident in the photographs below as well as that in Figure 12.

Figure 9: View towards the west showing the approximate footprint of the structure proposed for Phase 2 of the project.

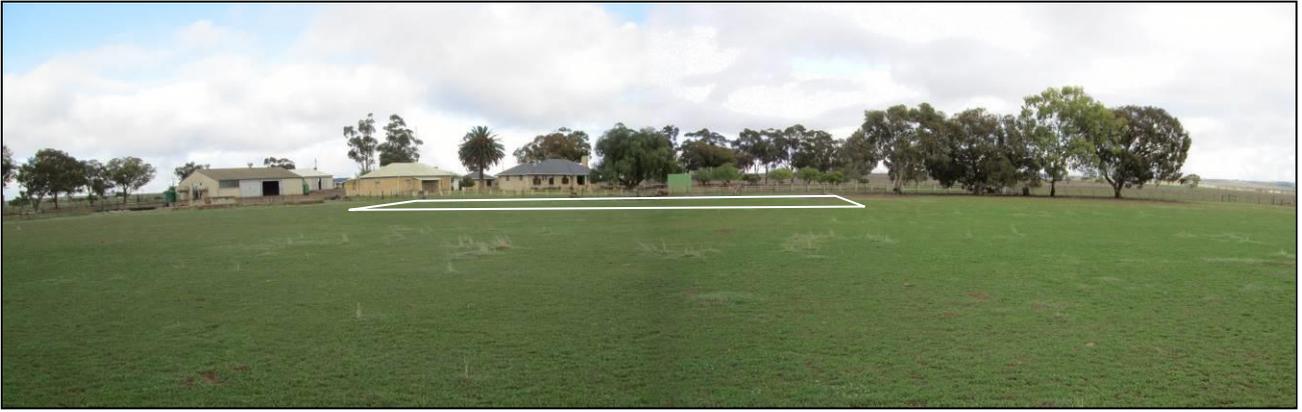
Figure 10: View towards the southwest showing the approximate footprint of the structure proposed for Phase 2 of the project.

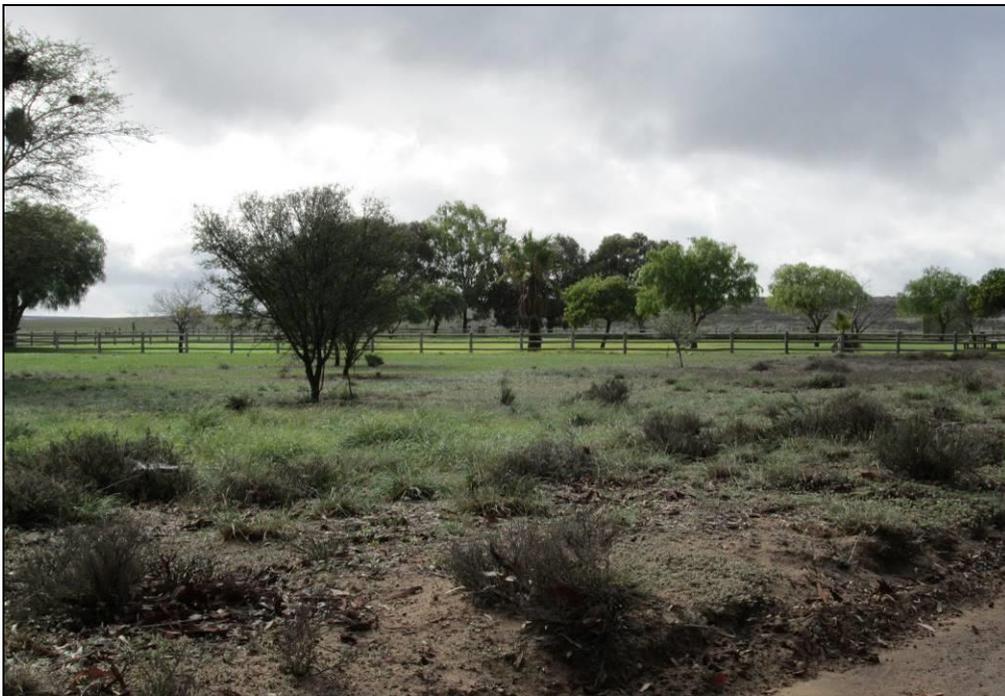
Figure 11: View towards the east from the access road towards the site of the structure proposed for Phase 2 of the project. The building would be located to the right of the gum trees in the background.

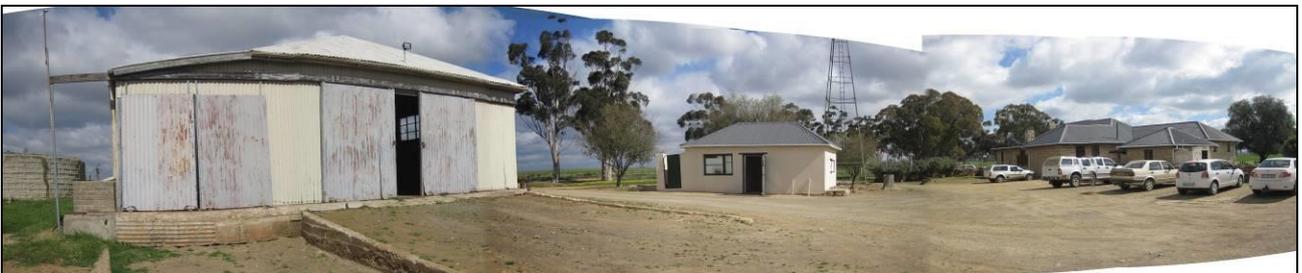
Figure 12: Panoramic view of the main werf area facing south on the left hand side of the image and northwest on the right hand side. The stone guest house is just out of picture to the right.

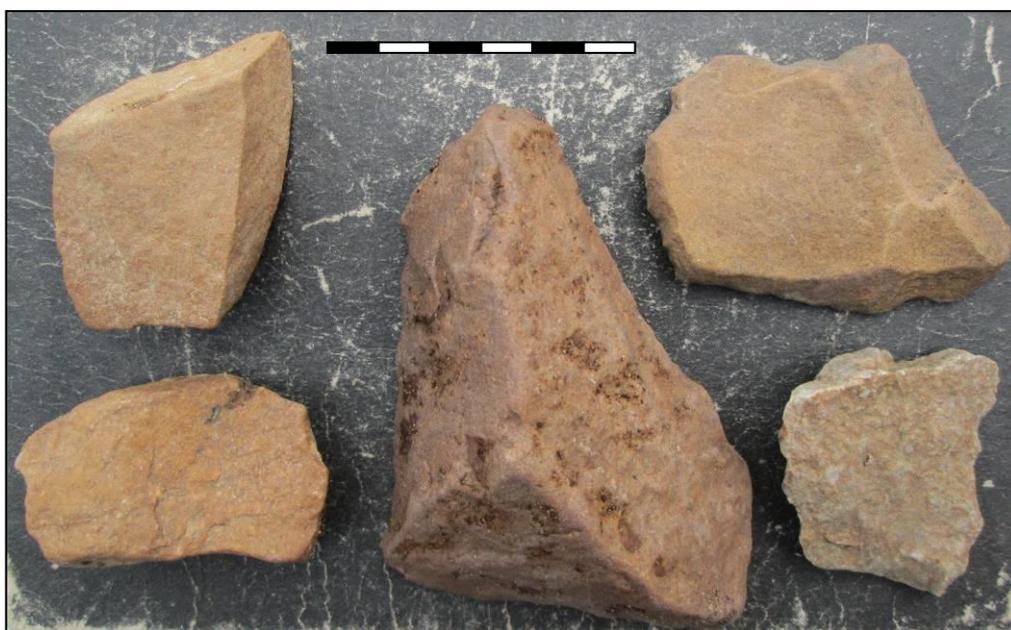
A small number of stone artefacts, all in quartzite, were noted scattered among the surface gravels on the site for the proposed new structure (Figure 13). These artefacts are likely to be of MSA antiquity, although one might be ESA. They are in variable states of weathering with none being fresh and ascribable to the LSA. The artefacts were found in secondary context and can be considered background scatter. They have no research value. No historical materials were seen during the survey.

Figure 13: Photograph of stone artefacts located in the site of the proposed new structure. Scale in cm.

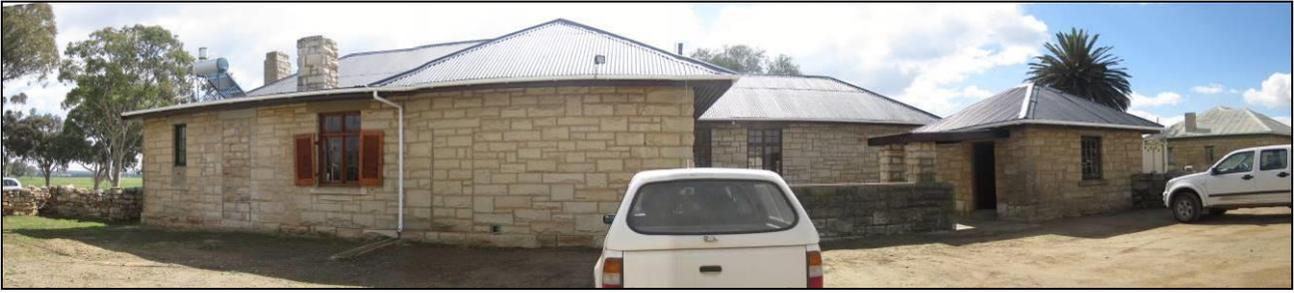
There are three significant structures greater than 60 years of age present on the site. They occur as a cluster, with other structures scattered about the werf area being more recent buildings no doubt added for various reasons while the property was still a working farm (See Appendix 1). The three buildings of concern are all stone-built structures. External alterations to the main (administration) building are evident in the closed up doorways visible in the southern elevation (Figure 14). These doors must have been closed quite early on because the construction style of the infill section perfectly matches the rest of the structure. The newer windows and roof betray a recent renovation and it appears that the lintels and window sills of the house were also replaced. Unfortunately these details could not be checked on site. The second stone structure is a small store room located just near the south-eastern corner of the administration building (Figures 14 & 15). It too appears to have been renovated in recent years.

Figure 14: View of the southern elevation of the main admin building. Two closed up doorways are evident to the left in this view. The small store room is visible to the right. Photograph: Kirsty Robinson (SEC).

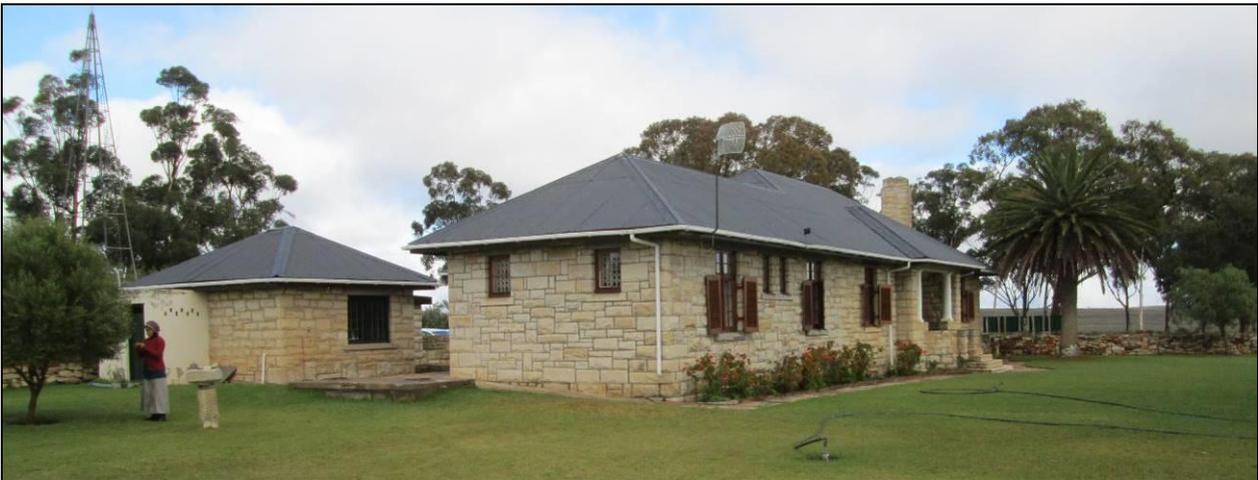
Figure 15: View of the north-eastern corner of the administration building. The small store room is visible to the left.

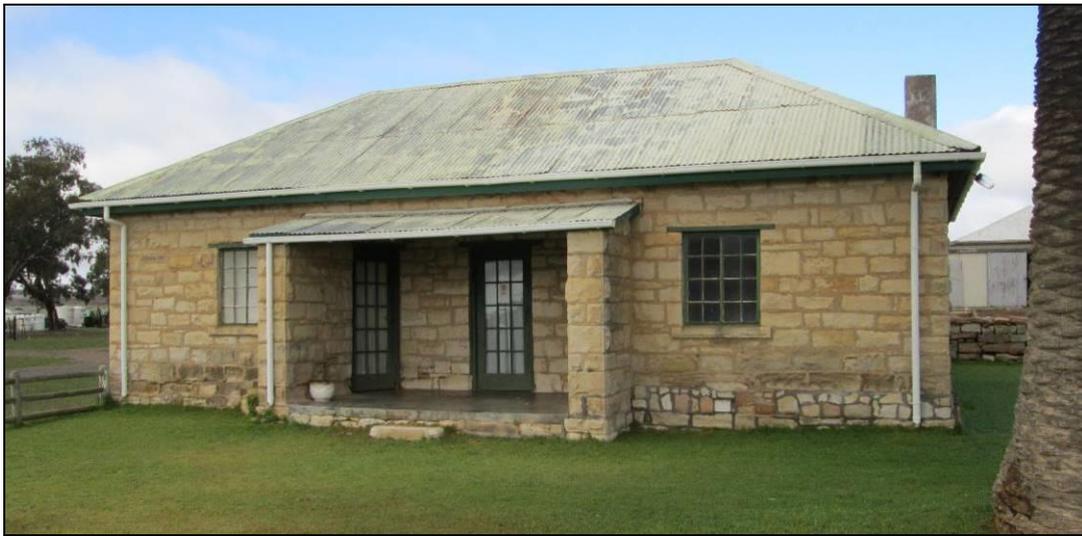
The third stone building is a house located directly to the east of the administration building. It is built in the same style but has different (older) fenestration and roofing (Figure 16). It appears as though the administration and store buildings have been recently renovated. This house retains far more of its original character than the other two structures because of the greater degree of authenticity given it by its older, perhaps original, joinery and roof. It is also the structure that will experience the greatest impact from the proposed development. Figures 17 and 18 indicate the spatial relationship between the three buildings. The two largest are built in the identical orientation, facing north, but the smaller house is set back a few metres from the plane occupied by the larger structure.

Figure 16: View of the north elevation of the stone house.

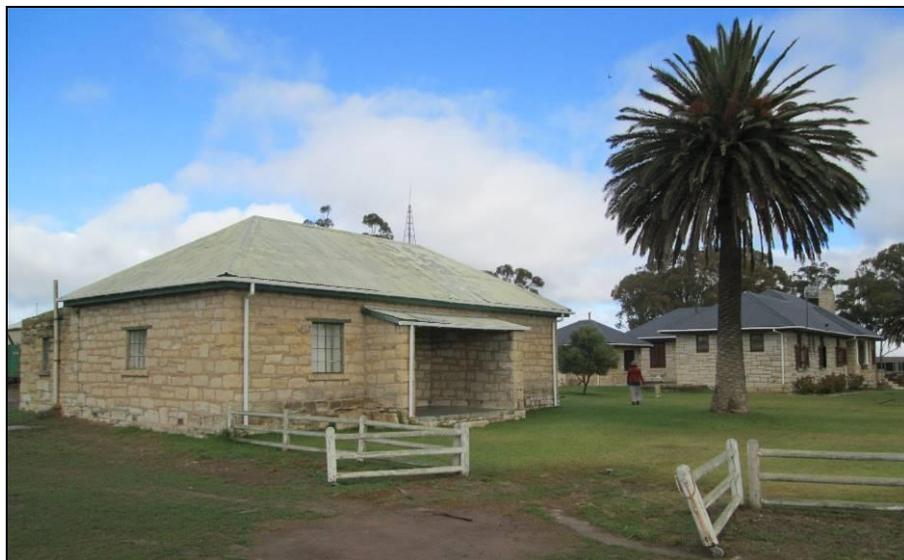
Figure 17: View of the three stone structures from the north-east.

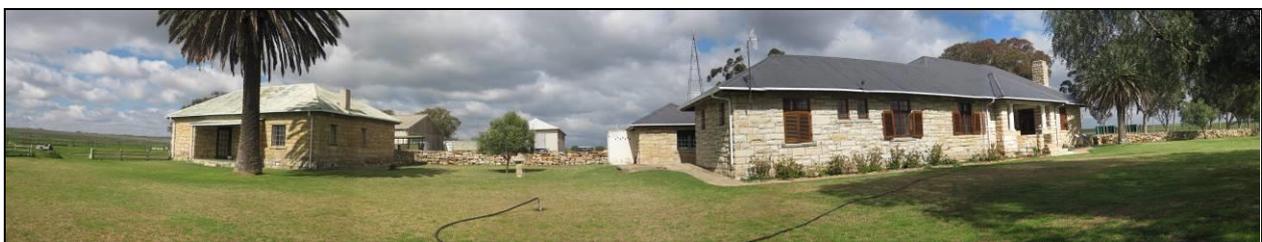
Figure 18: View of the three stone structures from the north. Photograph: Kirsty Robinson (SEC).

The age of these structures is unknown, but it seems logical to conclude from the similar styles here and in the village that they are approximately or just more than 100 years old, dating to around the time of the founding of Nieuwoudtville. Nigel Amschwand (pers. comm. 2014) who has researched the history of this area, agrees with this estimate. Figure 19 compares the earliest available aerial photograph for the area with a modern view. Over 60 years it is clear that the

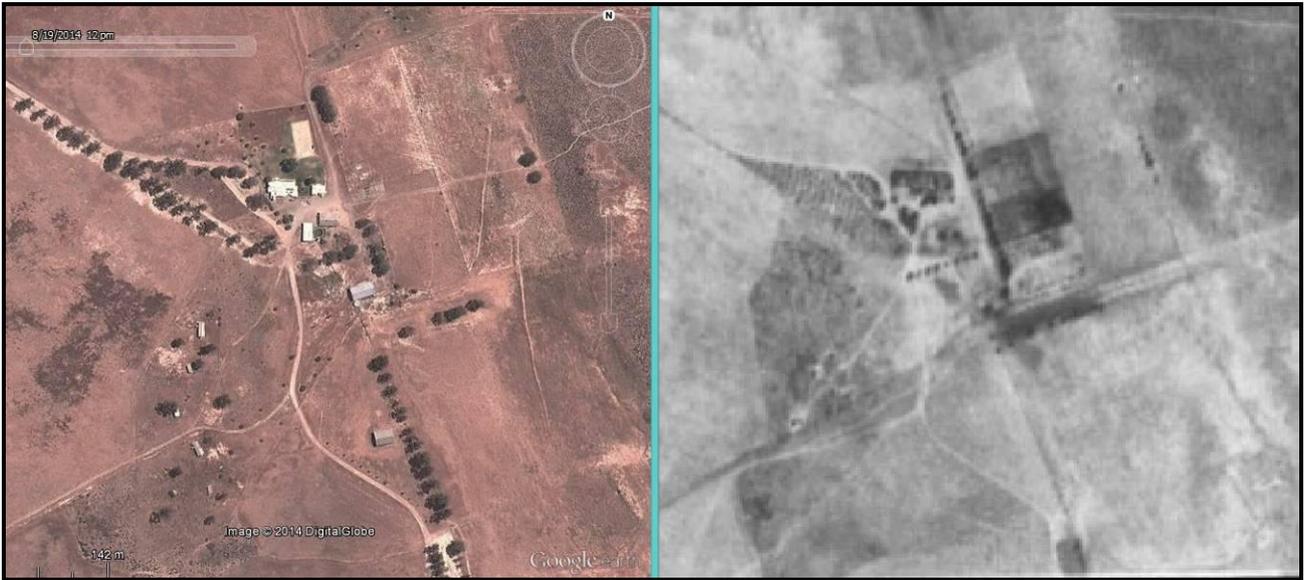
primary wharf structure has remained relatively unchanged with fields, tree lines and roads all being common to both images. Some trees have been removed, however, while others have been planted.

Figure 19: Comparative aerial views of the site as seen today (left) and in 1951 (right).

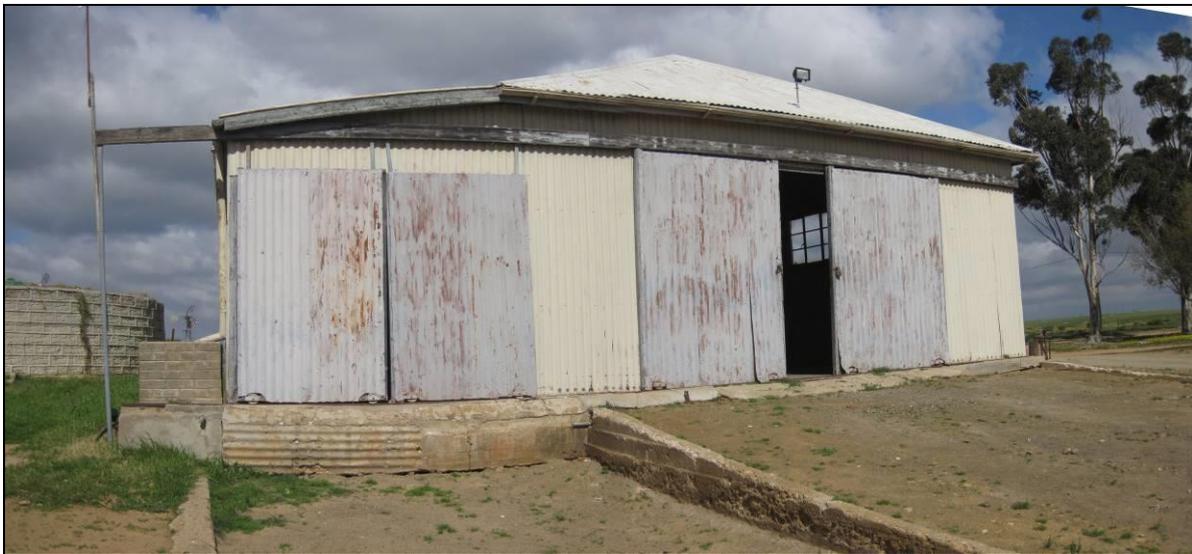
Figure 14 also shows that one of the large sheds (Figure 20) and the cement decorative breeze block dam (Figure 21) were also present by 1951, making them generally protected by S.34 of the NHRA. However, they have no particular heritage significance.

Figure 20: View towards the south of the corrugated iron shed that predates 1951.

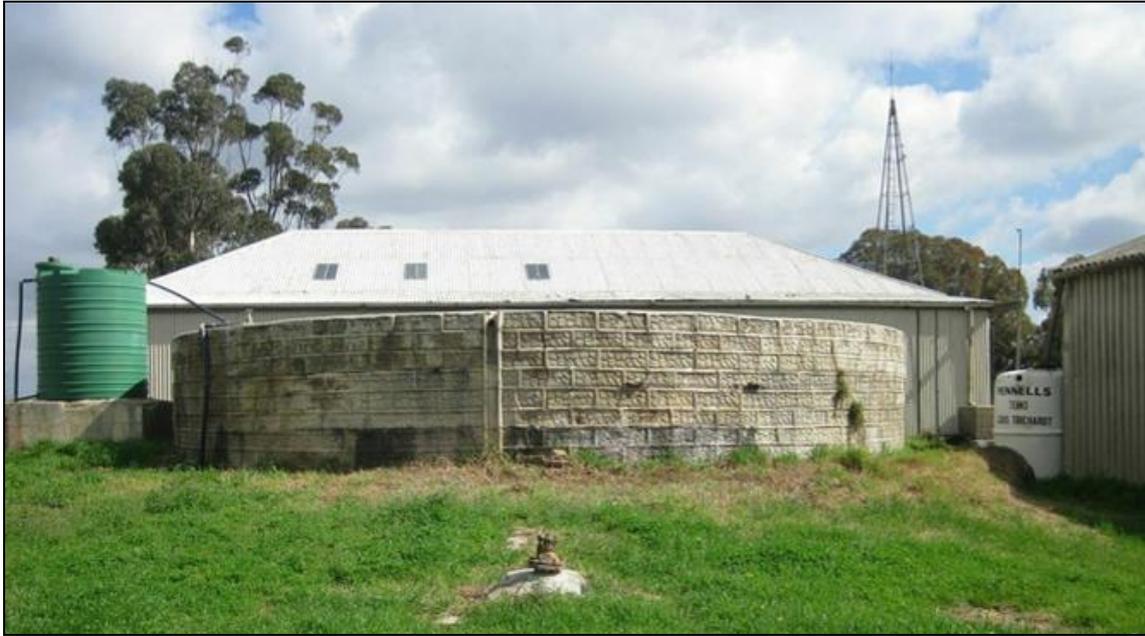
Figure 21: View towards the west of the decorative breeze block dam that predates 1951.

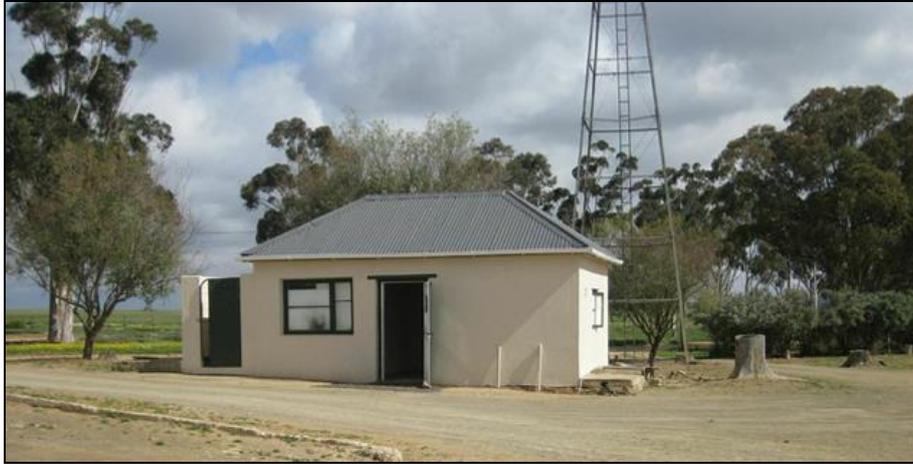
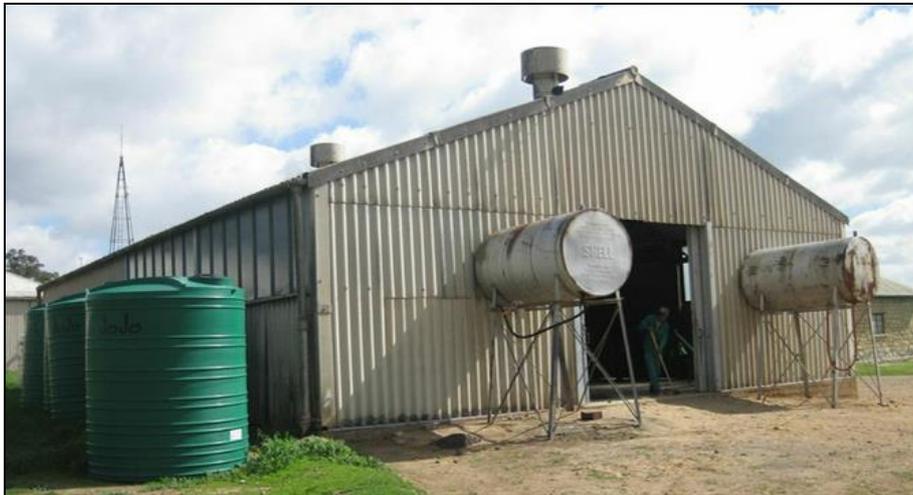
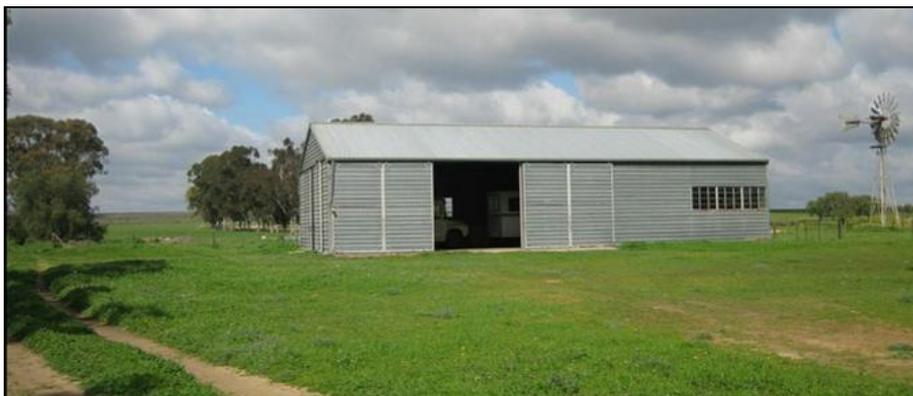
Photographs of other buildings on site less than 60 years of age. None of these structures is of any heritage value but they are noted here for the record. All pictures by Kirsty Robinson (SEC).
