Management Plan for Cultural Heritage Sites and proposed museum at Harold Johnson Management Unit

Prepared by	Celeste Rossouw (Heritage Officer, KwaZulu-Natal Amafa and Research Institute)
Date surveyed	10-11 February 2022
Date completed	31 March 2022
Accompanied by	Mrs Sharon Louw (District Ecologist of protected areas in the iLembe and King Cetshwayo Municipalities, EKZNW)

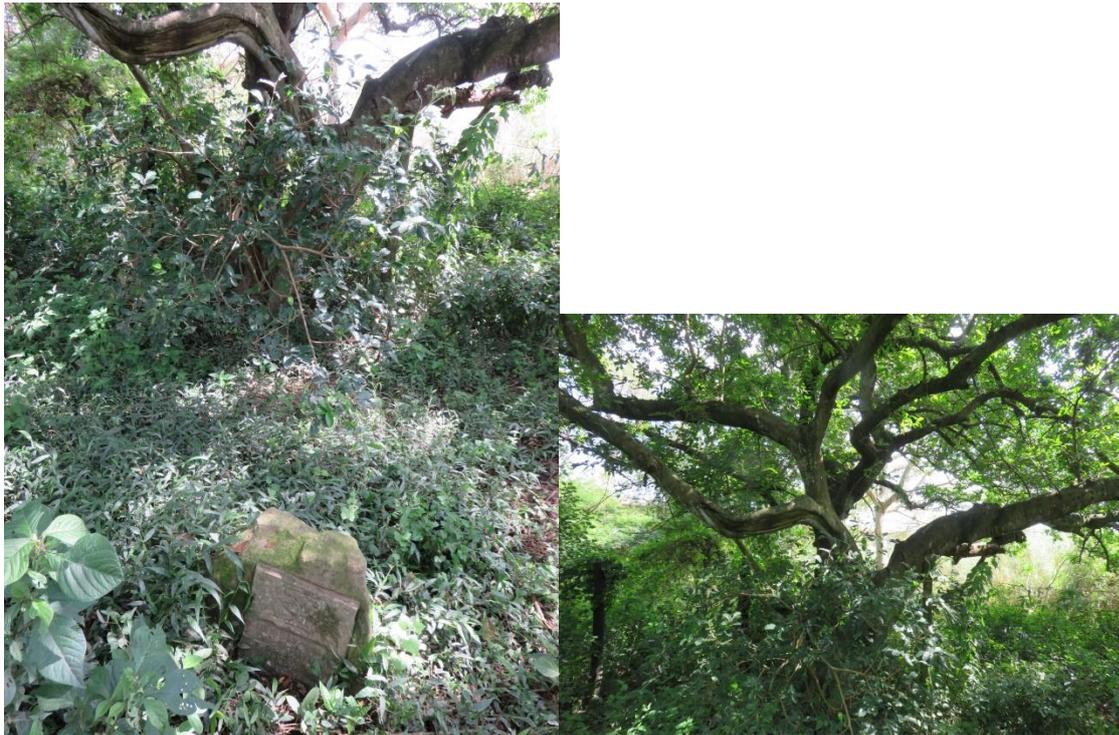
The Ultimatum Tree was possible more than thirty years old when the ultimatum was handed over and 100 years later it was still intact. However, the Domcina Floods of 1984 caused severe damage to the tree and later its death. A cutting was made and propagated. Further damage was caused during the floods of 1987 and another propagated cutting was made and planted next to the old tree stump in the 1990s. In 2004 the original tree stump was destroyed by a fire (Van Vuuren, James, 2014).

Figures Nos.4-5: A propagated tree from a cutting was planted next to the original stump, however, this stump was destroyed during the 1987-floods (Rossouw, C. 2 February 2022, storage: the Institute).

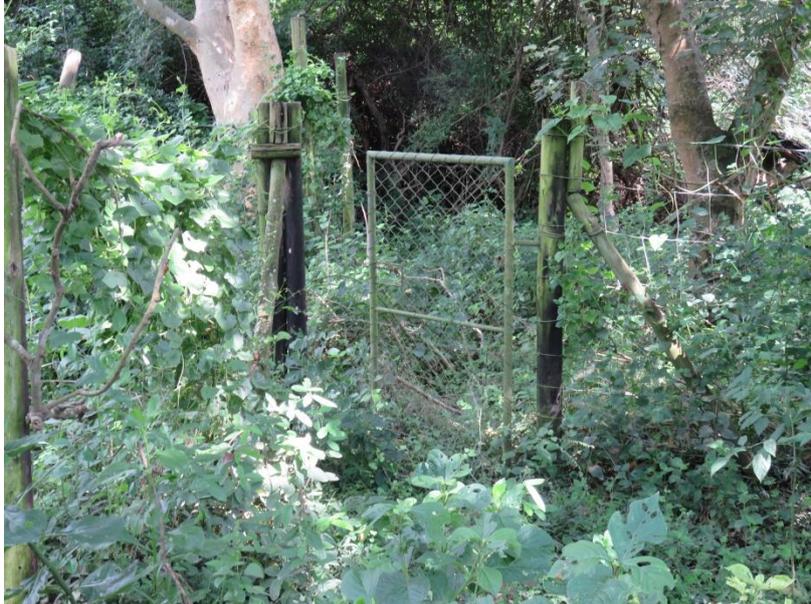
Figure No.6: Fences and park infrastructure must be maintained, and repainted annually, locks to be checked (Rossouw, C. 2 February 2022, storage: the Institute).

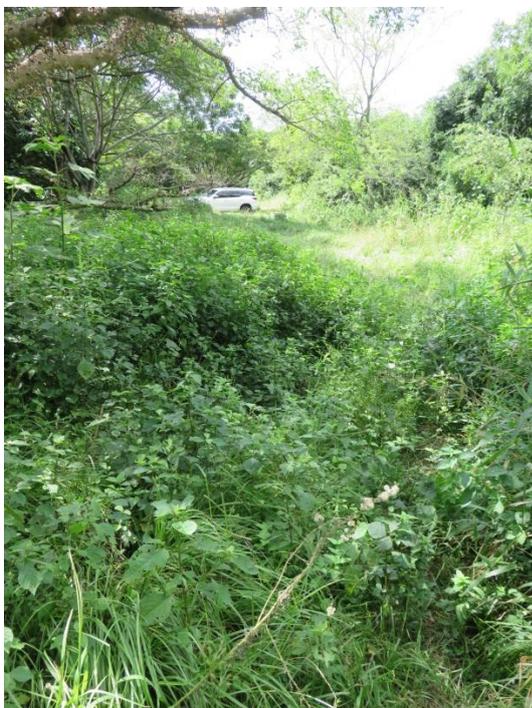
Figure No.7: Trials and pathways are overgrown, clearing is needed (Rossouw, C. 2 February 2022, storage: the Institute).

- 9) Pathways must be monitored and always maintained; paths must be trimmed every month. Self-guided trail markers must be legible and replaced if damaged.

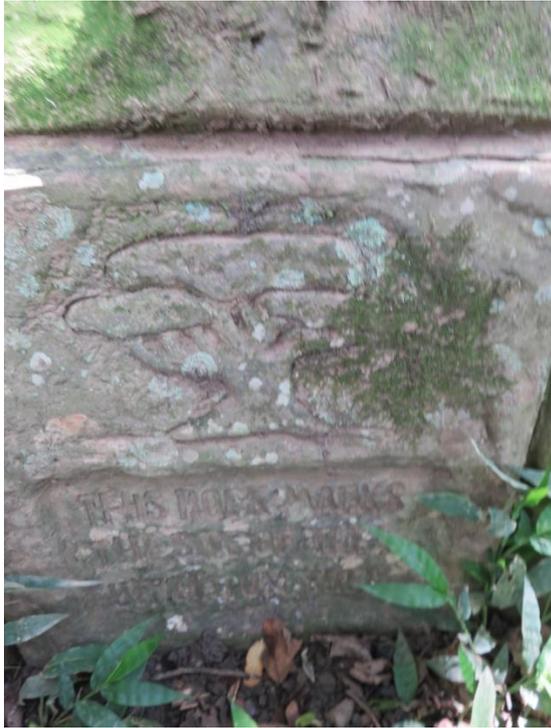
Figure No.8: Signage must be repainted in white or green when it becomes illegible “This rock marks the site of the Ultimatum Tree” (Rossouw, C. 2 February 2022, storage: the Institute).

Faded and blurred signage should be removed as this creates the impression that the protected area is not cared for and visitors will not respect a site, resulting in further disregard of the codes of conduct when visiting heritage sites, such as vandalism, littering, etc. Better Park furniture will enhance the visitors’ experience and will also encourage more visitations.

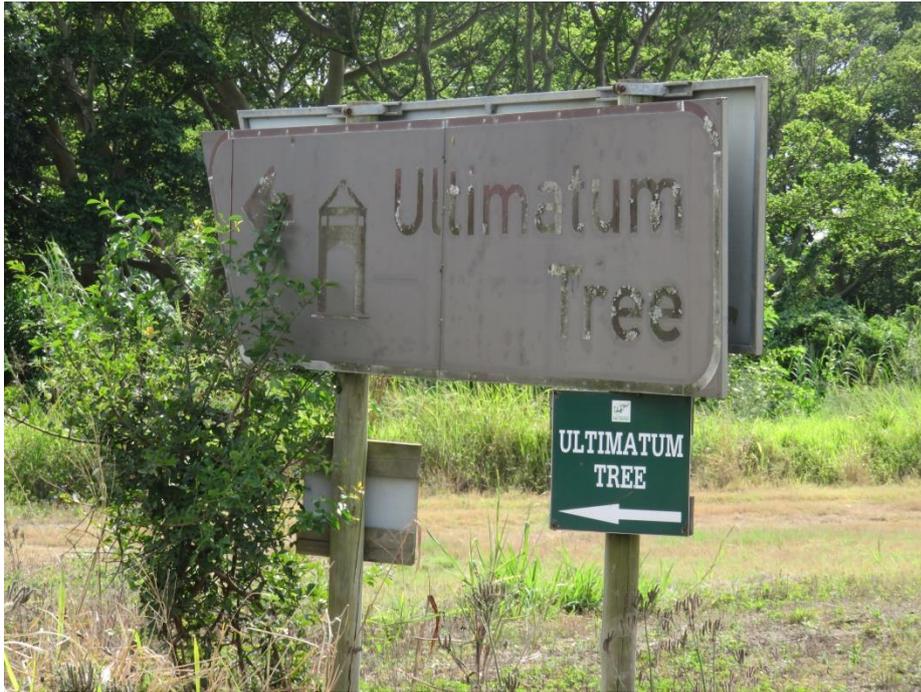
Figure No.9: Faded signage should be removed (Rossouw, C. 2 February 2022, storage: the Institute).

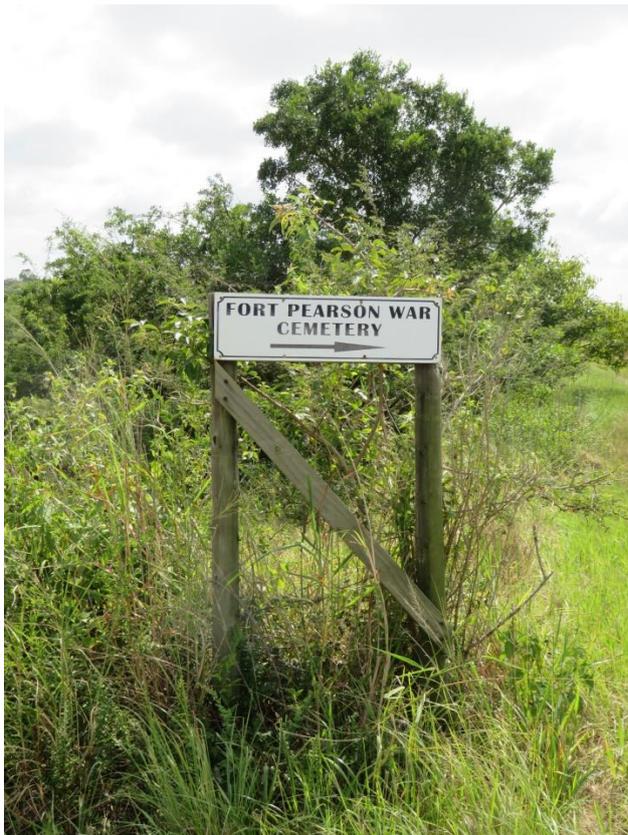
Signage is in good order. All park furniture and signage to be inspected and fixed or refurbished on annual basis.

Figure No.11: Sign indicating road to the Fort Pearson War Cemetery (Rossouw, C. 2 February 2022, storage: the Institute).

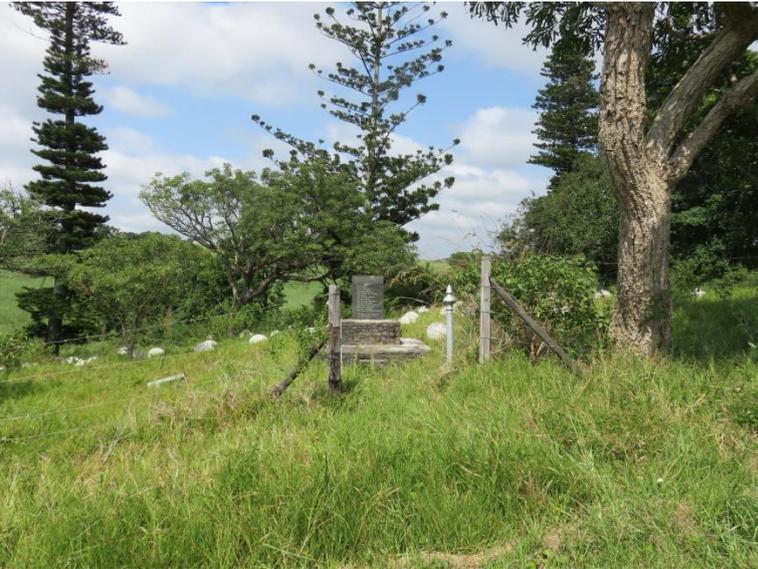
Figure No.12: Entrance to the Fort Pearson War Graveyard (Rossouw, C. 2 February 2022, storage: the Institute).

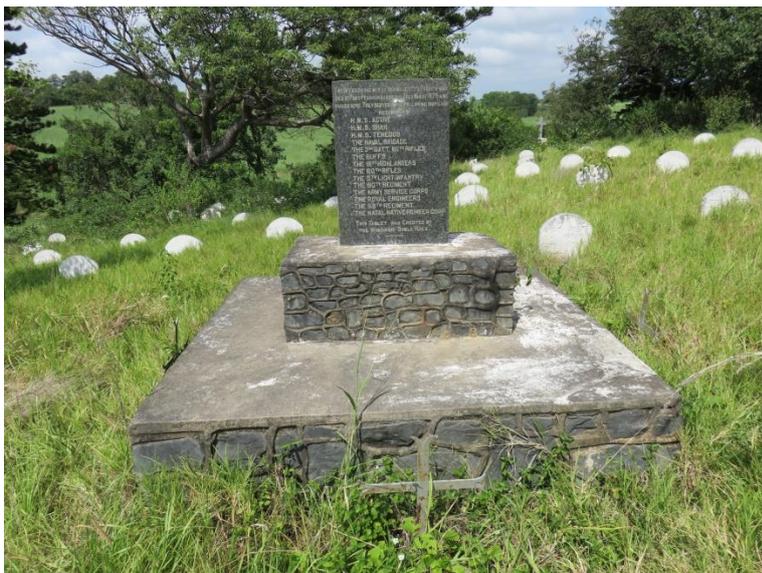
Figure No.13: tablet erected by the Windsor Shell Hole in memory of those who died at Fort Pearson (Rossouw, C. 2 February 2022, storage: the Institute).

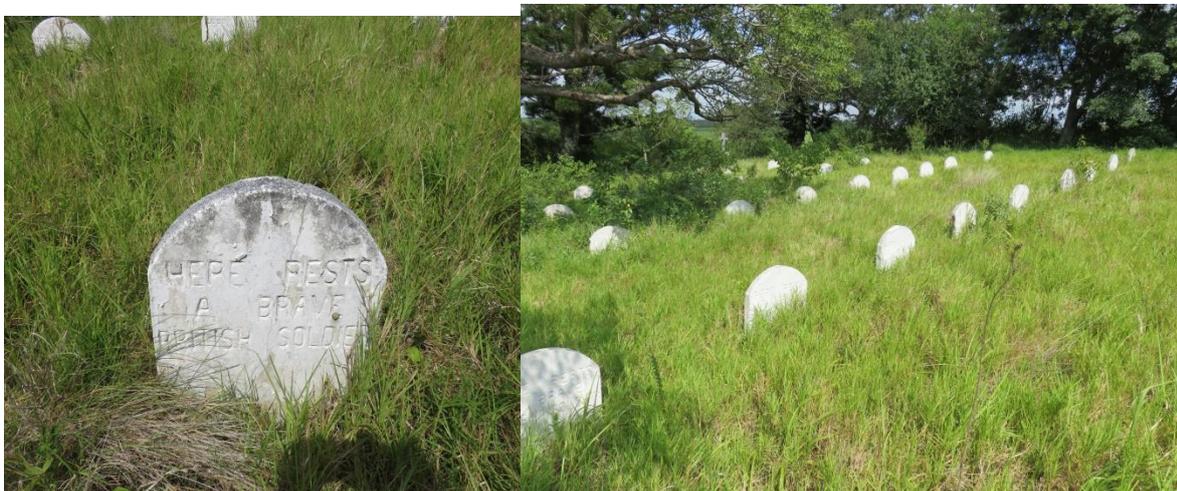
Figures No.15: There are also about thirteen graves that honours “Brave British soldiers” (Rossouw, C. 2 February 2022, storage: the Institute).

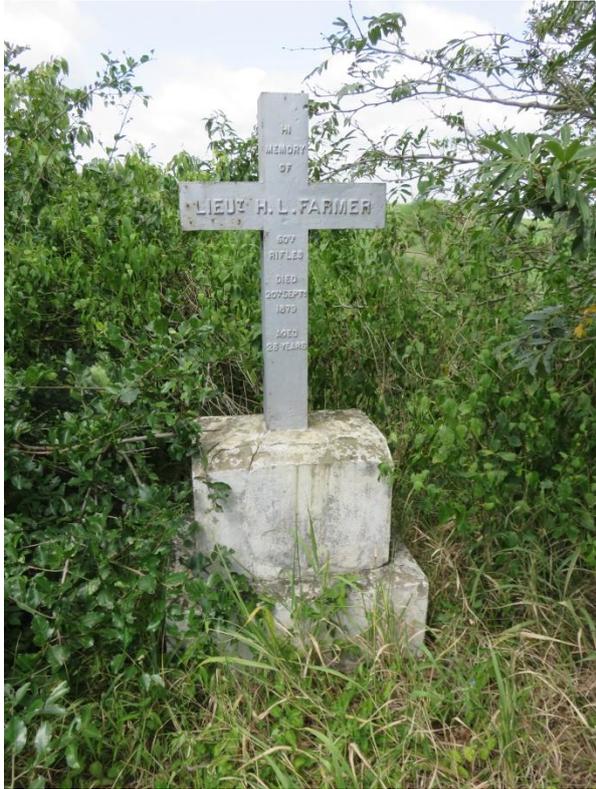
Figure No.16: Grave with metal, silver painted headstone on a concrete pedestal (Rossouw, C. 2 February 2022, storage: the Institute).

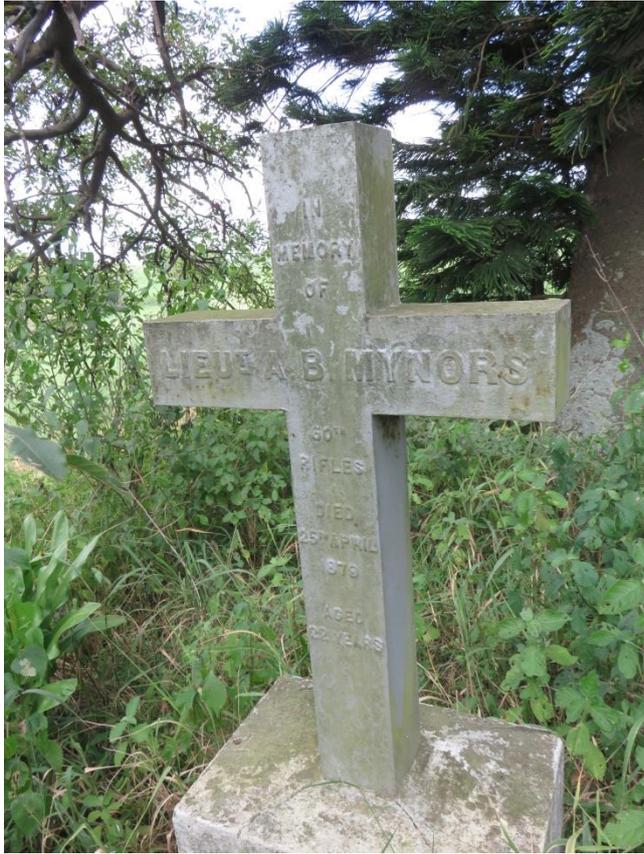
Figure No.17: Grave headstone painted silver on a concrete pedestal (Rossouw, C. 2 February 2022, storage: the Institute).

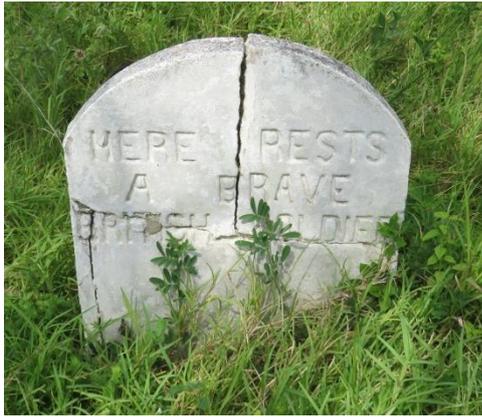
Figure No.18: Cracked headstone (Rossouw, C. 2 February 2022, storage: the Institute)

Morewood-Method: The headstone needs to be cleaned as per prescribed manner (refer to preventative care). The different pieces must be laid out flat and glued together with a mixture of blue stone chips or marble chips and a poly-sulphate rubber epoxy. The addition of chips is necessary since the expansion and shrinking during hot and cold weather conditions, will lead to abrasion between the different solid pieces, if only epoxy was applied. Pieces to be secured together and carefully laid out in a horizontal position until dry.

Watt-method: Always clean before starting the reconstruction. Use Epoxy, "Prostruct 617" and mix this in a ration 1:1 with water. This is toxic and accordingly safety clothing must be used: dress code includes gloves, goggles and a plastic overall. In cases where the stone is too brittle, the different sections can be mended together (Watt, Steve, Pers. Interview: 2010).

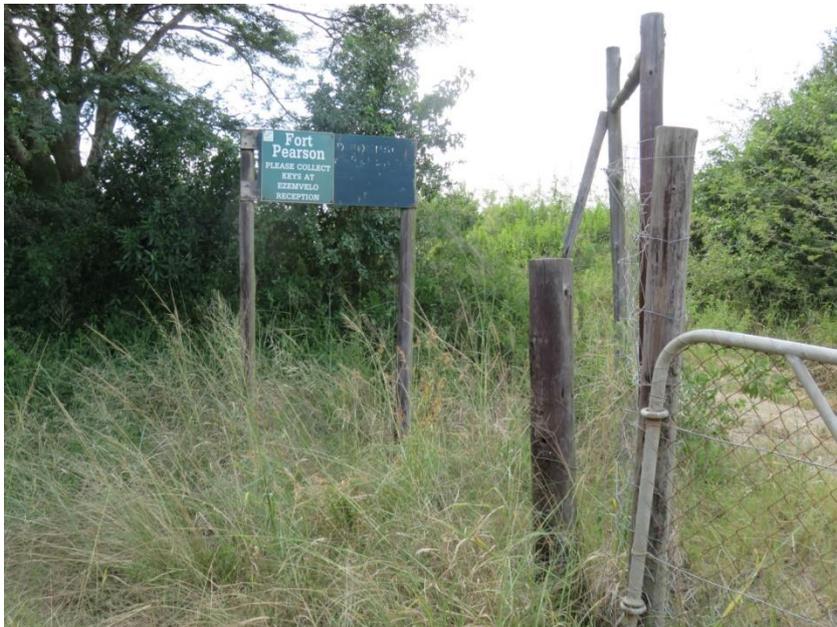
Figure No.19: Signage indicating position of the hospital graveyard of Fort Pearson (Rossouw, C. 2 February 2022, storage: the Institute).

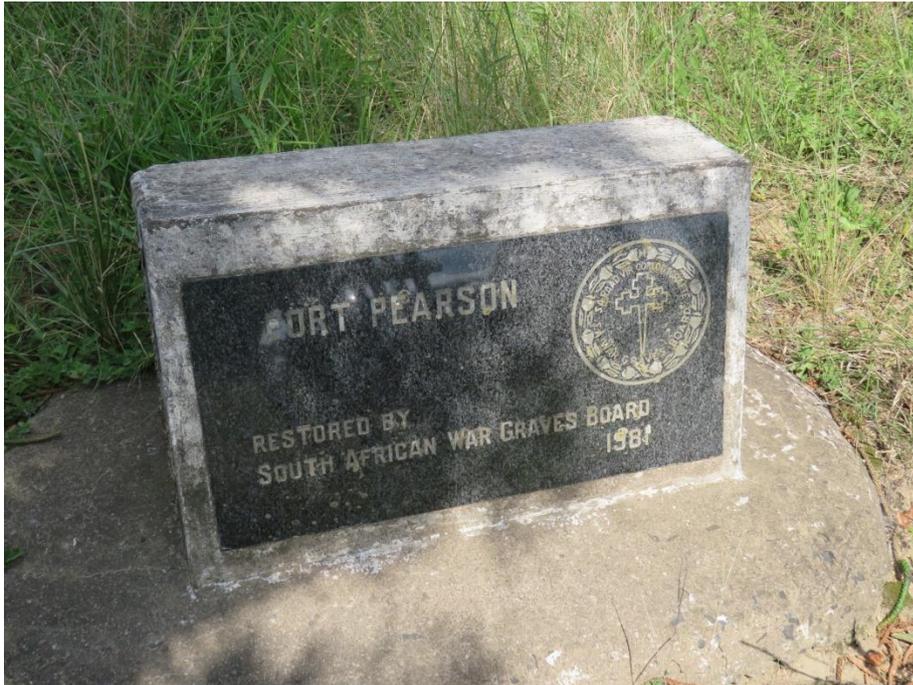
Figure No.20: Fort Pearson information plaque (Rossouw, C. 2 February 2022, storage: the Institute).

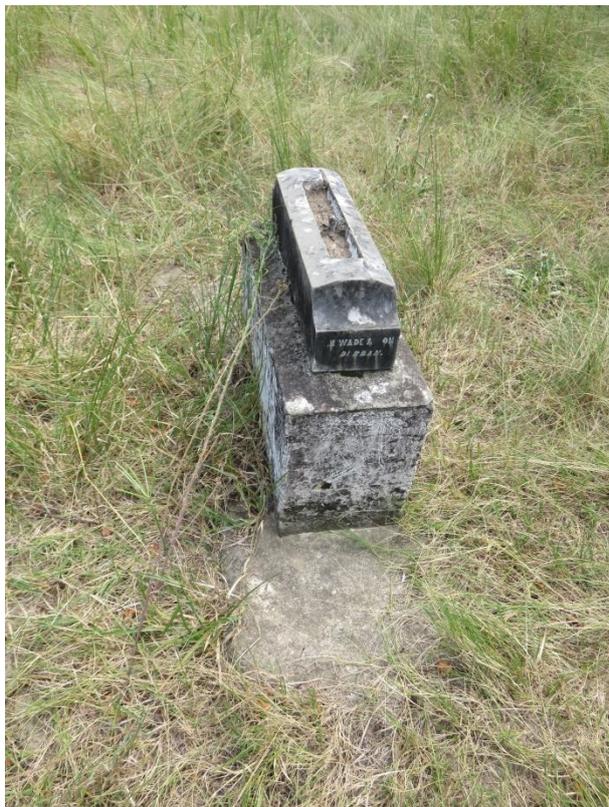
Figure No.21: Grave One – the headstone is missing, however, text on the side in led lettering reads “J.H. Wade & Son, Durban” (Rossouw, C. 2 February 2022, storage: the Institute).

Material: left over piece of a granite headstone on a concrete base or pedestal.

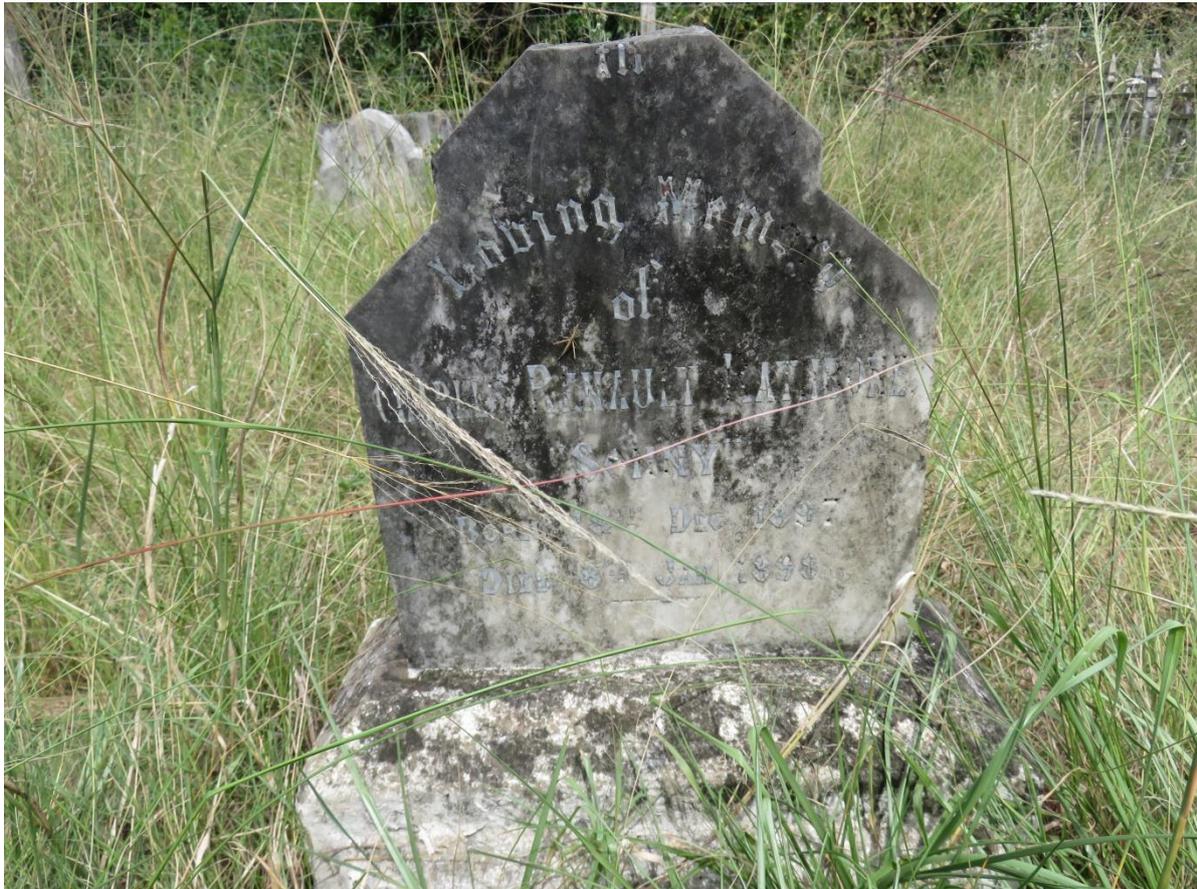
Figure No.22: Grave Two – Marble Headstone with led lettering on a concrete base (Rossouw, C. 2 February 2022, storage: the Institute).

Material: a marble headstone on a concrete pedestal, the lettering is led.

Condition: medium – the headstone is still in place but both the headstone and pedestal are covered with black lichen.

A high-pressured cleaner can only be used with granite and definitely not when the grave is severely fragile or damaged to remove especially lichen. A high-pressured cleaner may not be used when Sandstone or Marble is applicable or when the headstone is broken or very fragile. A water tank and generator will be needed when doing high pressured cleaning of a stable and thick granite headstone or ledger (Watt, Steve. Personal Interview: 2010).

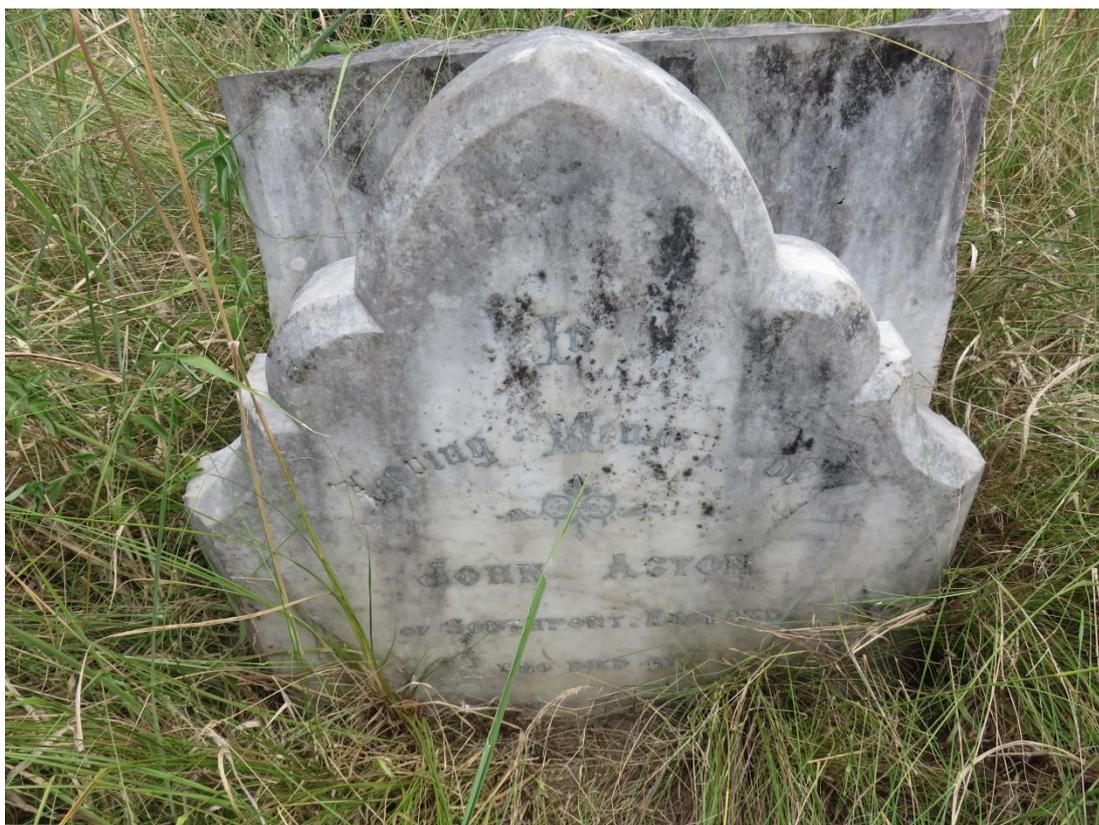
Figure No.23: Grave Three – In Loving Memory of, John Agton, of Southport England, who died at Lower Tugela (Rossouw, C. 2 February 2022, storage: the Institute).

Material: headstone of marble with led lettering.

Condition: Bad – the headstone is broken and covered with black lichen.

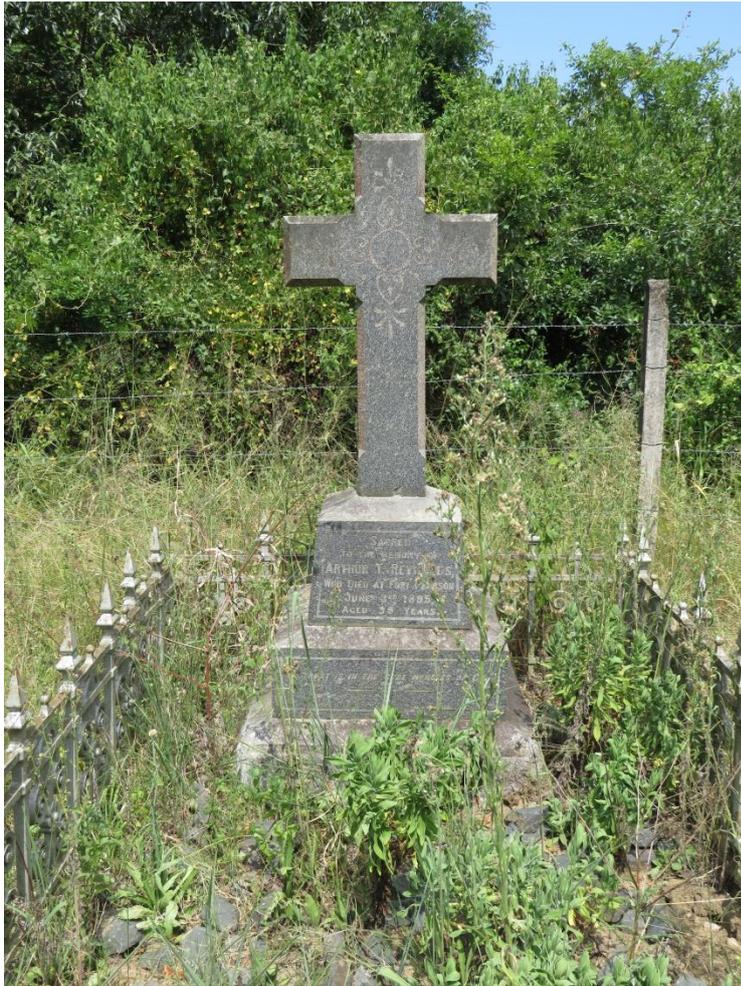
Figure No.24: Grave Four – the text reads “Sacred to the memory of, Arthur T. Reynolds, who died at Fort Pearson, June 3rd 1895, Aged 39 years/My trust is in the sure mercies of God” (Rossouw, C. 2 February 2022, storage: the Institute).

Material: The decorated headstone as well as three tiered bases is of granite and in a good condition. The ledger is of random rubble and the grave is fenced with cast iron.

Condition: the grave is in a good condition; however weeding is needed, Round-up should be used on a quarterly basis to prevent weeds and grasses on graves. If large shrubs grow on graves it can lead to subsidence.

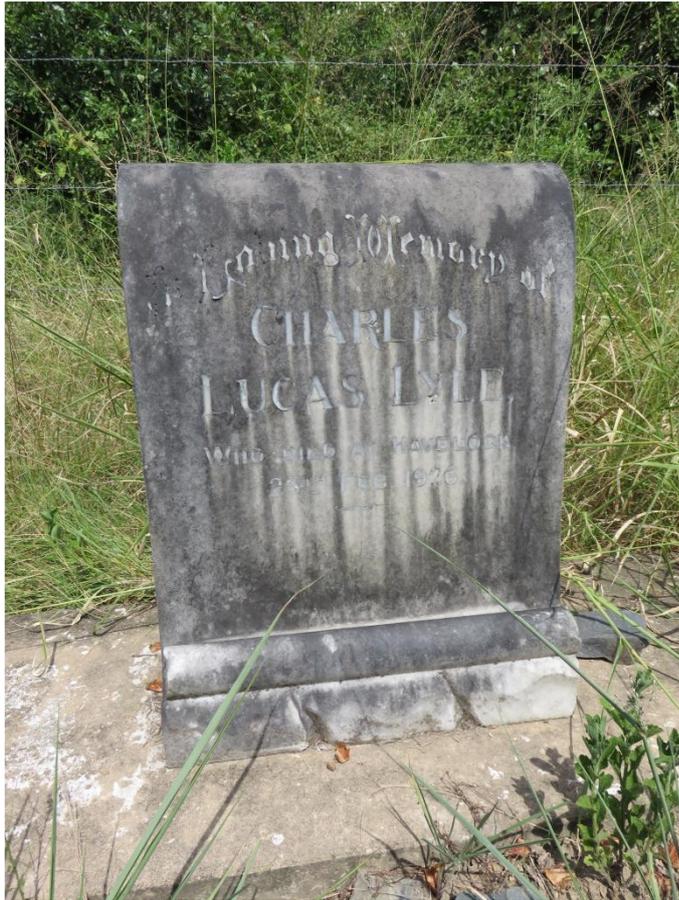
Figure No.25: Grave Five reads “In Loving Memory of, Charles Lucas Lyle, who died at Havelock, 25th Feb. 1926 (Rossouw, C. 2 February 2022, storage: the Institute).

Material: the headstone is of marble with led lettering and the base or pedestal is of concrete, the curbing is also of concrete. The ledger is filled with shale and random rubble.

Condition: The grave is in a medium condition, but it is covered with black lichen and shows chemical deterioration.

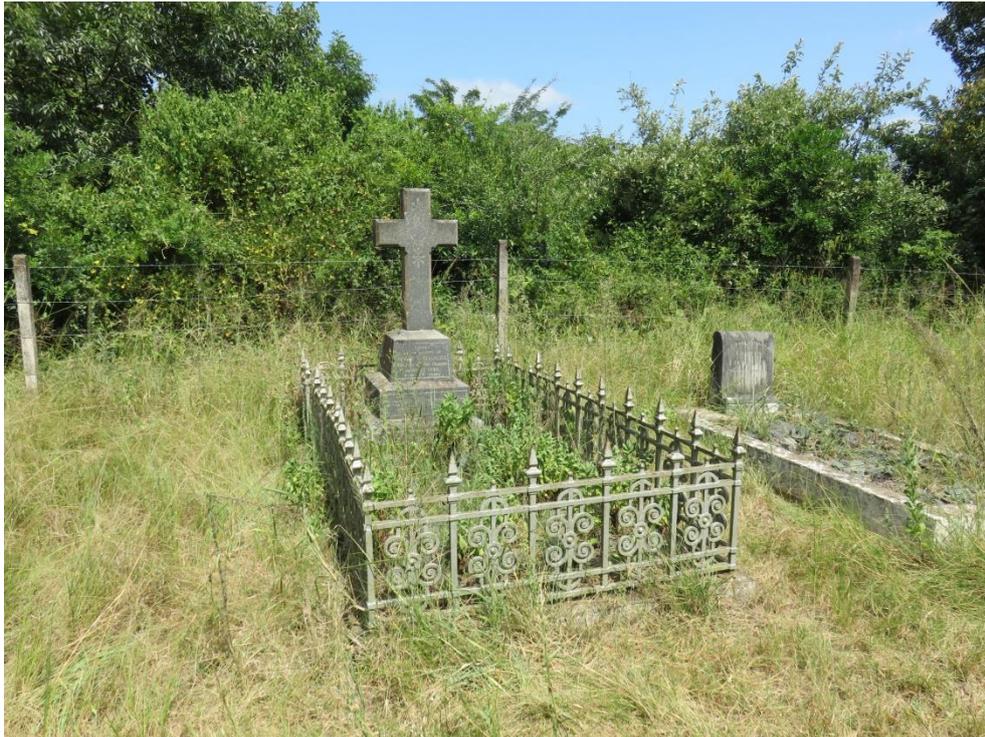
Figure No.26: Grave Number Four and Five from left to right (Rossouw, C. 2 February 2022, storage: the Institute).

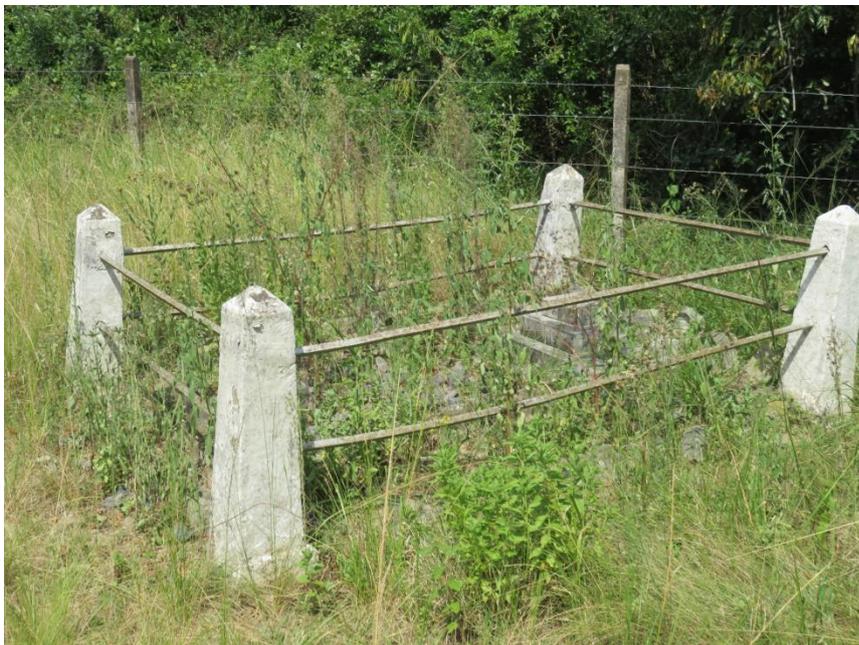
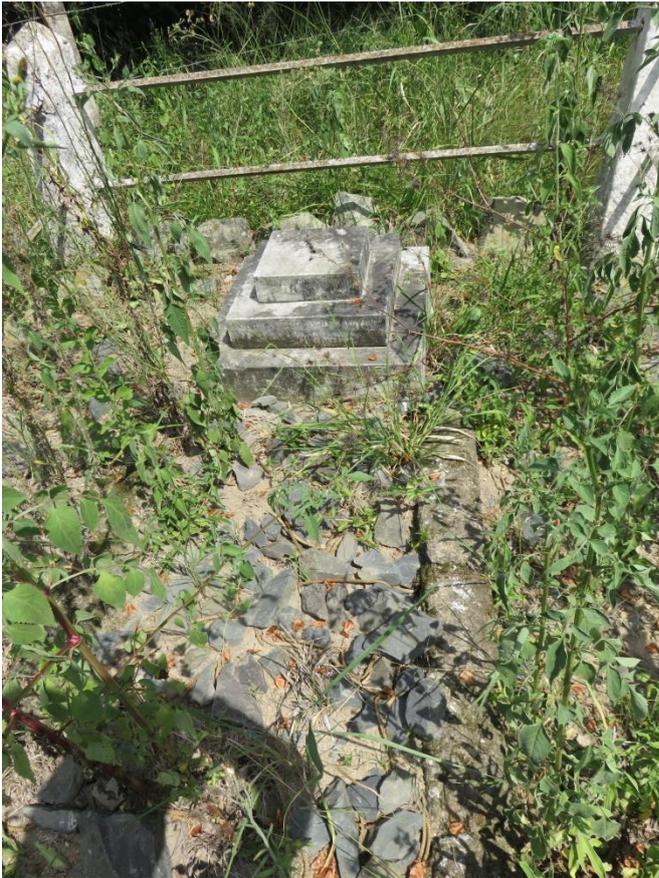
Figure No.27: Grave Number Six does not have a headstone but the three-tiered pedestals are still present with text (Rossouw, C. 2 February 2022, storage: the Institute).

Figure No.28: Three-tiered marble base/pedestal with led lettering and a ledger of concrete filled with slate and random rubble (Rossouw, C. 2 February 2022, storage: the Institute).

Condition: Bad – the cross was broken off and stolen; black lichen is present and the grave needs weeding.

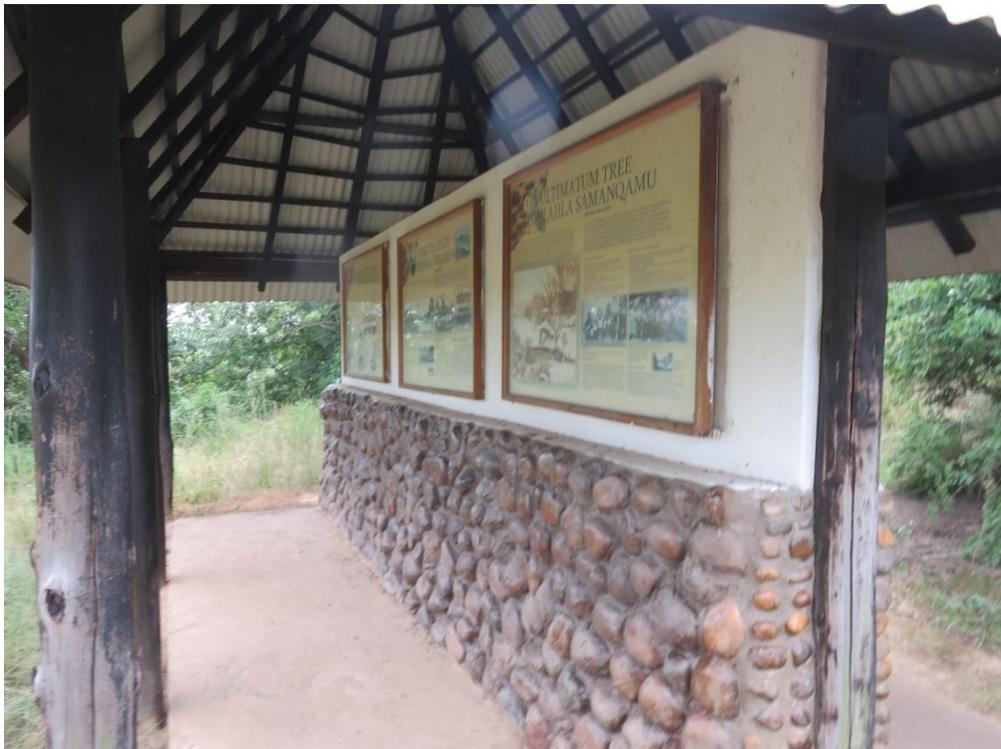
Figure No.29: Interpretive panels at the start of the trail to Fort Pearson (Rossouw, C. 2 February 2022, storage: the Institute).

The glass should be washed or cleaned at least once a month to make text more legible.

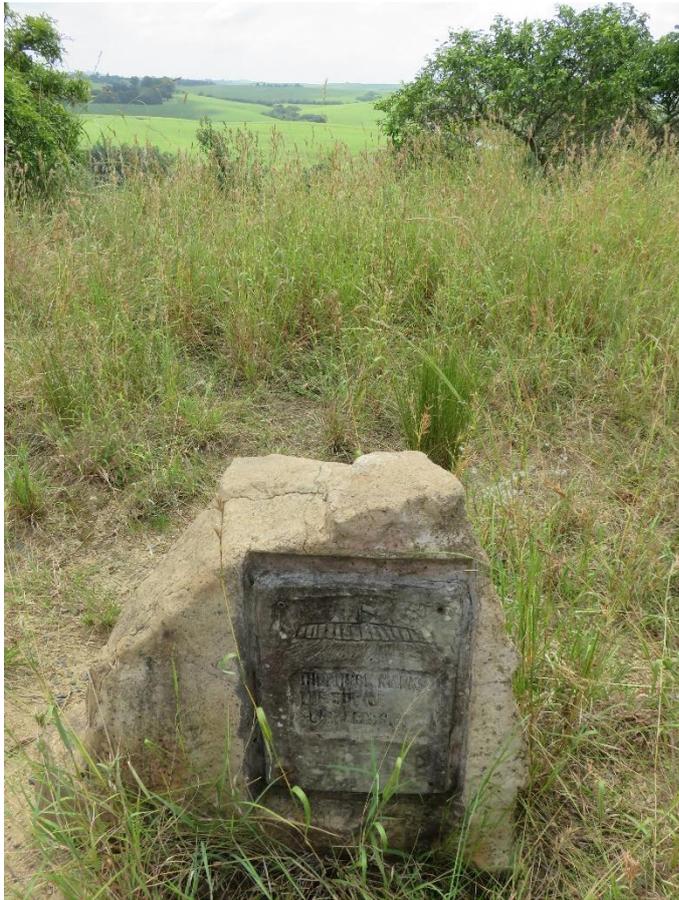
Figure No.30: Fort Pearson Site marker (Rossouw, C. 2 February 2022, storage: the Institute).

All markers, site interpretation plaques and other Park furniture must be monitored on a monthly basis and repaired at least on an annual basis. It is recommended to paint the text white or green so that it is easier to read.

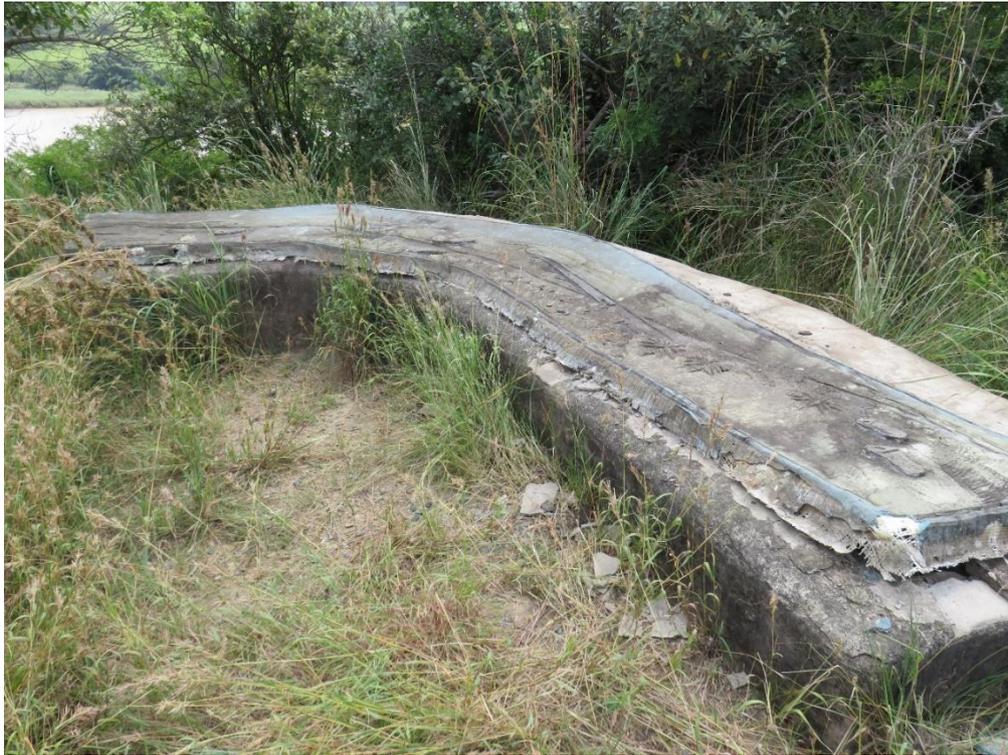
Figure No.31: Interpretive 3D-map of heritage sites to be viewed from this hill (Rossouw, C. 2 February 2022, storage: the Institute).

The condition is very bad, and it must be replaced as soon as possible.

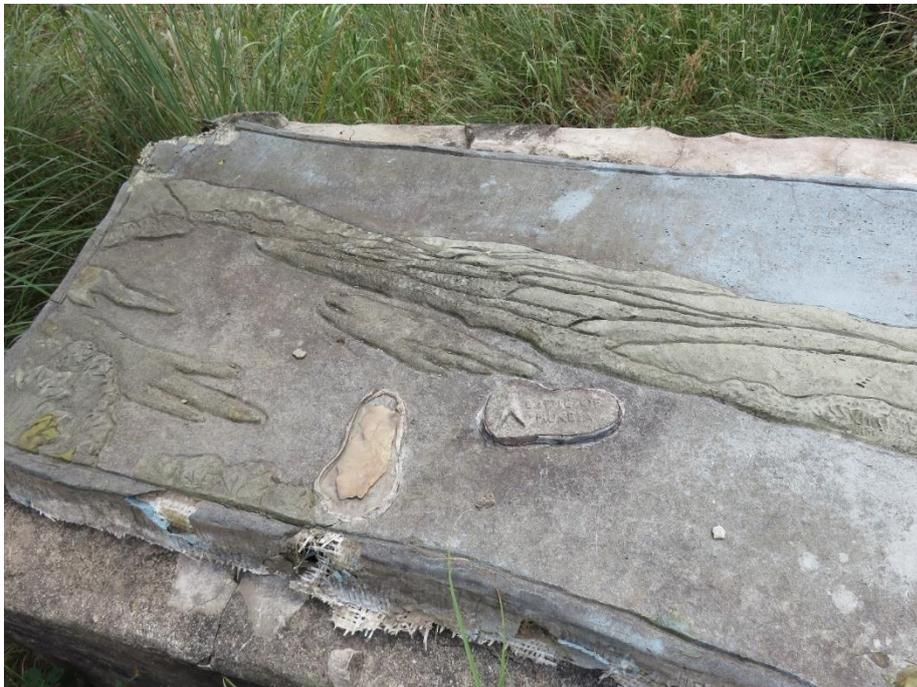
Figure No.32: Information labels from left to write: “unknown”; “Battle of Tugela” (Rossouw, C. 2 February 2022, storage: the Institute).

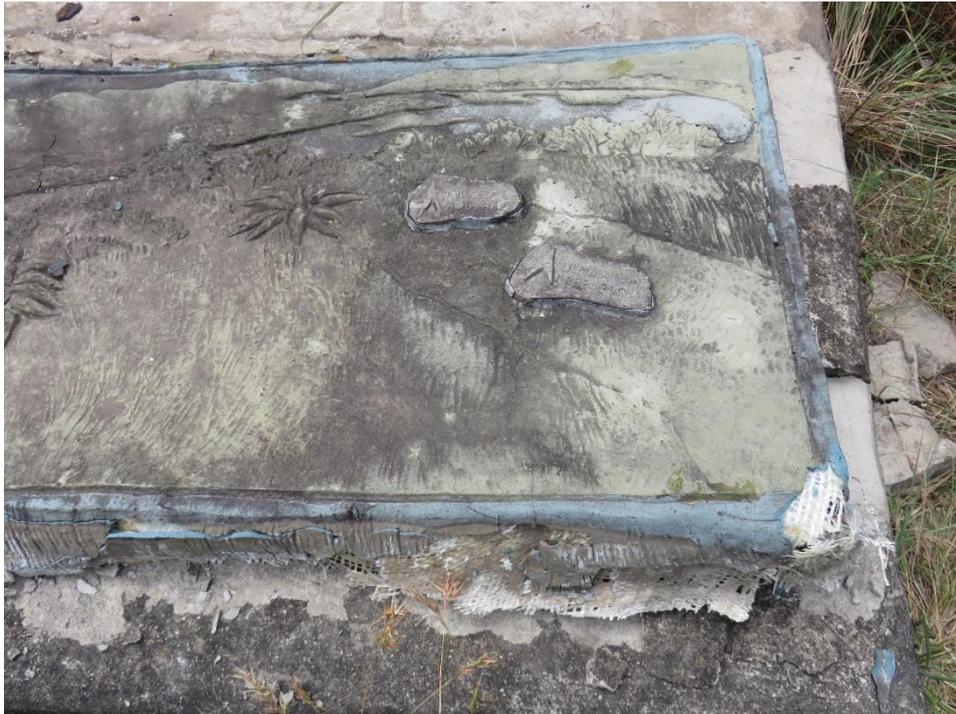
Figure No.33: Labels from left to right “Tugela Mouth” and “Ultimatum Tree 250m” (Rossouw, C. 2 February 2022, storage: the Institute).

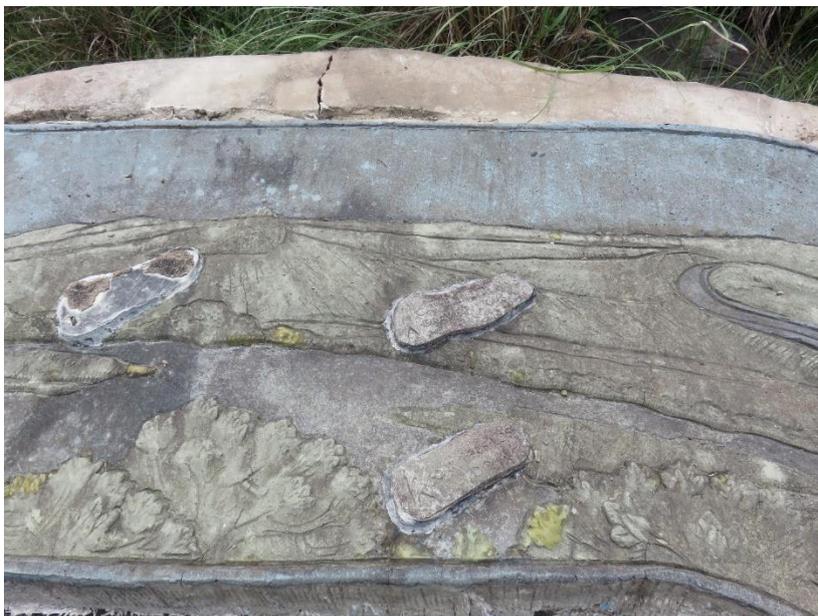
Figure No.34: Information labels form left to right, top to bottom: “Unknown” (must be replaced); “Catherine Dunn’s Grave” and “Fort Tenedos” (Rossouw, C. 2 February 2022, storage: the Institute).

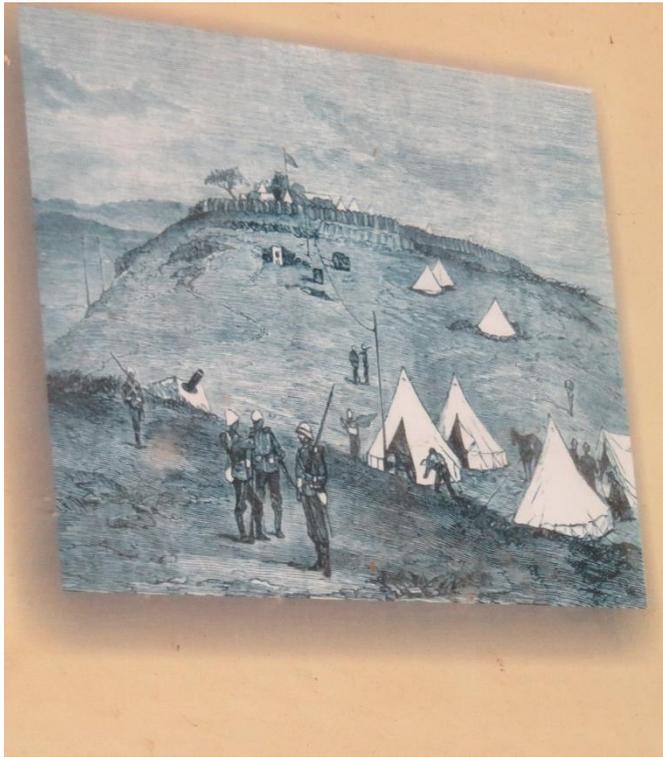
Figure No.35: Sketch of Fort Pearson (Rossouw, C. 2 February 2022, storage: the Institute).

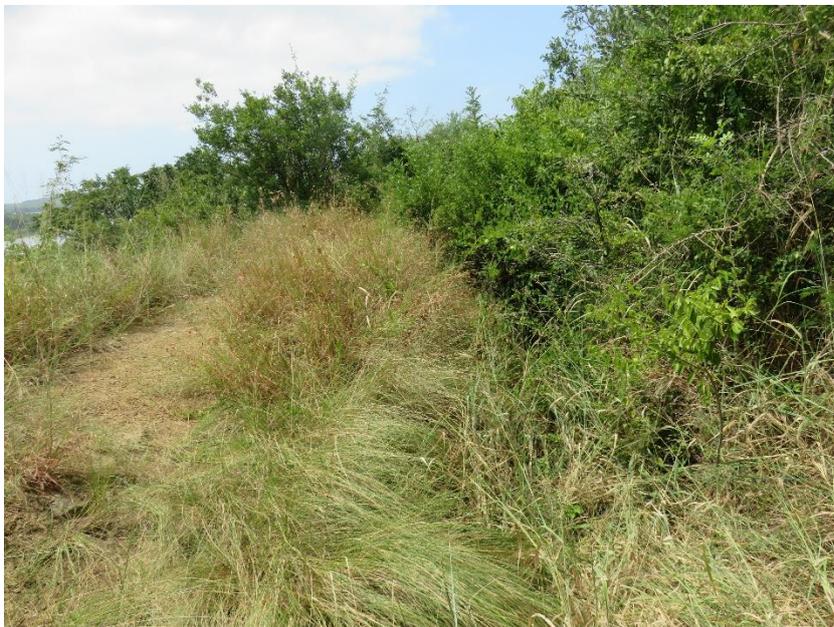
Figure No.36: The defensive earthwork surrounding Fort Pearson is still intact and well managed (Rossouw, C. 2 February 2022, storage: the Institute).

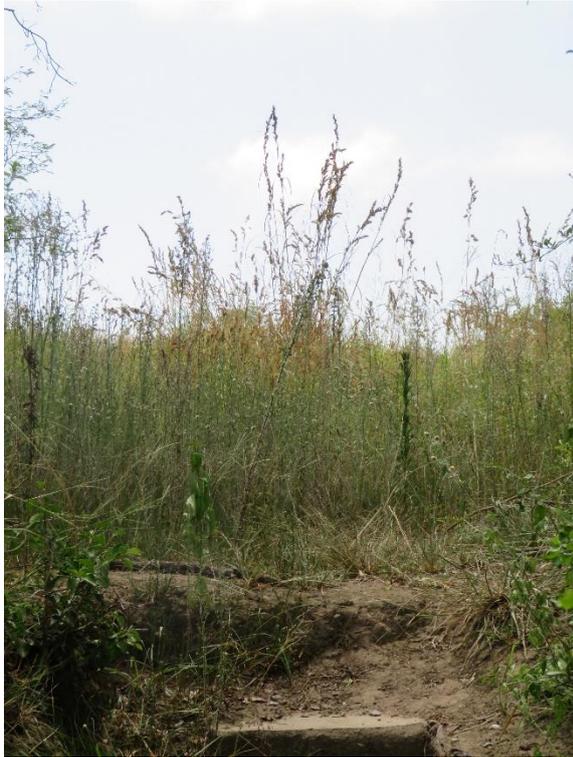
Figure No.37: Another example of earthworks at Fort Pearson (Rossouw, C. 2 February 2022, storage: the Institute).

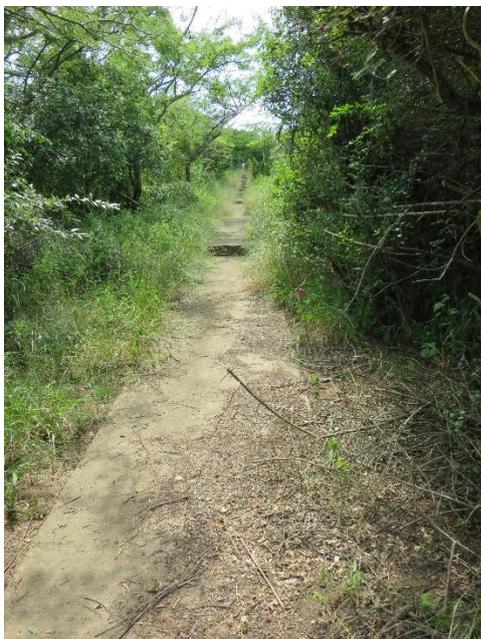
Figure No.38: Concrete walkway to Fort Pearson should be cleaned with a broom on a monthly basis and vegetation at the edges must be trimmed (Rossouw, C. 2 February 2022, storage: the Institute).
