# ARCHAEOLOGICAL IMPACT ASSESSMENT: PROPOSED DEVELOPMENT AT BOSCHENDAL WESTERN, EASTERN, CENTRAL AND SOUTHERN PRECINCTS, STELLENBOSCH DISTRICT, WESTERN CAPE

(Assessment conducted under Section 38 (8) of the  
National Heritage Resources Act as part of an EIA.)

Prepared for  
Baumann & Winter Heritage Consultants

June 2009

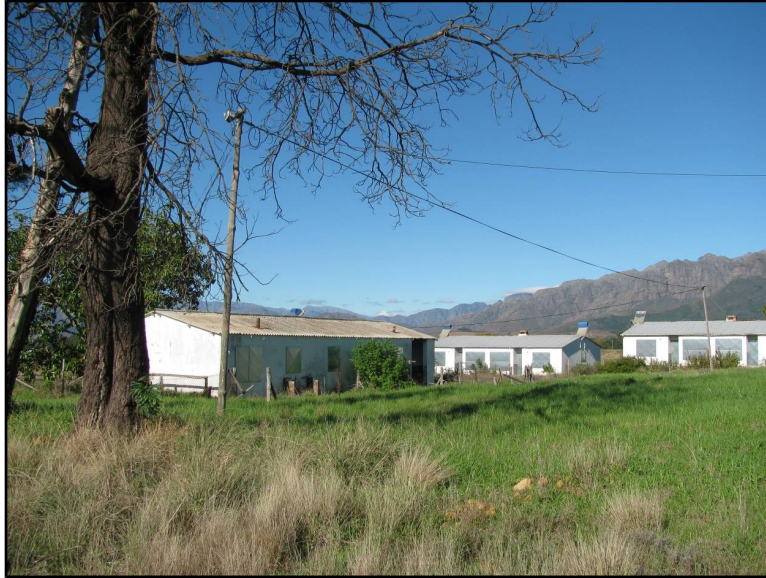
Node 6 also includes at least 5 workers houses. They are all identical in design and age. They are clearly recent and the windows have all been closed with aluminium sheeting.

Plate: Staff quarters in Node 6 of the Western Precinct, presently boarded up.

Presumably these will be retained and the other houses which fall outside of the development node will be destroyed?

The house and associated barn and graveyard in Node 6 of the Western Precinct appear to be at least 60 years old. If there are any plans for demolition, then it is important that a comprehensive mapping exercise needs to be undertaken of this house and the graveyard. Presumably the cemetery will be retained, but conservation plans need to be put in place to retain the site in good condition.

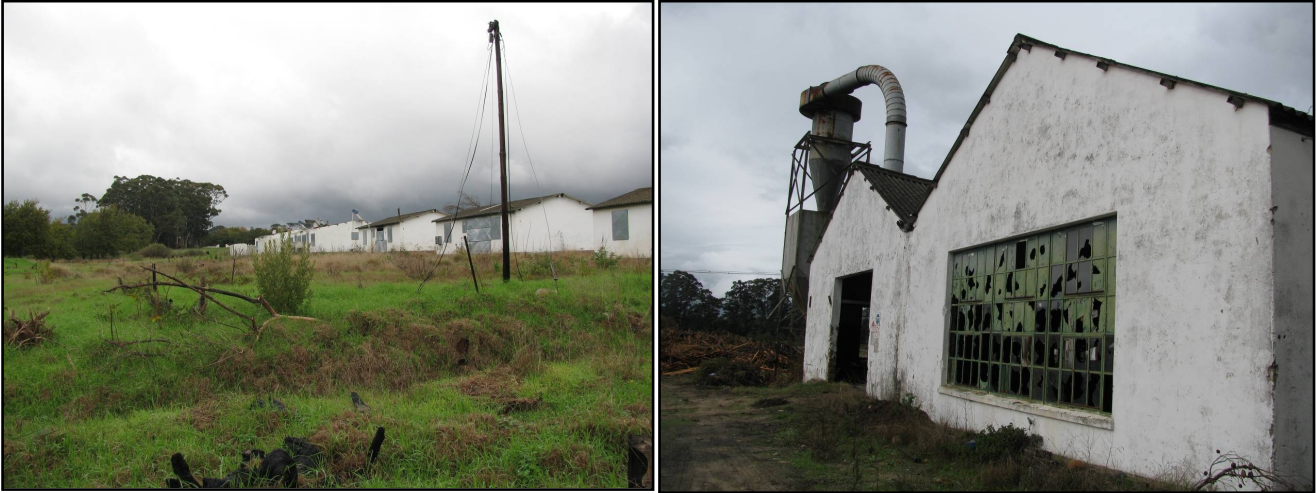
The land immediately to the north of the R310 contains a number of staff houses relating to the Rhodes Factory. Some of the houses are now unoccupied. However, all appear to be of recent construction and they are not 60 years of age.

Plate: Mix of staff housing and industrial style buildings at Groot Drakenstein.

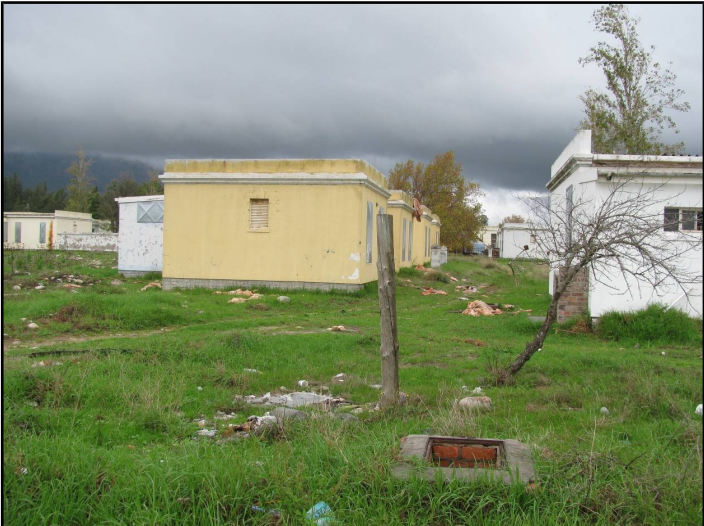
Plate: The Georgian style staff quarters in the Eastern Precinct, now boarded up.

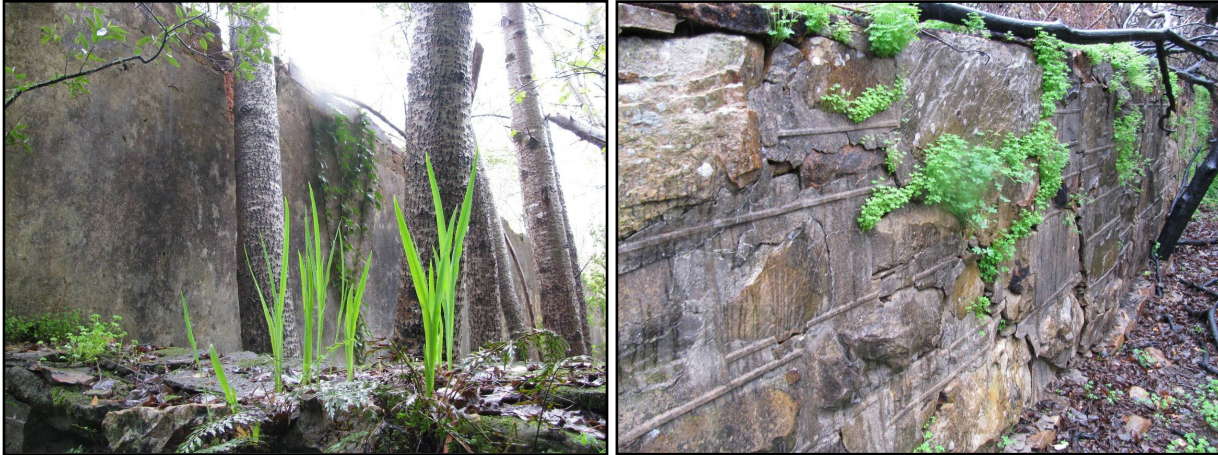
Approaching the house from the Dwars River, the ruins are on the right hand side of the road. They are well hidden by the dense vegetation and only faintly visible. The dense bush made digital photography and GPS readings difficult. The ruins consist of stone walls forming a large square, with evidence with that the interior walls had been plastered. There appears to be an entrance on one side. The walls are around 2 m high, but the one end wall is much higher, and of an uneven height. It is difficult to determine the function of this building. It does not appear to be a reservoir (it has an entrance), or a cemetery (walls too high) or a kraal (quality of the stone walling is too fine).

Plate: The ruins in the forest to the north of the Bethlehem farmstead.

*These ruins, if they belong to the original farmhouse, are potentially of great interest to historical archaeologists. They may be at risk, as inhabitants of new developments may be tempted to collect stone from these ruins. Mitigation should be undertaken and this can include, but should not be limited to, detailed survey of the ruins identified during the survey and targeted excavations of important elements.*
