**HERITAGE ASSESSMENT REPORT
ALTERATIONS TO THE EXISTING KITCHENS IN THE MARKS BUILDING
ERF 9557 CAPE TOWN**

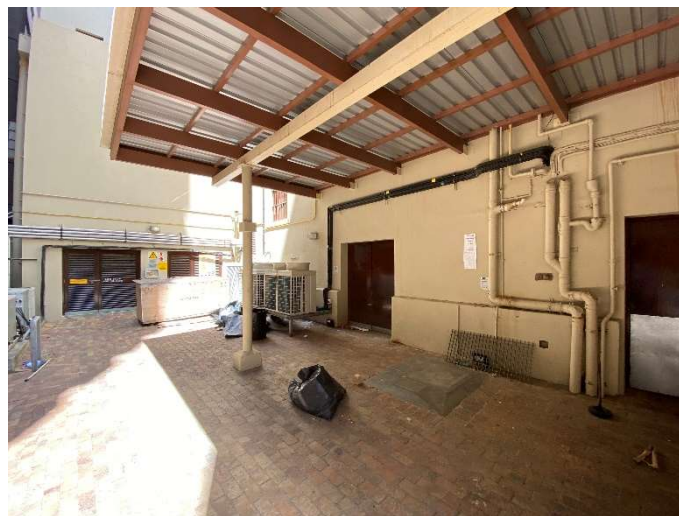
2. The Kitchens of the Marks Building are accessed from a service yard at the back of the building (see image below). From the service yard the kitchen is either accessed up an existing service stair or a lift (see images below).

Figure 2: Service yard

1. All building materials should be stored in the existing kitchen service yard.
2. All building rubble should be stored in the existing kitchen service yard.
3. Large pieces of equipment that cannot be stored in the loading area should be removed from site and temporarily stored until installed.

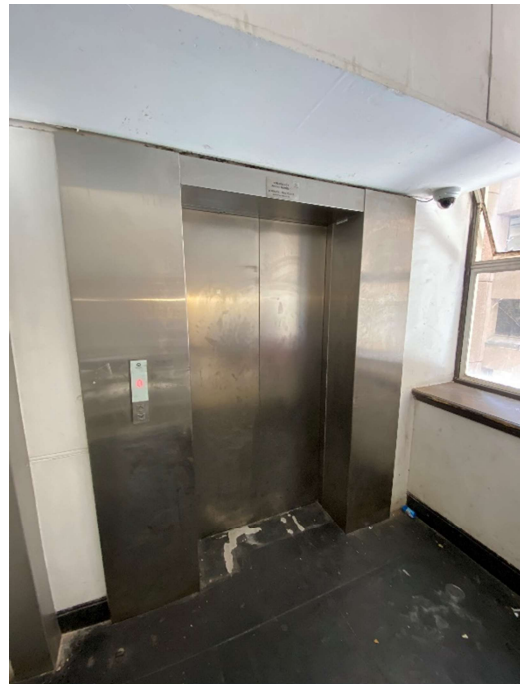
Figure 3 & 4: Access stair and service lift to the kitchen from the service yard

- Existing original windows should be protected during construction.
 - Access routes (lifts, stairs etc) should be protected from damage during the construction process. For the original staircase this should include the protection of the floors, stair treads, handrail and walls.

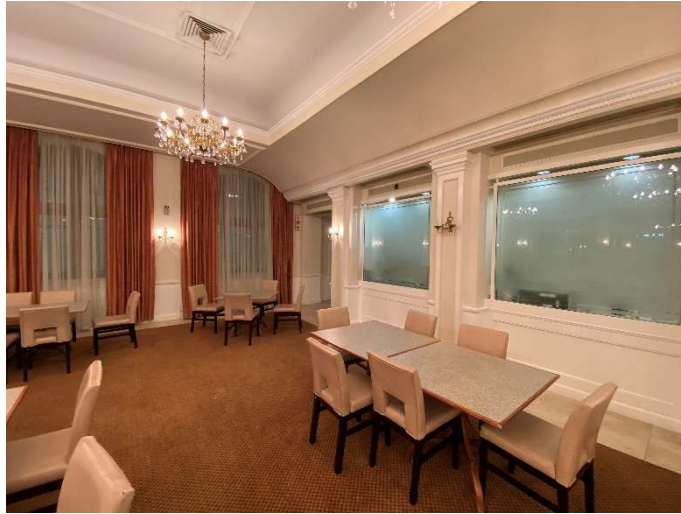
Figure 5: dining area adjacent to the kitchen with glazed openings (right) which are to be closed as part of the kitchen upgrade. No other work to occur in the dining area.

- The adjacent dining areas should have a small area cordoned off during the closing of the existing openings. The floor, walls and ceiling should be protected during the proposed work.

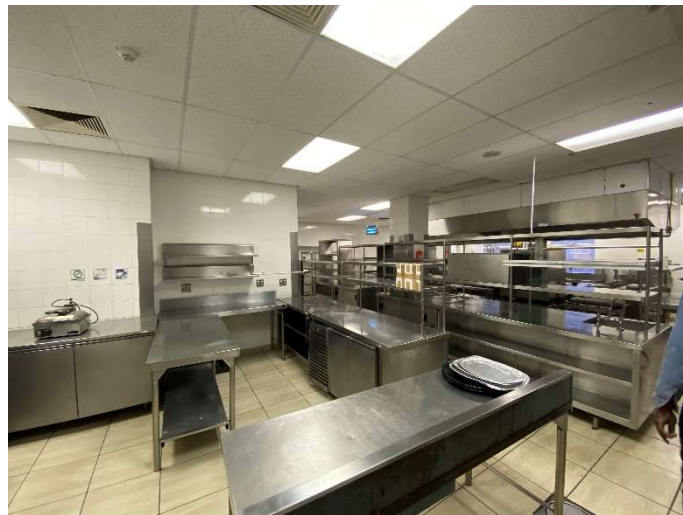
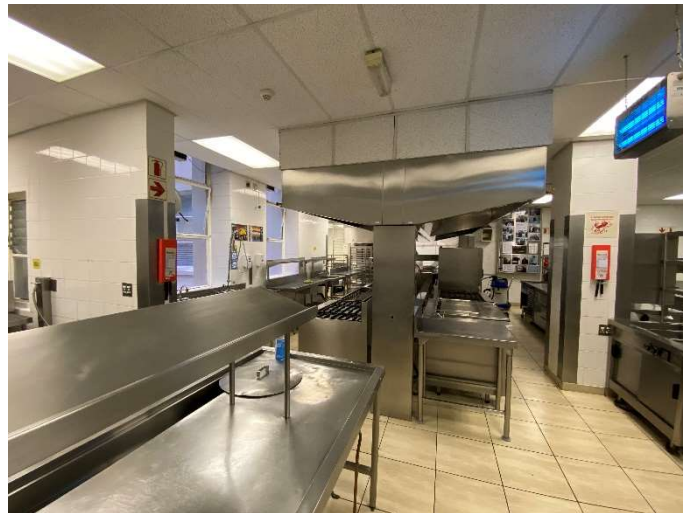
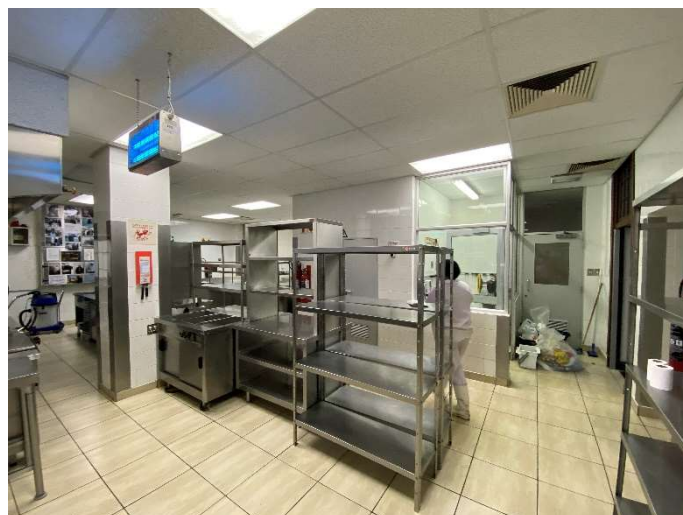
Figures 7 – 9: interior of the kitchen

- All existing wall and floor tiles are to be removed.
- All existing movable fixtures will be removed and, where possible, reused.
- Existing glazed openings to the adjacent dining room to be closed.
- The floors and walls will be retiled.
- Fittings and fixtures will be reinstalled
- The existing freezers will be retained.
- The existing layout will remain with no structural work.
- No work will take place in the adjacent dining areas.
