**HERITAGE CONSERVATION COMPONENT
OF THE STRUCTURE PLAN FOR**

SARON

**National Monuments Council
in partnership with the Saron Heritage Committee**

April 1998

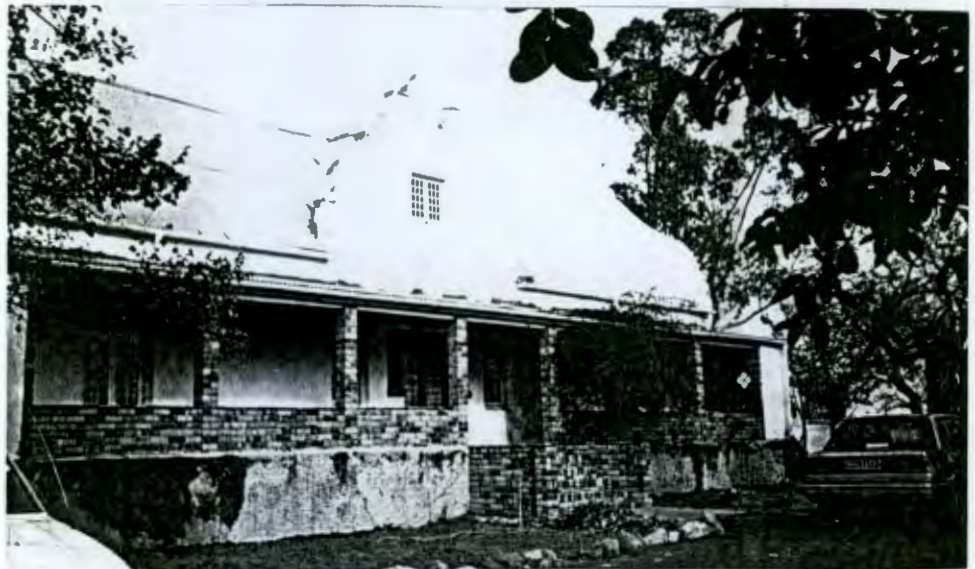
Walled area.

The walled area is located in front of the pastorie. This was originally a 'werf' wall. The area inside the wall was used for a vegetable garden by the missionaries. The wall is in need of repair.

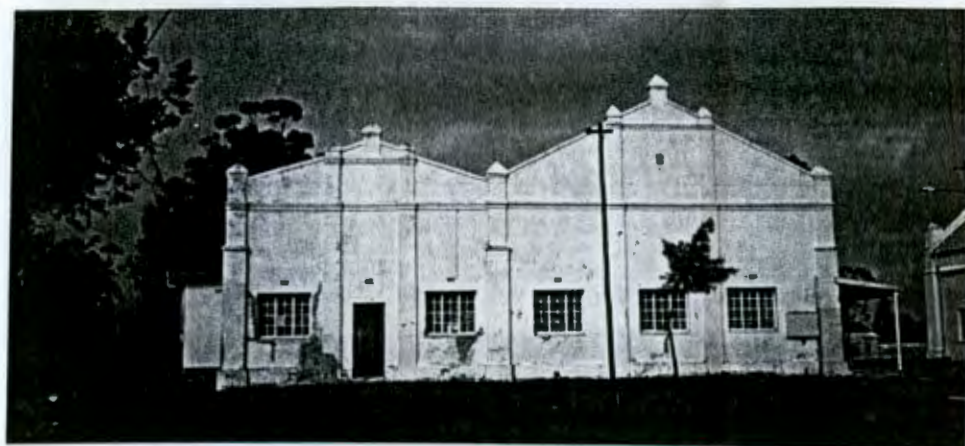
Site 4
Erf 40/2
Circa 1877

Retains some original joinery

Until 1877 school at Saron was held in a former wine-cellar of the farm De Leeuwenklip. In 1877 a new school/church hall was built alongside the church. In 1914 the building was significantly altered and given its present appearance.

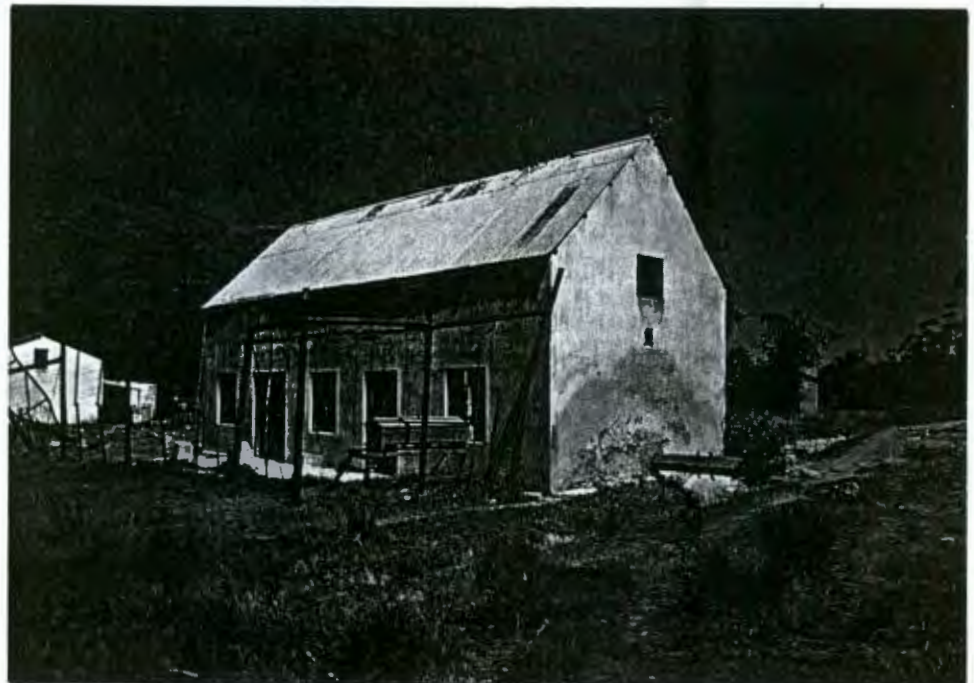
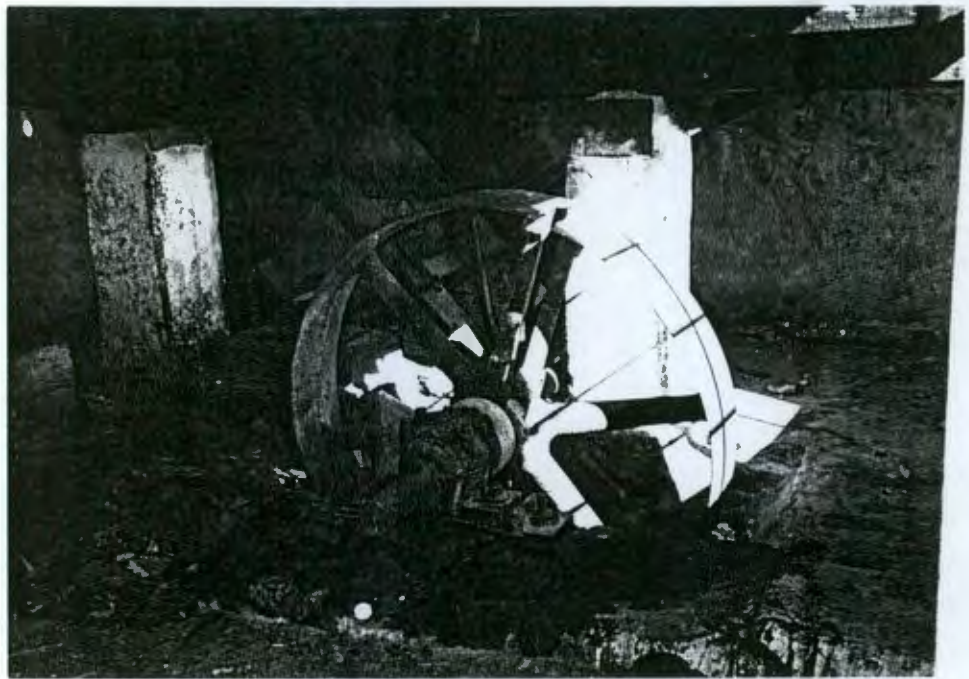
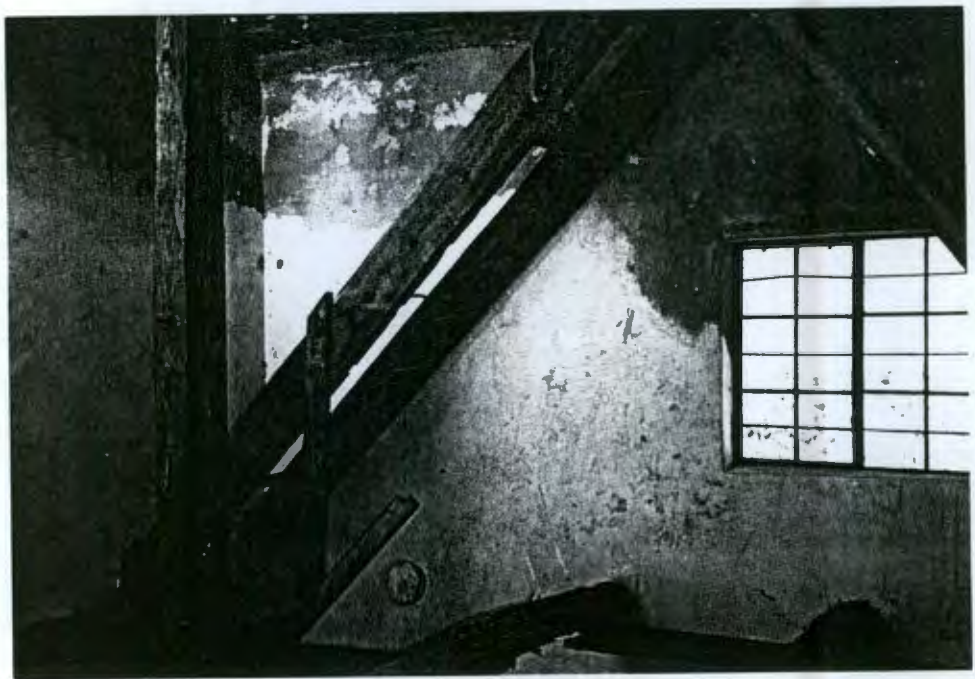
Water Mill

The mill represents a significant aspect of Saron's agricultural and industrial history. It is one of the few remaining mills in South Africa. While it is no longer in use, it retains its mill parts and the possibility of restoring the mill to a working condition appears to be feasible.

Site 8
Erf 40/3
Circa 1790
Note-worthy features **Retains original joinery and mill parts**
Comments **In use until 1945. The building represents an important aspect of Saron's industrial and agricultural history. It is one of the few remaining mills in South Africa.**

The NMC, the Saron Heritage Committee and the CPO have agreed to work together on this project. The NMC intends to donate funds towards emergency repairs of the mill.

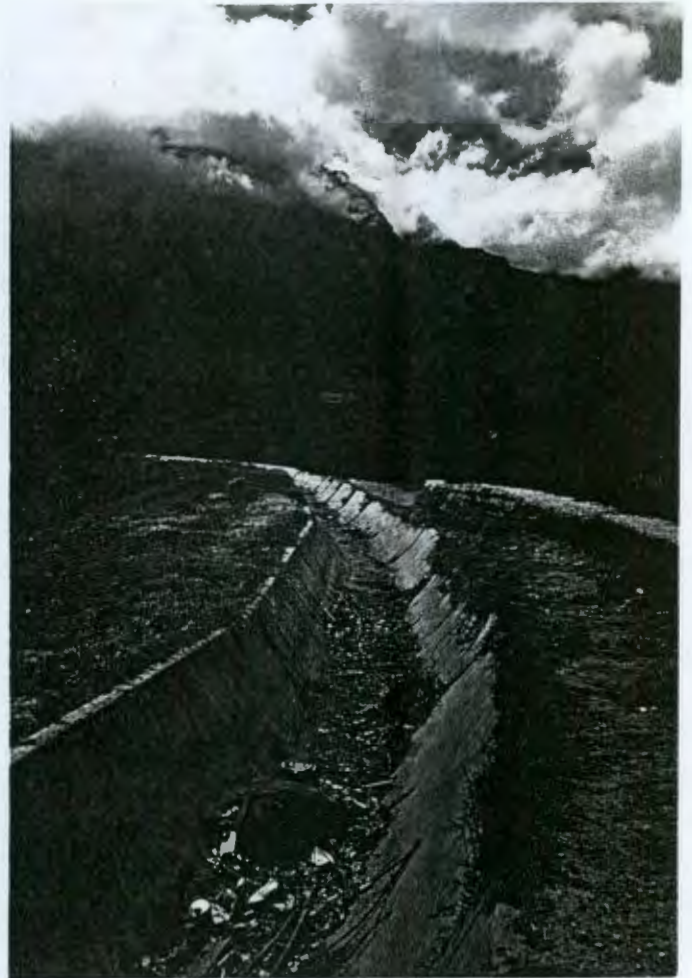
Mill sleut

The mill stream has been canalised.

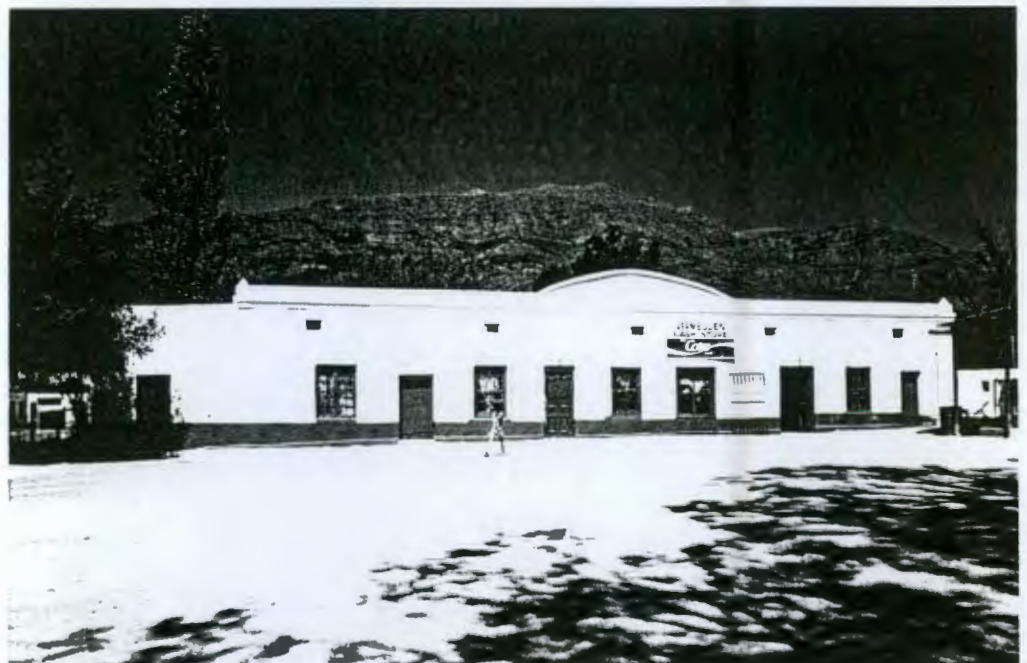
'Bo-winkel'

Retains original joinery, dating to c1870. Shop counter similar to one at Genadendal Mission

This was the mission store. It is one of the few flat-roofed buildings in Saron.

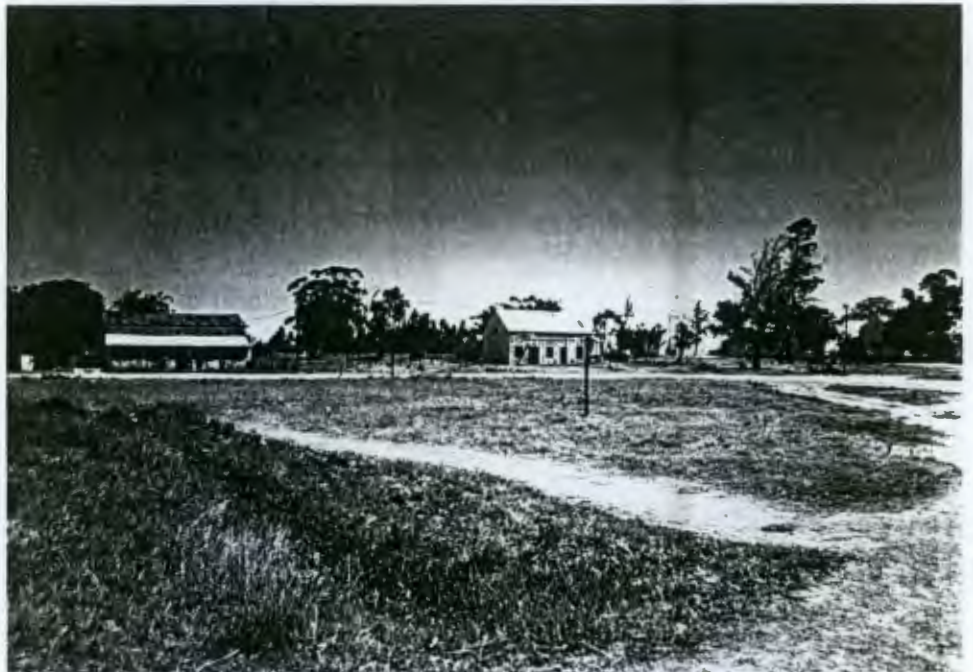
Mill square

The area referred to as mill square is an important open space, which forms part of the mission core area. The space is defined by the water mill, 'bo-winkel' and residential buildings.

“The square used to be shaded by oak trees, which were planted by the German missionaries” (Dan September, Heritage Committee, 1997).

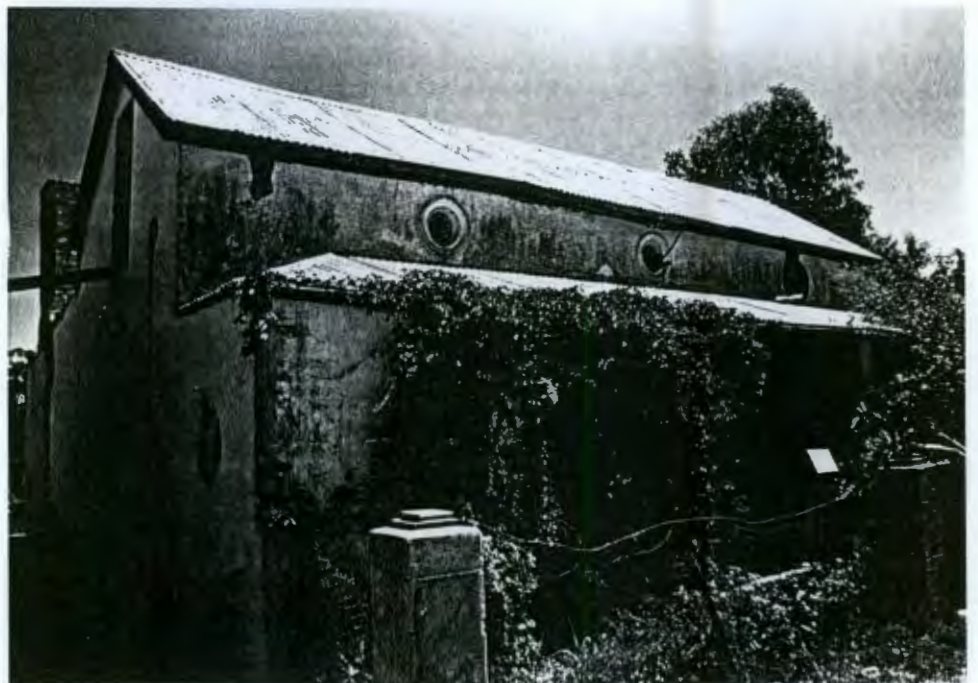
Site 12
Erf 4
Street Dam Street
Circa Mid-late 1800
Note-worthy features Retains original joinery. Wagon/car wheels - decorative feature.
Comments

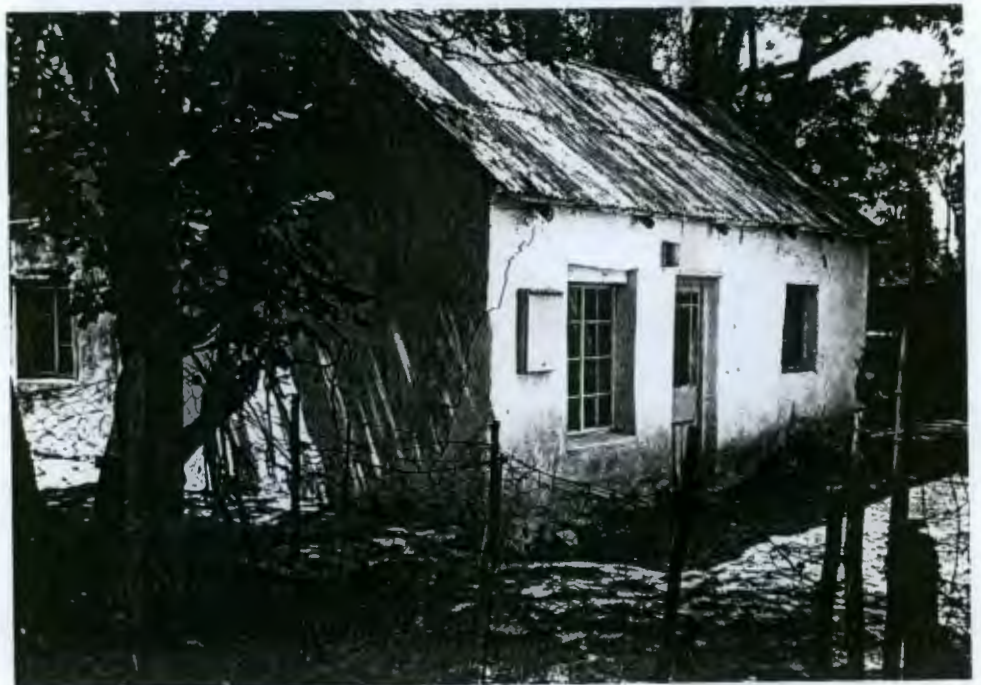
Site 14
Erf 22
Street Claremont
Circa Mid-late 1800
Note-worthy features Retains original joinery
Comments

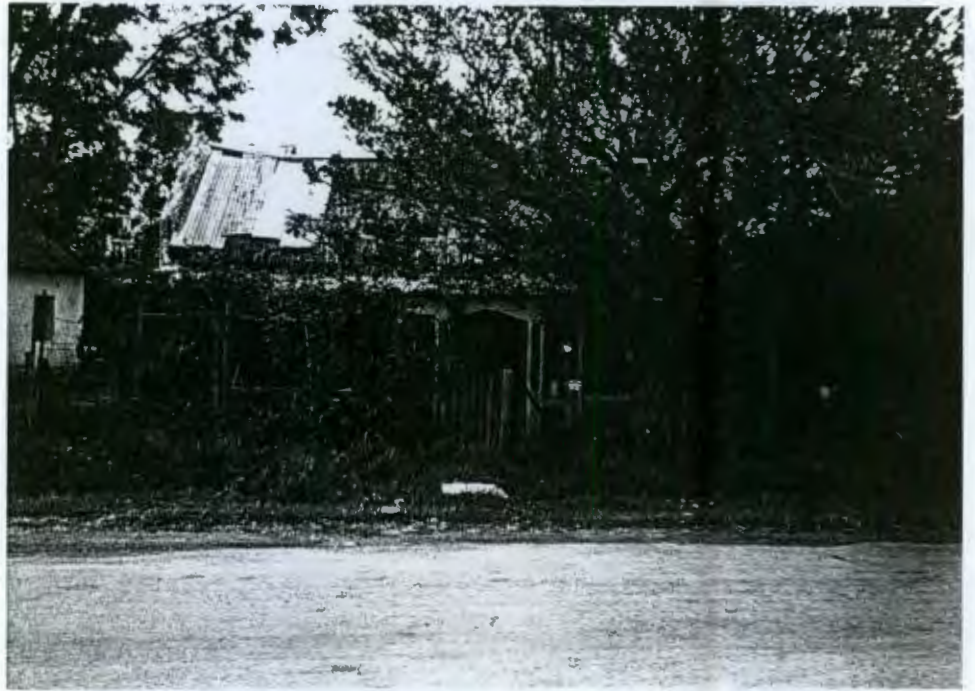
Site 15
Erf 24
Street Claremont
Circa Mid-late 1800
Note-worthy features Retains original joinery.
Comments

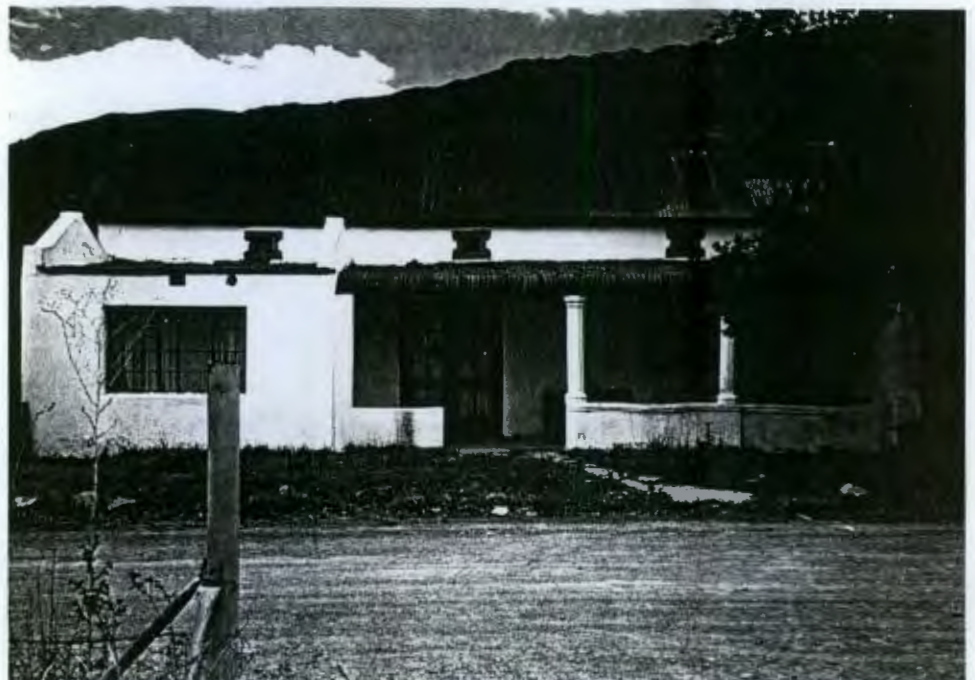
Site 16
Erf 26
Street Mill Street
Circa Mid-late 1800
Note-worthy features Retains original joinery. Wagon/car wheels - decorative feature.
Comments

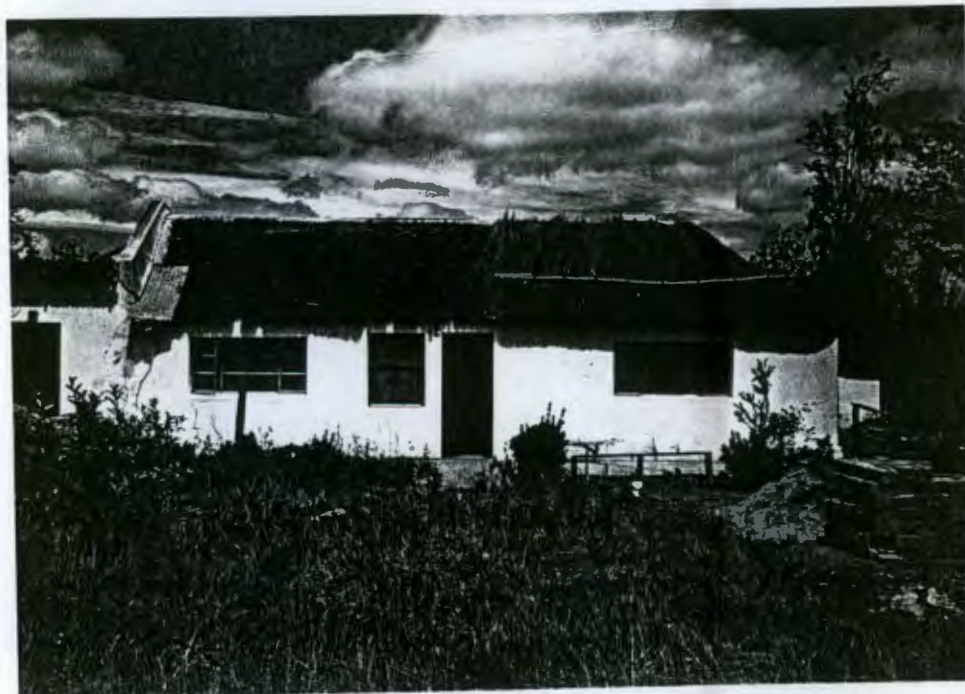
Site 18
Erf 36
Street Berg
Circa Mid-late 1800
Note-worthy features Retains original joinery. Reed ceiling. Thatch roof.
Comments

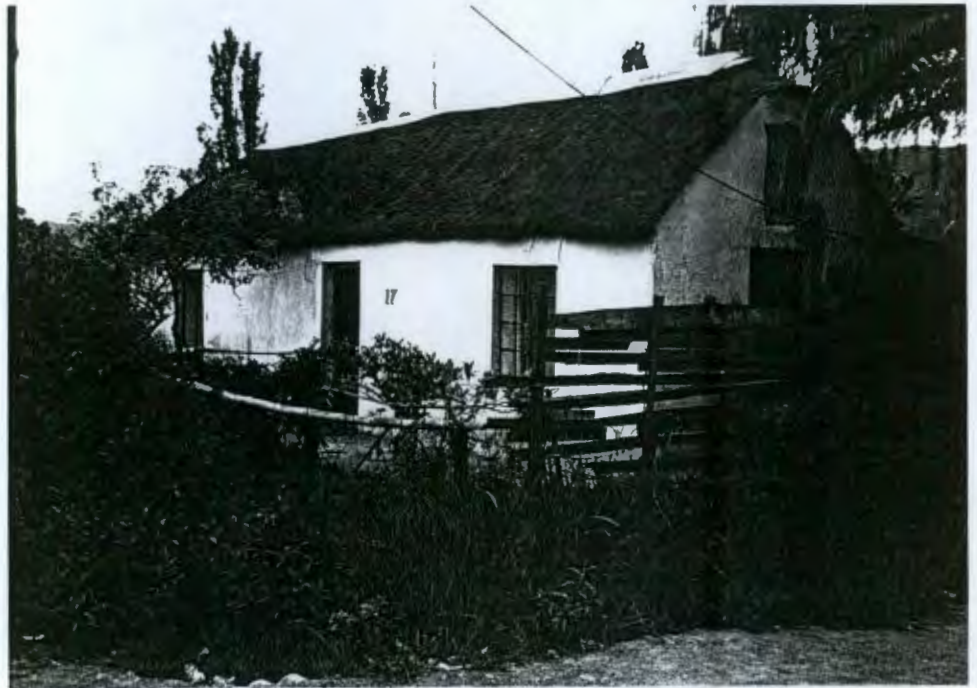
Site 19
Erf 51
Street Mill Street
Circa Mid-late 1800
Note-worthy features Retains original joinery. Reed ceiling. Thatch roof.
Comments

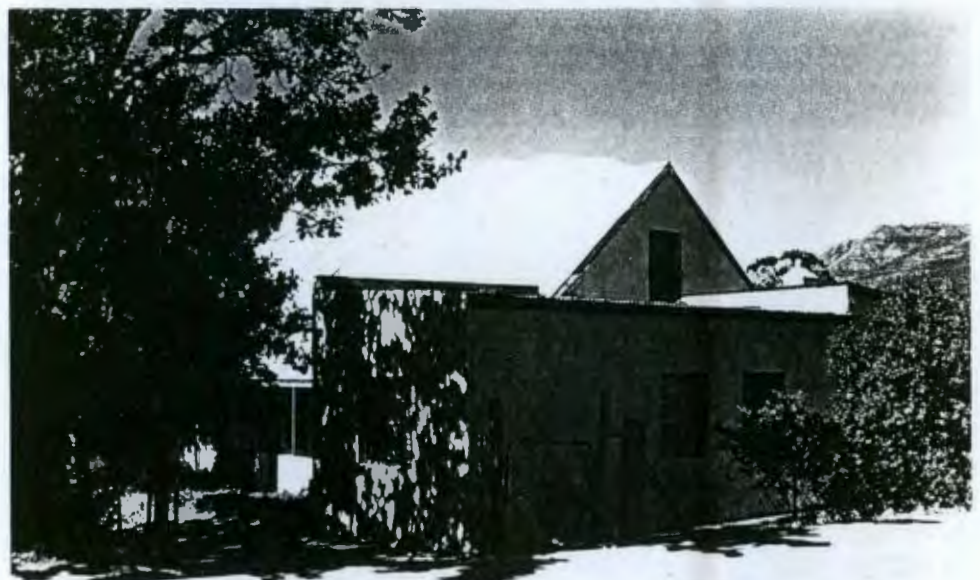
Site 20
Erf 54
Street Main Road
Circa Mid-late 1800
Note-worthy features Retains original joinery
Comments Known as "Mnr Andrag se huis" and "Oom Sarel se huis".

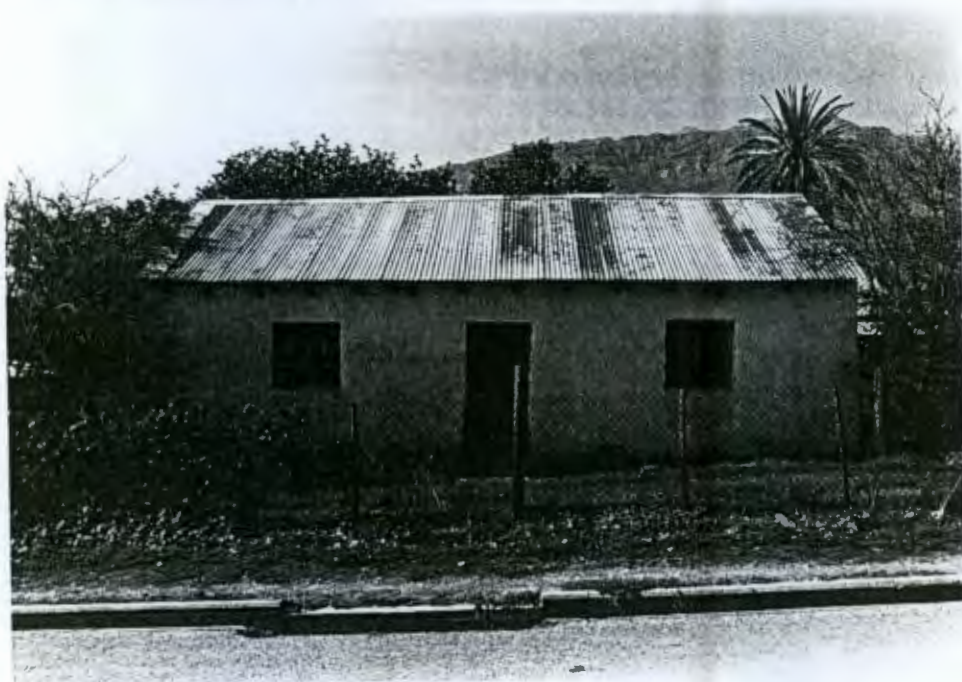
Site 21
Erf 54
Street c/o Church Street and Main Road
Circa Mid-late 1800

Originally the black smith's shop. Known as "Oupa Salie Beer se winkel".
Presently used as cement store

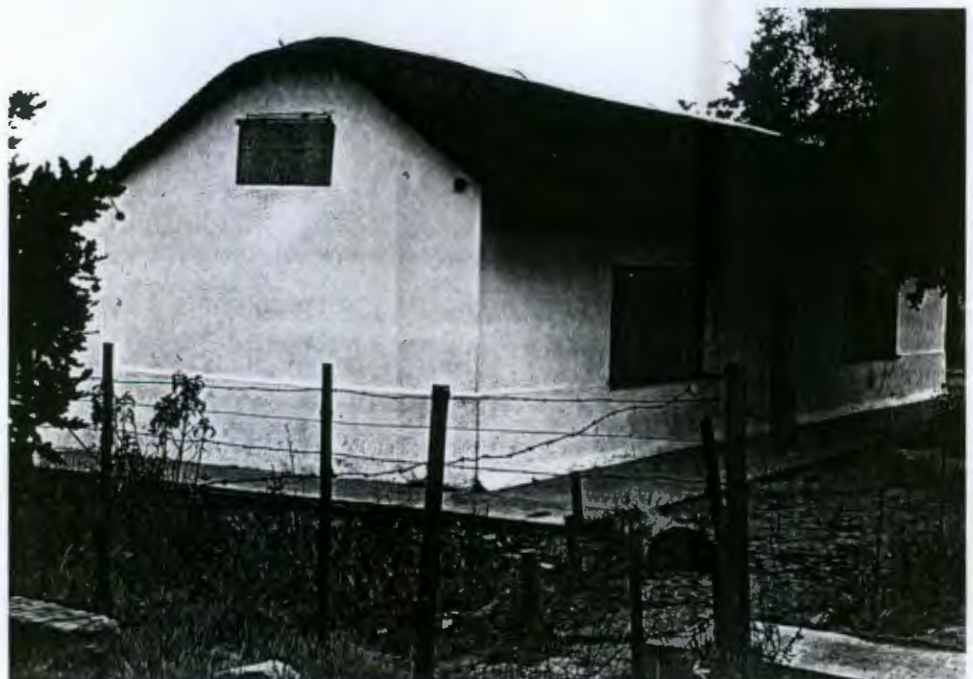
Site 24
Erf 87
Street Church Street
Circa Mid-late 1800
Note-worthy features Thatch roof.
Comments Originally the "perdemakery".

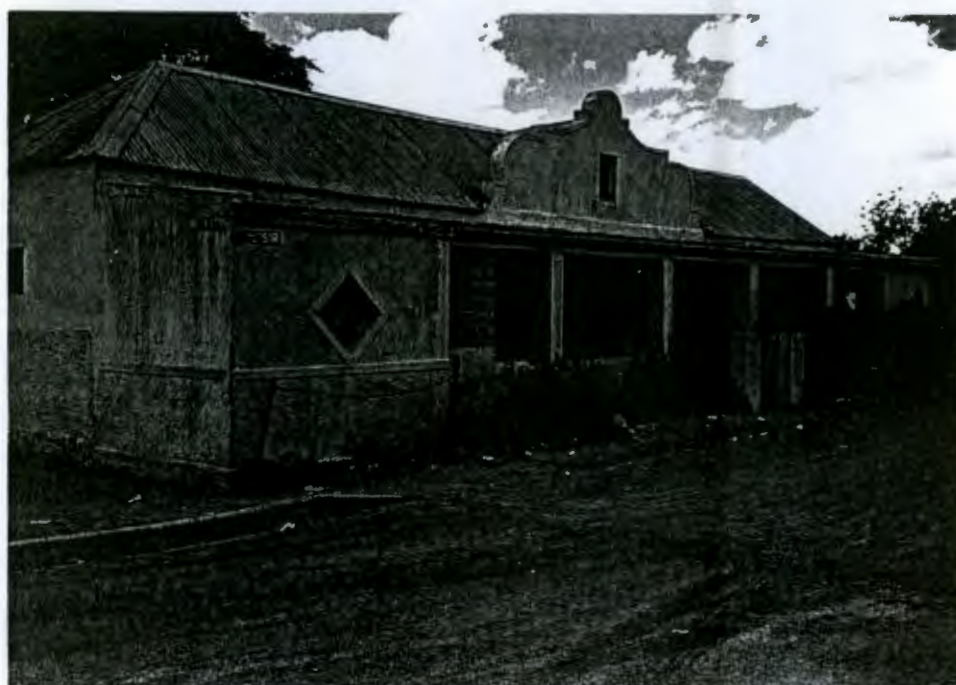
Site 28
Erf 125
Street c/o Main Road and Kling Street
Circa Mid-late 1800.
Note-worthy features Retains original joinery
Comments

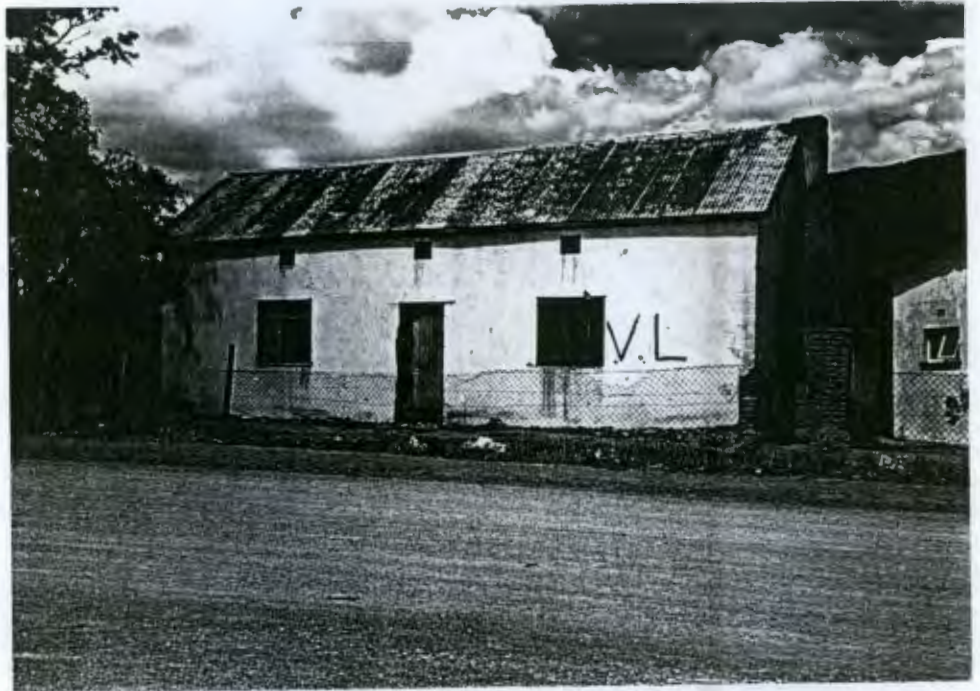
Site 29
Erf 126
Street c/o Main Road and Keerom Street
Circa Mid-late 1800
Note-worthy features Retains original joinery
Comments

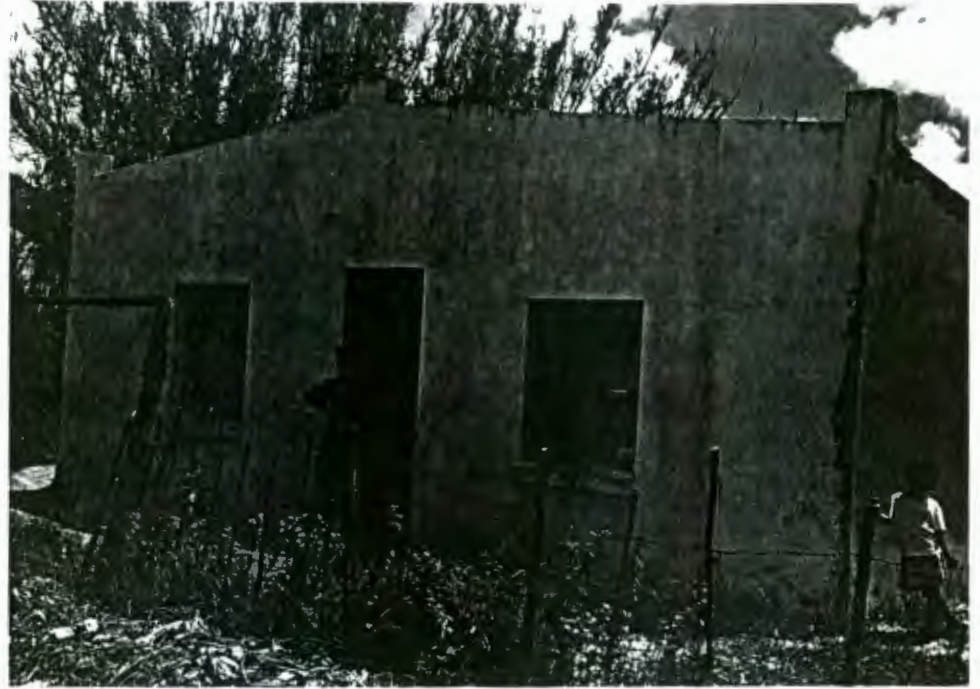
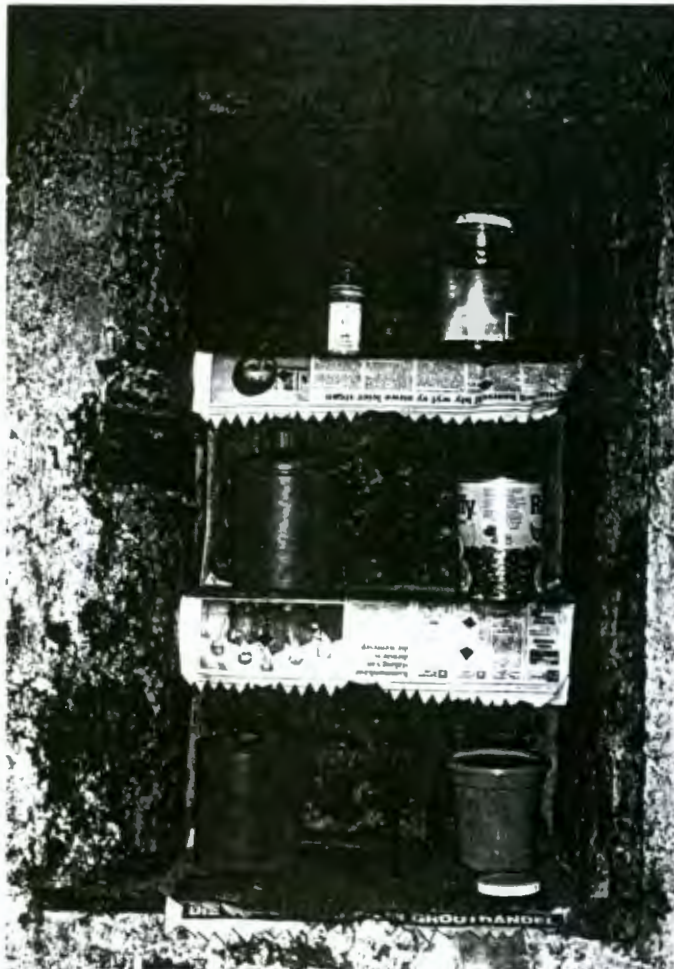
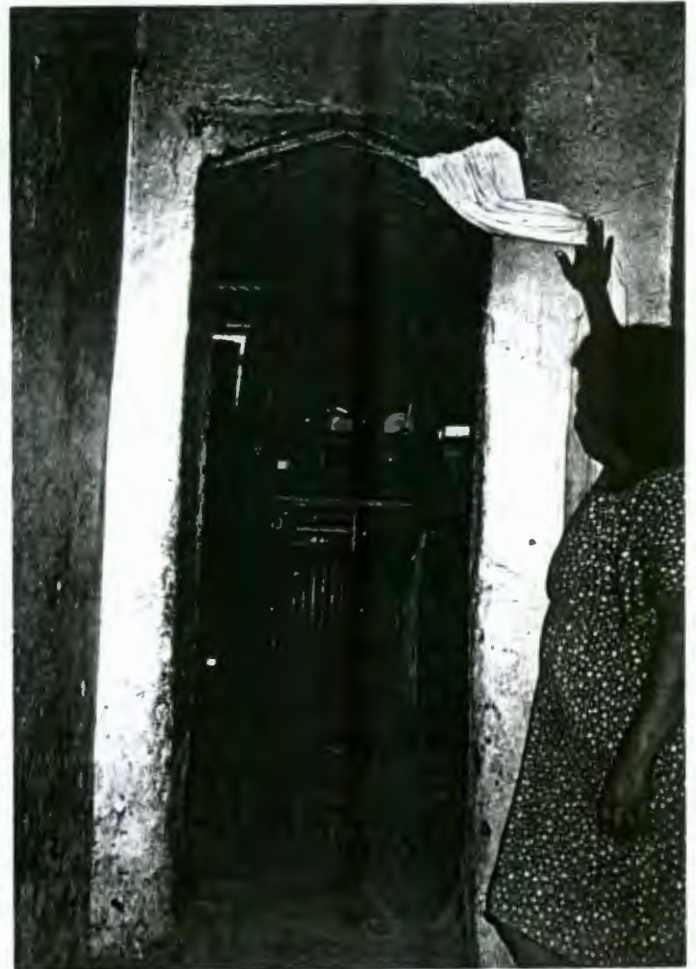
Site 31
Erf 148
Street Kling Street
Circa Mid-Late 1800
Note-worthy features Retains original joinery. Wall cupboard. Hallway entrance with pointed arch.
Comments

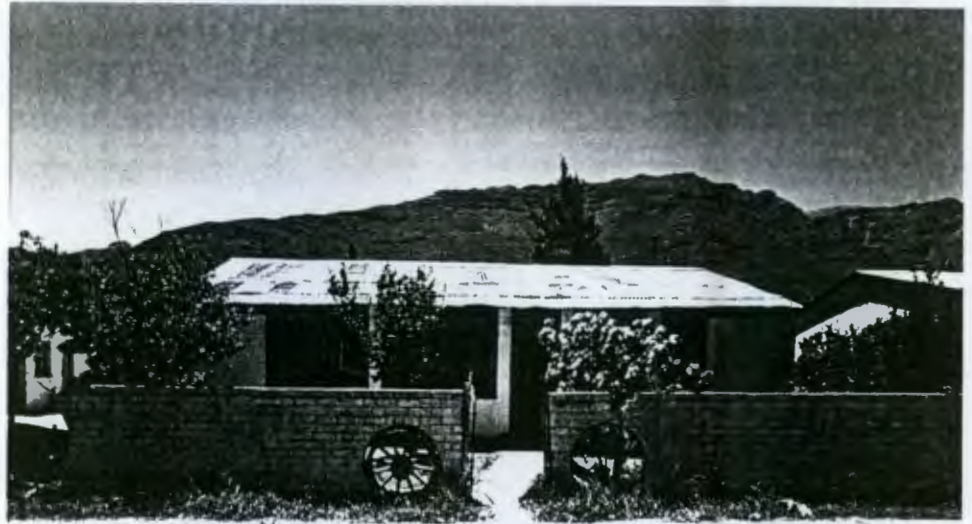
Site 32
Erf 163
Street Plein Street
Circa
Note-worthy features Wagon/car wheels - decorative feature
Comments

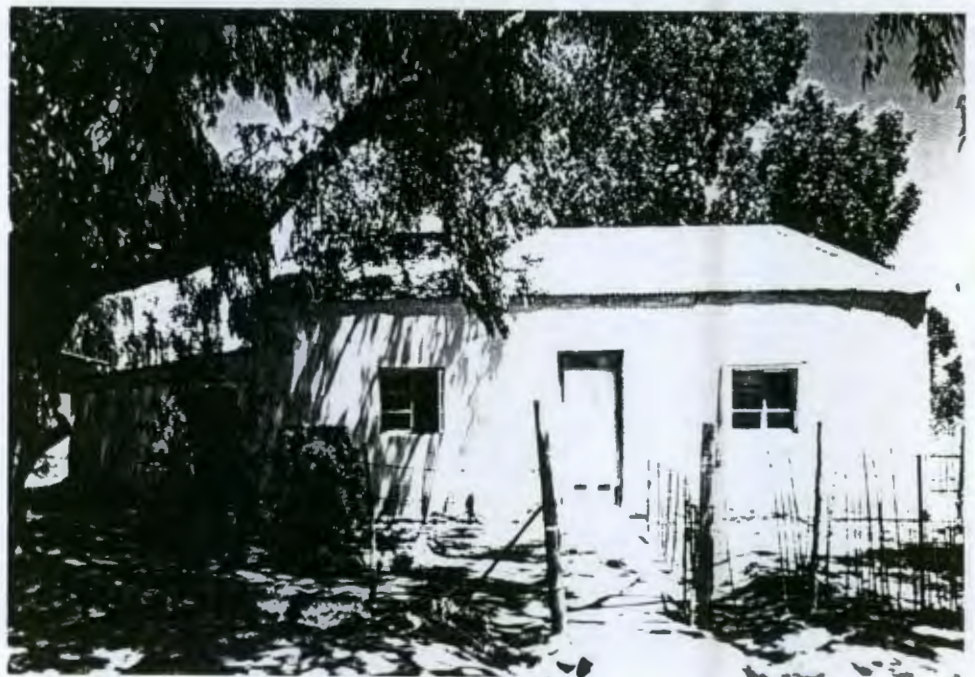
Site 33
Erf 168
Street Plein Street
Circa Mid-late 1800
Note-worthy features Retains original joinery
Comments Place where first Saron rugby team was established

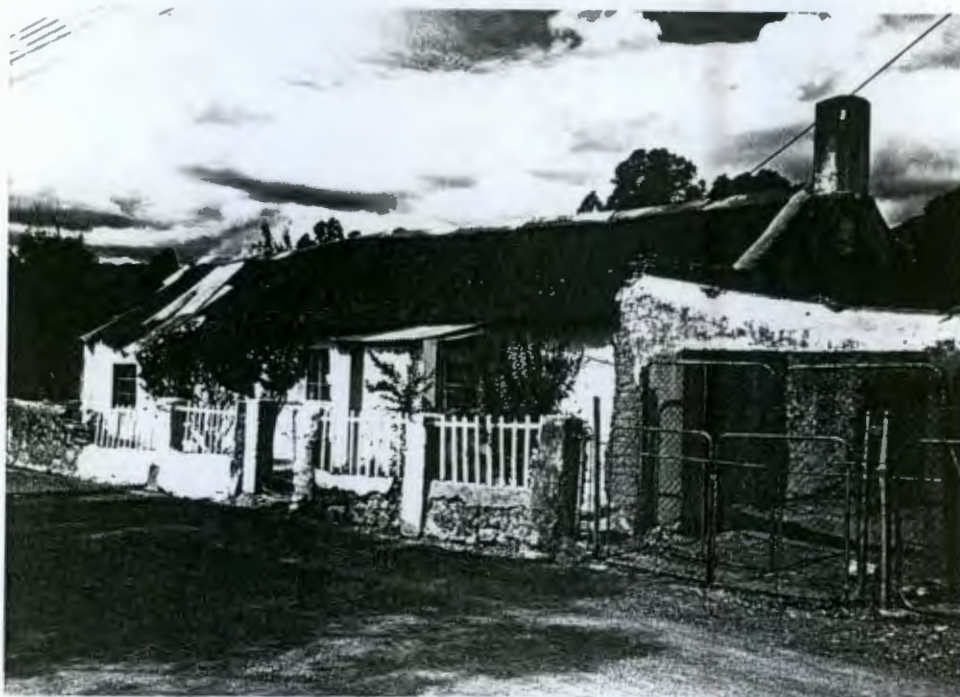
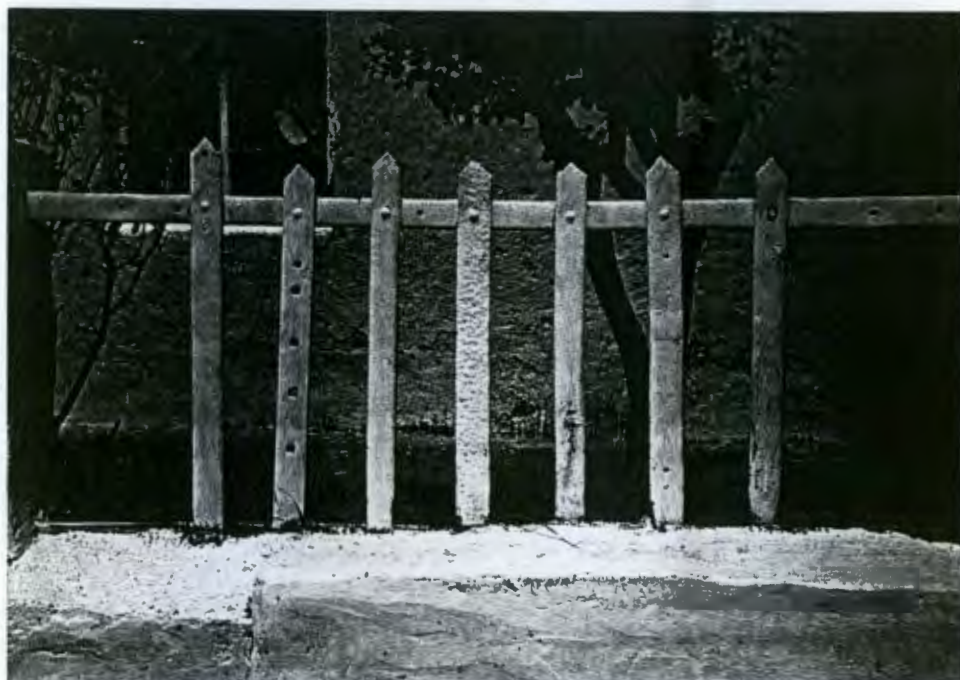
Site	34
Erf	169
Street	Lande Street
Circa	Mid-late 1800
Note-worthy features	Retains original joinery.
Comments	Iron work on boundary wall made locally

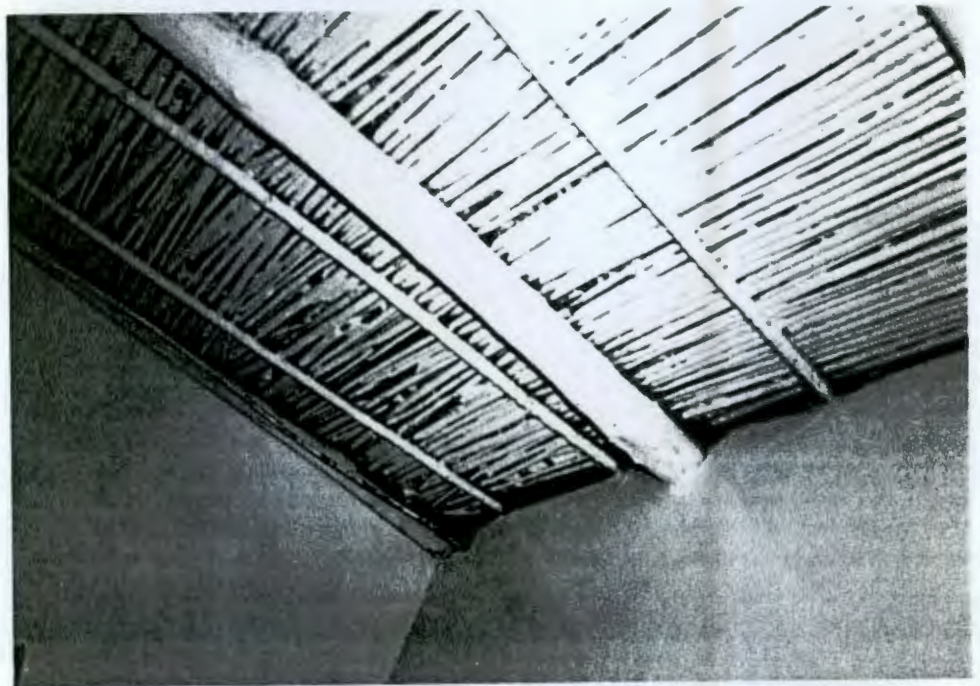
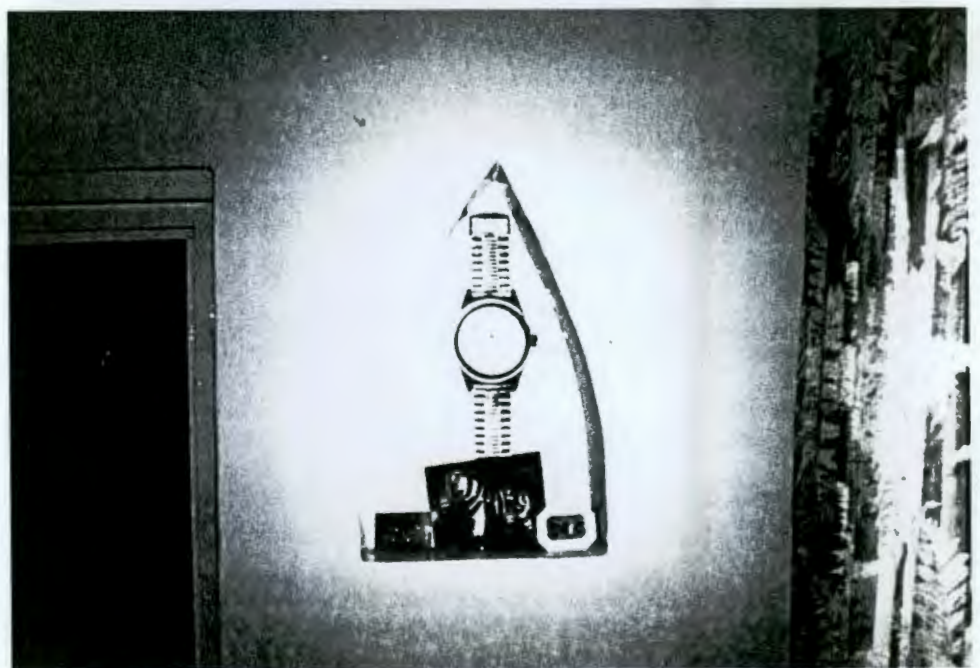
Site 37
Erf 173
Street Lande Street
Circa Mid-late 1800
Note-worthy features Retains original joinery. Reed ceiling. Interesting wall feature.
Comments

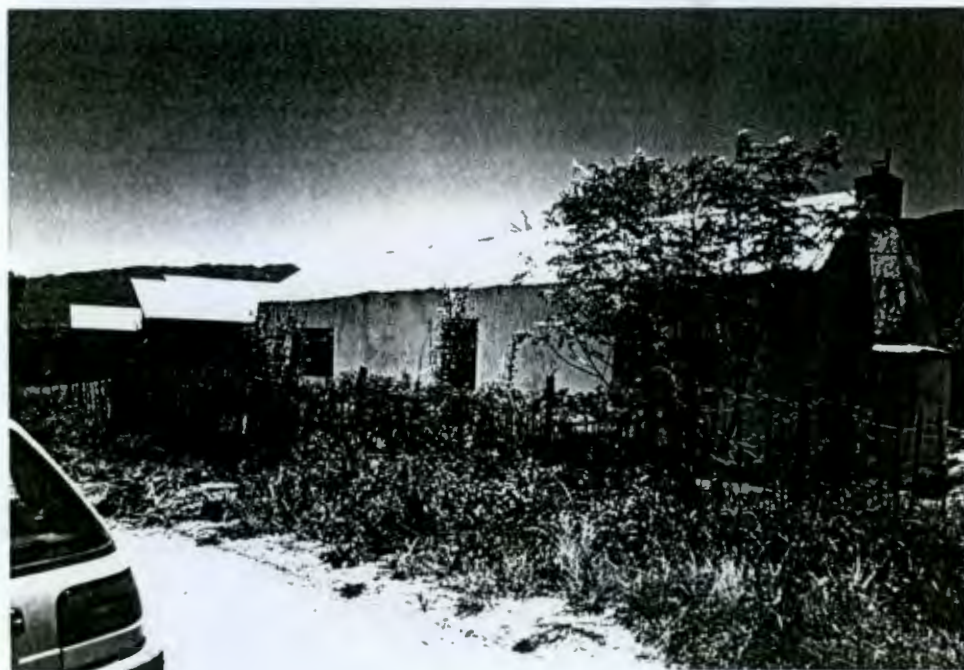
Site 39
Erf 178
Street Lande Street
Circa Mid-late 1800
Note-worthy features Retains original joinery
Comments

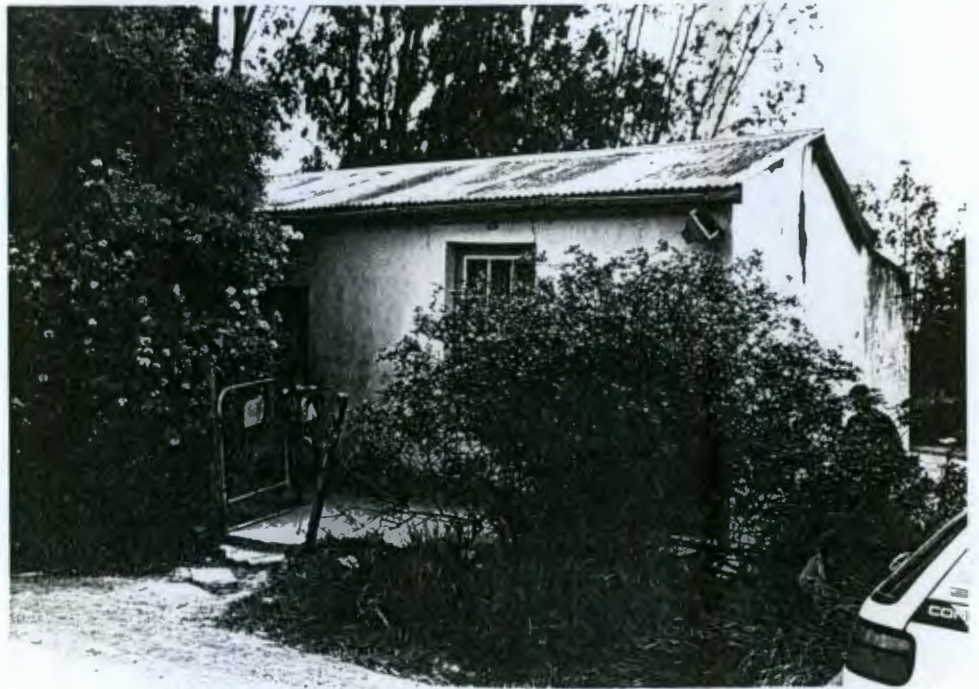
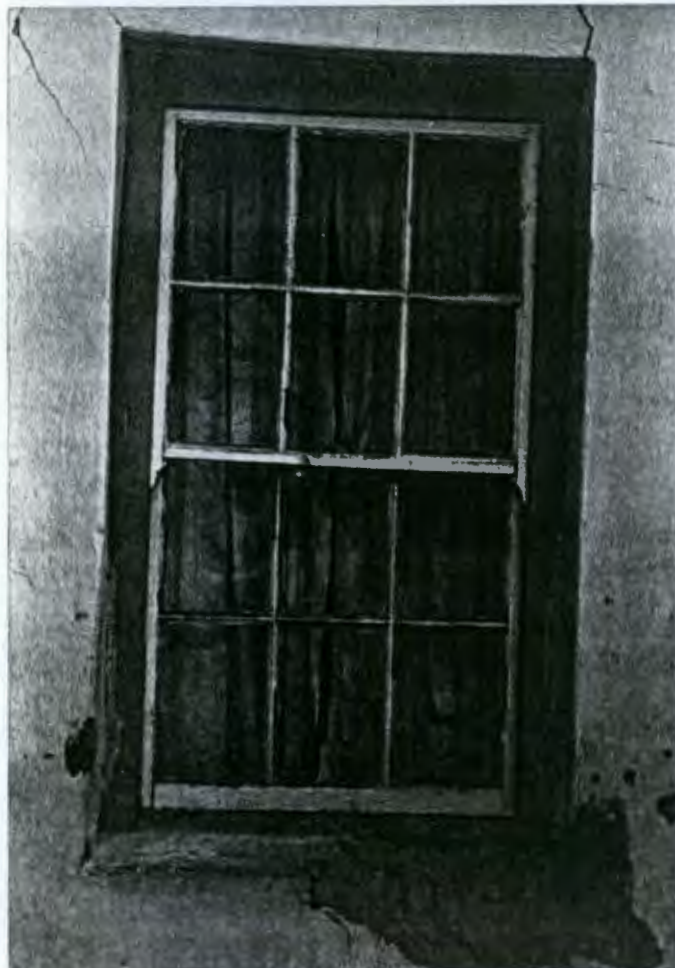
Site 40
Erf 191
Street Lande Street
Circa
Note-worthy features Original sash windows
Comments

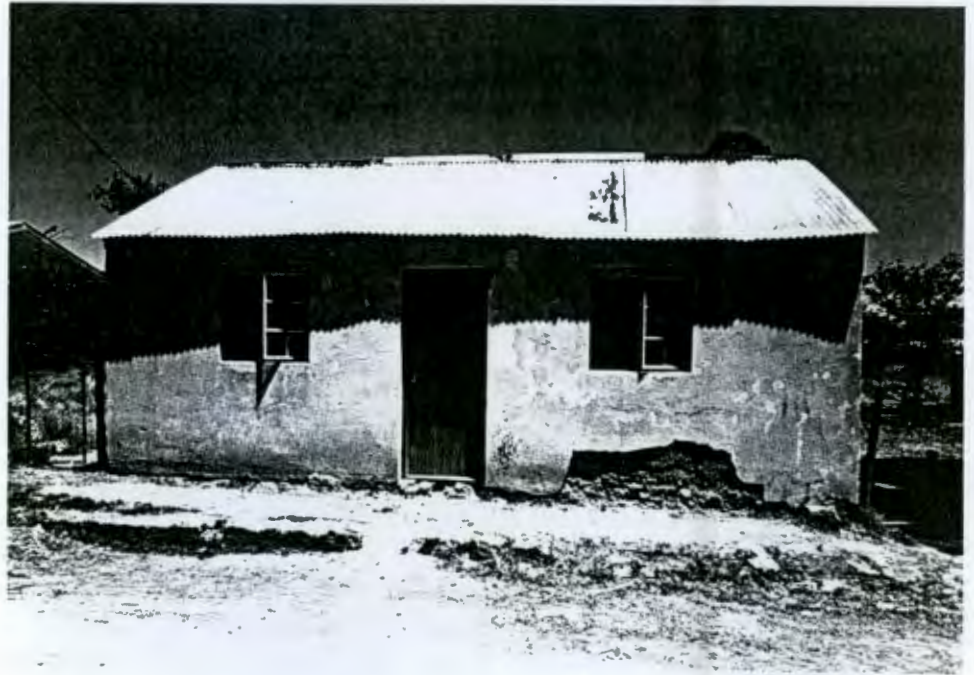
Site 41
Erf 196
Street Lande Street
Circa
Note-worthy features
Comments

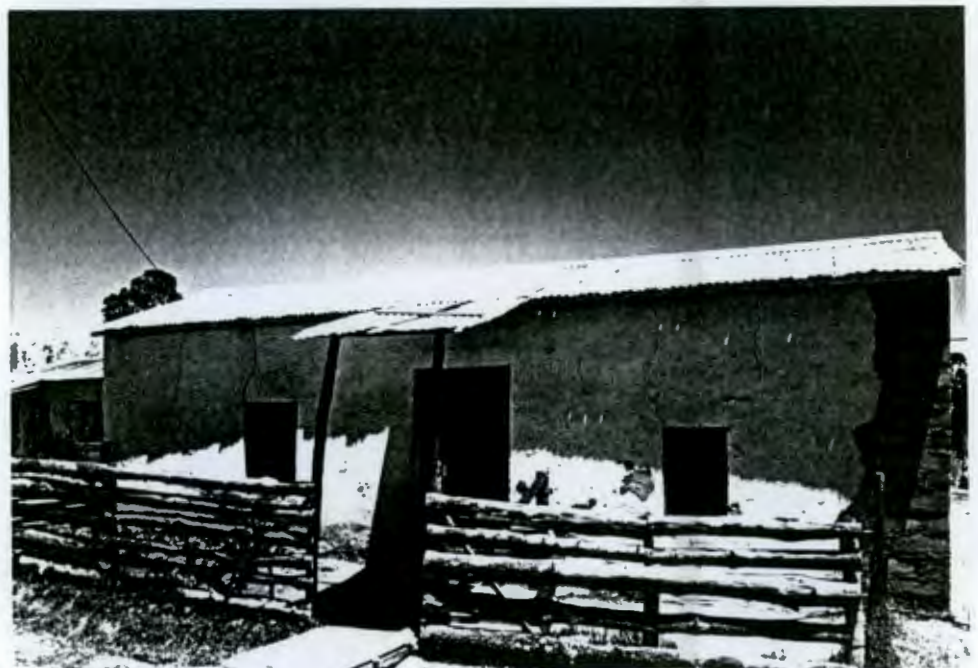
Site 42
Erf 201
Street Lande Street
Circa
Note-worthy features Wall cupboard
Comments

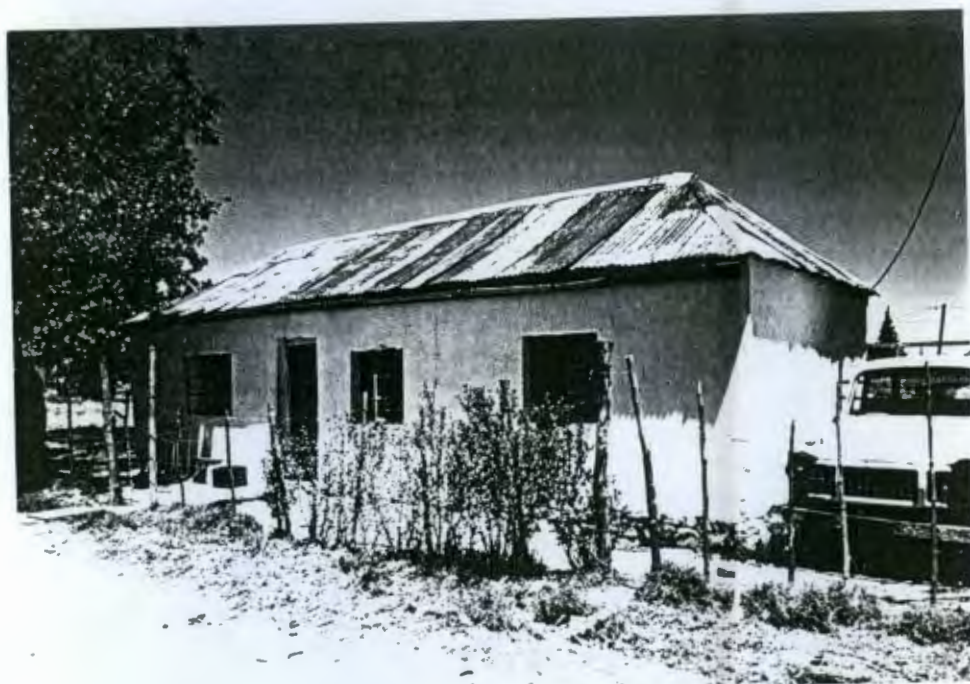
Site 43
Erf 205
Street Lande Street
Circa
Note-worthy features Hallway entrance with pointed arch.
Comments
