**HERITAGE CONSERVATION COMPONENT
OF THE STRUCTURE PLAN FOR**

SARON

**National Monuments Council
in partnership with the Saron Heritage Committee**

April 1998

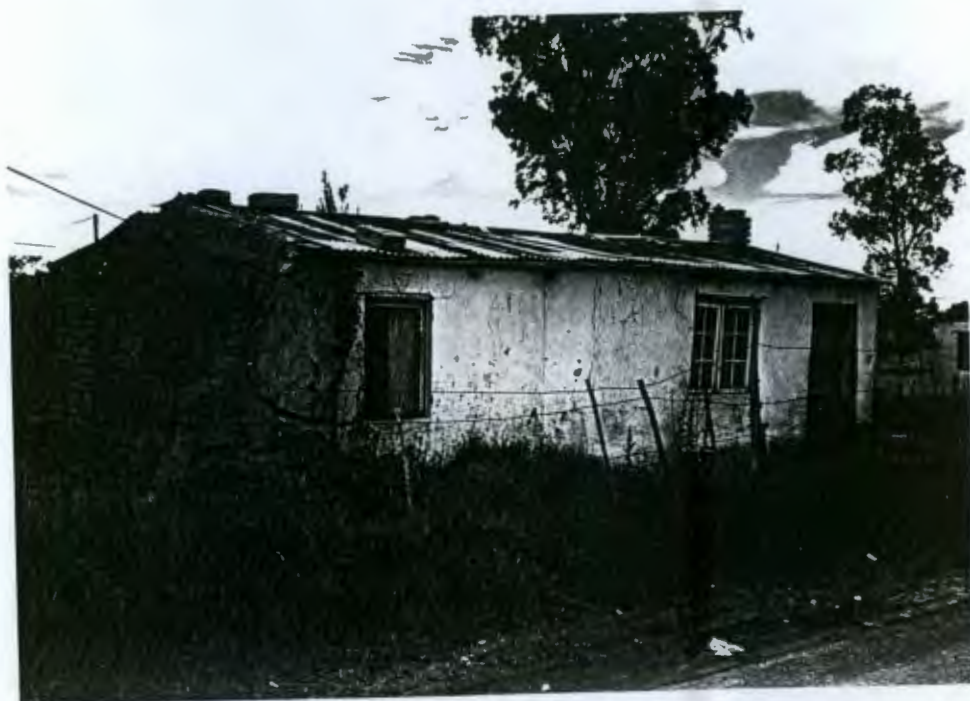
Site 44
Erf 214
Street Buitenkant Street
Circa
Note-worthy features Original casement windows.
Comments

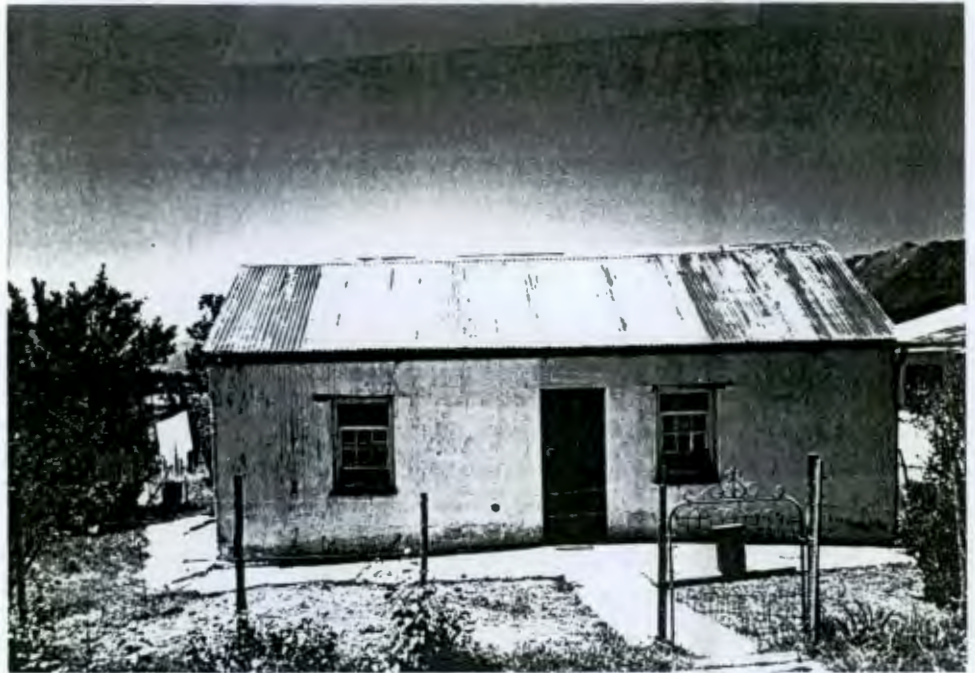
Site 45
Erf 233
Street Long Street
Circa
Note-worthy features Original sash windows
Comments

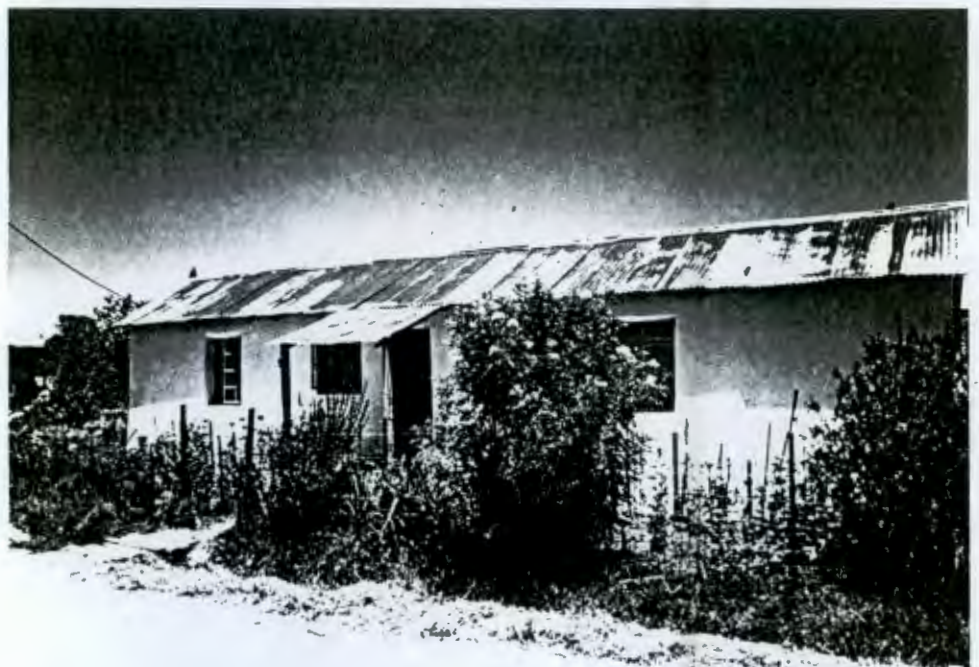
Site 46
Erf 234
Street Long Street
Circa
Note-worthy features
Comments

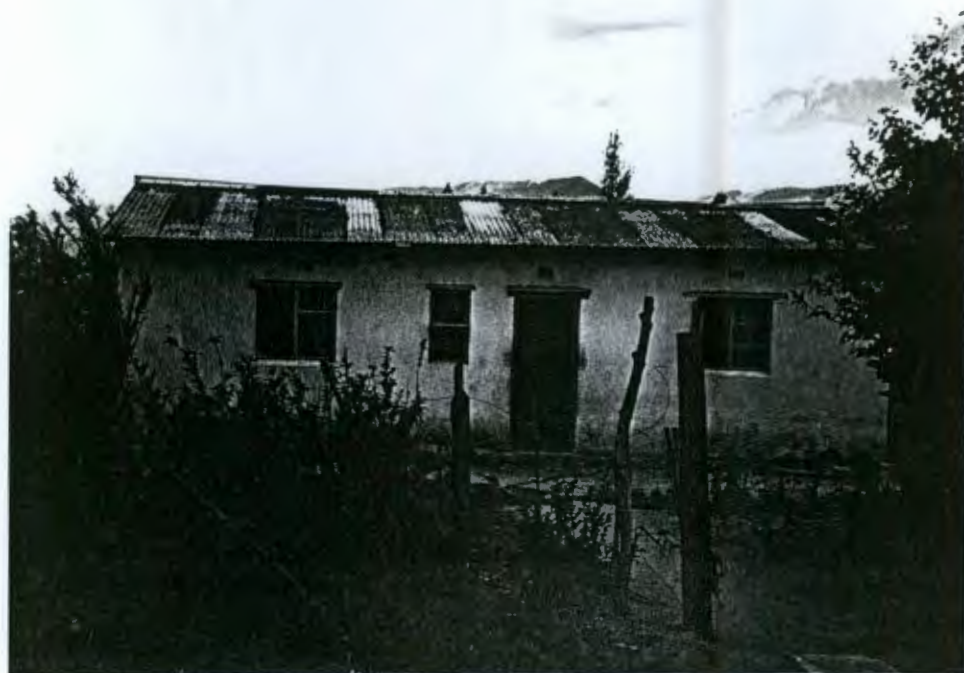
Site 47
Erf 251
Street Long Street
Circa
Note-worthy features
Comments

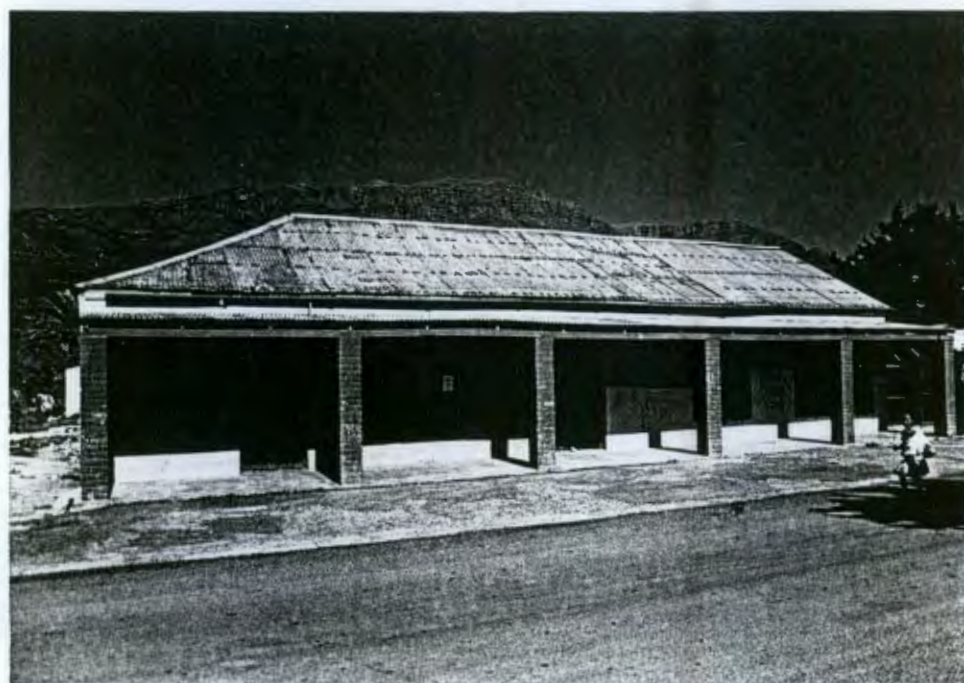
Site 48
Erf 279
Street Church Street
Circa
Note-worthy features
Comments Known as "Wilton's Shop"

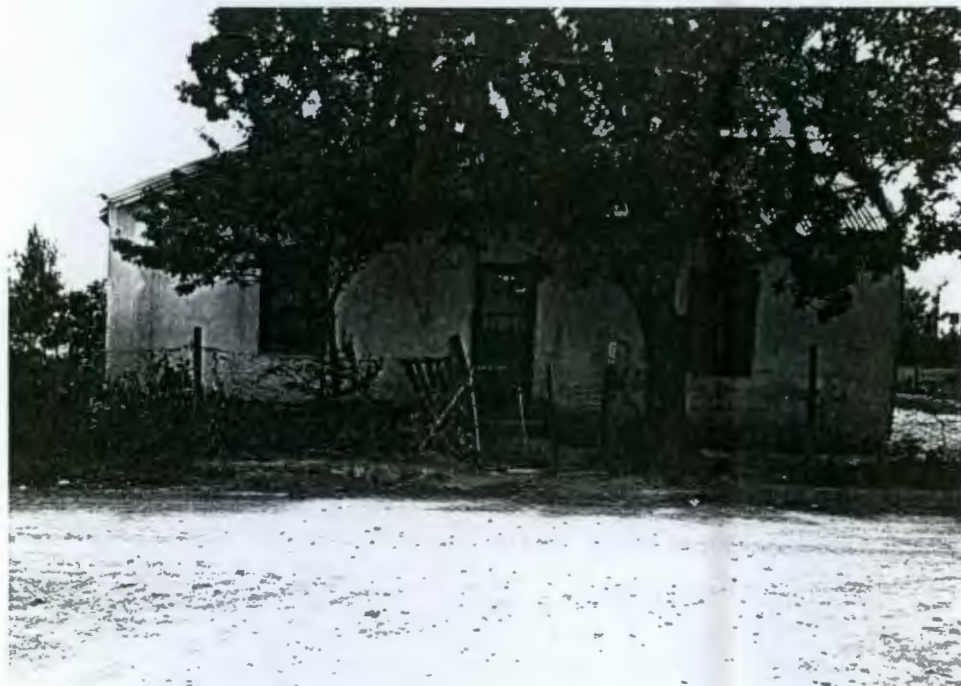
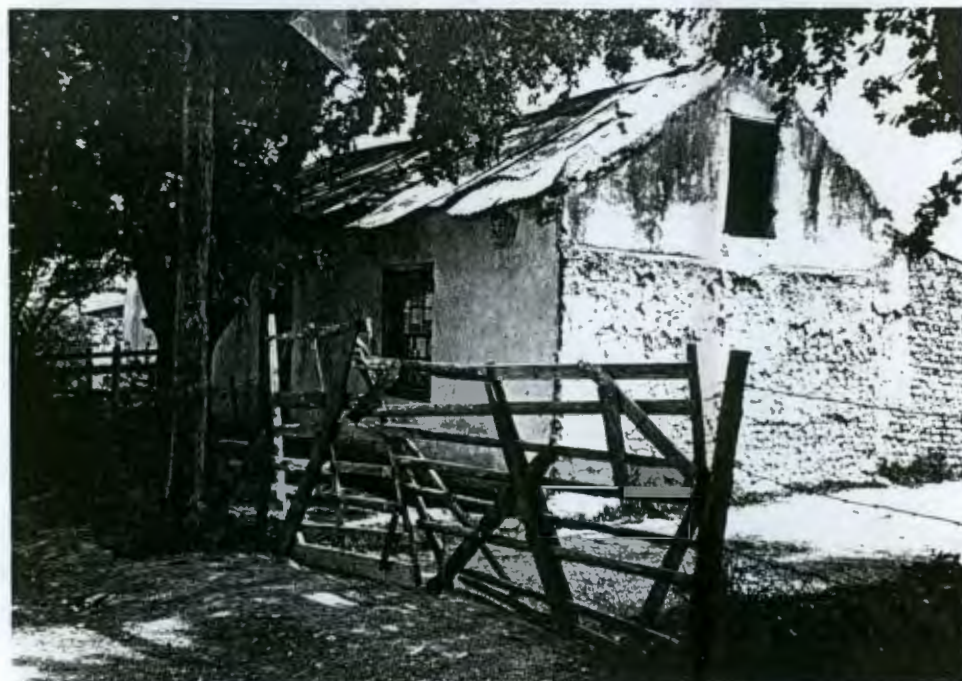
Site 49
Erf 312
Street Weber Street
Circa Mid-late 1800
Note-worthy features Retains original joinery. Thatch under iron roof.
Comments

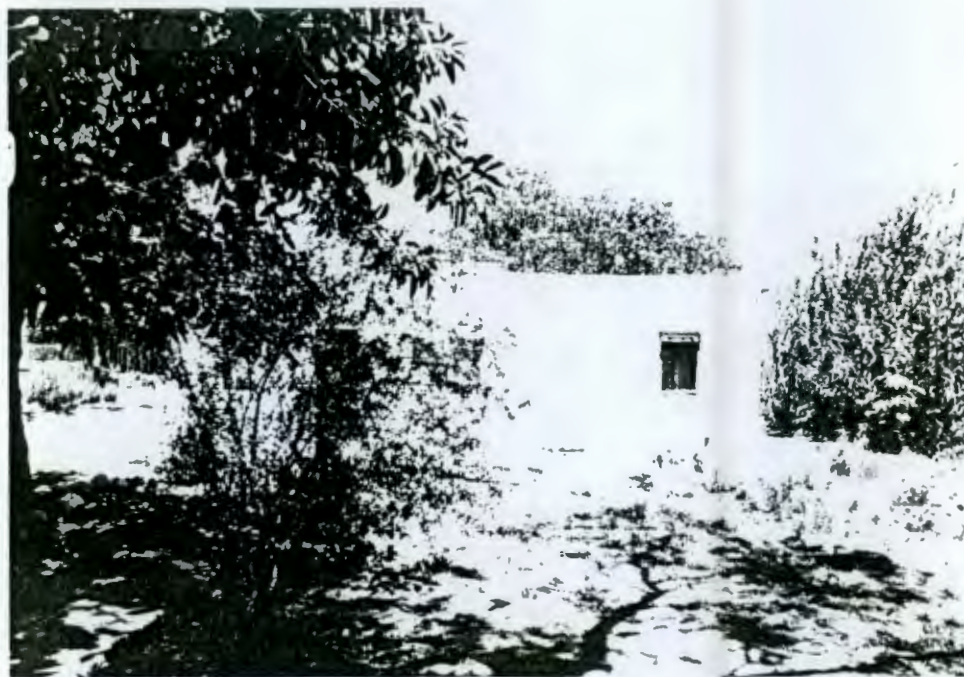
Site 50
Erf 320
Street Klip Street
Circa
Note-worthy features
Comments

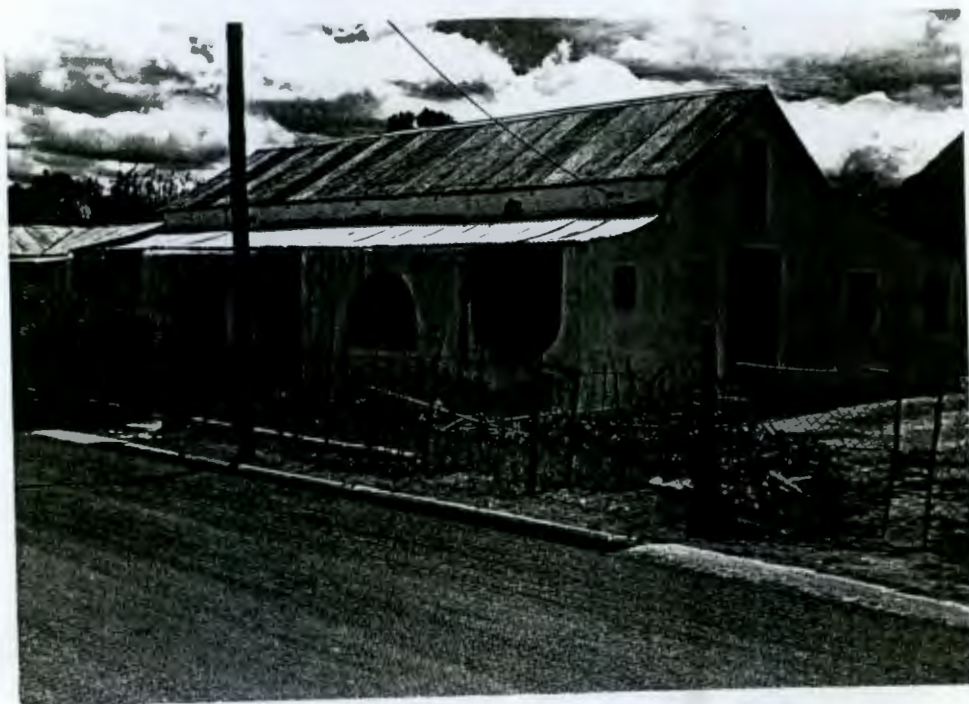
Site 51
Erf 338
Street Church Street
Circa Mid-late 1800
Note-worthy features Retains some original joinery
Comments

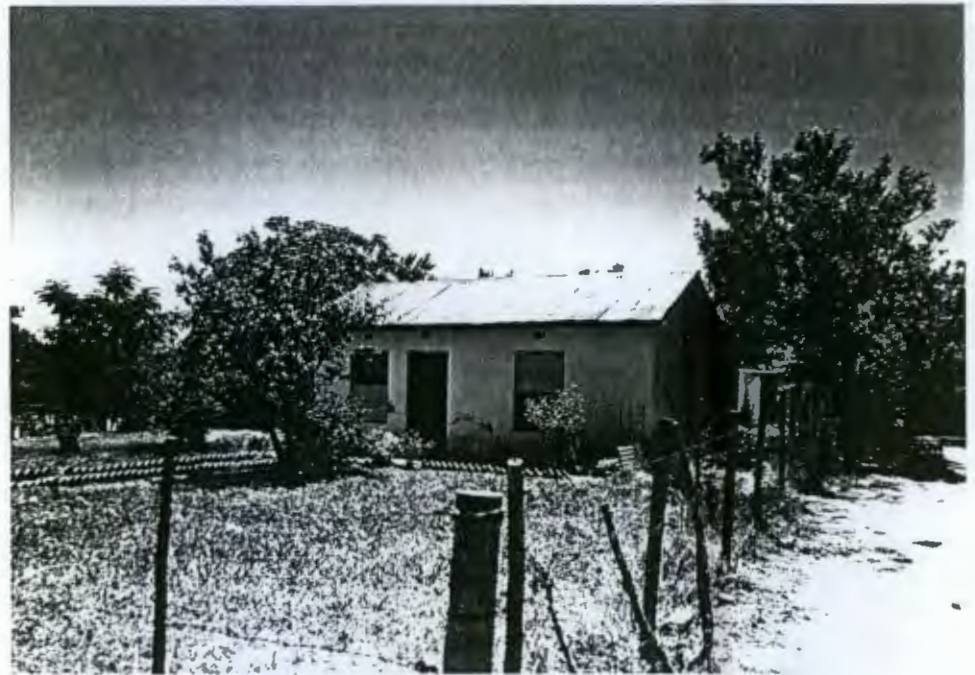
Site 52
Erf 354
Street Klip Street
Circa
Note-worthy features
Comments

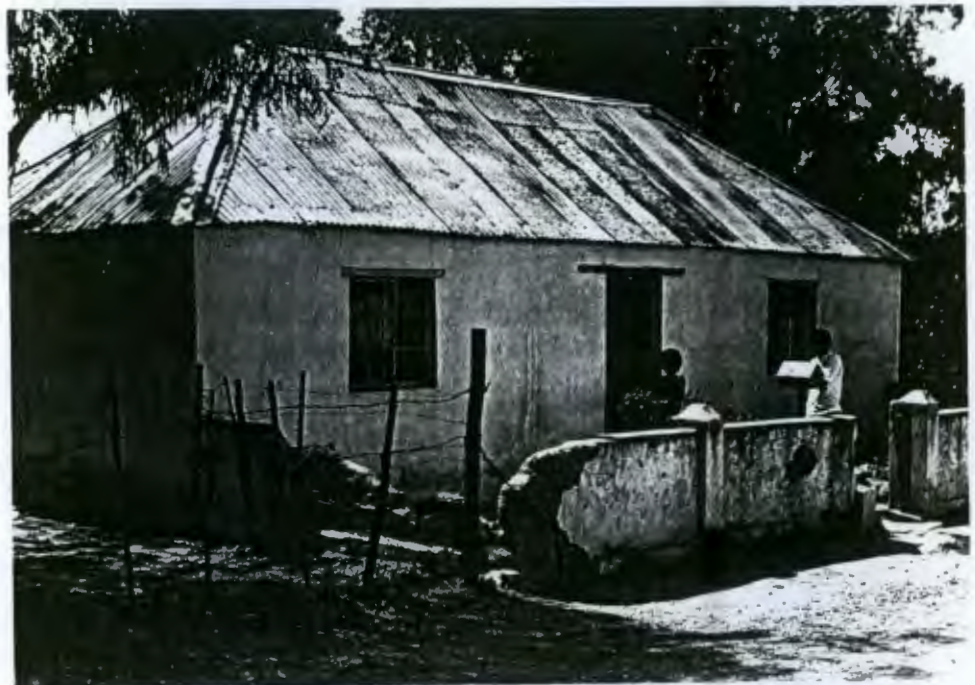
Site 53
Erf unknown
Street c/o Lande and Genadendal Street
Circa Mid-late 1800
Note-worthy features Retains original joinery. Roof loft door. Casement and sash windows.
Comments
