HERITAGE IMPACT ASSESSMENT

MOGALAKWENA MUNICIPALITY WATER MASTER PLAN: PHASE 2A BULK WATER SUPPLY ZONE 1, WATERBERG DISTRICT MUNICIPALITY, LIMPOPO PROVINCE

Report Author: Mr. J. van der Walt <u>Project Reference:</u> HCAC Project number 217509 <u>Report date:</u> May 2017

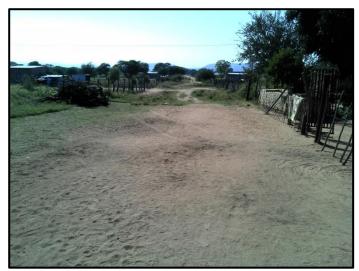
Figure 9. Pipeline route in-between houses

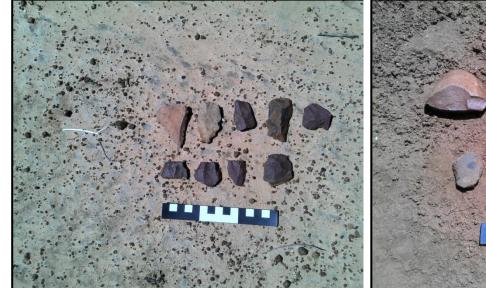
Figure 18. Dorsal view of artefacts from find spot Site 3

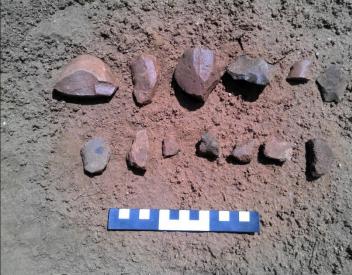
Figure 19. Artefacts from find spots Site 19 & 20

Several Iron Age find spots (Site 11, 17, 18 & 20) were also recorded; these consist of widely dispersed scatters of undecorated ceramics. Although they do not constitute a living or habitation site these occurrences were also recorded as sites. No other features were noticed in these areas (i.e. middens or structures) and these occurrences are therefore of no significance apart from noting their presence, which has been done in this report.

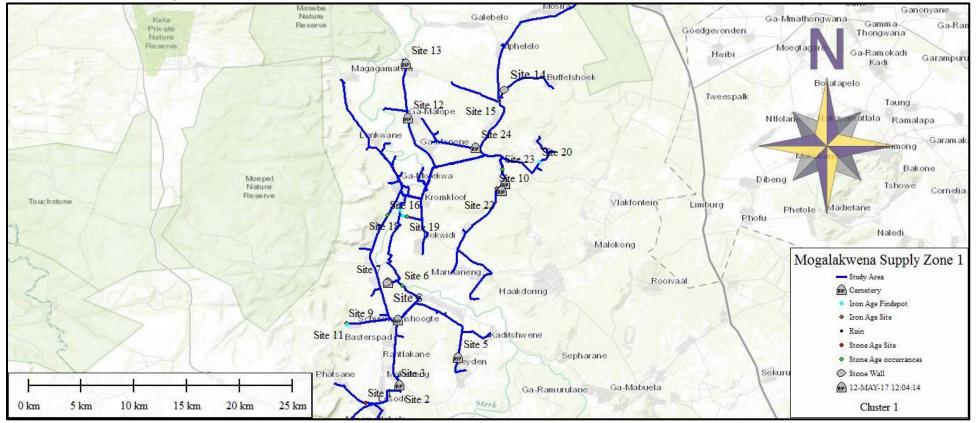
9.1 Site Distribution Map

Figure 20. Recorded sites in relation to Cluster 1.

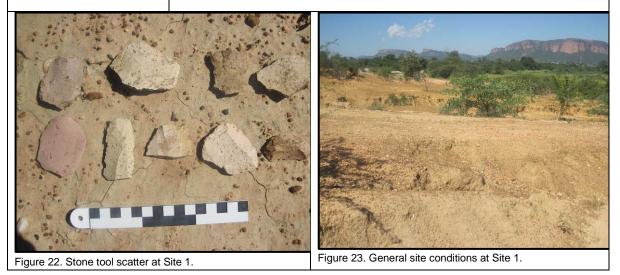
A low to medium density scatter of stone tools was identified at this location (± 5-8 artefacts per m ²). The site is situated approximately 100m south of the Mogalakwena River and also on the southern side of the proposed pipe line alignment. The artefacts were found in an area that was exposed by sheet erosion. The artefacts are classified as MSA and consist mainly of utilised and re-touched flakes, blades and scrapers.
Site Extent	Site 1 size: Approximately 50m in diameter. Site 6 size: Approximately 30m x 20m in size.
Depth and stratification of the site	Unknown but deposit is un likely.

Figure 24. General site conditions – Site 6	Figure 25. Stone Age artefacts at Site 6 Relatively few MSA sites have been studied on the Waterberg plateau and none is dated (Wadley <i>et al</i> 2016).
Field Rating (Recommended grading or field significance) of the site:	Therefore, the sites are of low to medium significance. Generally Protected B (GP.B).
Recommendations	These open-air sites occur along the river banks and will be directly impacted on. It is recommended that a surface sample is taken for analysis to positively ascribe the techno complex.

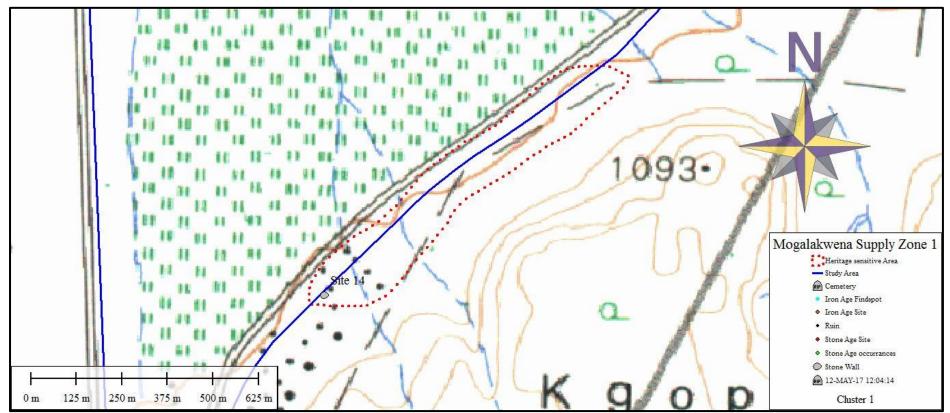
Figure 32. Area to be monitored during construction at Site 14

Figure 30. General site conditions Site 14	$\label{eq:constraint}$
Statement of Significance	Site 9 Iron Age site with Furnace. Due to the high degree of sheet erosion that impacted on the site and the lack of features on site the site is of low to medium significance Site 10 Stone walled site on summit of hill. The site layout is well preserved and therefore of medium significance. Site 14 Ephemeral stone walled settlement. The site is not very well preserved and impacted on by the existing water lines and road that impacted on the site and therefore of low to medium significance.
Field Rating (Recommended grading or field significance) of the site:	Generally Protected B
Recommendations	Site 9 Iron Age site with Furnace. Rerouting pipeline to the north where no other features were recorded during the survey. Site 10 Stone walled site on summit of hill. This site will be directly impacted on and should be mapped, test excavated and monitored during construction. Site 14 Stone walled settlement. The existing walling should be demarcated and earth works in this area must be monitored (Figure 32).

Most of the recorded sites will not be directly impacted on as per the current alignment and will be preserved. There is however a number of sites that will be impacted by the line (Site 2,7,9, 21, 24, 25, 26, 27,28), the line will have to be rerouted in order to avoid these sites and the sites will have to be demarcated during construction. The line cannot be rerouted at Site 1 and Site 10. At Site 1 a surface sample should be collected and analysed. Site 10 will have to be mapped, test excavated and monitored. It is also recommended that Site 14 should be monitored during construction.
