HERITAGE IMPACT ASSESSMENT REPORT

**PORTION 1 OF ERF 650
33 DEVENISH STREET
POLOKWANE CITY
POLOKWANE LOCAL MUNICIPALITY, LIMPOPO**

FOR: God's Tabernacle Christian Family Church
2 Kaye-Lyn Street
Magna Via, Polokwane, 0700

March 2021

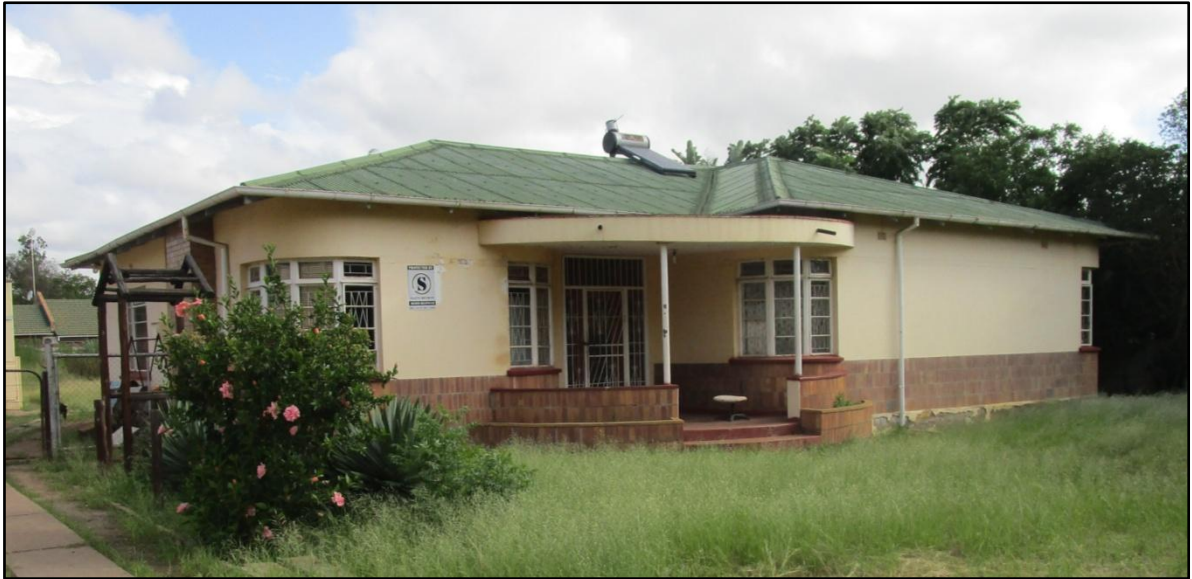
Figure 2. *Front elevation of the building.*

Plastered and painted on the interior and exterior with the exception of the lower part of the front wall that was built using the soldier course method (also known as “belt” course) with yellowish face-bricks - the bricks are laid standing on end with the narrow edge facing out. This type of course is used for decorative effects. Bonding is with cement, most probably from Pretoria. In 1908 the first cement factory in the old Transvaal, namely, the Eerste Cement Fabrieken (established in 1888) changed its name to the Pretoria Portland Cement Company – PPC as it is still known today. Vents were originally present below floor height to ventilate the space below the floor. The bathroom has been modernised and both the floor and walls are tiled. All walls except the bathroom are fitted with Oregon pine skirting boards of 110mm wide.

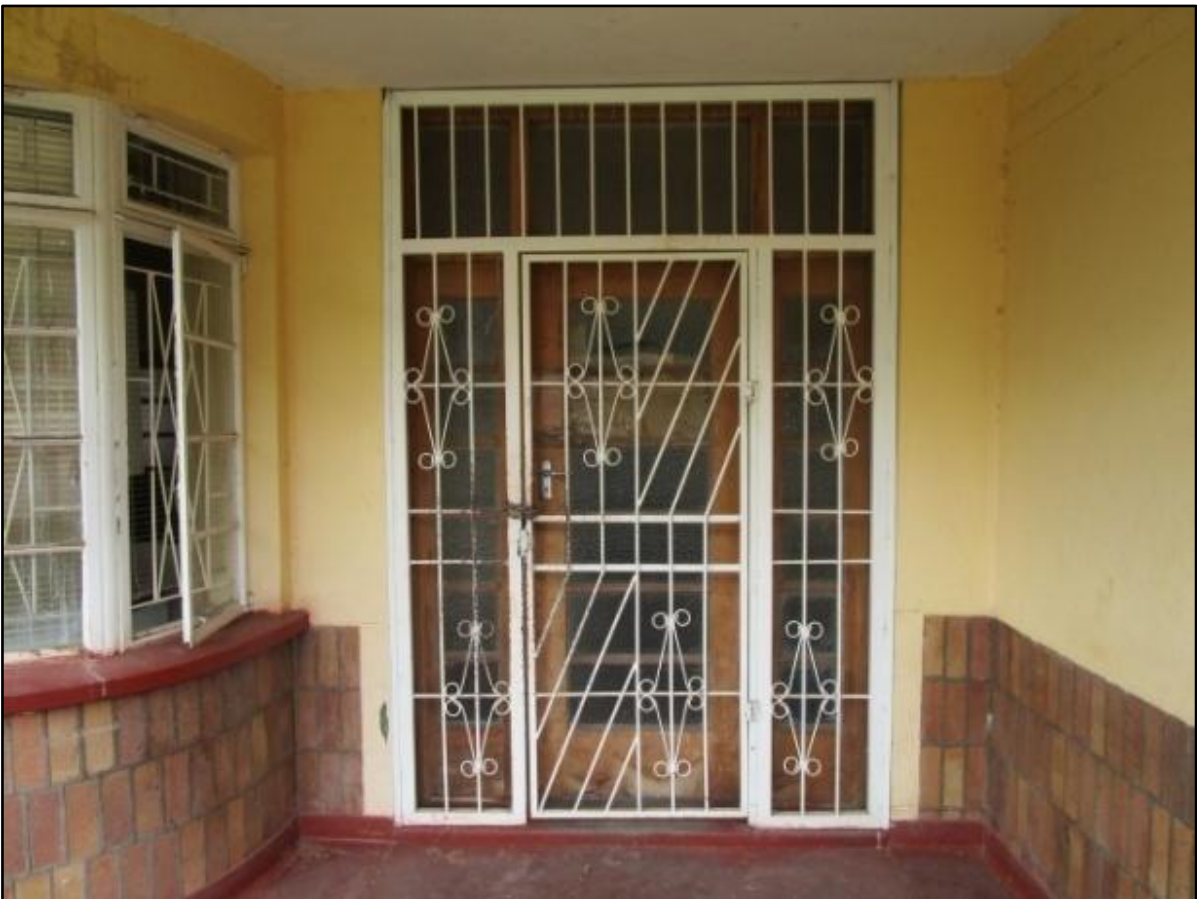
Figure 3. *The front composite door.*

The front door is a composite door with both the door and side windows fitted with frosted glass, opening into the small entrance hall. It is obscured from the outside by a steel burglar gate. The door between the lounge and dining room is a double French glazed door, typically with frosted glass panels. The pantry door is a transom door with a clear glass pane. All other doors are solid Oregon pine panelled doors.

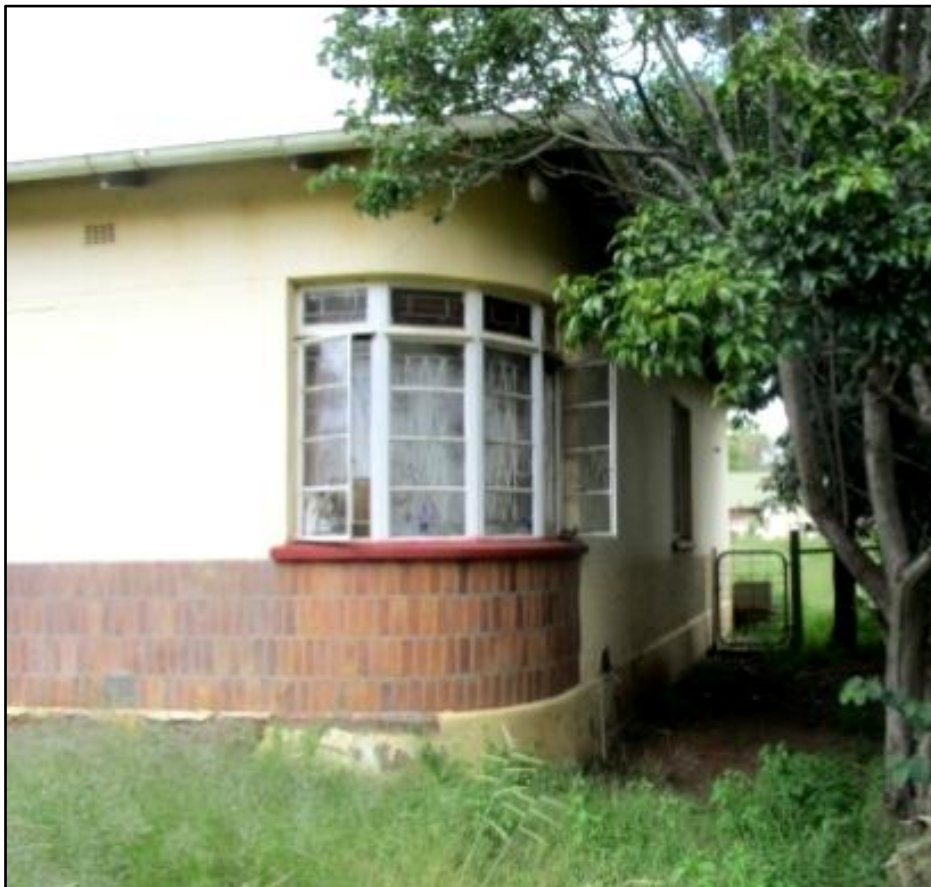
Figure 7. Arced "corner" window – note four panes.

The rounded corners of the lounge and two bedrooms are fitted with steel framed casement windows: the two windows facing the porch consist of three panels each while the “corner” windows (lounge and corner bedroom) have four panels each. Burglar proofing has been fitted over all windows. The pelmets are steel plate.

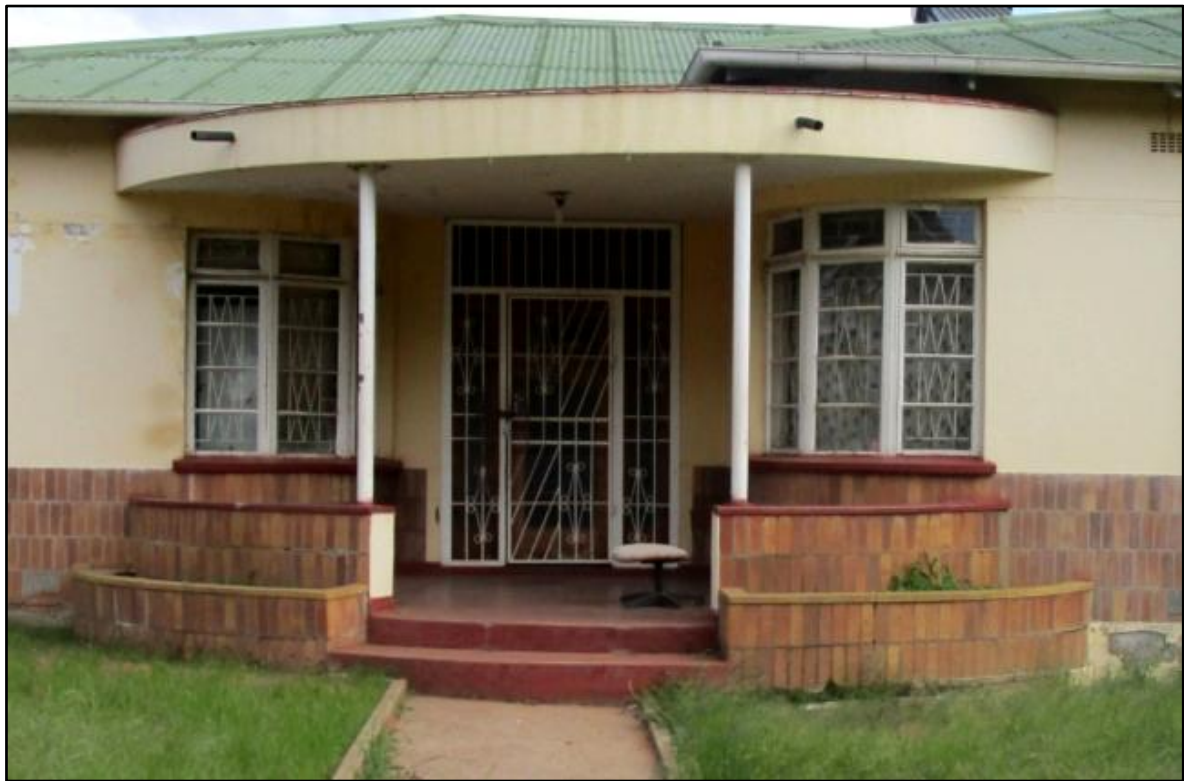
Figure 11. *Front porch showing steps, flower bed and pathway.*

The front porch protrudes beyond the front walls in the form of an arc with a built brick soldier course flower bed. The arced roof of the porch is flat and consists of cast concrete with two drainage pipes.

Simple concrete arced steps provides access to the front porch.

- **Garden.** The garden has not been maintained for a long period and natural grass has taken over.
- **Pathway.** A concrete pathway runs from the street pedestrian gate to the front door and a twin track concrete strips leads to the garage.
- **Outbuildings.** A rectangular outbuilding/garage exists on the eastern side of the erf. It is not apparent whether it is an original structure.

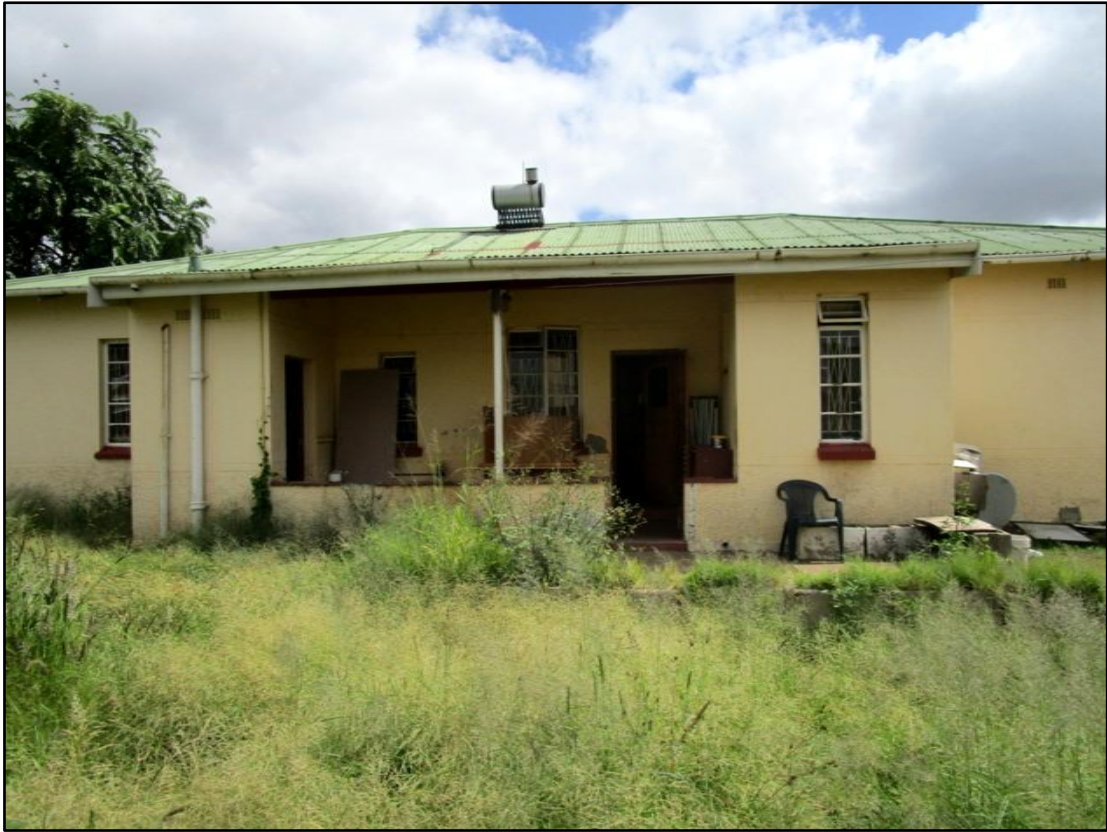
Figure 12. *Rear veranda.*

A rear veranda fills the space between the pantry and outer store room and is supported by a steel post in the centre.

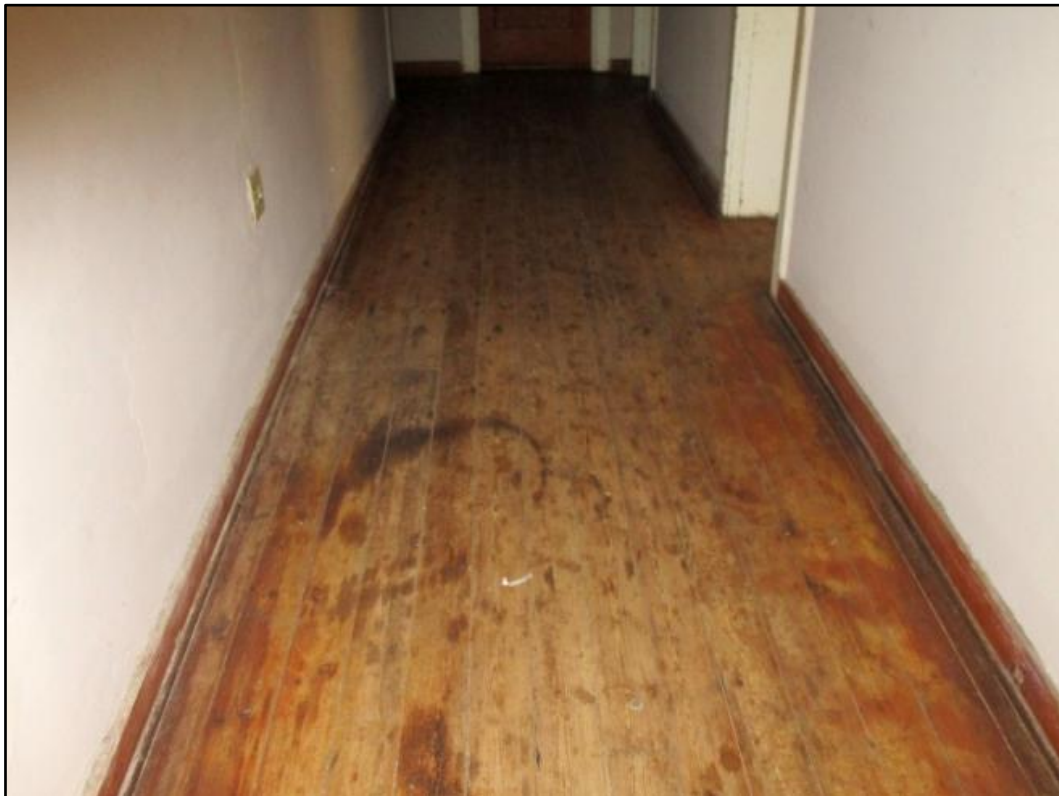
Figure 13. *Timber floor in passage.*

Oregon pine suspended floors – planks are 110mm wide. The kitchen and bathroom floors have been replaced with tiles.

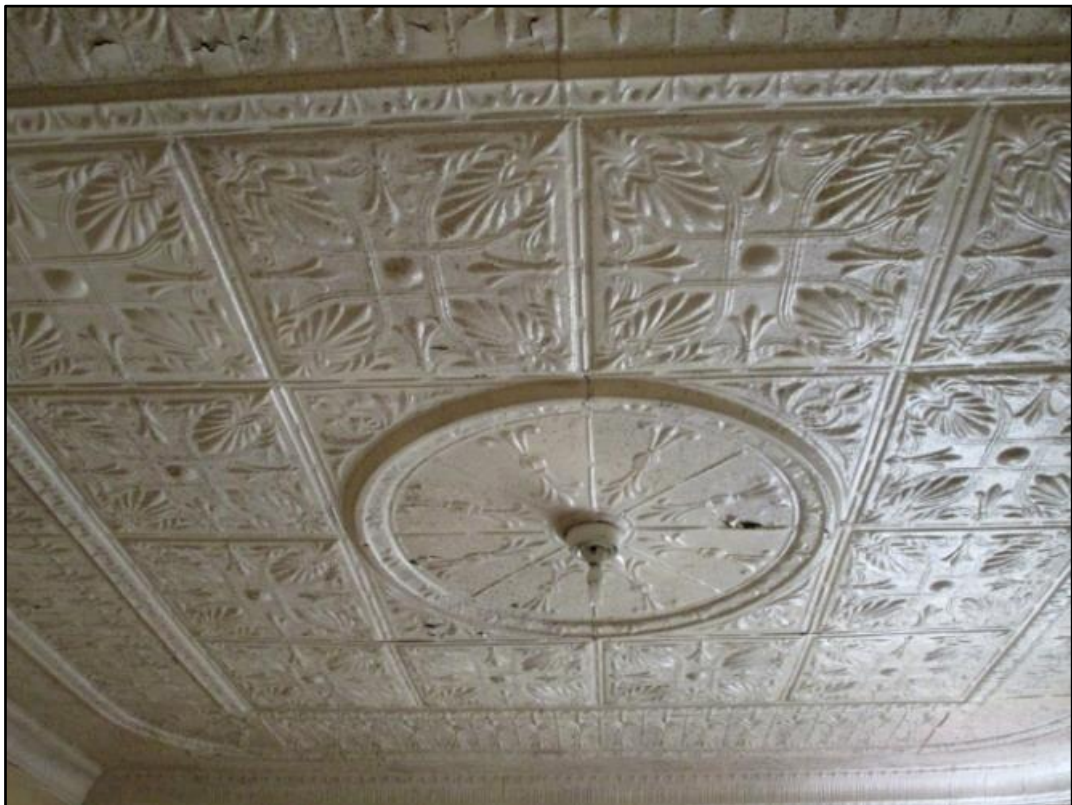
Figure 15. *Pressed metal ceiling.*

The entire house, except the bathroom, is fitted with original painted metal pressed ceilings. The ceilings are in good condition despite paint having peeled off in some sections.

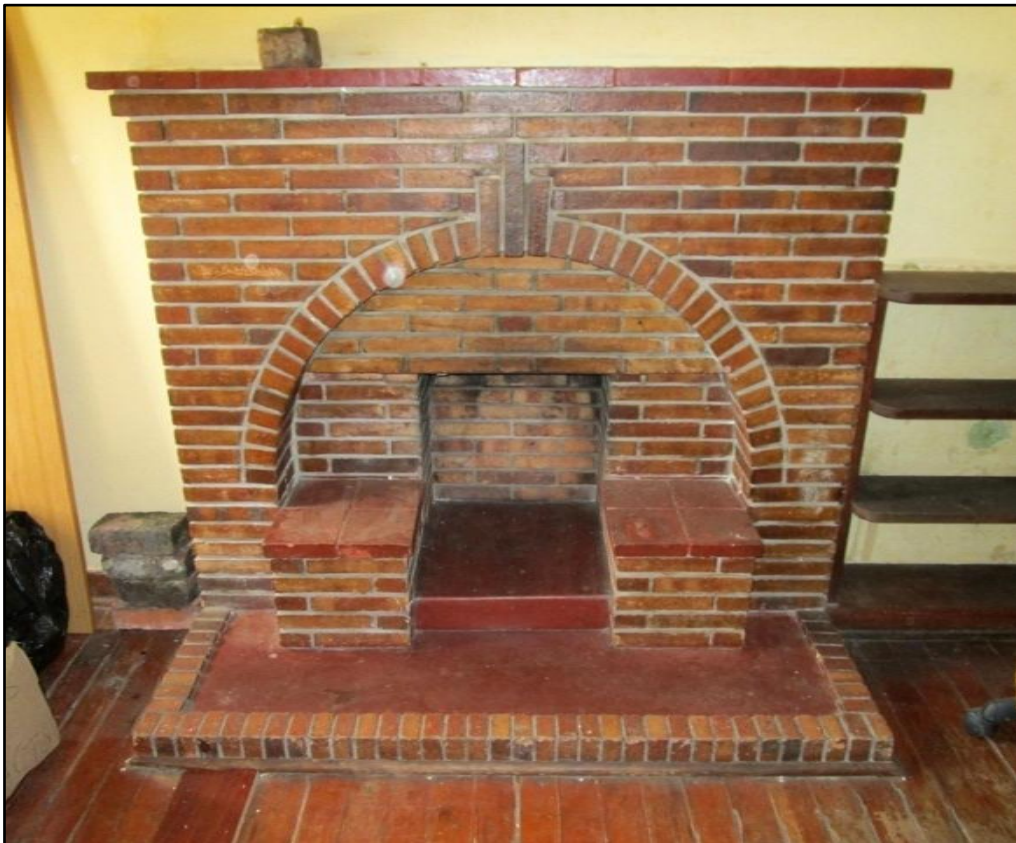
Figure 17. *Fire place in lounge.*

A custom-built face-brick fireplace decorates the lounge. The exterior of the chimney is still in place, but the chimney cap has been removed and probably sealed.
