# A REPORT ON A BASIC HERITAGE ASSESSMENT FOR THE PROPOSED ESKOM WARDEN-VREDE 88KV POWER LINE, FREE STATE PROVINCE

REPORT: AE01369V

November 2013

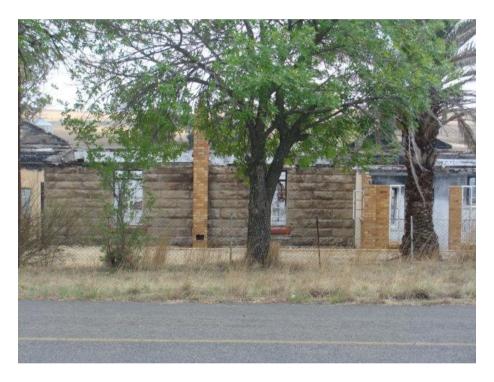
This is a number of 4 houses on the Vrede Station. The houses are dilapidated as it is not in use any more (Figure 23). However they are good examples of the era between the late 19<sup>th</sup> and early 20<sup>th</sup> century and made of sandstone. It would be possible to conserve these.

Figure 23 Some of the station houses in Vrede.

The site is regarded as having a medium cultural significance. It is not very unique, but most likely older than 60 years. The field rating thereof is Local Protection, Grade IIIB. It should be included in the heritage register and may not be mitigated.

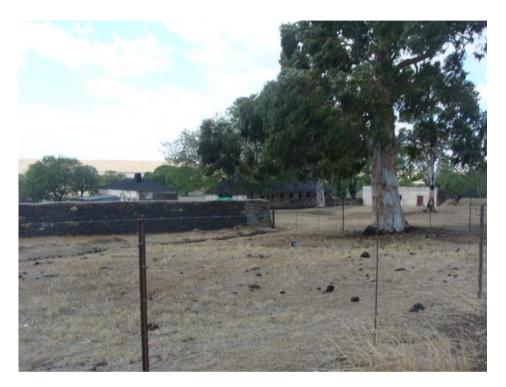
This is a farm yard consisting of a house, a stone packed kraal and 5 outbuildings. Only the kraal is likely older than 60 years, but not very unique (Figure 24). It is still in use.

Figure 24 Farm yard (site 2) along route alternative 2.

The site is regarded as having a low cultural significance. It is not very unique, but the kraal and some of the buildings may be older than 60 years. The field rating thereof is General Protection, Grade C (IVC). It should be included in the heritage register and may be demolished.

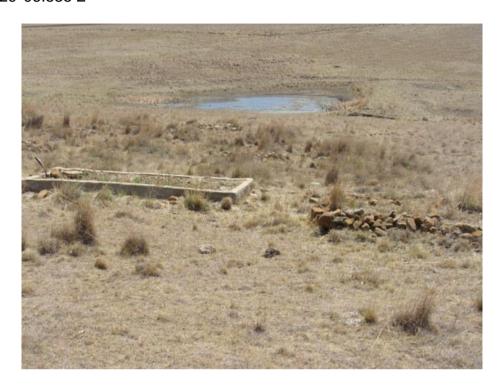
None of the graves have any legible information. Therefore only one of the three categories of graves was identified, being those without a date of death (called unknown graves). Unknown graves are handled similarly to heritage graves.

Figure 25 Some of the graves at site no. 3.

Graves are always regarded as having a **high** cultural significance. The field rating thereof is Local Grade III B. It should be included in the heritage register, but may be mitigated.

Two possibilities exist. The first option would be to fence the graves in and have a management plan drafted for the sustainable preservation thereof. This should be written by a heritage expert. This usually is done when the graves are in no danger of being damaged, but where there will be a secondary impact due to the development.

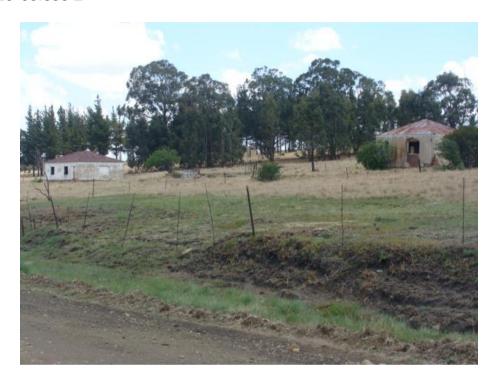
This is a farm yard consisting of two houses and a few associated structures. The two houses are in a reasonable condition, but still had been damaged much (Figure 26). It is not very unique although it may be older than 60 years.

Figure 26 Farm yard (site 4) along route alternative 2.

The site is regarded as having a low cultural significance. It is not very unique, but the two houses most likely are older than 60 years. The field rating thereof is General Protection, Grade C (IVC). It should be included in the heritage register and may be demolished.

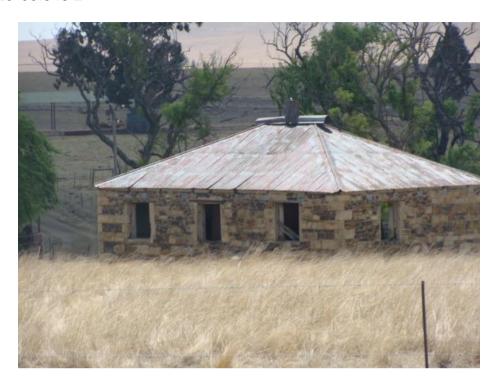
This is a historical farm house made from sandstone and with a corrugated iron roof. It is older than 60 years and most likely date to the early 20<sup>th</sup> century (Figure 27). It may not be very unique, but still is in quite a good condition.

Figure 27 Farm yard along route alternative 2.

The site is regarded as having a medium cultural significance. It is not very unique, but in a good condition, although the roof may have been added later on. The field rating thereof is General Protection, Grade A (IVA). It should be included in the heritage register and should be mitigated before it may be may be demolished. However, even if this route alternative is chosen, it is unnecessary to demolish it, as the route may be moved to the other (southern) side of the road.

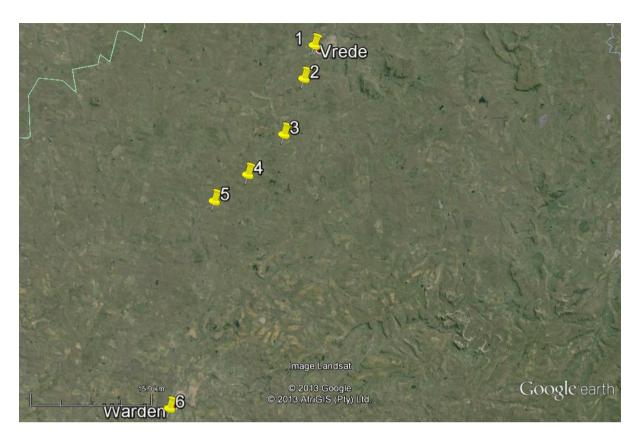
In conclusion it can be stated that the assessment of the area was conducted successfully. As indicated six sites of cultural significance has been found (Figure 28). One of these is on route alternative 1 and 5 on route alternative 2.

Figure 31 Location of the sites identified during the survey.

- From a heritage perspective it is recommended that alternative 1 be used for the Vrede-Warden power line, since it seems the impact is much less that on alternative 2.
