HERITAGE IMPACT ASSESSMENT OLD FORT, CONSTITUTION HILL

BRAAMFONTEIN, JOHANNESBURG

MAYAT HART ARCHITECTS & HERITAGE PRACTITIONERS

2023

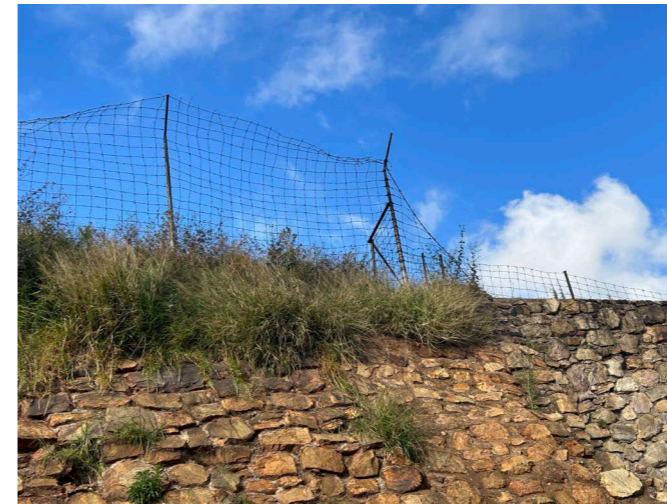
Figure 19: Damaged wire fence

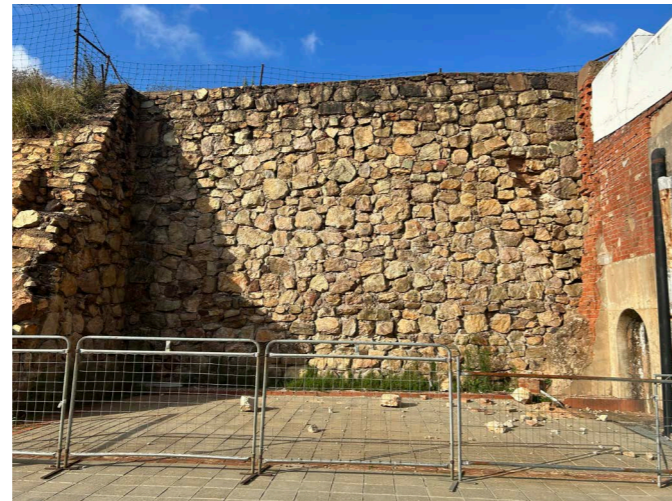
Figure 16: Vertical retaining wall on southern rampart

- The two retaining that are proposed to be reconstructed as part of the works are in a poor structural condition and at risk of collapse.
- The proposed will have a substantial impact on these walls as it requires their total demolition and reconstruction.
- The alternative to this controlled demolition is their eventual collapse and destruction by natural means with subsequent damage and risk.
- Of the two alternatives a controlled demolition and reconstruction has a better chance of mitigating the potential negative impact on cultural and heritage significance.

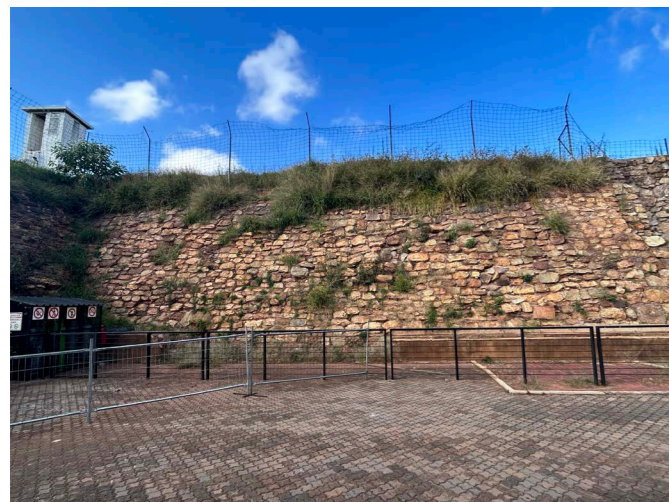
Figure 17: Inclined retaining wall on southern rampart

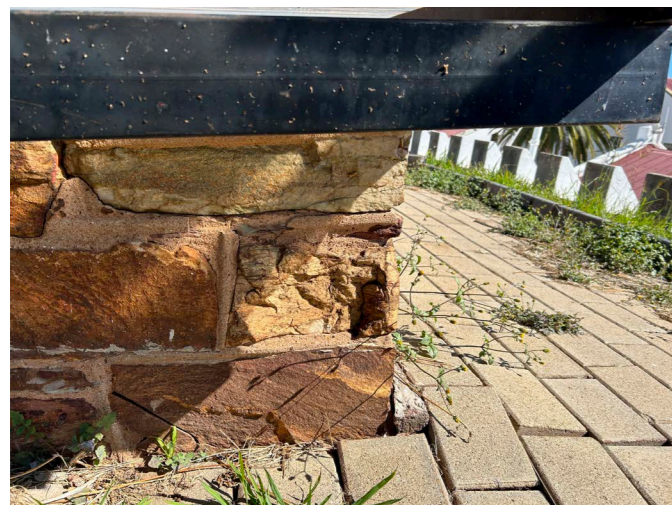
Figure 22: Vent shaft stone wall

- The proposed work involves substantial excavation of the sections of the ramparts which may disturb sections of the original barbed wire fences.
- This has the potential to negatively impact these as heritage resources.
- Ventilation shafts
 - The new covers/repairs to the existing covers to the air shafts are removable and will have no negative impact on the ventilation shafts as heritage resources.
 - The proposed waterproofing work involves substantial excavation of the sections of the ramparts around the ventilation shafts which may disturb the stone structure of the airshafts.
 - The work and excavation has the potential to negatively impact the stone structure of the shafts.
