**Proposed Extension of Acaciavale Township Development
Alfred Duma Local Municipality, Thukela DM, KwaZulu-Natal**

Observations

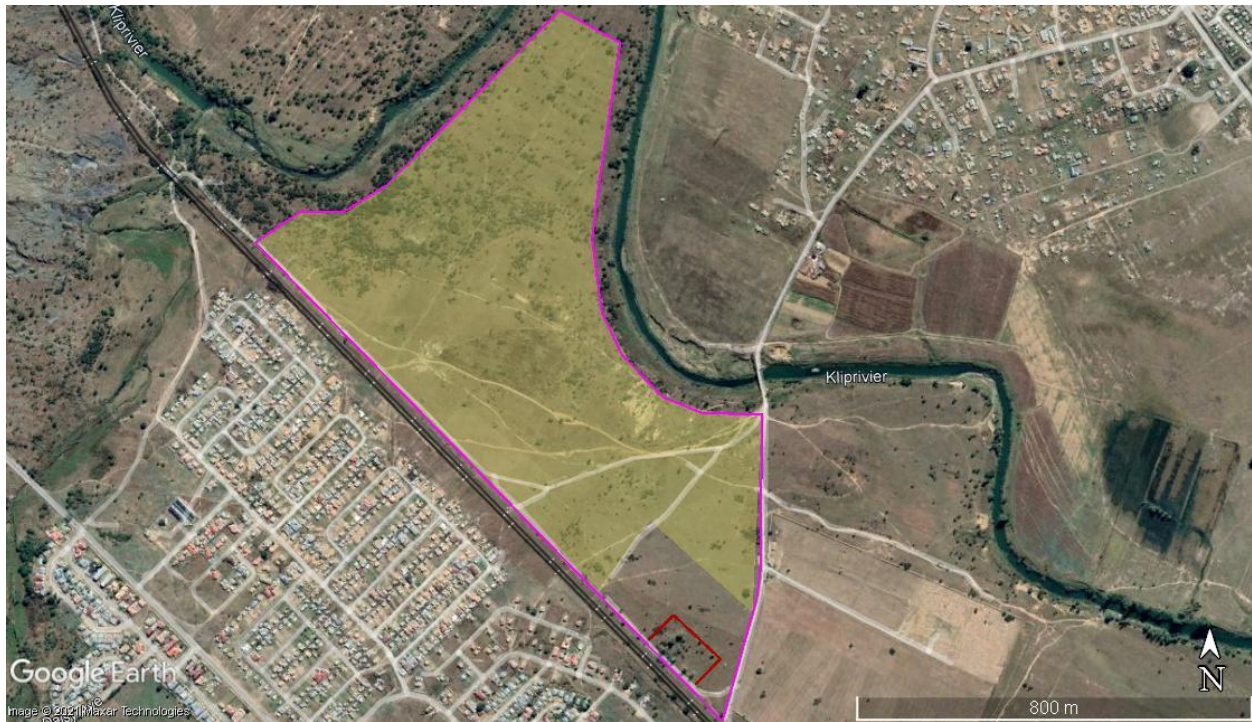
Figure 2 Aerial view of the Ntombi Memorial Cemetery (red rectangle) in relation to the the proposed housing development footprint (see kml. loaded to SAHRIS Case File).

The burial ground in question is in fact the Ntombi Memorial Cemetery (not stated in the original HIA). This Memorial was put in place with funds from the British War Graves Commission in the late 1990's but has subsequently been deplorably vandalised.

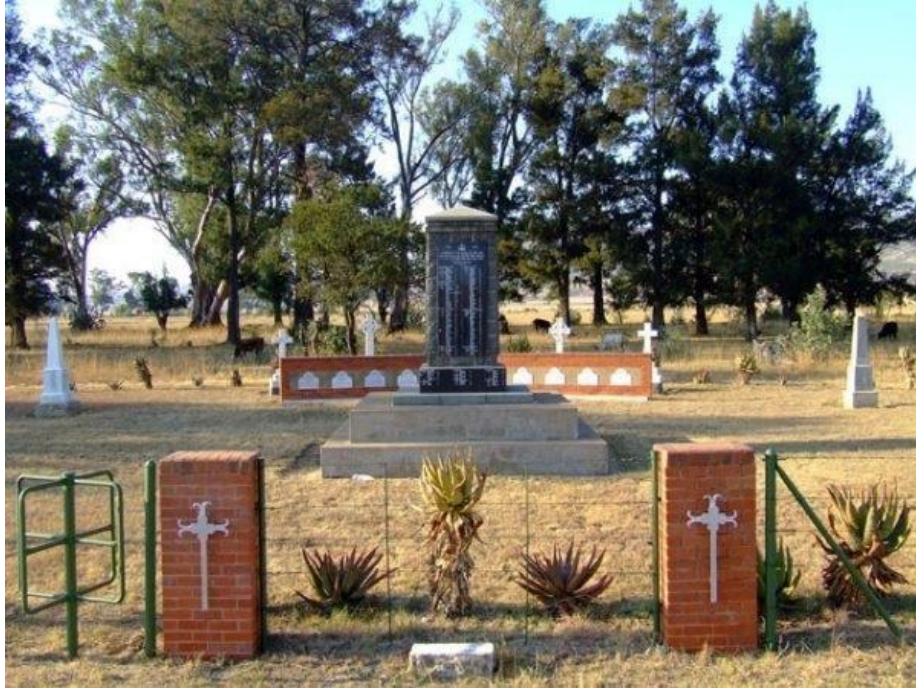
Figure 3 View of the Ntombi Memorial Cemetery at the time of restoration in the 1990's

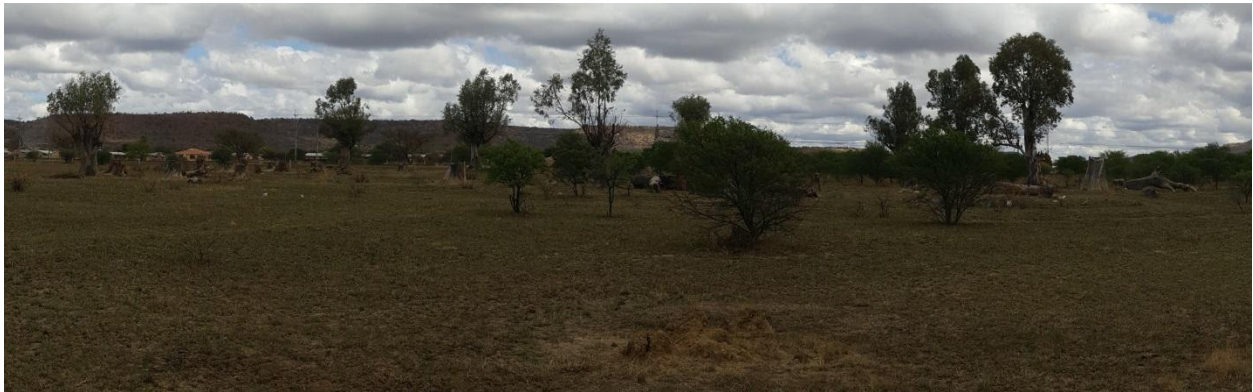
Figure 4 View of the vandalised Ntombi Memorial Cemetery precinct in September 2021

Consequently, the precinct around the Memorial Cemetery is a burial ground of, at present, indeterminate extent. **As a burial ground it remains of the highest heritage significance.**

4. The buffer zone, including the boundaries of the Memorial Cemetery should be secured by the local municipality by means of a concrete pallisade fence, as the one erected around the nearby current municipal cemetery. A lockable steel, vehicle-access gate should also be provided. If left unfenced, the buffer zone and remnant memorial cemetery will be subject to uncontrolled and indiscriminate uses, nullifying the attempts to sanctify the burial ground.
5. The KwaZulu-Natal Amafa and Research Institute must be liaised with by the development planners during this implementation to ensure adequate compliance.
6. Consideration should be given for Amafa and the Municipality to partner in making use of a revitalized burial ground as a showcase for the memorialization of those Black and Indian non-combatents who paid the final sacrifice.

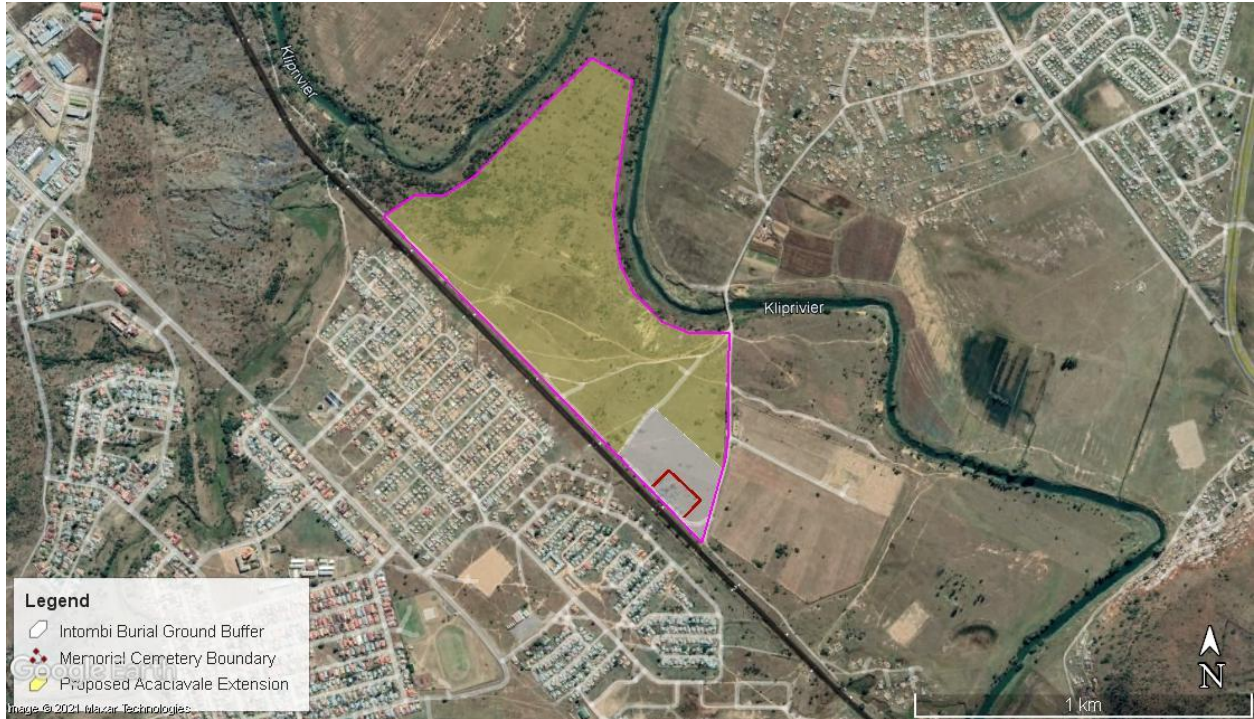
Figure 5 Aerial view of the Ntombi Memorial Cemetery (red rectangle) in relation to the the proposed housing development footprint and our recommended buffer zone. (see kml. loaded to SAHRIS Case File).

See Fig. 5. below.

3. In the light of the inderterminate extent of the burial ground, a ground penetrating radar survey should be undertaken to best assess the location of graves no longer visible at the surface. This will enable the exact delimitation of the buffer zone.⁵
