PGS
HERITAGE

PHASE 2 MITIGATION REPORT

**PROPOSED RECOMMISSIONING OF THE OLD BALGRAY COLLIERY LOCATED
NEAR DUNDEE, ENDUMENI LOCAL MUNICIPALITY, UMZINYATI DISTRICT
MUNICIPALITY, KWAZULU-NATAL PROVINCE.**

Issue Date: 31 January 2020
Revision Number: 1
Project Number: 447HM

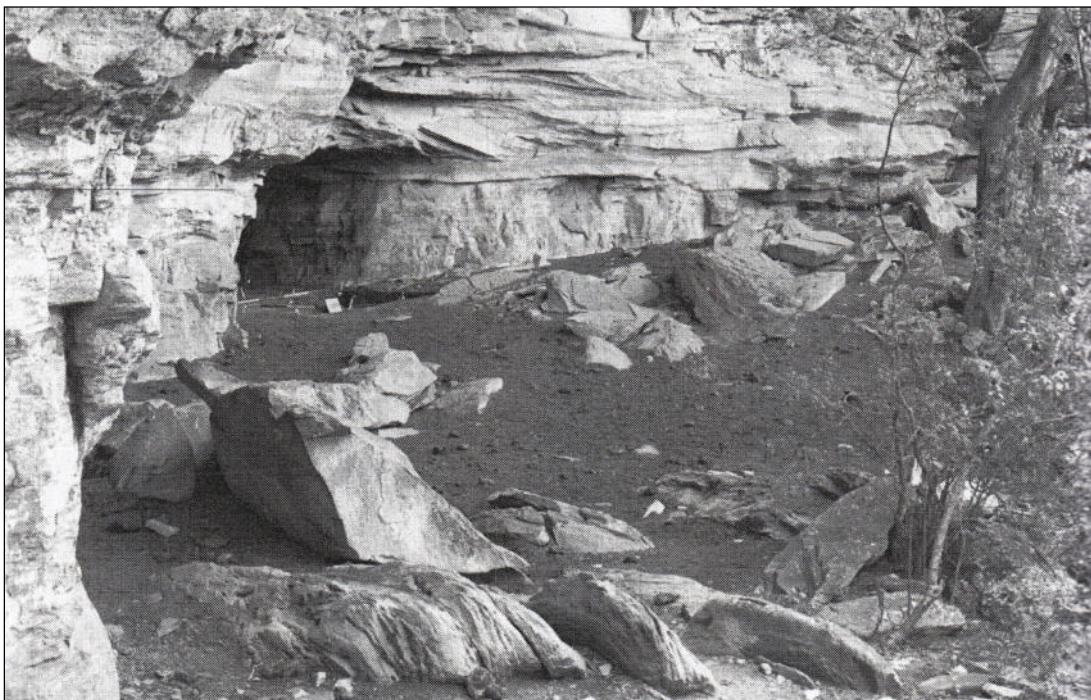
Figure 3 – Nkupe Shelter during the archaeological excavations of the early 1980s (Mitchell, 1999:168).

Dr. Mazel carried out three archaeological excavations at Nkupe, during the early 1980s, which established that Nkupe Shelter was “...one of the key sites for documenting and explaining the Thukela Basin hunter-gatherer Holocene past. It contains probably one of the most complete and detailed 7000-2000 BP sequences known in Southern Africa, and, in addition, produced a substantial quantity of subsistence and material cultural remains (Mazel, 1988:321).

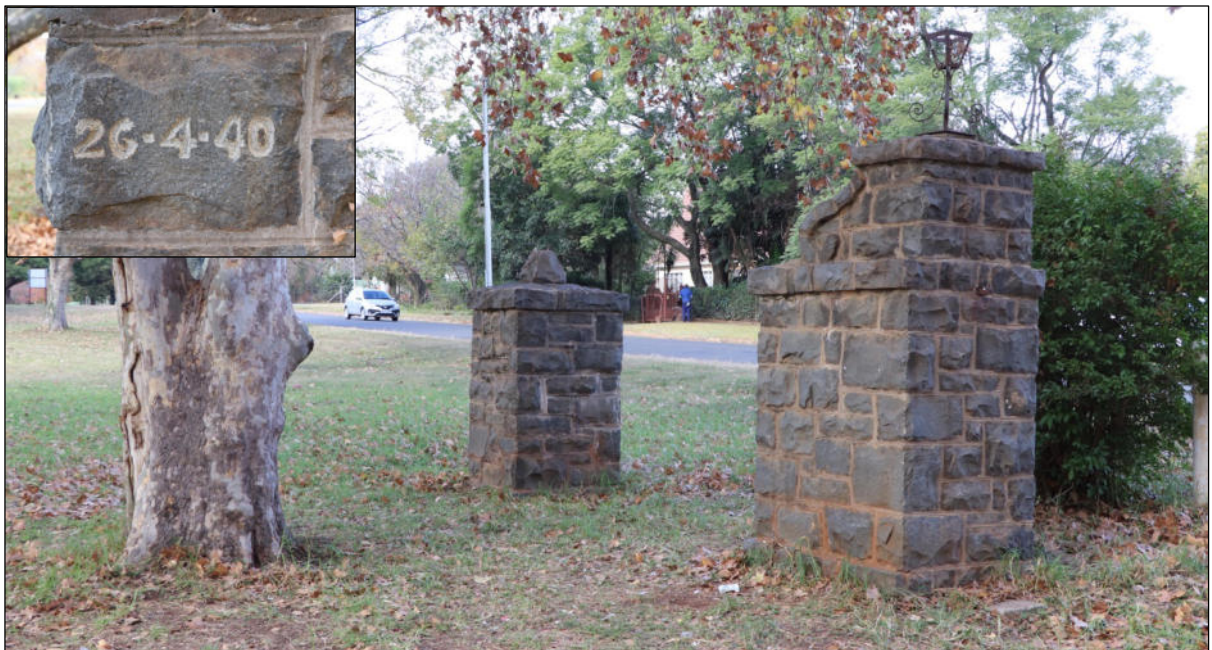
Figure 11 – Closer view of a section of the MacPhail Gates. The insert shows the date that was engraved into the masonry of one of the gate structures. It seems likely for this date to reflect the day on which the gates were erected at the entrance to the farm Craigside.

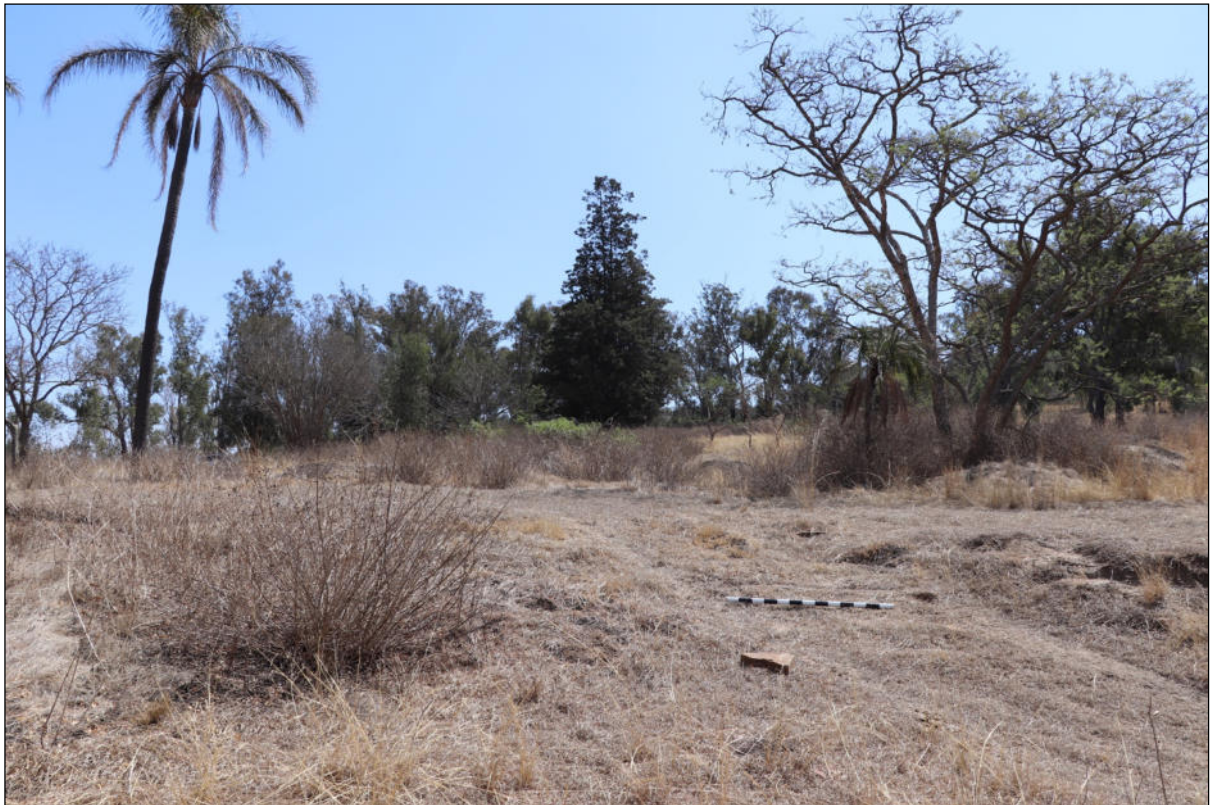
Figure 21 – General view of the raised rectangular area of soil. Scale is in 10cm increments. Refer photographic reference P1 on map depicted in Figure 20.

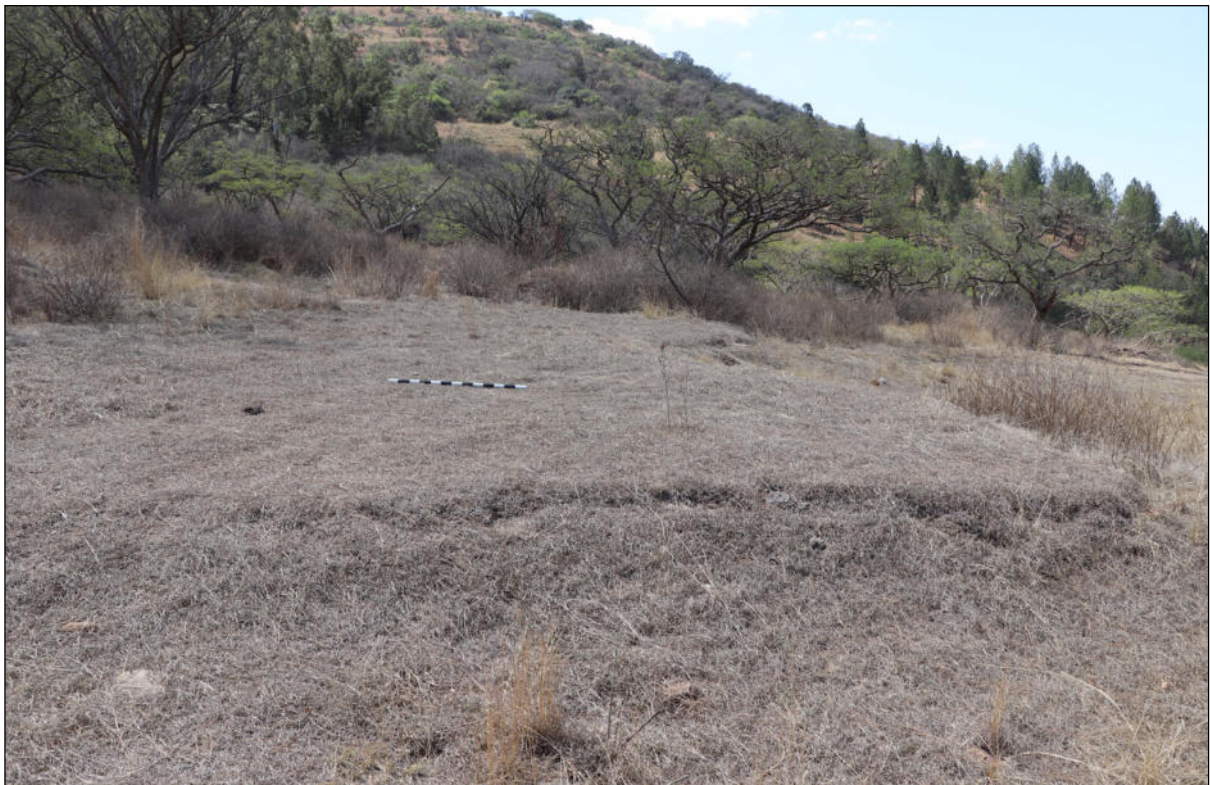
Figure 22 – Another view of the raised rectangular area of soil. Scale is in 10cm increments. Refer photographic reference P2 on map depicted in Figure 20.

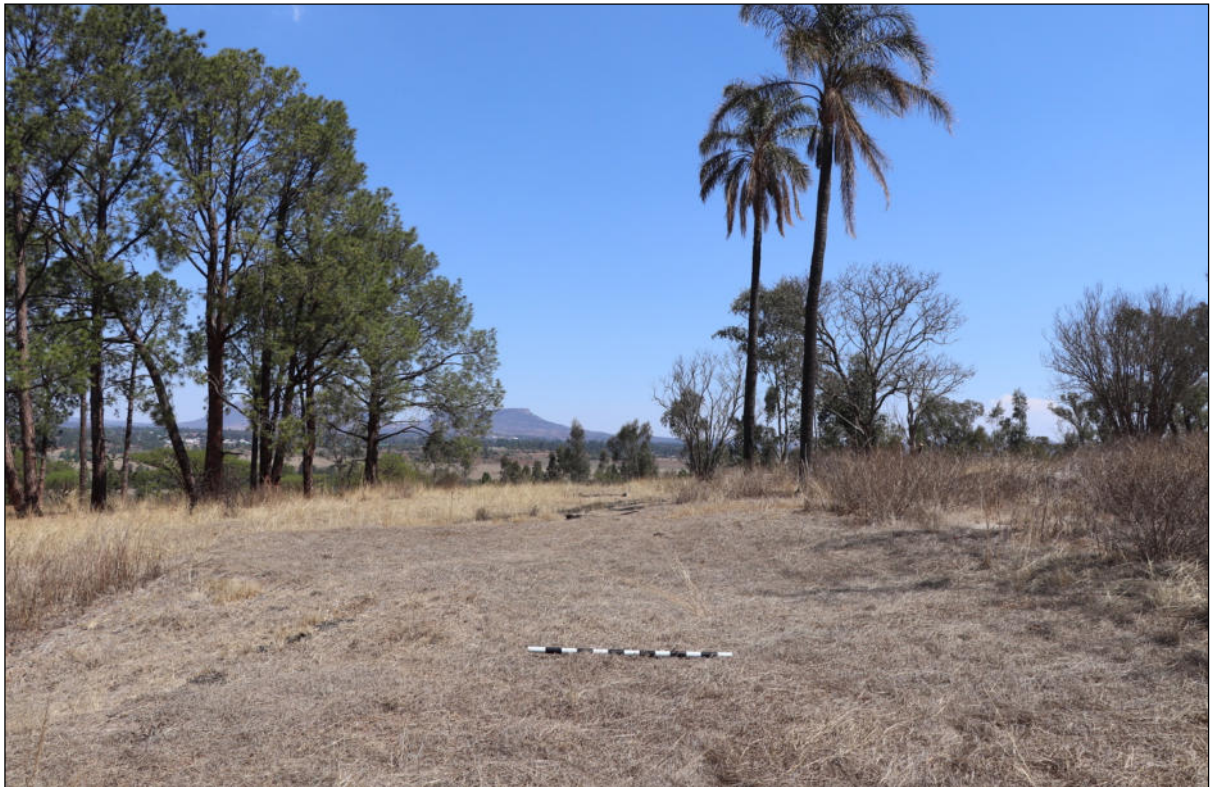
Figure 23 – View across the raised rectangular area showing the two palm trees and the double lane of pine trees. Scale is in 10cm increments. Refer reference P3 on map depicted in Figure 20.

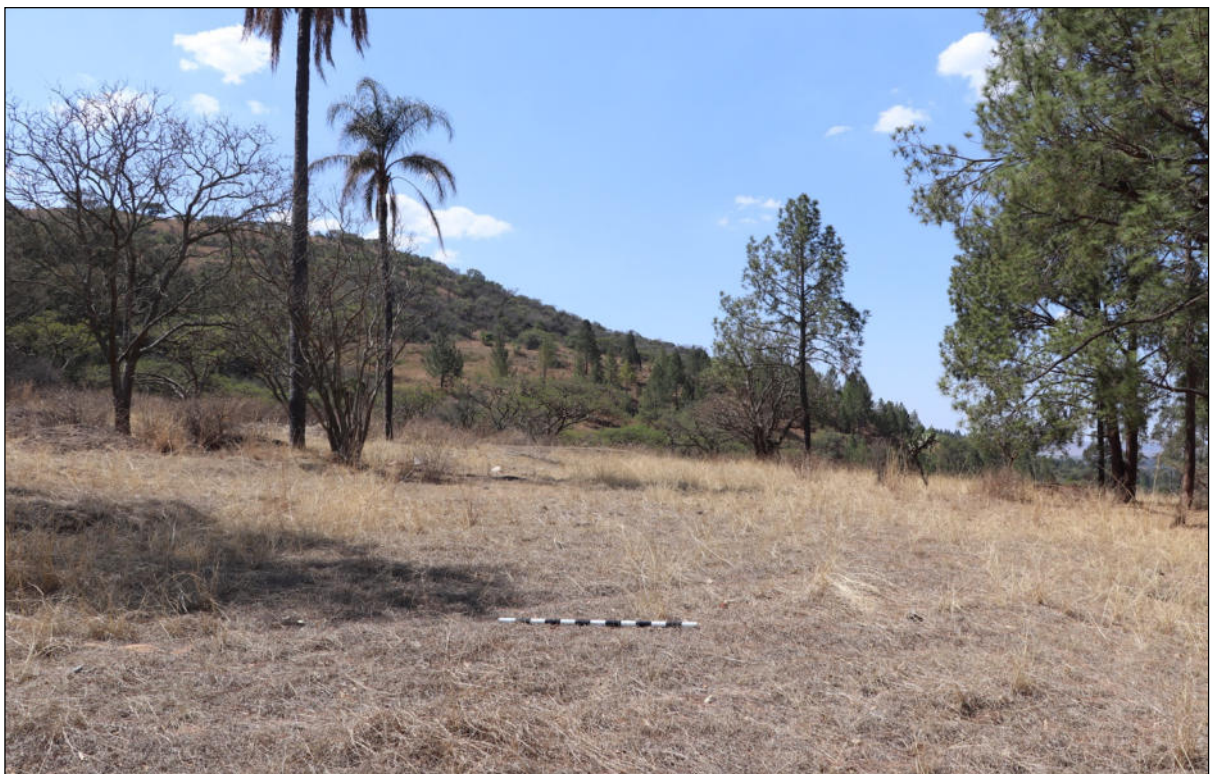
Figure 24 – View from the south-west towards the raised area of soil. The two palm trees can be seen on the left with a section of the double lane of pine trees evident on the right. Scale is in 10cm increments. Refer photographic reference P4 on map depicted in Figure 20.

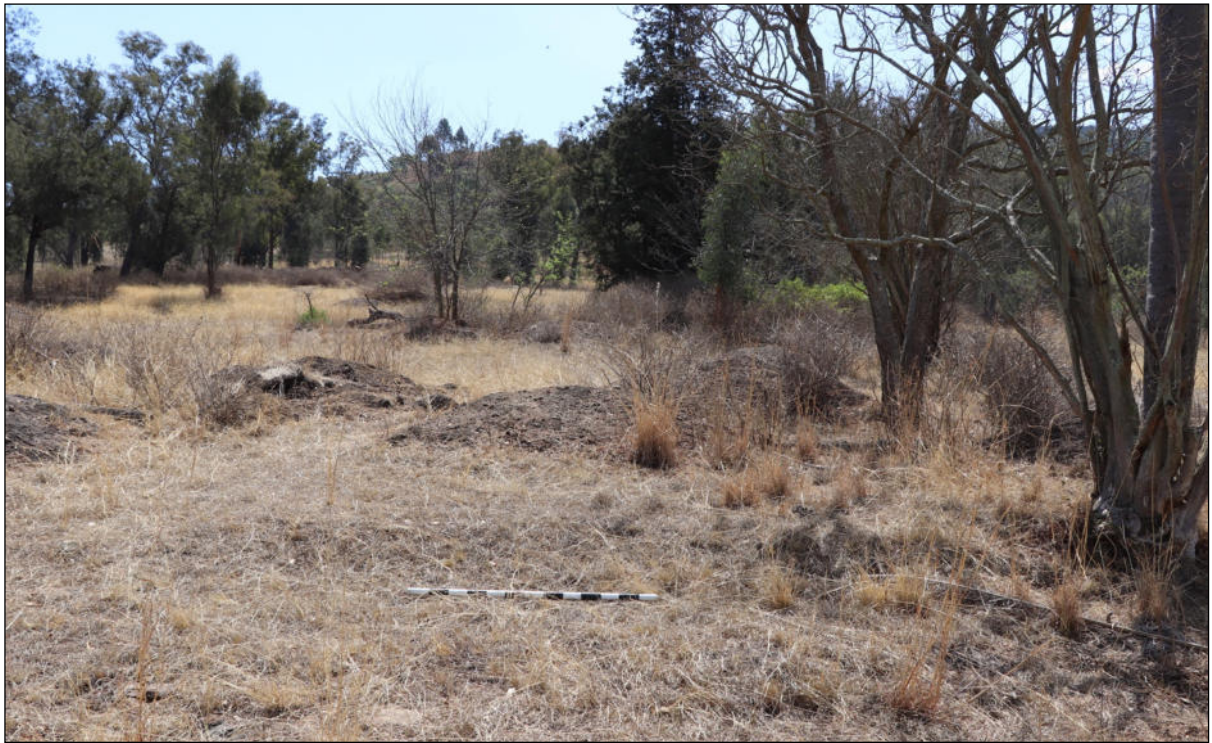
Figure 25 – General view of the area where the cluster of stonewalled features was identified. Note the number of soil heaps associated with the disturbance of the site surface. Scale is in 10cm increments. Refer photographic reference P5 on map depicted in Figure 20.

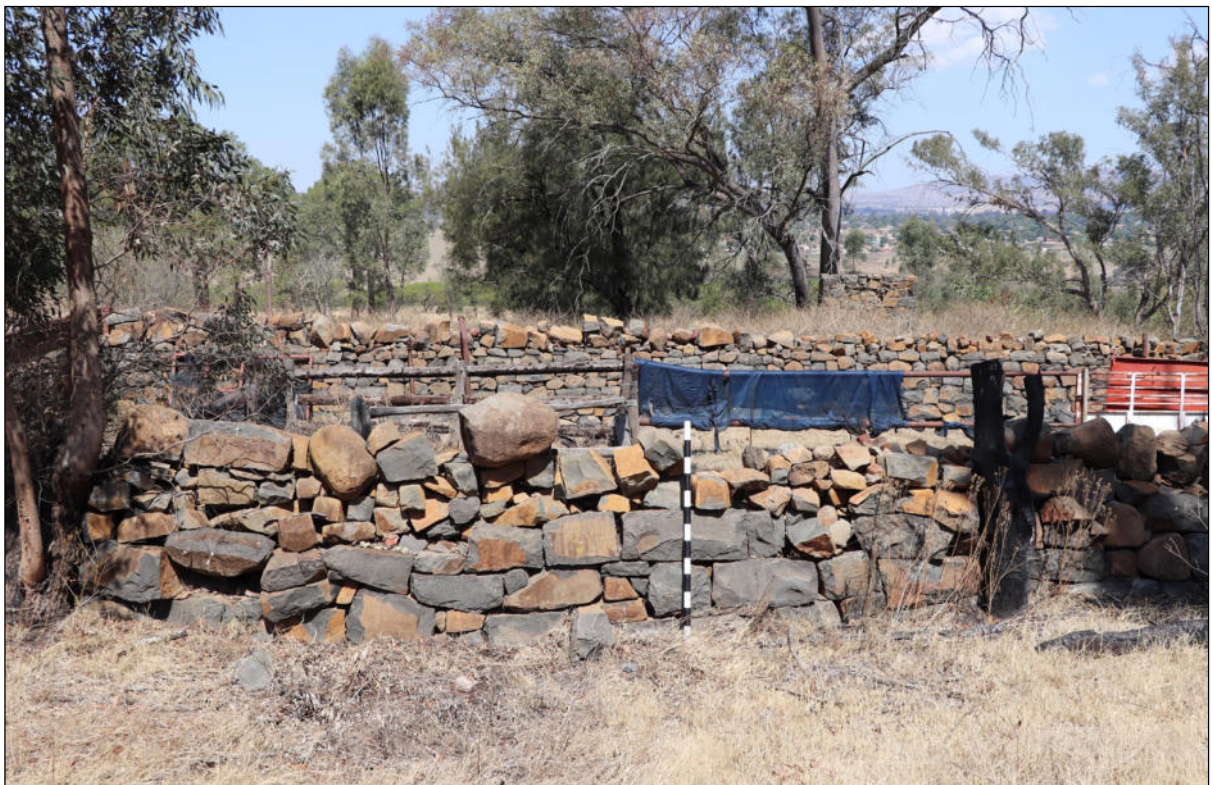
Figure 26 – General view across the livestock enclosure. In the background, a section of the remains of masonry shed can be seen. Scale is in 10cm increments. Refer photographic reference P6 on map depicted in Figure 20.

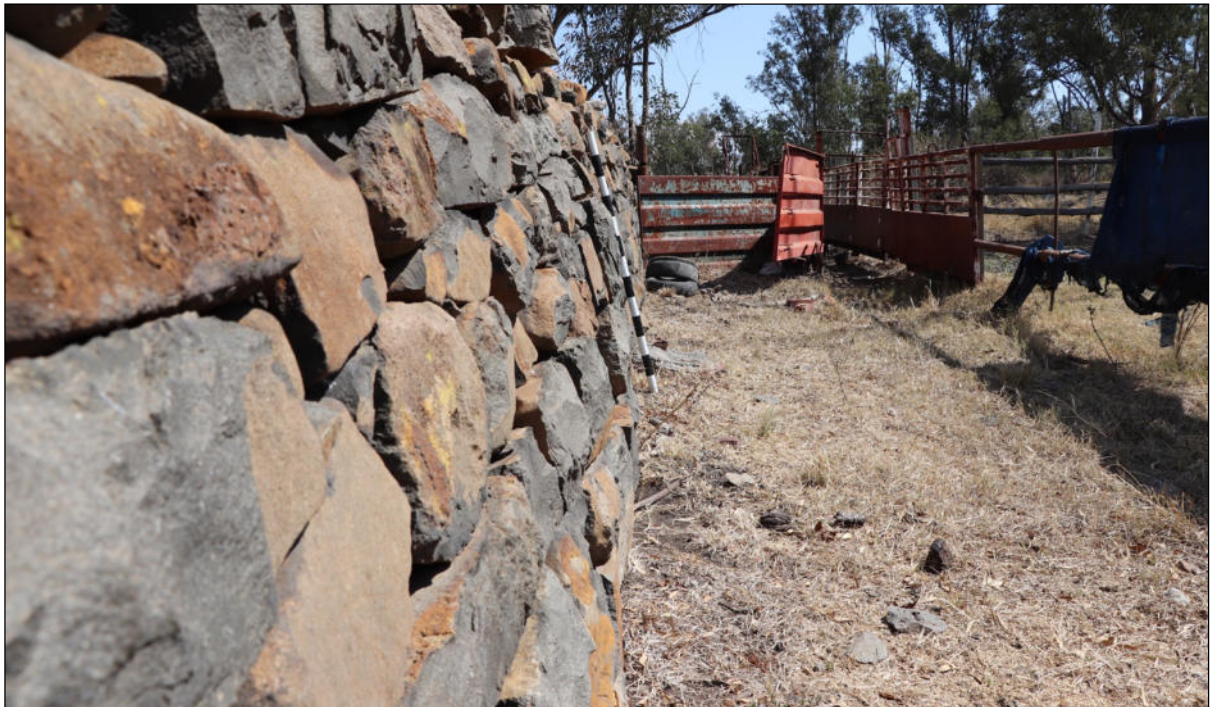
Figure 27 – This view along the inside wall of the original component of the livestock enclosure clearly depicts the battering that was built into the wall to increase its stability. This section of the livestock enclosure can be seen as the first building phase in its construction. Scale is in 10cm increments. Refer photographic reference P7 on map depicted in Figure 20.

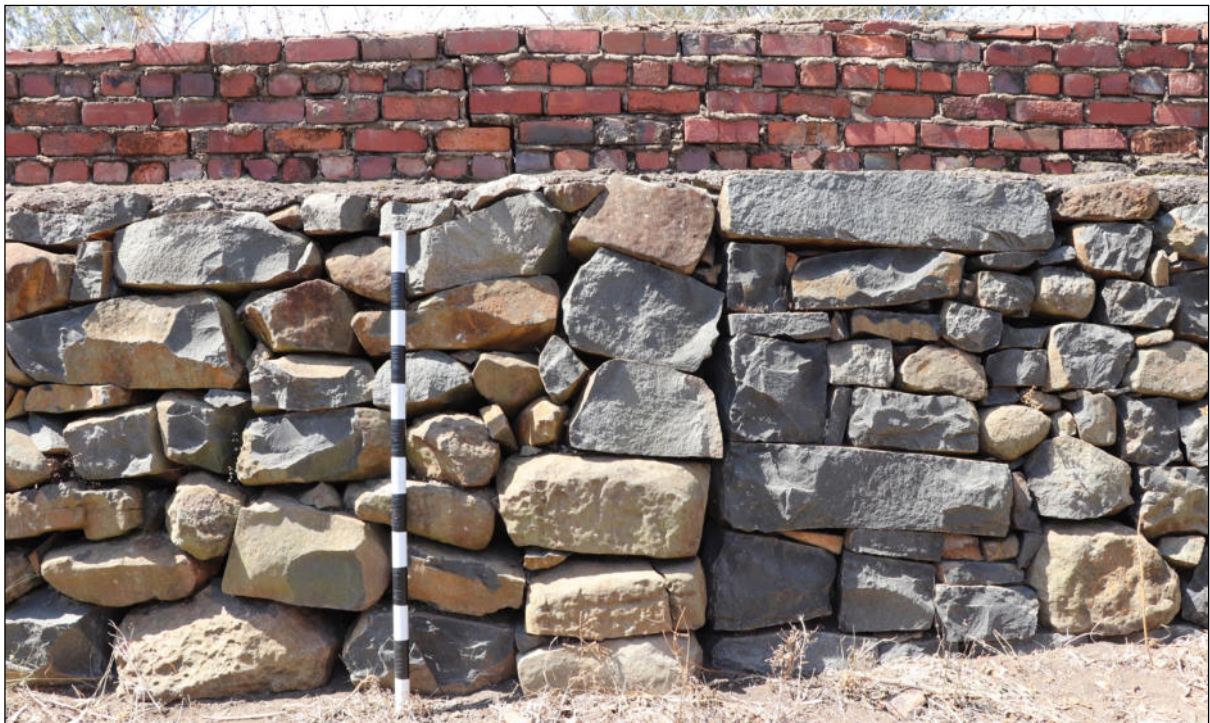
Figure 28 – Three building phases in the construction of the livestock enclosure can be identified on this image. The first building phase is represented by the stonewall on the right, with the second building phase represented by the stonewall on the left. The brickwork visible on top of both these stonewall sections, represents a third building phase. Refer photographic reference P8 on map depicted in Figure 20.

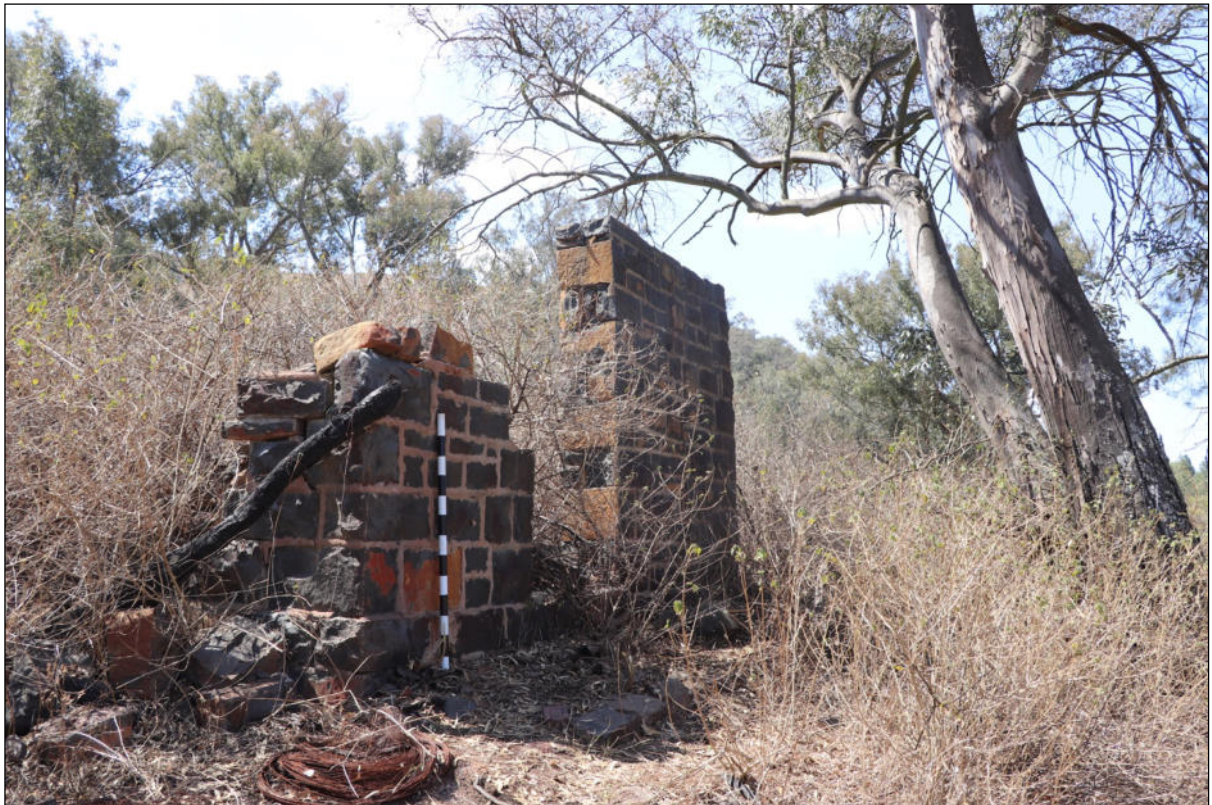
Figure 29 – General view of the tangible remains of the masonry shed. Scale is in 10cm increments. Refer photographic reference P9 on map depicted in Figure 20.

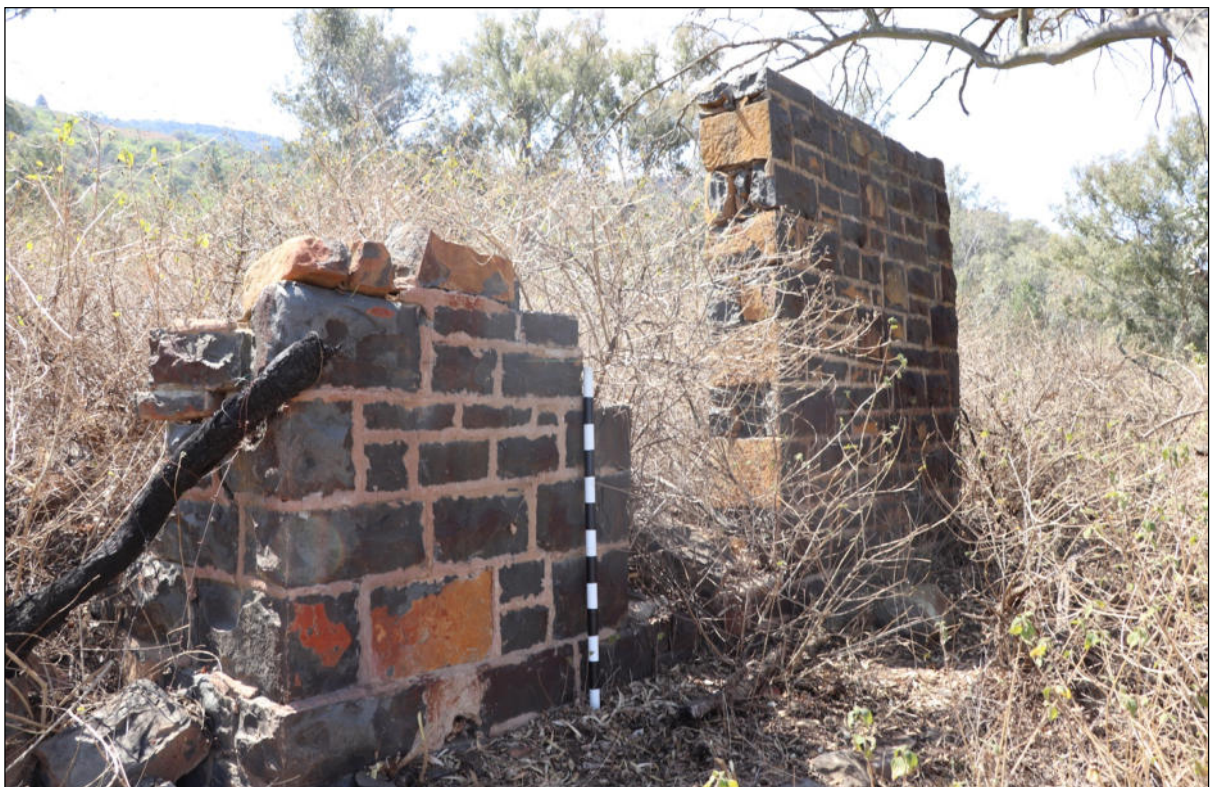
Figure 30 – Closer view of the tangible remains of the masonry shed. Refer photographic reference P10 on map depicted in Figure 20.

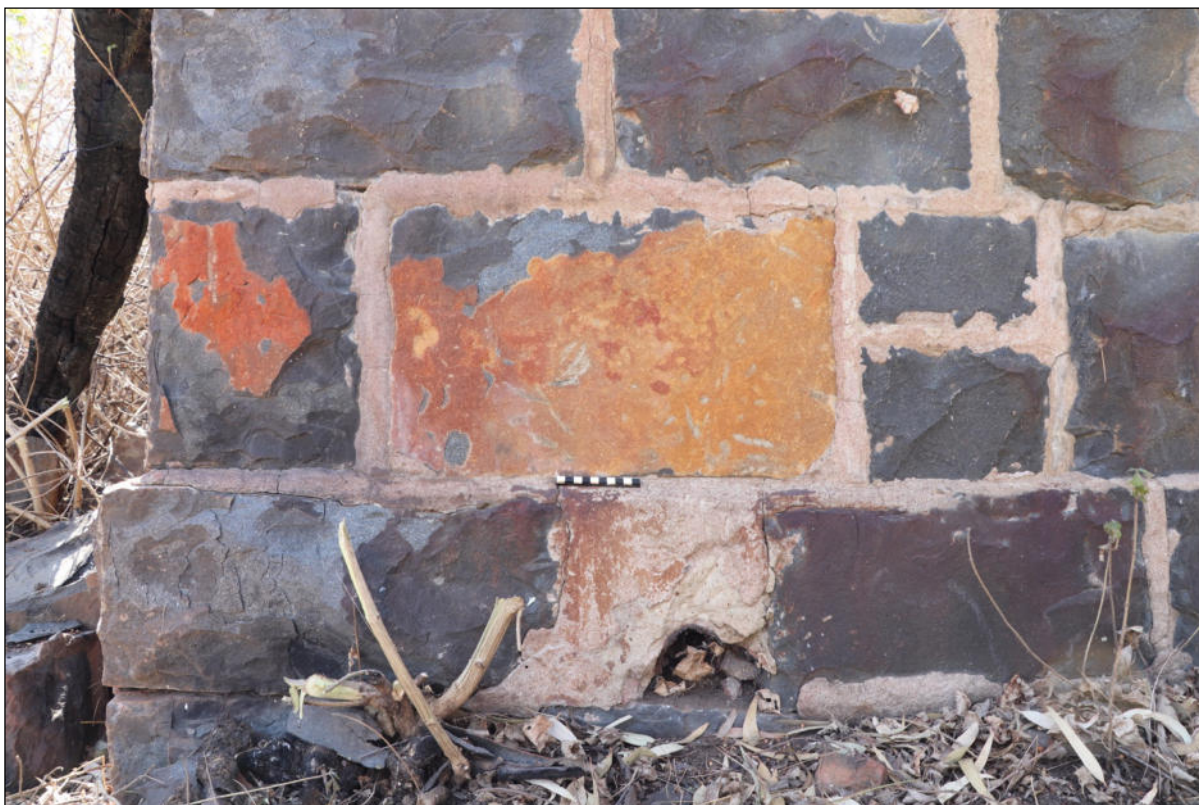
Figure 31 – Detailed view of a section of walling from the masonry shed. Scale is in 1cm increments. Refer photographic reference P11 on map depicted in Figure 20.

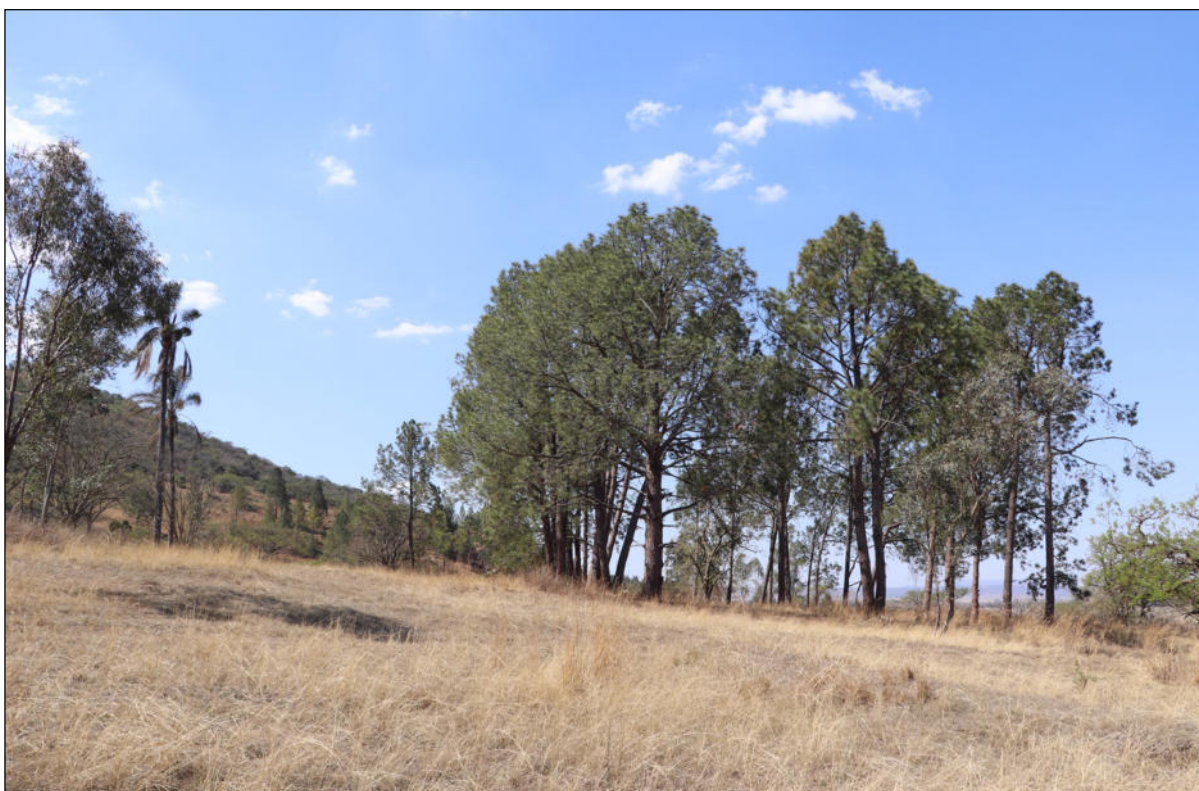
Figure 32 – General view of a section of the site showing the double lane of pine trees on the right with the palm trees on the left. Refer photographic reference P12 on map depicted in Figure 20.
