eThembeni
Cultural
Heritage

**Heritage Evaluation Report
Greater Mpofana Bulk Water Supply Scheme
Poplar Avenue on R103 / D146 Rosetta
Mpofana Municipality, KwaZulu-Natal**

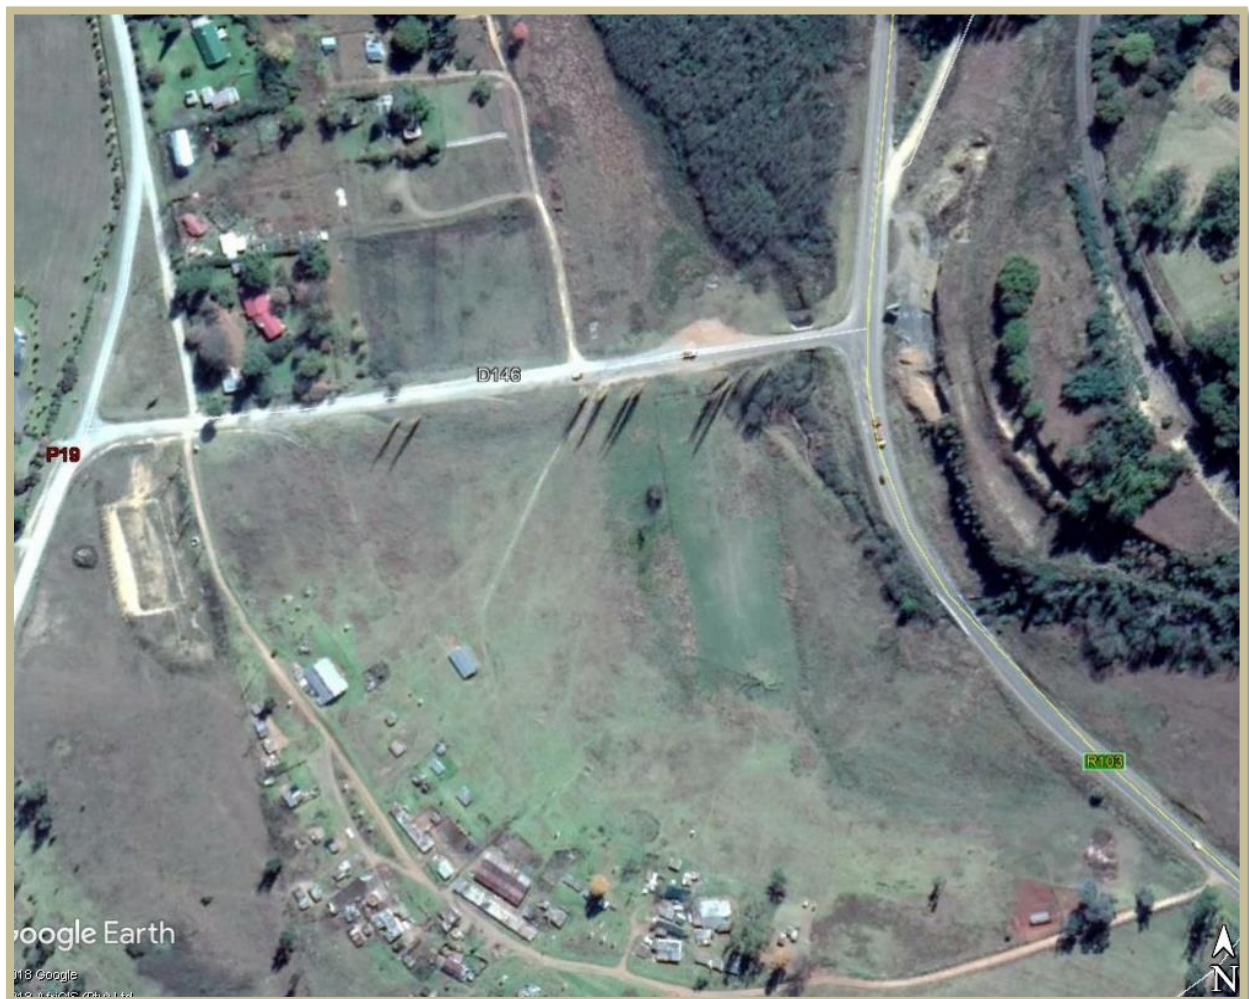
Figure 1a D146 – P19 Alignment (2017)

Figures 1a, 1b, 1c illustrate that, in contrast to expansion, the avenue has remained in degradation over the last decade.

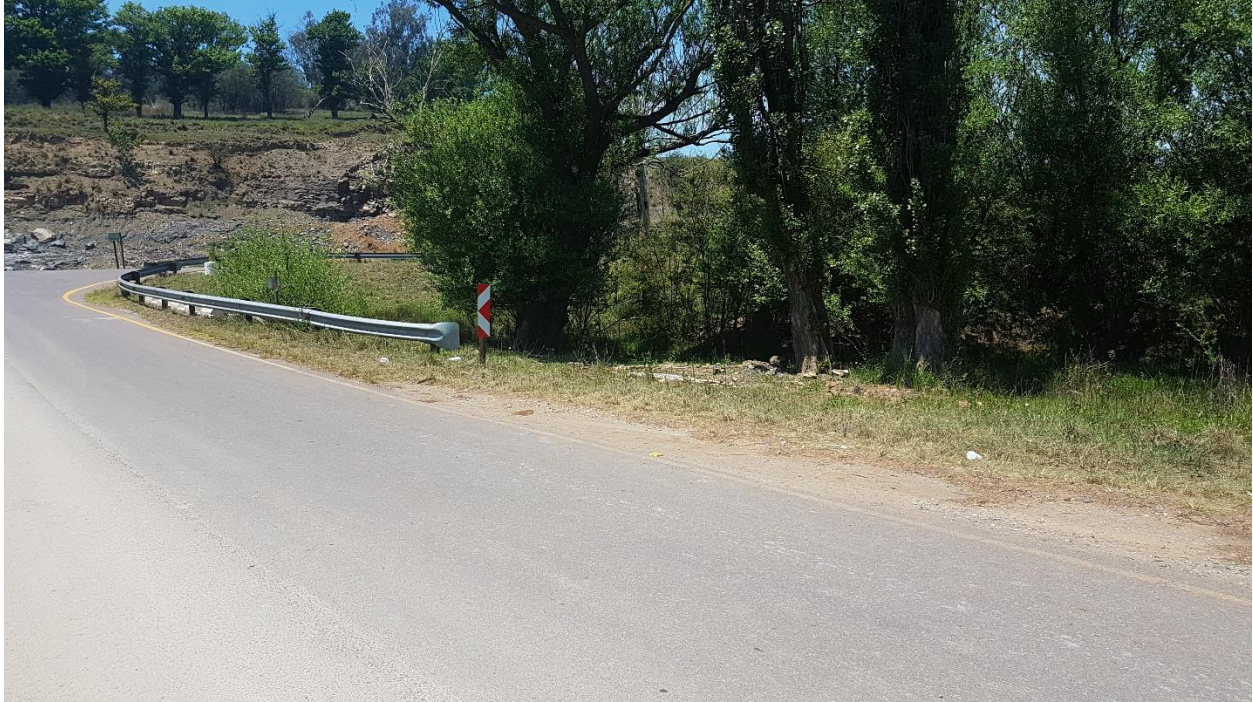
Currently only 11 trees remain erect along the avenue. At their established spacing of 3 m the avenue would have comprised in the region of 110 trees. Thus, only 10% of the original avenue is intact. Of these remaining trees, the majority show signs of fire, wind and snow damage that has led to them coppicing as multi-stemmed trees at lower to mid-height (see Figure 2). Poplars are further declared Category 2 aliens. Once removed they may not be replaced.

Thus, the retention of the remnant poplars is difficult to justify as an historical feature. They have lost their context in the extant landscape as the avenue no longer leads to the entrance of the parent farm. It does however provide a shielding boundary for the northern extent of the Spring Vale Housing development.² The avenue, in its current form, is reminiscent of a mandible with many missing teeth (see Figure 3).

Figure 3 Remnant poplar avenue at the junction of the R103 and D146.
(Note: sub-story of feral eucalyptus)

If it is the intention to attempt to recreate the historical avenue in the current landscape it is probably best to take the advice and recommendations of the appointed ecologist to plant high moisture tolerant endemic species, such as false olive (*Buddleja saligna*) and pom-pom (*Dias cotonifolia*) trees. These are quick growing species with relatively shallow root systems. They would quickly hide the landscape scarring caused by the pipe excavations, and mature within a few years to provide a robust avenue of vegetation along the previous alignment.

On the basis of this heritage evaluation we request that Amafa allow the remnant poplar avenue to be removed for laying of the pipeline reticulation and that, on project completion, the ECO ensures that the historical avenue is re-established with endemic species compatible to the envisaged reinstatement.
