**eTHEMBENI
CULTURAL
HERITAGE**

Heritage Scoping Report

**Proposed construction of 7.6 km gravel road in Obisini Village
on the Farm Qamu Location 17484
Msinga LM, Mzinyathi District DM, KwaZulu-Natal.**

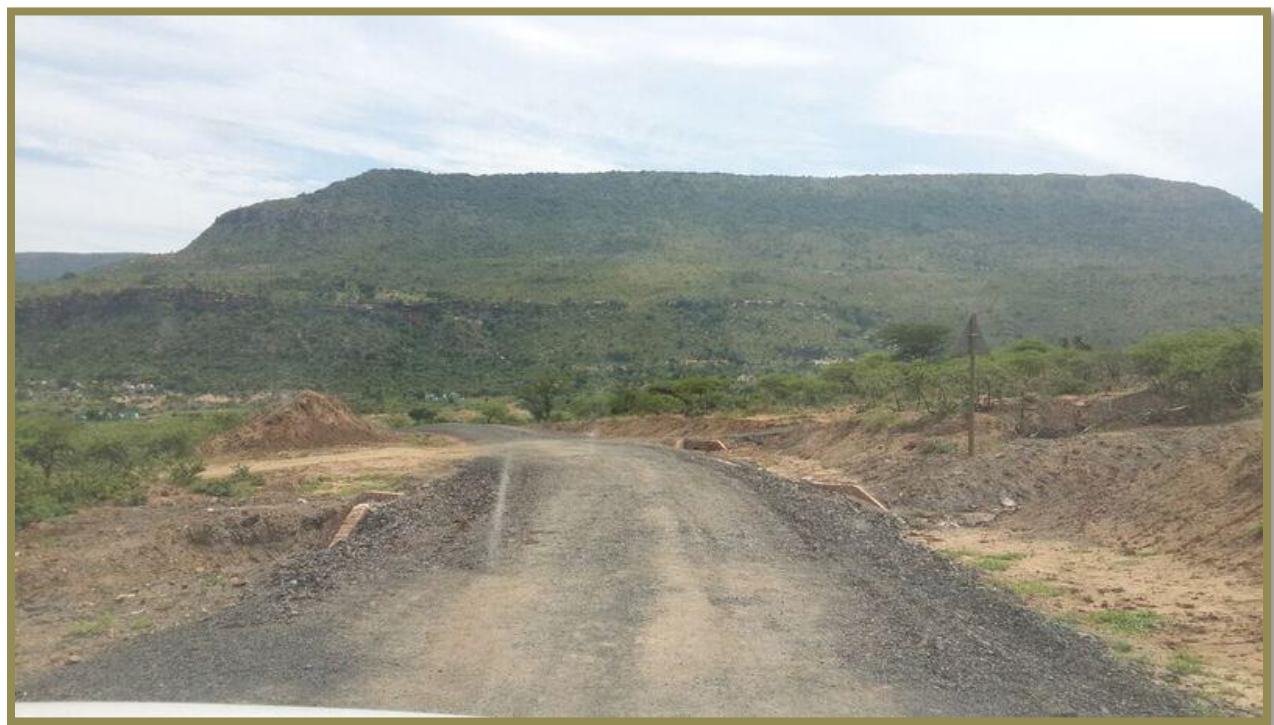
eThembeni staff inspected the study area on 03-04 March 2017. Road construction had already been incepted along existing roads and track alignments. In the greenfield sections all observed graves and cemeteries that fall within 20m of the final road carriageway were marked. Local informants were aware of the proposed road upgrades and were supportive of the initiative. Induna Zondi and Messers Bekizitha Zuma, Madondo and Maphumulo were invaluable in pointing out grave sites that were observed to be potentially impacted by the road alignments in the Obisini area. These grave sites are tabled below.

Figure 2 Obisini road upgrade along existing road alignment

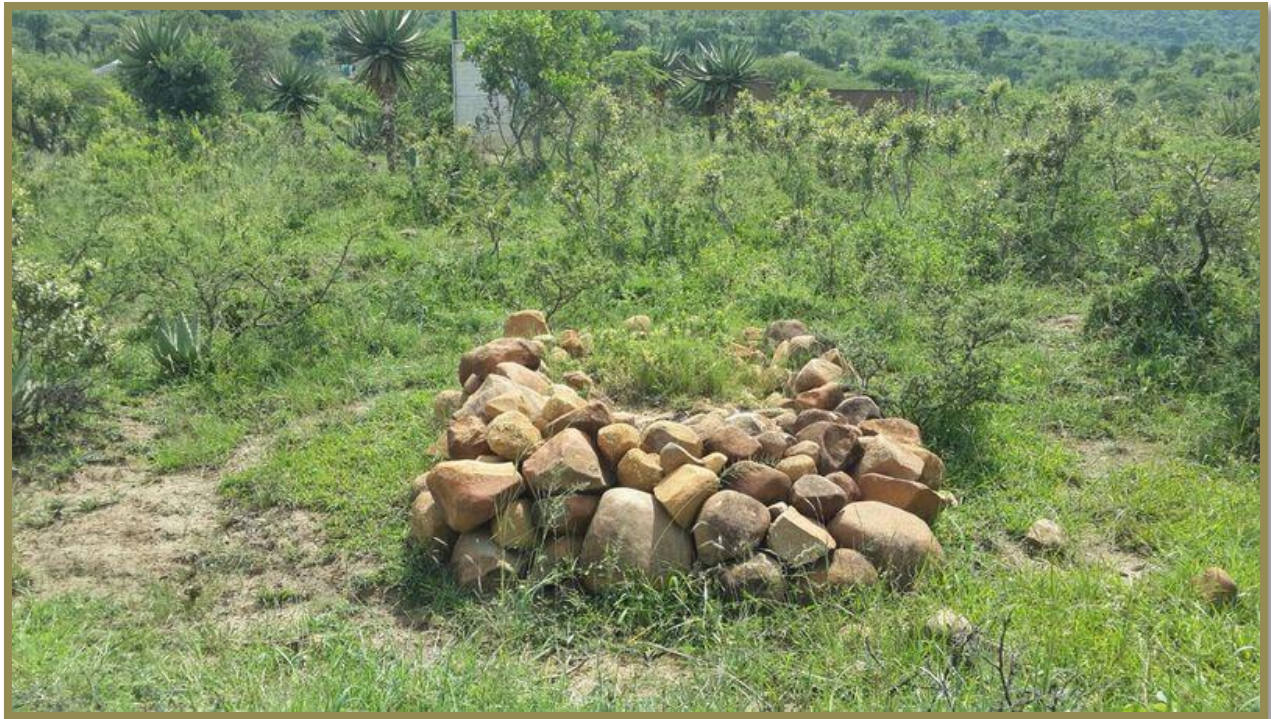
Figure 3 Typical stone-packed grave

All graves tabled above (see also Appendix 3) must be fenced by the contractor or his agents prior to road construction starting in the “greenfield” belts of Obisini Routes 1 & 2. Fencing should comprise of metal standards and 3 strands of barbed wire to a height of 1,2m.

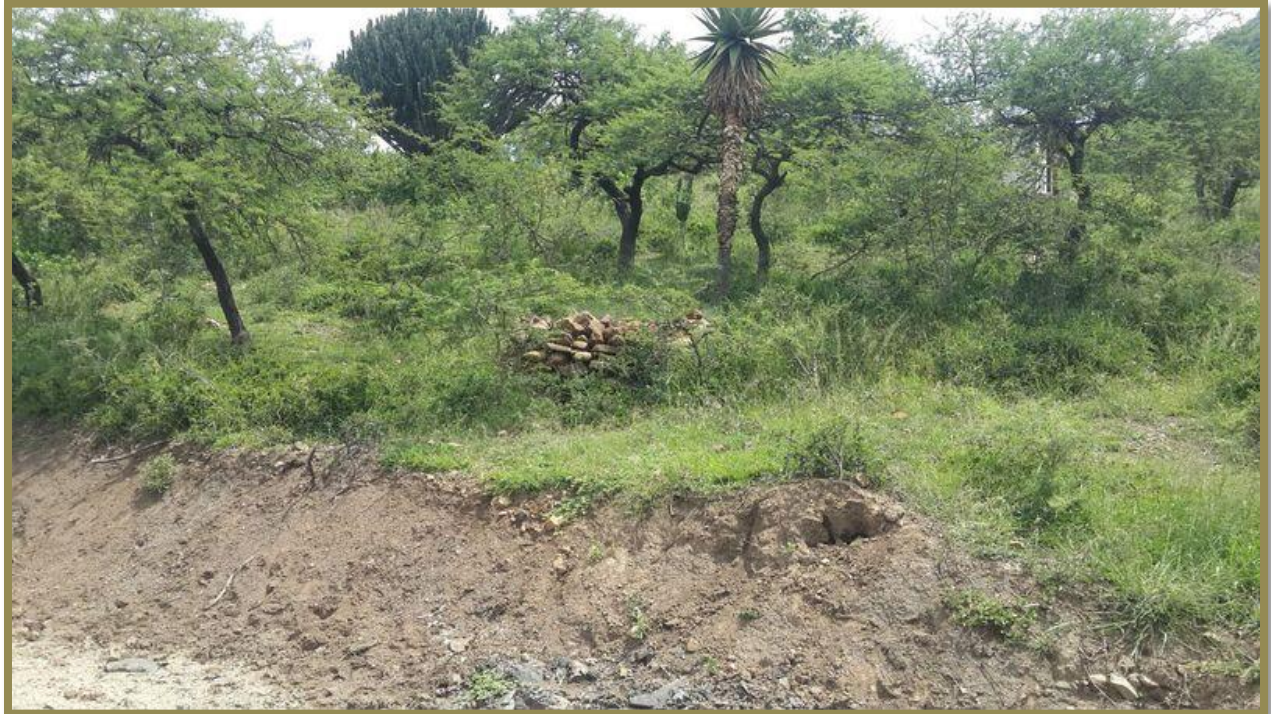
Figure 4 Stone-packed grave in close proximity to graded existing alignment

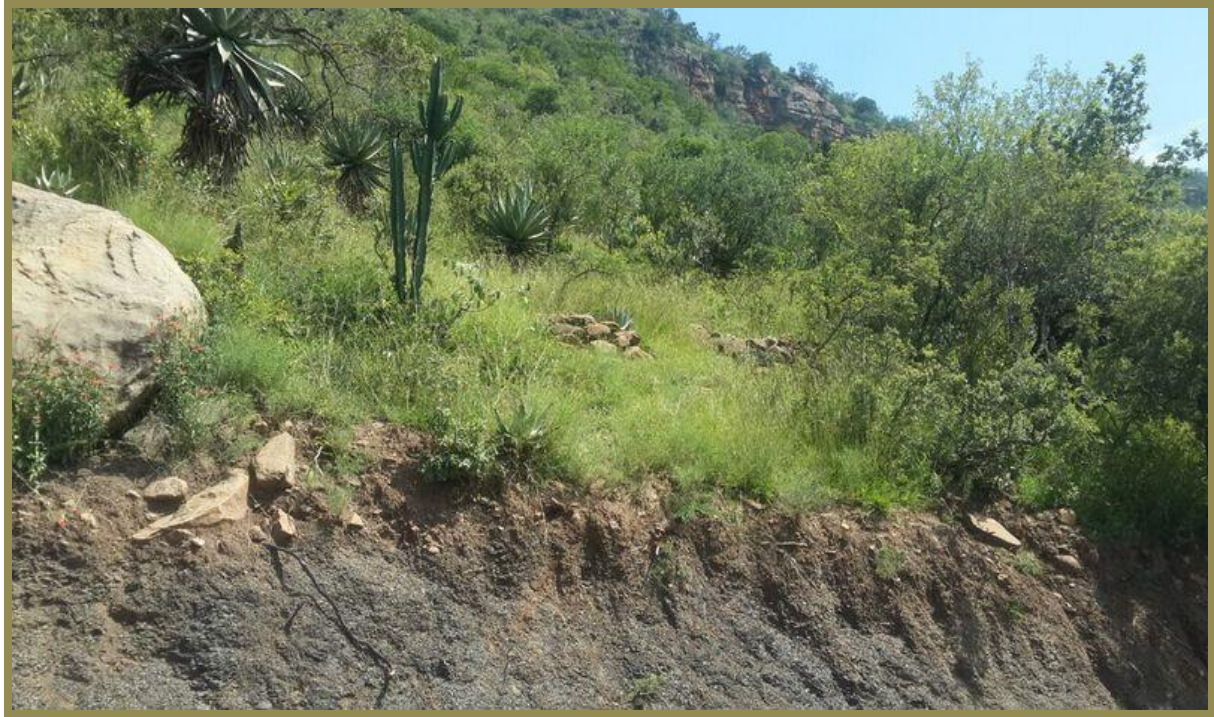
Figure 5 Graves located precariously above the hanging wall of a road cutting

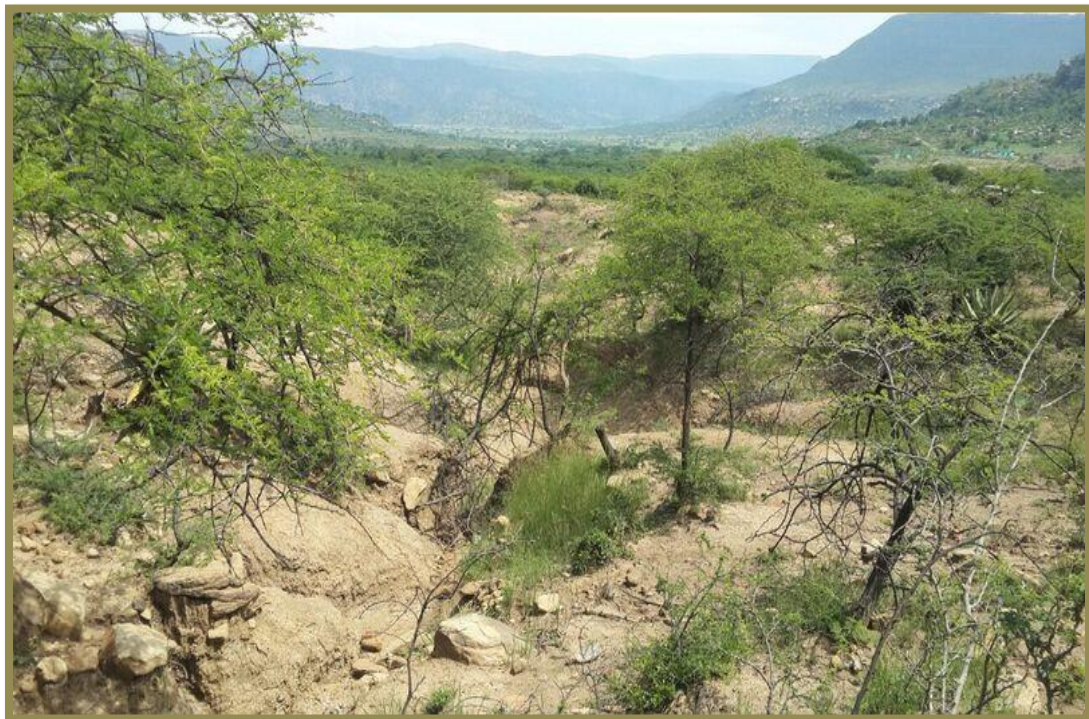
Apart from randomly scattered colluvially washed and patinated hornfels MSAdebitage and flakes washing out of water courses and along rill lines, no concentrations of archaeologically significant Stone Age material was observed. Adiaagnostic pottery fragments (< 1-2 cm) were observed in the vicinities of both extant and abandoned homesteads. These fragments too appear to have moved downslope under colluvial action and were rounded and abraded by water action. They are considered to be of historically recent origin and little heritage significance.

Figure 6 Typical donga environment within which scattered colluvially washed and patinated hornfels MSA debitage was observed
