## **Heritage Scoping Report**

### **Proposed Cemetery at Glencoe Endumeni Local Municipality, Mzinyathi DM, KwaZulu-Natal**

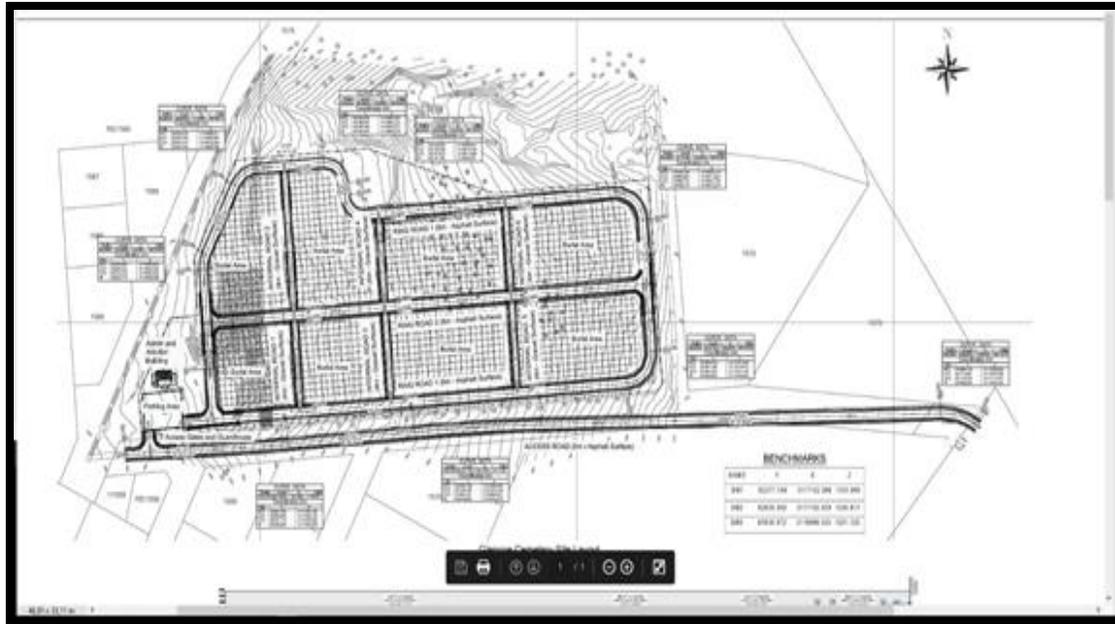
**Figure 1.** Proposed Cemetery Layout. (Original pdf. Loaded to SAHRIS Case File).

The project involves the establishment of a new cemetery, including access road and ancillary infrastructure, providing an unspecified number of grave sites, covering an area of just under 7.9 hectares on the property Erf 1574 in the Township of Glencoe. The property is registered to the Endumeni Local Municipality under Title Deed T5982/1957, registered on 12 July 1957. Diagram Deed T5978/957 (extent of 14.186 ha. (See Figure 1).

- the establishment of a 675m long tarred access road on Alice Road, leading from the access point to the cemetery to Karel Landman Street, with associated storm water management infrastructure.
- lockable pedestrian and vehicle access gates with guard house.
- a tarred parking area for approximately 20 vehicles.
- a combined administration and ablution block sited adjacent to the parking area
- municipal services as required.
- internal tarred (6m wide) and gravel (4m wide) access roads.
- the perimeter of the site shall be closed off with palisade fencing.

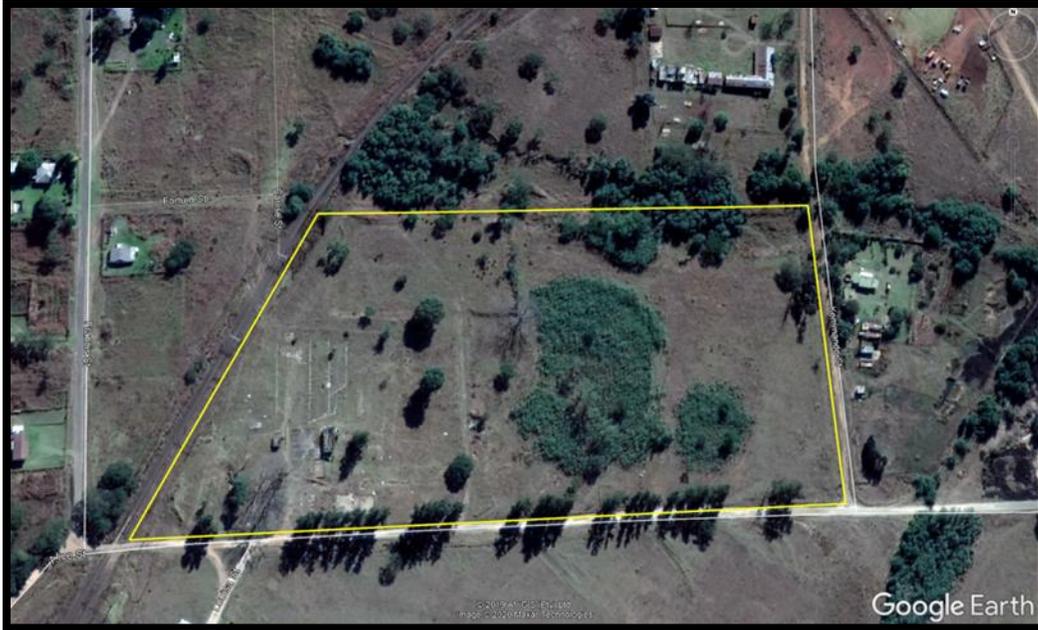
**Figure 2.** Erf 1574, Glencoe. The previous municipal park now earmarked for cemetery development.

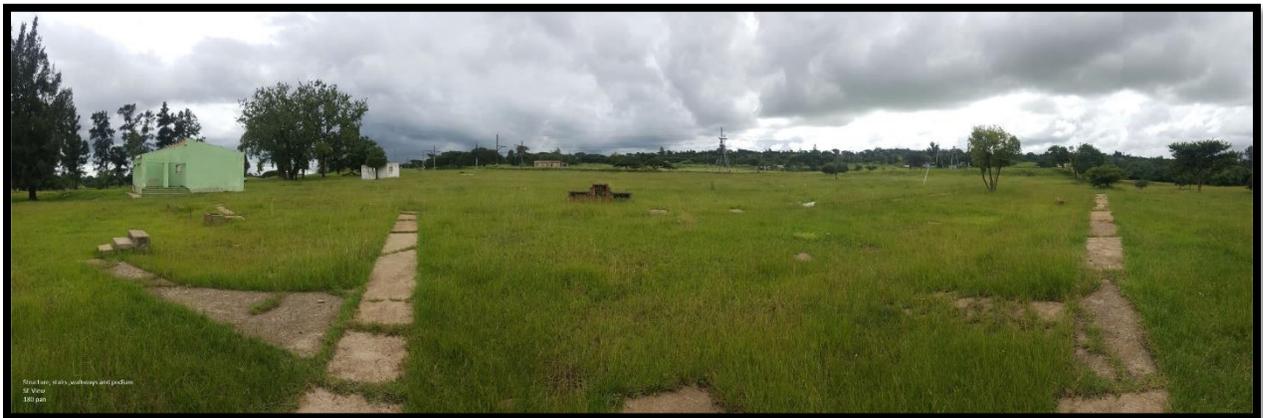
eThembeni staff inspected the site on 10 February 2020. The Erf is situated on the corner of Kommando and Alice Street, Glencoe, and borders the railway line. The site is largely grassed, with copses of trees and a patchwork of residual plant beds. One standing structure, a derelict ablution block, can be found on the western section of the site, and is surrounded by several other built feature ruins, including foundations, walkways and drainage covers towards the eastern side.

The erf appears to have functioned as a recreation park in the recent historical past and was associated with the railway station and its attendant railway residences. All the park infrastructure is in ruin and display signs of rampant vandalism. The gardens and lawns are unkept and the tree stands have been left to go feral. The park's historical context within the remaining townscape has been lost.

**Figure 3.** Previous municipal park infrastructure.  
See further images loaded to the SAHRIS Case File.

There are several derelict structures and foundations within the footprint that will require demolishing and the residual material will be removed from site for disposal at a registered disposal site for that type of waste.
