Heritage Scoping Report

Proposed Cemetery at Craigside, Dundee Endumeni Local Municipality, Mzinyathi DM, KwaZulu-Natal

Project Area and Project description¹

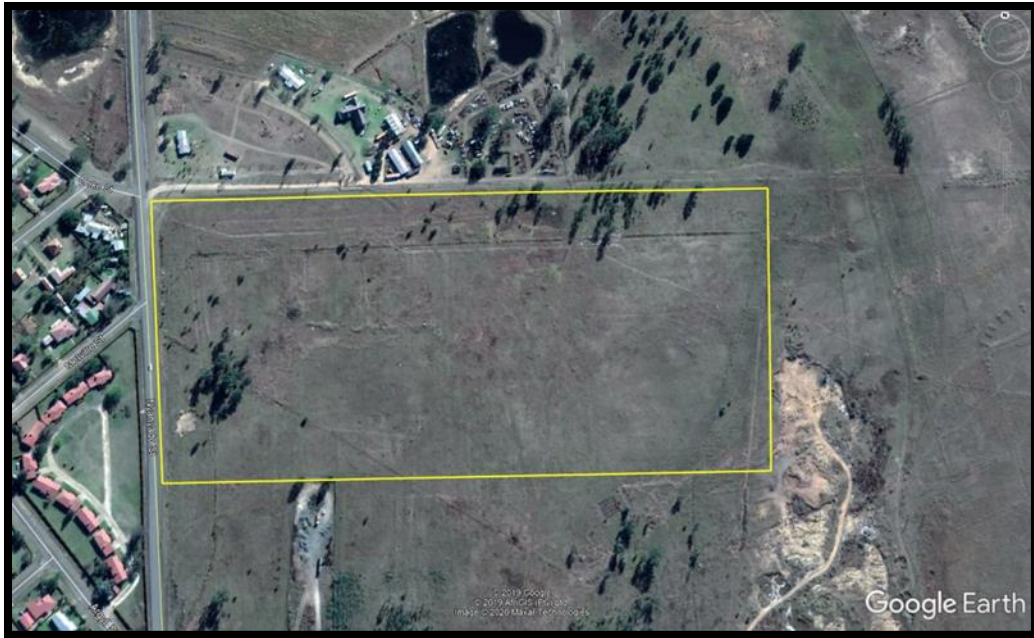
eThembeni staff inspected the site on 10 February 2020. Located along Nyanyadu Street, Dundee, the site is nearly completely covered in grass with the exception of some trees on the eastern and boundaries. The site appears to have been used as a grazing camp in the past and is currently informally grazed by livestock from Craigside township. Consequently, surface visibility was fair.

No standing structures or visible foundations are present, and no archaeological residues were observed.

Figure 2 Aerial view of the proposed Cemetery site at Craigside

In the absence of any heritage resources of significance, and that no further palaeontological mitigation is required, we accordingly request that Amafa allow the cemetery development to proceed with no further heritage resource mitigation; suffice that the protocols in Appendix 1 are made binding to any Environmental Authorisations issued.

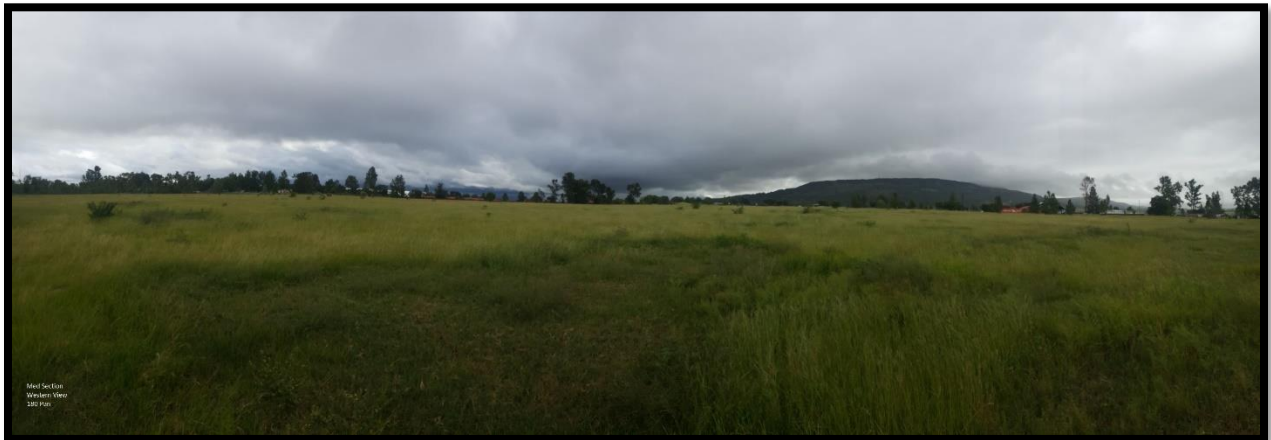
Figure 3 Landscape view of the proposed Cemetery site at Craigside
