1. INTRODUCTION

PERCEPTION has been appointed by the registered property owner to compile and lodge a Notice of Intent to Develop to Heritage Western Cape in terms of Section 38 of the National Heritage Resources Act, 1999 (Act 25 of 1999) to Heritage Western Cape. Details of the proposed development are as set out in paragraph 3 below.

The registered property owner is of the intention to develop the said property by establishing a resort development thereupon and subsequently commissioned *PERCEPTION* to compile and submit to Heritage Western Cape a Notice of Intent to Develop (NID) and Heritage Statement for adjudication.

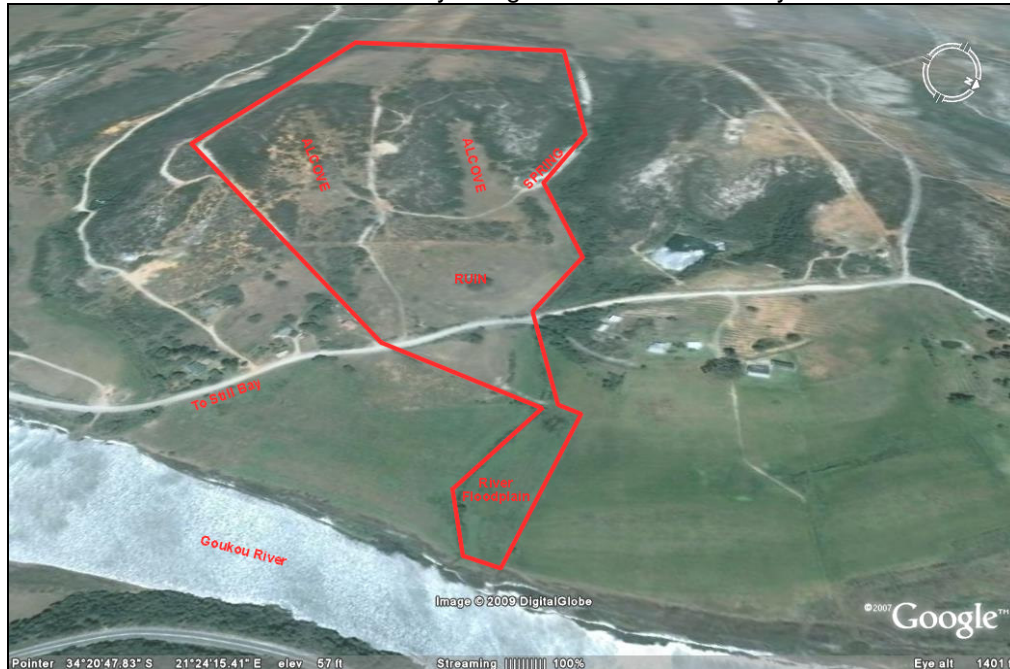
The property forms part of an undulating landscape that extends eastwards from a higher-lying coastal plateau towards the Goukou River floodplain to include two natural alcoves as illustrated with the 3D image below. A natural spring defines the jagged northern property boundary. Most of the surface area appears to have been transformed from its natural state through former agricultural activities. As such, it was found during the site visit that the property is generally heavily infested by alien invasive vegetation, save from some milkwood thickets remaining along the edges of the two “alcoves” and within the valley along the northern boundary.

3D/ Bird's eye view of the property (generated through GoogleEarth).

At least two ruins, most likely older than 60 years were noted on the site – one being a former labourer's cottage. The most prominent ruin, a former T-shaped residence constructed using local stone, has an impressive setting overlooking the Goukou River valley as shown above. Existing access roads on the property are merely narrow tracks, through the track leading to the northern alcove/ natural spring was recently graded.

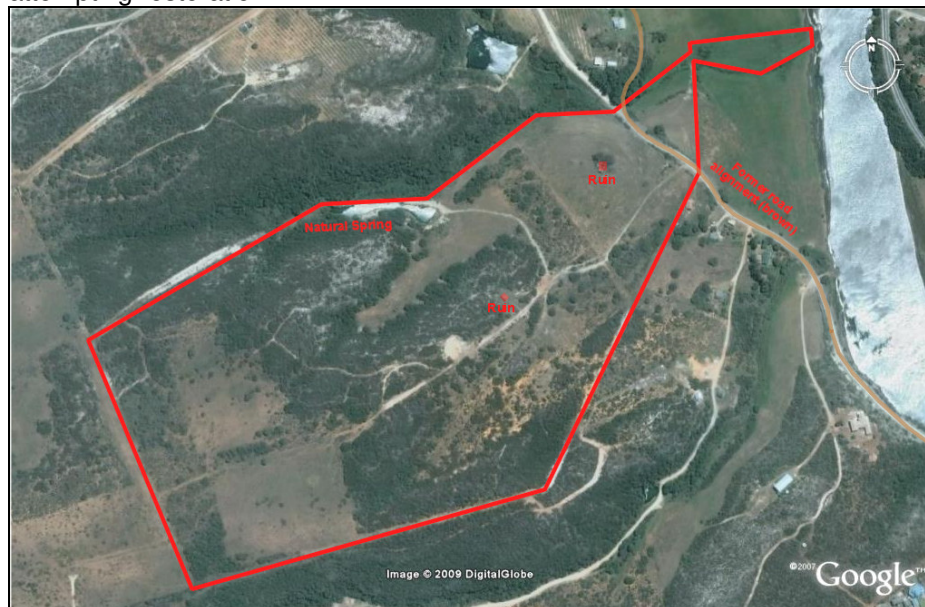
At least two ruins older than 60 years were located on the property, the approximate locality of which are illustrated below. The most significant ruin is that of a large T-shaped dwelling, with prominent setting along a gradual – east-facing hillside and framed in the landscape through mature bluegum trees on either side. Also refer to photographs (Annexure 2). From remaining walling of this ruin it is evident that several additions had been made to the original structure over an extended period of time and further study in relation to construction methods and materials used is advisable prior to (possibly) attempting restoration.

Recent aerial photograph (Source: GoogleEarth)

Another less prominent ruin with remaining chimney and foundations, most likely part of a former labourer's cottage, was noted within close proximity to an existing track extending to the fresh water spring, southwest of the above T-shaped ruin (see insert above).

A small section of the former alignment of the access road along the river is highlighted in brown on the above aerial photograph and shows how this former road followed the natural contour line.

The ruins of the historic residence would be restored; possibly to be used as a clubhouse as part of the proposed development. It is understood that the architectural style to be employed throughout the development would match that of the original historic residence. A conceptual site development plan is attached as part of Annexure 3.
