PROPOSED STORE

BABYLONSTOREN, FARM 1740, PAARL

Section 34 Application; Building Older than 60 Years

July 2019

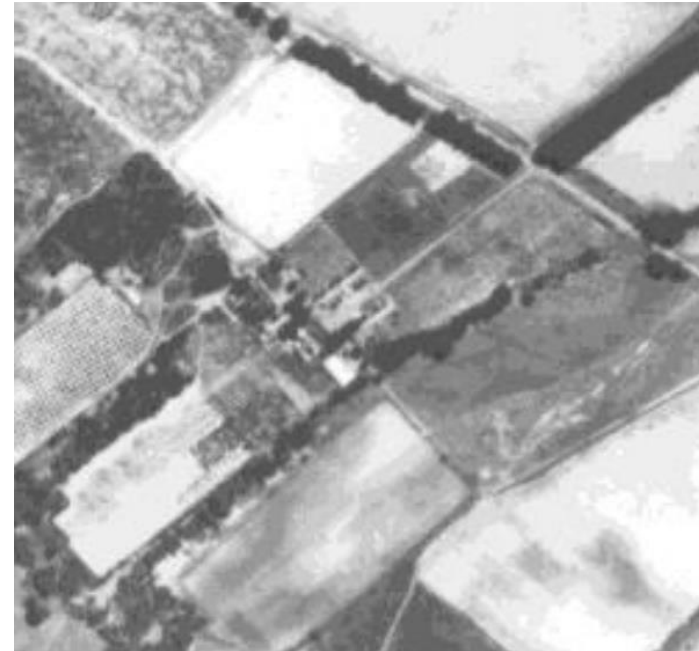
Figure 6: 1938 Aerial Photograph above and 1945 Aerial Photograph below. The pigsties are not yet visible on the photographs.

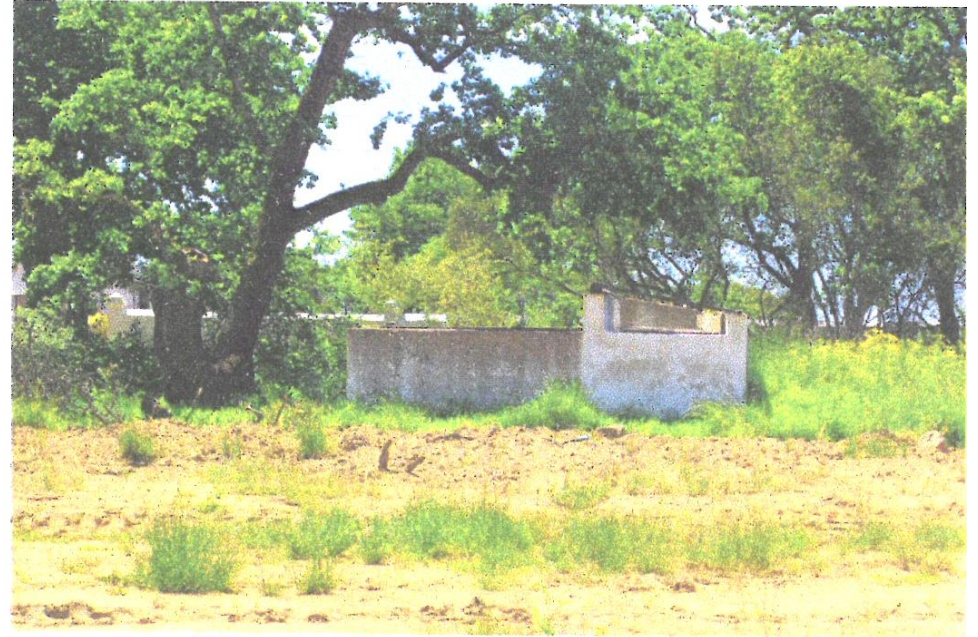
Figure 8: 2009 Photograph. Source: HIA, A. Pentz, 2009

Old pig shed west of ruin

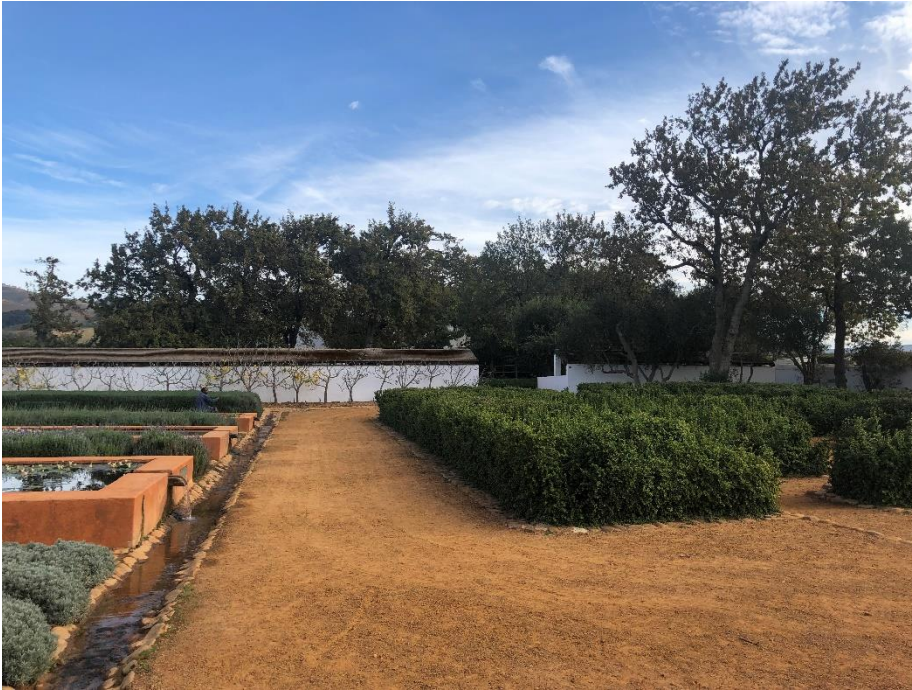
Figure 9: Footpath approaching the existing buildings from the north west. The guest cottages are located beyond the existing buildings.

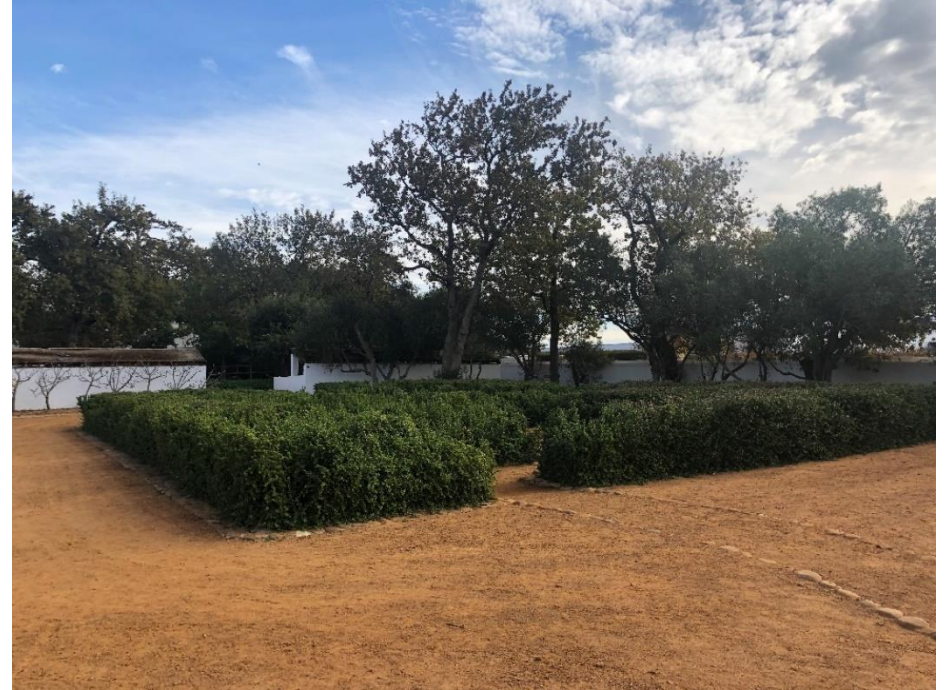
Figure 10: Spekbos tuin in front of the existing buildings, seen from the north west.

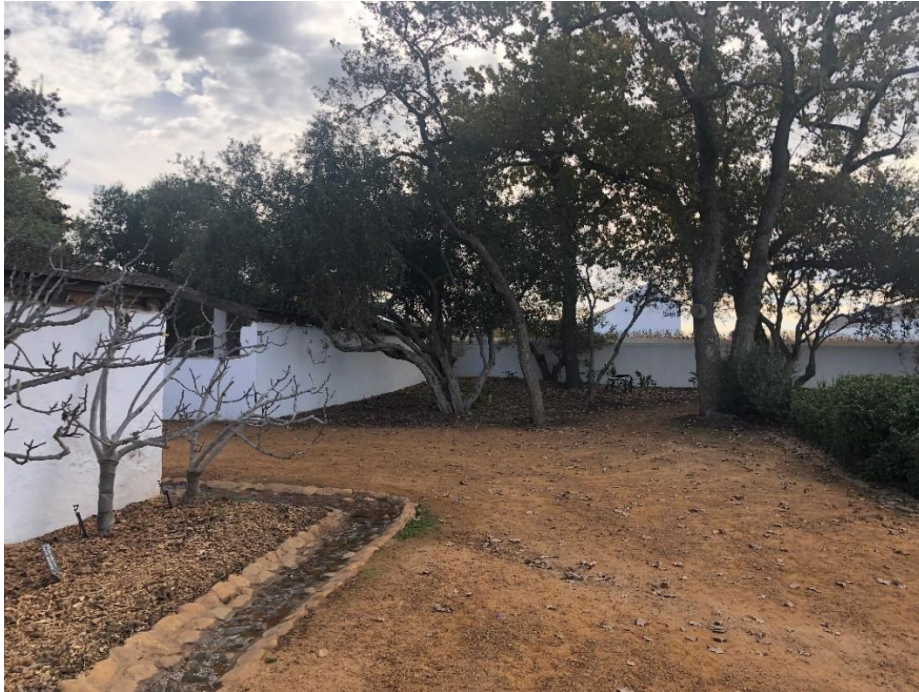
Figure 11: Close-up image of the structures, with the 'pigsty' on the west visible in the background.

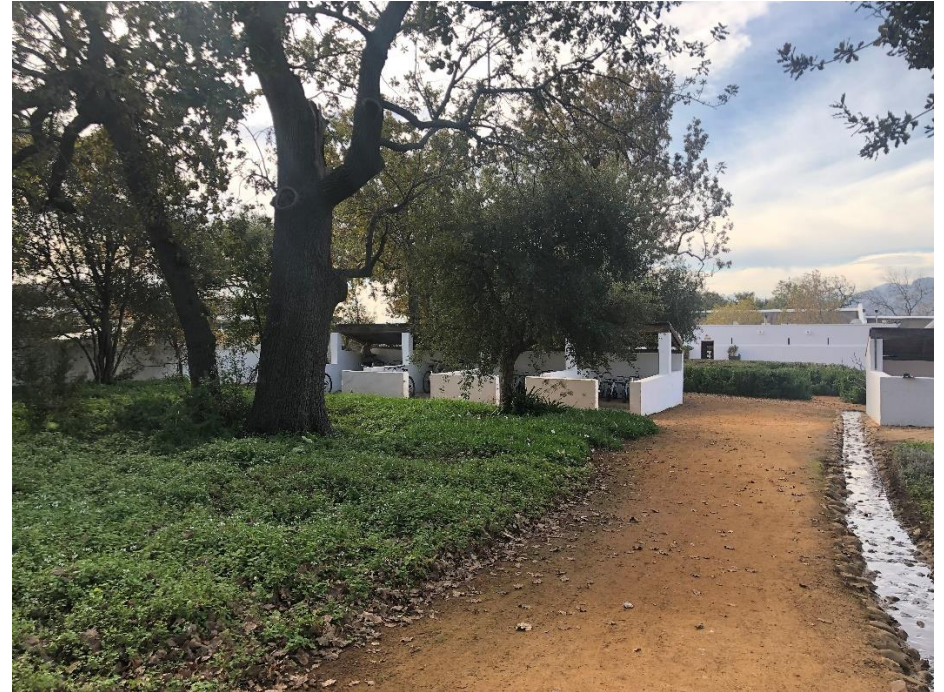
Figure 12: Photograph of the 'pigsty' on the west, viewed from the other side (south east). The Spekbos tuin and Kraal buildings are visible in the background.

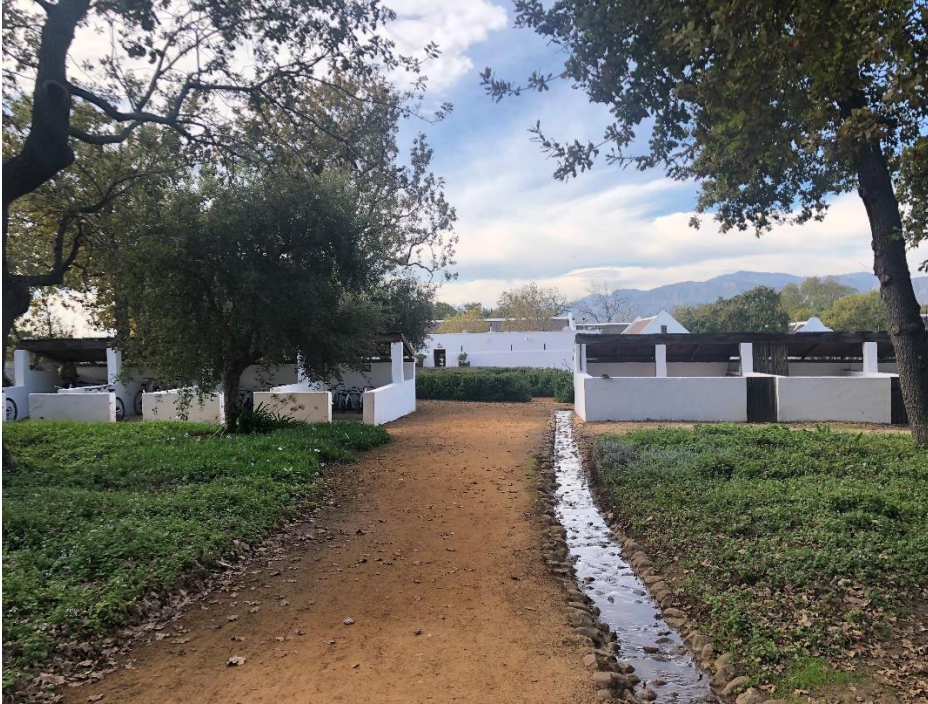
Figure 13: Same footpath seen from the south east side. The spekbos tuin and Kraal buildings are visible in the background.

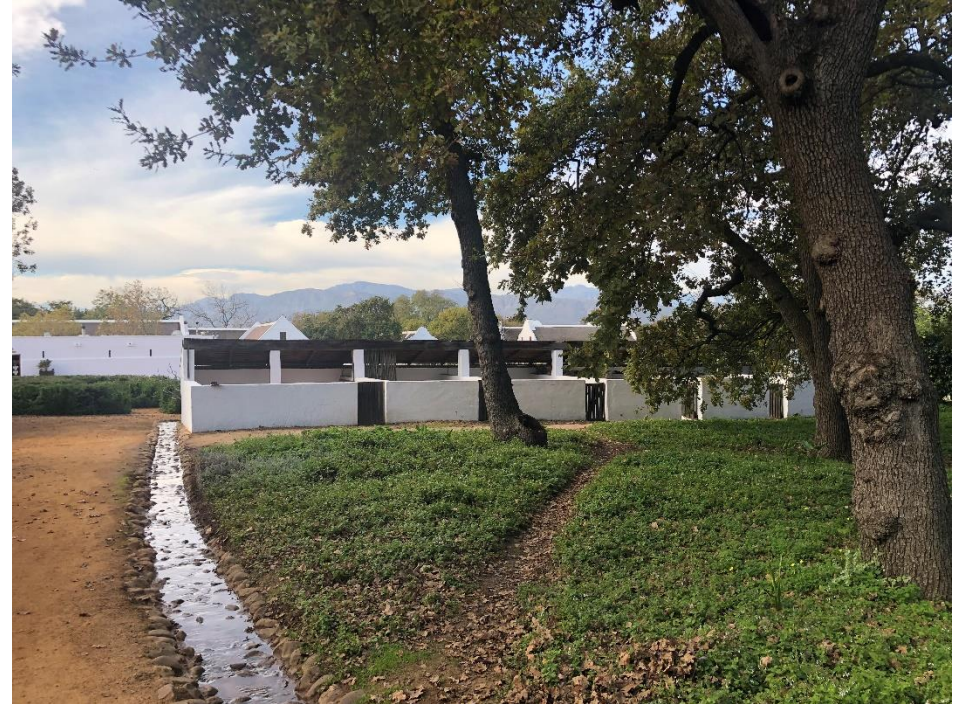
Figure 14: Image taken more to the north east. Oak trees visible in the foreground.

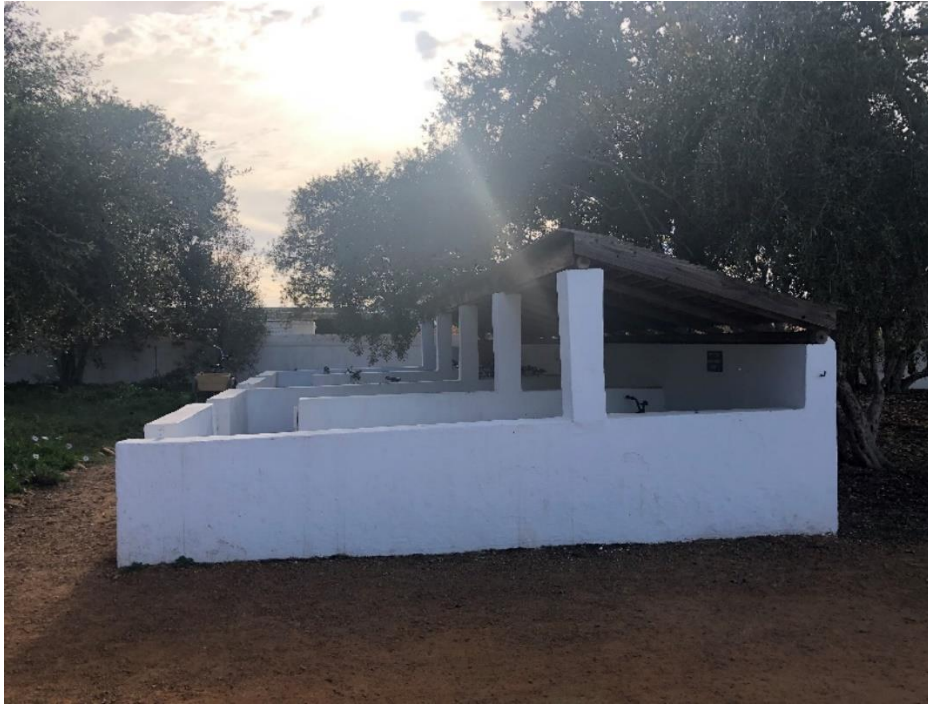
Figure 15: East elevation of 'pigsty' proposed to be demolished.

The brickwork of the structures are modern clay-baked bricks used in the 1950/60s. Although the structures are older than 60 years, **the buildings themselves have little or no significance.**

- The building itself is not significant or conservation worthy.
- The footprint, materiality and scale of the existing building in relation to other structures on the farm is important and will be retained in the proposed structure.

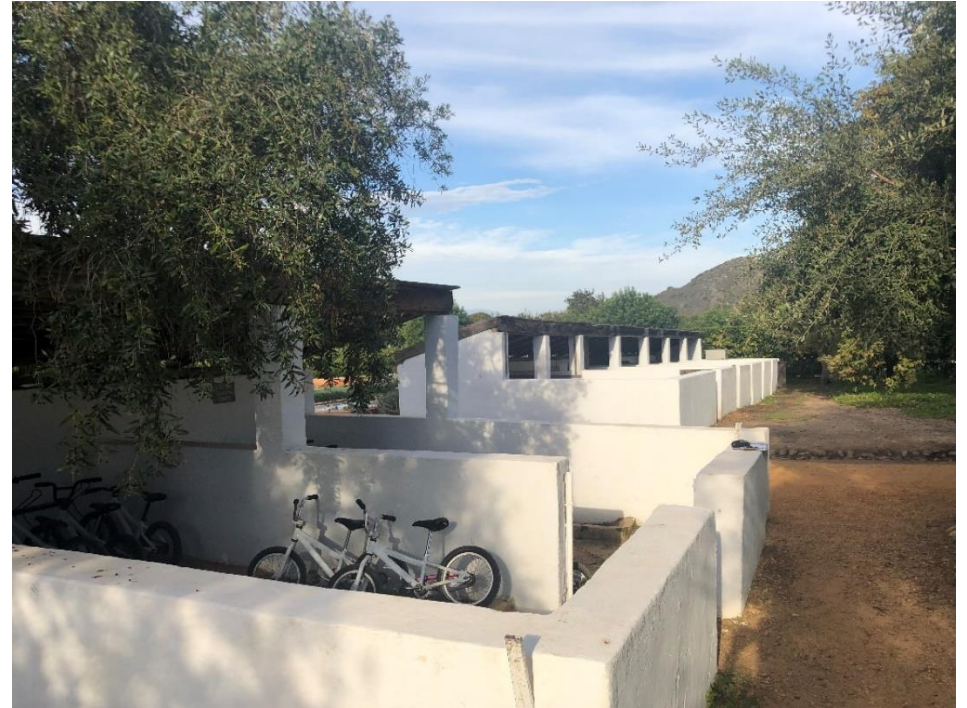
Figure 16: West elevation of 'pigsty' to be demolished in the foreground, and 'pigsty' to be altered seen beyond.

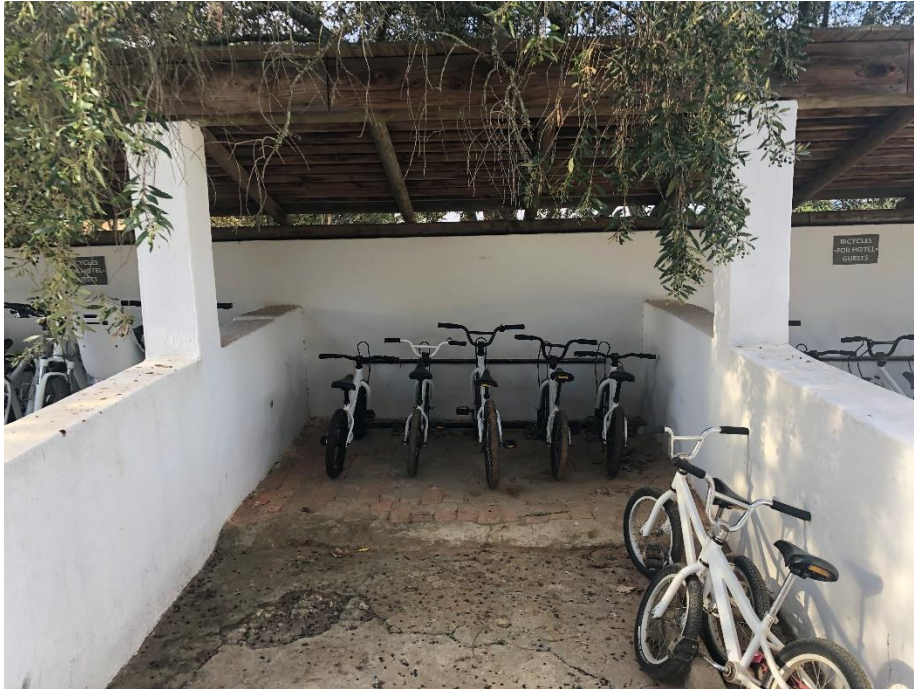
Figure 17: Inside one of the pens on the west side.

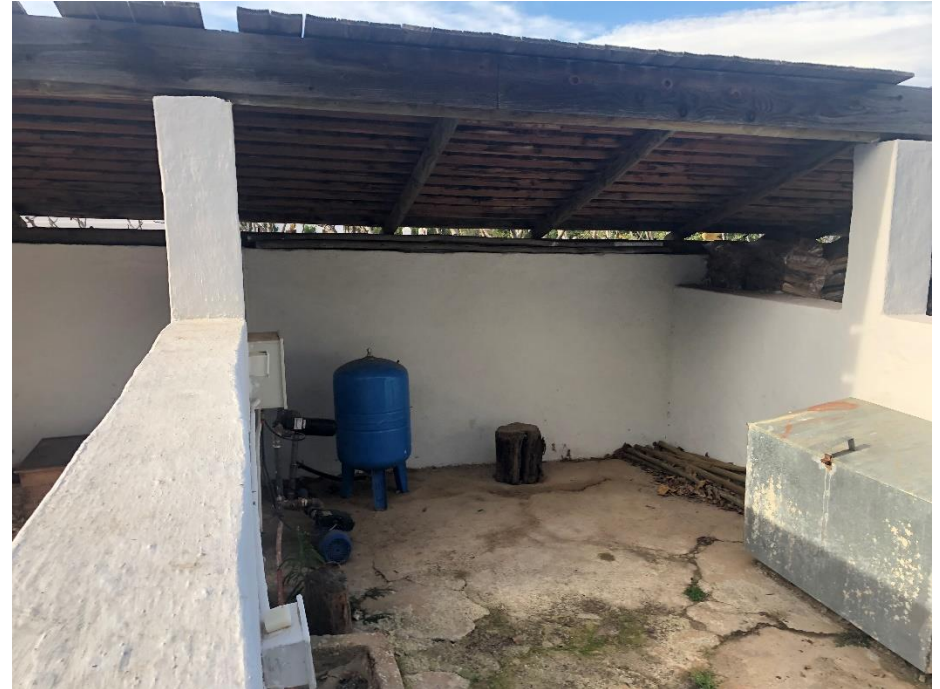
Figure 18: Inside one of the pens on the east side.

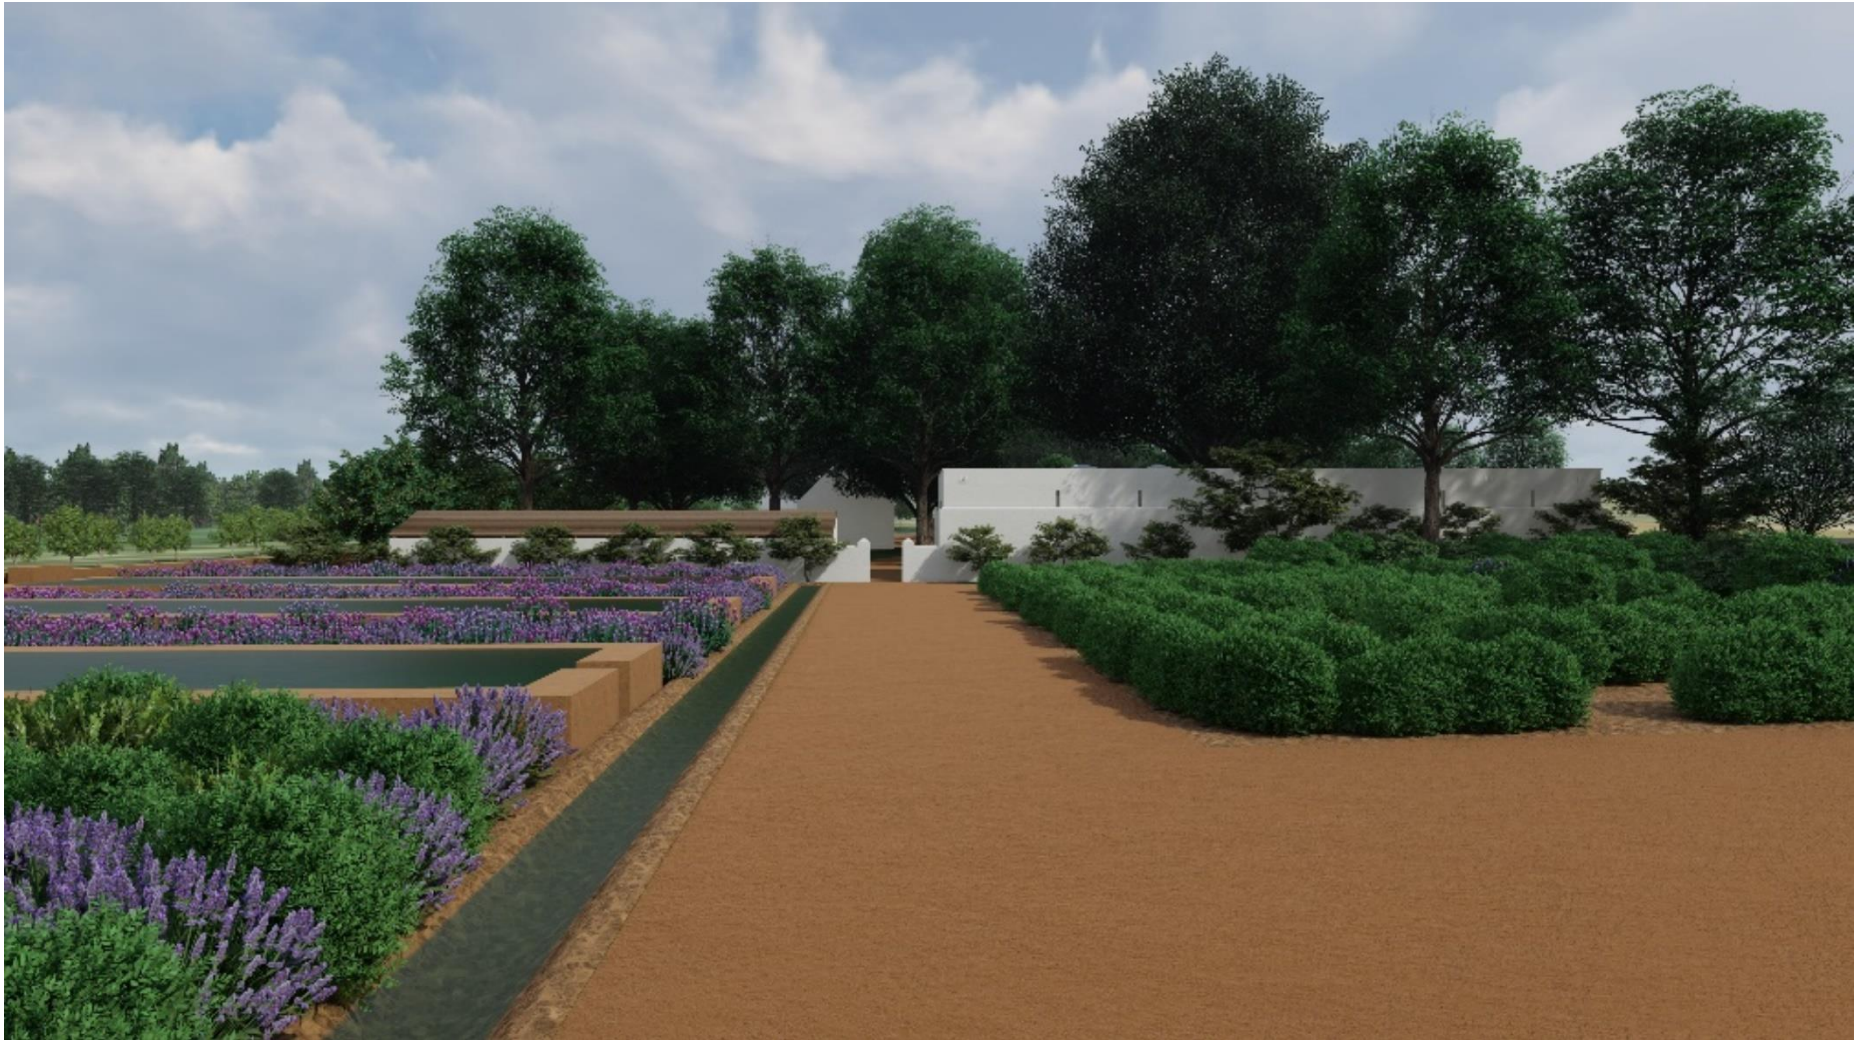
Figure 19: Architectural render of the proposed development. Image for information only.

- The new luggage store will be built on the footprint of the existing pen, and follow the same internal partitioning and openings (for e.g. the doors are proposed in the same position as existing gates).
- The orientation and size of the new building closely relates to the existing structure.
- The materiality and finish of the proposed building will be the same (building kept as low as possible with a 'working farm' character).
- The building style follows the contemporary architectural style/ layer set by other new buildings on the farm.
- The axis from the historic werf through to the cottages are reinforced with the placement of the new building, which has a positive impact on the significance of the historic werf.

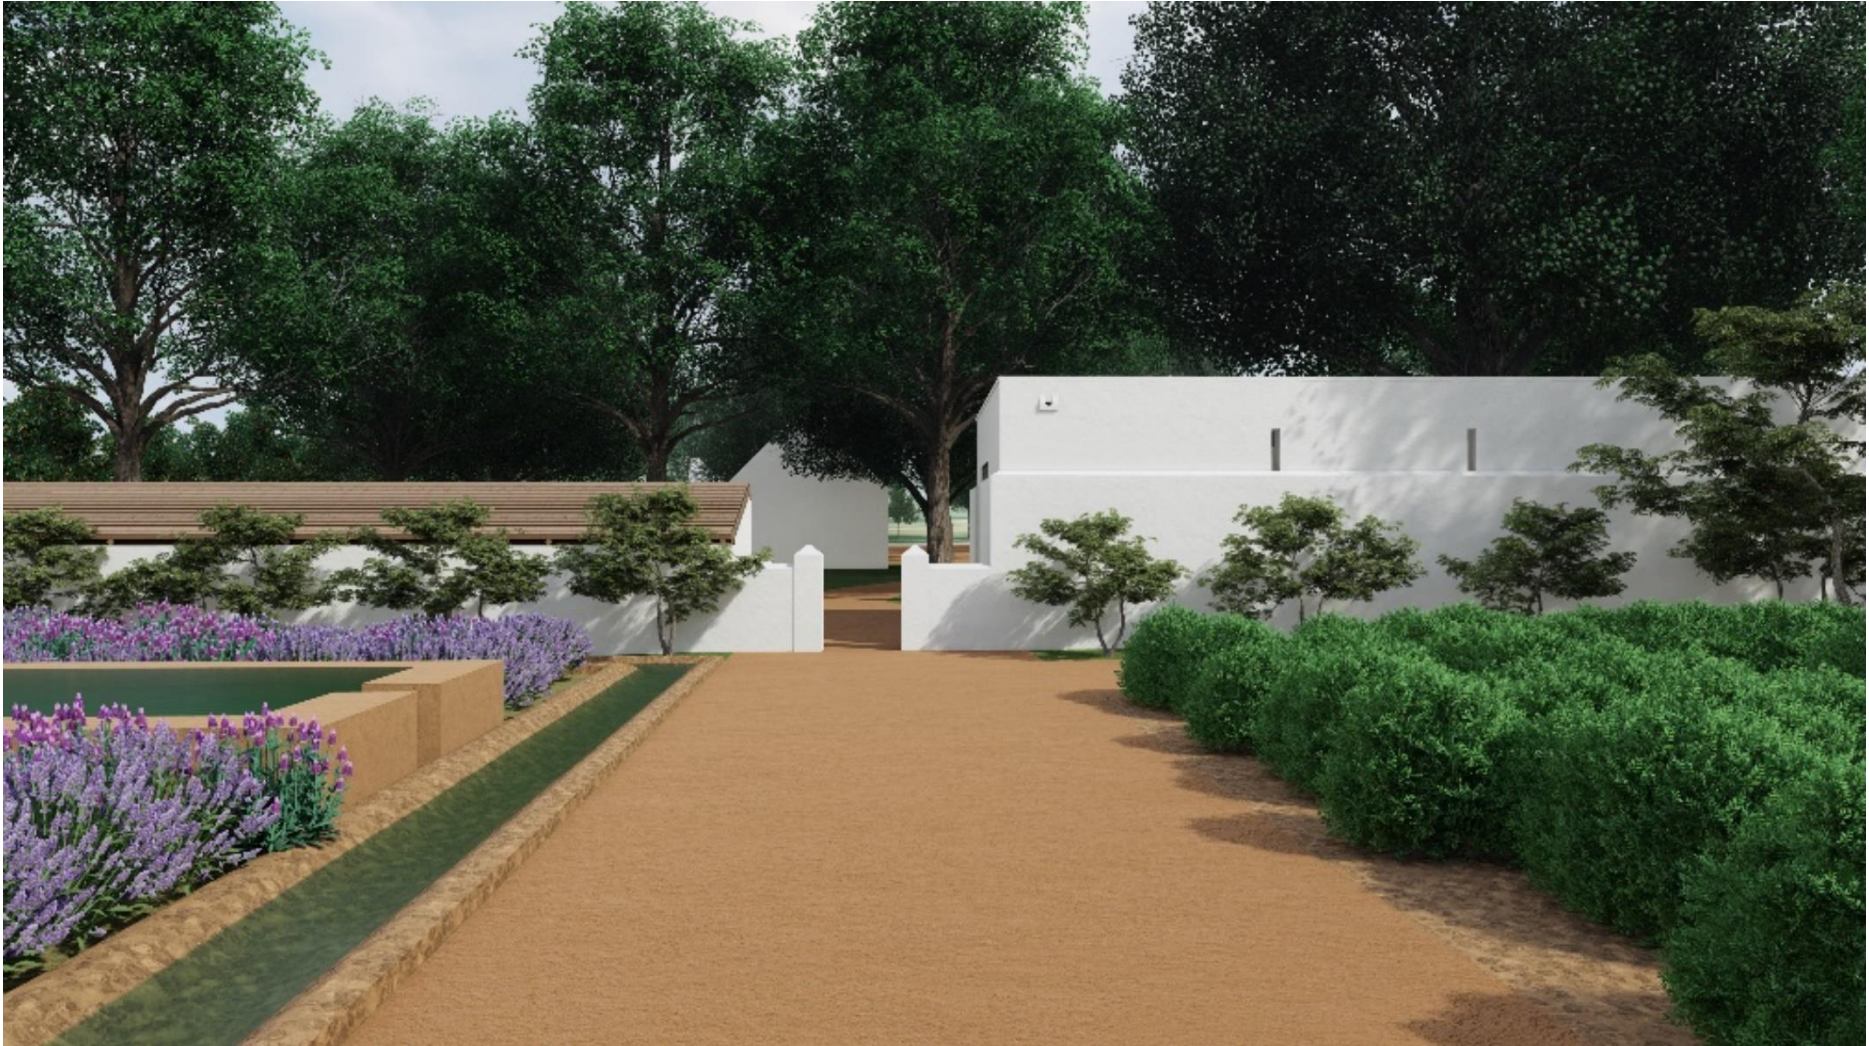
Figure 20: Architectural render of the proposed development, showing the existing pigsty on the left with proposed luggage store on the right. Image for information only.

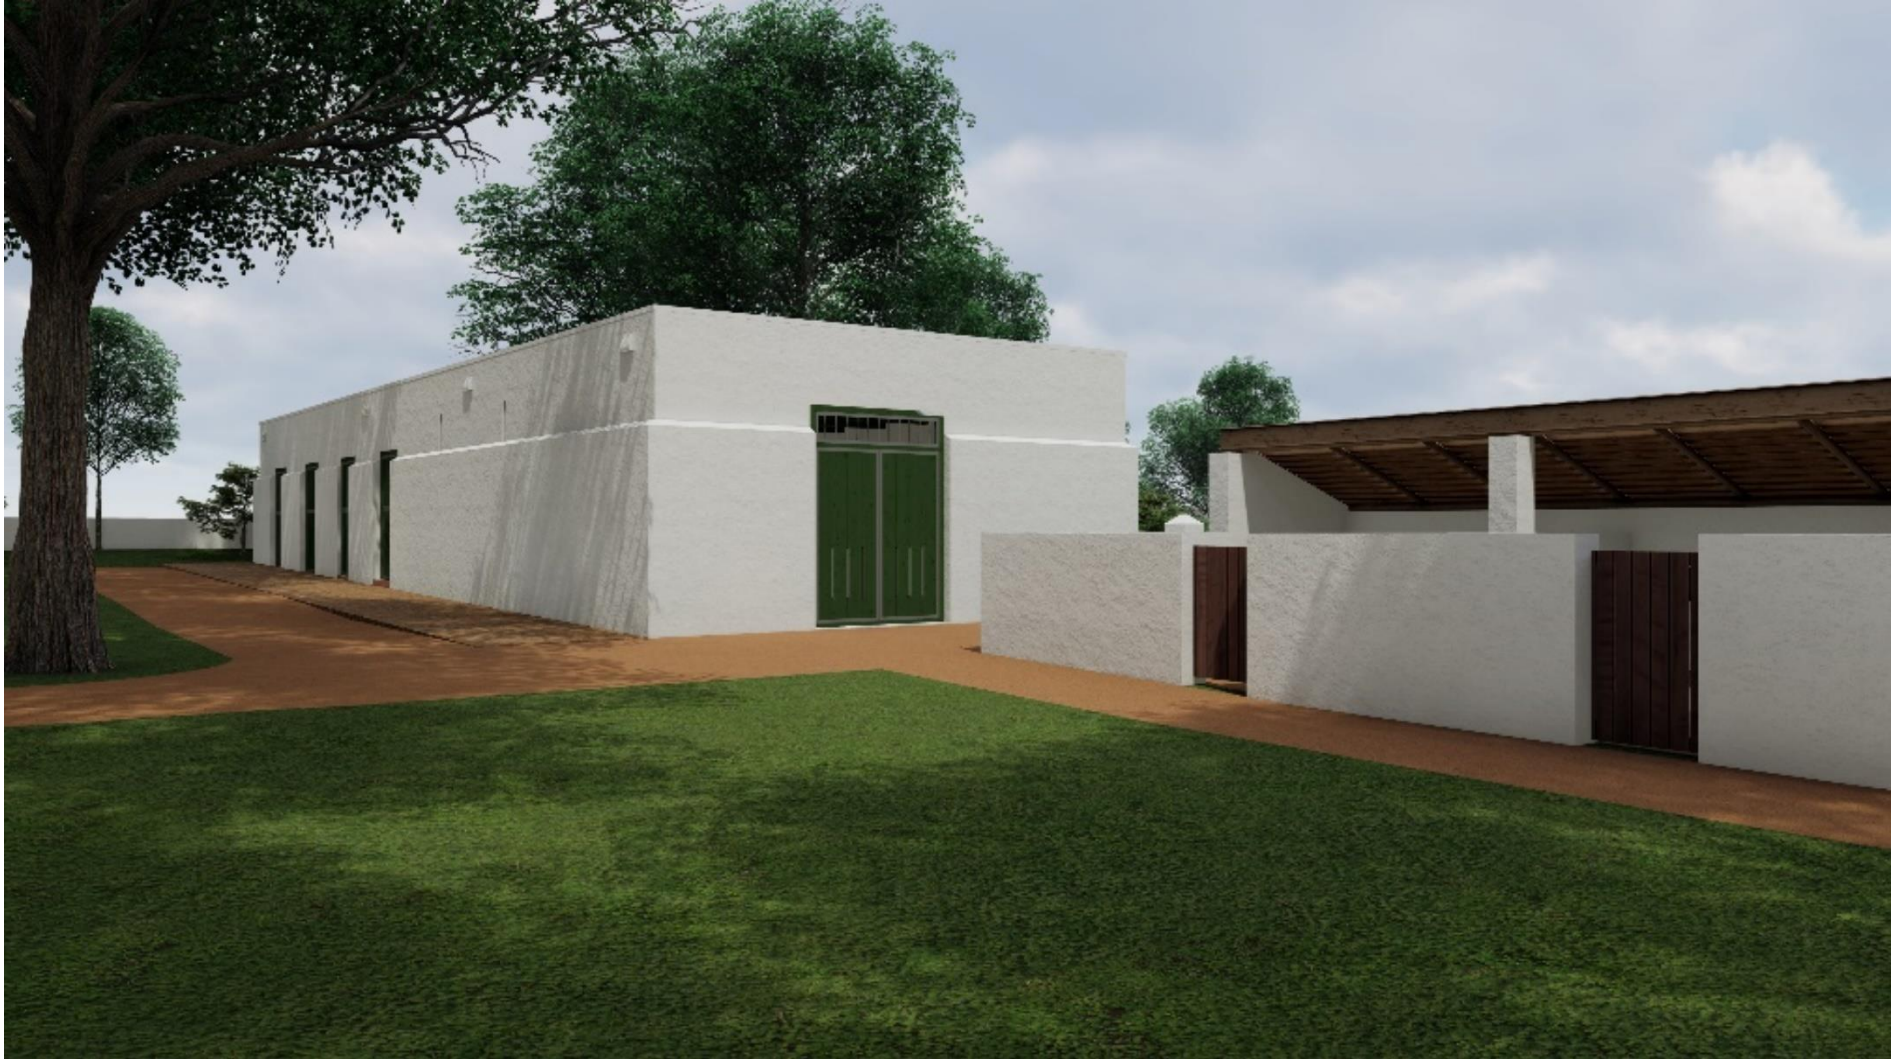
Figure 21: Architectural render showing the position, orientation, scale and materiality of the proposed building in relationship to the existing pigsty and surrounding landscape. Image for information only (the double swing door was initially proposed on the short end of the building, but is proposed on the long end in the final drawings).

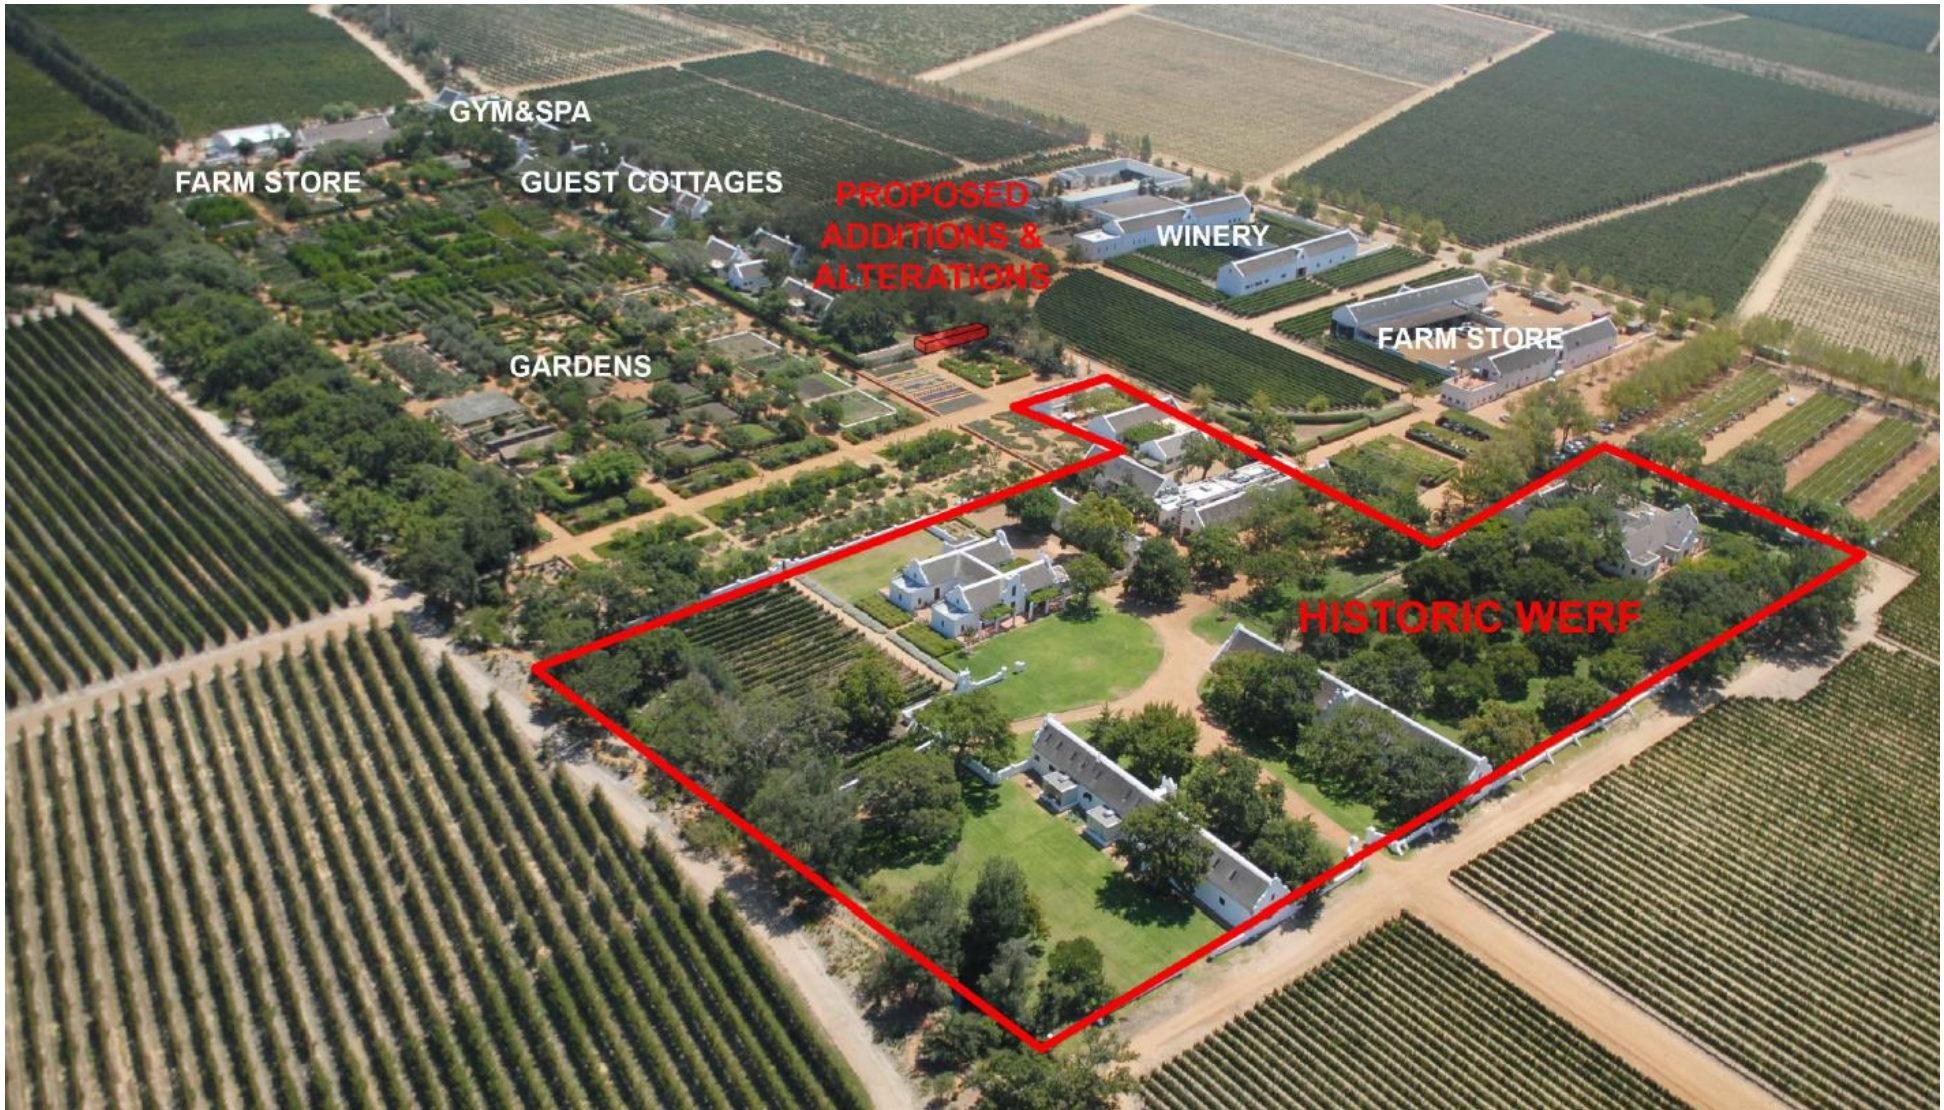
Figure 22: Aerial photograph showing the proposed development in relation to the historic werf.
