AFRICAN HERITAGE CONSULTANTS CC

2006 08 01

CULTURAL HERITAGE IMPACT ASSESSMENT ON THE FARM KAFFERSKRAAL 475 JR CULLINAN

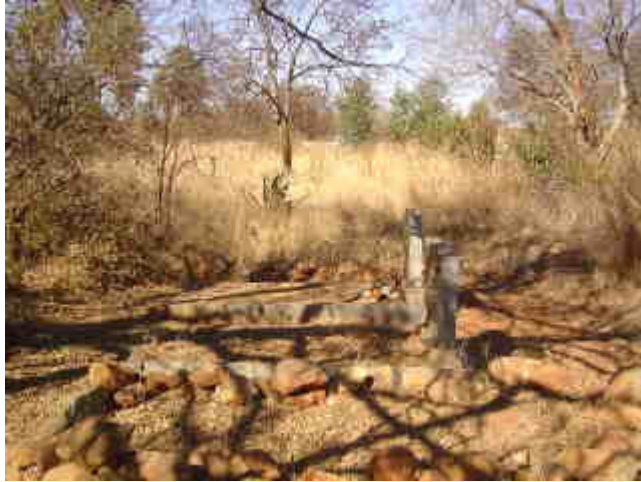
- Cemetery (± 150 graves). A very large cemetery has been found just east of the Eskom premises. Most of the graves are unmarked. The oldest marked grave dates to 1933. The grass in the cemetery is very tall which makes the finding of individual graves very difficult. There are about 150 graves, most probably those of farm workers. Some of the graves have recently been cleared of grass and are still visited by relatives of the deceased (S25° 39' 23.7" and E 28° 32' 26.8") (see photograph 1).

No. 1. Two of the cleared graves in the western cemetery

It is recommended that the two cemeteries be fenced in, cleaned of grass and weed and be kept as a feature in the new development. Provision should also be made for easy excess for family members of the deceased to visit the graves. It will be costly and impractical to move all the graves to a new site, though this might be an option.

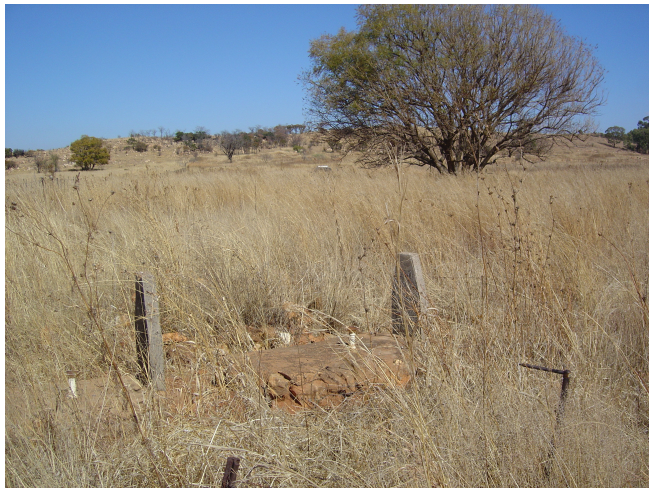
- Cemetery (± 200 graves). This cemetery lies on the eastern boundary of the proposed development area. The site is also overgrown with tall grass. Most graves are unmarked. The oldest graves most probably also date to the 1930s. Some graves have been cleaned recently and are visited by relations of the deceased (S25° 39' 31.8" and E28° 33' 08.6") (see photograph 2).

No. 2. The eastern cemetery

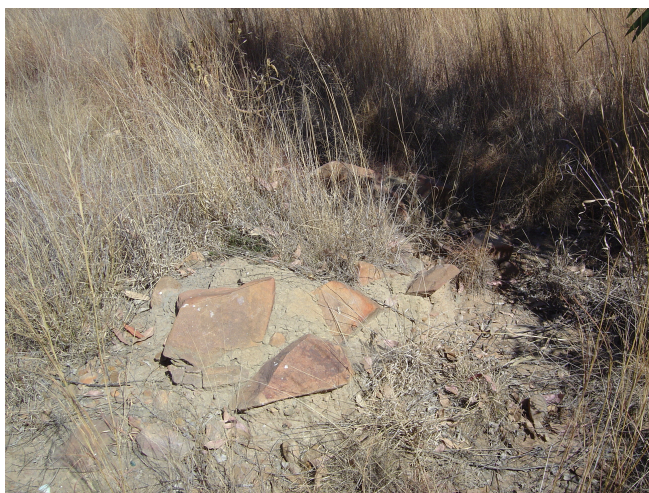
- Single grave. At S25° 39' 00.1" and E28° 32' 36.7" a single possible grave was found near the ruin of a farm workers home. Though the heap of stones look like a typical African grave it might turn out not to be a grave. This site will need further investigation (see photograph 3).

No. 3. The possible single grave

The possible single grave needs more investigation by a grave relocation specialist.

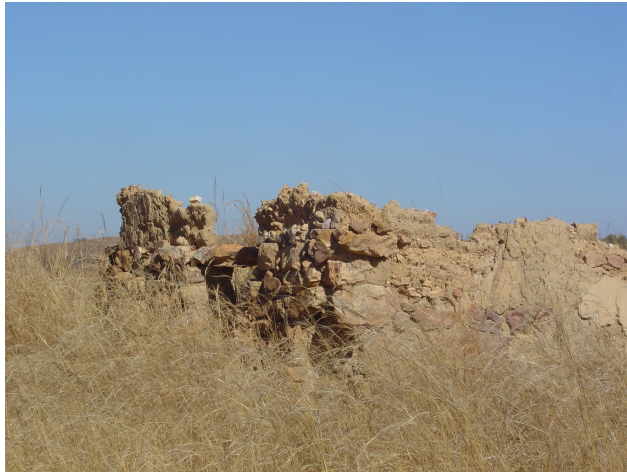
In some cases portions of the walls of the buildings are still standing. In most cases only the foundations are still visible (see photographs 4 and 5).

No. 4. Ruin of farm workers house

As far as the ruins of farm workers settlements and homes are concerned it is extremely difficult to determine which of these fall in the sixty years clause of the National Heritage Resources Act, Act No. 25 of 1999. This can only be determined by a phase 2 investigation if specified by the Provincial Resources Authority.

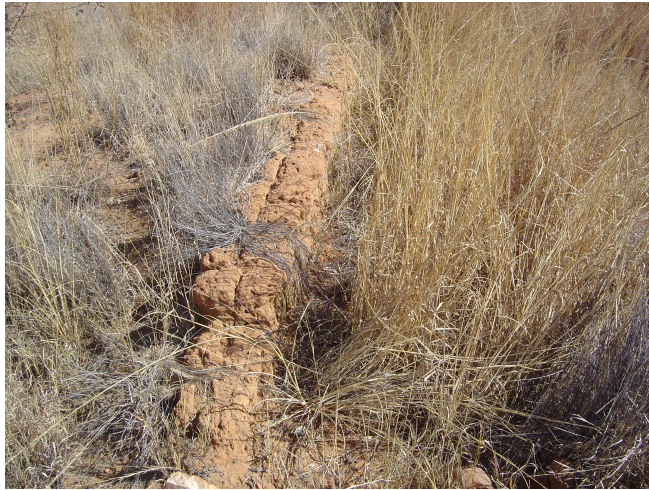
No. 5. Remains of foundation of farm workers house

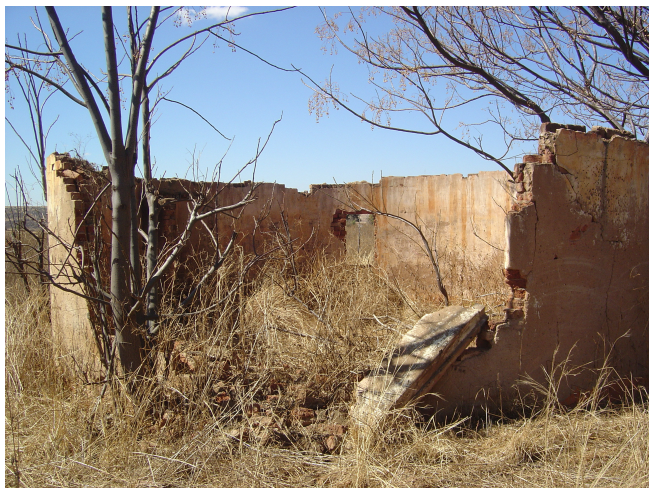
- Ruin of rondavel. The ruin of a brick and cement built rondavel was found at S25° 39' 31.9" and E28° 33' 08.6" (see photograph 6).

No. 6. Remains of rondavel
