Application to KwaZulu-Natal AMAFA & Research Institute  
for the Demolition of existing buildings  
at 23/25 HIGHLANDS ROAD, Hillcrest  
on Erf 2909, Hillcrest

May 2022

FRANK REITZ ARCHITECT

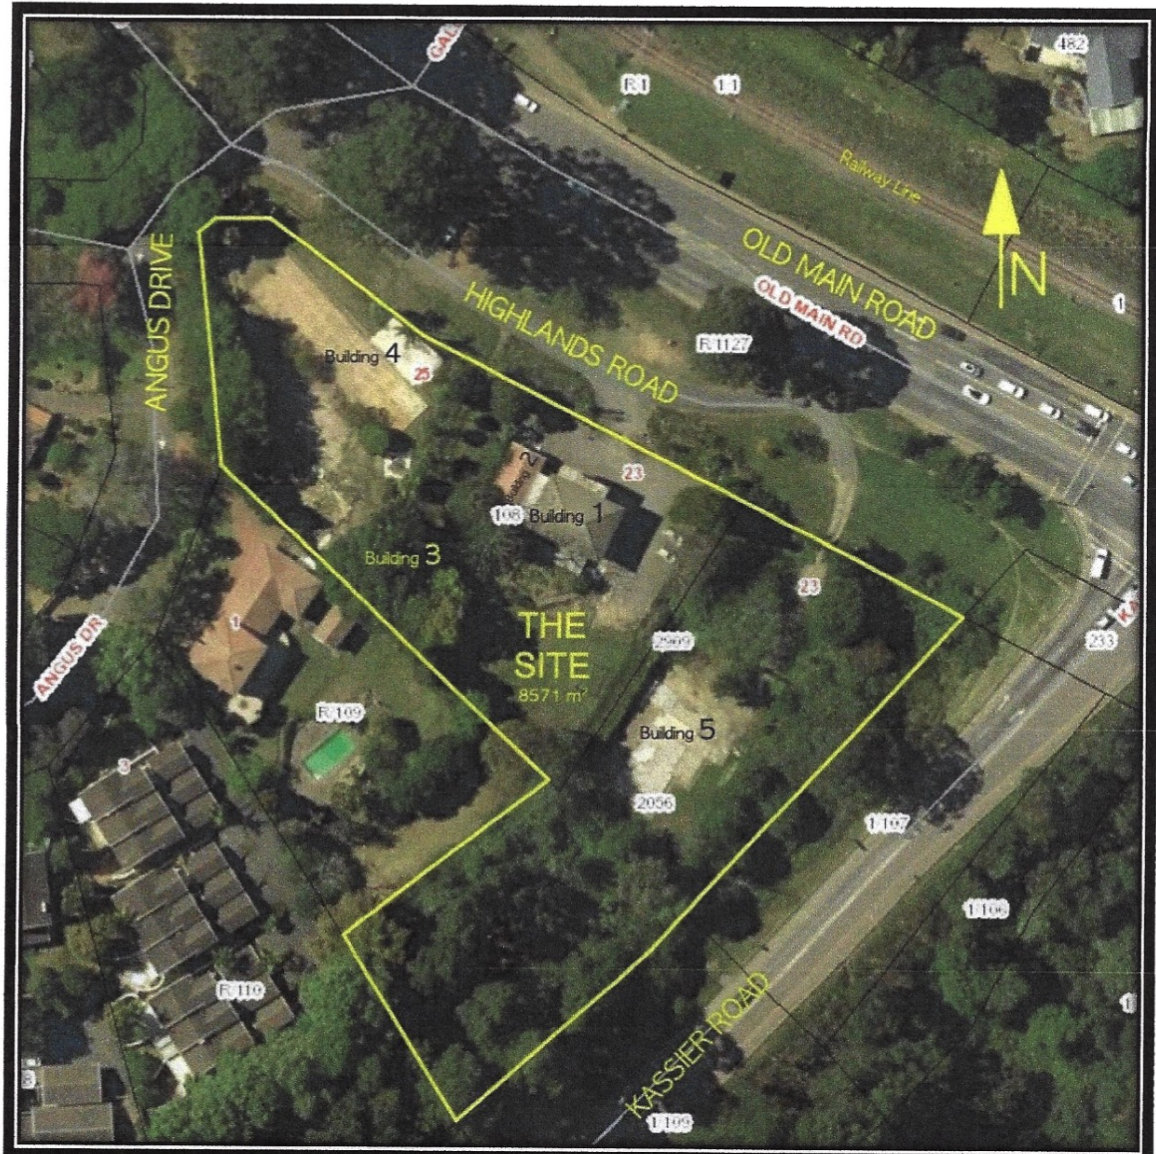
## SITE PLAN

### Original Construction date of buildings

Building 1 –	1955	Over 60 years, not listed	Demolition application
Building 2 –	1955	Over 60 years, not listed	Demolition application
Building 3 –	1955	Over 60 years, not listed	Demolition application
Building 4 –	1993	Not protected	Demolished
Building 5 –	1968	Not protected	Demolished a number of year ago

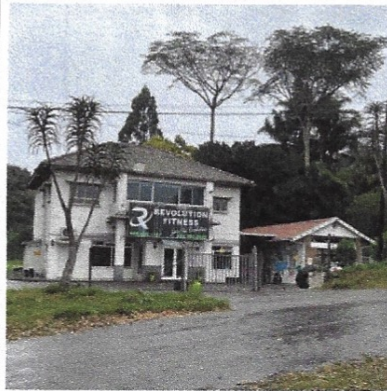
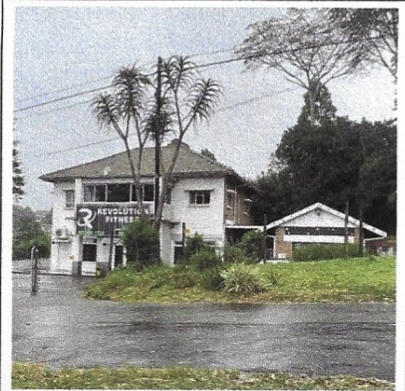
Highlands Road  
Street Elevation /  
North - West Elevation

Building 1 –	Building is structurally sound but has many material changes. <ul style="list-style-type: none"> <li>• Tile roof has been painted.</li> <li>• Face brick walls been painted on main facades.</li> <li>• Upper veranda enclosed.</li> <li>• Lower entrance portico enclosed.</li> <li>• Original timber windows replaced with steel windows.</li> <li>• Change of use - Interior walls gutted to create a gym.</li> </ul>
Building 2 –	Fair condition
Building 3 –	Very poor condition. Derelict. No windows or doors.
Building 4 –	Demolished
Building 5 –	Demolished

- Simple building in form and design.
- Not enough detail to label this building of been of a specific architectural style.
- Extended lintols are a interesting modernist detail but execution is poor and is not a strong Architectural feature or statement.
- This building is of little Architectural Significance.
- The internal alterations further reduces this building's Significance.

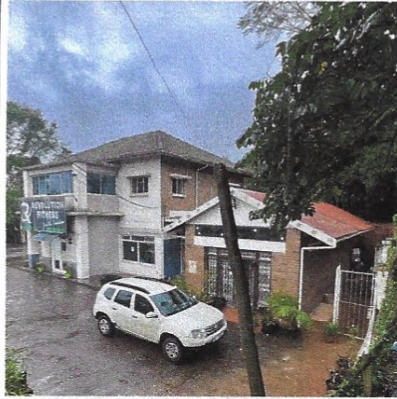
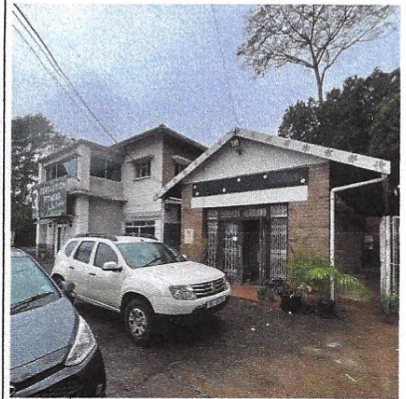
BUILDING 2 (out-building)  
North - West Elevation

- Simple out-building.
- This building has no Architectural Significance.

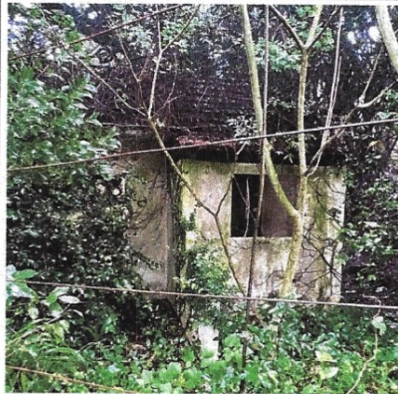
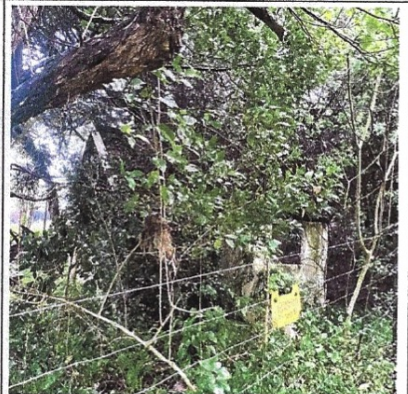
BUILDING 3 (out-building)  
North Elevation

- Small, simple staff quarters building.
- Very poor condition.
- This building has little Architectural Significance.
