**HERITAGE SURVEY FOR THE PROPOSED HILLCOVE
HOUSING DEVELOPMENT, PIETERMARITZBURG**

FOR LAURUSCO DEVELOPMENTS (PTY) LTD

DATE: 27 SEPTEMBER 2011

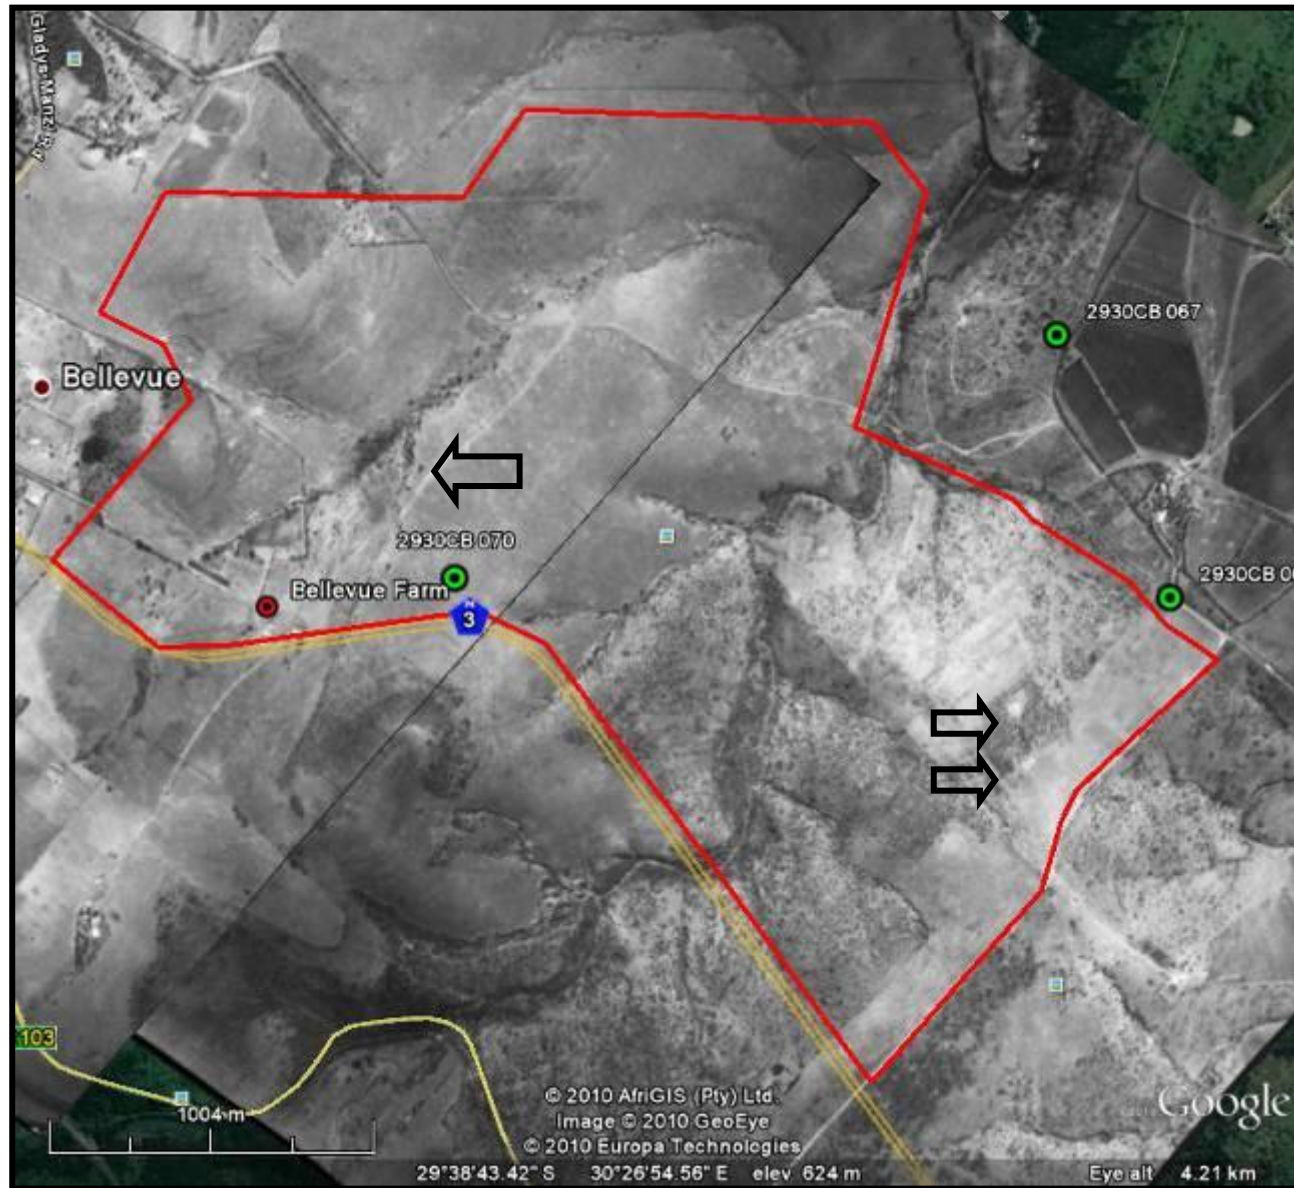
FIG. 4: 1937 AERIAL PHOTOGRAPH OF THE AFFECTED AREA⁴

⁴ Yellow arrows indicate labourer's houses

The desktop study of the 1968 topographical map and 1937 aerial photographs show that Bellevue farm, and the labourers' houses were in existence by 1937 (fig.'s 3 – 4). These are all still visible on the current Google Earth maps. This implies that many of the buildings predate 1937, and are thus protected by the KZN Heritage Act of 2008. Furthermore, there is a possibility that graves may exist near the farm labourers' houses. The report by Anderson and Whitelaw (1998) did not note these labourers' houses as the aerial maps were not available at that time.

There are also two areas that have potential human graves. Figures 3 – 4 indicate that labourers’ houses existed in the affected area before 1937. Graves of that age would be closer to the surface, or even sunken. The second survey did not observed any graves. I suggest that these two areas are noted as being sensitive during the development, and if any human remains are observed, then it is reported to KZN Heritage.

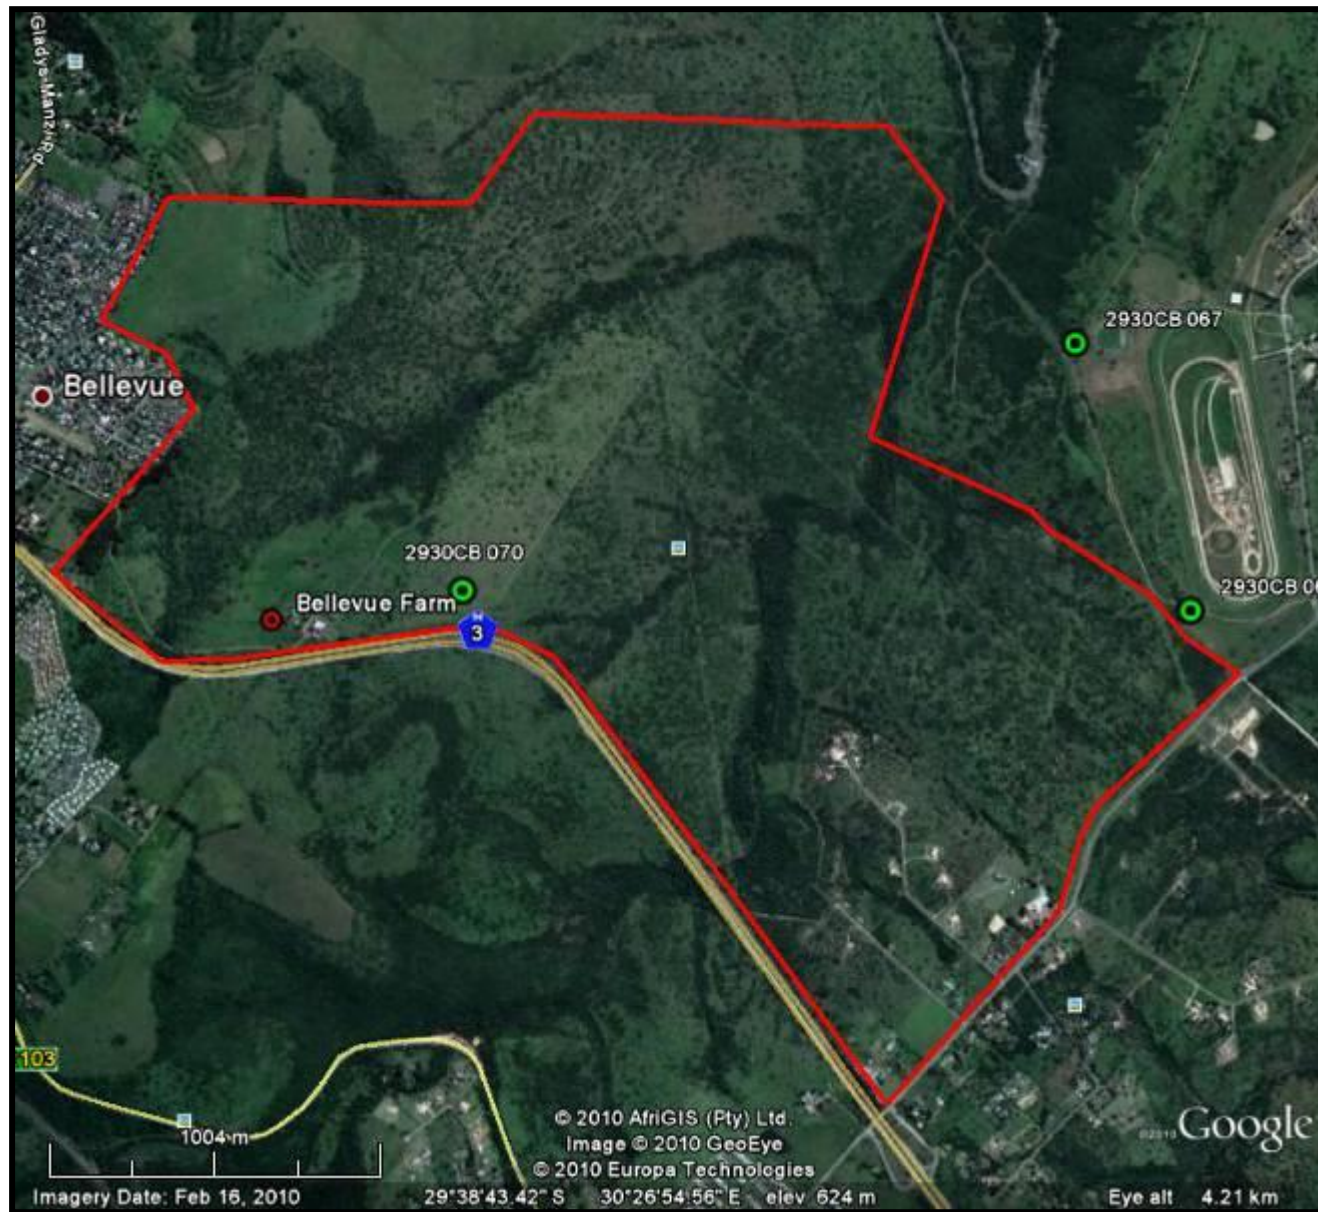
FIG. 5: LOCATION OF HERITAGE SITES IN THE AFFECTED AREA

Three archaeological sites have been recorded in the general area; however one of these occur in the affected area and one may extend into the affected area. This is shown in Figure 5.

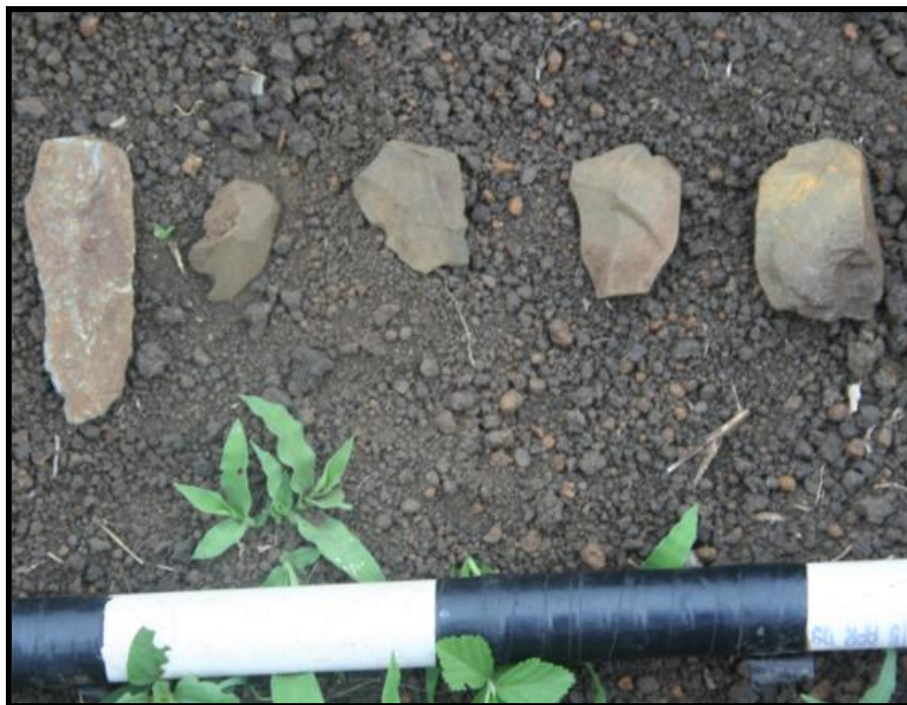
FIG. 6: SOME TOOLS ASSOCIATED WITH 2930CB066

The main part of the site occurs outside of the affected area; however, it probably extends into the development zone. The site occurs on a hill with a gentle slope that has been flattened by the Ashburton Race Track. The site consists of an extended scatter of Middle Stone Age flakes over a 300m area and merges with the MSA component of 2930CB 067. That is, the site extends over the entire hill. Due to the race track, Ashburton House, and various roads, as well as the age of the site. I believe that most of the artefacts are in a secondary context. The site has been further affected by the NMPPP line (Anderson and Anderson2012), where permission was granted for the site to be damaged. The tools were ephemeral in number and consists of: a few flakes with(out) utilisation, irregular cores, and one unifacial point (fig. 6).

Significance: The site is of low significance

Mitigation: No further mitigation is required as most of the site has already been destroyed.

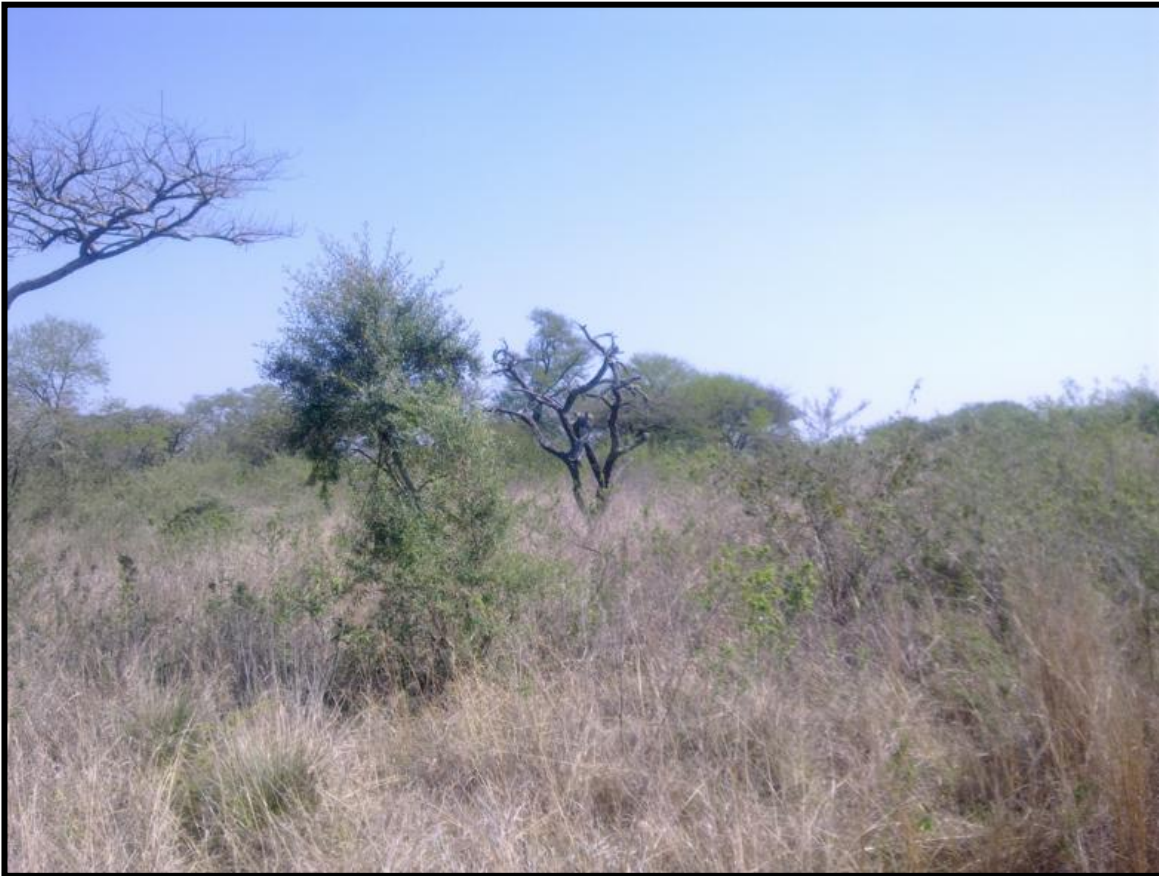
FIG. 7: DENSE VEGETATION AT THE SOUTHEASTERN PART OF THE STUDY AREA

The two remaining sensitive areas (in the northwest and southeast) should be revisited after vegetation clearance. The vegetation is currently too dense to make an accurate assessment. It is unlikely that the two areas would have highly significant sites, as these would have been previously recorded in other surveys. If any material is observed, then it can be sampled, or excavated, without hindering the development.

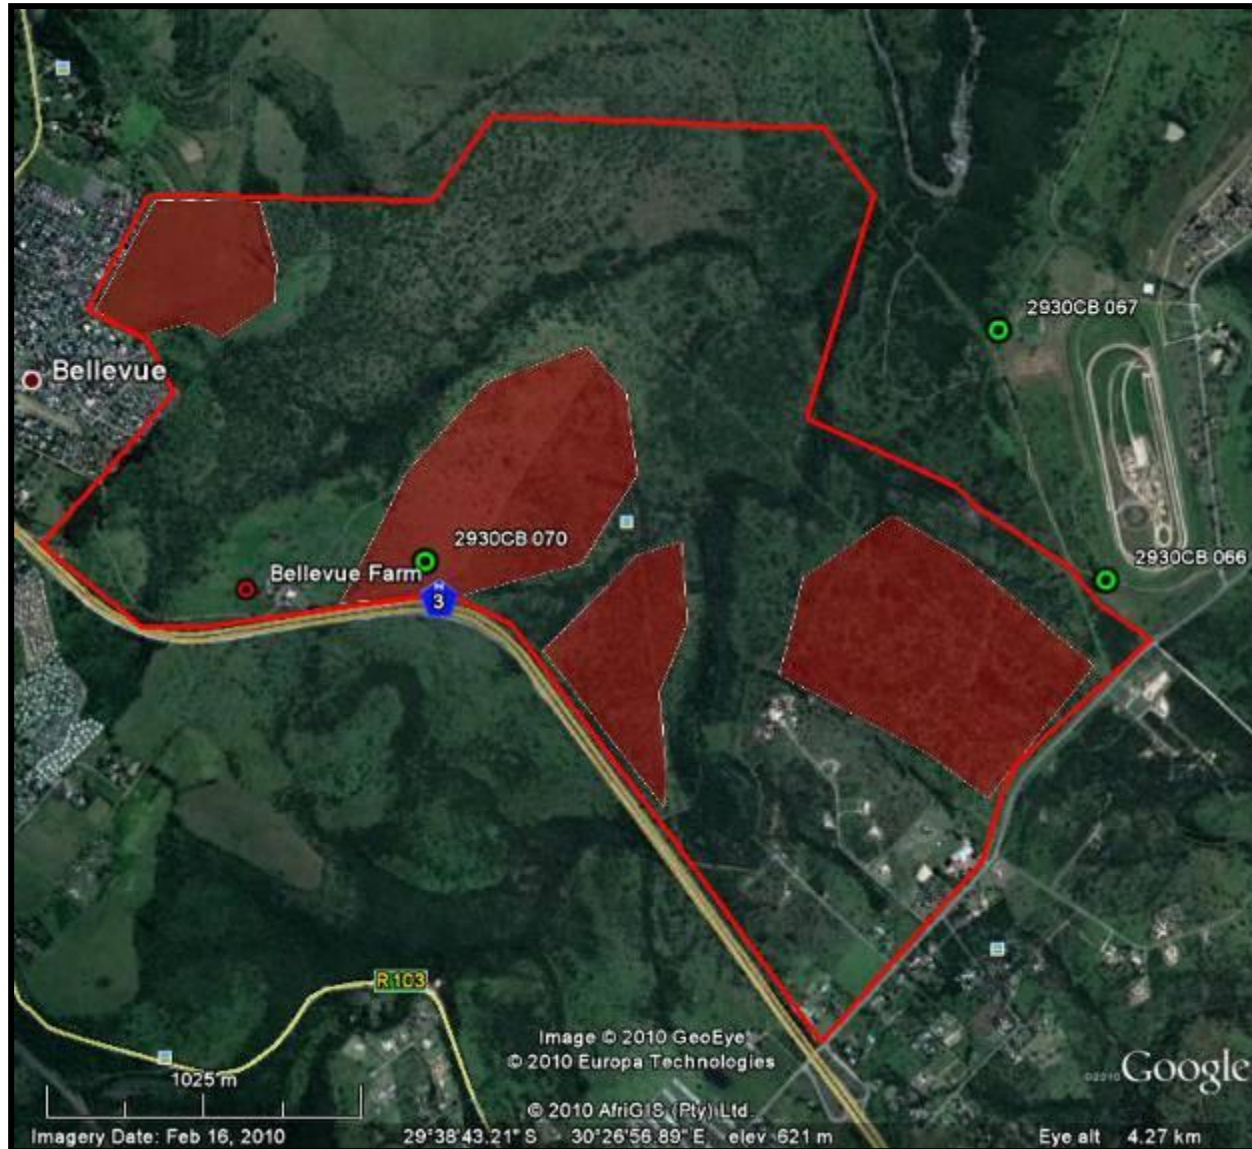
FIG. 8: LOCATION OF SENSITIVE AREAS IN THE AFFECTED AREA⁵

These sensitive areas are illustrated in figure 8.

⁵ Shaded red = sensitive areas

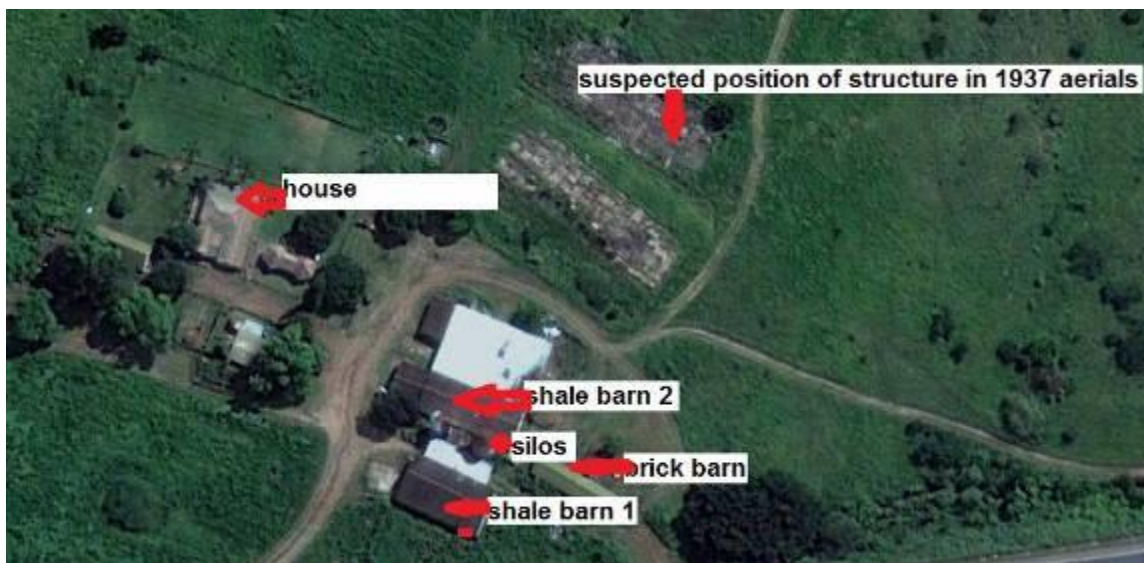
Fig 1: Site layout showing buildings of concern

Fig 1 above shows the site layout and the structures of concern. It is related to Fig 2 below, in that the latter is the aerial photograph from 1937 showing the farmstead as it stood then.

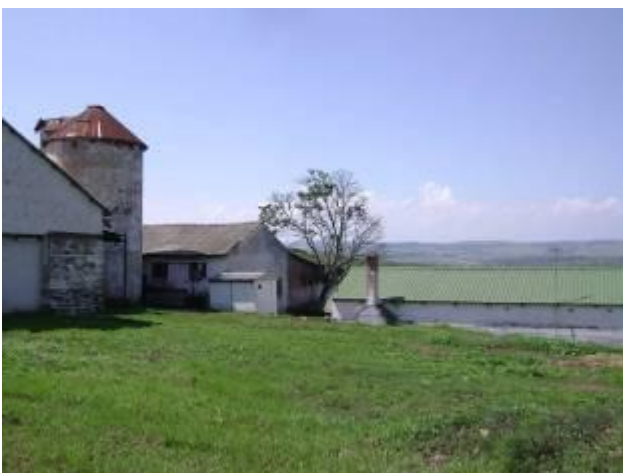
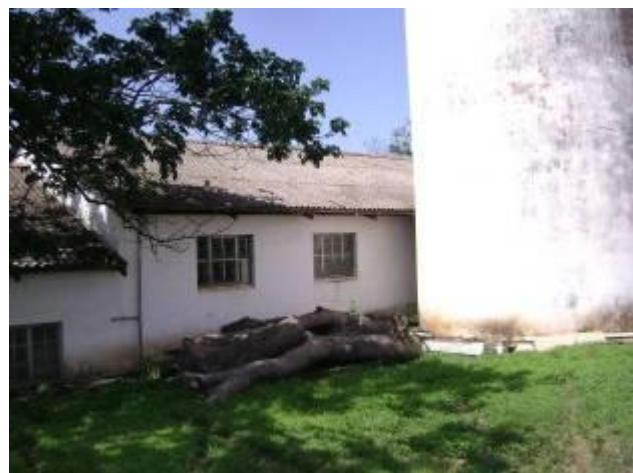
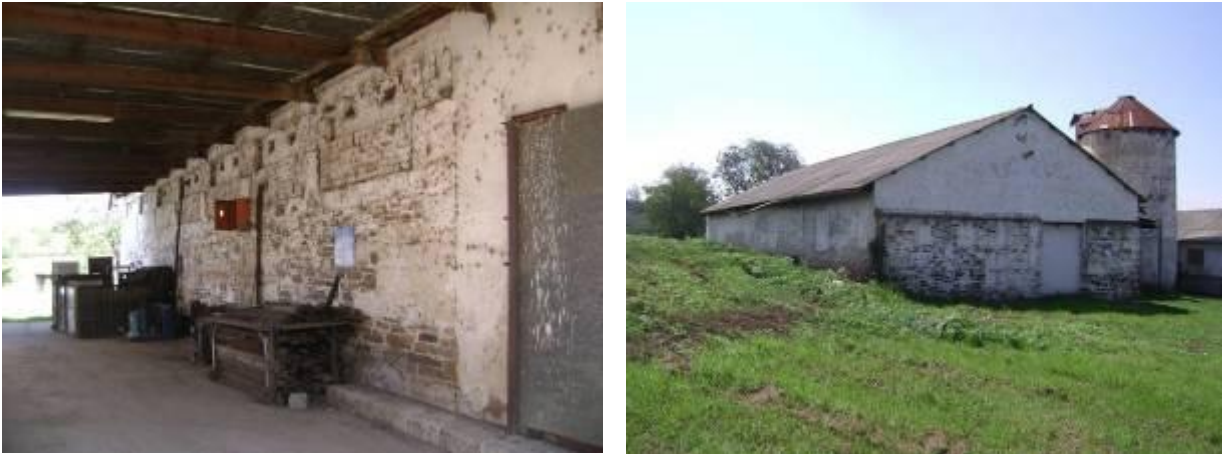
Both of the barns are of mixed, though largely shale construction, which situates them as vernacular buildings located any time between the middle years of the 19th century and 1937 when they are present on the photographs. Barn no 2 has been extended more recently to the north-west. The roof sheeting is old, and there is little diagnostic marking on the underside of the sheeting. However, the space between the barns was roofed in times that are more recent. Apertures below wall-plate level have been filled in with brick at some time.

In addition, an important feature of the site is the two silos. They form part of the architectural massing of the barns and create a tophophilia on the site. For travellers along the N3, this farmstead is characterised by the barns and the silos, and forms a landmark along the road.

Figs 5 and 6: Showing grouping of silos, barns 1 and 2 and brick barn, and extended portion of barn no 1 with silo in foreground

Figs 5 and 6: The covered space between shale barns and Barn no 1 with a silo behind

RECOMMENDATIONS: Given the age and scale of the shale barns, it is recommended that these structures, together with the silos be reused in the new development. Since the brick barn is likely of an age, and part of an architectural grouping, its contribution to the topophilia of the site indicates that it too, should be retained and reused.

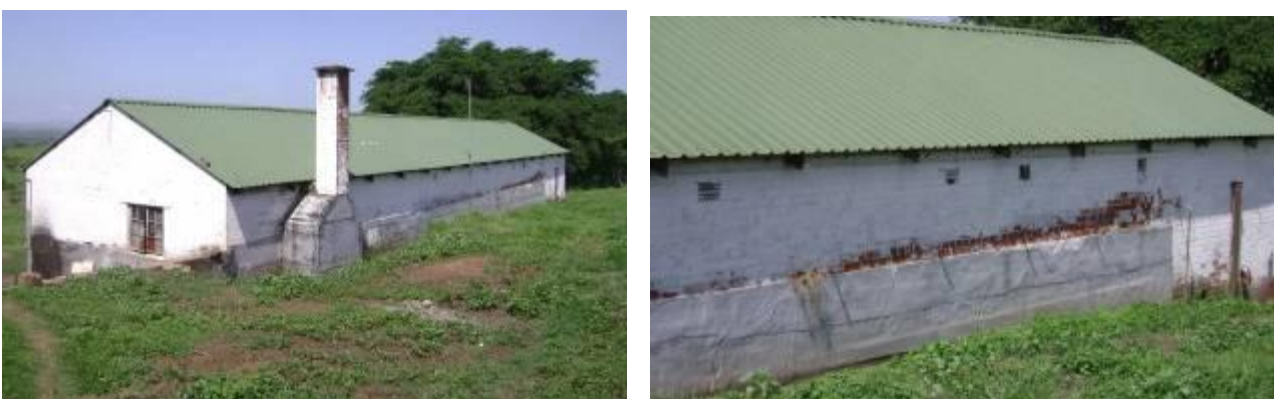
This structure is of painted brickwork in English bond under a corrugated sheeting roof. It is suspected that it dates to pre-1950. It forms part of a group together with the shale barns. It has certainly been extended to the north-west since its original construction.

Figs 7 and 8: Showing the old brick barn: the portion towards the trees is in English bond suggesting that this portion was pre- or immediately post- World War II.

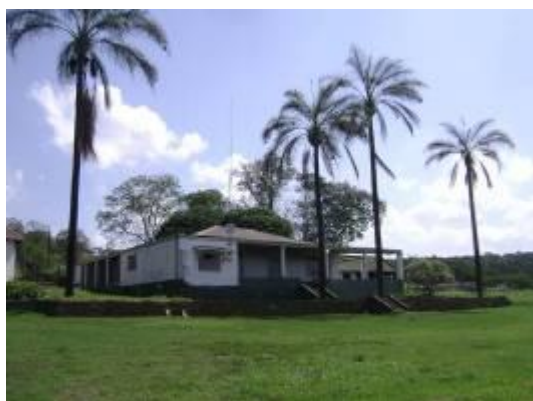
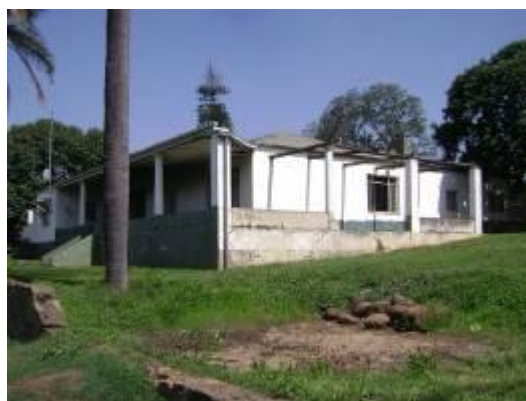
It is of conventional construction under a low-pitched corrugated sheeting roof. The windows are mainly stock steel items and there is little evidence of these being changed, suggesting that they are largely original windows. The floors are parquet, and the ceiling painted strip timber. There is an extensive veranda to the north and the west, which is a state of disrepair. Simple pre-cast Tuscan columns support the veranda roof.

The house does not feature on the 1937 aerial photograph. It is suspected that the Ferguson family could have constructed it in either 1943 or later in 1965. It is currently unoccupied and needs much work for full rehabilitation. It is removed from the group of barns and has little relation to them.

Figs 9 and 10: The main house at Bellevue from the northeast and from the north-west

RECOMMENDATIONS: Given the dislocation from the farmstead, the lack of association with buildings of landmark, and its minimal architectural, social or historical merit, it is suggested the demolition of this building could be considered an option.
